Wilderness Inventory Unit Index of Documents
Keeney Creek OR-034-035, 22 total pages

Year: 2008 **Unit Number/Name:** OR-034-035 -- Keeney Creek

FORM 2 -- DOCUMENTATION OF CURRENT WILDERNESS INVENTORY CONDITIONS

Wilderness Inventory Unit Name/Number: OR-034-035 – Keeney Creek

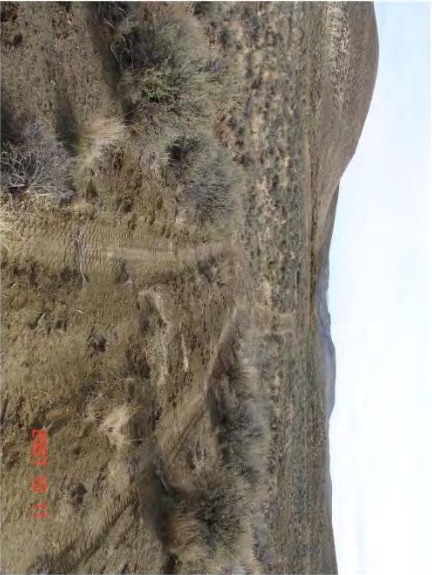
034-RT27-D-E.JPG

PHOTO LOCATION *	DIRECTION	PHOTO TYPE	PHOTO DATE	COMMENTS
034-RT27-A	W	Route	20071011	start of route 034-RT27
034-RT27-B	W	Route	20071011	cut & fill - signs of maintenance
034-RT27-C	W	Route	20071011	unmaintained crossing
034-RT27-D	E	Route	20071011	trail - signs of recent use
034-RT27-E	W	Route	20071011	changed route from use
034-RT27-F	E	Route	20071011	changed route from use
034-RT27-F	N	Route	20071011	intersection with unmapped spur
034-RT27-F	S	Route	20071011	intersection with unmapped spur
034-RT27-F	NE	Route	20071011	intersection with unmapped spur
034-RT27-G	E	Route	20071011	intersection near Lower Slim & Fatty Reservoir
034-RT27-G	S	Route	20071011	intersection near Lower Slim & Fatty Reservoir
034-RT27-G	SE	Route	20071011	intersection near Lower Slim & Fatty Reservoir
034-RT27-G	N	Route	20071011	intersection near Lower Slim & Fatty Reservoir
034-RT27-G	N	Route	20081119	Trend plot access
034-RT27-G	NE	Route	20081119	Water bar

Describe: Date of construction is not known, although it existed in the late 1970's when BLM conducted its initial wilderness characteristics inventory. Remnant visual evidence of only one short (about 300 feet) cut/fill, likely done for access during reservoir construction more than 40 years ago. Otherwise, route's presence is dominated by the result of repeated use of traveling vehicles. There is one segment of re-routing for approximately 300 feet where the original route washed on a grade (photo point 034-RT27-E, alias photos 9 and 10 for the 3-41A route references).
