Wilderness Inventory Unit Index of Documents  
**Lower Cow Lake OR-036-052, 22 total pages**

Year: 2011 Unit Number/Name: OR-036-052 – Lower Cow Lake

## **FORM 2 -- DOCUMENTATION OF CURRENT WILDERNESS INVENTORY CONDITIONS**

**APPENDIX C – ROAD\* ANALYSIS**

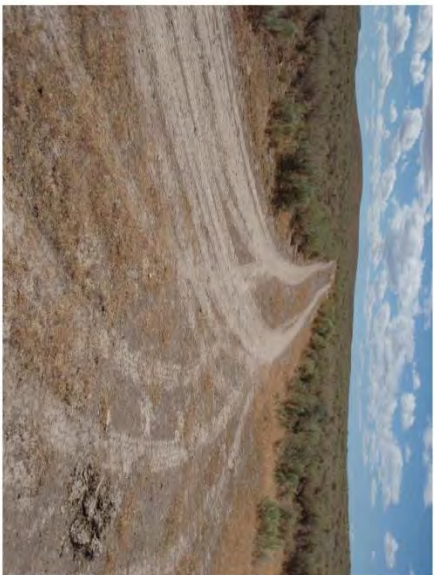
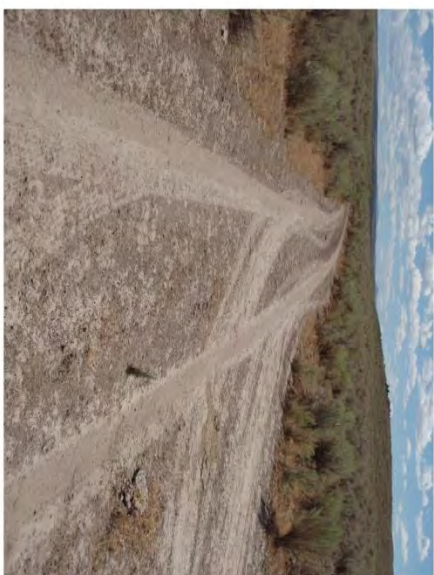
036-RT5-B-SW.JPG

BLM has conducted maintenance to BLM Road 036-RT5 over time as needed to keep this route passable. Earthen berms and drainage ditches on the edge of the road in photographs 036-RT5-set B and E-W show maintenance work that has been performed on BLM Road 036-RT5 in the past since the road was constructed. Although it has been many years since maintenance has been performed on the entire length of BLM Road 036-RT5, it is evident from photographs BLM has taken, that little to no maintenance is needed to keep the roadbed in good operational condition.

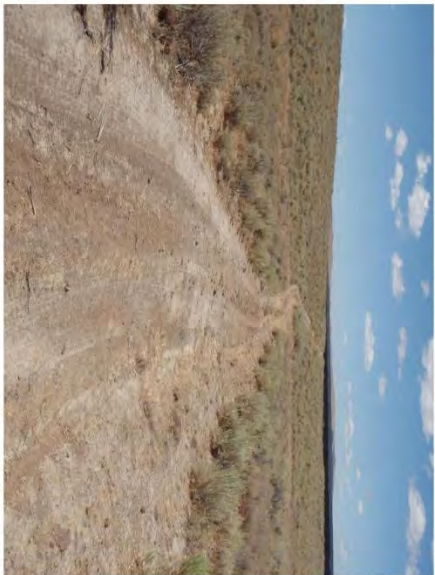
036-RT5-E-W.JPG

Existing roadside berms are not particularly pronounced in some segments of BLM Road 036-RT5, especially in areas where the roadway travels over small hill tops (BLM photos 036-RT5-C-NE and 036-RT5-E-E) or in relatively flat topography (BLM photos 036-RT5-A-NW and 036-RT5-B-SE) since these areas require little maintenance to remain passable by vehicles. In other areas along BLM Road 036-RT5 some of the berms are covered with brush as well as sediment filling in the some of the remaining depth of ditches (BLM photo 036-RT5-E-W).

**Describe:** A few sections of BLM Road 036-RT5 (BLM photo 036-RT5-E-W) contain ditches along the roadbed to drain water from the road and are usually part of the original construction. Therefore, the drainage ditches are considered an improvement even through many roads throughout the Vale District may not contain this feature.

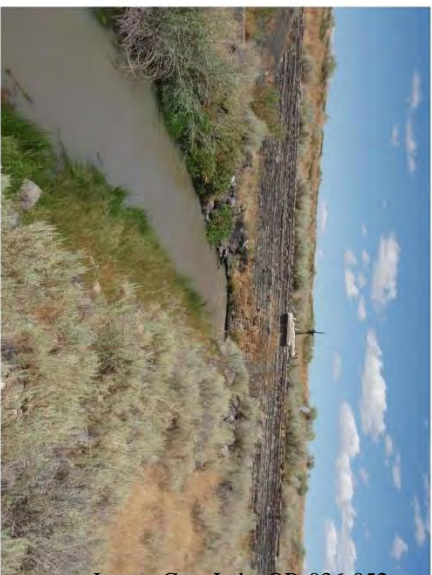
OR-036-052-F-N.JPG

BLM Road 036-RT5 photos 036-RT-A – 036-RT5-H (16 photos); photo OR-036-052-F-N (photo of dam outlet)

**Describe:** BLM Road 036-RT5 is utilized mainly for reservoir dam and outlet administration and maintenance by the local irrigation users on an annual basis and by ranchers and BLM staff for the administration of rangeland resources and livestock grazing. The road is also used on a seasonal basis during the summer all months by hunters and recreationist to access Lower Cow Lake. BLM Road 036-RT5 photographs 036- RT5-A– 036-RT5-H (16 photos) and photograph OR-
