Wilderness Inventory Unit Index of Documents
Lower Owyhee Contiguous OR-036-077, 36 total pages

Prepared by:
U.S. Department of the Interior
Bureau of Land Management
Vale District Office
100 Oregon Street
Vale, Oregon 97918

Year: 2011 Unit Number/Name: OR-036-077 – Lower Owyhee Contiguous

Unit Number/Name -- OR-036-077 – Lower Owyhee Contiguous

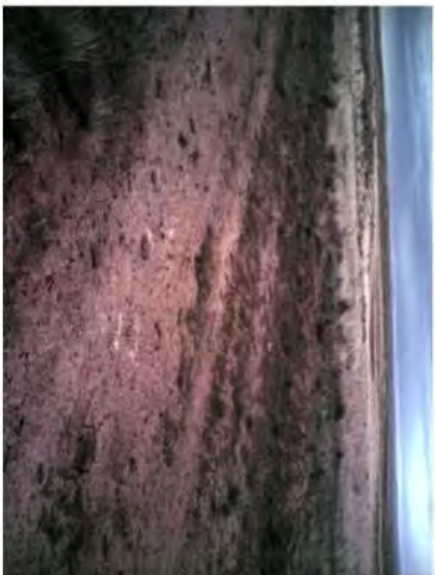
036-RT20-A-SE.jpg

BLM has conducted maintenance to BLM Road 036-RT20 over time as needed to keep this route passable. Earthen berms on the edge of the road in photographs 036-RT20-A-SE and D-S show maintenance work that has been performed on BLM Road 036-RT20 in the past since the road was constructed. Although it has been many years since maintenance has been performed on the entire length of BLM Road 036-RT20, it is evident from photographs BLM has taken, that little to no maintenance is needed to keep the roadbed in good operational condition.

BLM Road 036-RT20 receives annual use, as evidence by the lack of brush in the roadway and by well-used bare ground where vehicles travel. It should be noted that small amounts of brush occur sporadically throughout the length of the road along berms. Vale District has reduced road maintenance needs on roads to only the roadbed and does not blade originally constructed berms unless vegetation encroachment on berms tend to restrict vehicular travel or blade ditches unless drainage from roadways is impeded (as evident in photos 036-RT20-A-SE and D-S).

Comments: Although there is no recent (1-3 years) evidence of maintenance on BLM Road 036-RT20, BLM will approve maintenance with hand tools or machine as needed when road conditions warrant actions to keep it in a usable condition. Maintenance will be conducted in this road because it is a well-used loop route between and for accessing Lower Owyhee WSA and the Owyhee River Rim as well as access for ranchers and BLM staff for administration purposes.
