Wilderness Inventory Unit Index of Documents
Monuments OR-034-069, 30 total pages

Year: 2009 Unit Number/Name: OR-034-069 — Monuments

**FORM 1 -- DOCUMENTATION OF BLM WILDERNESS INVENTORY
FINDINGS ON RECORD**

FORM 2 -- DOCUMENTATION OF CURRENT WILDERNESS INVENTORY CONDITIONS

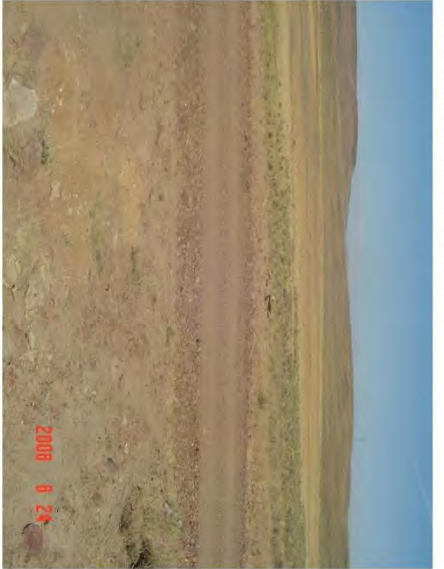
7324-0-0A0-A-NW.JPG

Comments: The route is not in good condition; rather, it is in poor condition. Although passable by a four-wheel drive vehicle (e.g., standard sized pickup truck or an all-terrain vehicle) -- due to the substantially near-flat terrain and nature of the natural materials on its travel surface -- the extent of vegetation encroachment at the route’s outer edge of travel surface and in its median indicates no maintenance has occurred. Given the nature of the terrain it traverses, in the event of required maintenance of the earthen reservoirs, the route would not need mechanical maintenance actions to provide access for the heavy equipment performing the task.

The extent of vegetation encroachment at the route’s outer edge of its travel surface and in its median indicates very infrequent use. Travel in relatively recent years appears likely to be limited to dispersed use such as vehicle-supported dispersed hunting activities. No tracks observed; any use is not on a relatively regular basis.

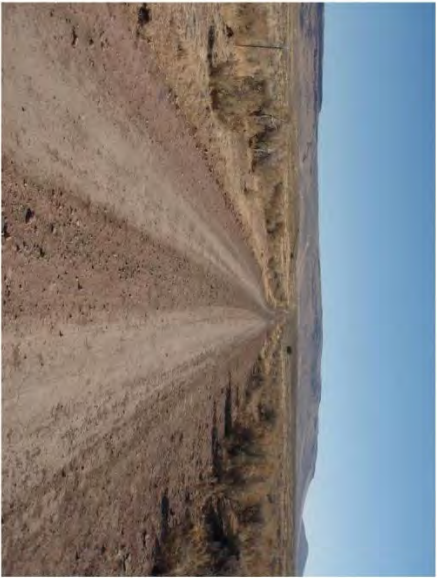
CNTY514-A-E.JPG

Describe: Serves as a recognized primary county route associated substantially with access to and through private lands of this larger area within which is this BLM inventory unit.

Describe: Date of construction is unknown. Obvious berms along the route -- some are fresh (without vegetation on them), while others with varying extent of vegetation re-growth associated with them. Berms with thick and woody vegetation may more so be associated with initial construction of the route, while fresher berms may more so be a result of maintenance activities since the route's development.

Explain: Obvious signs of blading and resultant berm located within the outer width of the route's disturbed surface area

Comments: The route is in excellent condition, and there is evidence of recent blading. As a county primary access route, maintenance would continue to occur to provide for regular and continuous use over time.

Obvious signs of ongoing, repeated travel on a well maintained route.

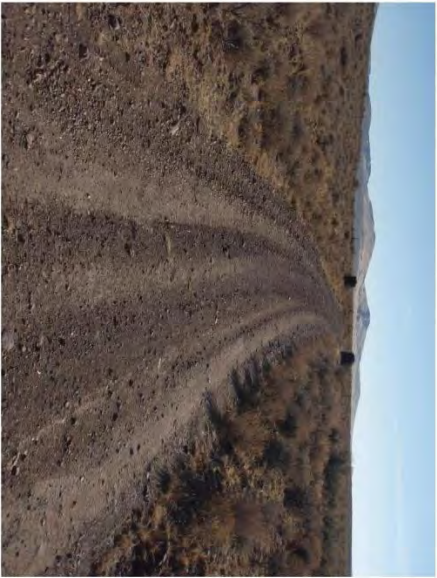
CNTY576-A-SE.JPG

Describe: Serves as a recognized primary county route associated substantially with access to and through private lands of this larger area within which is this BLM inventory unit.

XI. CONSTRUCTIONYes X No _____Examples: Paved _____ Bladed X Graveled _____ Roadside
Berms X Cut/Fill _____ Other _____**Describe:** Date of construction is unknown. Berms are evident, with vegetation (e.g., sagebrush and grasses) growing on them. It is not distinguishable whether the berms are a result of route construction or of route maintenance since the route's original construction.**XII. IMPROVEMENTS**Yes _____ No X
