Wilderness Inventory Unit Index of Documents  
**Northeast Lake Ridge OR-034-003, 28 total pages**

Year: 2010 Unit Number/Name: OR-034-003 — Northeast Lake Ridge

**FORM 1 -- DOCUMENTATION OF BLM WILDERNESS INVENTORY  
FINDINGS ON RECORD**

## **FORM 2 -- DOCUMENTATION OF CURRENT WILDERNESS INVENTORY CONDITIONS**

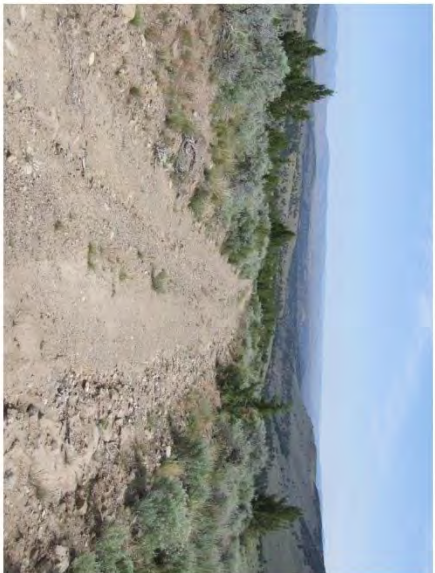
034-RT67-A-N.JPG

7352-00-Z	NW	Route	20090623	Berm.
7352-00-Z	SE	Route	20090623	Berm.
034-RT67-A	N	Route	20090625	Double berm s.
034-RT67-A	S	Route	20090625	Double berms.
034-RT67-B	NE	Route	20090625	Side cut.
034-RT67-B	SW	Route	20090625	Side cut.
034-RT67-C	NE	Route	20090625	Double berms.
034-RT67-C	SW	Route	20090625	Double berms.
034-RT67-D	N	Route	20090625	Side cut. Berm.
034-RT67-D	S	Route	20090625	Back
034-RT67-E	N	Route	20090625	Berms.
034-RT67-E	S	Route	20090625	Berms.
034-RT67-F	N	Route	20090625	Double berms.
034-RT67-F	S	Route	20090625	Double berms.
034-RT67-G	NW	Route	20090625	Berms.
034-RT67-G	SE	Route	20090625	Berms.
034-RT67-H	NE	Route	20090625	Berms.
034-RT67-H	SW	Route	20090625	Berms.
034-RT67-J	NE	Route	20090625	Side cut. Berms.
034-RT67-J	SW	Route	20090625	Berms.
034-RT67-J	N	Route	20090625	Fence and gate - Sunshine Ln. street sign.
034-RT67-J	S	Route	20090625	Berms.
034-RT84-A	N	Route	7/22/09	Small berm. Slight sidecut.

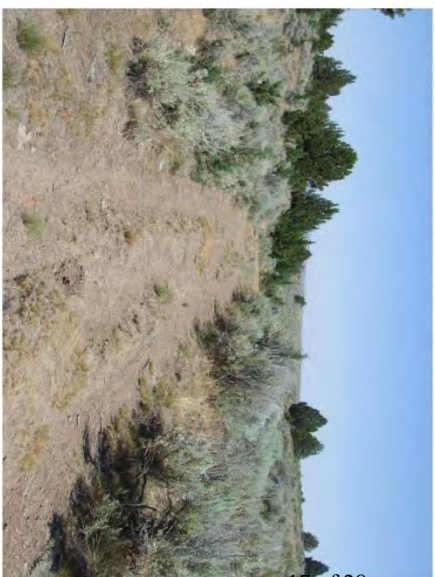
034-RT81-A-N.JPG

034-RT82-D	NE	Route	7/22/09	Slight side cut.
034-RT82-D	SW	Route	7/22/09	Slight side cut.
034-RT81-A	S	Route	7/22/09	Side cut.
034-RT81-A	N	Route	7/22/09	Back.
034-RT81-B	S	Route	7/22/09	No evidence of construction or maintenance.
034-RT81-B	N	Route	7/22/09	No evidence of construction or maintenance.
034-RT81-C	S	Route	7/22/09	Fence and gate.
034-RT81-C	N	Route	7/22/09	Side cut.

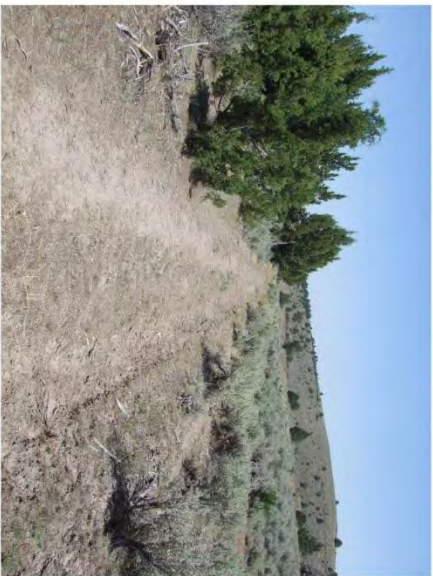
034-RT82-C-NE.JPG

034-RT83-D	SW	Route	7/22/09	No evidence of construction or maintenance.
034-RT83-D	NE	Route	7/22/09	No evidence of construction or maintenance.
034-RT83-E	SW	Route	7/22/09	Gate and fence.
034-RT83-E	NE	Route	7/22/09	No evidence of construction or maintenance.
034-RT83-F	SW	Route	7/22/09	No evidence of construction or maintenance.
034-RT83-F	NE	Route	7/22/09	No evidence of construction or maintenance.
034-RT83-G	S	Route	7/22/09	End of route. No evidence of construction or maintenance.
034-RT83-G	N	Route	7/22/09	No evidence of construction or maintenance.
034-RT82-A	NE	Route	7/22/09	No evidence of construction or maintenance.
034-RT82-A	SW	Route	7/22/09	Rough route. No evidence of construction or maintenance.
034-RT82-B	NE	Route	7/22/09	No evidence of construction or maintenance.
034-RT82-B	SW	Route	7/22/09	No evidence of construction or maintenance.
034-RT82-C	NE	Route	7/22/09	Small berms.
034-RT82-C	SW	Route	7/22/09	Small berms.

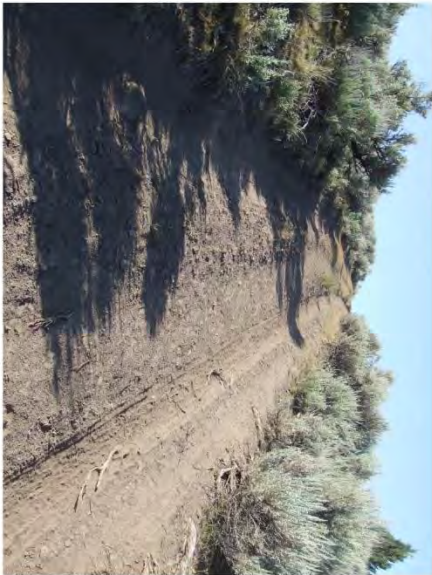
034-RT84-A-S.JPG

034-RT84-A	S	Route	7/22/09	Small berm. Slight sidecut.
034-RT84-B	N	Route	7/22/09	Very slight side cut.
034-RT84-B	S	Route	7/22/09	Very slight side cut.
034-RT84-C	N	Route	7/22/09	No evidence of construction or maintenance. Cow trails only
034-RT84-C	S	Route	7/22/09	No evidence of construction or maintenance. Cow trails only
034-RT84-D	N	Route	7/22/09	Small berms.
034-RT84-D	S	Route	7/22/09	Small berms.
034-RT84-E	N	Route	7/22/09	Route ends at troughs.
034-RT84-E	S	Route	7/22/09	Route ends at troughs.
034-RT83-A	SW	Route	7/22/09	No evidence of construction or maintenance.
034-RT83-A	NE	Route	7/22/09	No evidence of construction or maintenance.
034-RT83-B	SW	Route	7/22/09	No evidence of construction or maintenance.
034-RT83-B	NE	Route	7/22/09	No evidence of construction or maintenance.
034-RT83-C	SW	Route	7/22/09	No evidence of construction or maintenance.
034-RT83-C	NE	Route	7/22/09	No evidence of construction or maintenance.

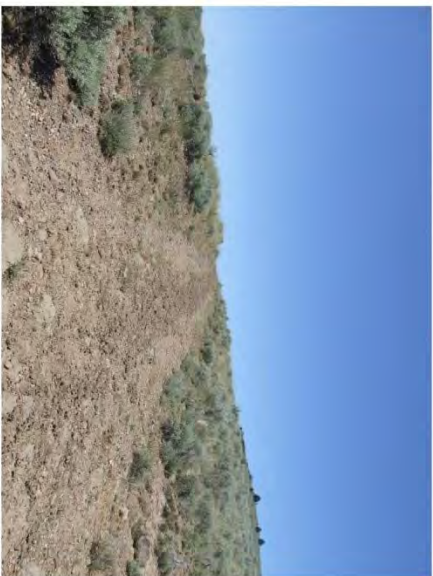
7352-00-P-NW.JPG

PHOTO_LOCATION*	DIRECTION	PHOTO_TYPE	PHOTO_DATE	COMMENTS
7352-00-O	N	Route	20090623	Side cut. Ditch.
7352-00-O	S	Route	20090623	Side cut.
7352-00-P	NW	Route	20090623	Small ditch. Berm.
7352-00-P	SE	Route	20090623	Small ditch. Berm.
7352-00-Q	N	Route	20090623	Side cut. Berm.
7352-00-Q	S	Route	20090623	Side cut. Berm.
7352-00-R	NW	Route	20090623	Large berm. Small ditch.
7352-00-R	SE	Route	20090623	Large berm. Small ditch.
7352-00-S	NW	Route	20090623	Large berms.
7352-00-S	SE	Route	20090623	Large berms.
7352-00-T	N	Route	20090623	Side cut.
7352-00-T	S	Route	20090623	Back
7352-00-U	N	Route	20090623	Creek crossing
7352-00-U	S	Route	20090623	Projects. Troughs.
7352-00-V	NW	Route	20090623	Side cut.
7352-00-V	SE	Route	20090623	Back.
7352-00-X	N	Route	20090623	Slight side cut.
7352-00-X	S	Route	20090623	Back
7352-00-Y	E	Route	20090623	Large berm. Side cut.
7352-00-Y	W	Route	20090623	Large berm. Large rocks moved off route.
