Wilderness Inventory Unit Index of Documents
River OR-034-106, 78 total pages

Year: 2012 Inventory Unit Number/Name: OR-034-106 – River

FORM 2 - DOCUMENTATION OF CURRENT WILDERNESS INVENTORY CONDITIONS

Unit Number/Name: OR-034-106 – River

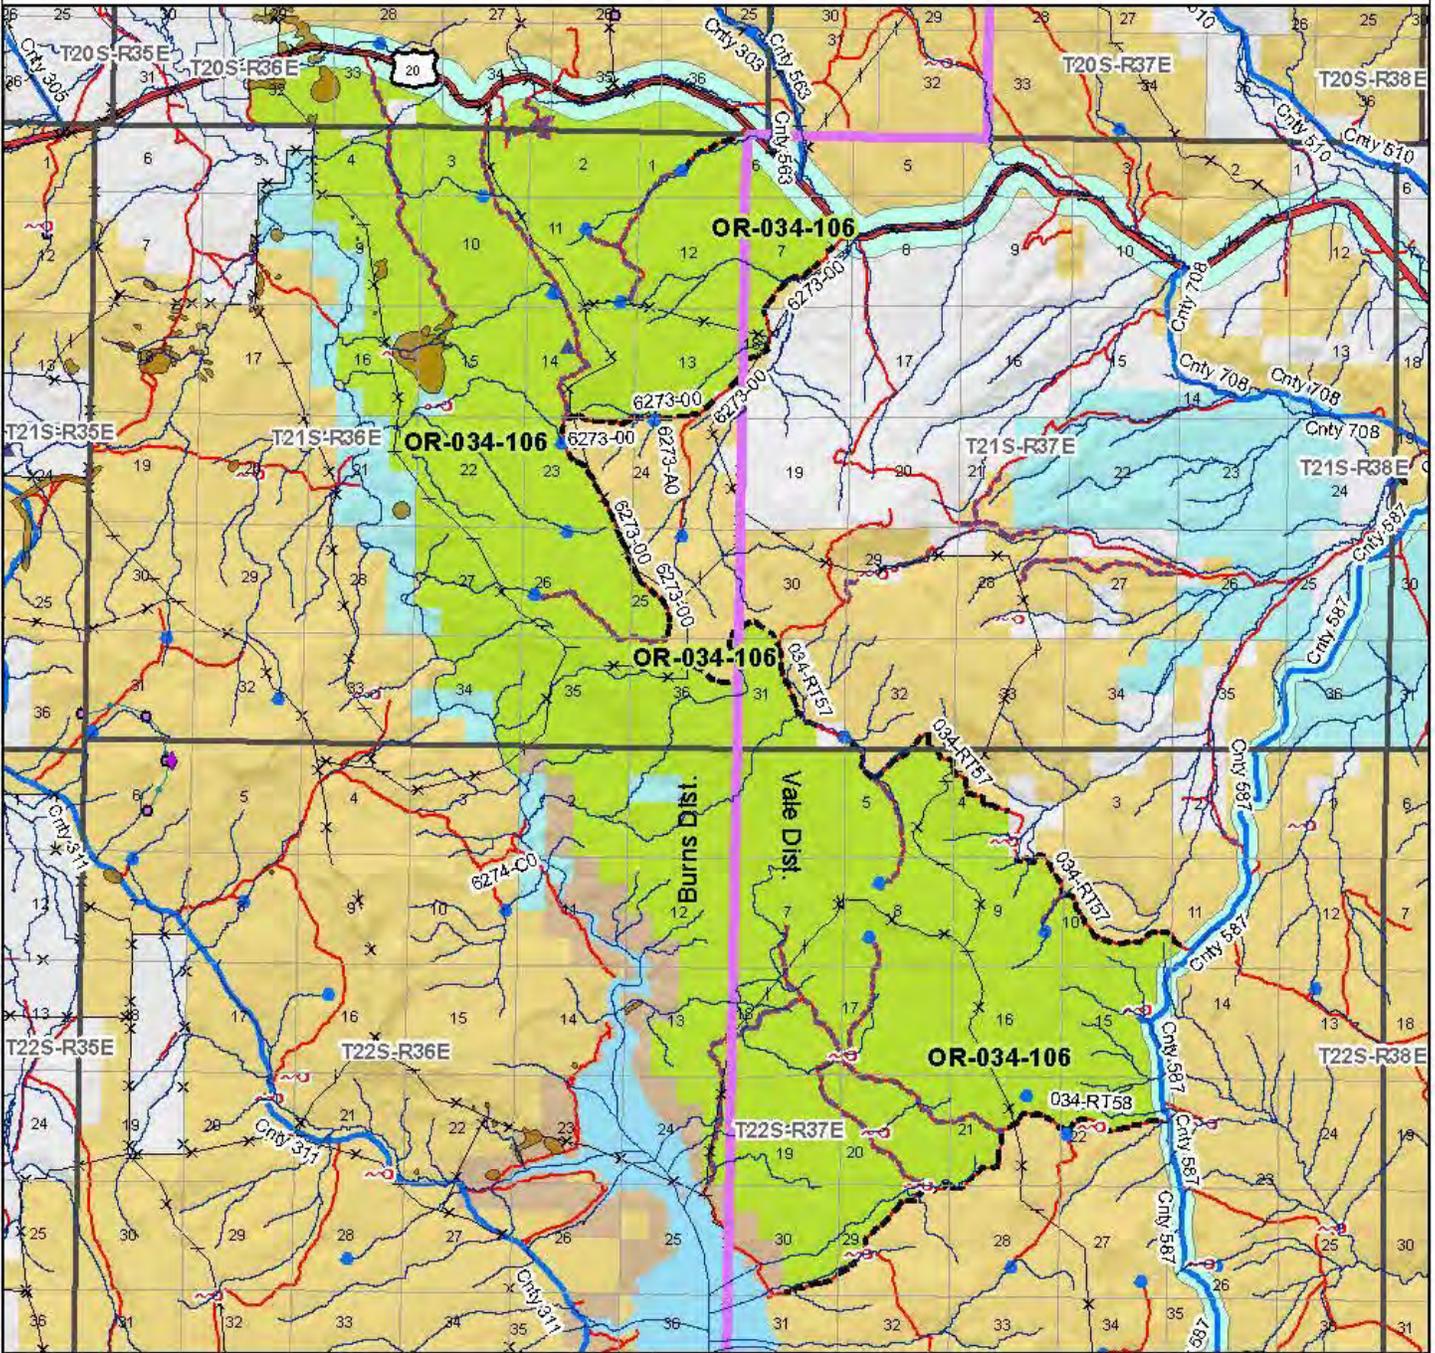
Wilderness Characteristics - Overview River - OR-034-106 - Map 1 of 2

Current Unit Boundaries: (Refer to Vale District’s BLM Map 1): The River unit consists of public land within both Vale District (9,343 acres) and Burns District (13,310 acres), for a sum total of 22,653 acres of contiguous public lands. The unit does meet wilderness characteristics size criteria.

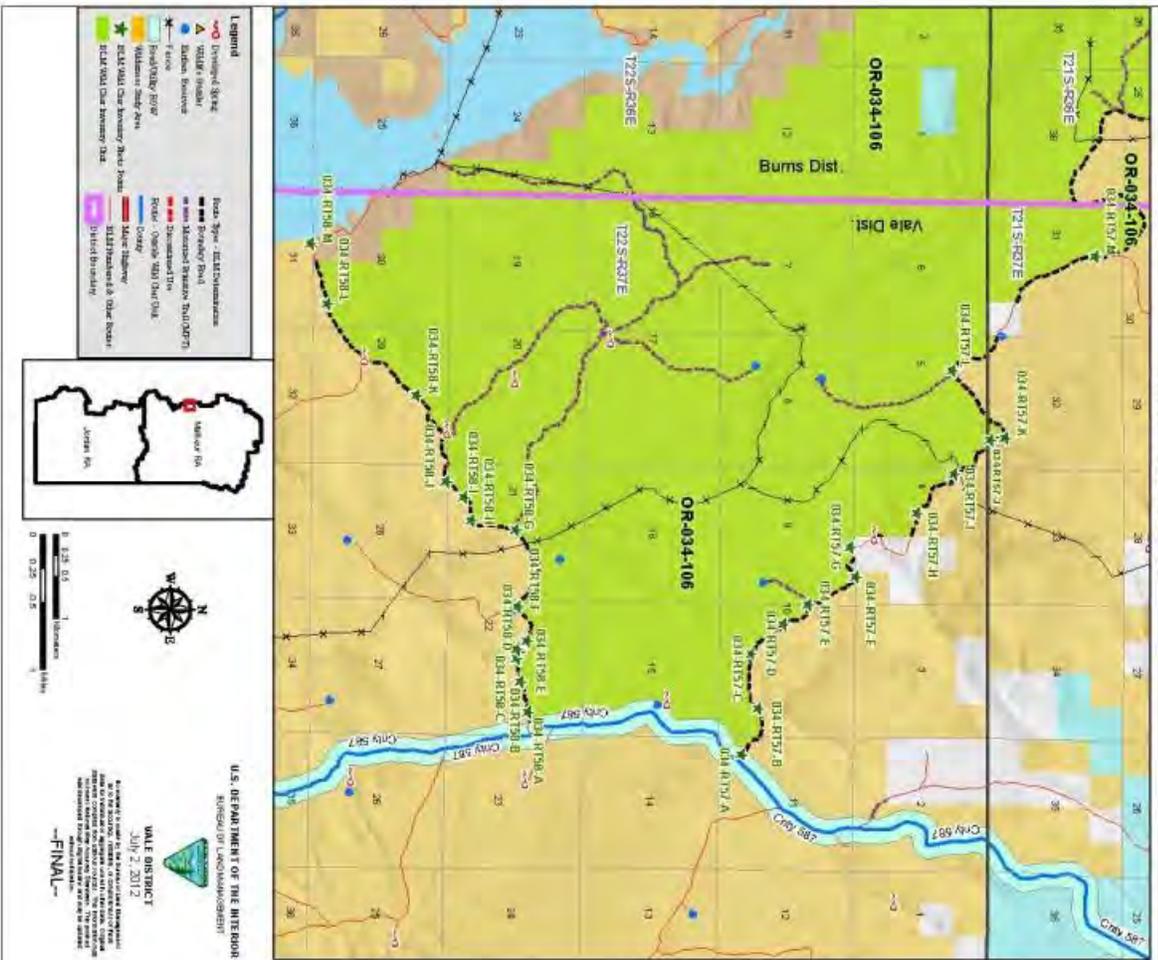
Wilderness Characteristics - Vale District BLM Photo Points
River - OR-034-106

PHOTO_LOCATION	DIRECTION	PHOTO_TYPE	PHOTO_DATE	COMMENTS
034-RT157-A	W	Route	20090407	Recent activity, berm, back.
034-RT157-A	E	Route	20090407	Recent activity, berm, front.
034-RT157-B	N	Route	20090407	Small berm, front.
034-RT157-B	S	Route	20090407	back.
034-RT157-C	E	Route	20090407	back.
034-RT157-C	W	Route	20090407	front.
034-RT157-D	SE	Route	20090407	Berm, back.
034-RT157-D	NW	Route	20090407	front.
034-RT157-E	E	Route	20090407	back.
034-RT157-E	W	Route	20090407	front.
034-RT157-F	W	Route	20090407	front.
034-RT157-F	E	Route	20090407	back.
034-RT157-G	SE	Route	20090407	Hill cut, front.
034-RT157-G	NW	Route	20090407	back.
034-RT157-H	E	Route	20090407	Berms, small ditch, back.
034-RT157-H	W	Route	20090407	Berms, small ditch, front.
034-RT157-I	E	Route	20090407	Berms, back.
034-RT157-I	W	Route	20090407	front.
034-RT157-J	SE	Route	20090407	back - berm present.
034-RT157-J	NW	Route	20090407	front - berm present.
