Wilderness Inventory Unit Index of Documents

Rocky Basin OR-02-017, 37 total pages

**FORM 2 - DOCUMENTATION OF CURRENT WILDERNESS INVENTORY
CONDITIONS**

Unit Number/Name: **2-17, Rocky Basin**

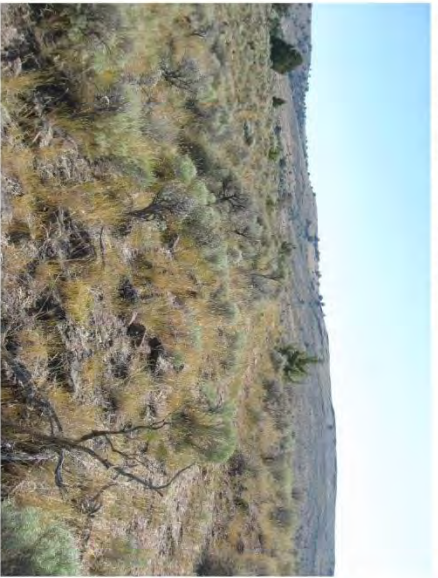
XG-22-74-N; Rd6263-0-AO; rocky berm; 7-28-09.jpg

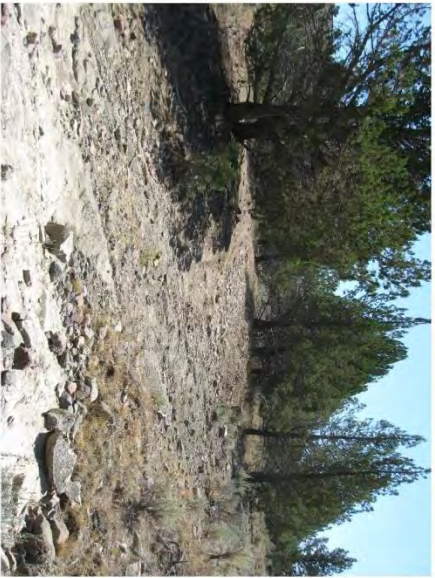
to the north and subunit E to the south is no longer a road and, the Beede Desert Road is now cherry-stemmed due to a washed-out section in Rocky Basin.

XG-24-79-S; rte around washout; Rd6263-0-AO; 7-28-09.jpg
