Wilderness Inventory Unit Index of Documents  
**Rye Grass OR-036-020, 32 total pages**

**Year:** 2011      **Unit Number/Name:** OR-036-020 -- Rye Grass

## **FORM 2 -- DOCUMENTATION OF CURRENT WILDERNESS INVENTORY CONDITIONS**

**Wilderness Inventory Unit Name/Number (UNIT\_ID): OR-036-020 --- Rye Grass**

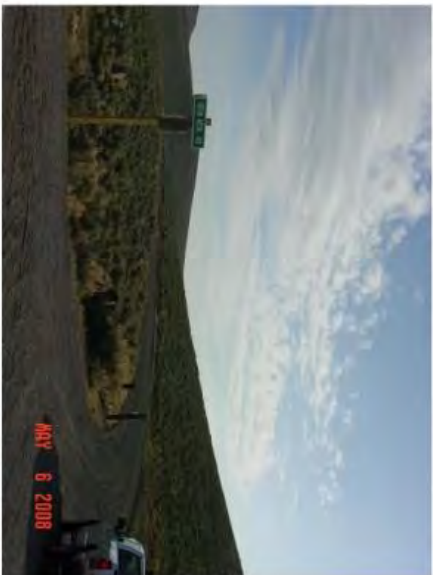
036-RT1-A-E.JPG

**Describe:** Road 036-RT1 is mostly an east-west oriented road that serves as a portion of the unit's north and western boundary with end points at the junction of State Highway 78 (buffered by the Utility Corridor) and a private land parcel in the SESE corner of section34, T29S, R38E. BLM Road 036-RT1 was at one time designated as Malheur County Road 602 during the mid-1970s. At some time during the mid-1980s Malheur County removed the route designation from this road. From the mid-1980s it is not clear whether the County or the BLM claims responsibility for this segment of road. During the decade from 2000-2010 this road segment received a gravel road base (presumably by Malheur County) and a new and shorter spur was developed as the main access point to and from State Highway 78. The entrance to this road from State Highway 78 is approximately ½ mile southeast of the historic point of access and has a new road sign in place indicating that the road is called Iron Mtn Road.

**Describe:** BLM Road 036-RT1 was constructed by heavy equipment many decades ago. No historic information as to when or by who is currently not available but in the mid-1970s this road was part of the Malheur County road system with a designation of County Road 602. Since the 1980s Malheur has dropped this road from its system and currently BLM does not have this road as part of its Transportation Plan. BLM communication with Malheur County is presently ongoing to determine responsibility of maintenance for this road. Recently (2000-2010) Road 036-RT1 has been bladed, contains roadside berms, and has received a gravel road base over its entire length (presumably by Malheur County). Refer to BLM photographs 036-RT1 A through C.

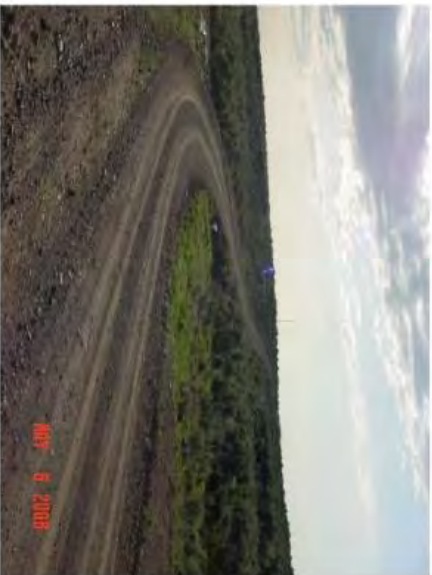
036-RT1-C-E.JPG

**Describe:** In addition to the gravel road base that BLM Road 036-RT1 has received sometime over the last 10 years a culvert that has been placed in the road at the location of BLM photograph 036-RT1-C looking eastward. Presumably Malheur County installed this culvert because BLM did not.
