Wilderness Inventory Unit Index of Documents  
**Three Fingers Rock North OR-034-056, 20 total pages**

Year: 2009 Unit Number/Name: OR-034-056 — Three Fingers Rock North

## **FORM 2 -- DOCUMENTATION OF CURRENT WILDERNESS INVENTORY CONDITIONS**

**Wilderness Inventory Unit Name/Number: 034-056 – Three Fingers Rock North**

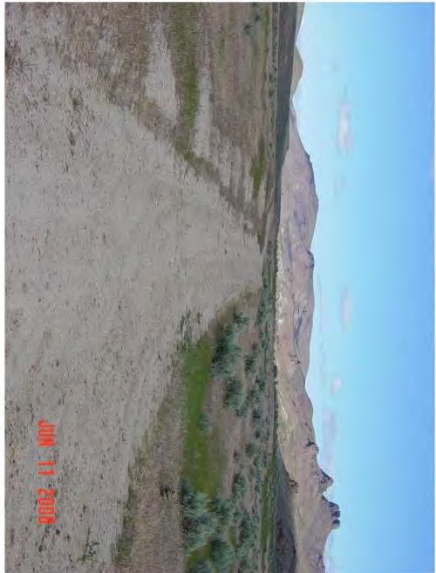
034-RT26-A-NW.JPG

PHOTO_LOCATION + DIRECTION	PHOTO_TYPE	PHOTO_DATE	COMMENTS
034-RT26-A SE	Route	20080611	No berm, evidence of maintenance, no hard veg.
034-RT26-A NW	Route	20080611	No berm, evidence of maintenance, no hard veg.
034-RT26-A N	Route	20080611	Veg in center of route, no evidence of maintenance.
034-RT26-B NW	Route	20080611	Berm, evidence of maintenance.
034-RT26-B SE	Route	20080611	Berm, evidence of maintenance.
034-RT26-D SE	Route	20080611	Berm present, some evidence of maintenance.
034-RT26-D NW	Route	20080611	Berm present, some evidence of maintenance.
034-RT26-D W	Route	20080611	Berm present, some evidence of maintenance.
034-RT26-F NE	Route	20080611	Berm with some vegetation present.
034-RT26-F SW	Route	20080611	Berm with some vegetation present.
034-RT26-H NE	Route	20080611	Berm, light vegetation, evidence of blading.
034-RT26-H SW	Route	20080611	Berm, some vegetation present.
034-RT26-J SE	Route	20080611	Evidence of blading, some vegetation present.

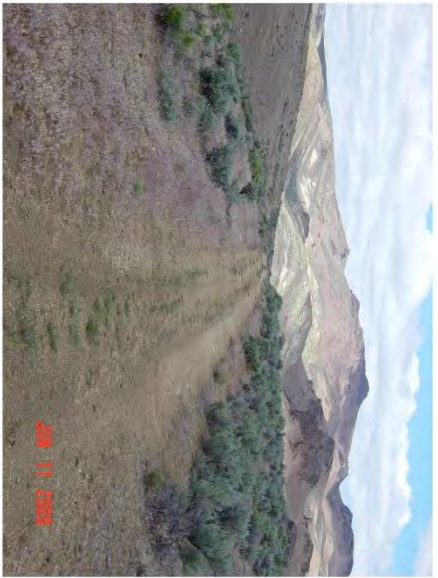
034-RT26-J-NW.JPG

034-RT26-J NW	Route	20080611	Evidence of blading, some vegetation present.
034-RT26-K N	Route	20080611	Berm, evidence of blading, light vegetation.
034-RT26-K SE	Route	20080611	Berm, evidence of blading, light vegetation.
034-RT26-L NE	Route	20080611	Light vegetation present.
034-RT26-L W	Route	20080611	Evidence of blading.
034-RT26-L S	Route	20080611	Evidence of blading.
