Wilderness Inventory Unit Index of Documents  
**Three Fingers Rock South OR-034-055, 20 total pages**

**Year:** 2009      **Unit Number/Name:** OR-034-055 -- Three Fingers Rock South

## **FORM 2 -- DOCUMENTATION OF CURRENT WILDERNESS INVENTORY CONDITIONS**

**APPENDIX C – ROAD\* ANALYSIS**

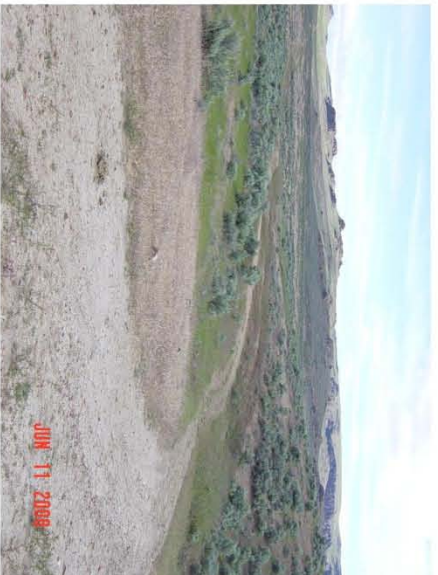
034-RT26-A-N.JPG

PHOTO_LOCATION*	DIRECTION	PHOTO_TYPE	PHOTO_DATE	COMMENTS
034-RT26-A	SE	Route	20080611	No berm, evidence of maintenance, no hard veg.
034-RT26-A	NW	Route	20080611	No berm, evidence of maintenance, no hard veg.
034-RT26-A	N	Route	20080611	Veg in center of route, no evidence of maintenance.
034-RT26-B	NW	Route	20080611	Berm, evidence of maintenance.
034-RT26-B	SE	Route	20080611	Berm, evidence of maintenance.
034-RT26-D	SE	Route	20080611	Berm present, some evidence of maintenance.
034-RT26-D	NW	Route	20080611	Berm present, some evidence of maintenance.
034-RT26-D	W	Route	20080611	Berm present, some evidence of maintenance.
034-RT26-F	NE	Route	20080611	Berm with some vegetation present.
034-RT26-F	SW	Route	20080611	Berm with some vegetation present.
034-RT26-H	NE	Route	20080611	Berm, light vegetation, evidence of blading.
034-RT26-H	SW	Route	20080611	Berm, some vegetation present.
034-RT26-J	SE	Route	20080611	Evidence of blading, some vegetation present.

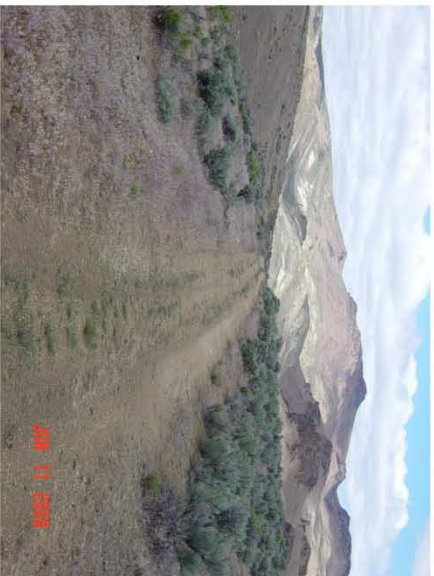
034-RT26-J-NW.JPG

034-RT26-J	NW	Route	20080611	Evidence of blading, some vegetation present.
034-RT26-K	N	Route	20080611	Berm, evidence of blading, light vegetation.
034-RT26-K	SE	Route	20080611	Berm, evidence of blading, light vegetation.
034-RT26-L	NE	Route	20080611	Light vegetation present.
034-RT26-L	W	Route	20080611	Evidence of blading.
034-RT26-L	S	Route	20080611	Evidence of blading.
