AQUATIC HABITAT MANAGEMENT PROGRAM

2019 UTAH ACCOMPLISHMENT REPORTING

The Dolores Berm Site Project

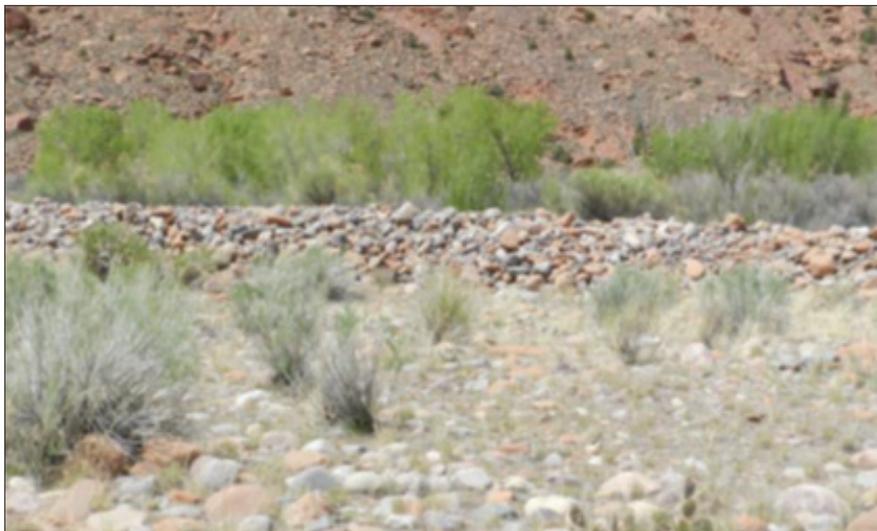
Figure 2 – Historic gravel/cobble berm.

This berm has persisted over the years dramatically changing the hydrology of the 38-acre site (Figure 3) and diminishing nursery habitat for native fish. Historically, the Dolores River would convey large flood discharges in the spring, with a high discharge of 17,000 cfs measured in the 1970's. In the 1980's, McPhee Dam was constructed upstream in the watershed, significantly reducing historical peak flood flows.

The Environmental Assessment for the berm removal was part of a larger project effort lead by the BLM Grand Junction Field Office in collaboration with the Moab Field Office Hydrology staff. In February 2019, a portion of the gravel/cobble berm was successfully removed at the upstream end using heavy equipment over the course of 4 days. Peak 2019 flows (~5,000-6,000 cfs) reestablished hydrologic connectivity of the historic channel, floodplain, and wetland habitat at the contemporary bankfull discharge, for the first time in 50-60 years (Figures 4 and 5). This marks the beginning of periodic inundation of this area which transitions from a lotic system to a lentic pond as flows recede.

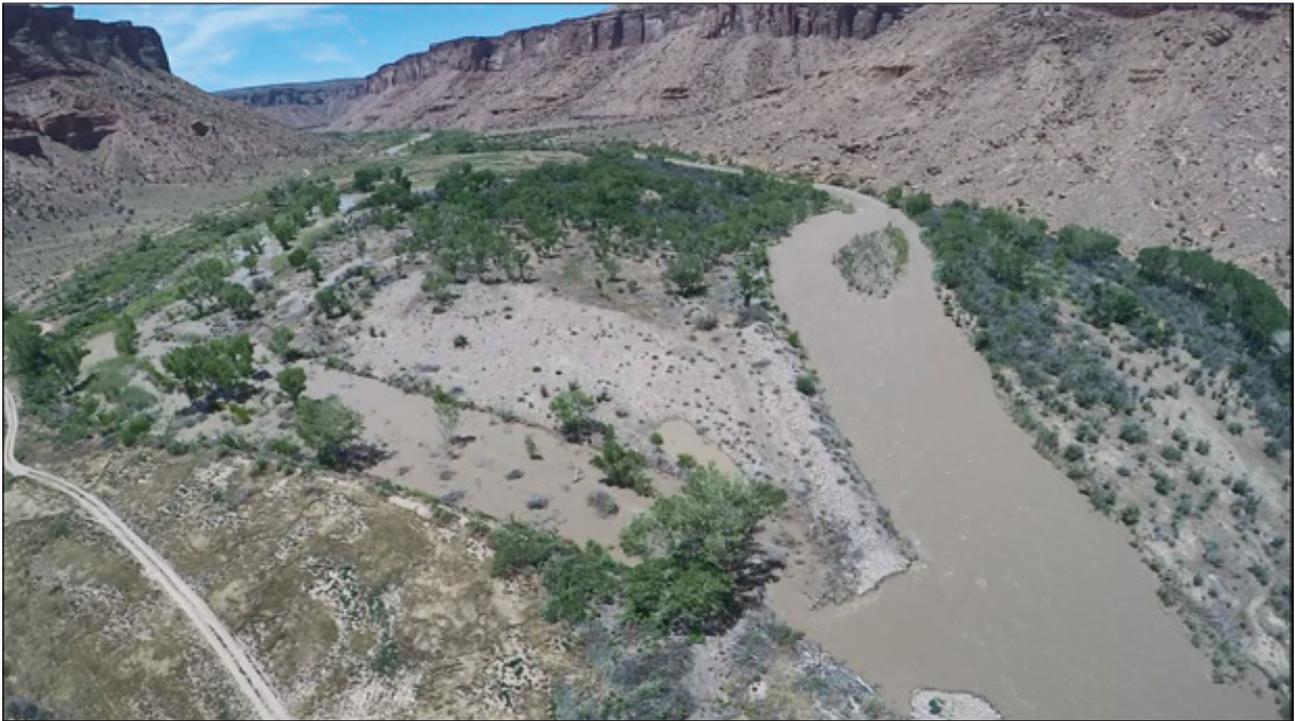
Figure 4. Inundation on June 17, 2019 at ~5400 cfs at upstream berm removal area.

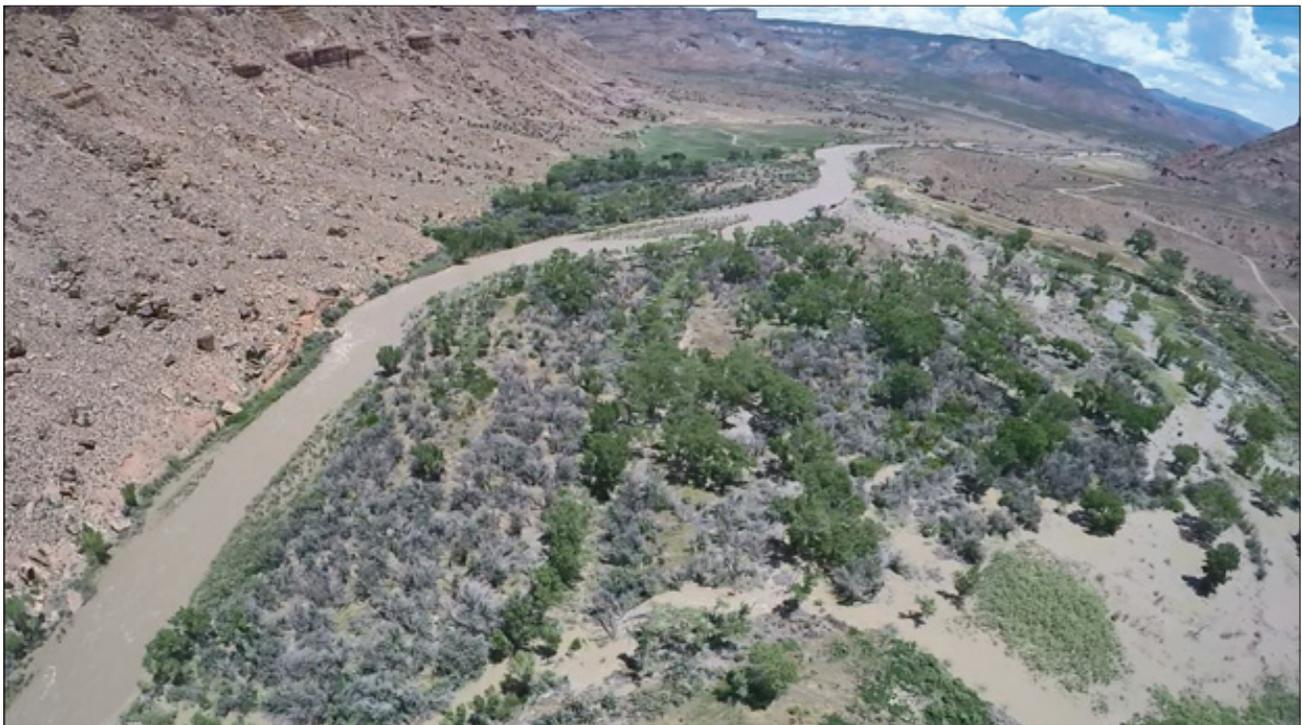
Figure 5. Inundation on June 17, 2019 at ~5400 cfs at downstream end looking upstream.

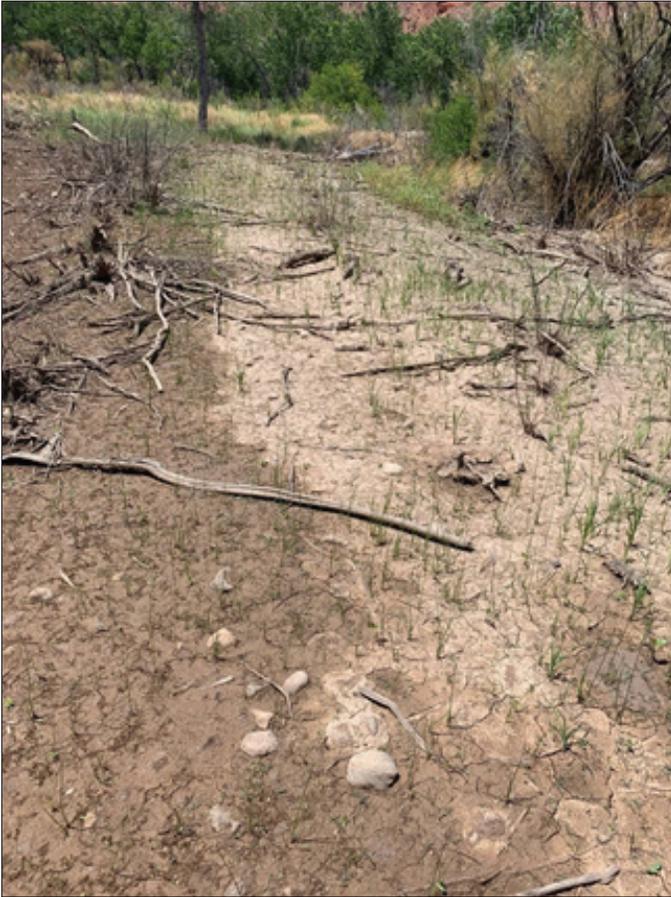
water cycling, plant and animal production and hydrologic connectivity. Sedges, rushes, and cottonwood seedlings have begun to colonize the site (Figures 6 and 7). The perennial wetland area was inundated by surface waters (Figure 8). Fine sediments are being removed at the downstream-end exposing cobble and gravel channel substrates improving aquatic habitat for macroinvertebrates and fish (Figure 9).

Figure 6. New sedge and rush colonization.

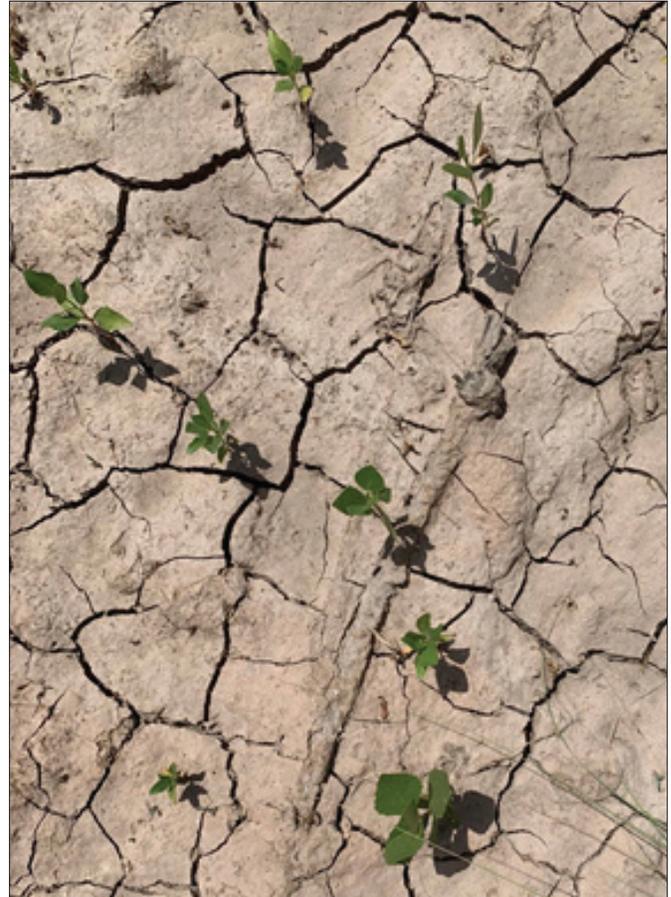
Figure 7. New cottonwood seedlings.

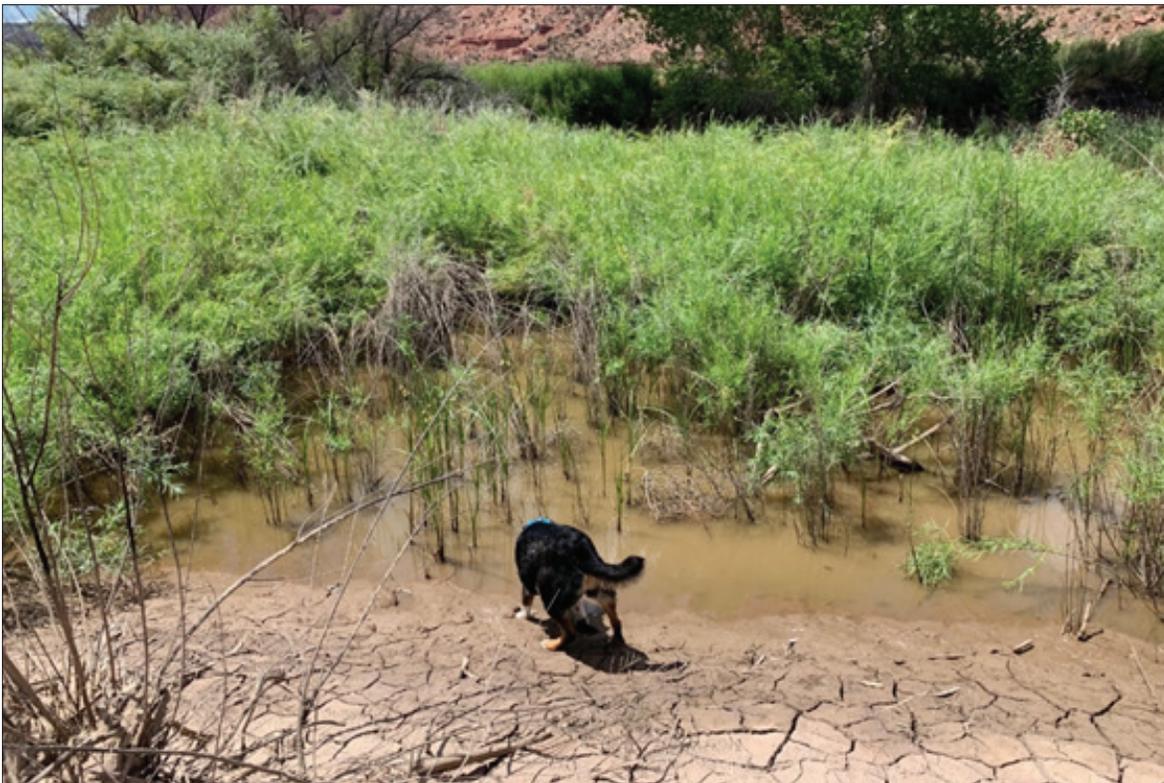
Figure 8. Inundated wetland area resulting from reestablishment of hydrologic connectivity.

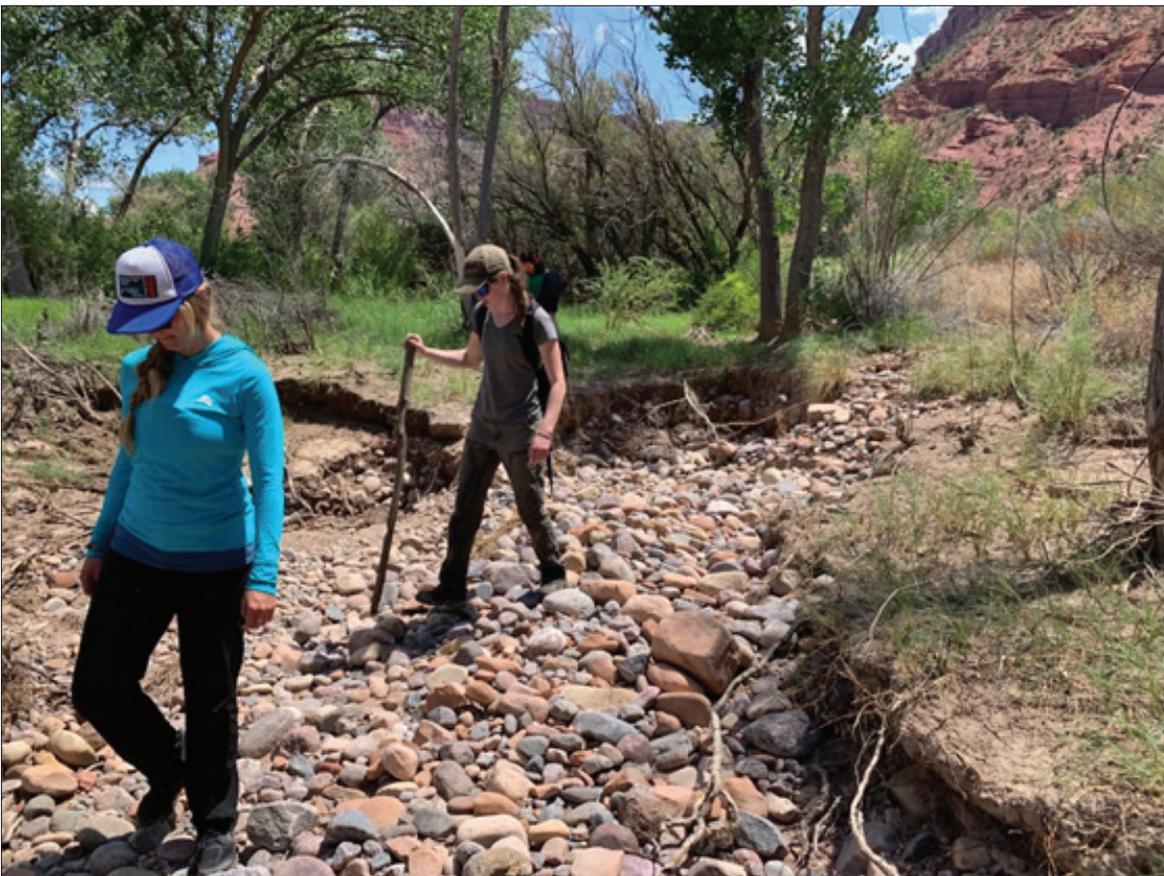
Figure 9. Cleaning fine sediments and exposing gravel and cobble substrates noticed during WRI project planning site visit with partners from the Western Conservation Corps, Canyon Country Youth Corps, and the Dolores River Restoration Partnership.

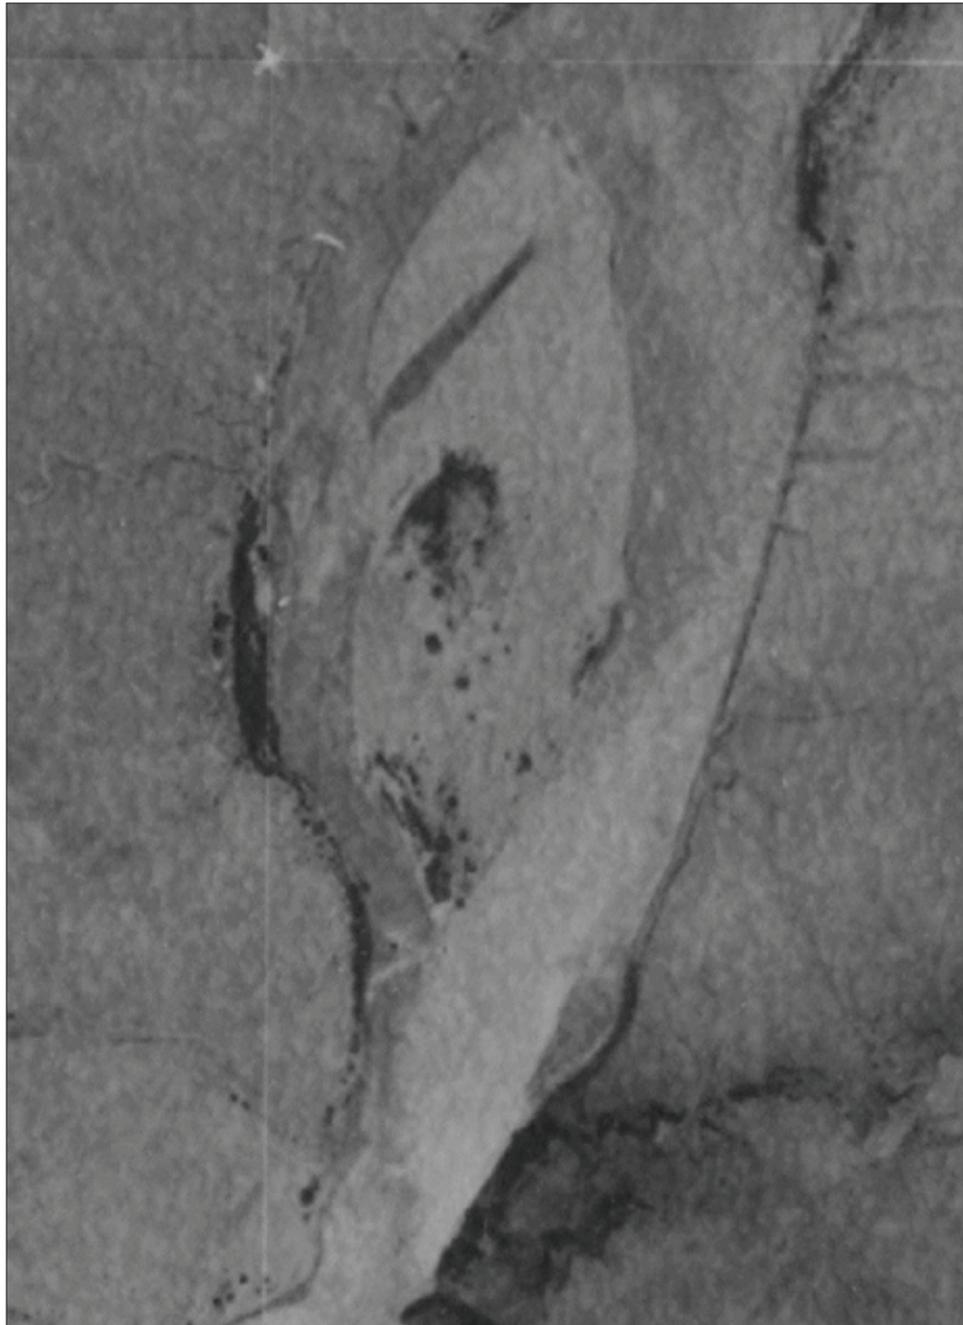
Figure 10. Above New Rapid Side Channel in July 15, 1937.

This project area was historically a mid-channel island with perennial flow in both the main and side channel and was characterized by little vegetation in 1937 (Figure 10). Tamarisk has since invaded the island and in the absence of scouring flow events has become well established (Figure 11). Woody invasive species create roughness in these channels that slows water velocity and causes sediment to deposit and fill in the channel. Today the primary side channel has significantly narrowed (Figure 11) and is only seasonally inundated during very high water events like 2011. This encroachment also decreases the native vegetation's rate of succession and degrades wildlife habitat. Additionally this stand of tamarisk has succumbed to the defoliation effects of the tamarisk leaf beetle, which increases the risk of wildfire adjacent to a popular lunch stop for rafters.

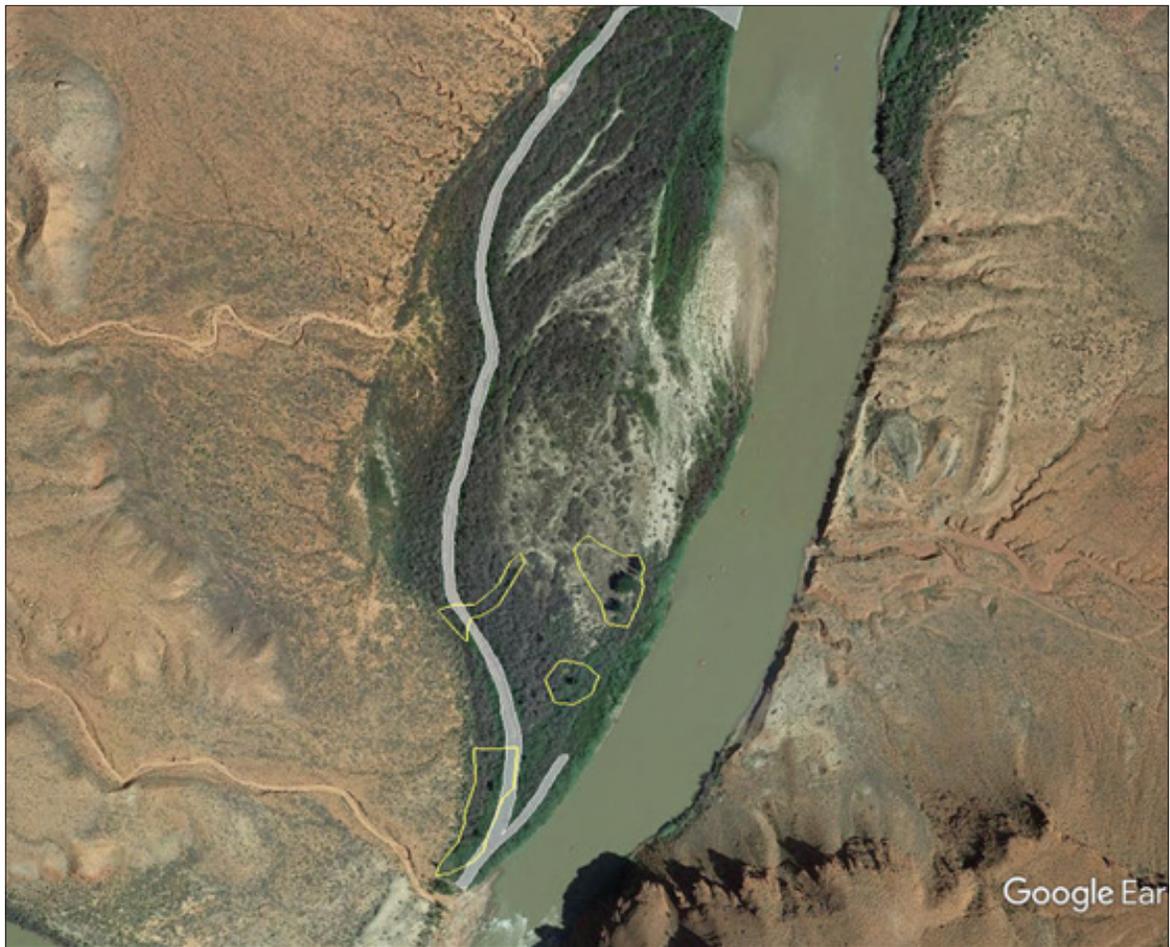
Figure 12. Completed work. White areas showed cleared side channel areas. Yellow shows areas cleared around native cottonwoods and shrubs.

Since 2018, the main side channel and part of the secondary side channel have been cleared of tamarisk (Figures 12-14) and a buffer cleared around native cottonwoods (Figure 12). This work was funded through the Watershed Restoration Initiative (WRI) and completed by the Utah Conservation Corps (UCC) and Rim to Rim Restoration for the BLM Canyon Country Aquatic Habitats program. Future work will include clearing the smaller side channels and potentially streambank alteration to allow inundation at lower flows.

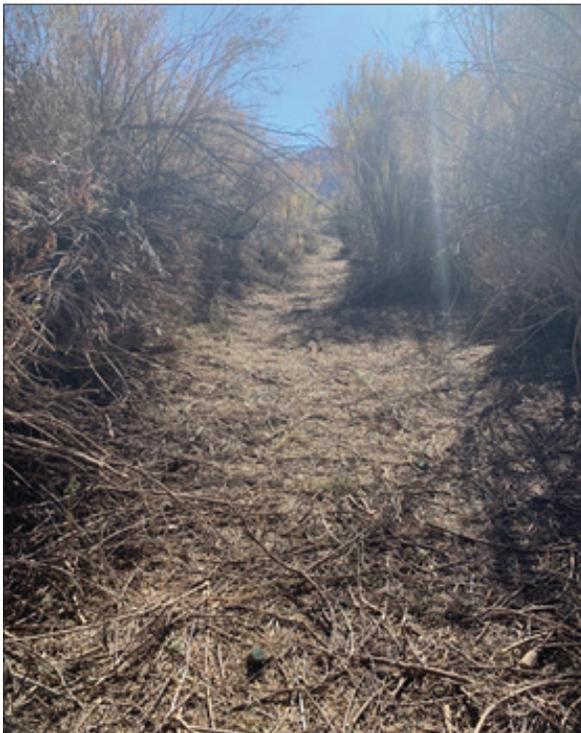
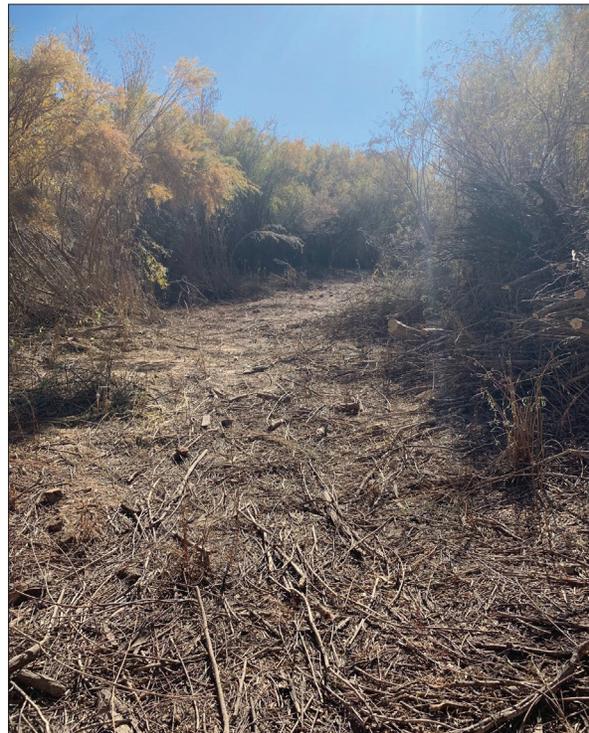
Figures 13 and 14. Side channel cleared of tamarisk.

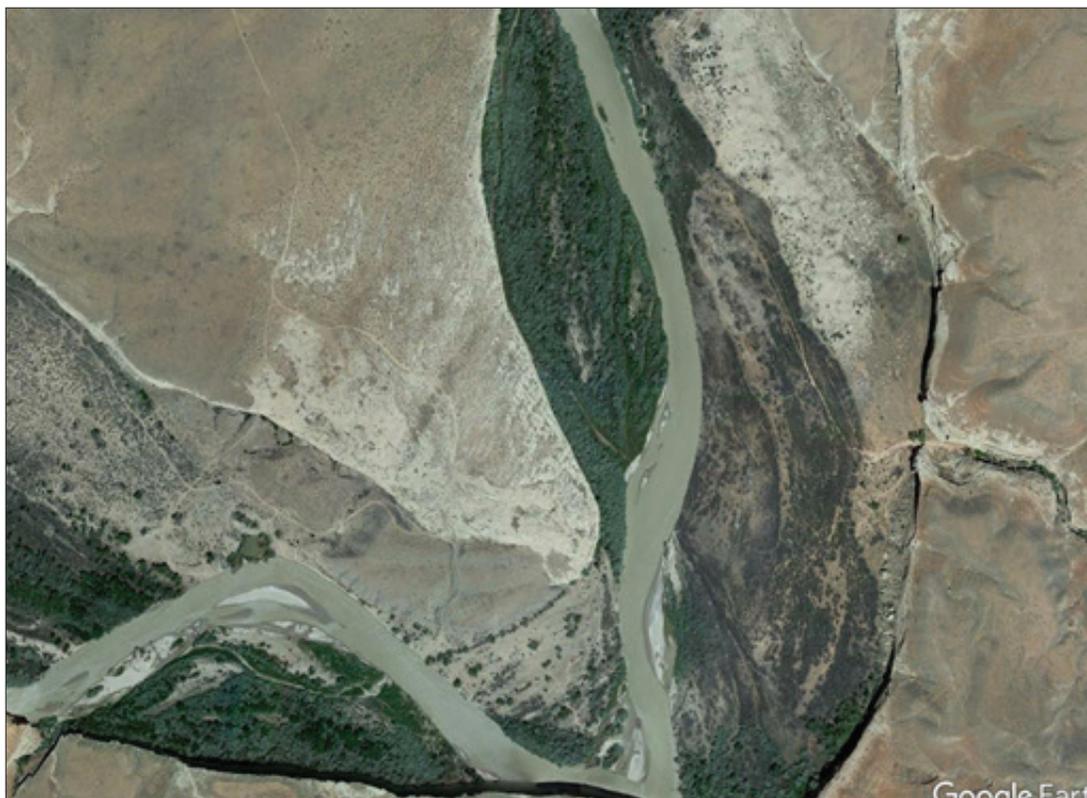
Figure 18. May 3, 2017 photo of project area showing channel narrowing and vegetation encroachment on the river channel.

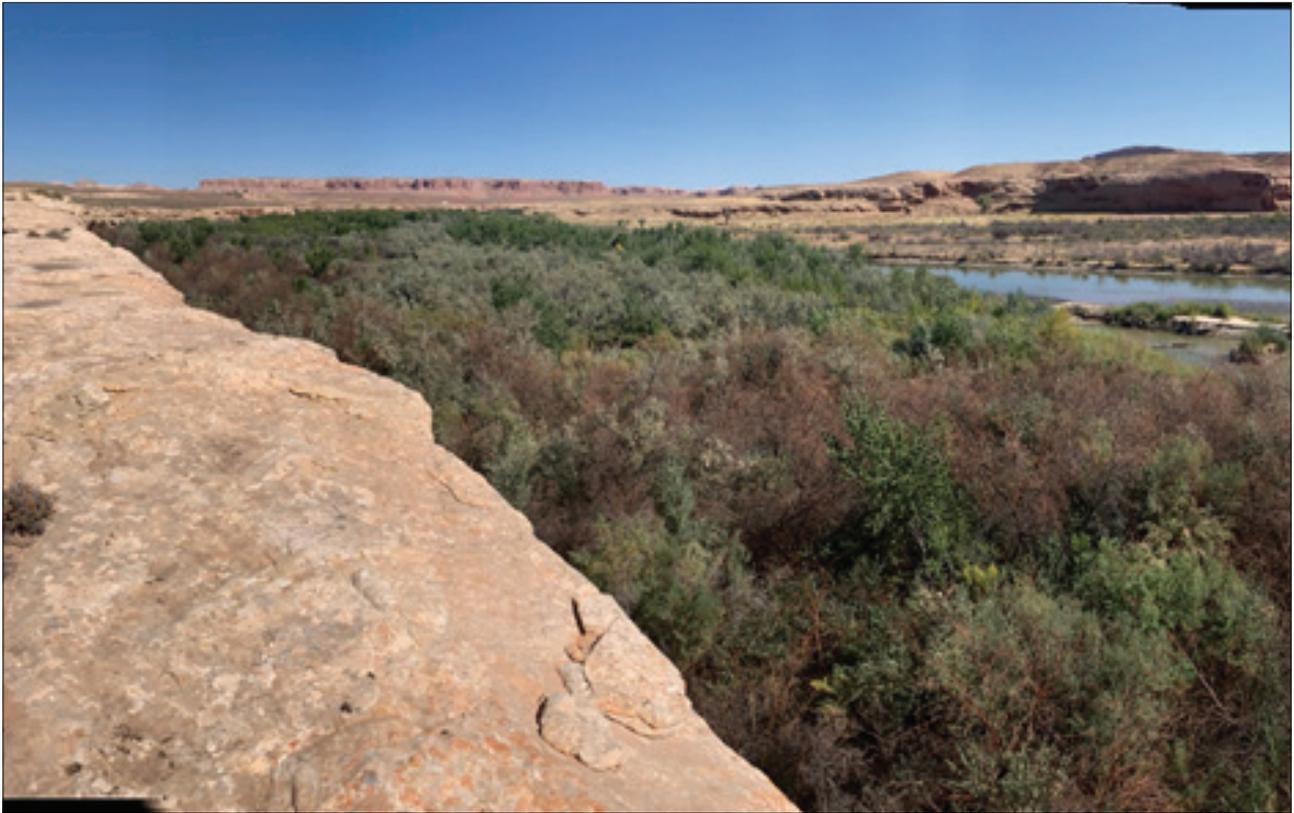
Figure 19. Senesced canopies of frill cut Russian olive along side channel (Oct. 2019).

Once mortality of Russian olive is confirmed, and pending an Environmental Assessment (EA), a whole tree extraction methodology is desired to completely remove and pile the invasive trees in an area for future burning. Complete removal of Russian olive above and below ground biomass in and adjacent to side channels will allow these habitats to widen and reach equilibrium with the current flow regime.

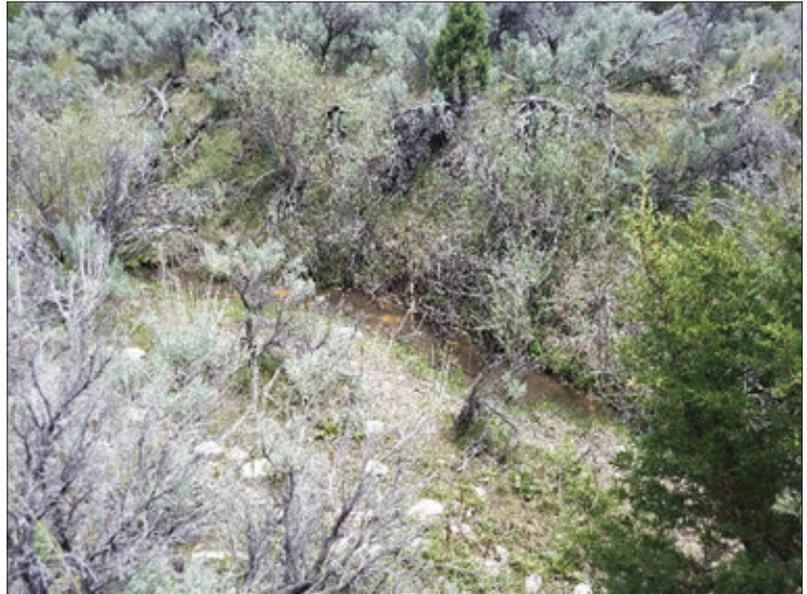
Figure 21. Kimball Creek before structures -- note minimal riparian vegetation.

West Box Elder Beaver Dam Analogs – Kimball Creek Project

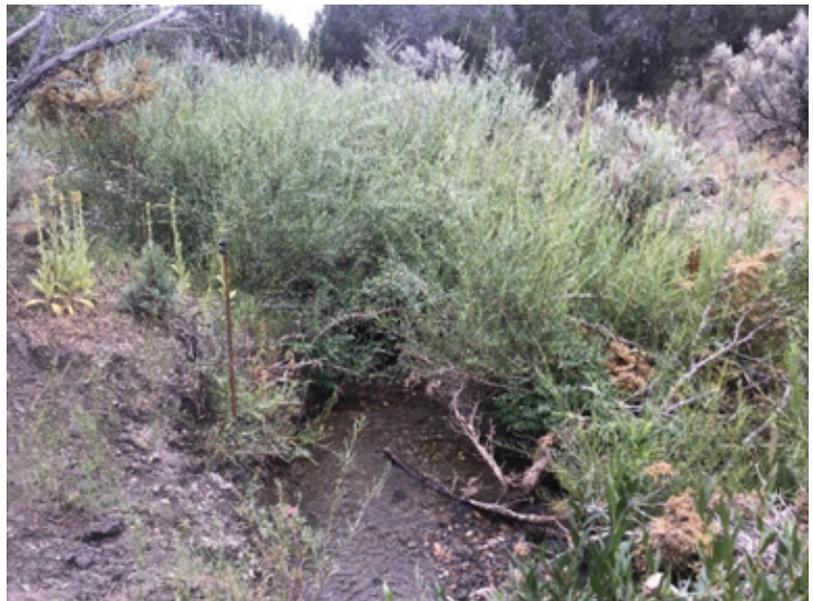
Figure 22. Kimball Creek after structures -- note dead junipers from structure and willow recruitment covering majority of structure.

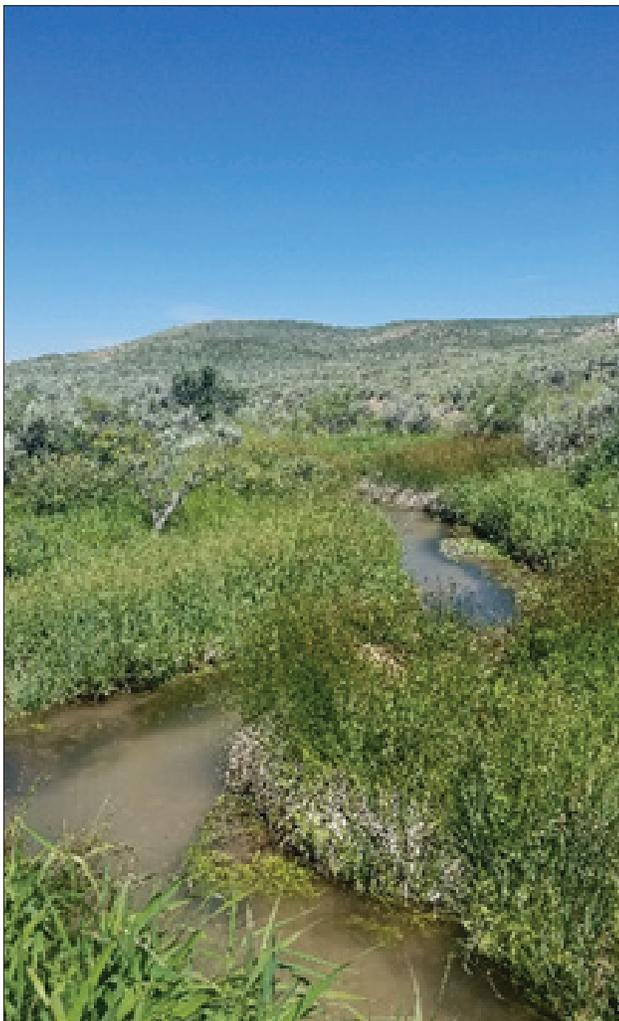
Figure 23. Habitat with brook trout removed.

Completion of four year effort to remove non-native brook trout and restore native Bonneville cutthroat trout took place in 43 miles of streams on BLM, private, and USFS lands in the Big Creek – Bear River watershed (Figures 23 and 24). This is a partnership project between Utah Division of Wildlife Resources, Trout Unlimited, U.S. Forest Service, and private landowners.

- Construction of two barriers to prevent non-native fish from re-invading from the mainstem Bear River
- Culvert replacement to improve fish passage
- Irrigation diversion modification to improve water users irrigation and allow fish passage
- Multiple rotenone treatments
- Restocking streams with native Bonneville cutthroat trout and northern leatherside chub

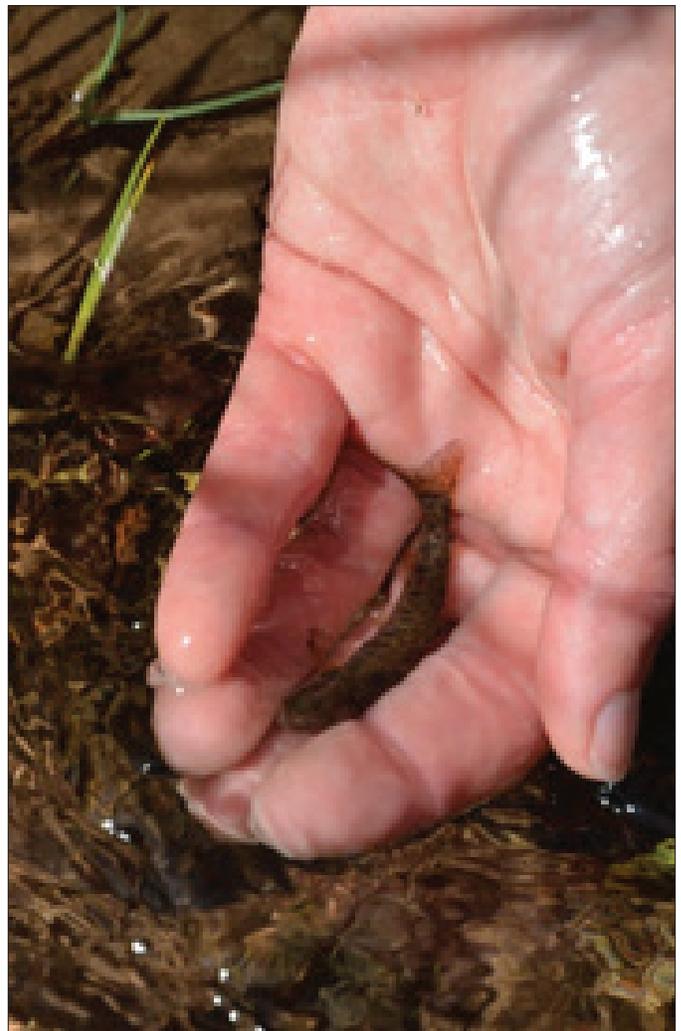
Figure 24. Juvenile Bonneville cutthroat trout reintroduction.

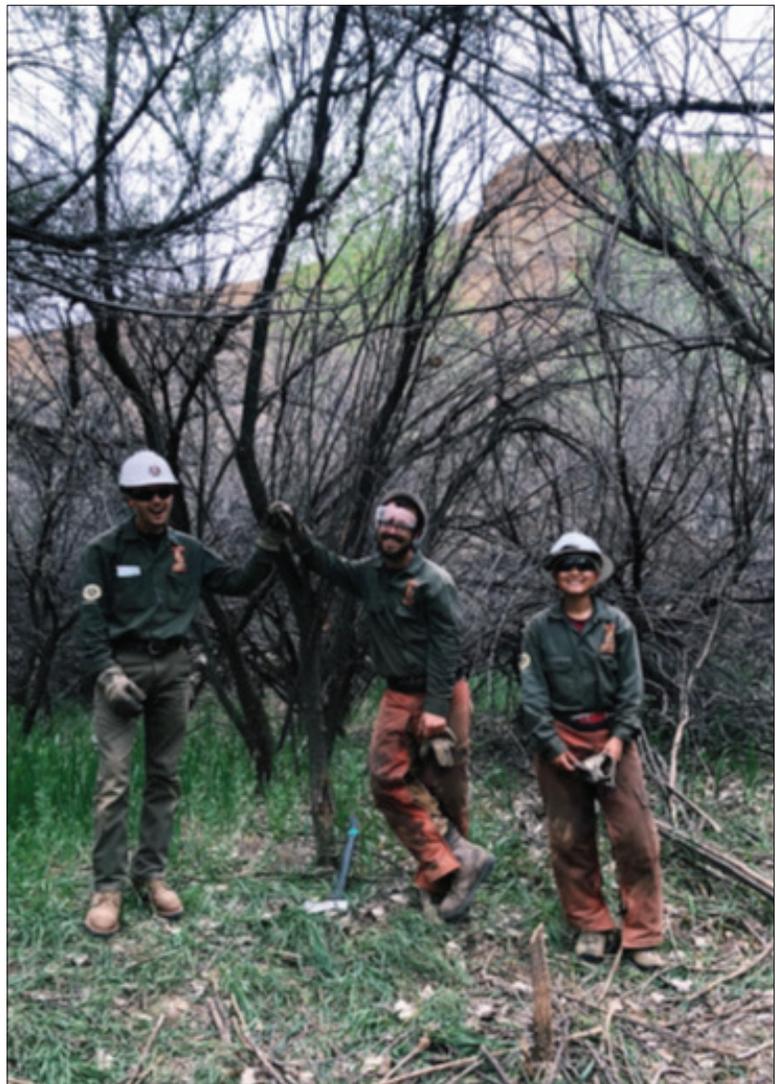
Figure 28. UCC Crews on the White River.

This project involves working with youth Utah Conservation Corps (UCC) to remove non-native vegetation along the White River riparian area (Figure 28). Four 5-person crews based out of Logan and Cedar City, UT conducted chainsaw training and project work on the White River. Crews cut and treated non-native vegetation on remote sites which were accessed by rafting on the White River. Crews worked in eight day periods from April 28 - May 25, 2019 and were based out of remote backcountry spike camps. The crews treated an area which was previously treated by 2017 crews who frill cut 100% of the Russian Olive in the area with approximately 80% success rate as some resprouting was observed. Spring 2019 crews removed both dead and living Russian Olive and Tamarisk stems under and around existing cottonwood stands to reduce hazardous fuel loads and increase stand resiliency in the event of a wildfire (Figures 29-32). A mixed biomass disposal prescription was implemented that consisted of habitat piles, lop and scatter.

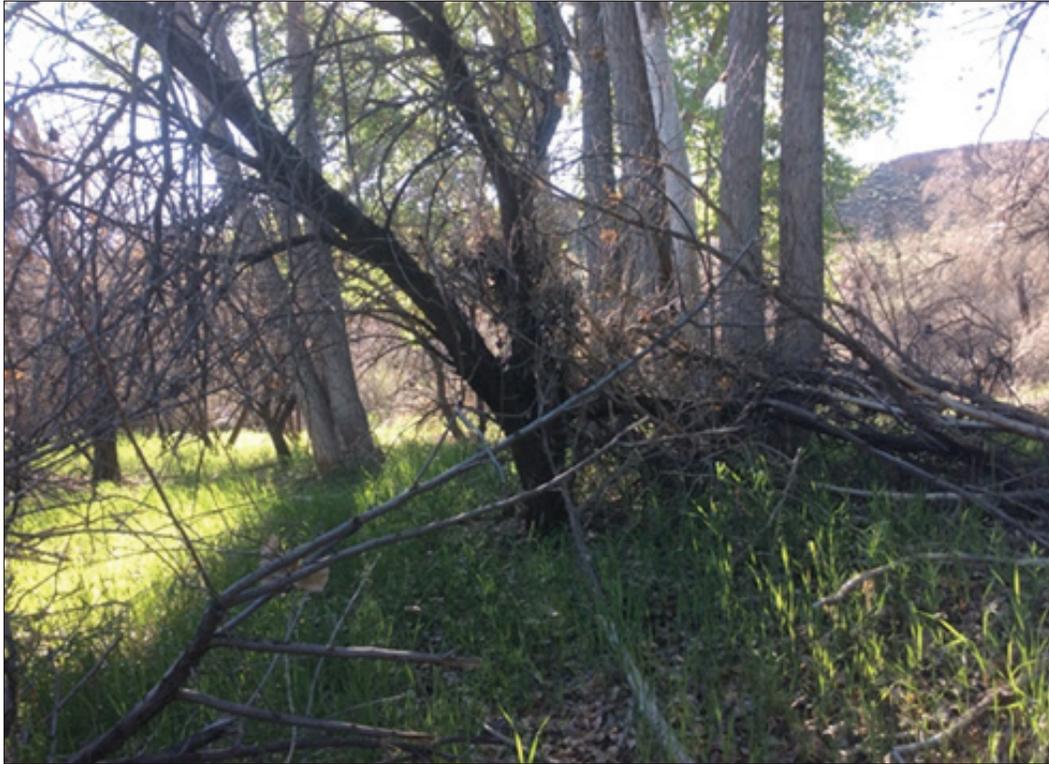
Figure 29. Before: Non-native tamarisk and Russian Olive on native cottonwood stands along the White River riparian corridor.

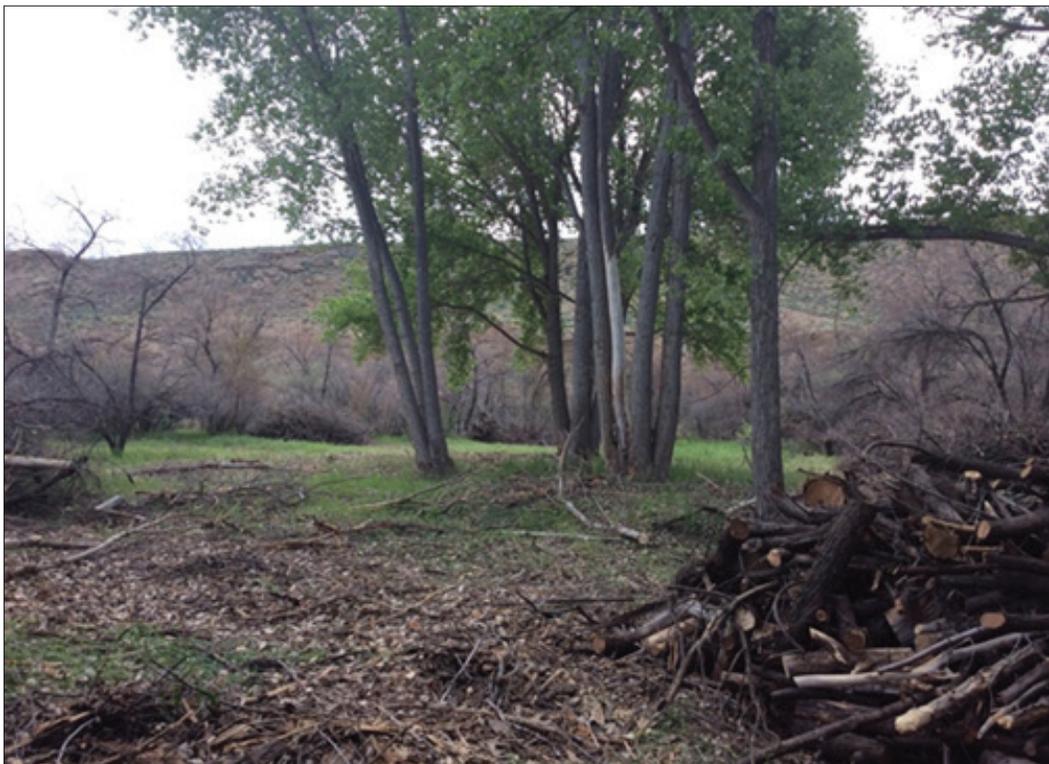
Figure 30. After: Non-native tamarisk removed from native cottonwood stands along the White River riparian corridor.

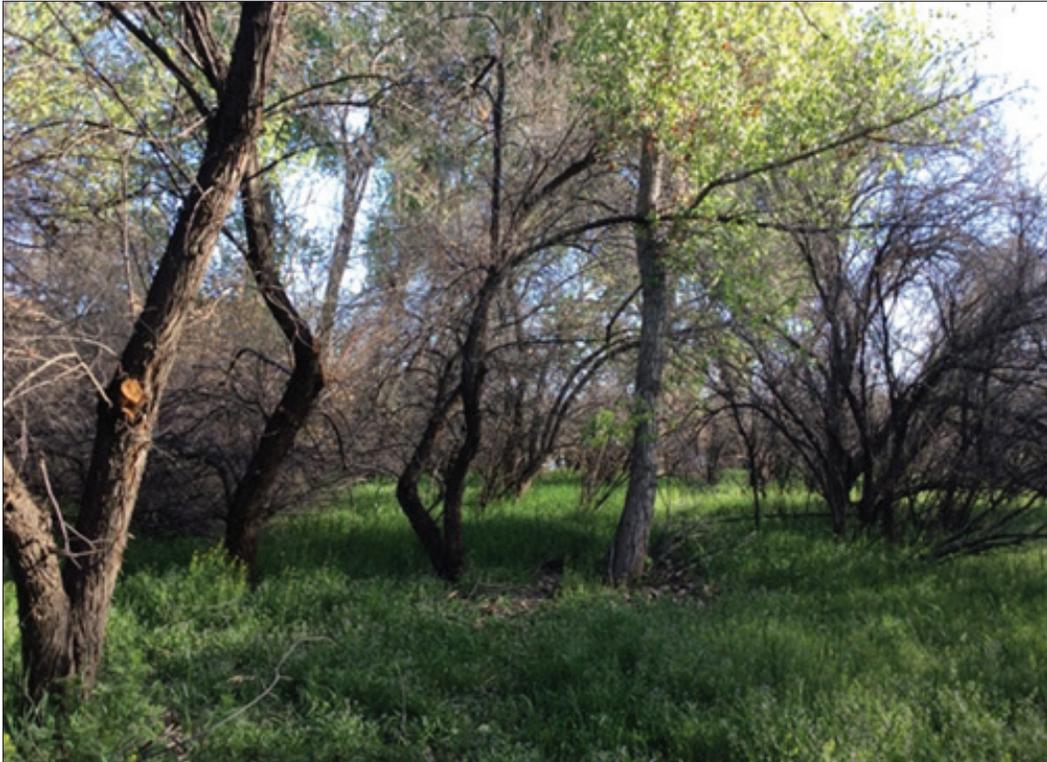
Figure 31. Before: Non-native tamarisk and Russian Olive on native cottonwood stands along the White River riparian corridor.

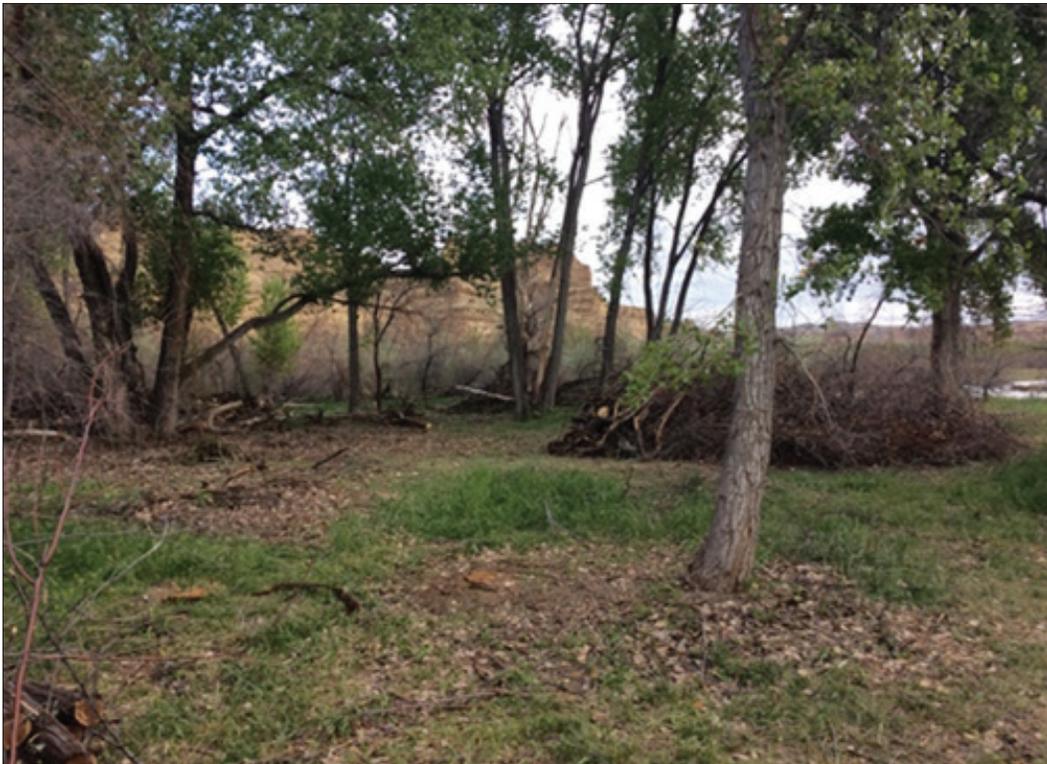
Figure 32. After: Non-native tamarisk removed from native cottonwood stands along the White River riparian corridor.

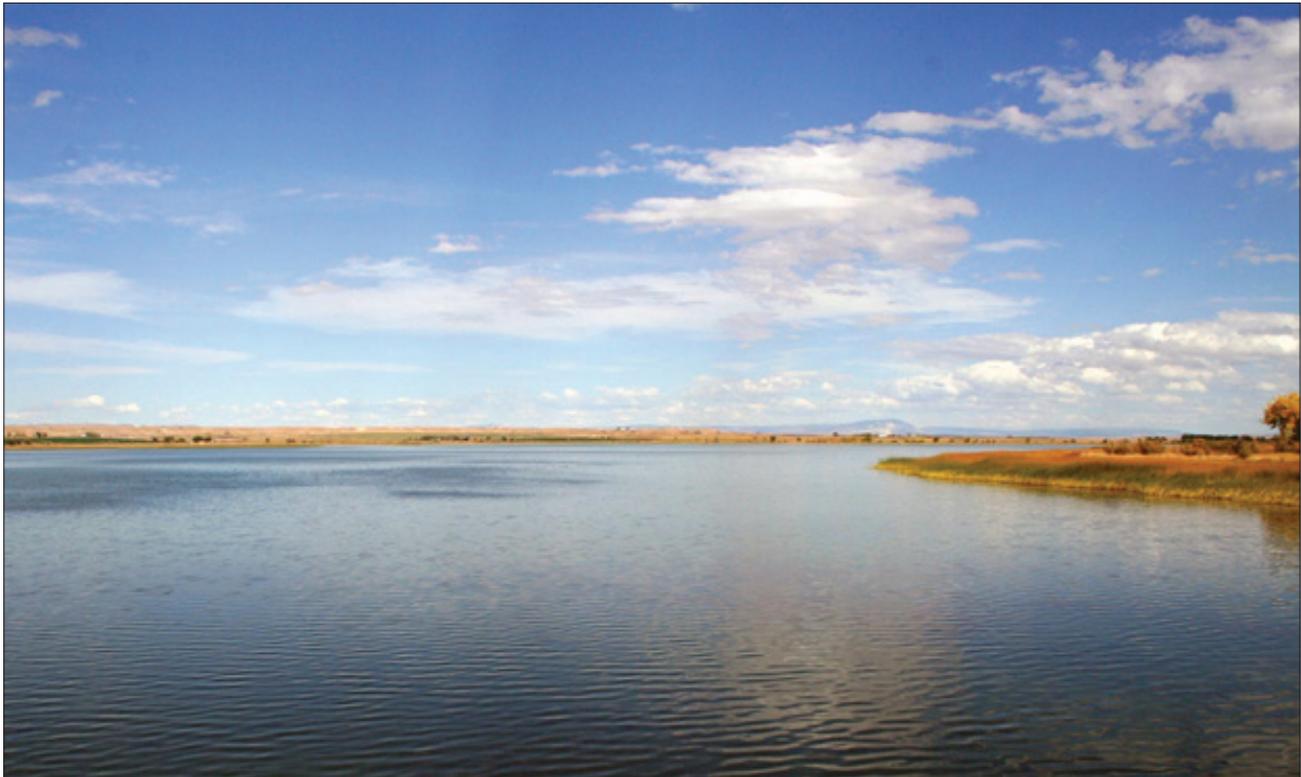
Figure 33. Pelican Lake, photo provided by UDWR.

Pelican Lake is a Blue Ribbon Bluegill Fishery located 20 miles southwest of Vernal, Utah in Uintah County, BLM Vernal Field Office (VFO). It is a 1,680 surface acre, 15,850 acre foot, irrigation storage reservoir (Figure 33) and was intensively sampled in 2013 to evaluate largemouth bass and bluegill relative abundance, growth, and health. Results determined that growth rates for juvenile bluegill are much slower than during the last intensive sampling performed in the 1970s due to an invasion of common carp. In 2015 an advisory committee was formed to provide public input to the management of the Pelican Lake fishery. Members of the committee were selected from government agencies with management responsibilities for the lake and from the angling public that indicated an interest in serving on the committee. A management plan was created. Objective one was to eradicate common carp from Pelican Lake.

In October 2018 the BLM, UDWR, and Ouray Irrigation company worked cooperatively to treat Pelican Lake with Rotenone. This treatment eradicated all fish species in the lake except black bullhead which are highly tolerant of rotenone. Largemouth bass and bluegill from a local source were used to repopulate Pelican Lake. UDWR plans to purchase fingerling bluegill in 2019 and fingerling largemouth bass in 2020. Channel catfish will continue to be stocked as needed to support management goals.

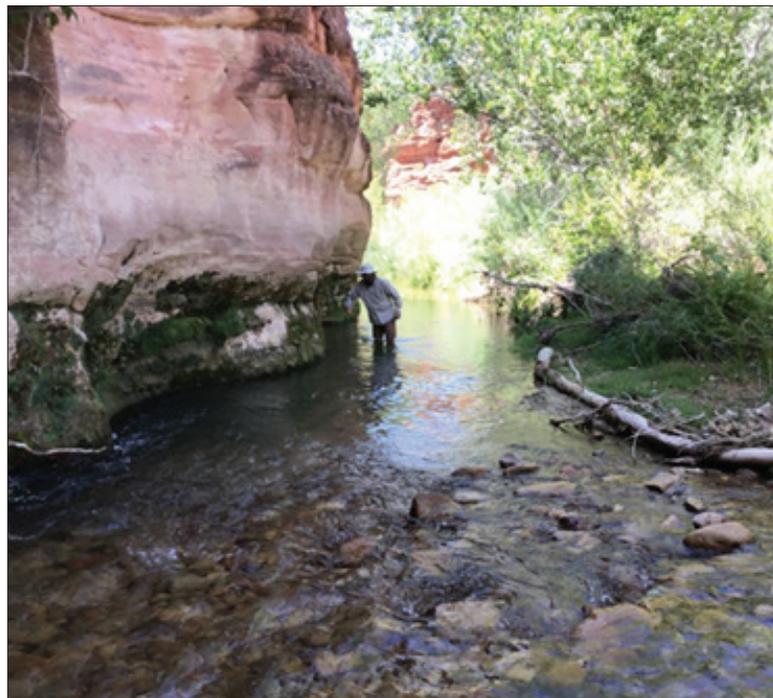
Figure 34. Sampling the East Fork Virgin River in the Kanab Field Office.

In FY2019, Color Country District began the first year of the Aquatic Assessment, Inventory and Monitoring (AIM) random sample design. During the first year, 43 random sites were sampled throughout the four field offices in the districts (Figures 34 and 35). Sites were stratified by stream order and Field Office to produce a statistically valid sample design for the entire District. Two targeted sites were also sampled in 2019 for use in future stream restoration planning and monitoring.

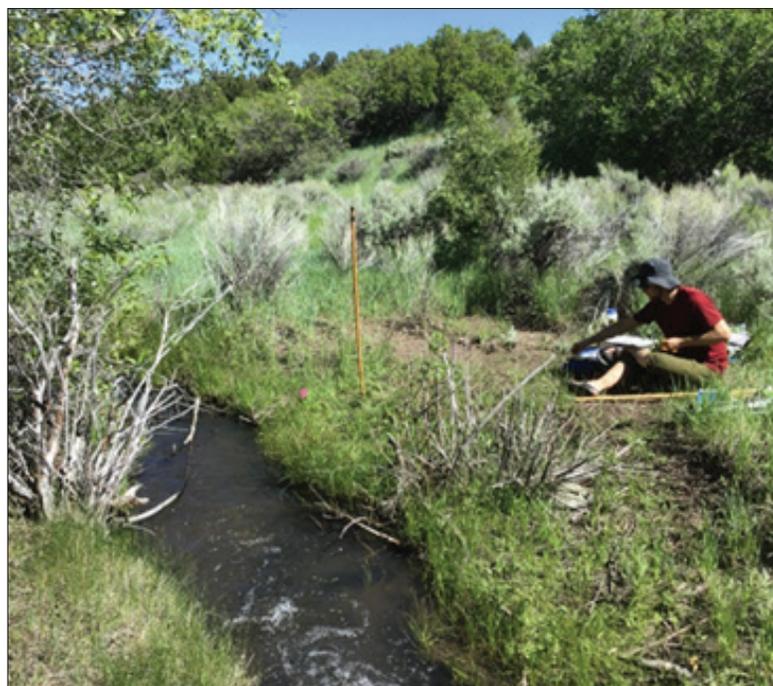
Figure 35. Sampling Birch Creek in the Cedar City Field Office.
