AQUATIC HABITAT MANAGEMENT PROGRAM

2019 UTAH ACCOMPLISHMENT REPORTING

The Dolores Berm Site Project

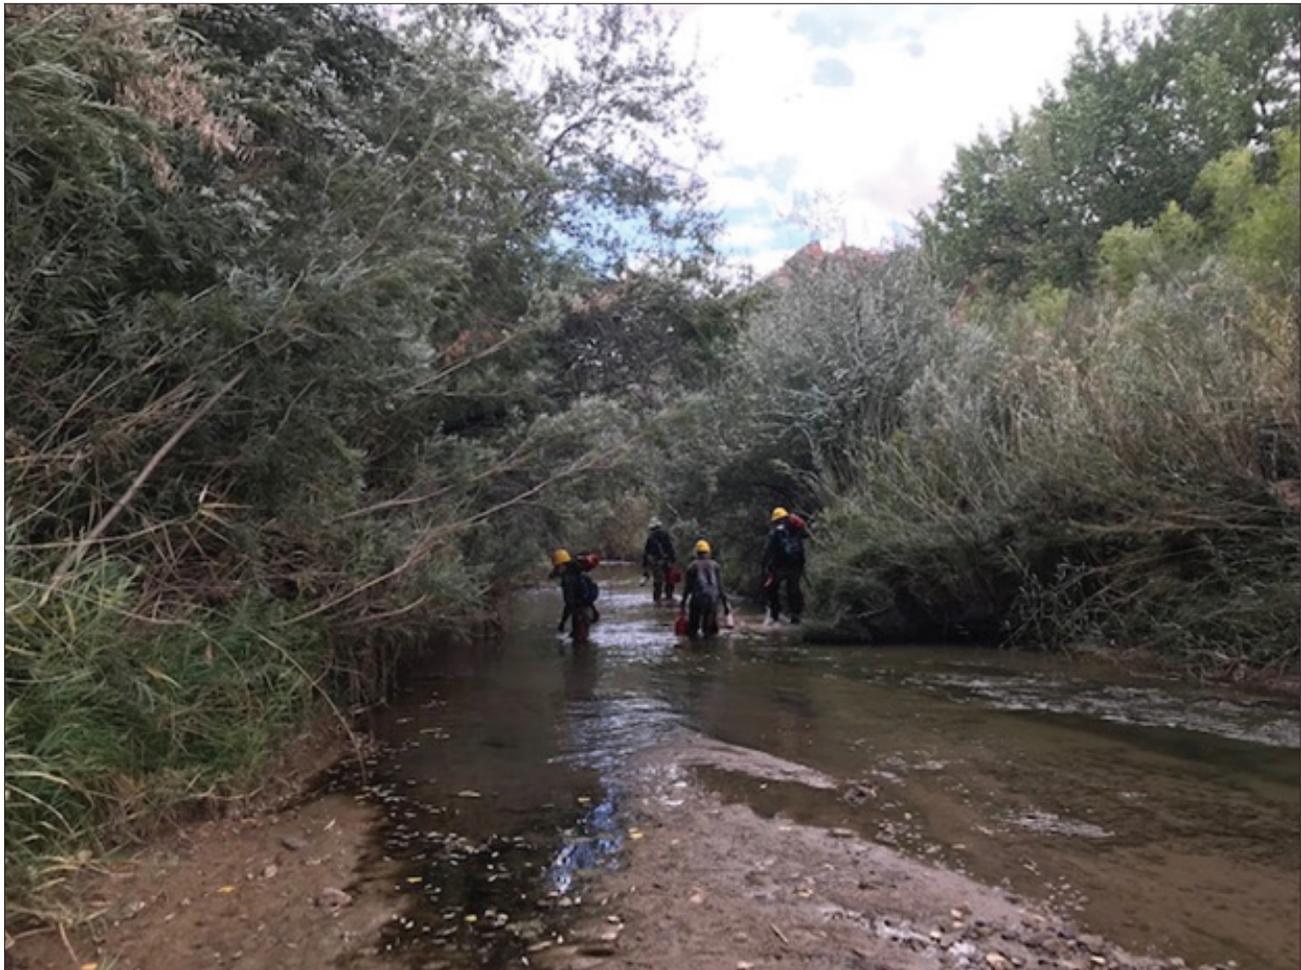
Figure 37. UCC crews working along Escalante River removing Russian olive.

For eight days at a time, crews worked and lived in the backcountry (Figure 36). As part of four UCC chainsaw crews, this team completed 42 acres of treatment along the Escalante, which was the final mile of treatment remaining on the river (Figure 37). This work was chainsaw heavy with herbicide application, both cut stump and frill cut methods. The UCC field supervisor for both crews and stated, “ It was incredible to be part of the final leg of primary treatment for a effort that has been ongoing for years, has had loads of people from different backgrounds pouring their blood, sweat and tears toward a common goal.” This goal being removing an invasive species opening the river corridor, allowing native species a chance to repopulate the area and improving the recreation opportunities in this beautiful area.
