Wilderness Inventory Unit Index of Documents

***Updated** – Howluk Butte East OR-036-049, 20 total pages

Year: 2012 Unit Number/Name: OR-036-049 -- Howluk Butte East

Wilderness Inv Unit Name/Number: OR-036-049 – Howluk Butte East

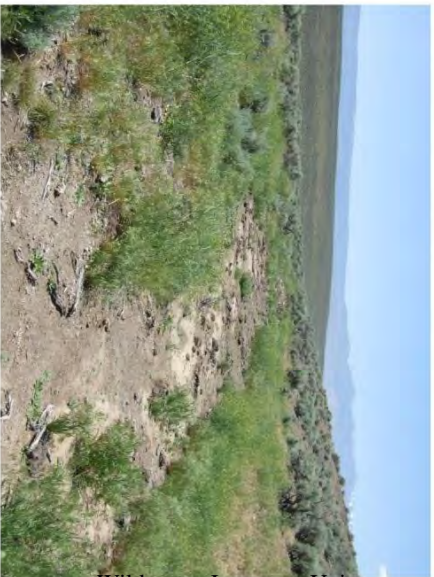
036-RT27-E-NW.JPG

PHOTO_LOCATION	DIRECTION	PHOTO_TYPE	PHOTO_DATE	COMMENTS
036-RTZ7-A	W	Route	7/12/09	No evidence of construction or maintenance.
036-RTZ7-A	E	Route	7/12/09	No evidence of construction or maintenance.
036-RTZ7-B	NW	Route	7/12/09	No evidence of construction or maintenance.
036-RTZ7-B	SE	Route	7/12/09	No evidence of construction or maintenance.
036-RTZ7-C	W	Route	7/12/09	No evidence of construction or maintenance.
036-RTZ7-C	E	Route	7/12/09	No evidence of construction or maintenance.
036-RTZ7-D	NW	Route	7/12/09	Fence, gate.
036-RTZ7-D	SE	Route	7/12/09	No evidence of construction or maintenance.
036-RTZ7-E	NW	Route	7/12/09	No evidence of construction or maintenance.
036-RTZ7-E	SE	Route	7/12/09	No evidence of construction or maintenance.

Comments: The route – where existing (i.e., to BLM photo point 036-RT27-E) -- is not in good condition. It appears to remain in existence due only to occasional passage by a vehicle.

There is no evidence of relatively regular and continuous use. The route is virtually non-existent northwest of BLM photo point 036-RT27-E.
