Wilderness Inventory Unit Index of Documents  
**West River Breaks OR-034-121, 25 total pages**

Year: 2009 Inventory Unit Number/Name: OR-034-121, West River Breaks

Unit Number/Name: **OR-034-121, West River Breaks**

**Wilderness Characteristics Inventory; OR-034-121, West River Breaks**

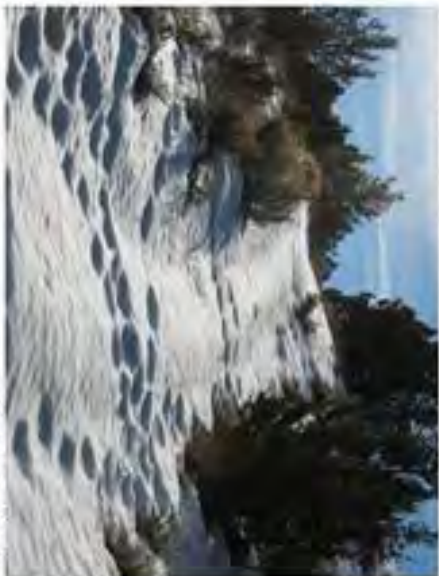
6266-0-00-A-SW.jpg

PHOTO LOCATION	DIRECTION	PHOTO TYPE	PHOTO DATE	COMMENTS
6266-0-00-A	SW	ROUTE	1/12/09	Up Side of hill showing cut/ri on a slope. ?
6266-0-00-B	NW	ROUTE	1/12/09	Route 6266-0-00, rd route goes to 2 reservoirs and drift fence. ?
6266-0-00-A	N	ROUTE	1/12/09	Side route of 2 6266-0-00 to level above mt.s. ?
6266-0-00-A	N	ROUTE	1/12/09	Route 6266-0-00
6266-0-00-B	S	ROUTE	1/12/09	Route through Sagebrush Flat.
6266-0-00-B	N	ROUTE	1/12/09	Route up hill toward switchbacks.
6266-0-00-C	S	ROUTE	1/12/09	Cut/ri. ?
6266-0-00-C	N	ROUTE	1/12/09	Cut/ri. large haul der on route past bed of rd e. ?
6266-0-00-D	E	ROUTE	1/12/09	Going down switchbacks. Cut/ri. Rocky berm. ?
6266-0-00-D	NW	ROUTE	1/12/09	Up to top of ridge. End of switchbacks.
6266-0-00-E	W	ROUTE	08/26/09	Berms with big sagebrush. Cut/ri. ?
6266-0-00-E	S	ROUTE	08/26/09	Berms. cut/ri. gravel. ?
6266-0-00-F	N	ROUTE	08/26/09	Cut/ri. berm. ?
6266-0-00-F	N	ROUTE	08/26/09	Cut/ri. ?

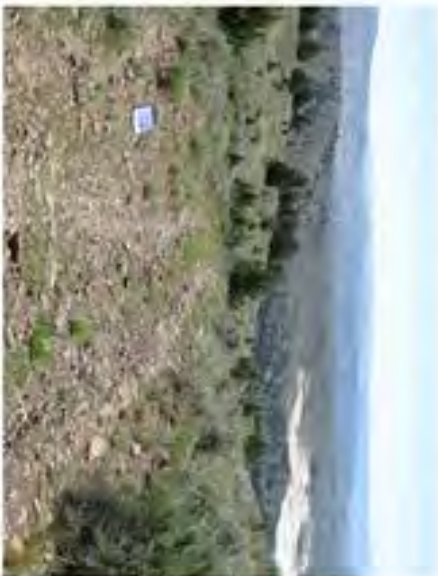
6266-0-00-H-SE.jpg

6266-0-00-G	NW	ROUTE	08/26/09	Weeds in route. Recent vehicle tracks.
6266-0-00-G	SE	ROUTE	08/26/09	Berms. cut/ri. EP Mn in BG. ?
6266-0-00-H	SE	ROUTE	08/26/09	Rocky berms. Vehicle tracks.
6266-0-00-H	NW	ROUTE	08/26/09	Same as previous photo.
6266-0-00-H	NW	ROUTE	08/26/09	Berms. Natural gravel. Recent vehicle tracks.
6266-0-00-I	N	ROUTE	08/26/09	Rocky berms. Ditch.
6266-0-00-I	S	ROUTE	08/26/09	Rocky berms.
6266-0-00-I	N	ROUTE	08/26/09	Bladed. Rocky berms.
6266-0-00-I	S	ROUTE	08/26/09	Rocky berms.
6266-0-00-K	S	ROUTE	08/26/09	Large rocky berms.
6266-0-00-K	S	ROUTE	08/26/09	No comment.
6266-0-00-K	N	ROUTE	08/26/09	No comment.
6266-0-00-L	N	ROUTE	08/26/09	Low berms.
6266-0-00-L	S	ROUTE	08/26/09	Low berms.
6266-0-00-M	W	ROUTE	08/26/09	Rocky berms.
6266-0-00-M	E	ROUTE	08/26/09	Rocky berms.
