**NATIONAL
CONSERVATION
LANDS**

Steese

National Conservation Area

Annual Manager's Report—Fiscal Year 2017

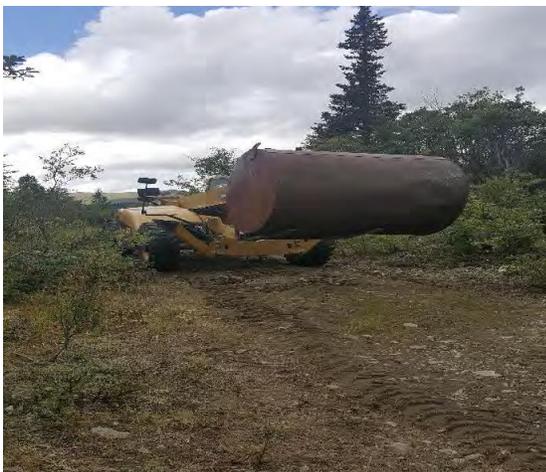
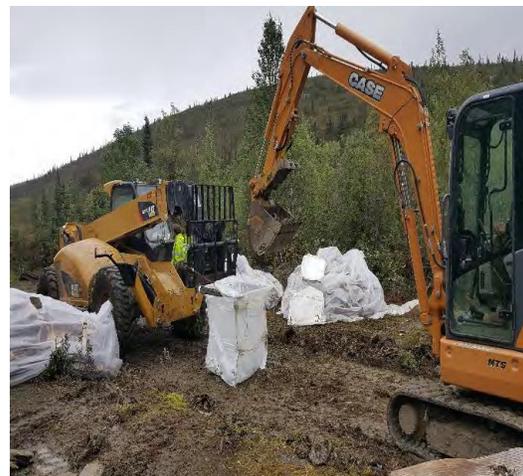
Loaders haul out solid waste debris and remove contaminated soils from the site

Project pictures show the effort and planning required for the Harrison Creek clean up. Items removed from the site include a furnace, a smoker, tanks and fuel drums, household appliances, wood debris and a trailer painted with lead-based paint (not pictured).

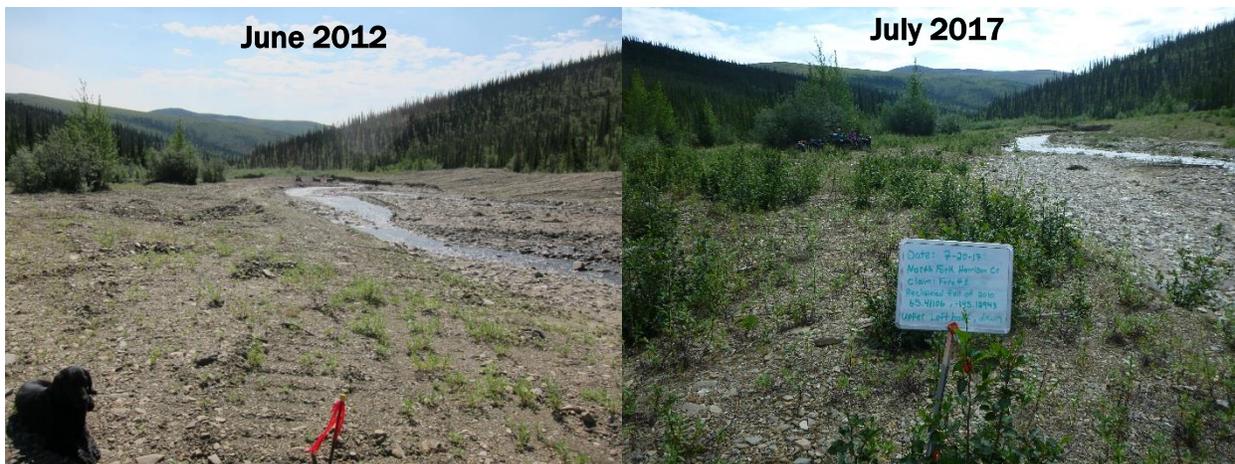
This reclamation occurred in 2010. Lateral stability, bedform diversity, and riparian vegetation are not trending towards proper functioning condition. Floodplain vegetation, not riparian, emergence indicates a lack of vegetative trend.

The stream and riparian conditions monitored in 2017 showed little change from previous years and three of four of the sites have not achieved the reclamation requirements. The lack of streambank riparian vegetation indicates a primary deficiency for a stable stream channel and rehabilitation of fish habitat. Other deficiencies include the lack of bed form diversity (pools and riffles or other structures that dissipate stream flow energy), streambank erosion levels that measure in the high-to-extreme category, and bank height ratios that indicate the stream remains disconnected from its floodplain.

Monitoring indicates more successful techniques are necessary for future reclamation projects. Monitoring shows that the simplistic reclamation techniques used at these sites do not create sufficiently stable stream conditions for many years. In interior Alaska, the commonly used approach of restoring a “pilot channel” in the low spot in the valley, then reliance upon natural stream and revegetation processes to recreate a stable stream channel takes decades. The BLM incorporates lessons learned from monitoring these reclaimed streams into the education provided to miners. The BLM’s monitoring continues until completion of the stream’s reclamation.

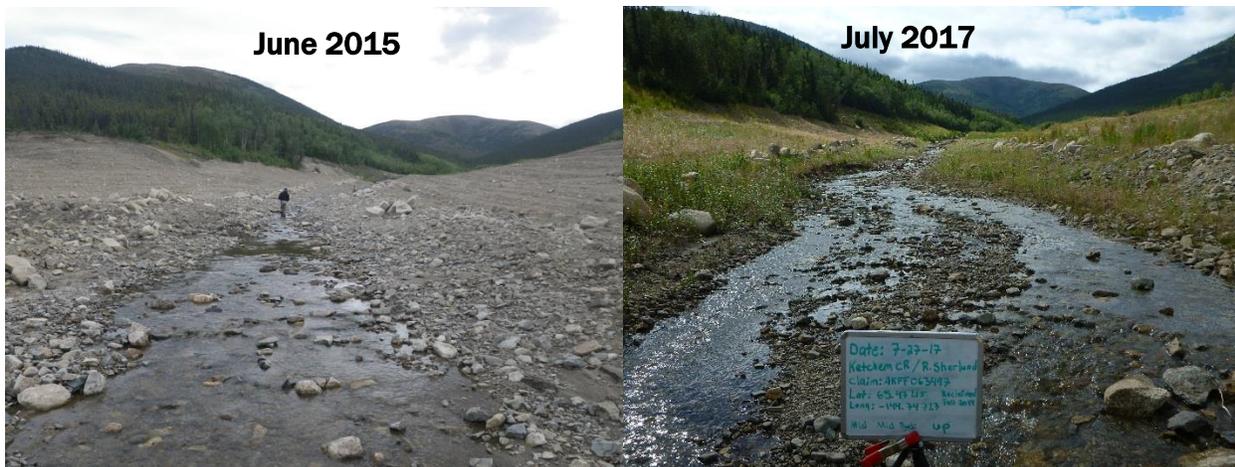
This reclamation occurred in 2014. Lateral stability, bedform diversity, and riparian vegetation are not functioning. The channel lacks stability, as illustrated by formation of the mid-channel sand bar.

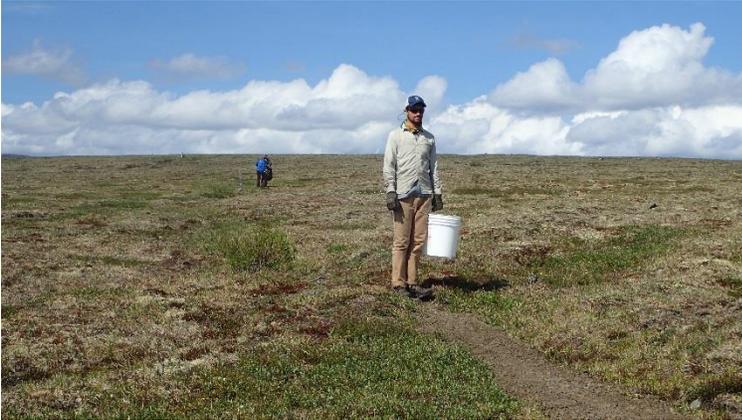
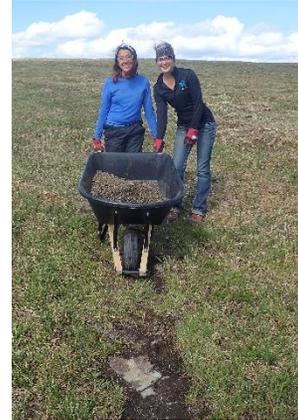
In June 2017, the SNCA hosted a six-person Student Conservation Association (SCA) trail crew to work on the Pinnell Mountain National Recreation Trail. The crew distributed gravel along 4 miles of trail near Eagle Summit to harden the trail.

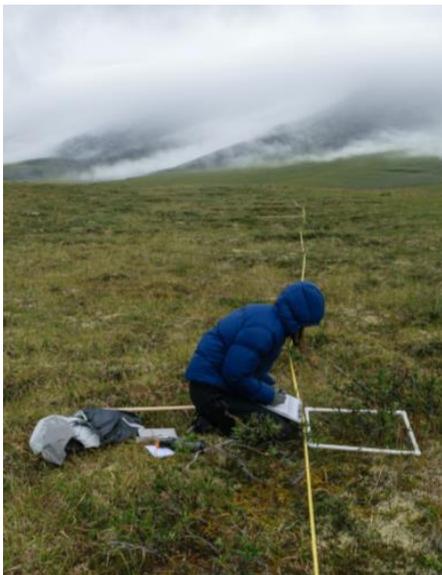
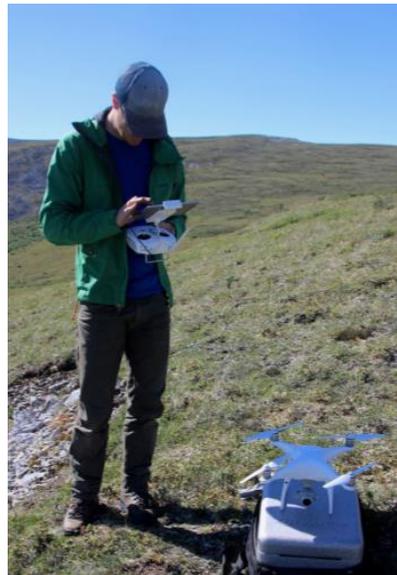
Eric Palm, NASA ABoVE Animals on the Move project member and University of Montana PhD student, quantifies lichen cover in plots and utilizes a UAV to capture high-resolution photography used to develop and improve mapping of lichen cover over the entire historical Fortymile Caribou Herd range in Alaska and Yukon Territory.
