AQUATIC HABITAT MANAGEMENT PROGRAM

2021 UTAH ACCOMPLISHMENT REPORTING

Aquatic Habitat Management Program 2021 Utah Accomplishment Reporting

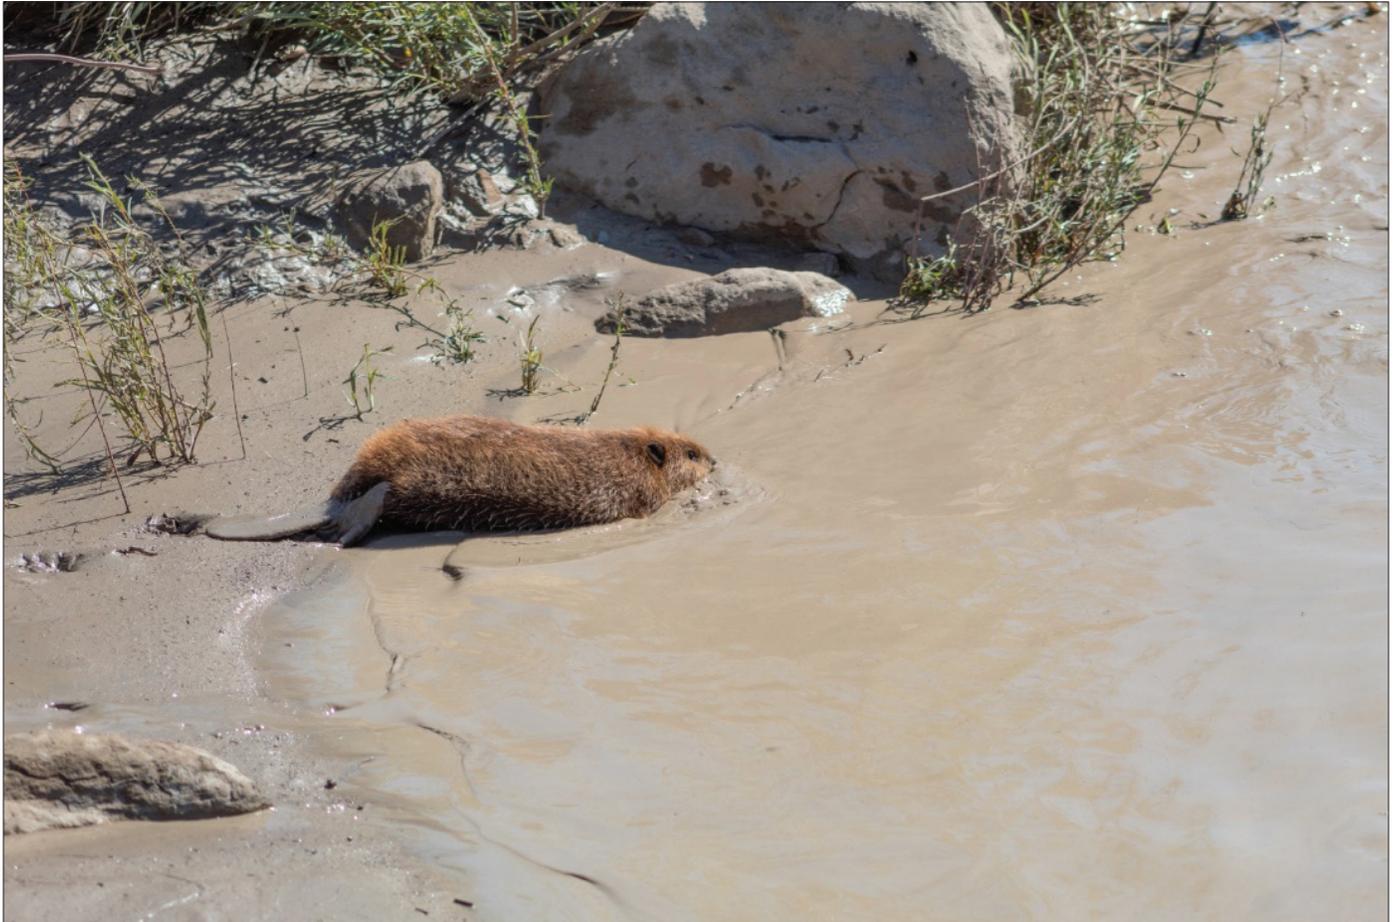
Figure 2. Release of translocated beaver (Photo credit: Kegen Benson)

- Native vegetation planting (~850) including cottonwoods, three leaf sumac, New Mexico privet, fourwing saltbrush, silver leaf buffalo berry and desert holly.
- Multiple beaver translocation and releases into the project area (Figure 2).
- Effectiveness monitoring

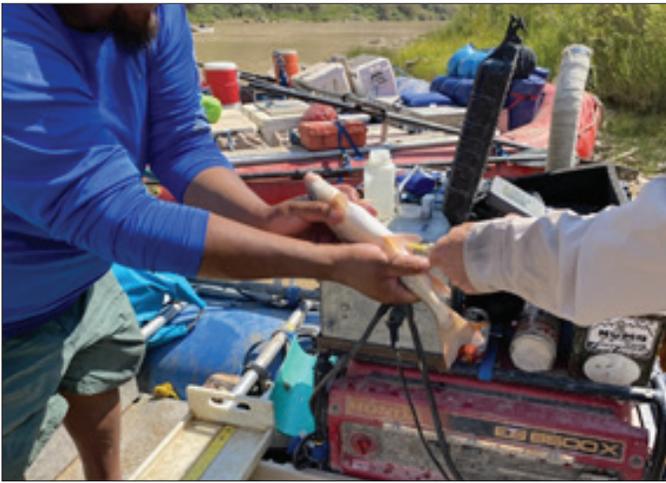
Figure 5. Tagging Flannemouth Sucker and Figure 6. Verifying tag number (Photo credits: Jordan Detlor)

Data was collected on fish health, population trends, age structure, basic water quality characteristics, and occupancy throughout the reach (Figures 5 and 6). Sampling was conducted by continuous shoreline cataraft electrofishing of both shores through Desolation Canyon (Figure 4).

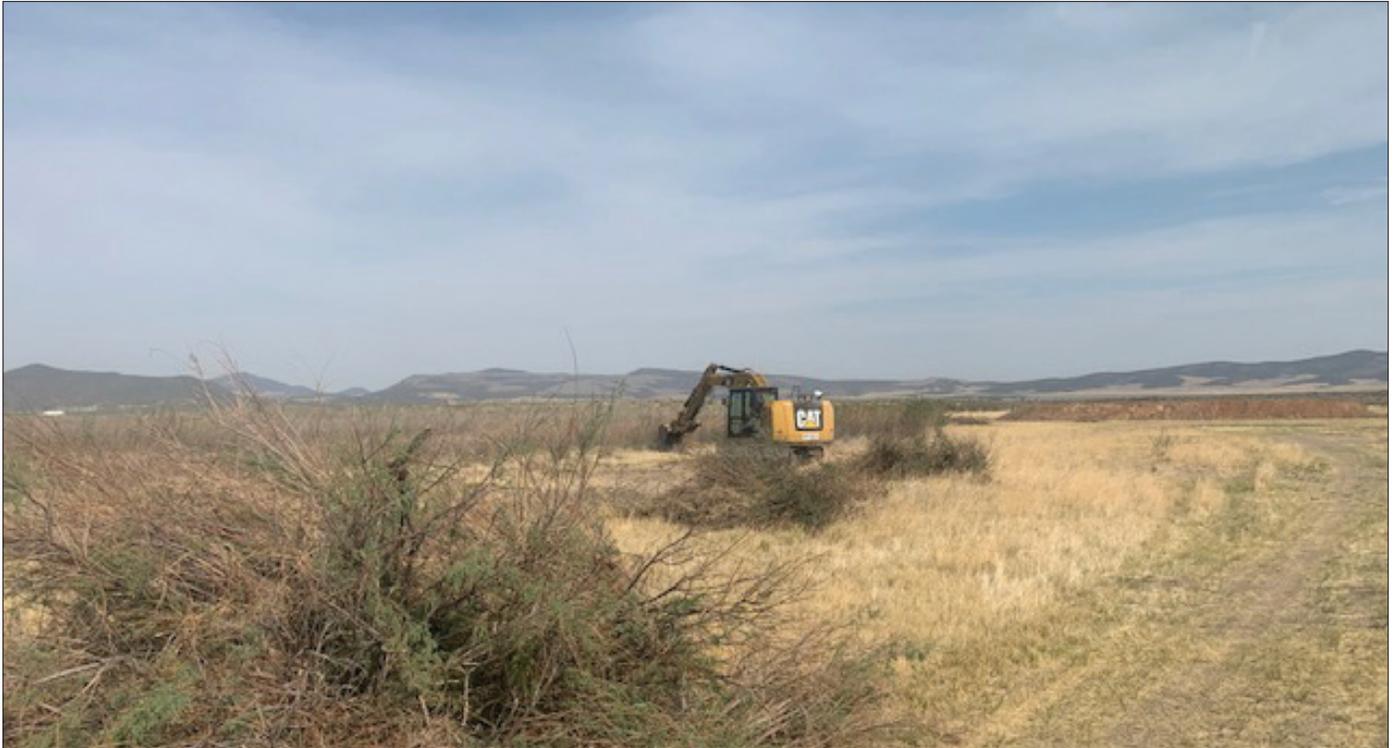
Figure 11. Clearing tamarisk near Quichapa Lake.

- In May/June 2021, 10 retention basins and islands were excavated and constructed in Quichapa Lake, a terminal wetland (Figures 12 and 13). Additionally, tamarisk removal was initiated by pulling and piling using an excavator in a 10-acre ephemeral area (Figure 11). Additional tamarisk removal is scheduled to continue in fiscal year 2022. The Field Office also organized a clean-up day and removed tires, metal, several dump sites from the wetland area.

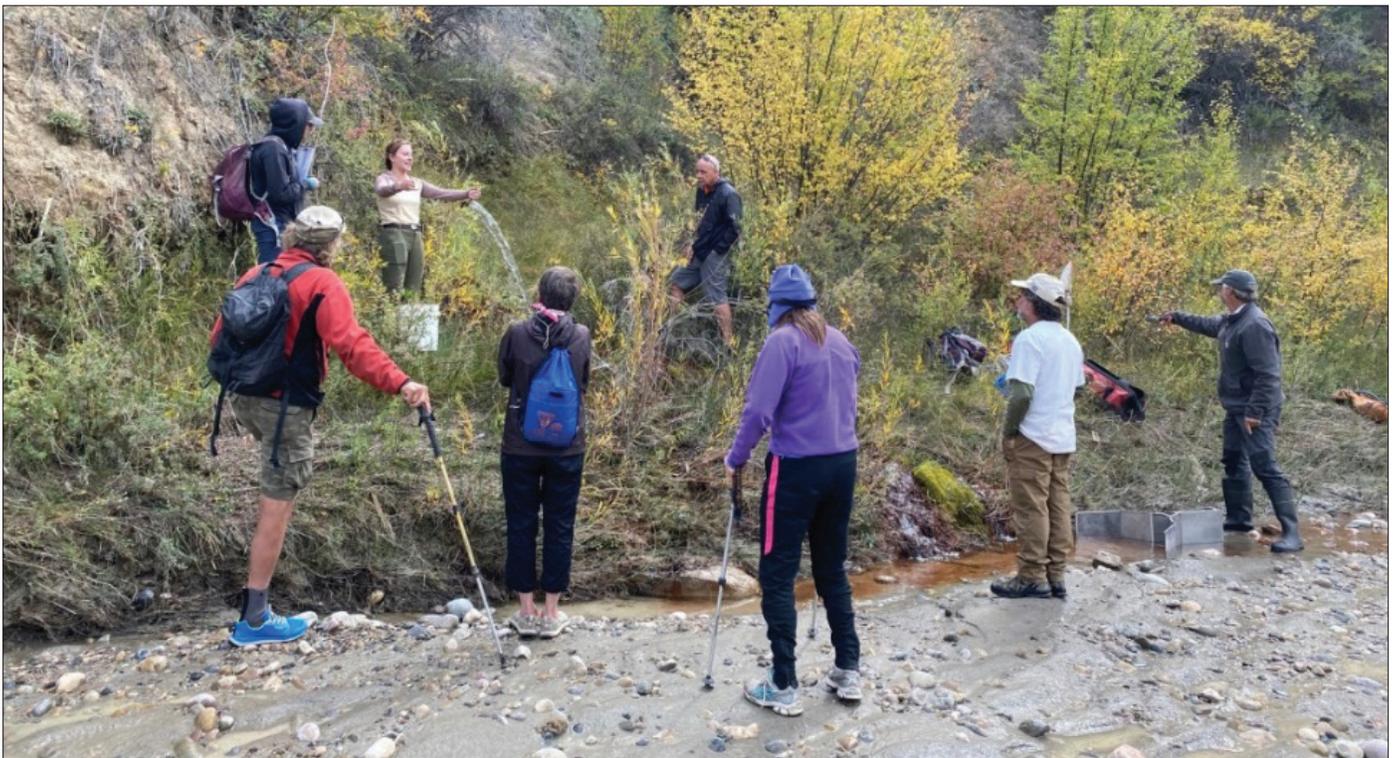
Figure 16. SSI Leaders demonstrating the springs monitoring protocol.

collected data and assessment of these springs was then input into the Springs Online database that was created by SSI. This project will result in a baseline inventory of springs/seeps across GSENM, additional inventory of springs/seeps, input of data into the Springs Online database, and training for local specialists to continue inventory and monitoring efforts into the future. Larry Stevens, of SSI, lead a field trip for the public and BLM staff demonstrating SSI's springs monitoring protocol to fulfill the education portion of the agreement (Figure 16). This trip had a great turn out and lasted longer than expected due to participant engagement. Data from SSI inventory will be used alongside Lentic AIM data when conducting monitoring efforts and will influence future management decisions.

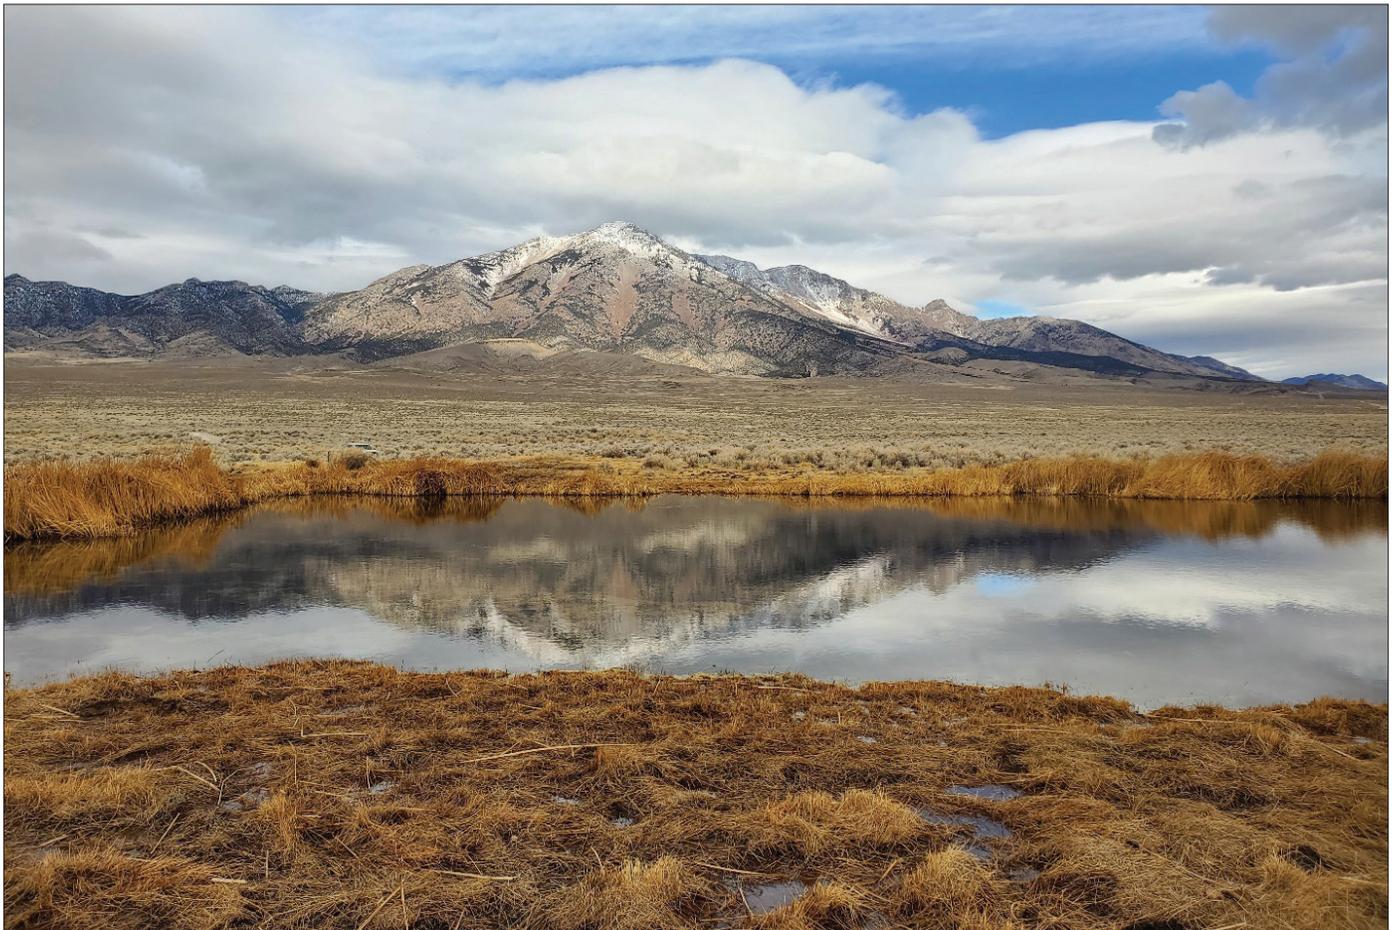
Figure 19. Hall's Meadow and Pilot Peak

Hall's Meadow is a spring on BLM land that supports a 13-acre wetland (Figure 19). This habitat supports sensitive aquatic springsnail species as well as wildlife such as elk, antelope, waterfowl, and migratory birds. BLM holds a water right on the spring for 0.03 cfs for stock watering and wildlife uses with a priority date of 1903.

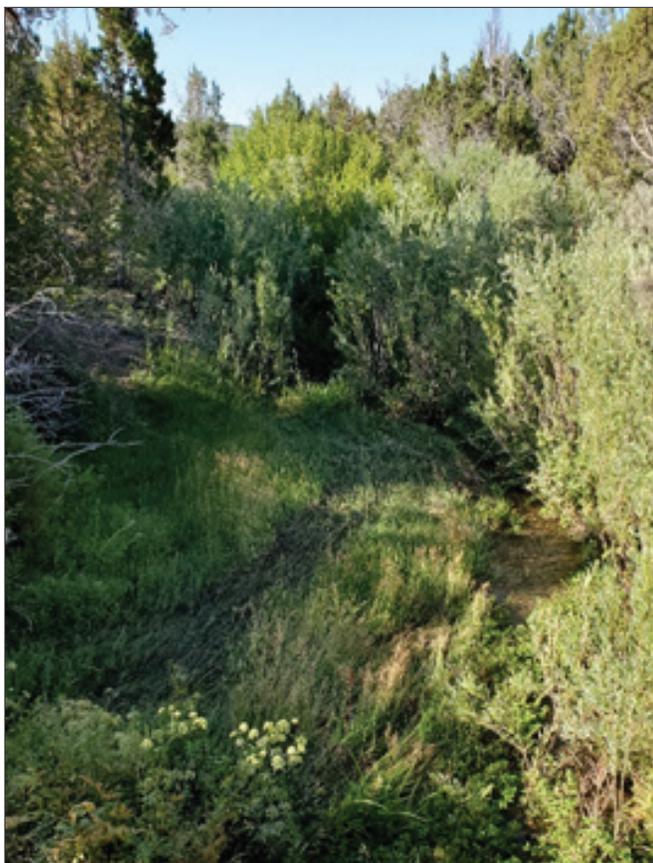
Figure 22. Kimball Creek August 2021.

Showing recruitment of woody and herbaceous riparian vegetation and increased habitat complexity. Photos are examples of changes, not photo points of the same location.

Analysis of individual structures showed an increase in number of structures forcing overland flow from 8 in 2020 to 13 in 2021. Imagery analyzed from drone flights estimate the area of inundation increased from 3062-4593 m² pre-restoration to 7305 m² in 2021 (Shahverdian, S. and Macfarlane, W.). AIM monitoring shows an improvement in floodplain connectivity from a major departure from reference conditions – or poor connectivity -- in 2018 to minimal departure from reference condition in 2021. PFC assessments show an improvement from one portion of the treatment reach

rated as Functioning at Risk in 2006 and another portion of the treatment reach rated as Not Functioning in 2006 to both reaches rated as Properly Functioning in 2021 (Figure 22).
