U.S. Department of the Interior
Bureau of Land Management

Open File Report #169

Developing Quantifiable Management Objectives from Reference Conditions for
Wadeable Streams in the Eastern Interior Field Office

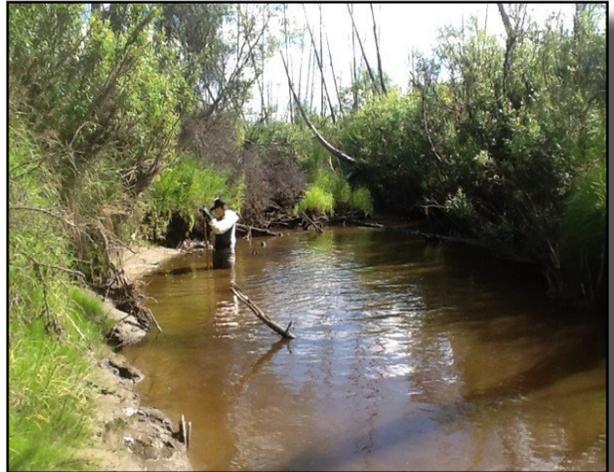
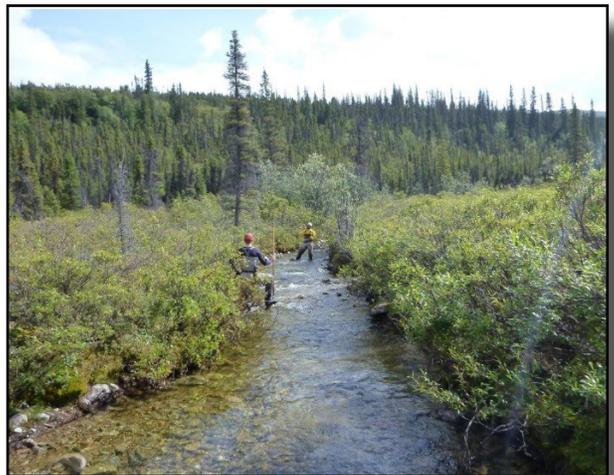
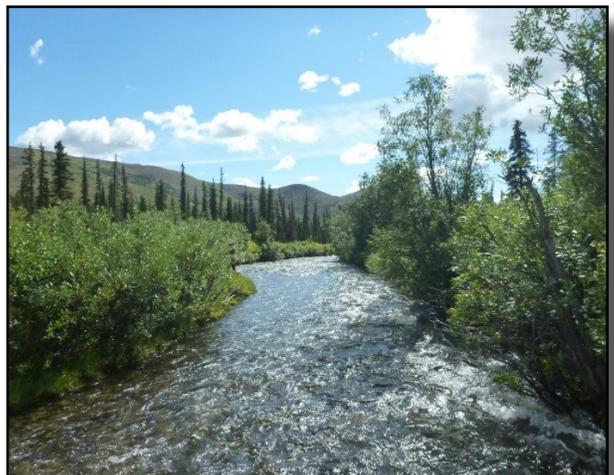
Figure 4. Channel Incision Benchmarks

The following box plot depicts the range of channel incision observed throughout the BLM-managed lands within the EIFO boundaries. The upper image depicts conditions greater than the 95th percentile of the distribution. In the image you can see that the stream is incised, meaning that the stream cannot easily access its floodplain. In the middle (50th percentile) and lower (5th percentile) images you can see that the stream is well connected to its floodplain. Incision values above the 75th and 95th percentiles of minimally disturbed conditions were used as benchmarks for Functioning at Risk and Non-Functioning ratings, respectively.

Channel incision results in disconnected floodplains and can negatively impact nutrient retention, dissipation of stream energy, riparian ecosystem development and maintenance, and biological diversity (Knighton 1998, Leopold et al. 1992). Channel incision is computed from the difference in elevation of the bankfull stage and the top of low bank, and can range from -1 (non incision: low bank height = to bankfull stage) to ~ 2 (significant incision: low bank height $>$ bankfull stage height)(BLM TR 1735-3). We observed a minimum value of -1 and a maximum value of 0.15, with the 75th and 95th percentiles equal to -0.155 and 0.002, respectively, among the 39 reference sites (Figure 4). Overall, these benchmarks suggest a low degree of naturally occurring incision throughout the BLM-managed lands within the EIFO boundaries.

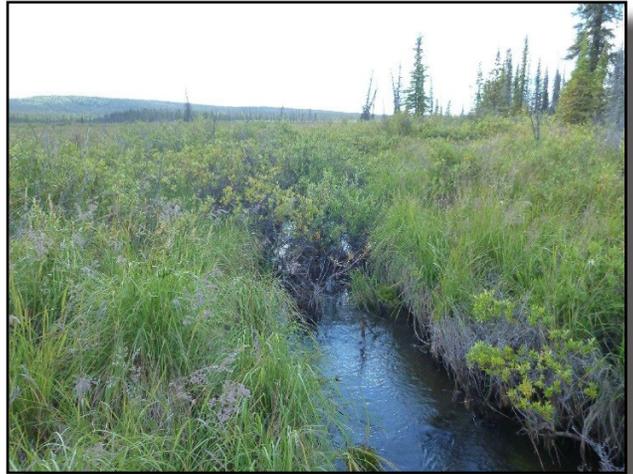
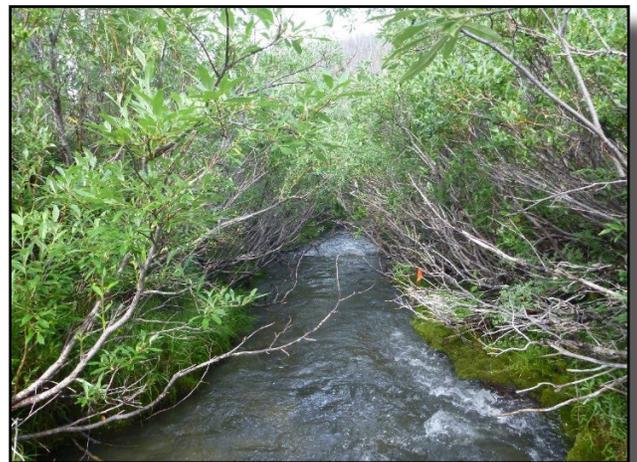
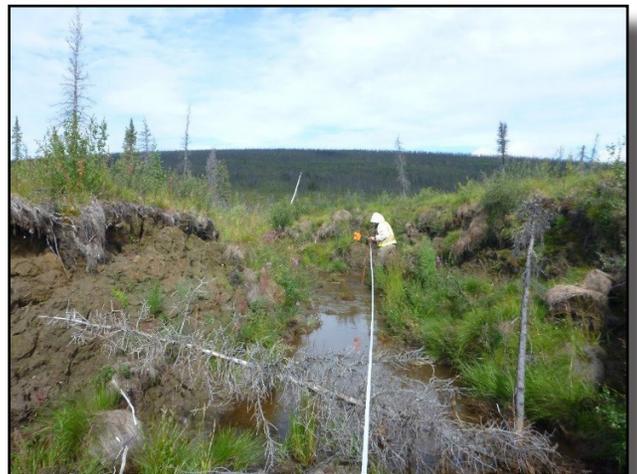
Figure 5. Bank Cover and Bank Stability Benchmarks

The following box plot depicts the range of bank cover/stability measured within the BLM-managed lands within the EIFO boundaries. The upper image depicts the 95th percentile of the distribution. In the image you can see that the streambanks are well covered with a diverse mix of vegetation types and high root densities. In the middle image (50th percentile) the banks are well covered and stable. The lower image, which represents conditions less than the 5th percentile, illustrates streambanks that are actively eroding with patchy vegetation. Bank cover and stability values below the 25th and 5th percentiles of minimally disturbed conditions were used as benchmarks for Functioning at Risk and Non-Functioning ratings, respectively.

Bank cover and stability are calculated as one metric. A bank is considered stable and covered if it has greater than 50% cover and lacks features of instability (e.g., fracture, slump block). The combined bank cover and stability indicator is determined by collecting 42 bank stability and cover measurements at each site. Bank cover and stability ranges from zero to 100, with lower values indicating banks susceptible to accelerated erosion. We observed a minimum value of 37% and a maximum value of 100%, with the 25th and 5th percentiles equal to 64 and 41.9%, respectively (Figure 5). These values characterize the range of potential natural conditions throughout the field office and suggest a moderate degree of naturally occurring bank cover and stability. Bank cover and stability values need to be lower than 41.9% before they would be characterized as having 'major' departure from reference (bottom photograph in Figure 5).

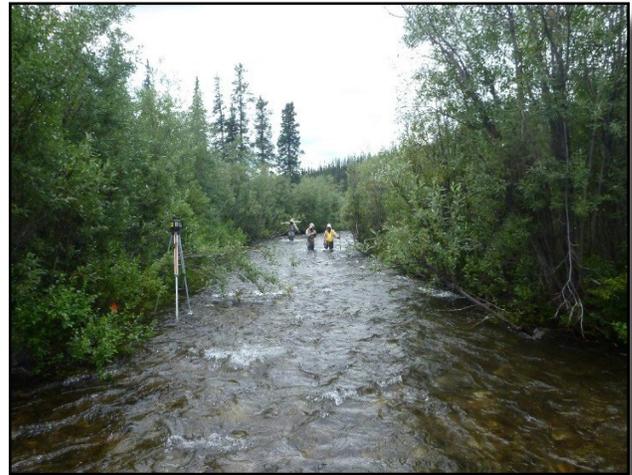
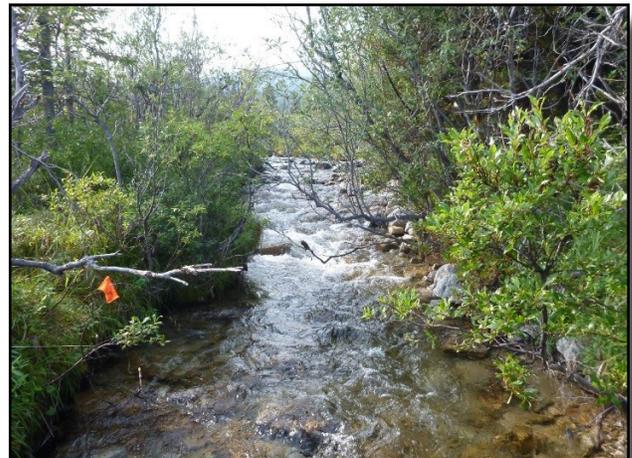
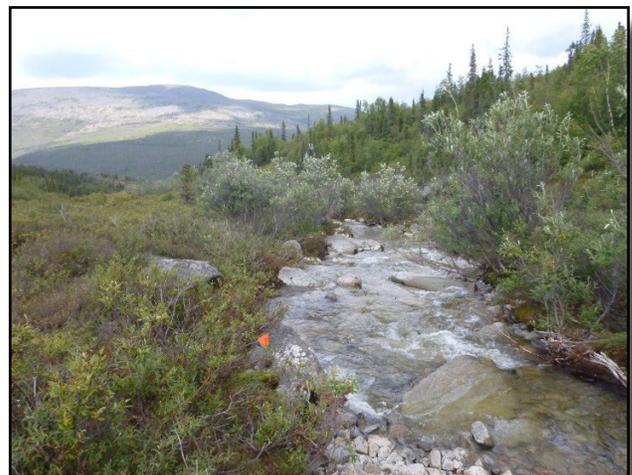
Figure 6. Riparian Vegetation Complexity Benchmarks

The following box plot depicts the range of riparian vegetation complexity measured within the BLM-managed lands within the EIFO boundaries. The upper image depicts the 95th percentile of the distribution. In the image you can see that the riparian vegetation includes a diverse canopy, understory, and groundcover of varying age classes. In the middle (50th percentile) image, the vegetation is also diverse, but is more shrub dominated. The lower (5th percentile) image illustrates a riparian community containing a lower diversity of the three vegetative strata. Values below the 25th and 5th percentiles of minimally disturbed conditions were used as benchmarks for Functioning at Risk and Non-Functioning ratings, respectively.

Riparian zones are transitional areas between terrestrial and aquatic ecosystems that provide important habitat for organisms and influence many physical and ecological processes including flood dissipation, nutrient cycling, shade, and cover to reduce thermal loading (Naiman and Decamps 1997). Maintaining an intact riparian corridor is fundamental to a stable stream channel and supports both chemical and biological stream functions (Harman et al. 2012, Perucca et al. 2007). Riparian vegetative complexity is determined by visually estimating the percent aerial cover for the three different layers, or strata, of vegetation (canopy, understory, and groundcover) and can range from zero (<10% vegetation cover) to 2.6 (> 87% vegetative cover for all three strata). We observed a minimum value of 0.66 and a maximum value of 2.16, with the 25th and 5th percentiles equal to 1.22 and 0.99, respectively (Figure 6). The wide range of values highlight the diversity of riparian conditions from forested systems to more open tundra systems. Riparian vegetative complexity values need to be below 0.99 before they would be characterized as having 'major' departure from reference (bottom photograph in Figure 6).

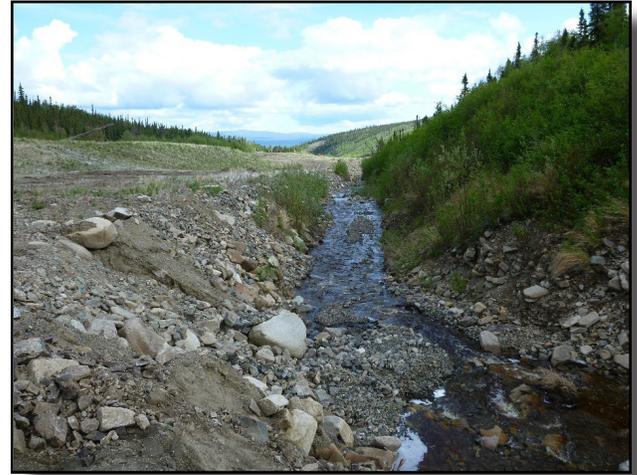
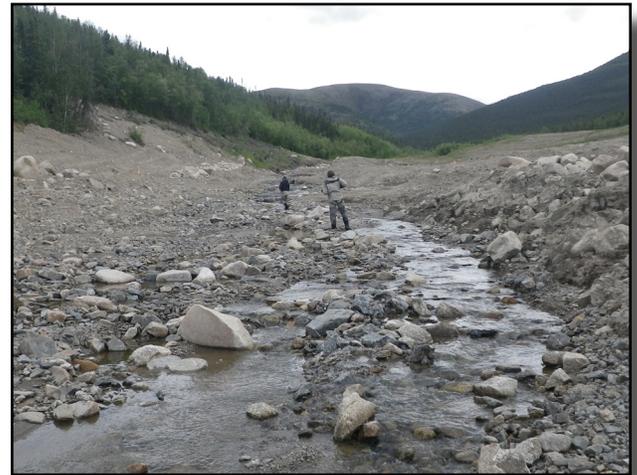
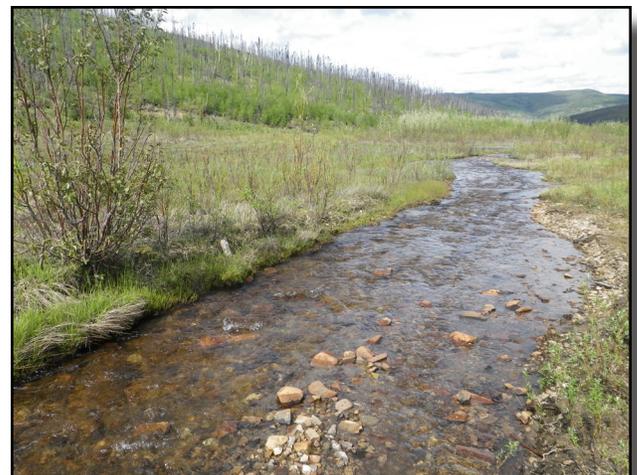
Figure 7. Channel Incision at Reclaimed Sites Compared to Benchmark Values

The following box plots depict the range of channel incision measured at reclaimed placer mined sites compared to the range of reference condition within the BLM-managed lands within the EIFO boundaries. The upper image depicts conditions greater than the 95th percentile of the reclaimed distribution, which represents a deeply incised channel that is disconnected from the floodplain. In the middle image (50th percentile) the stream is Functioning at Risk with slight incision, while the lower image (5th percentile) is well connected to its floodplain and within the range of properly functioning condition.

Upper Photograph
Ketchum Creek, Steese Planning Unit, Eastern Interior planning area, five years since reclamation

Middle Photograph
Ketchum Creek, Steese Planning Unit, Eastern Interior planning area, one year since reclamation

Lower Photograph
Kokomo Creek, Steese Planning Unit, Eastern Interior planning area, eleven years since reclamation.

As noted in the table above, the majority (6 of 10) of the assessed streams were found to have channel incision values that were within the Functioning at Risk category based on a moderate departure from reference condition (-0.16, Figure 7, page 14). Minimum and maximum values for channel incision were -0.2 and 0.52 respectively. Only one site, Kokomo Creek, was found to be within the Properly Functioning Condition category for channel incision.

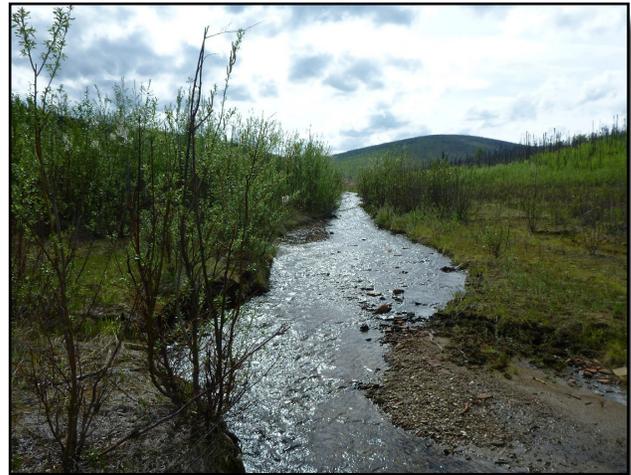
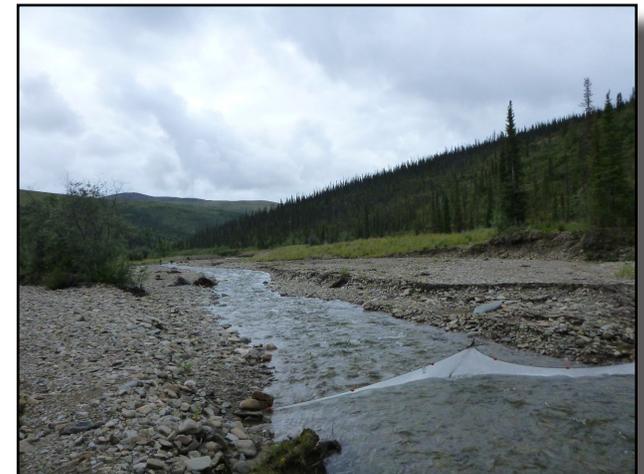
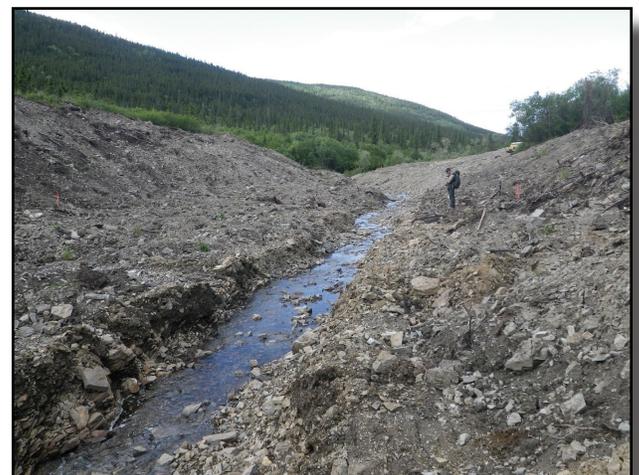
Figure 8. Bank Cover and Bank Stability Box Plots

The following box plots depict the range of bank cover and bank stability measured at reclaimed placer mined sites compared to the range of reference condition within the BLM-managed lands within the EIFO boundaries. The upper image depicts conditions greater than the 95th percentile of the reclaimed distribution, which is within the Functioning at Risk range of the reference distribution roughly 11 years after reclamation. In the image you can see that the streambanks are moderately covered with herbaceous species and sparse early age class willow species. In the middle image (50th percentile) the banks are dominated by unconsolidated gravel and cobble, with evidence of scour. The lower image (5th percentile) illustrates unstable streambanks dominated by sand with some cobble and gravel. The vast majority of surveyed reclamation sites were Non-Functioning for this indicator.

Kokomo Creek, Steese Planning Unit, Eastern Interior planning area, eleven years since reclamation.

The majority (8 of 10) of reclaimed reaches were found to have bank cover and stability values that were within the Non-Functioning category based on a major departure from reference condition (<41.9%, Figure 7). Minimum and maximum values for bank cover and stability were 0% and 47%, respectively. Even after 11 years of post-reclamation recovery, bank cover and stability values still indicated a moderate departure from reference condition at one site (Kokomo Creek) (Figure 8, upper image, page 15).

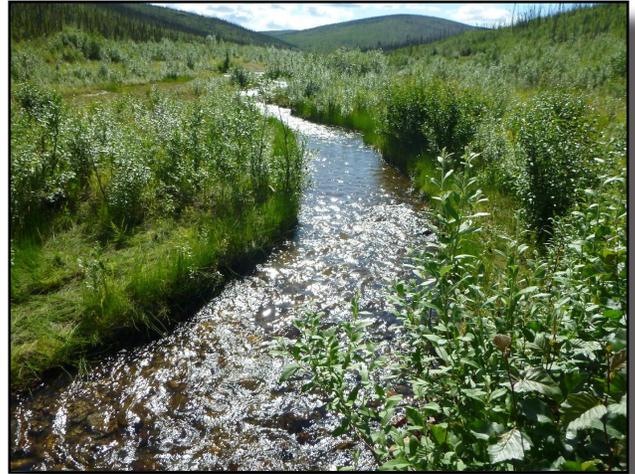
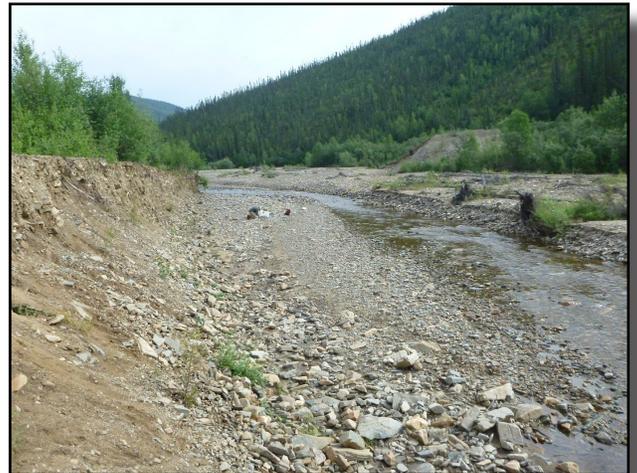
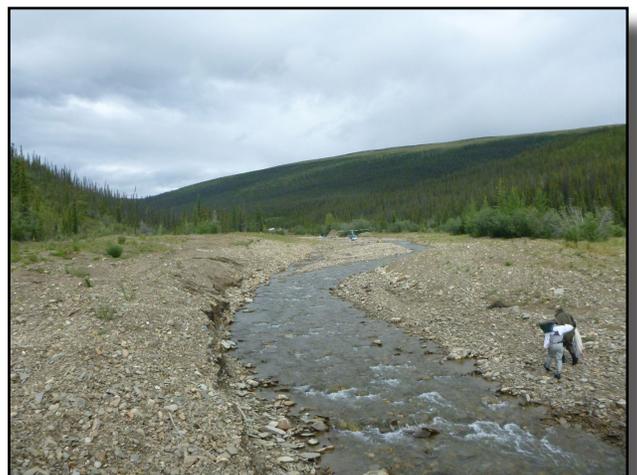
Figure 9. Riparian Vegetation Complexity Box Plots

The following box plots depict the range of riparian vegetation complexity measured at reclaimed placer mined sites compared to the range of reference condition within the BLM-managed lands within the EIFO boundaries. The upper image depicts the 95th percentile of the reclaimed distribution. In the image you can see that the riparian vegetation has limited structural diversity; however, conditions are within the Functioning at Risk portion of the reference distribution. In the middle image (50th percentile) vegetation is largely absent and the floodplain is made up of small cobbles and gravels, which make it difficult for riparian vegetation to establish itself. The lower 5th percentile contains basically no vegetation near the stream channel even four years after reclamation. The majority of reclaimed sites have limited riparian vegetation near the stream and are Non-Functioning.

Kokomo Creek, Steese Planning Unit, Eastern Interior planning area, eleven years since reclamation

The majority (8 of 10) of reclaimed reaches were found to have riparian vegetation complexity values that were within the Non-Functioning category based on a major departure from reference condition (<0.99, Figure 9, page 16). Minimum and maximum values for riparian vegetation complexity were 0 and 1.25, respectively. These results are largely due to the reliance on natural recovery processes to reestablish near stream riparian habitat, which is difficult based on the loss of growth medium during mining, the short growing season, concentrated run-off during spring break-up of channel ice, and channel adjustments following reclamation. Only one reclaimed stream reach was within the Functioning at Risk category based on a moderate departure from reference condition with a value of 1.04.

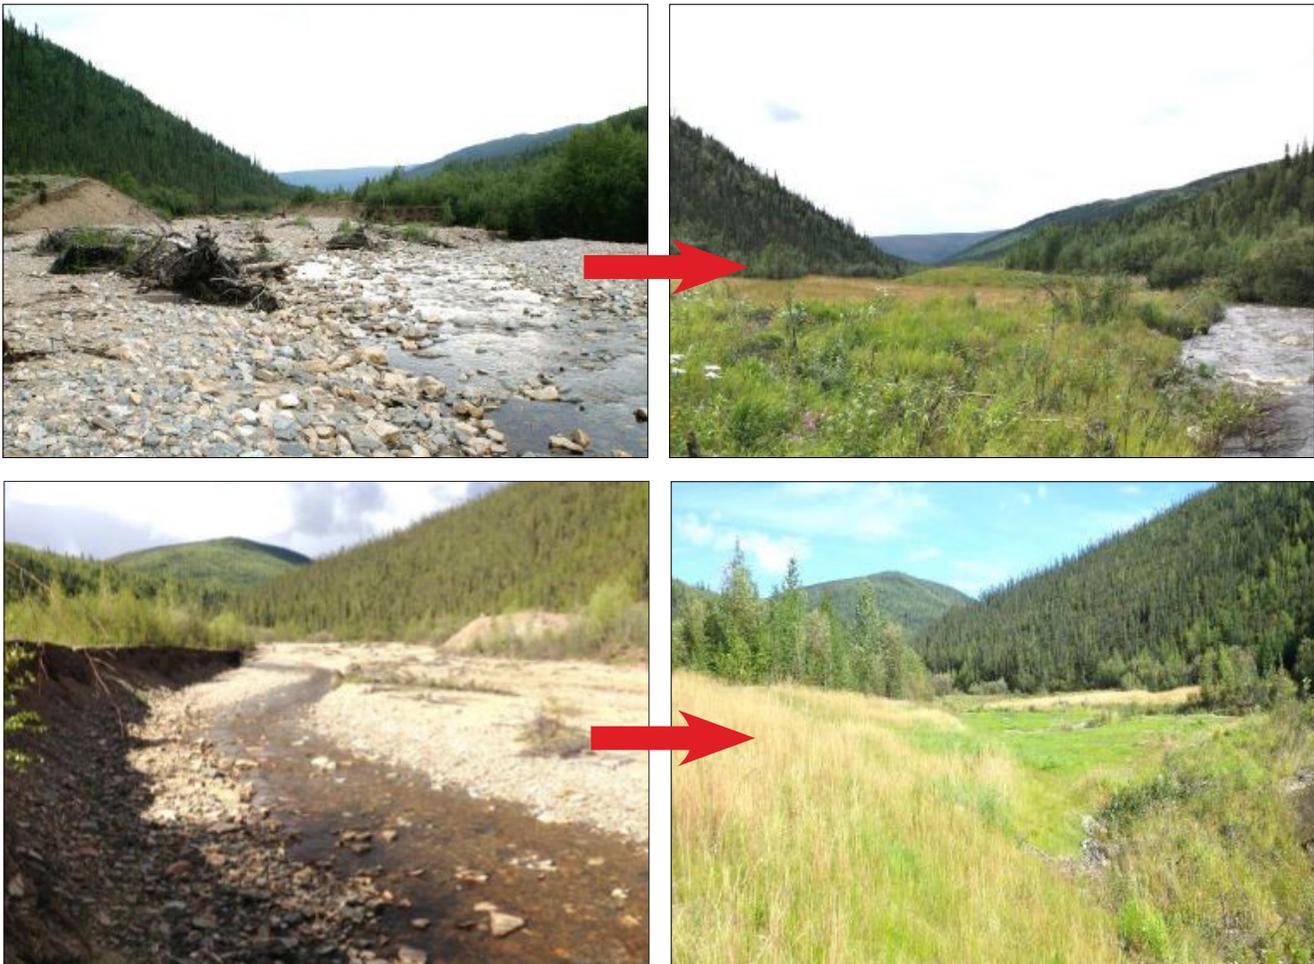
Photographs 1, 2, 3, & 4. Jack Wade Creek (MP 85 on Taylor Highway). Left images illustrate conditions after being mined and left to reclaim naturally for over 20 years. Right images show conditions one year after implementing the latest science regarding natural channel design.

In addition to the photographs above, Table 2 shows the conditions of the Jack Wade Creek site following 20 years of natural recovery after mining ended, as well as conditions after implementation of the BLM project in early 2015. These results strongly contrast with AIM-NAMF data collected from past reclamation projects using traditional techniques. By applying the latest science and techniques commonly used outside of Alaska, the BLM was able to move stream conditions from largely non-functioning to functioning for most indicators within a few weeks at this previously mined site. Riparian vegetation complexity remained non-functioning due in part to the transplanting of vegetation mats, which had the shrubs cut back thereby removing the canopy cover, and the predominately herbaceous vegetation on the site. Recent monitoring has noted improved structural diversity within the transplanted areas and young willows emerging along the stream point bars. A project completed in 2017 utilized uncut transplants to create the streambanks and floodprone benches of the stream. This site is shown in the photographs below and will be evaluated using AIM-NAMF beginning in 2018.

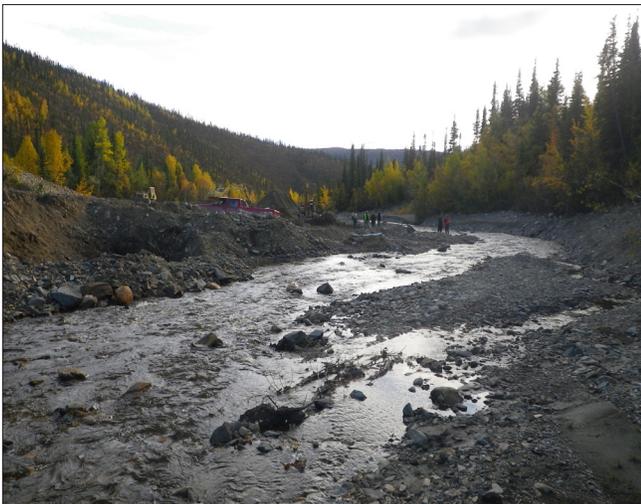
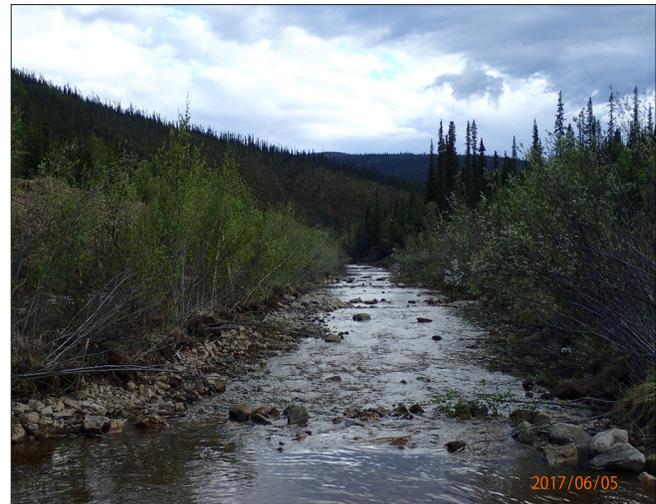
Photographs 5 & 6. Left image depicts pre-reclamation conditions at the site, which contained limited streambank vegetation, no pool habitats, and unstable streambanks. The image on the right was taken on Day 5 of the stream reclamation project, which took less than two weeks to complete. The streambanks were transplanted with vegetation from the next mining cut and stream habitats were created via the construction of pools and riffles.
