RIPARIAN AREA MANAGEMENT

Process for Assessing
Proper Functioning Condition

U.S. Department of the Interior Bureau of Land Management Proper Functioning Condition Work Group

Technical Reference 1737-9 1993; Revised 1995, 1998

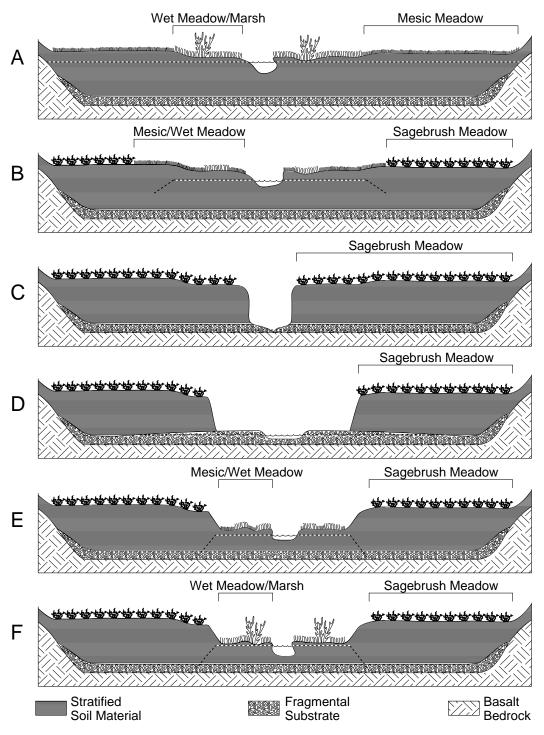
Figure 1. Succession of states for alluvial/nongraded valley-bottom type.

To understand these processes, an example of an alluvial/nongraded valley-bottom type riparian area in both a functional and nonfunctional condition is provided in Figure 1 (Jensen, 1992). Using the Bureau's definitions for PFC, **State A** represents

States C and D would be classified as nonfunctional conditions. **State C** represents incisement of the stream channel to a new base level. There is little or no bank stabilizing vegetation and no floodplain. Channel widening exhibited in **State D** must occur to restore floodplain development. Vegetation, if present, is often only temporary due to the large adjustment process occurring. The following changes in attributes/processes are likely in **States C and D**:

State E may again be classified as functional-at risk or functional depending on vegetation, soil, and hydrologic attributes. Establishment of the floodplain and bank stabilizing vegetation indicate reestablishment of functional conditions. However, stream segments in this state are usually at risk for the same reasons described for **State B**. Attributes and processes would revert back to those that appear in **State B**.

Appendix C contains examples of other kinds of riverine systems found on BLM managed lands (Jensen, 1992). The analogy used for Figure 1 can be applied to most of the examples found in Appendix C because differing channel types do have functional commonality. However, differing channel types may accommodate their own unique evolutionary processes. Information concerning the classification system used by Jensen can be found in BLM technical reference TR 1737-5 (Gebhardt et al., 1990).

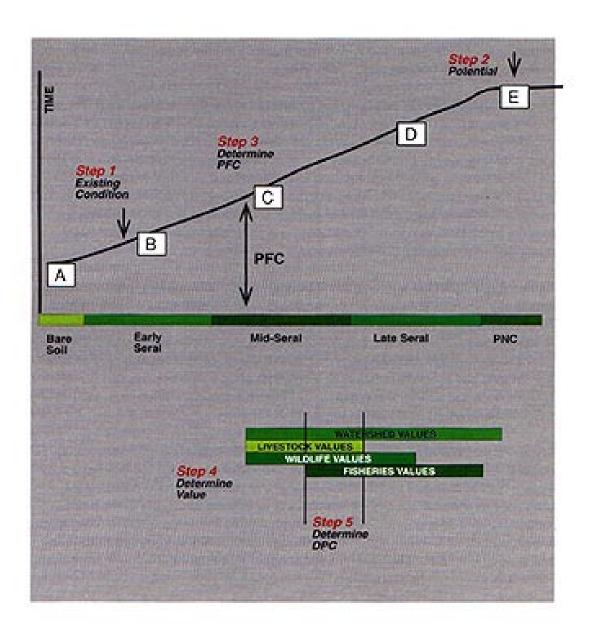
Figure 2. Succession for stream recovery.

Figures 2 and 3 provide an example of the relationship between PFC and vegetation community succession for one area. Assuming succession continues uninterrupted (Step 1 to Step 2 in Figure 2), the channel will evolve through some predictable changes from bare ground to PNC (although not necessarily as linearly as depicted). The riparian-wetland area will progress through phases of not functioning, functioning—at risk, and properly functioning along with plant succession. In this example, PFC occurs at the mid-seral stage (Step 3). Figure 3 shows a stream cross section of each condition (A-E) displayed in Figure 2.

At various stages within this successional process, the stream can provide a variety of values for different uses (Step 4). In Figure 2, optimal conditions for grazing occur when forage is abundant and the area is stable and sustainable (mid-seral). Wildlife goals depend upon the species for which the area is being managed. If the riparian zone in Figure 2 is to provide habitat for shrub nesting birds, the optimum conditions would be from mid- to late seral. Trout habitat conditions would be optimum from mid-seral to late seral. The threshold for any goal is at least PFC because any rating below this would not be sustainable.

A logical manner to incorporate the information collected into a management plan is as follows (refer to Figure 2 in the Functioning Condition section):

By the end of the 1978 growing season, Texas Creek progressed to where it had crossed its threshold as described in Figure 2 in the Functioning Condition section. Using the Bureau's definitions, in October 1978, Texas Creek would have a rating of *PFC*. Yet, by no means had Texas Creek achieved its capability or potential. However, it may have achieved its management objectives and obtained its desired plant community (early seral versus PNC). The early seral vegetation community that had established itself in the October 1978 photo possessed the ability to dissipate stream energies associated with high flows for Texas Creek. The instability that was present in Texas Creek in June 1978 had dissipated and the soil and vegetation attributes that placed Texas Creek into the category of *functional—at risk* were no longer present. Attributes such as reduced erosion; improved water quality; floodplain development; trapment of woody debris; improved retention of flood-water and ground-water recharge; diverse ponding; channel characteristics that provide habitat and water depth, duration, and temperatures necessary for fish production; and other wildlife values had been greatly strengthened.

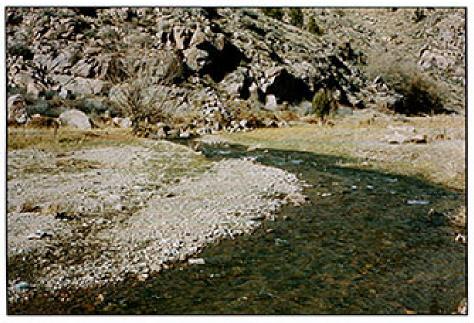
Texas Creek—Colorado June 1978 Functional—At Risk

Texas Creek, located in south-central Colorado on public lands administered by the Canon City District Office, would have been rated *nonfunctional* in 1976 based on the Bureau's definitions. Texas Creek is a small coldwater perennial stream that originates in the Sangre De Cristo Mountains, flowing for approximately 24 miles before it enters the Arkansas River. Inventories conducted in 1976 classified the stream as a laterally unstable area that was moderately confined, severely impacted from continuous grazing, and providing limited fish and wildlife values.

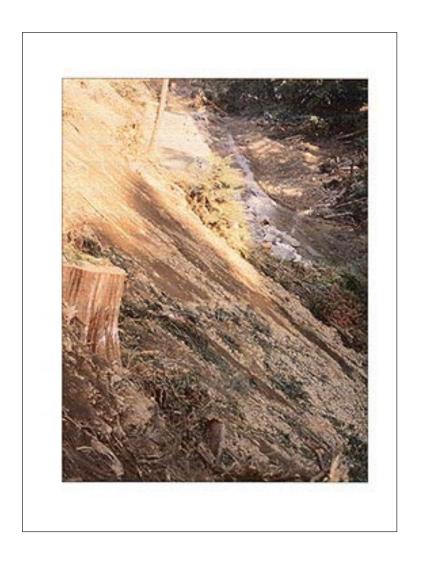
Forested Coastal Stream—Oregon Nonfunctional

The below photograph gives an example of a coastal stream, located in Oregon, that would be rated as *nonfunctional* relative to BLM's definitions for proper functioning condition. The riparian area is clearly not providing adequate vegetation, landform, or large woody debris to dissipate stream energies associated with high flows. During precipitation events, the stream channel migrates, erosion continues, sediment is not filtered, flood-water retention and ground-water recharge are limited, and water quality is altered. Wildlife values are limited, and the area is not providing diverse ponding or channel characteristics that provide habitat and water depth, duration, and temperature necessary for fish production. The area provides little biodiversity.

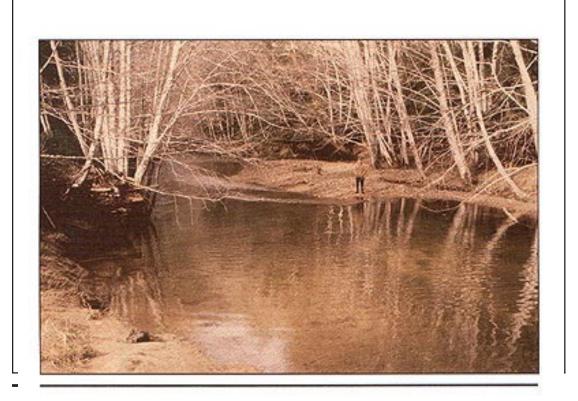
Forested Coastal Stream—Oregon Functional—At Risk

Establishment of alders provides the capacity to dissipate some stream energies that occur with flow events in this area. This capability results in captured sediment and bedload, reduced erosion, and improved water quality, and aids floodplain development and improves flood-water retention and ground-water recharge. In other words, the area has started to function physically.

In spite of functioning, this area would be rated as *functional—at risk* because a vegetation and hydrologic attribute still make the area susceptible to degradation. While the alder plant community does provide root masses that stabilize streambanks against cutting action, it probably is insufficient for major flow events. Large woody debris (hydrologic controls) is also lacking, which inhibits capture of sufficient bedload to aid in the development of habitat that provides water depth, duration, and temperature necessary for fish production, waterfowl breeding, and other uses, thus supporting greater biodiversity.
