Inventory Unit Number/Name: Rock Creek OR135-01

DOCUMENTATION OF BLM WILDERNESS INVENTORY FINDINGS ON RECORD:

a. Unit Number/Name Rock Creek OR135-01

Wilderness Characteristics Inventory Results

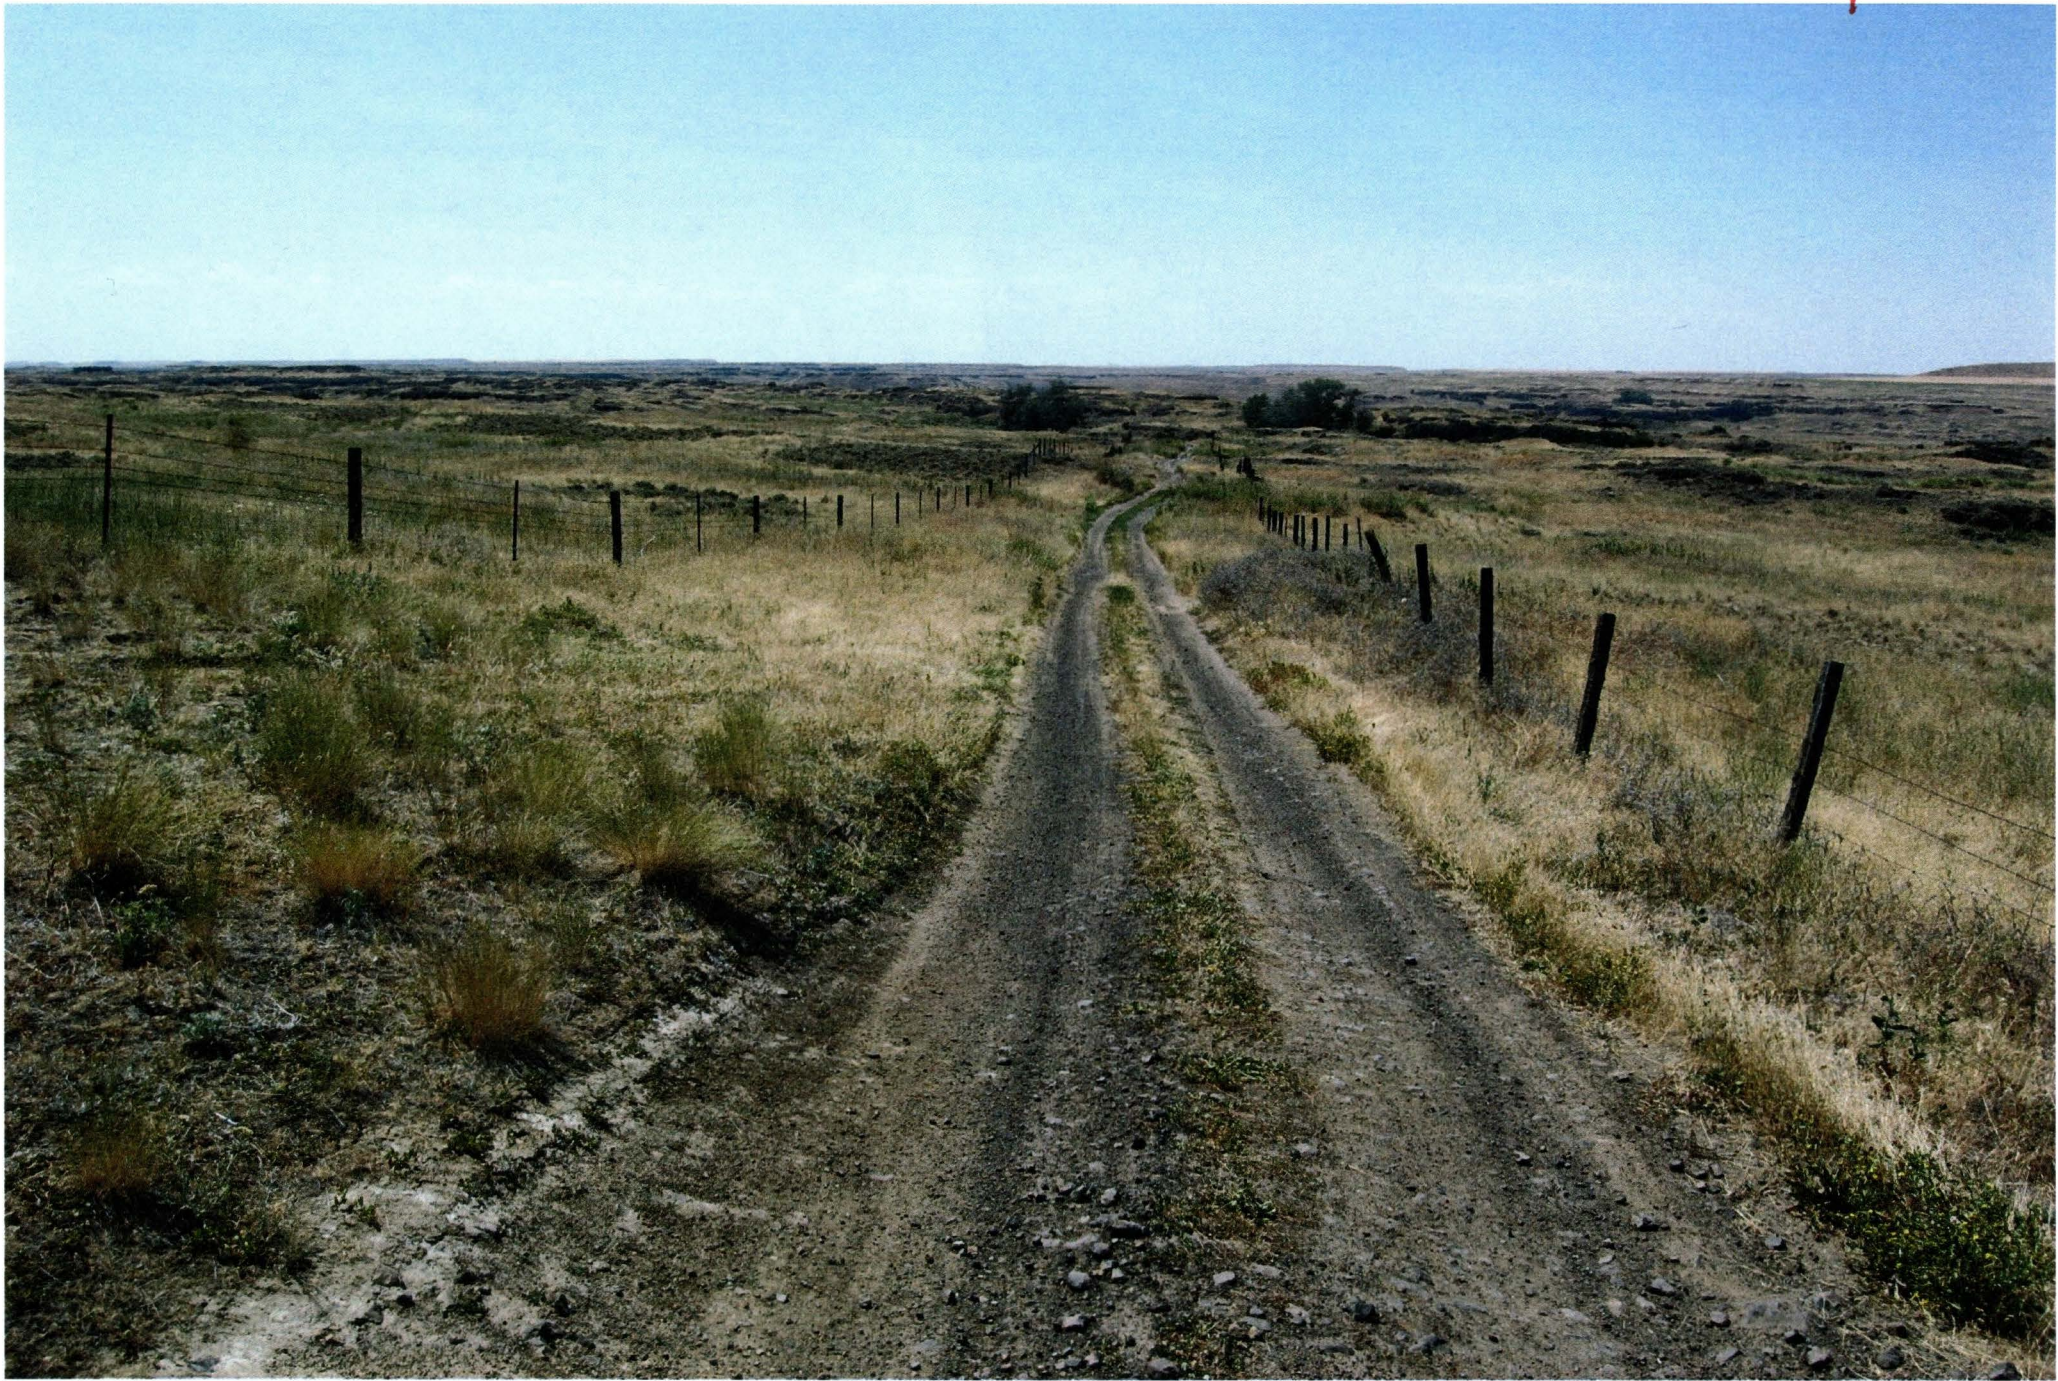
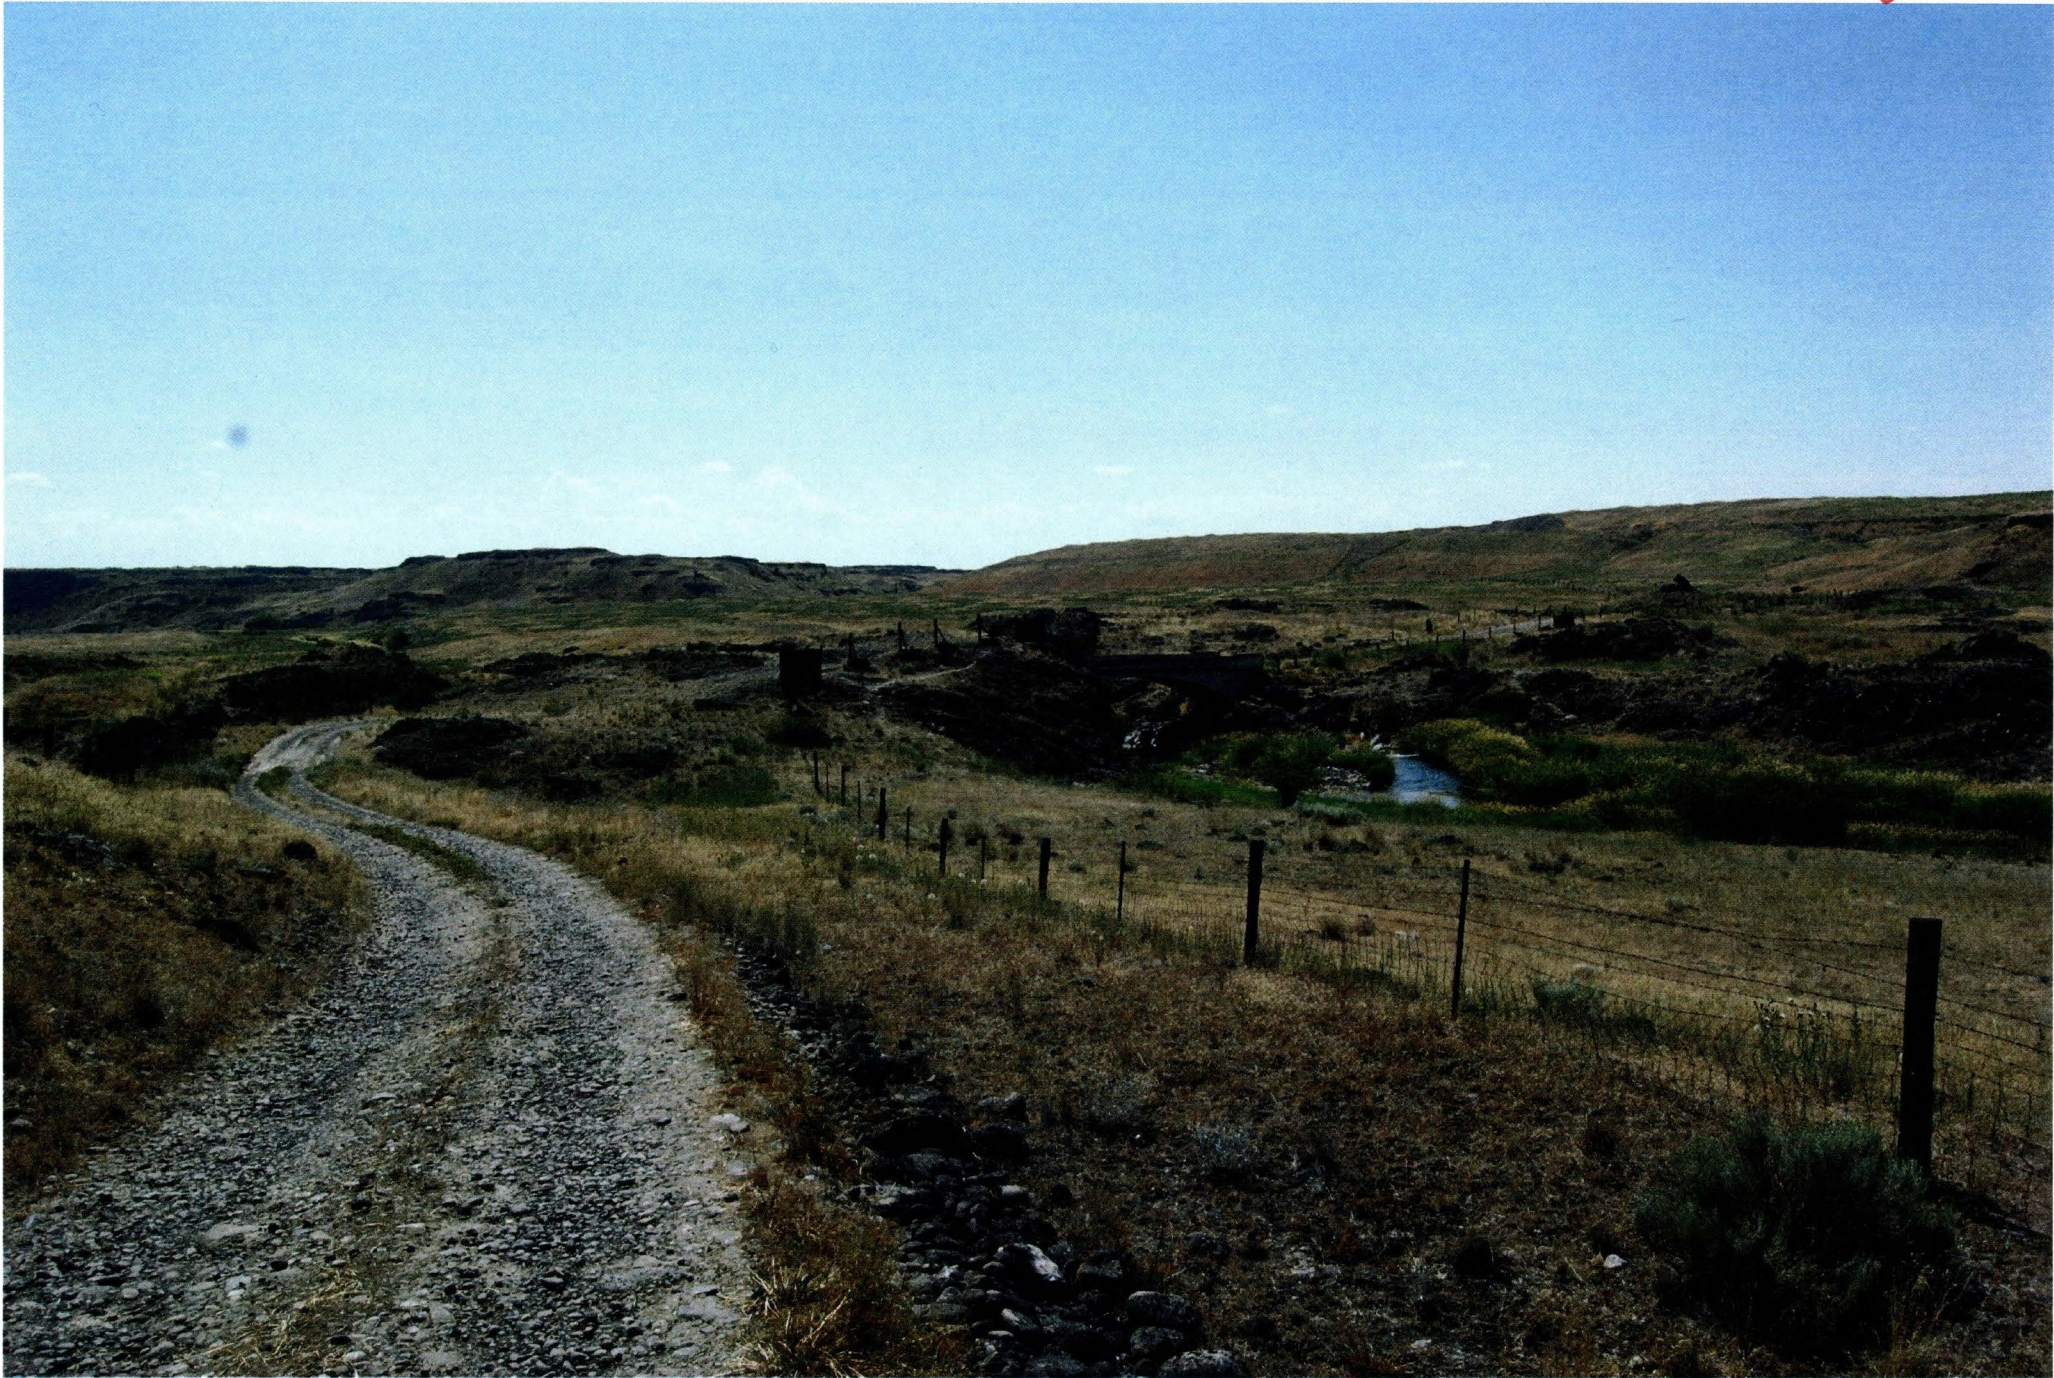
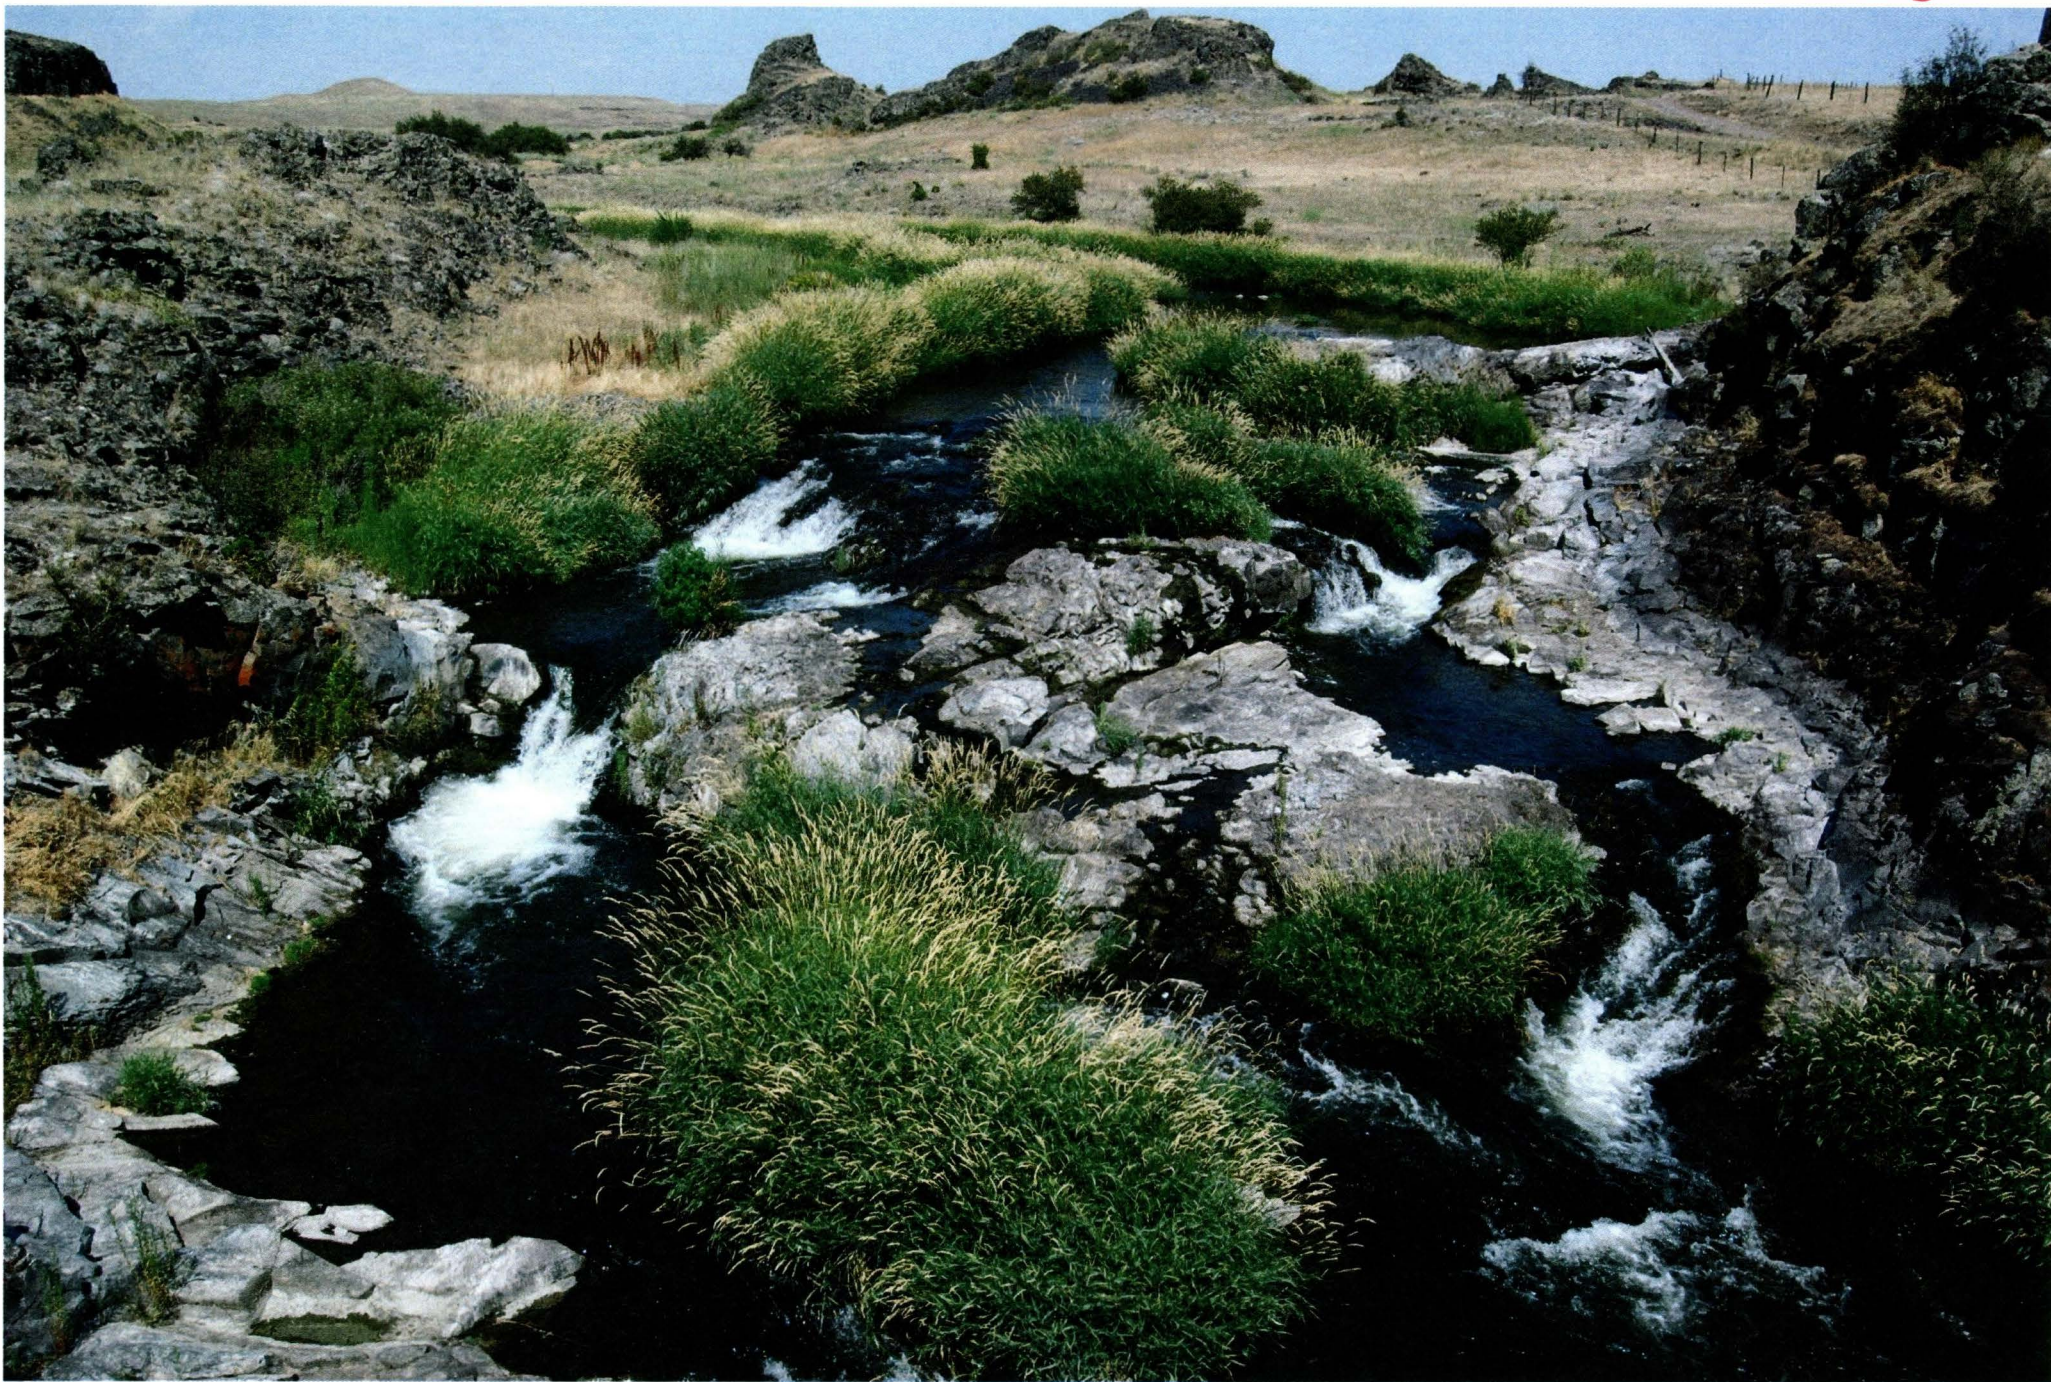
I. LOCATION: refer to attached field and final map and BLM corporate data (GIS). T 18 N., R 39 E., Section 18, running west towards Paxton. Reference photos #1-3.

Describe: substantial improvements located along it, including signing and a concrete bridge spanning Rock Creek.

Explain: Although not recent, there is evidence of graveling and grading of the road to the point of allowing access for regular and continuous use for vehicles suited to the purpose of the road.

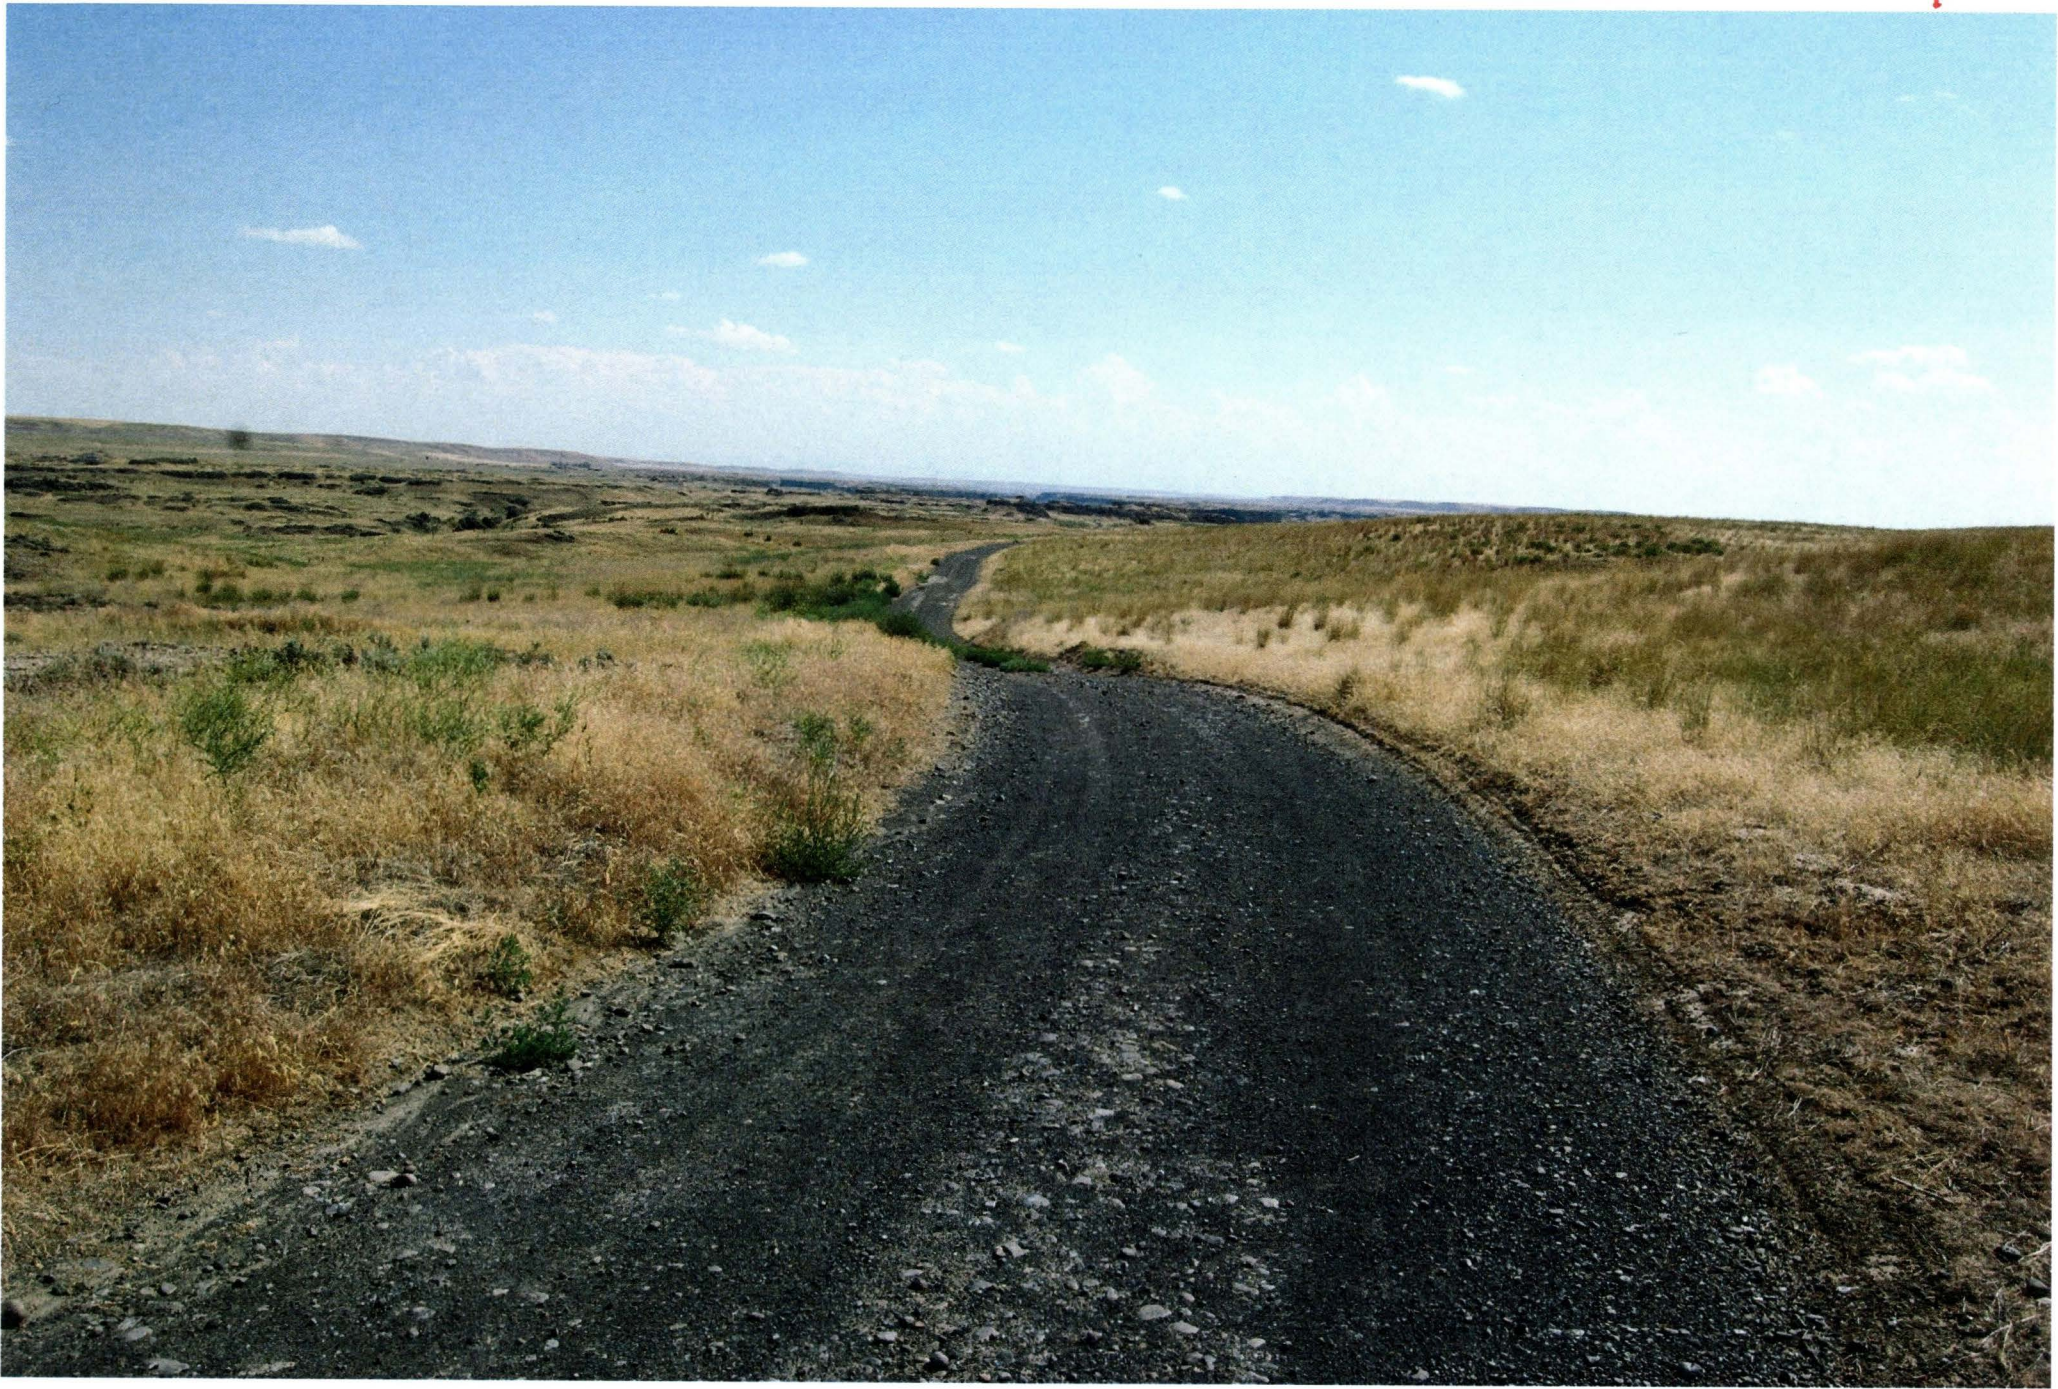
I. LOCATION: refer to attached field and final map and BLM corporate data (GIS). T 18 N., R 39 E., Section 18, running south towards Rock Creek Recreation Site. Reference photo #4.

Explain: The road is visibly graveled and rock raked as to the point of allowing access for regular and continuous use for vehicles suited to the purpose of the road.
