Inventory Unit Number/Name: Rock Creek OR135-01

DOCUMENTATION OF BLM WILDERNESS INVENTORY FINDINGS ON RECORD:

a. Unit Number/Name Rock Creek OR135-01

Wilderness Characteristics Inventory Results

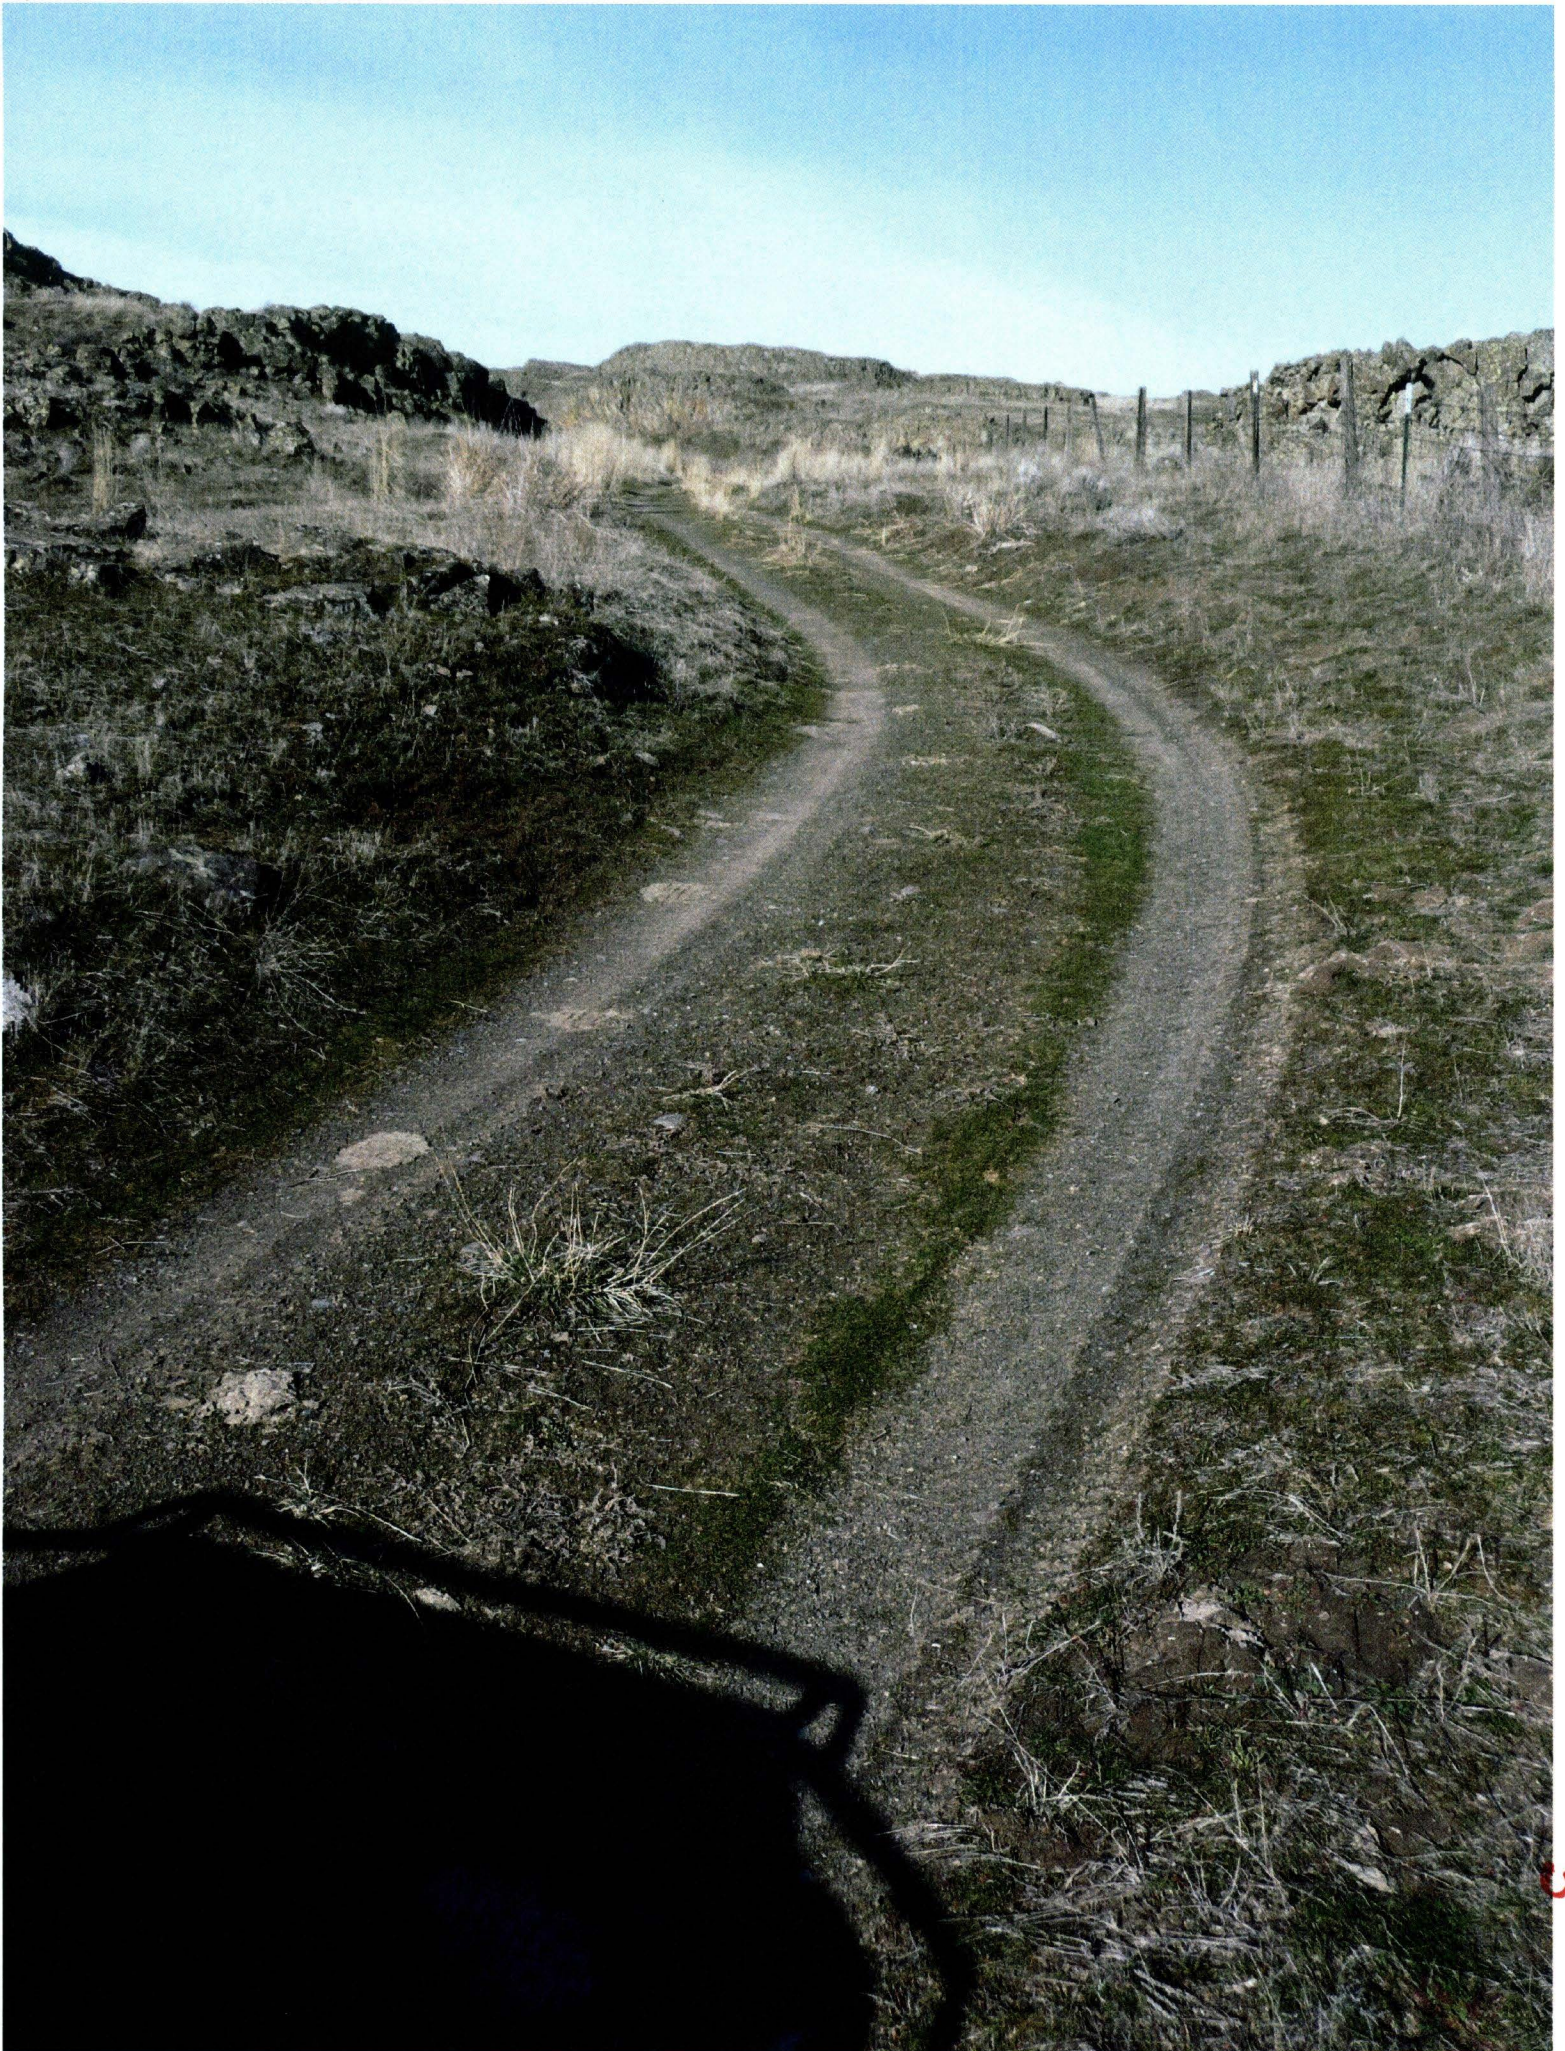
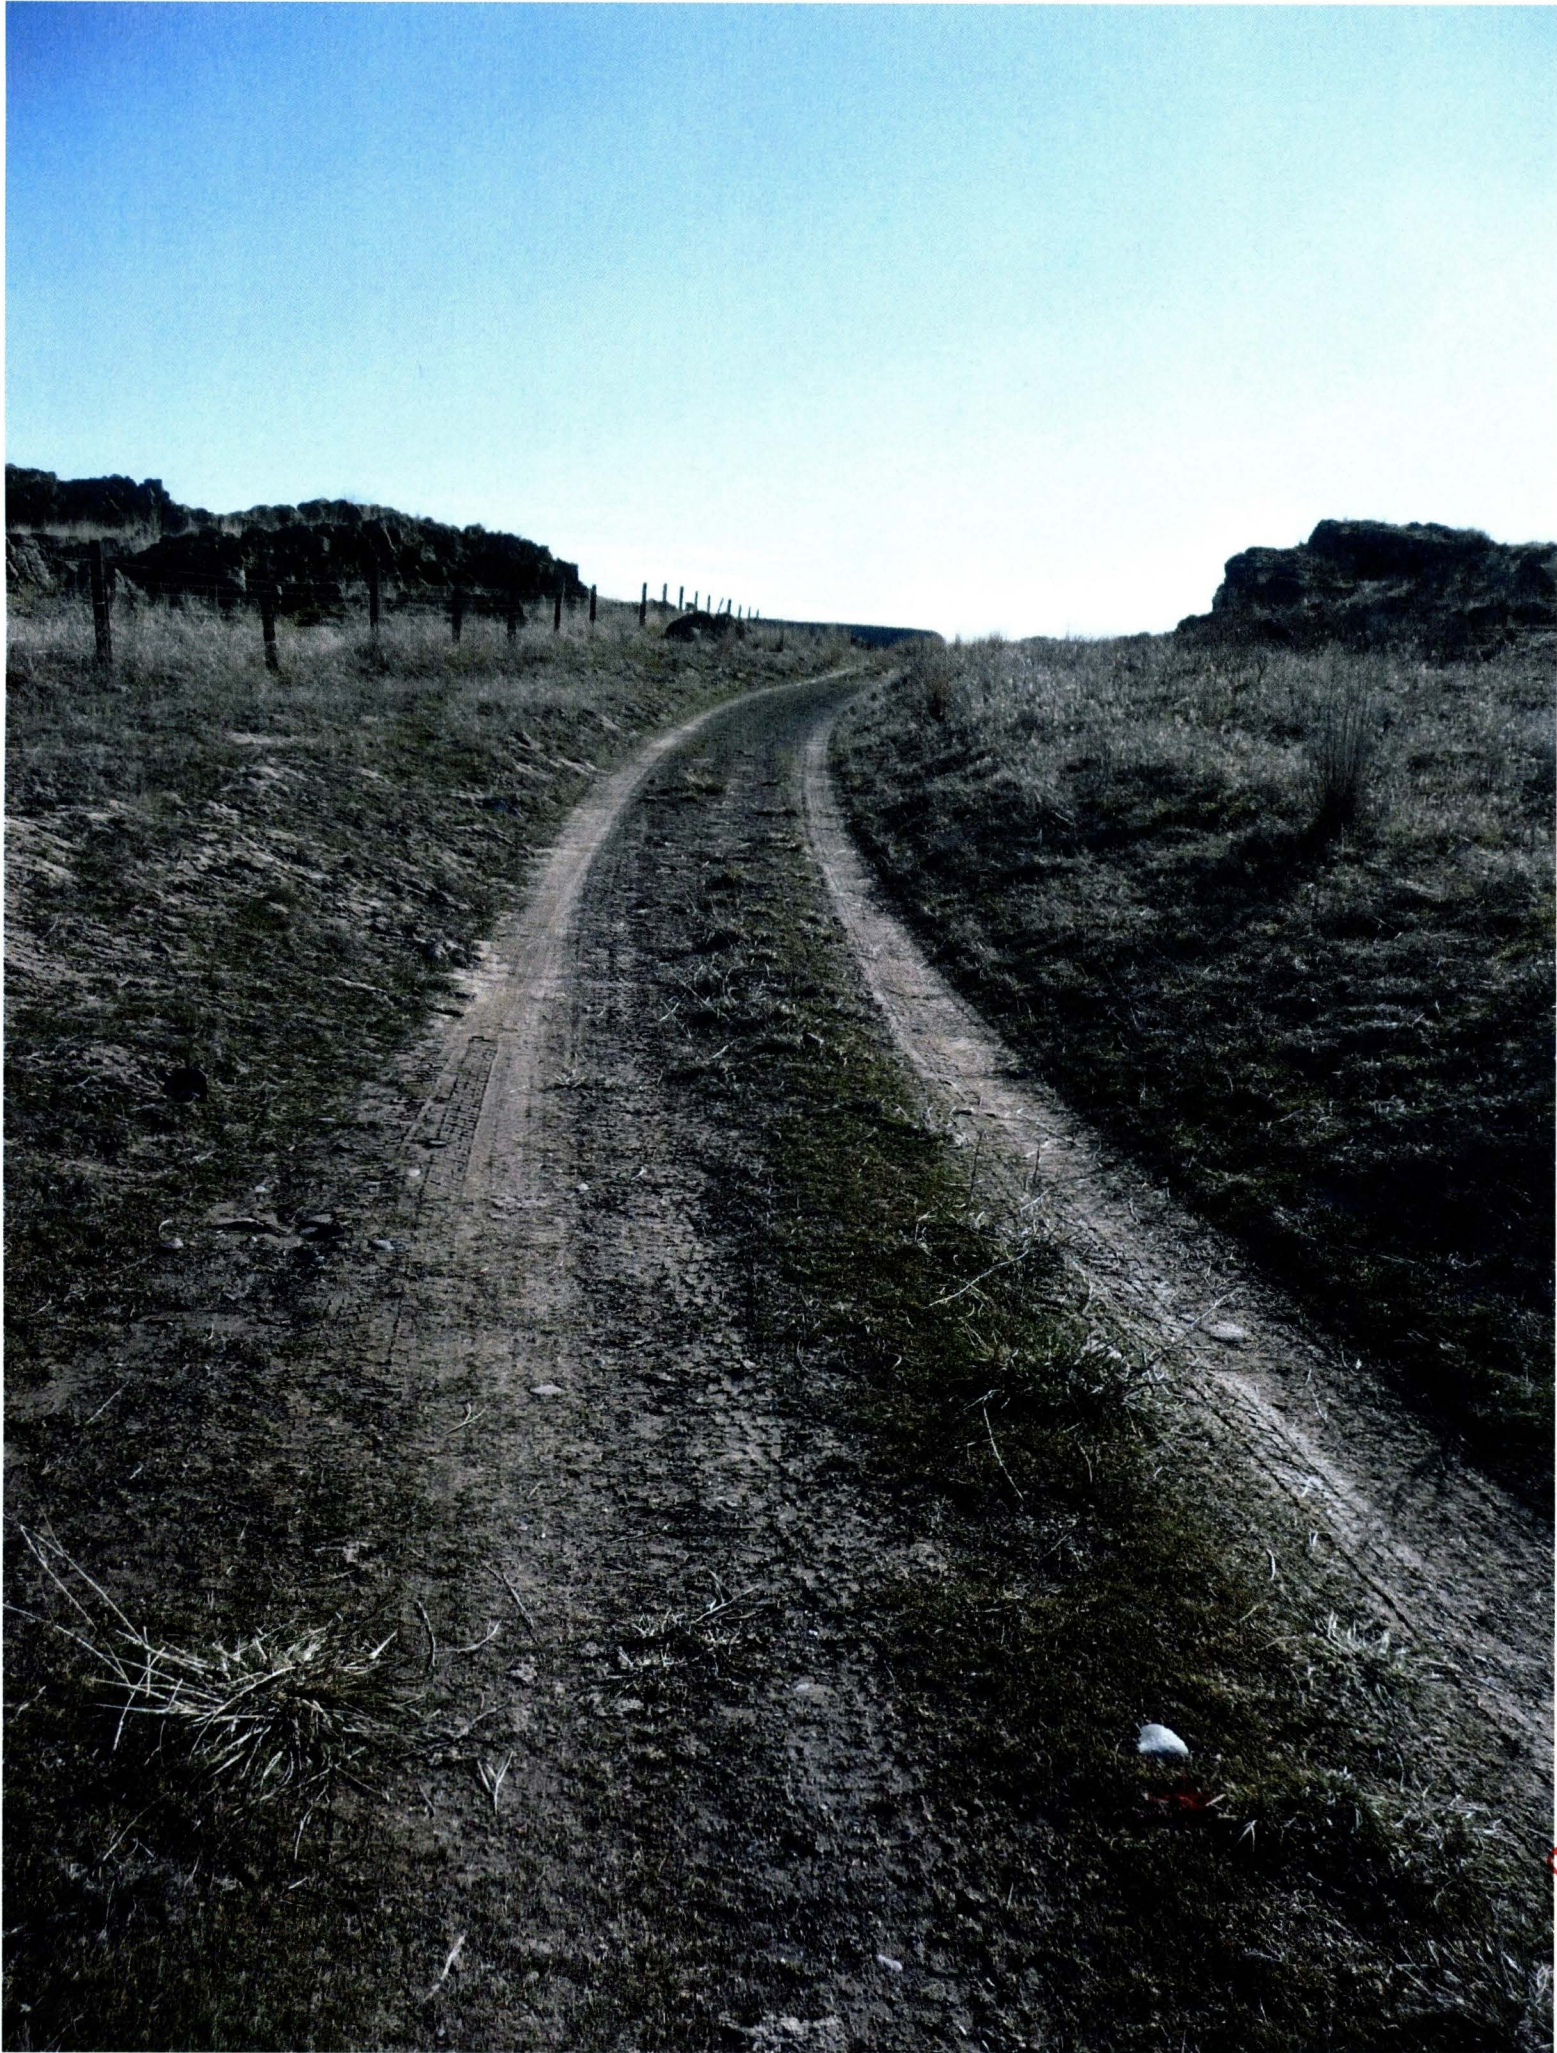
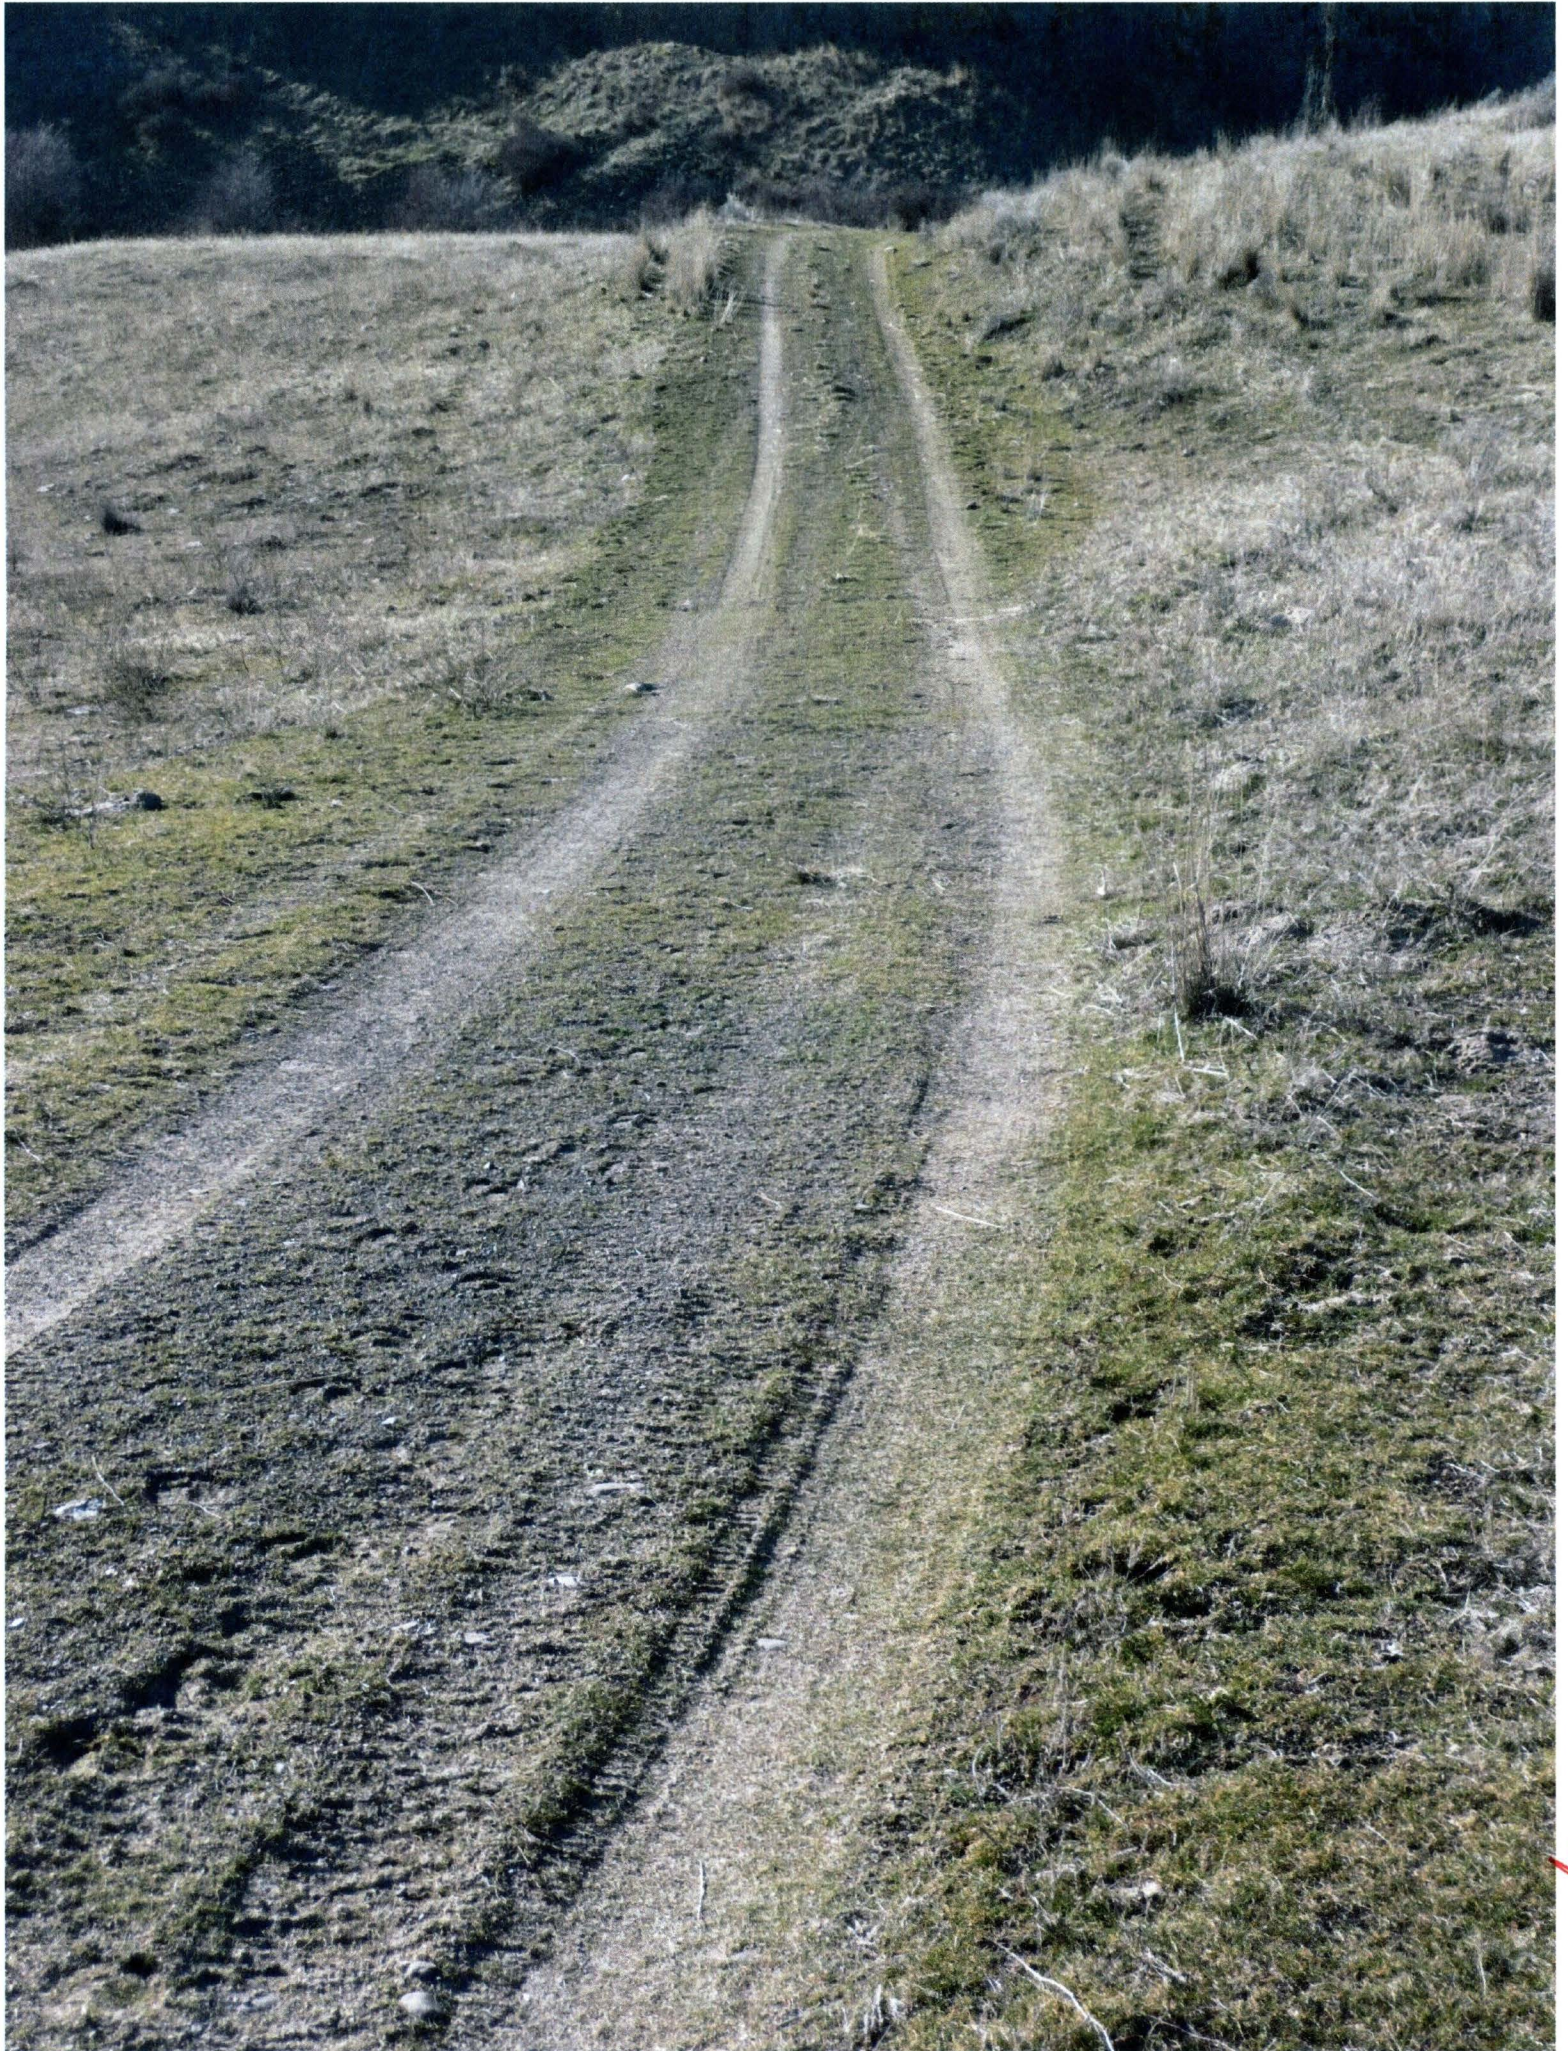
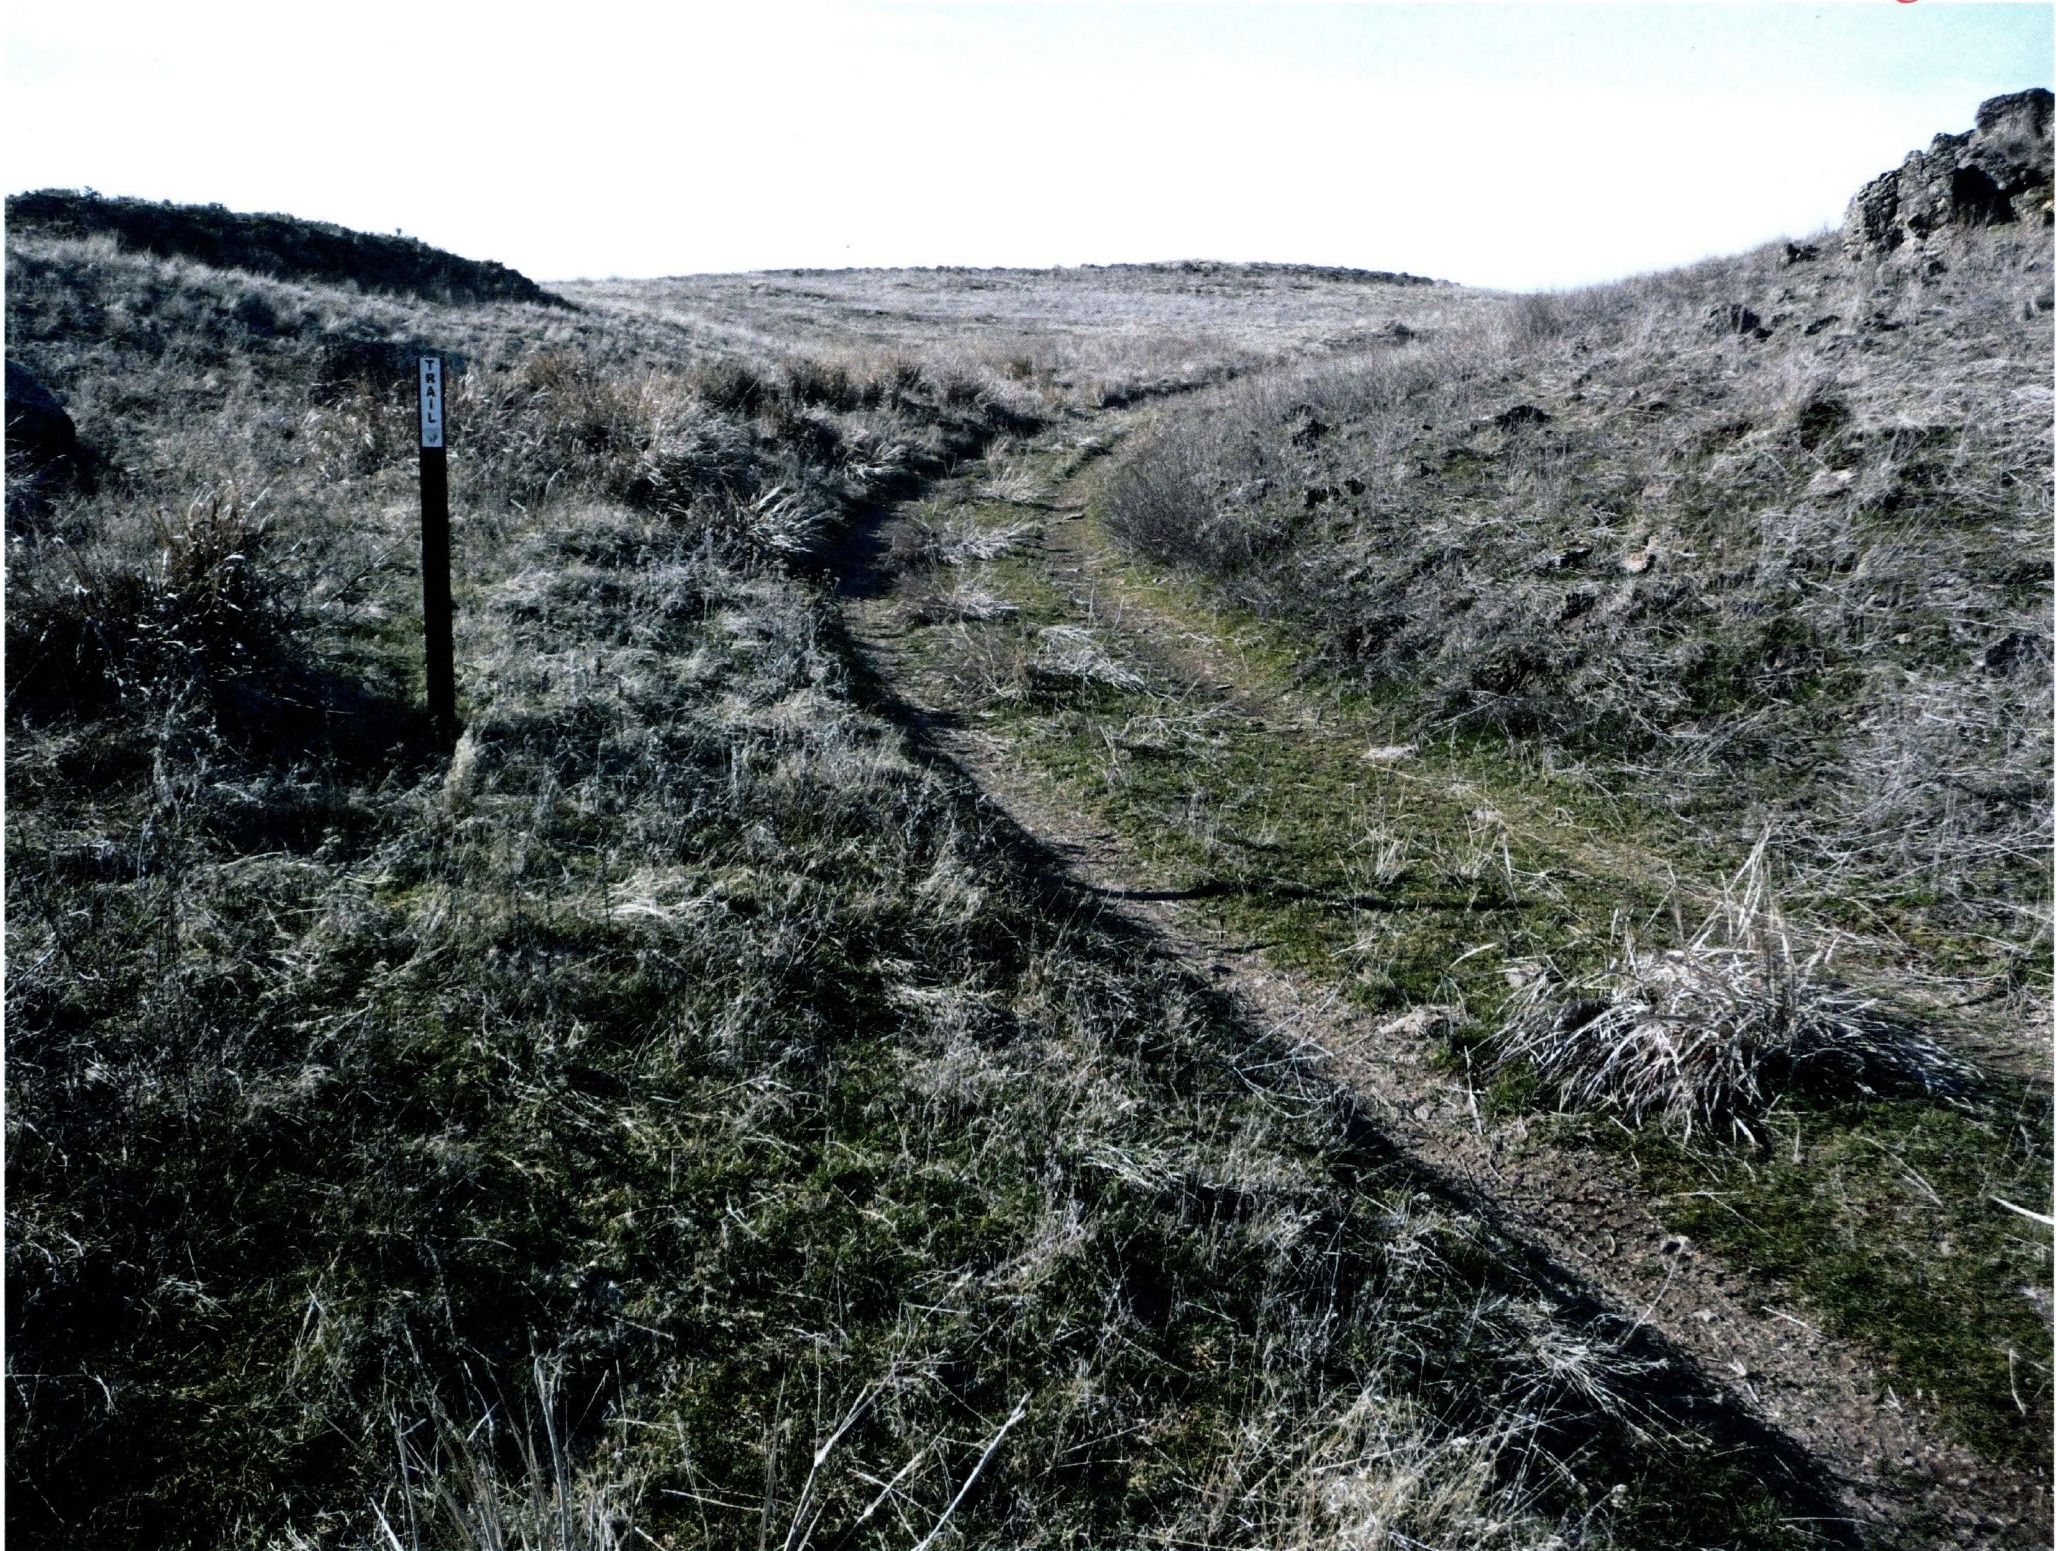
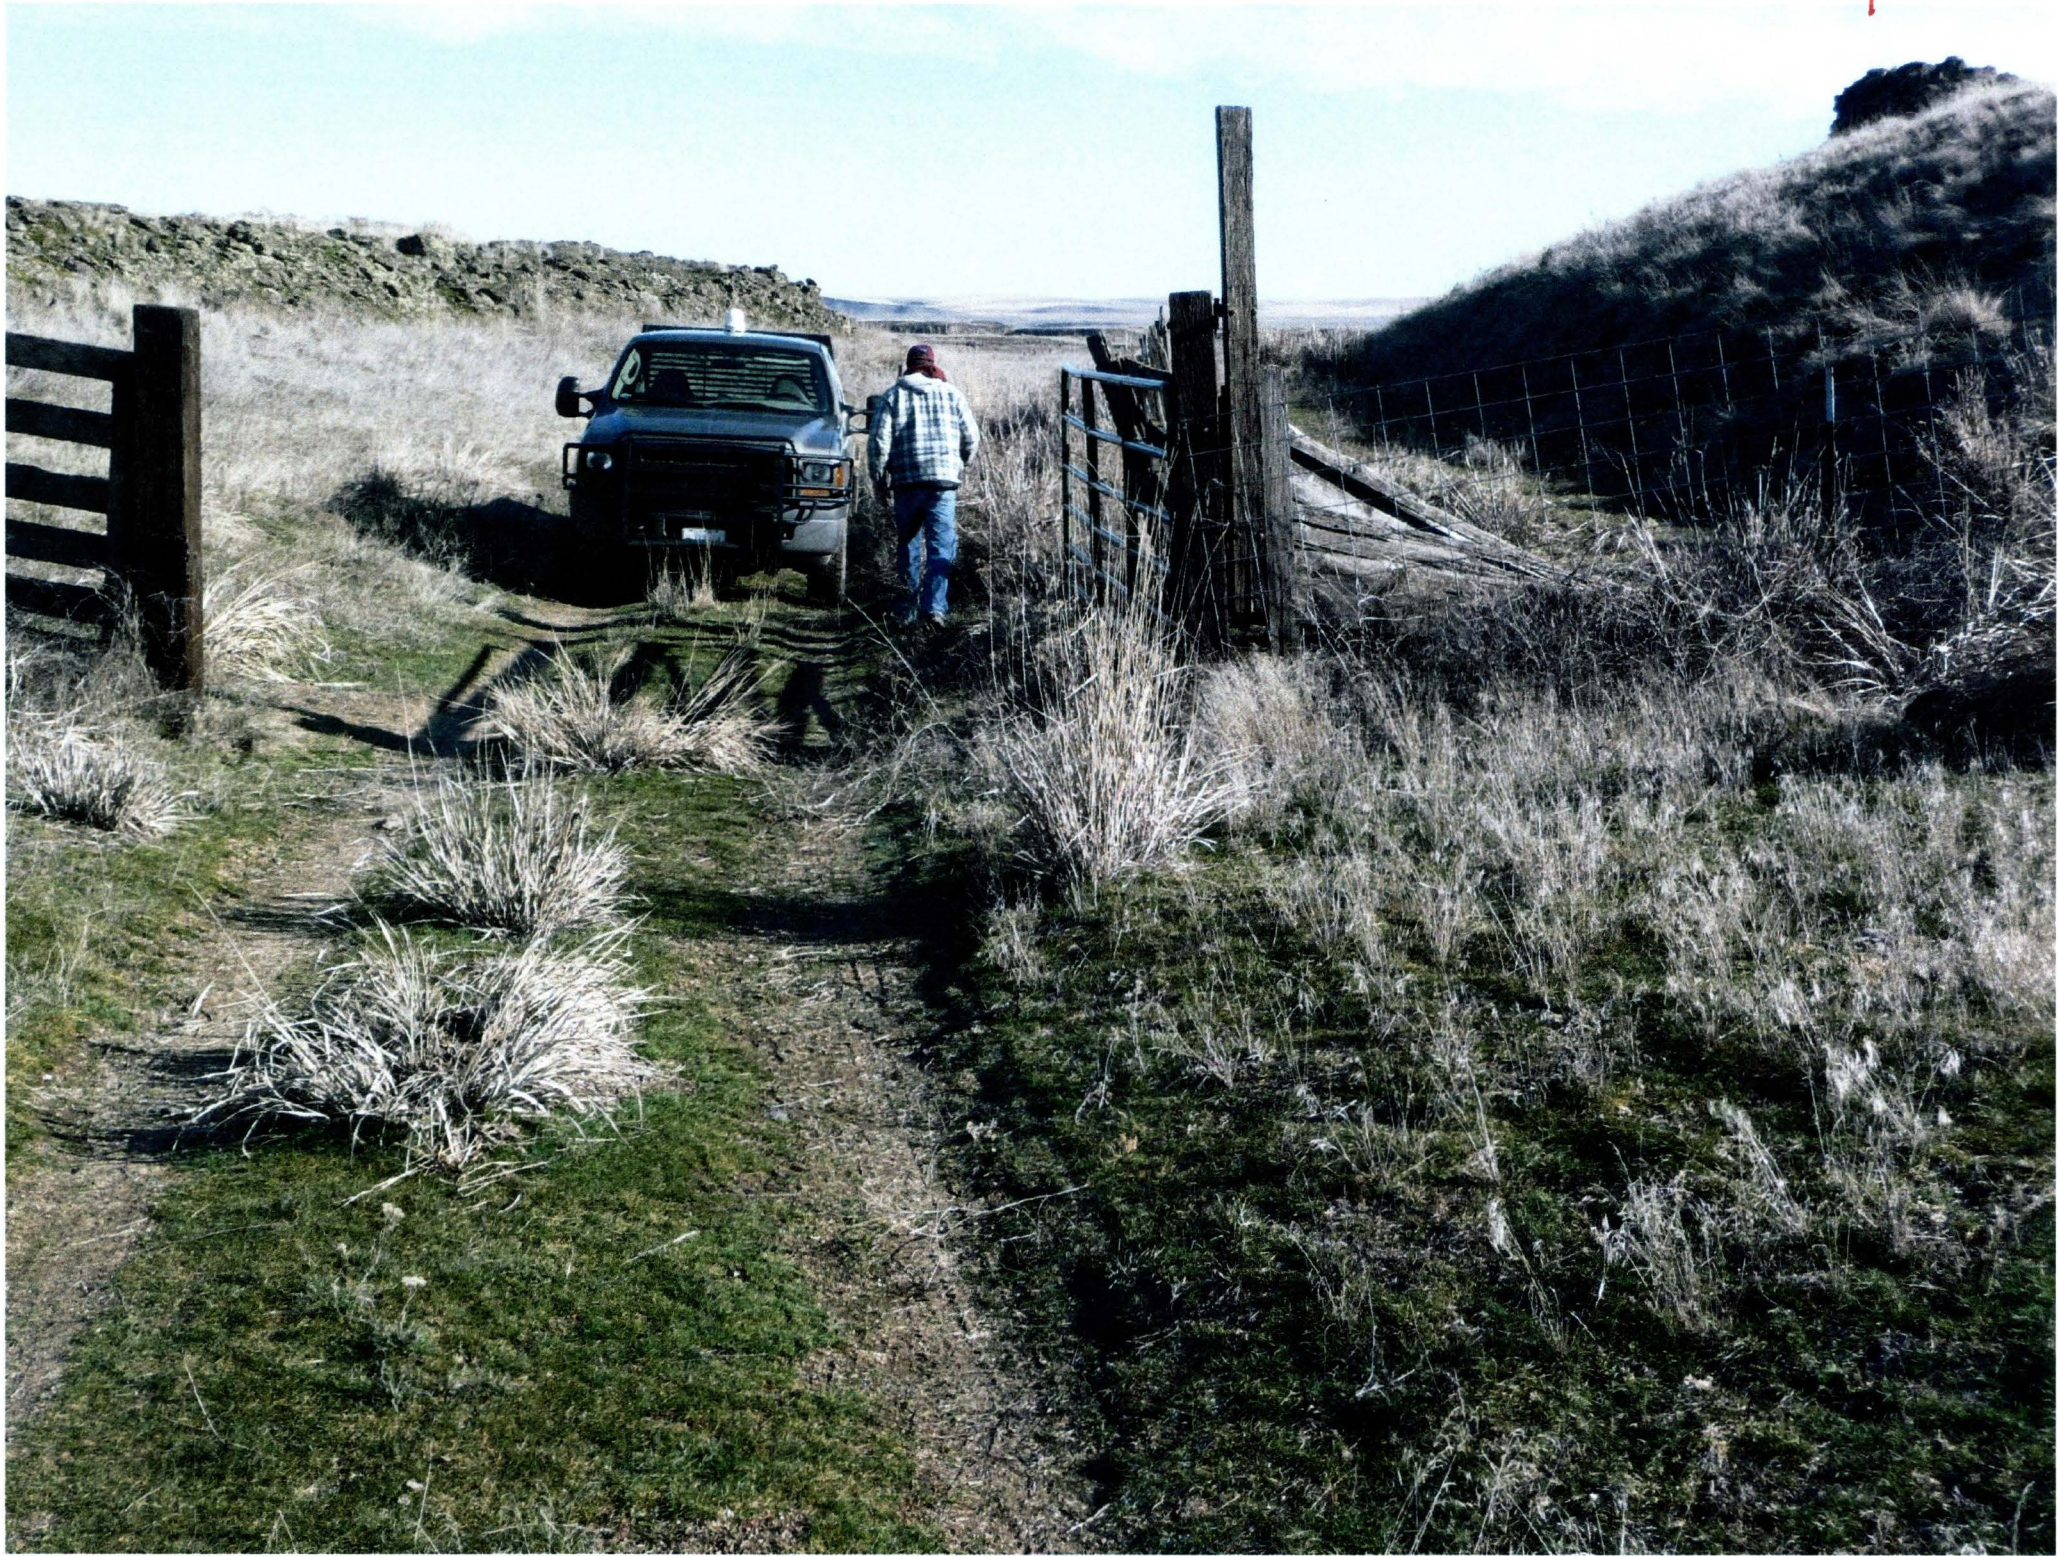
I. LOCATION: refer to attached field and final map and BLM corporate data (GIS). T 18 N., R 39 E., Section 31, running west from the ranch buildings vicinity to just south of Turtle Lake, then north past the west side of Wall Lake to Breeden Road. Reference photos # 5 - 11

Describe: There are several cuts or berms visible identifying that the road was constructed by mechanical means.

There are considerable signs of tire tread wear from occasional to regular use from BLM administrative access and range permittee vehicle access.
