Inventory Unit Number/Name: Lakeview Ranch OR135-15

DOCUMENTATION OF BLM WILDERNESS INVENTORY FINDINGS ON RECORD:

**DOCUMENTATION OF CURRENT WILDERNESS INVENTORY
CONDITIONS**

Wilderness Characteristics Inventory Results

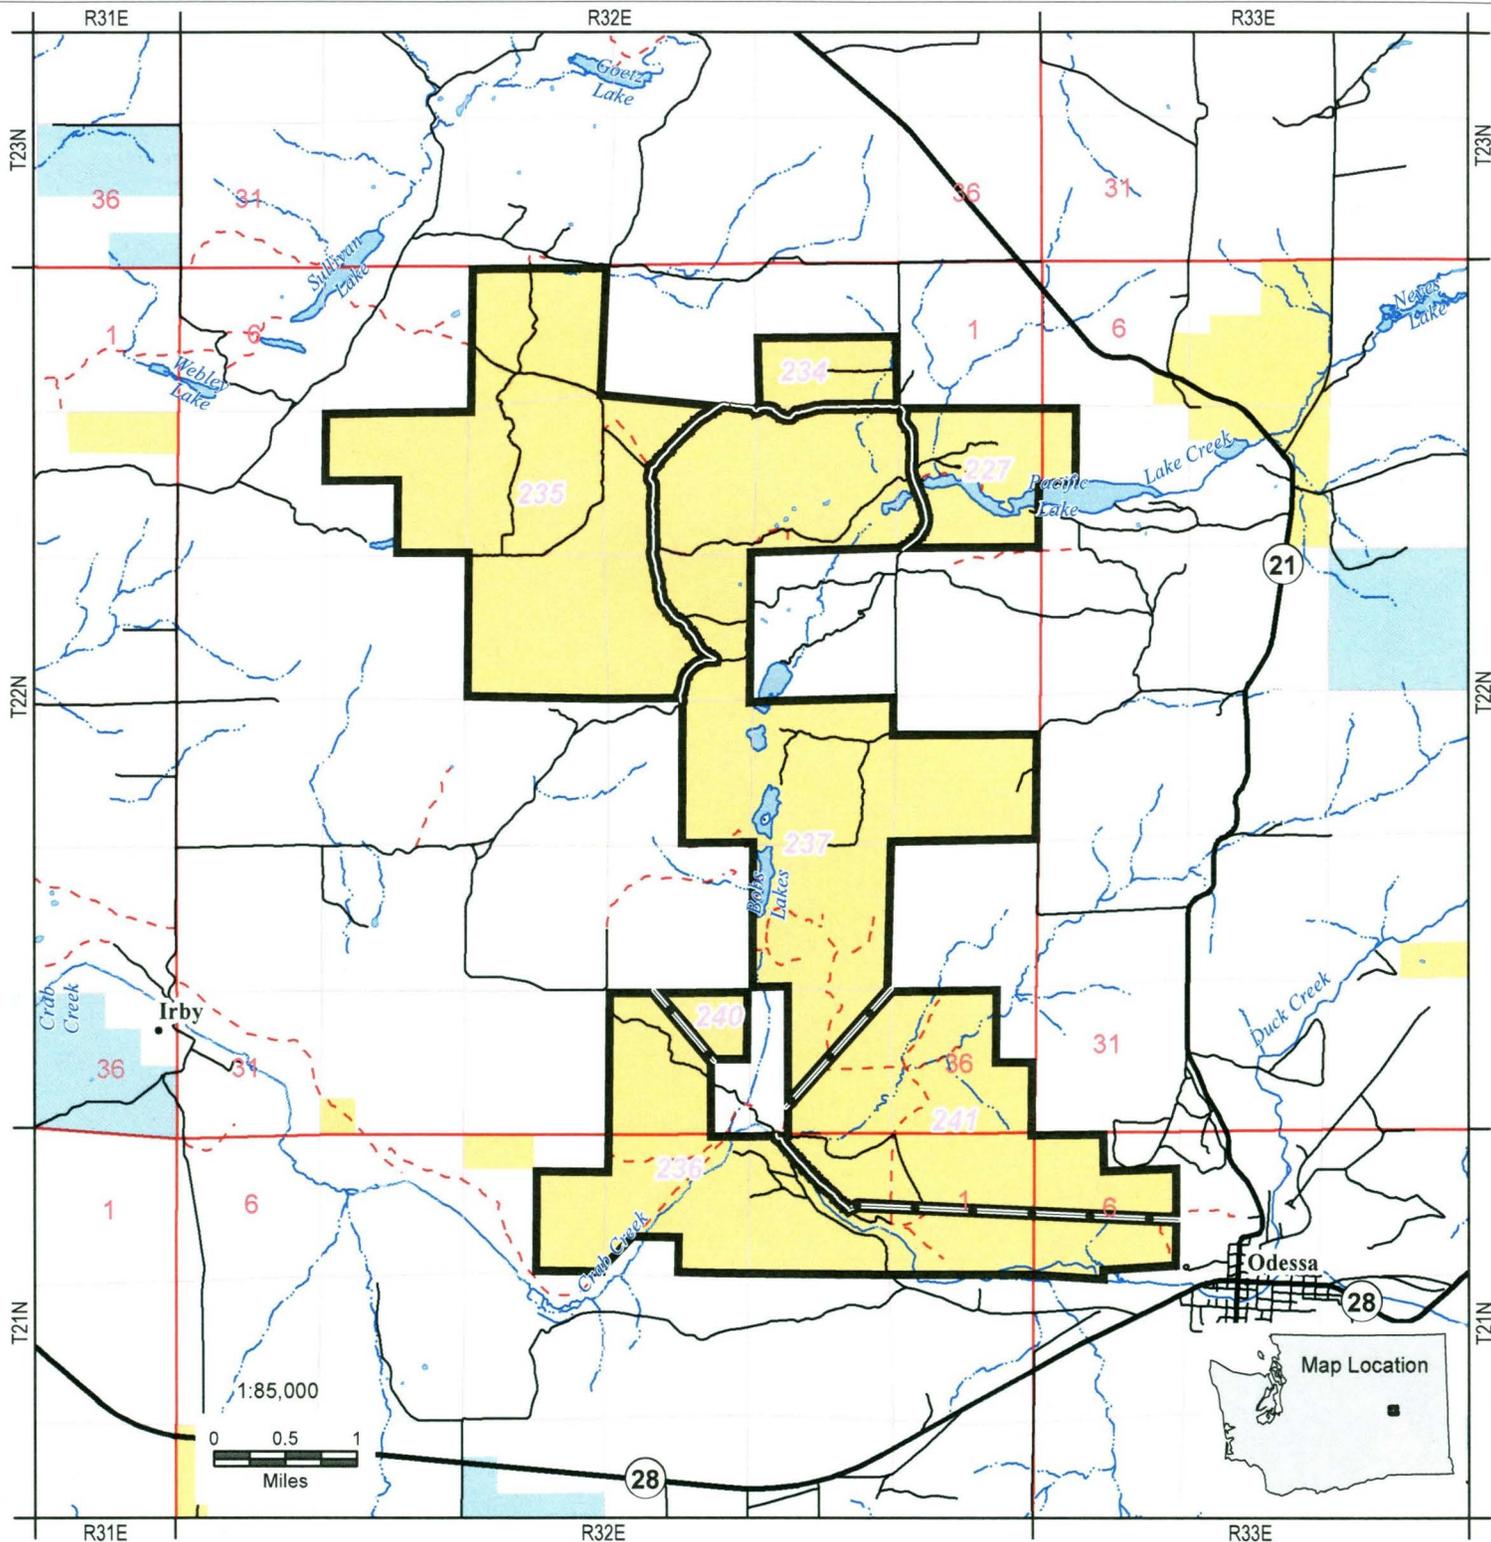
The unit does not possess wilderness characteristics because six (6) portions of the unit are isolated by man-made features or have significant man-made intrusions on them, and are individually less than 5,000 acres in size and lack wilderness characteristics.

Unique ID	Unit Evaluation	Acres
227	N	665
234	N	335
235	N	3011
236	N	2216
237	N	3788
240	N	148
241	N	1684
Total		11847

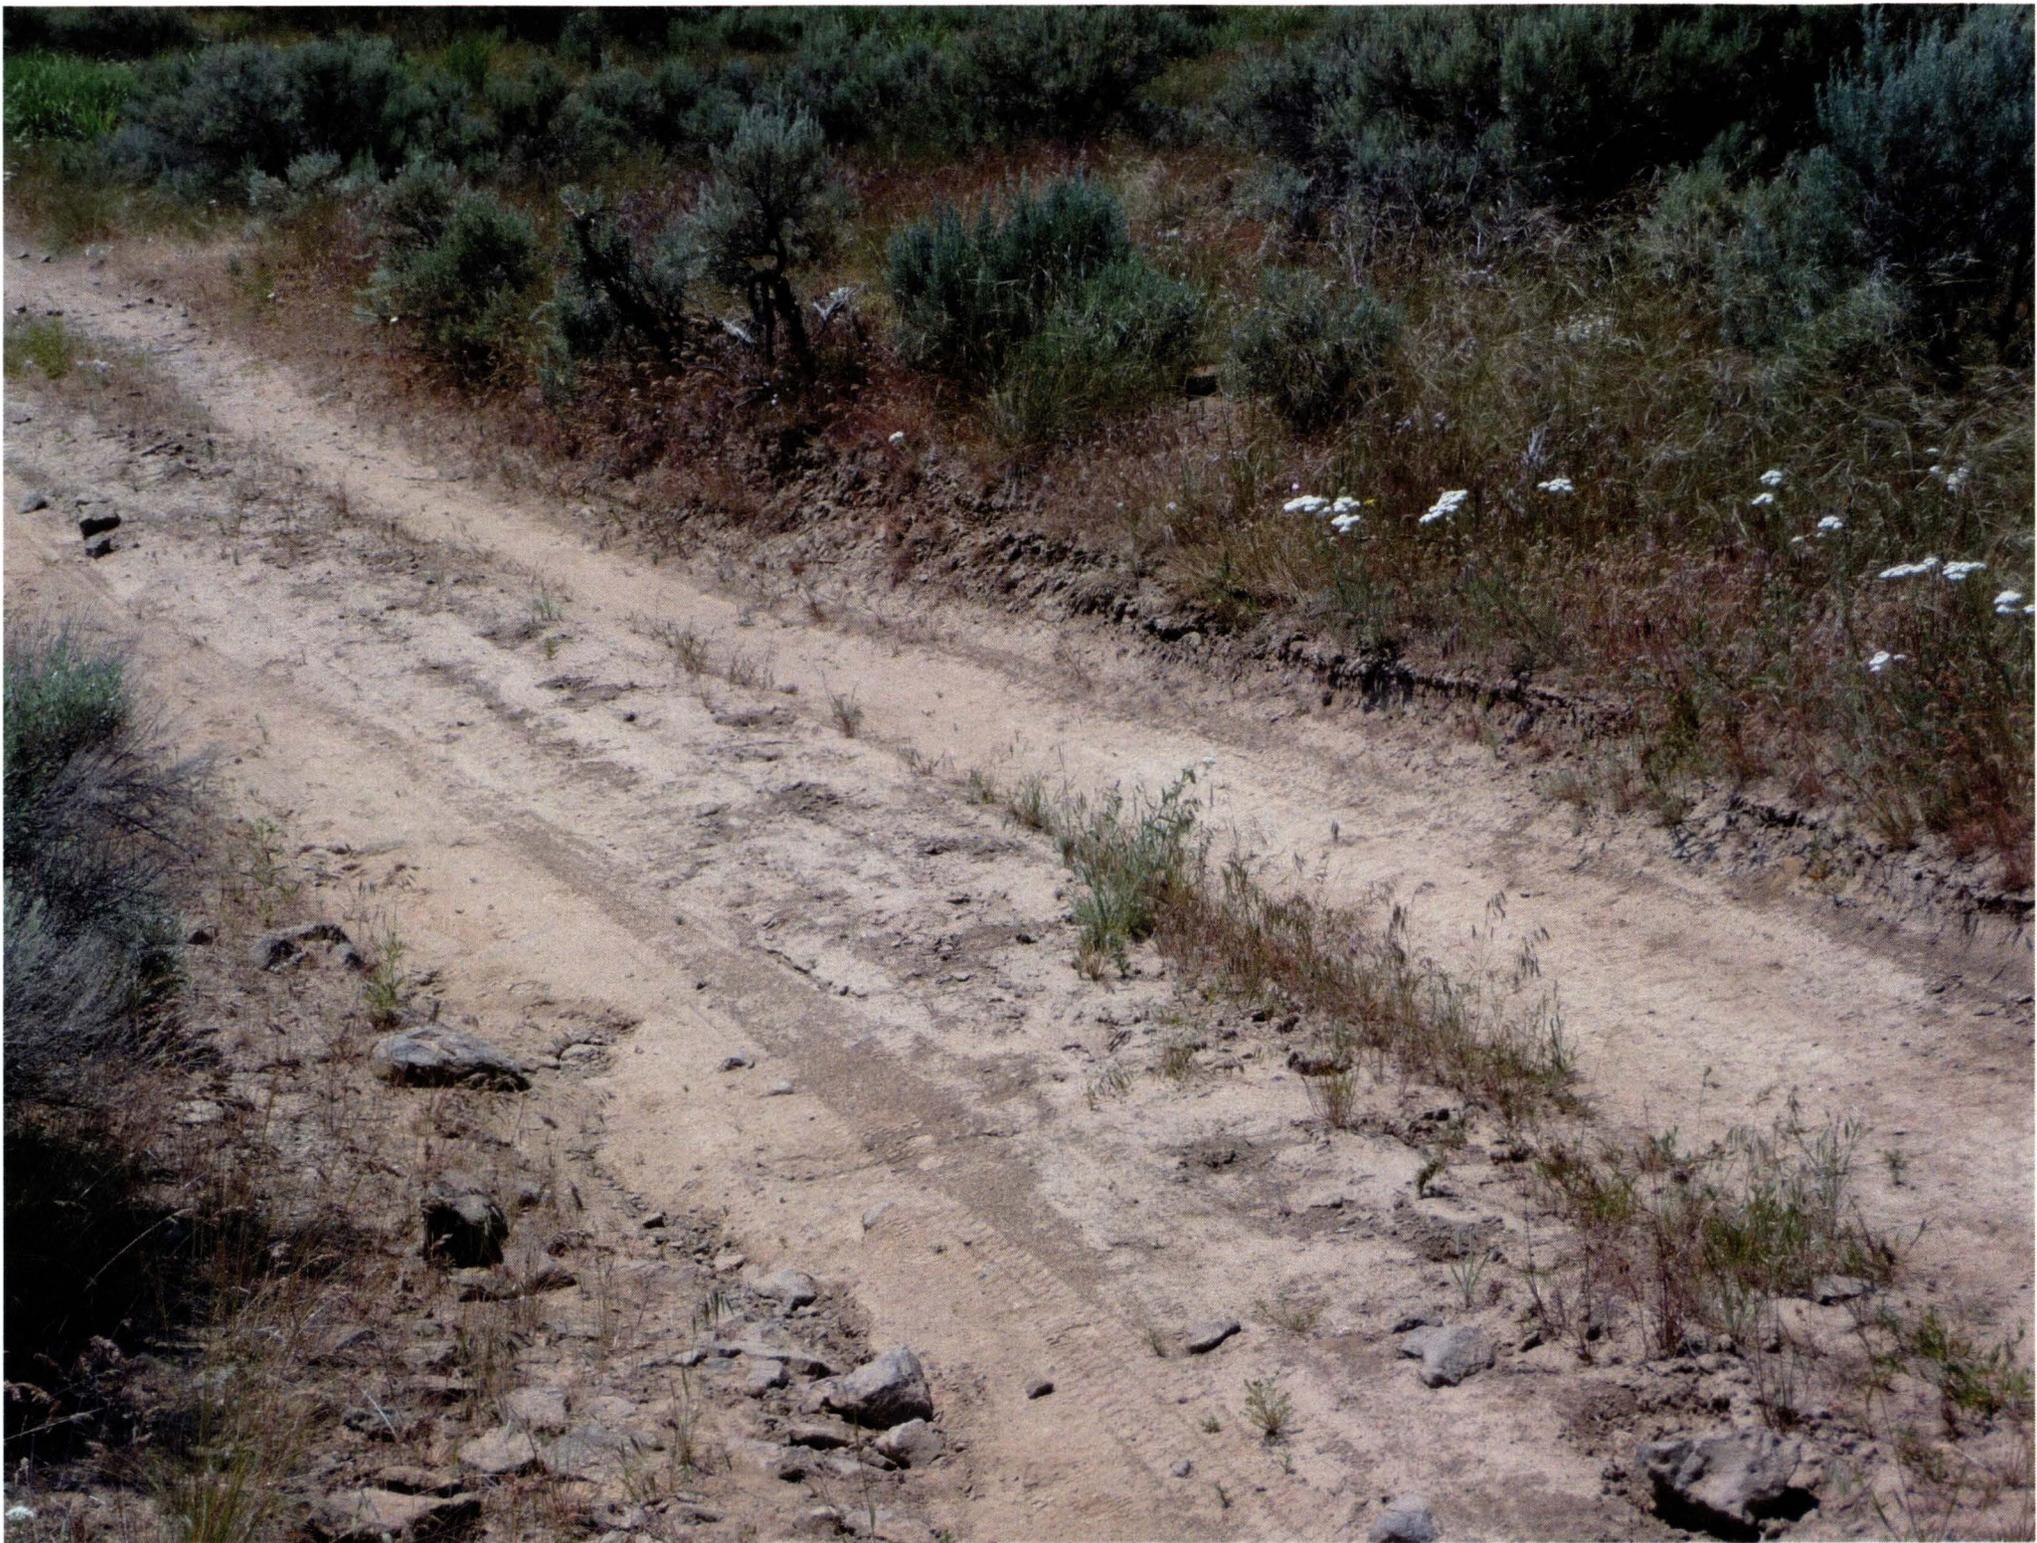
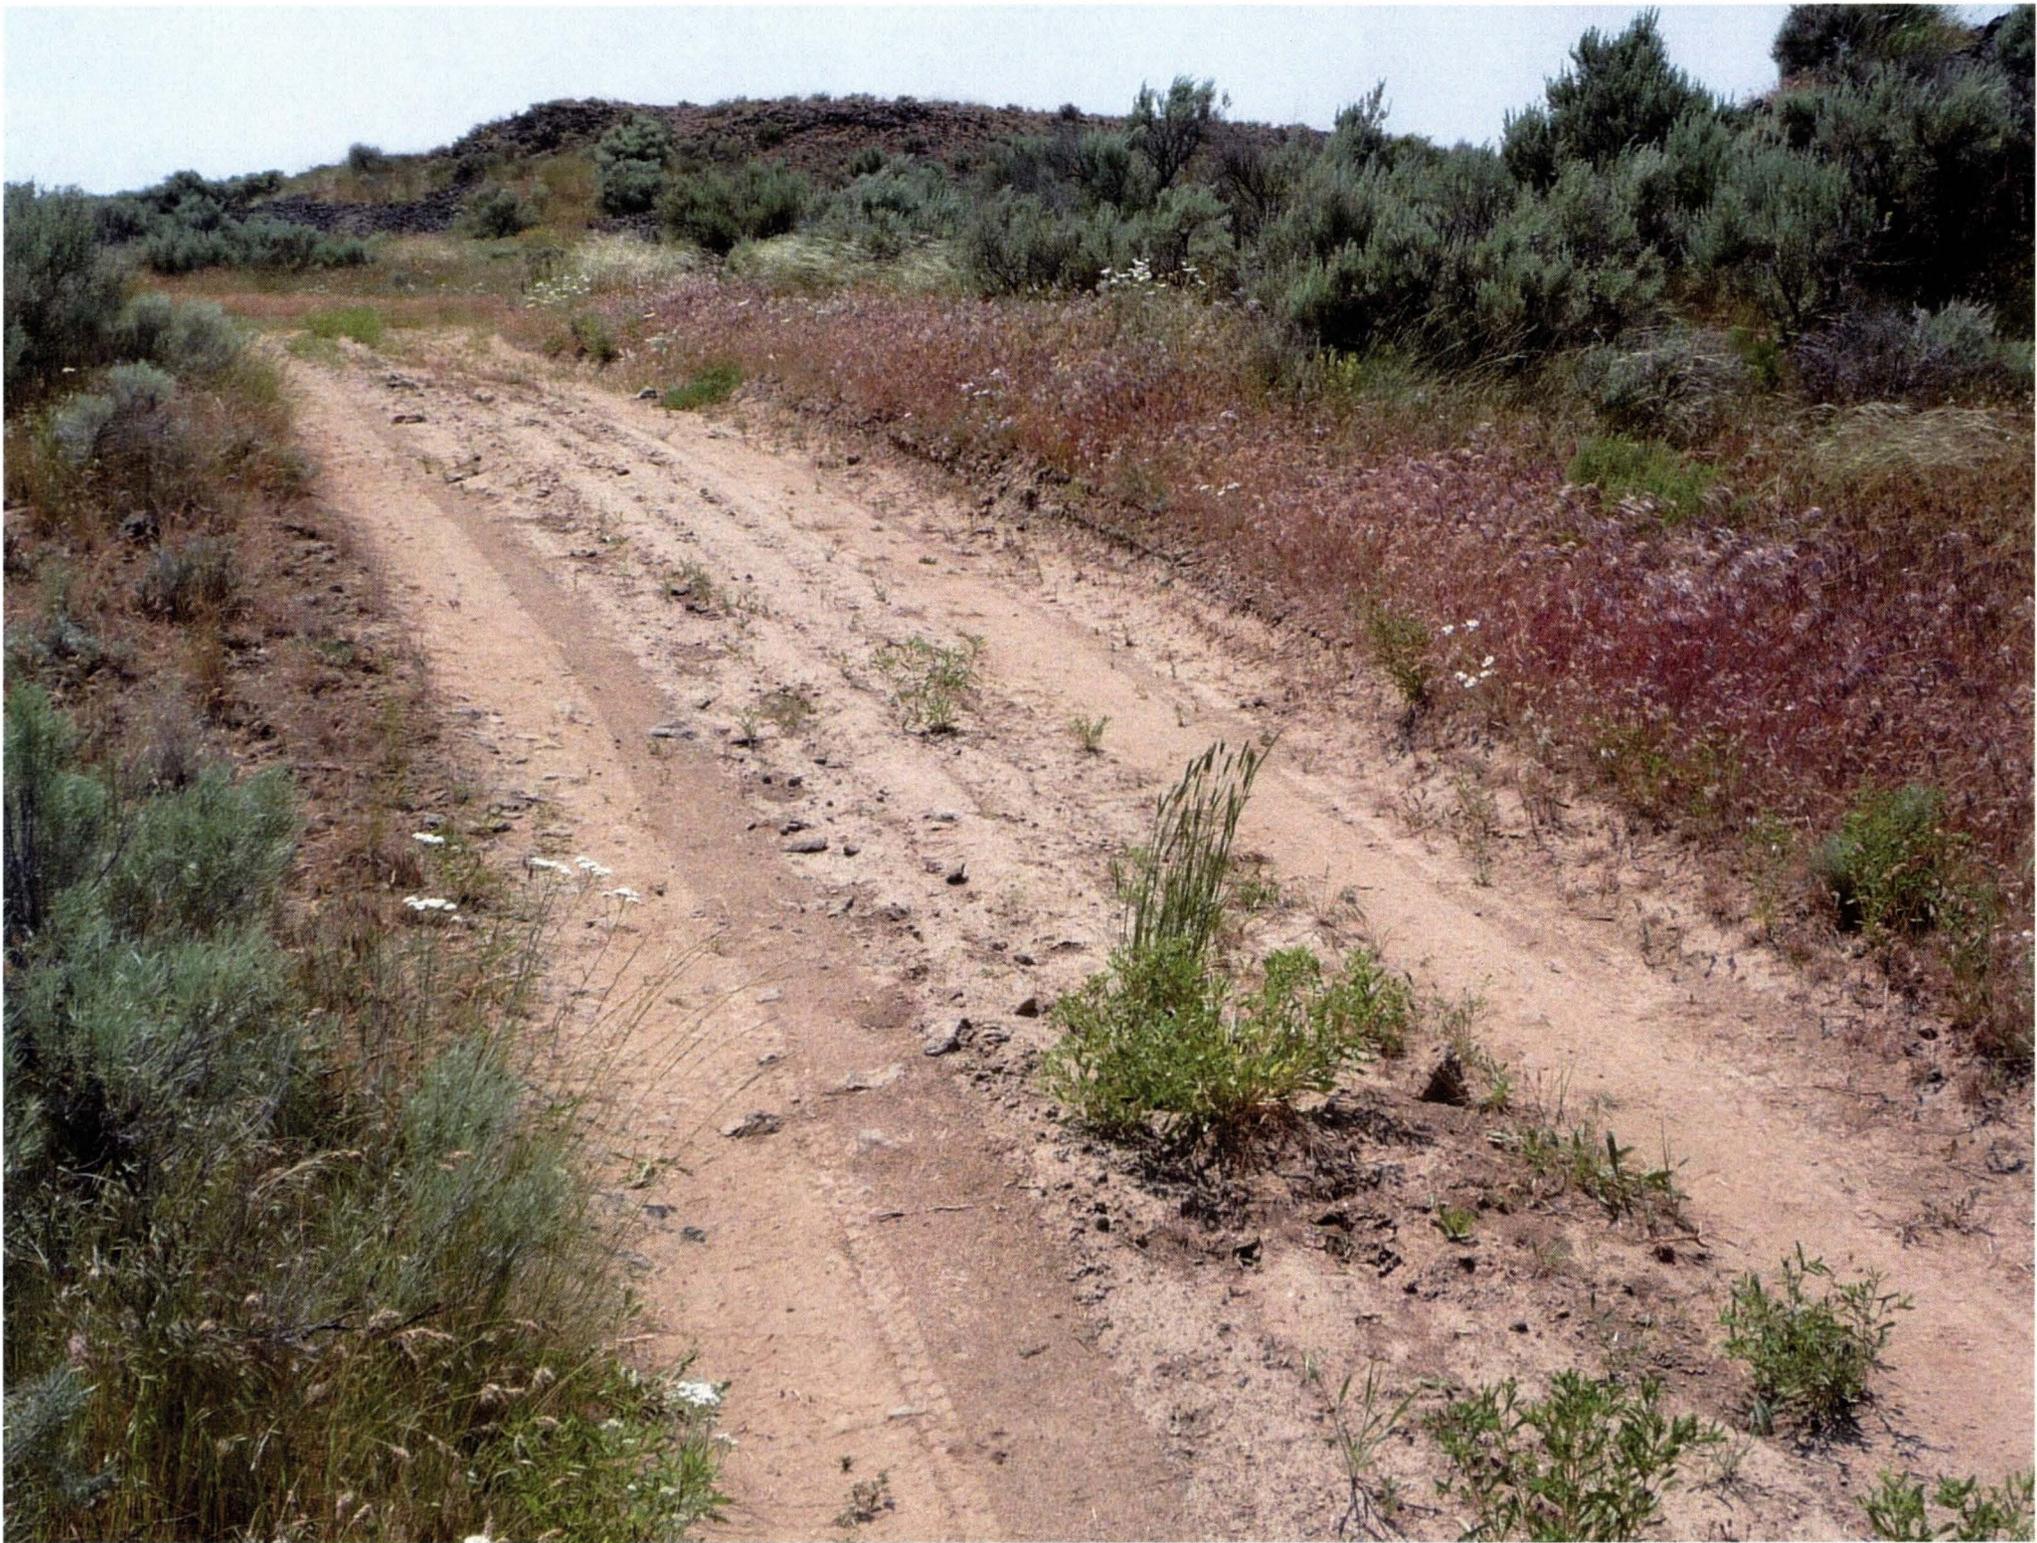
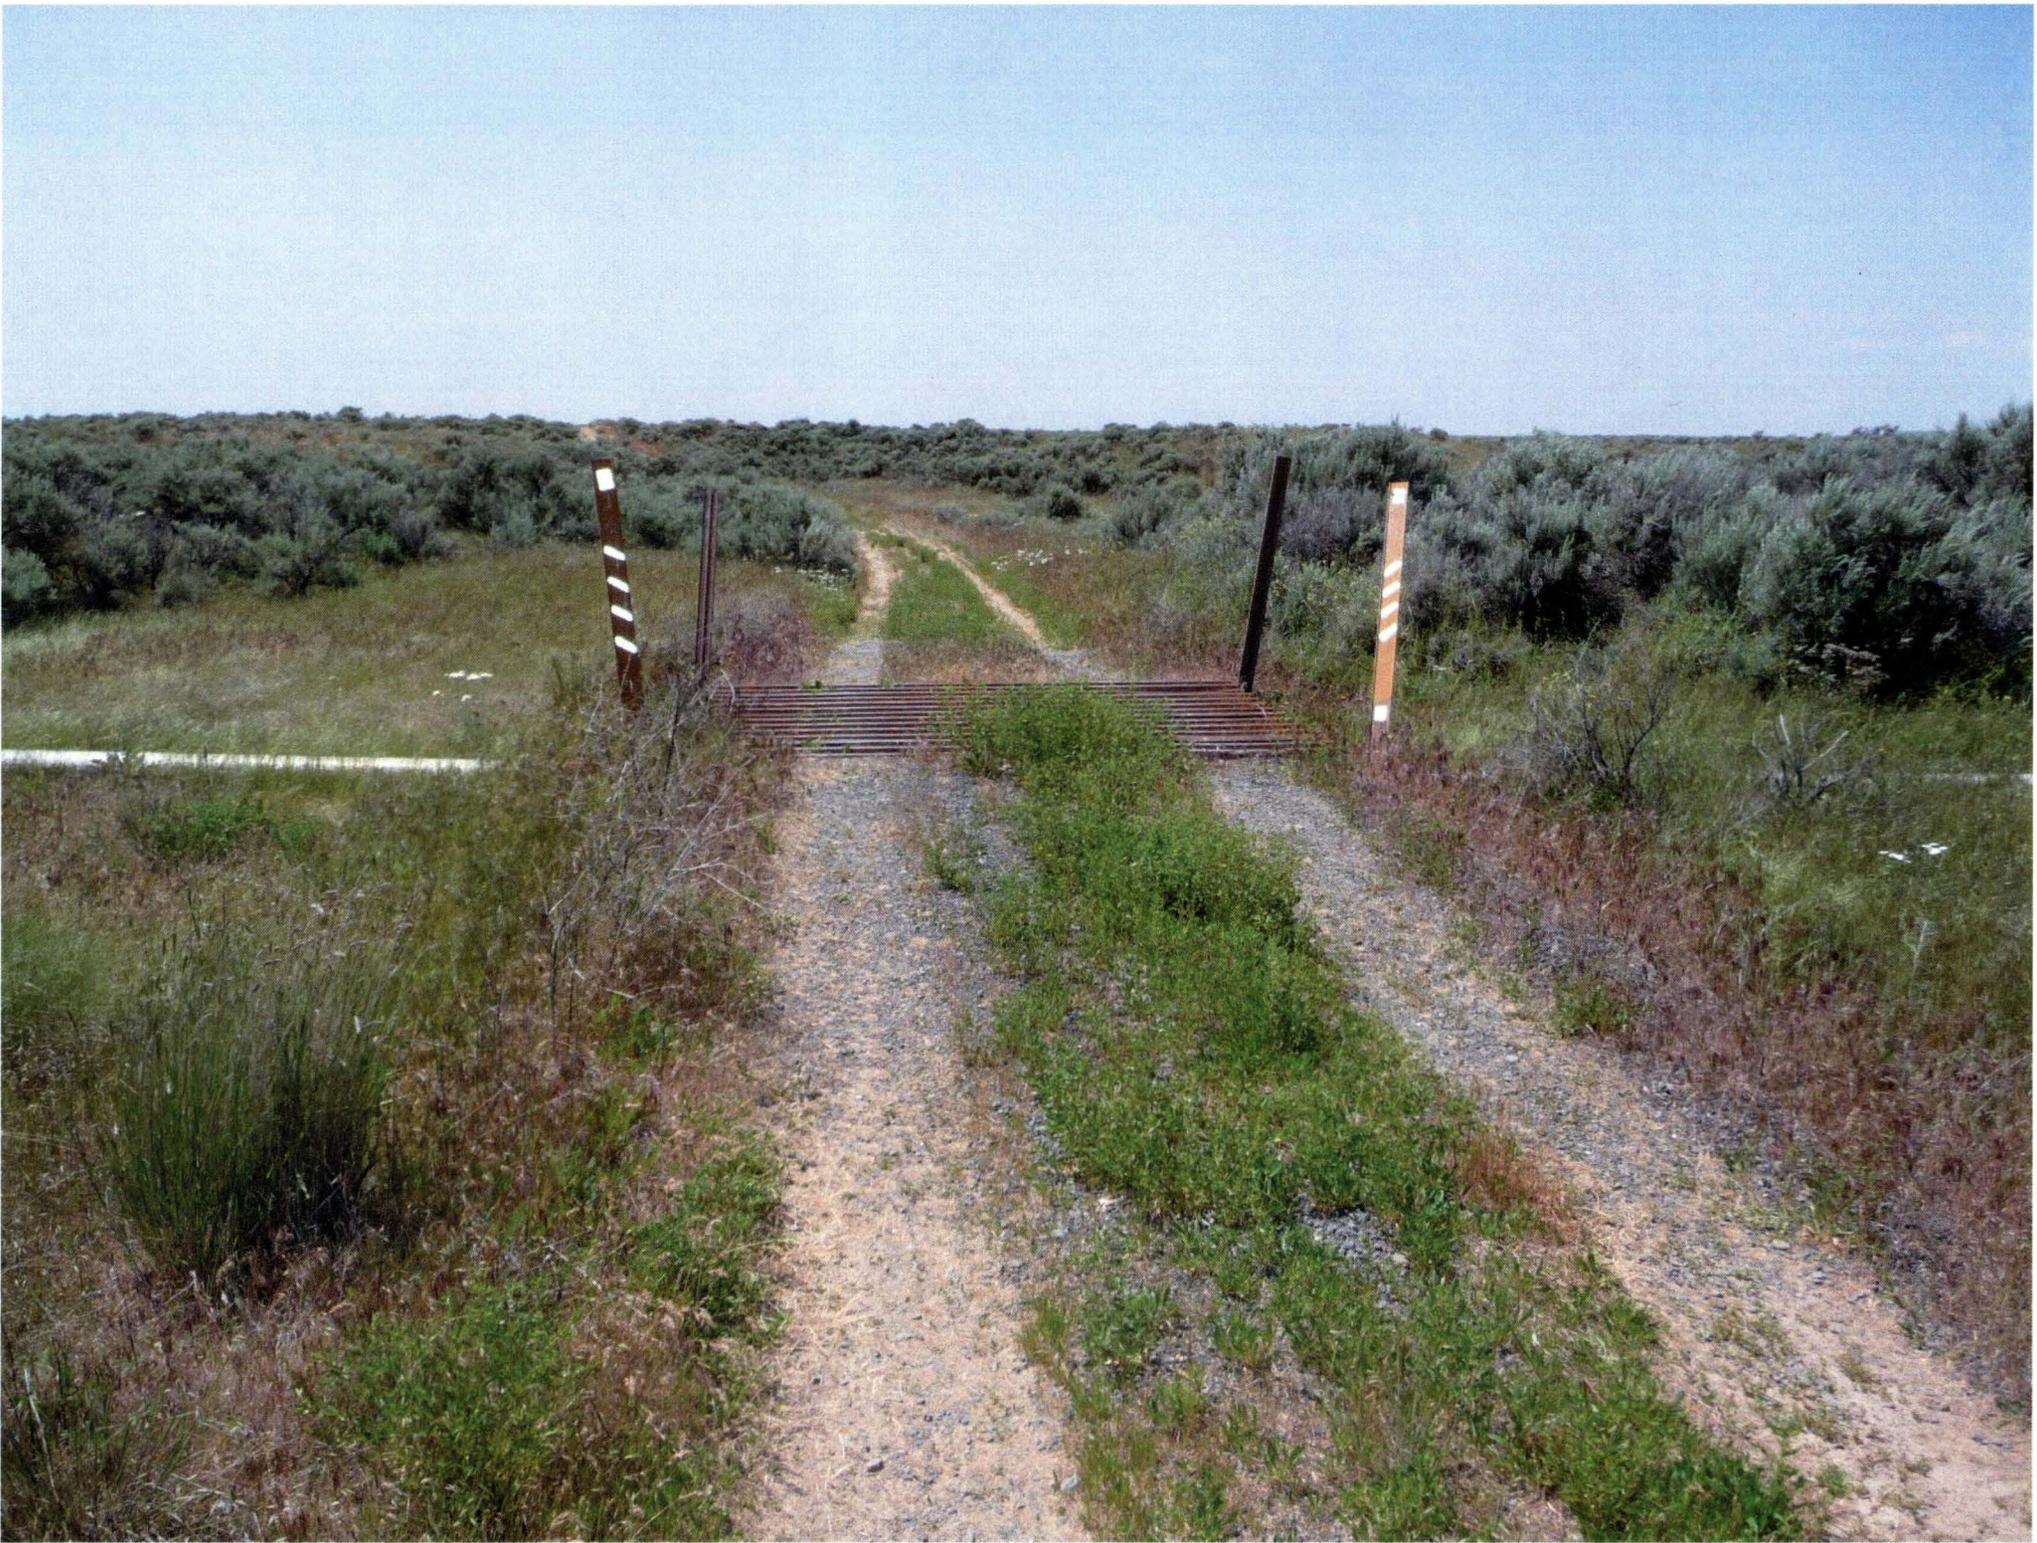
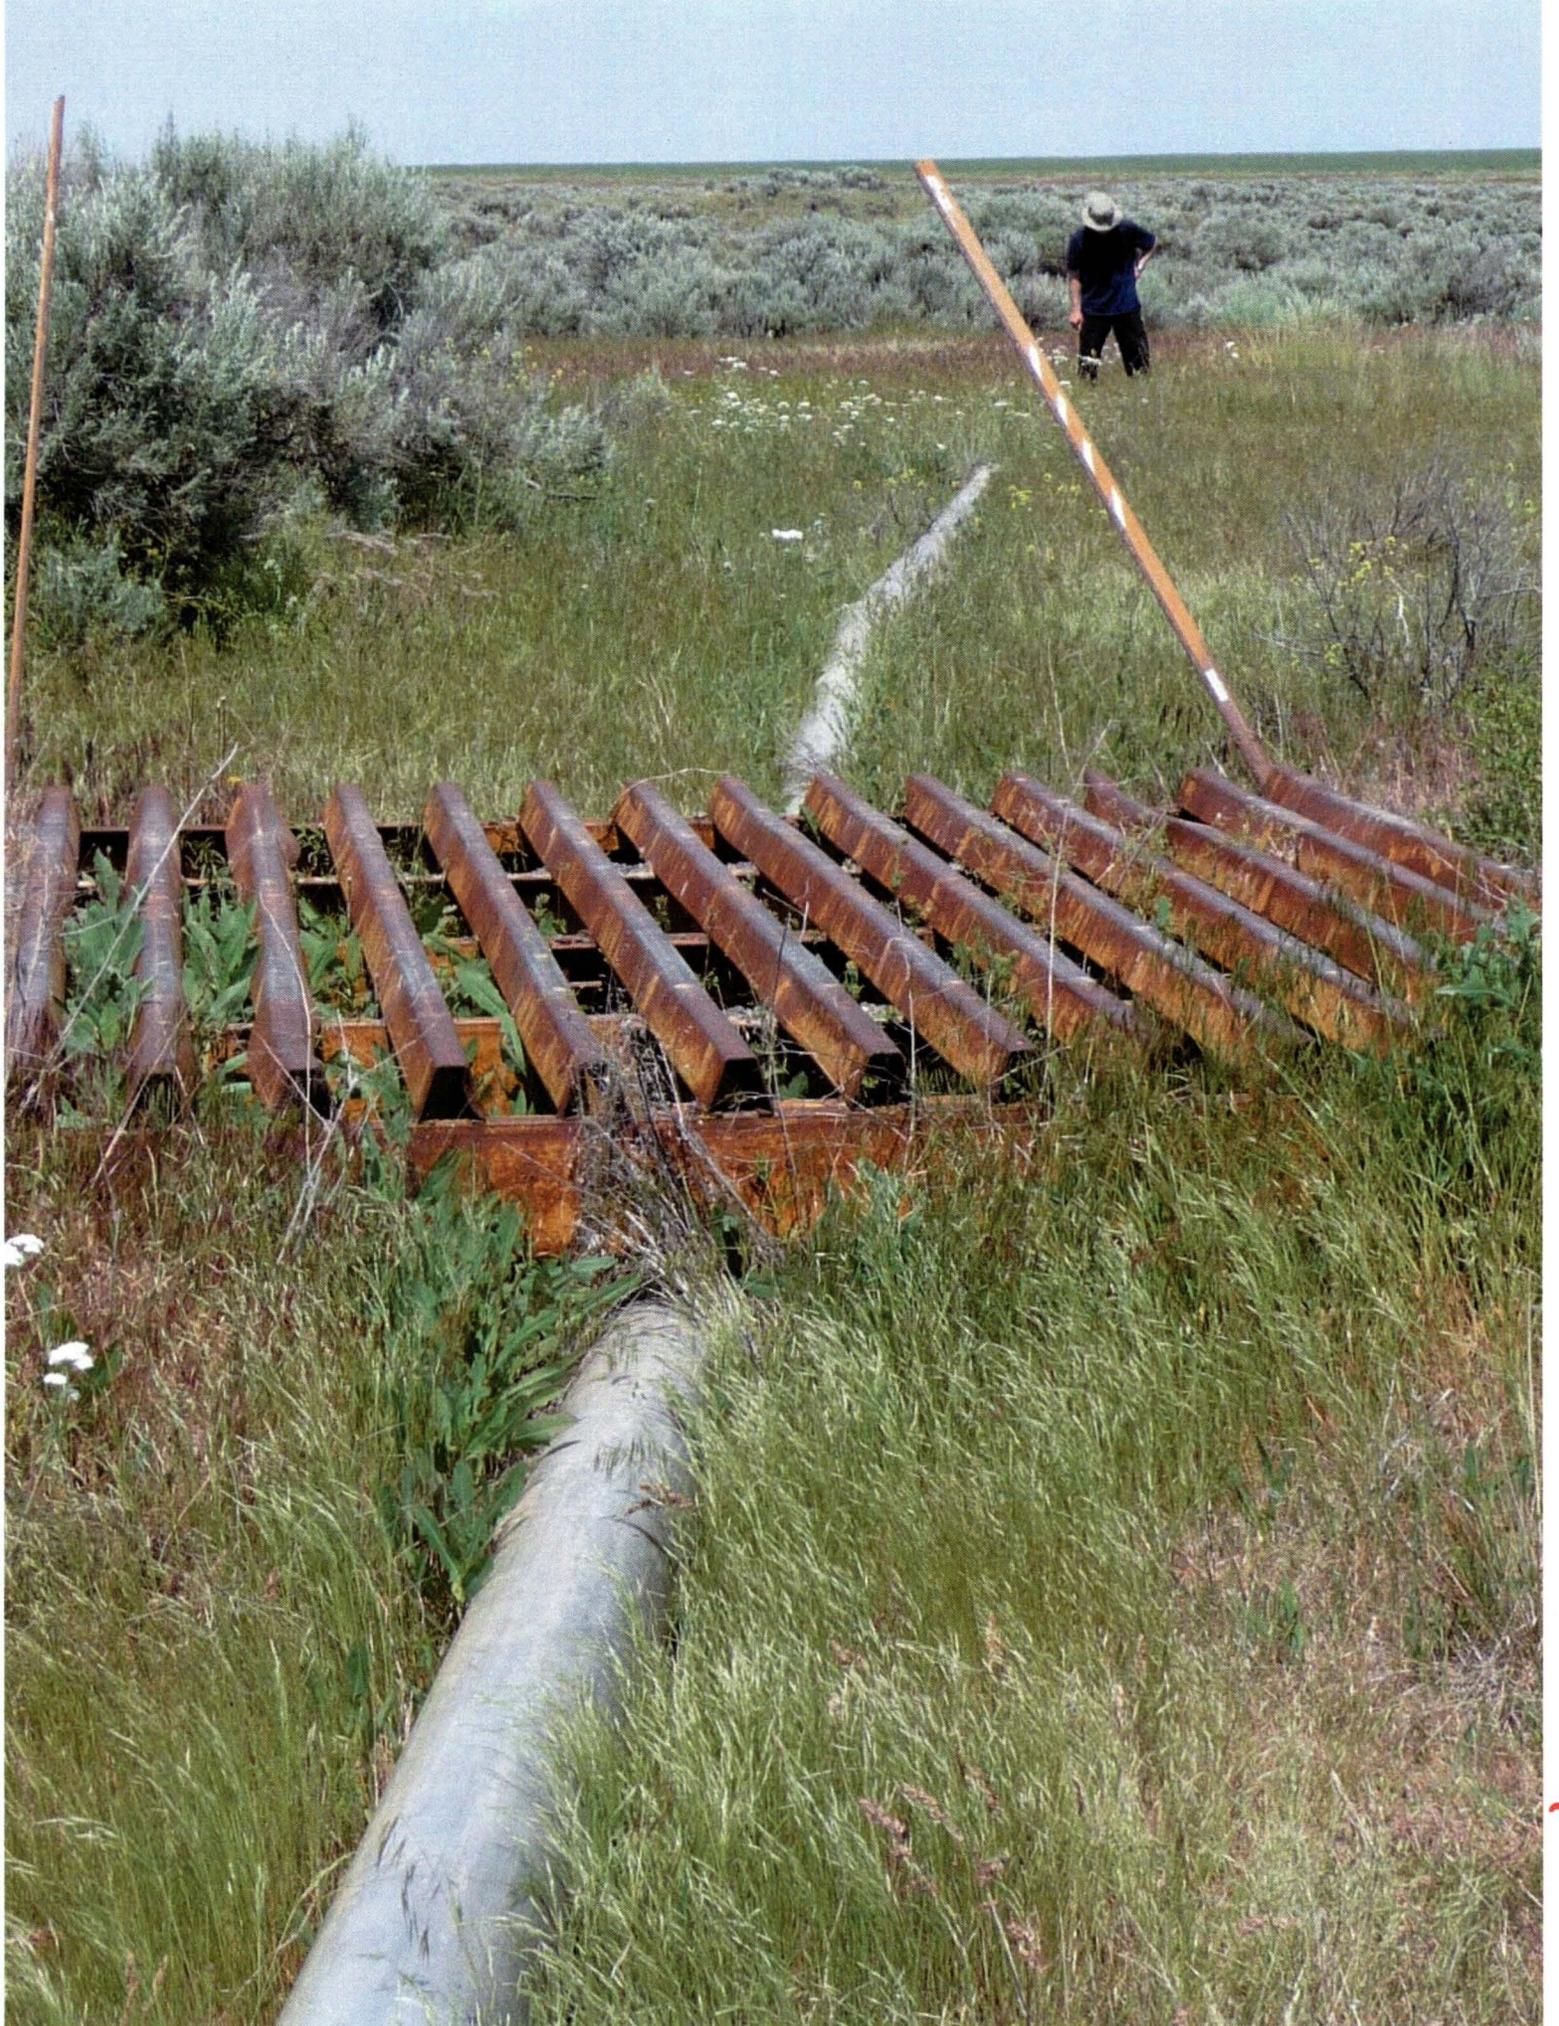
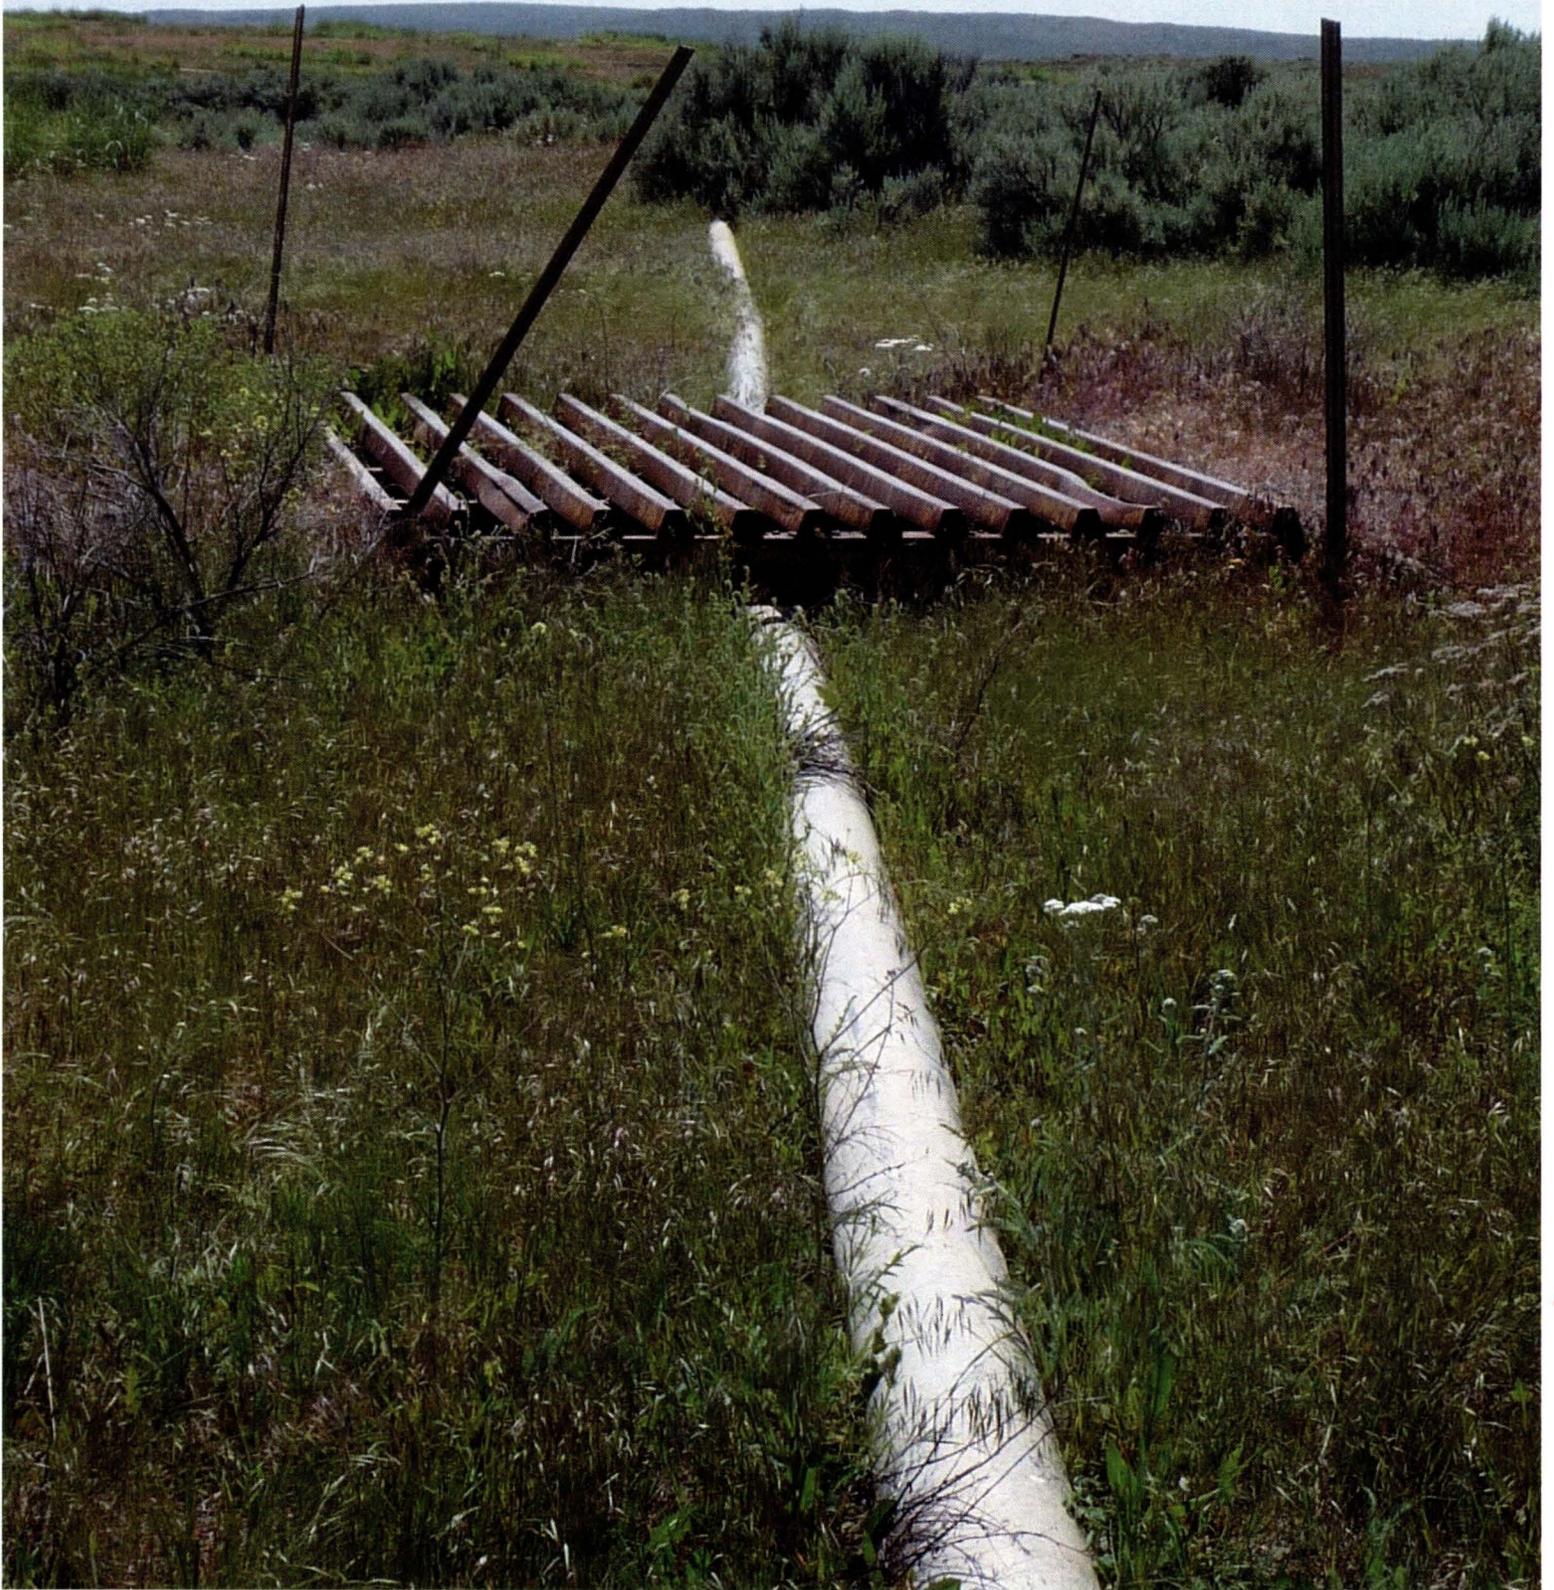
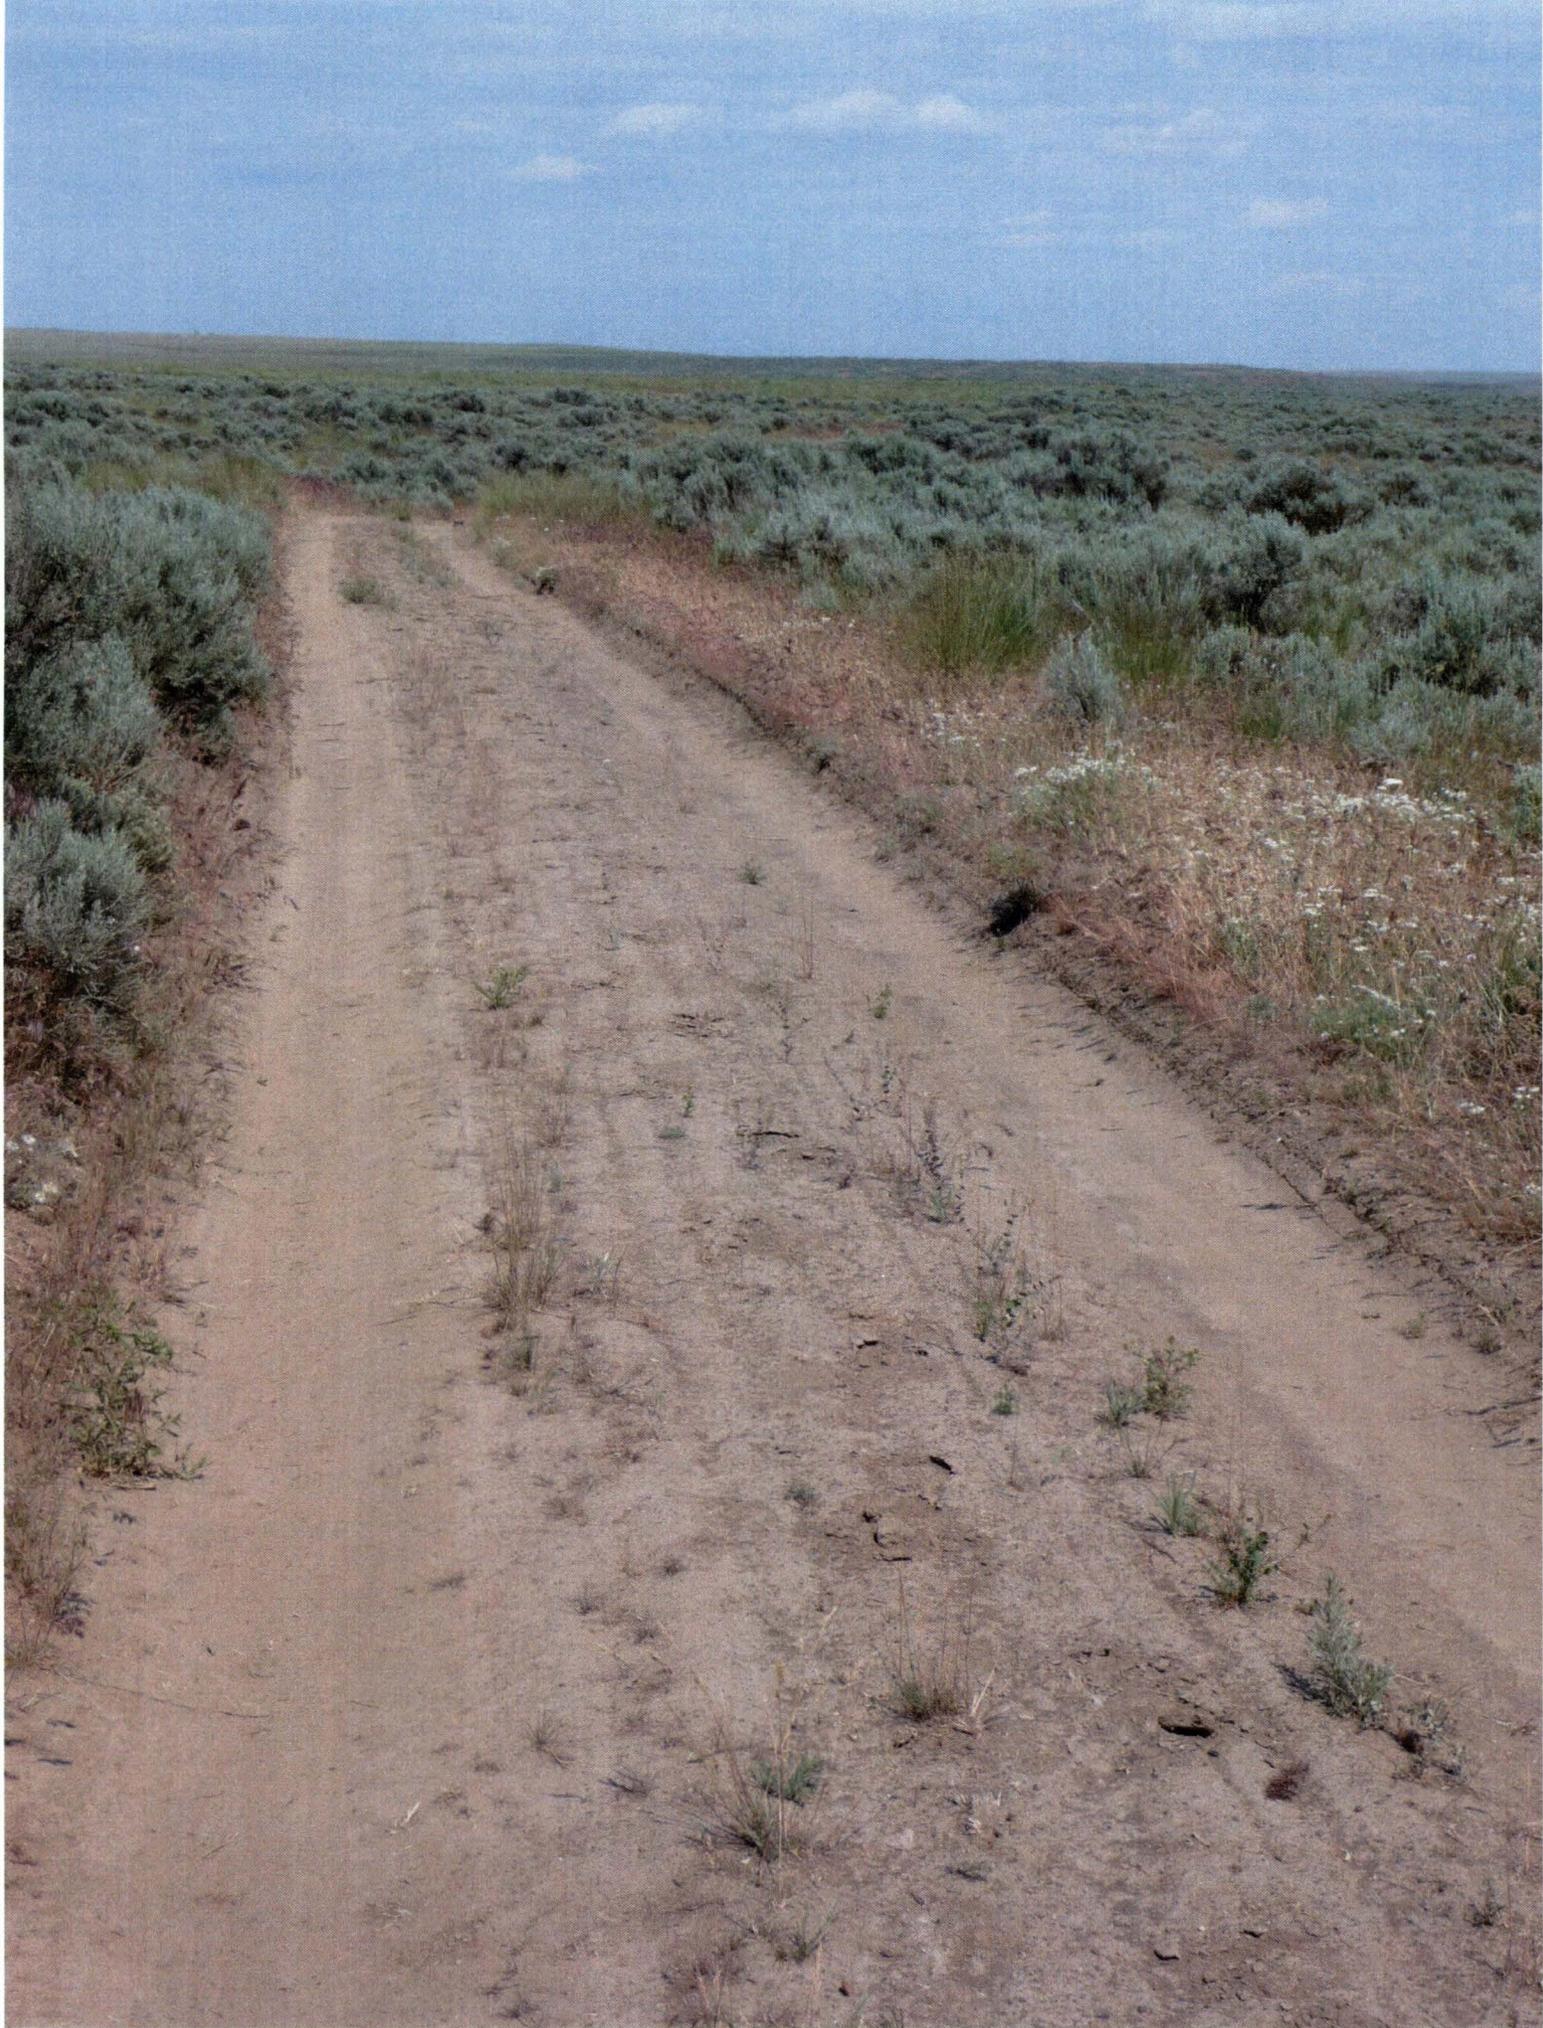
**APPENDIX D – PHOTO LOG
(modify form as needed)**

Describe: A cattleguard style bridge allows vehicle passage over an irrigation pipe on the ground surface that runs perpendicular to the road. As shown in the photo log, minor bank cuts created by a grader blade can be found in spots.

Date	Frame #	Camera Direction	Description	GPS/UTM Location	Township	Range	Sec.
6/17/11	1	northwest	Cut	N47 25.239 W118 45.452	22N	32E	11
6/17/11	2	northwest	Cut	45 yds east of frame #1	22N	32E	11
6/17/11	3	northwest	Bridge / Cattleguard 1	N47 25.265 W118 45.682	22N	32E	11
6/17/11	4	north	Bridge / Cattleguard 2	N47 25.265 W118 45.682	22N	32E	11
6/17/11	5	south	Bridge / Cattleguard 3	N47 25.265 W118 45.682	22N	32E	11
6/17/11	6	east	Cut	N47 25.358 W118 45.314	22N	32E	11
8/7/09	7	south	Historic site		22N	32E	24
8/7/09	8	west	Vehicle route / spur off of Lake Creek Trail Road		22N	32E	11
8/7/09	9	west	Vehicle road		22N	32E	11
2/3/11	10	north	Feature: powerline NE from inholding ranch		22N	32E	35
10/12/11	11	northwest	Vehicle road		21N	32E	1
10/12/11	12	northwest	Bridge		21N	32E	2
10/12/11	13	southwest	Powerline crossing Cemetery		21N	32E	2
