Inventory Unit Number/Name: Lakeview Ranch OR135-15

DOCUMENTATION OF BLM WILDERNESS INVENTORY FINDINGS ON RECORD:

**DOCUMENTATION OF CURRENT WILDERNESS INVENTORY
CONDITIONS**

Wilderness Characteristics Inventory Results

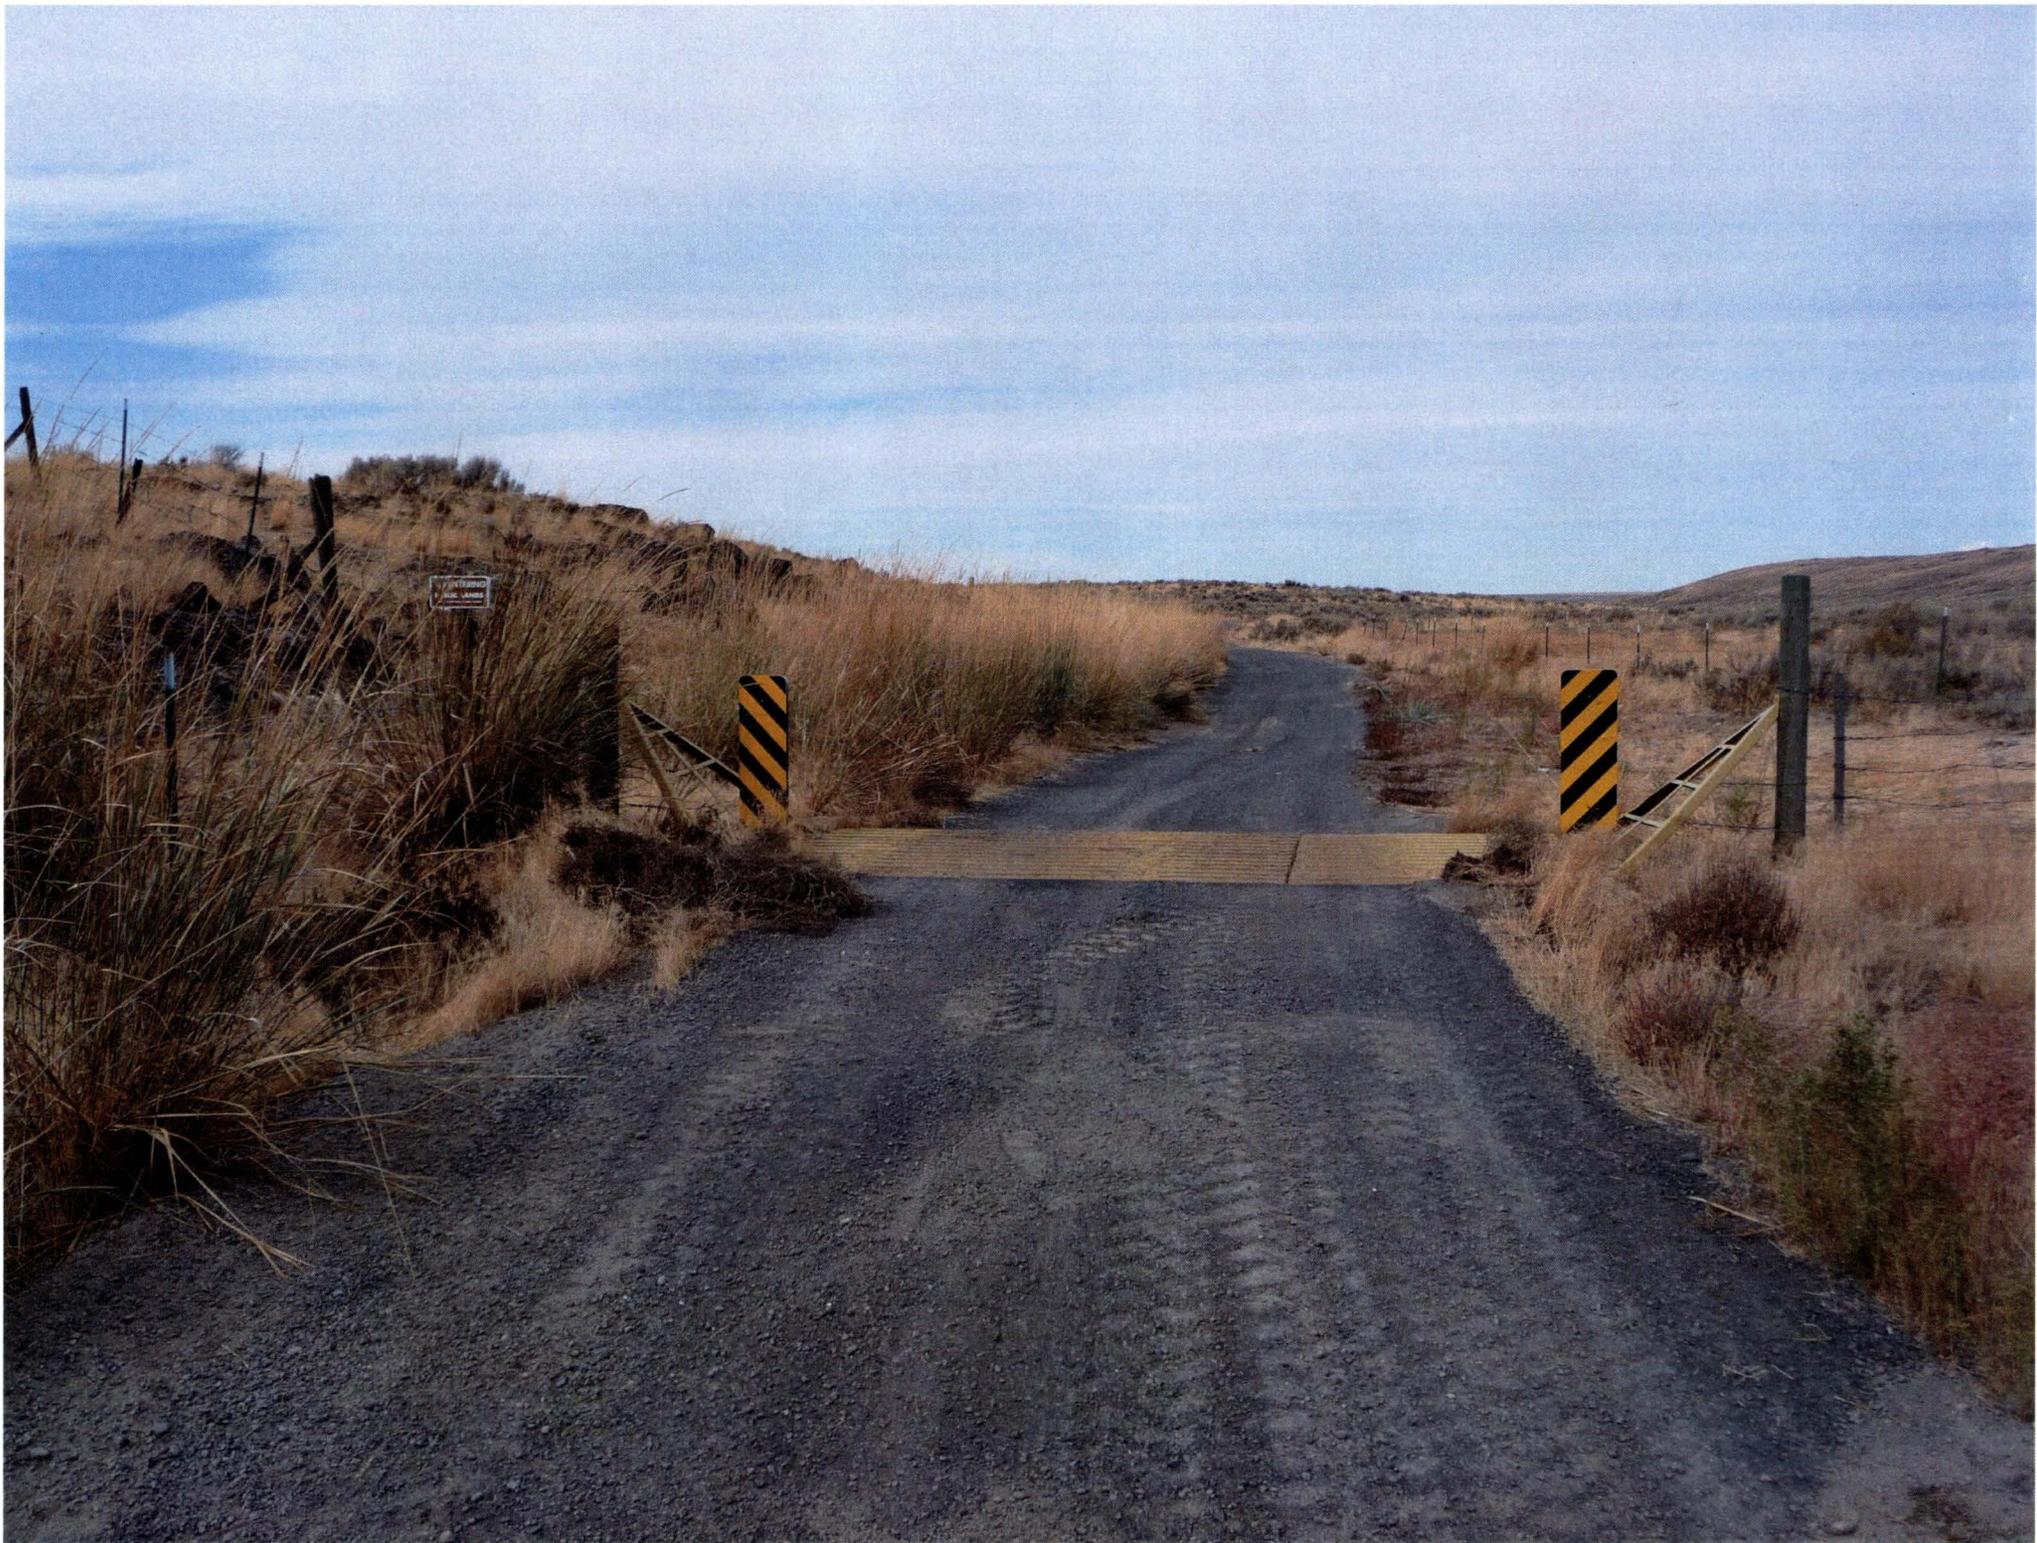
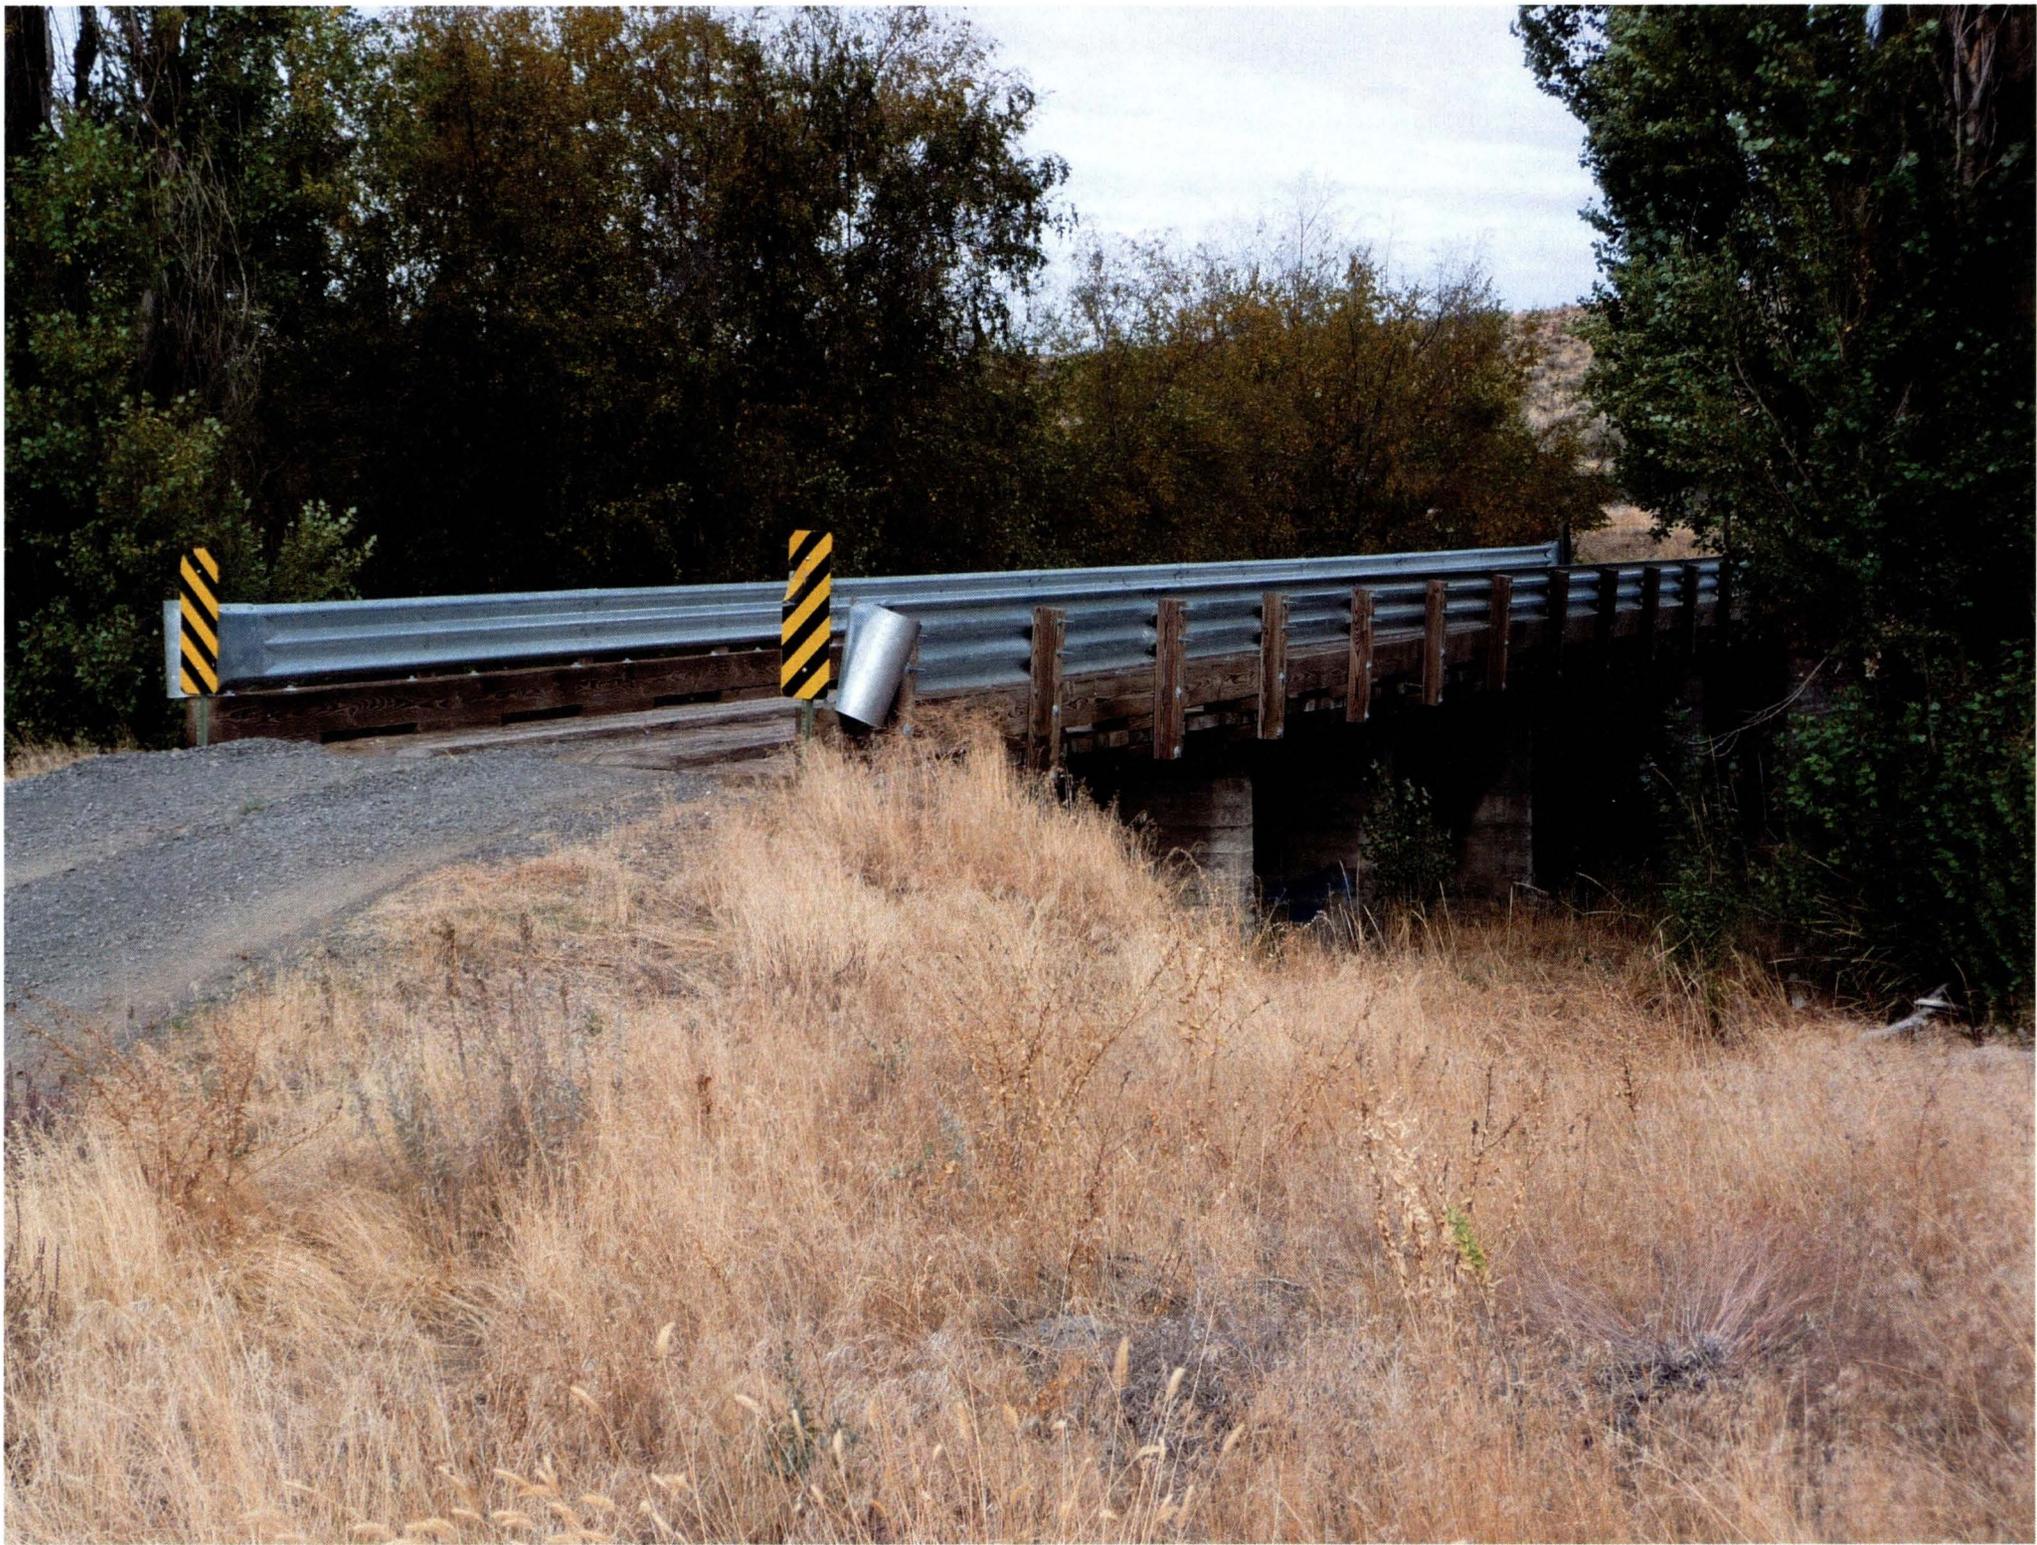
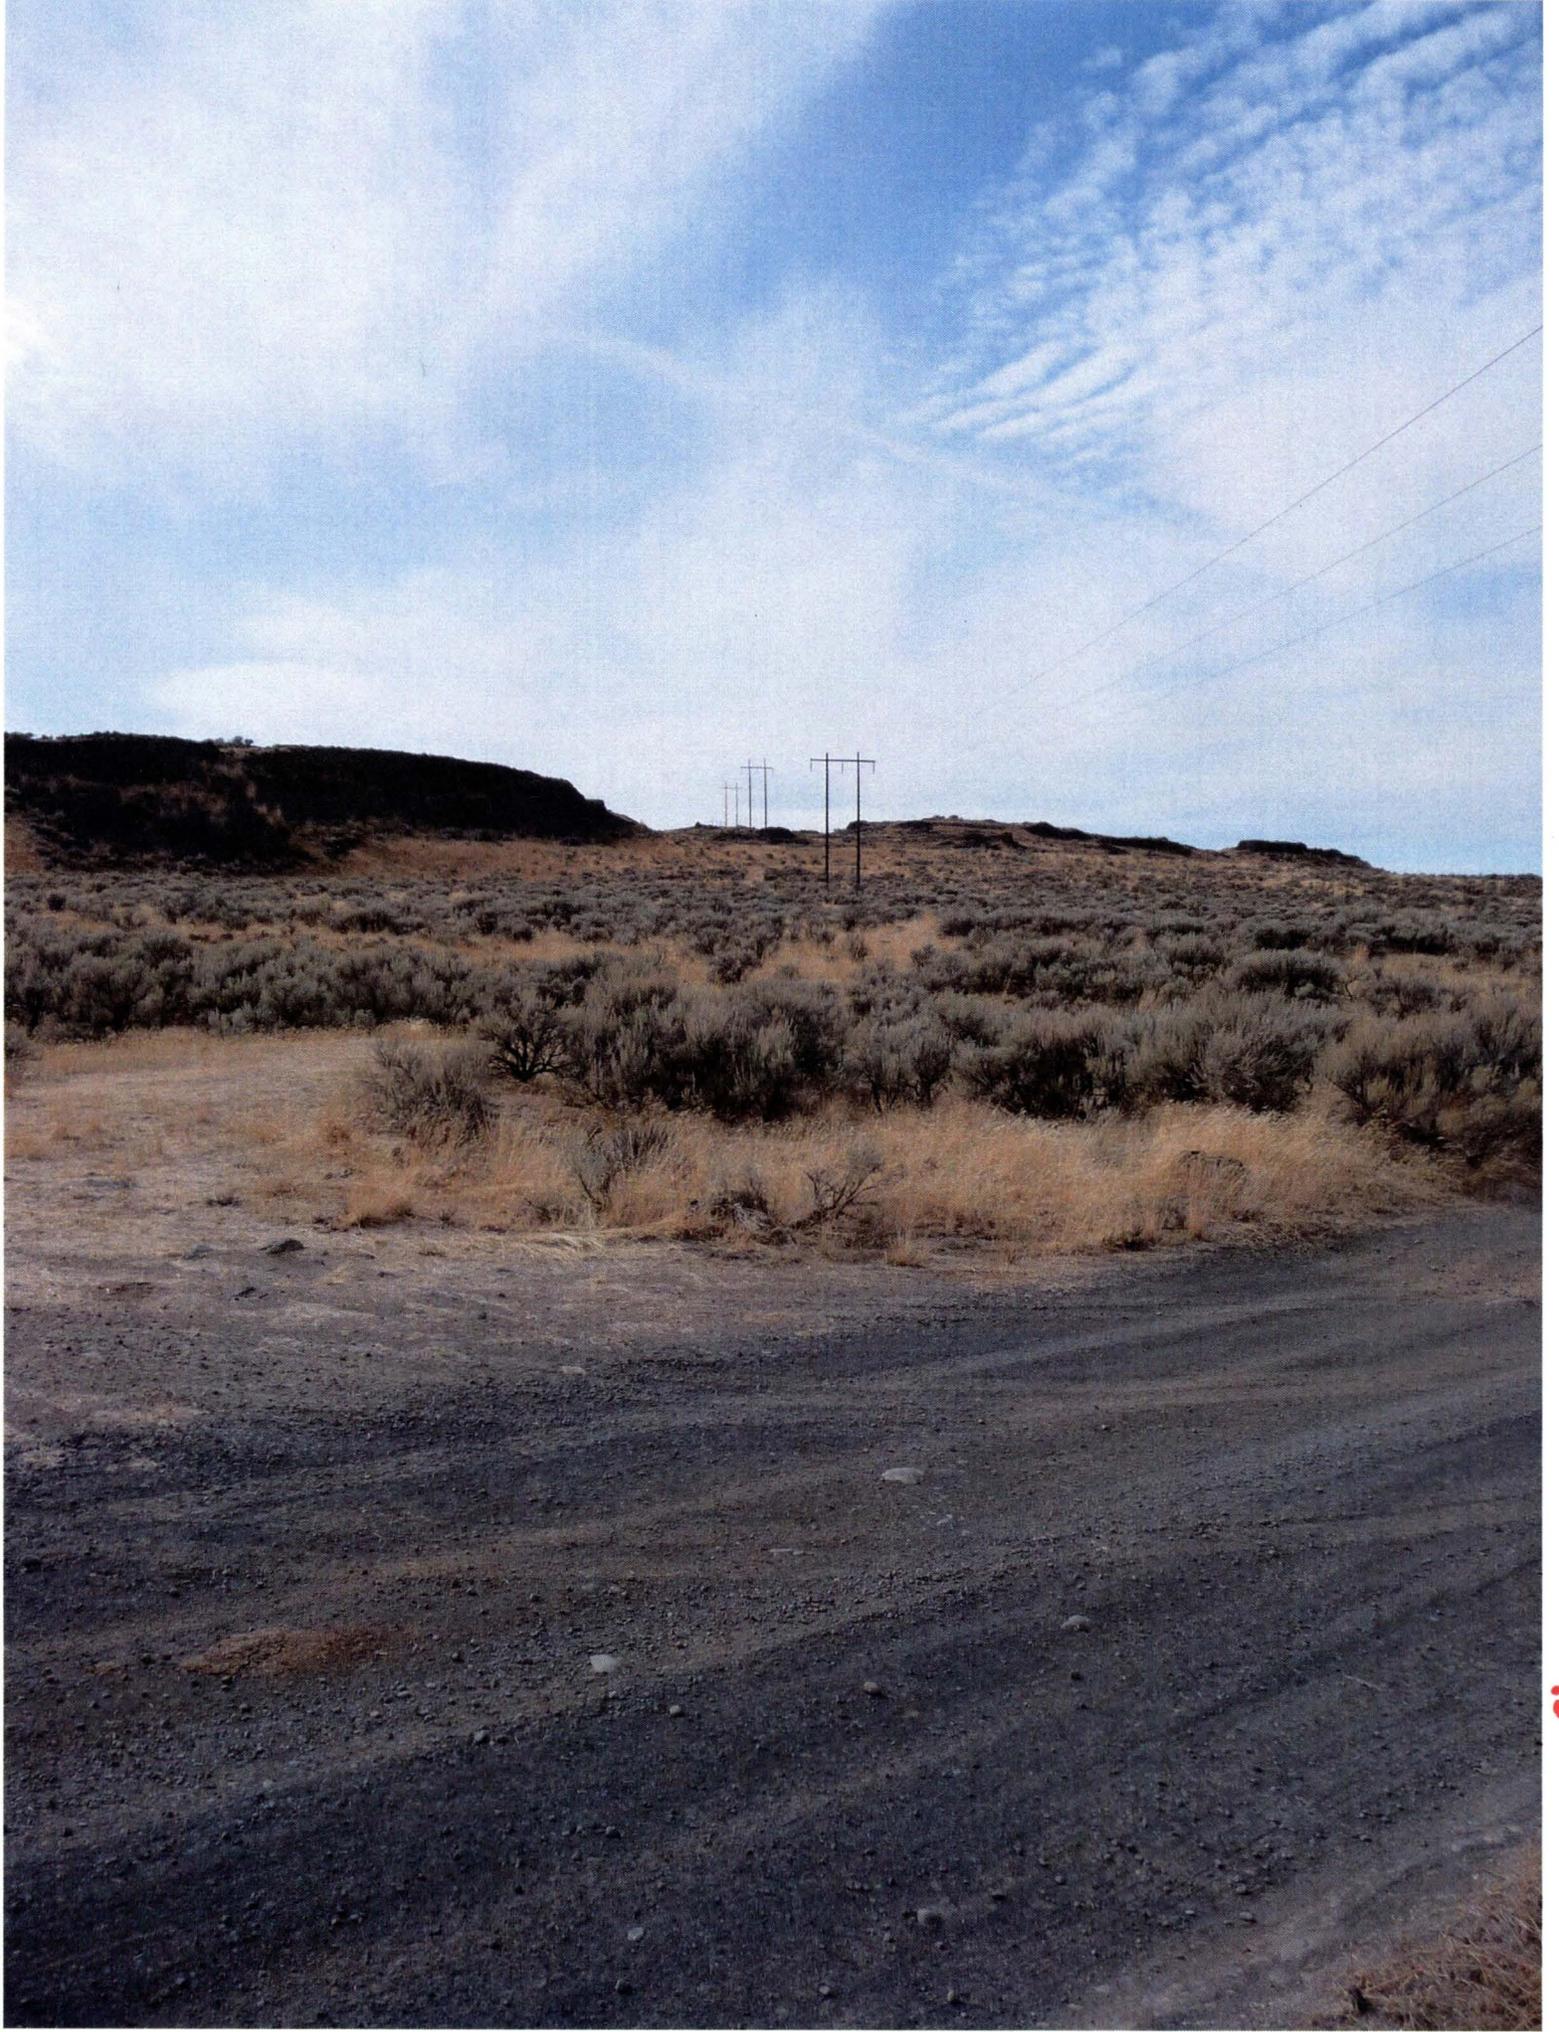
- I. LOCATION:** refer to attached Field map, BLM Minerals Management Status Map, 1/100,000 Scale and BLM corporate data (GIS). List photo point references (where applicable): ___T 21 N., R. 32 E., Section 1 to T 21 N., R. 32 E., Section 2; see photos # 11 – 13___

Describe: A wood and iron vehicle bridge crosses Crab Creek on BLM land prior to the private in-holding, and there are two cattle guards on the BLM section of the road.
