United States Department of the Interior

BUREAU OF LAND MANAGEMENT
Alaska State Office
222 West Seventh Avenue, #13
Anchorage, Alaska 99513-7504
www.blm.gov/alaska

Subject: Supplement to Navigability Report Dated April 10, 2002, for the Knik River in Southcentral Alaska

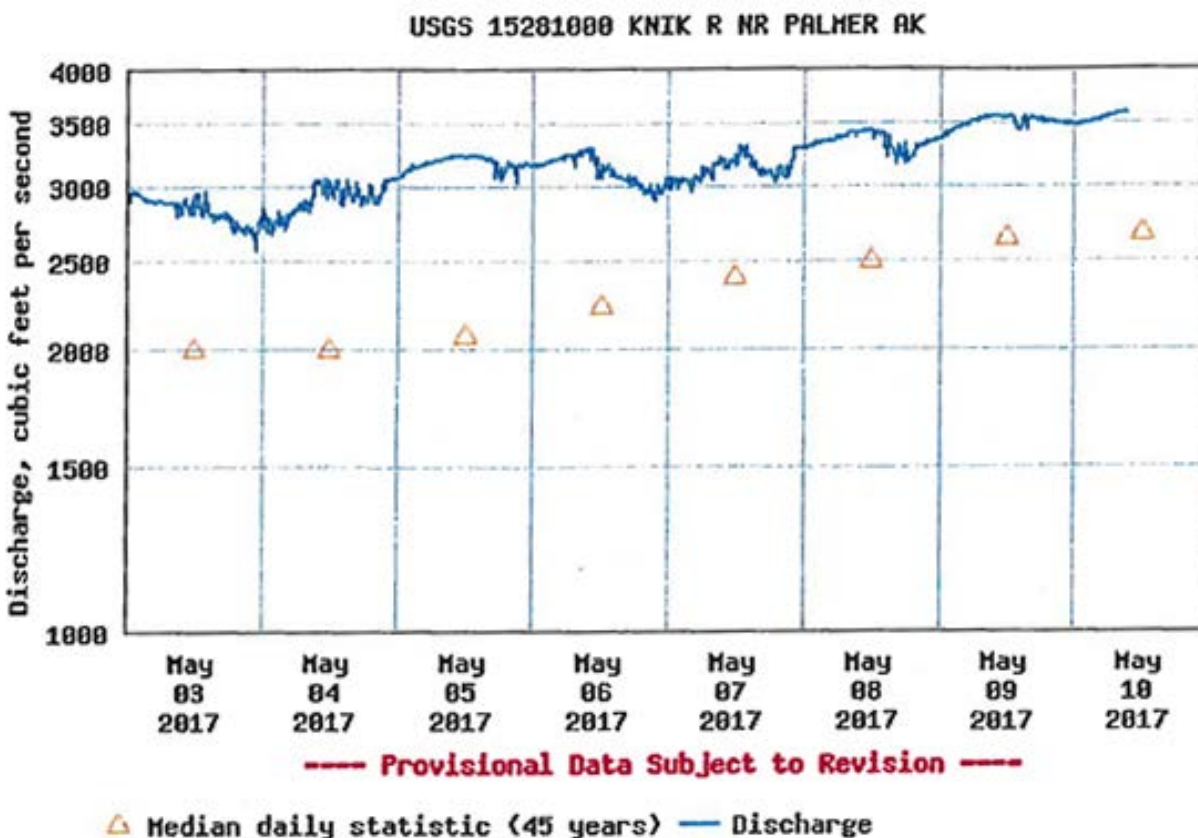
Figure 1: Flow data reported for the Knik River by USGS on their National Water Information System: Web Interface. BLM's field examination was conducted on May 9, 2017.

2017 showed flow levels of approximately 3000 cfs, close to what the State documented in its trips.

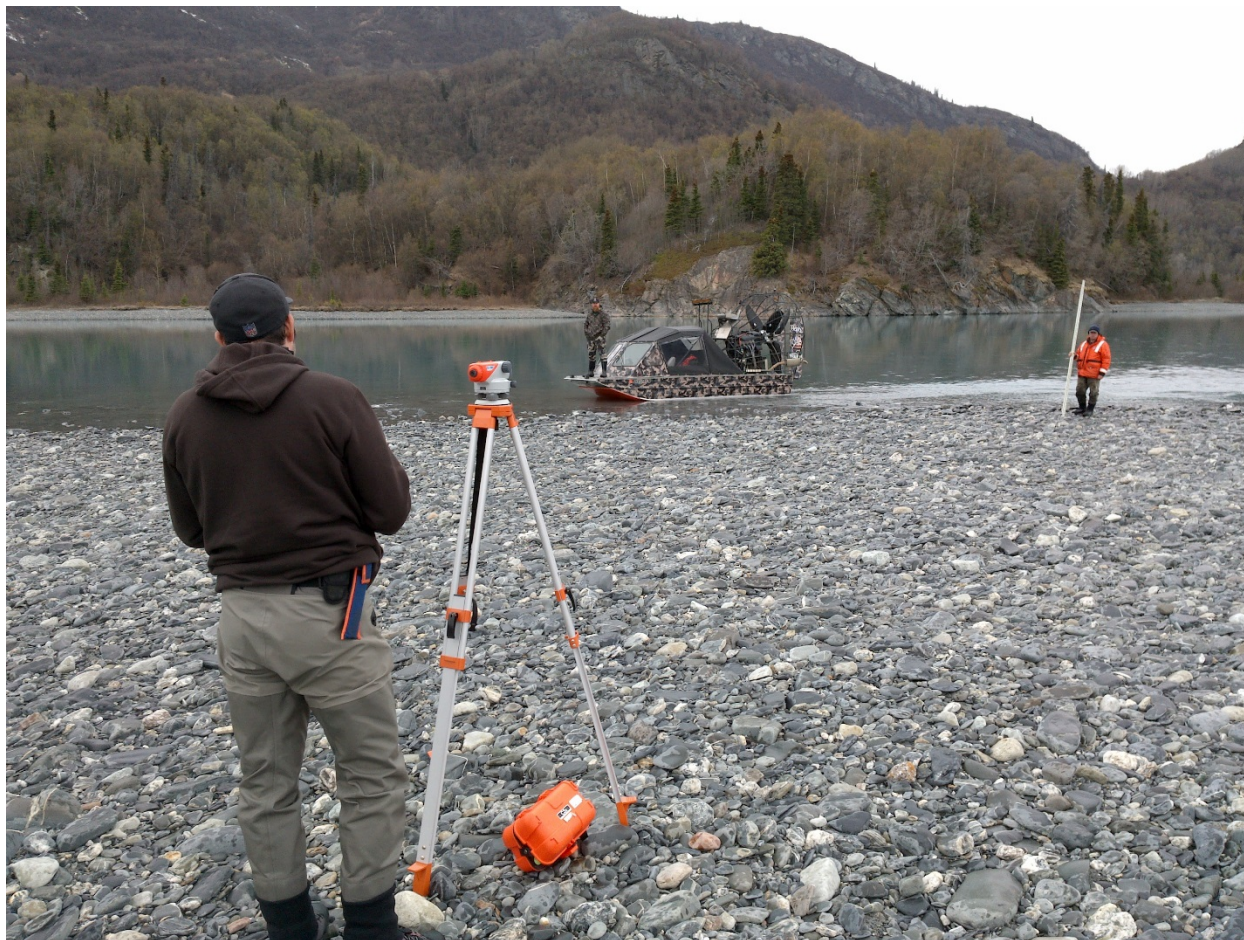
Figure 2: Ben Stratton (foreground) and Merlyn Shelske (background) taking measurements of the Knik River at the eastern township line of T. 16 N., 4 E., SM. The airboat operator, Joe Tate, and his boat are also pictured. Ben Stratton noted that the depth at this location was in excess of three feet deep.

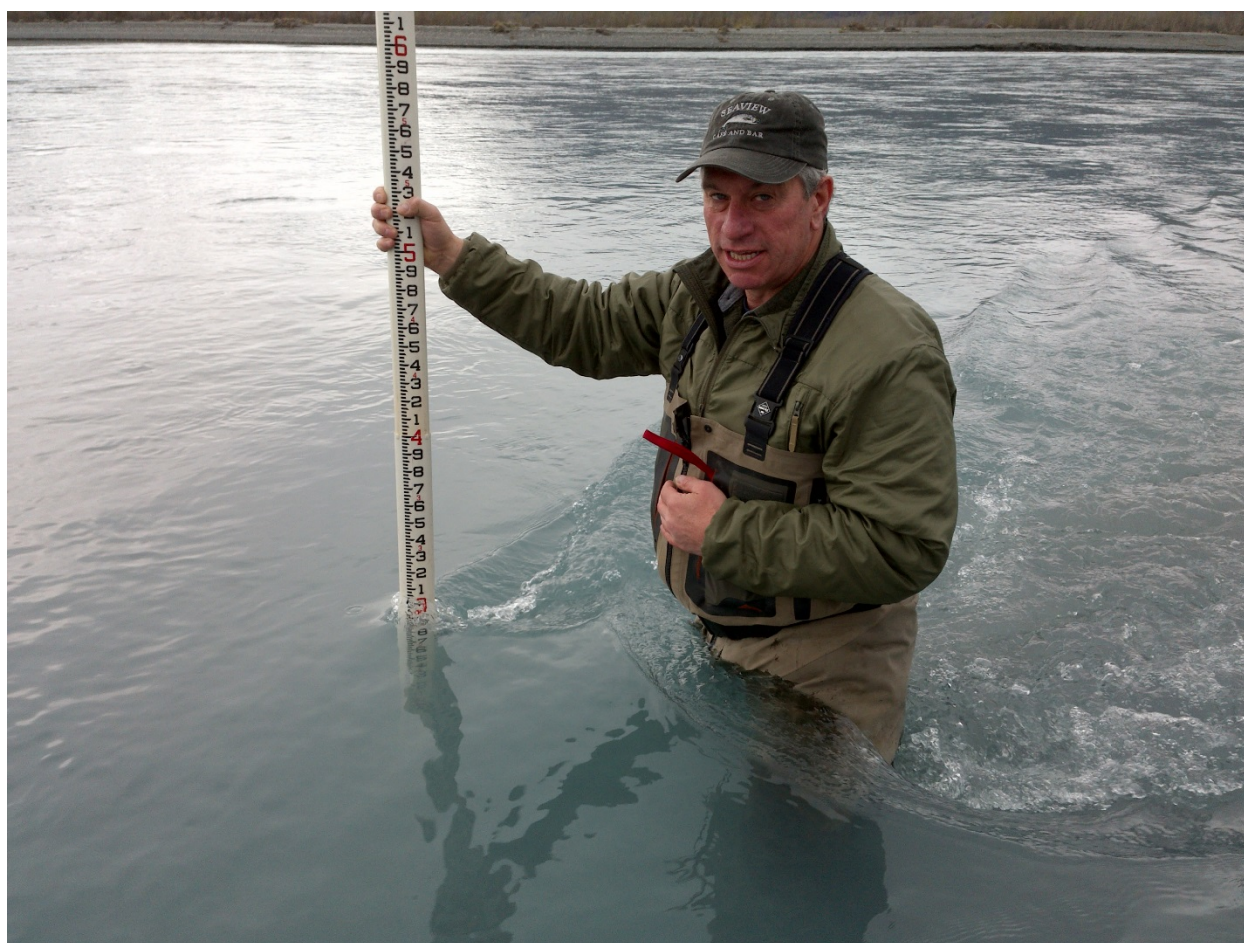
Figure 3: Merlyn Shelske, recording the depth of the Knik River at a location near the western township line of T. 16 N., R. 4 E., SM. The depth noted on the survey rod shows approximately 3 feet.

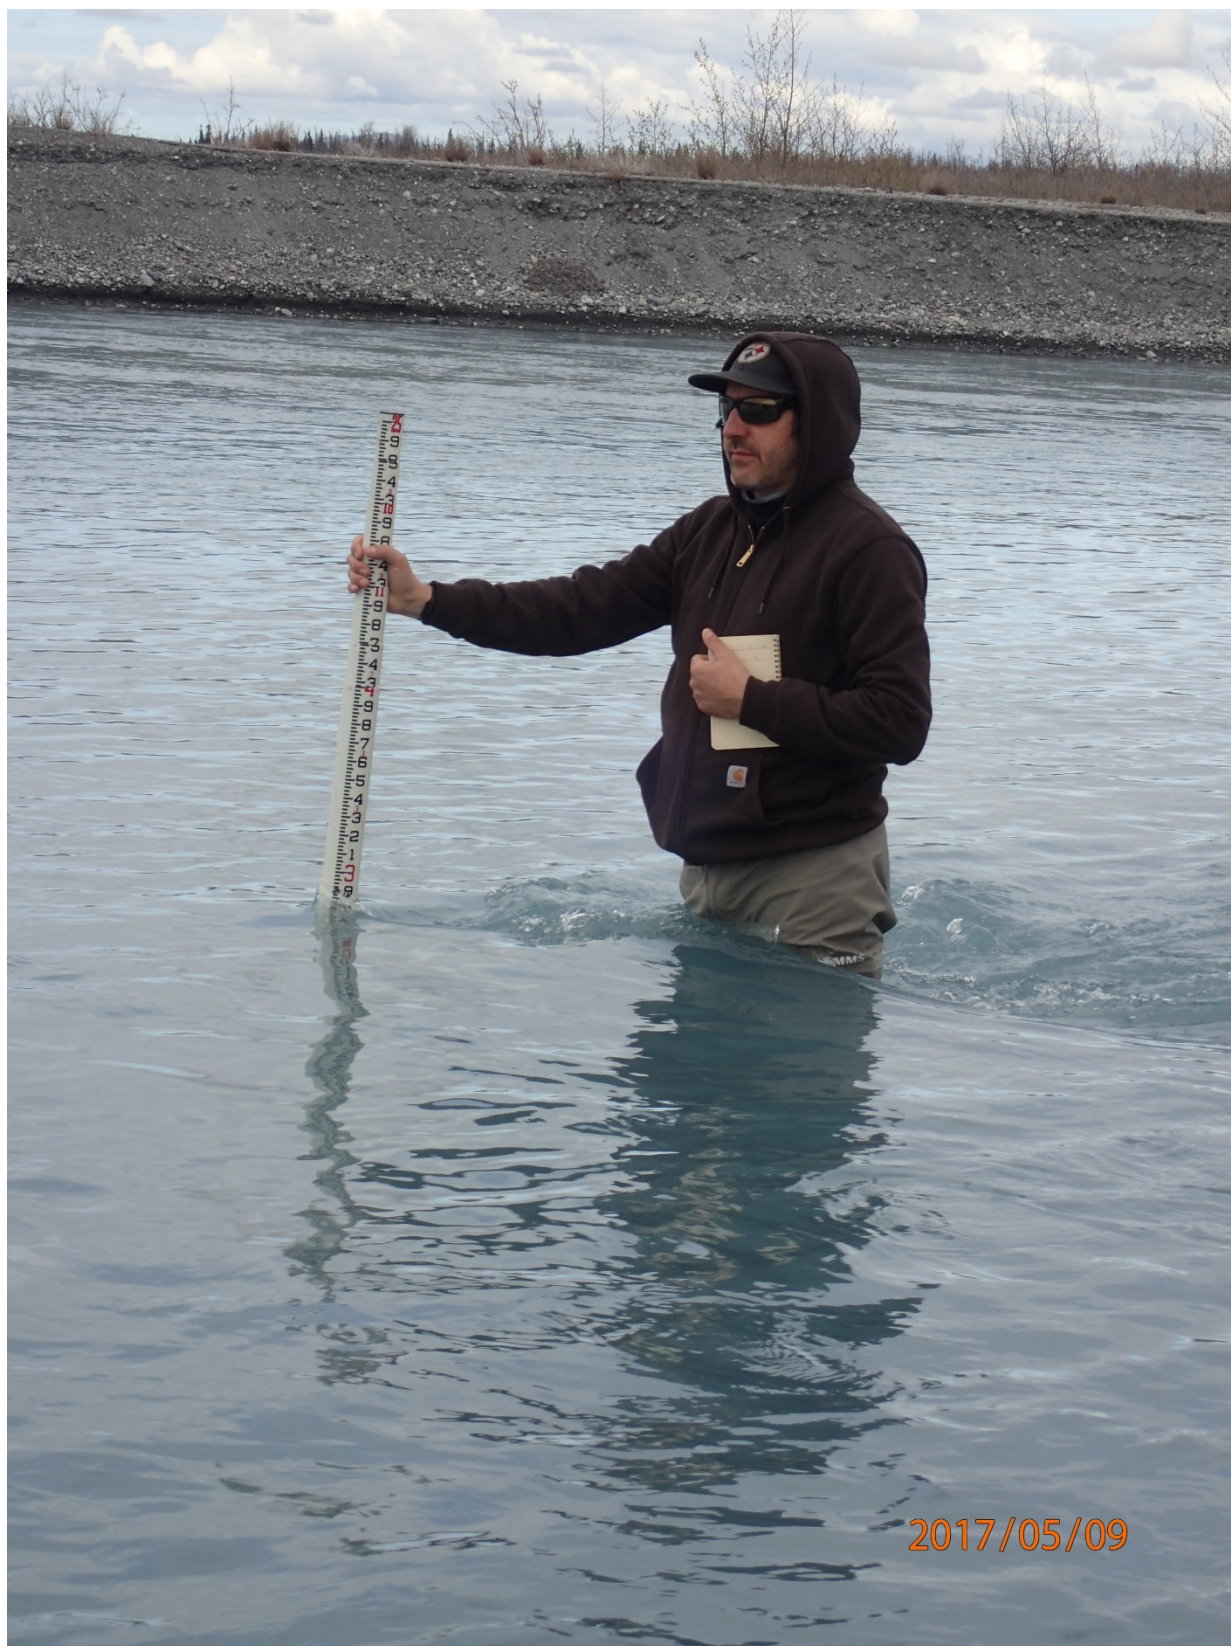
Figure 4: Ben Stratton measuring the depth of the Knik River at the midpoint stop in T. 16 N., R. 4 E., SM. The depth was nearly 3 feet deep.

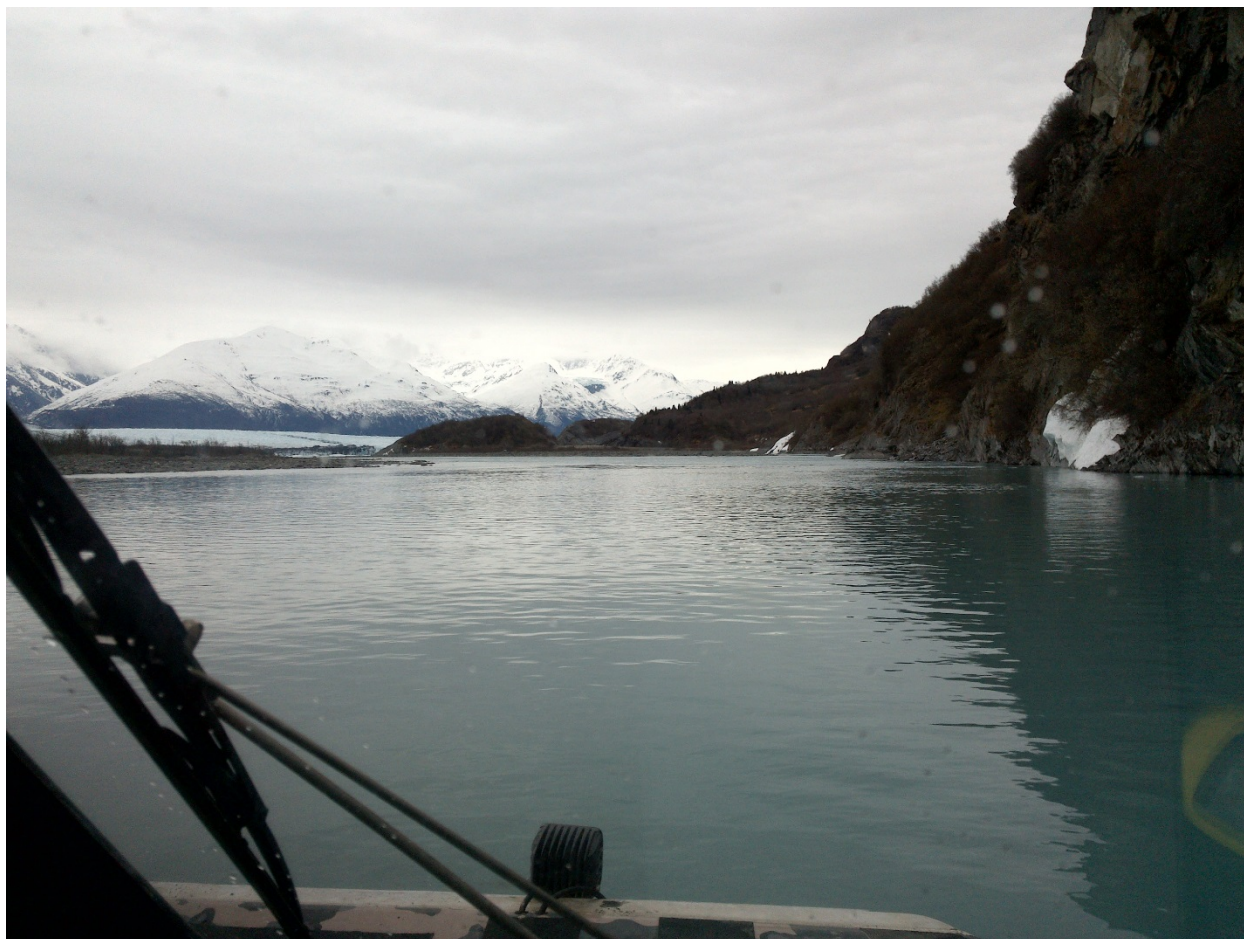
Figure 5: Picture taken near the Knik glacier. The river is now a deep single channel as we approach the glacier.

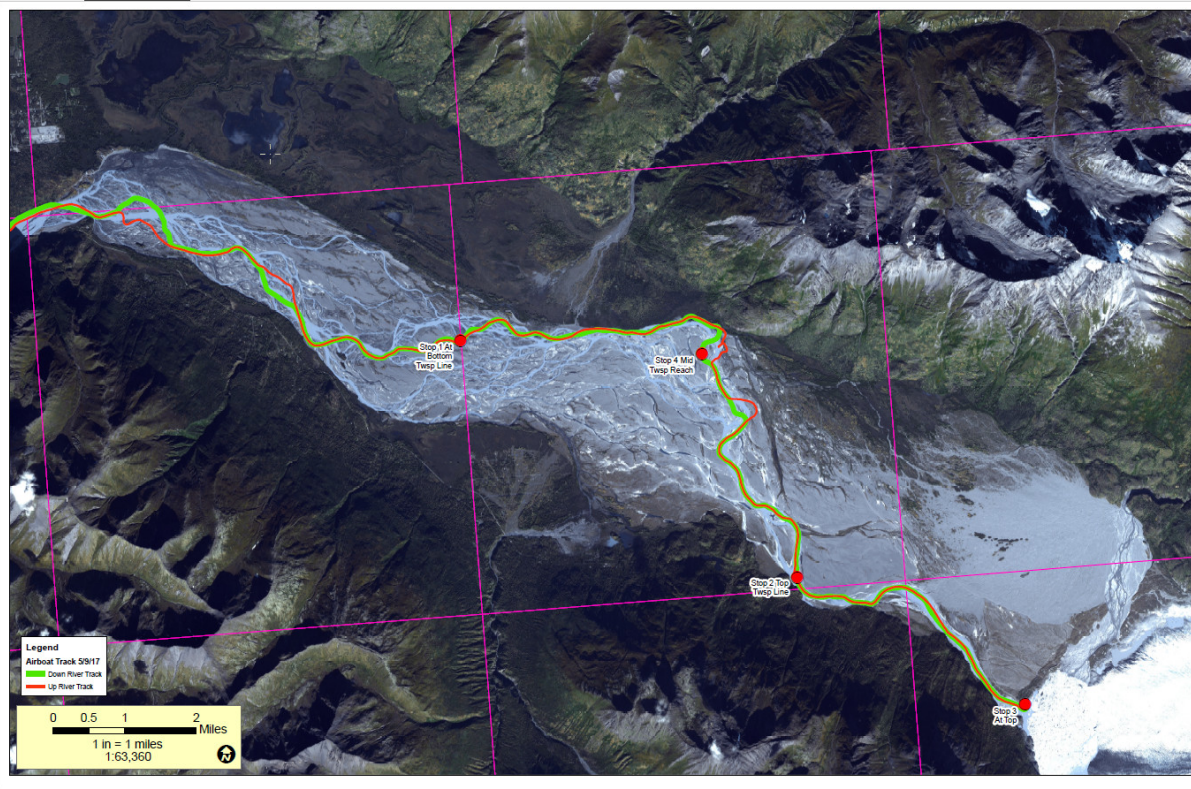
Figure 6: Knik River Field data map from May 9, 2017 that displays the gps track upstream to the glacier and downstream to the upper bridge that the BLM traveled.

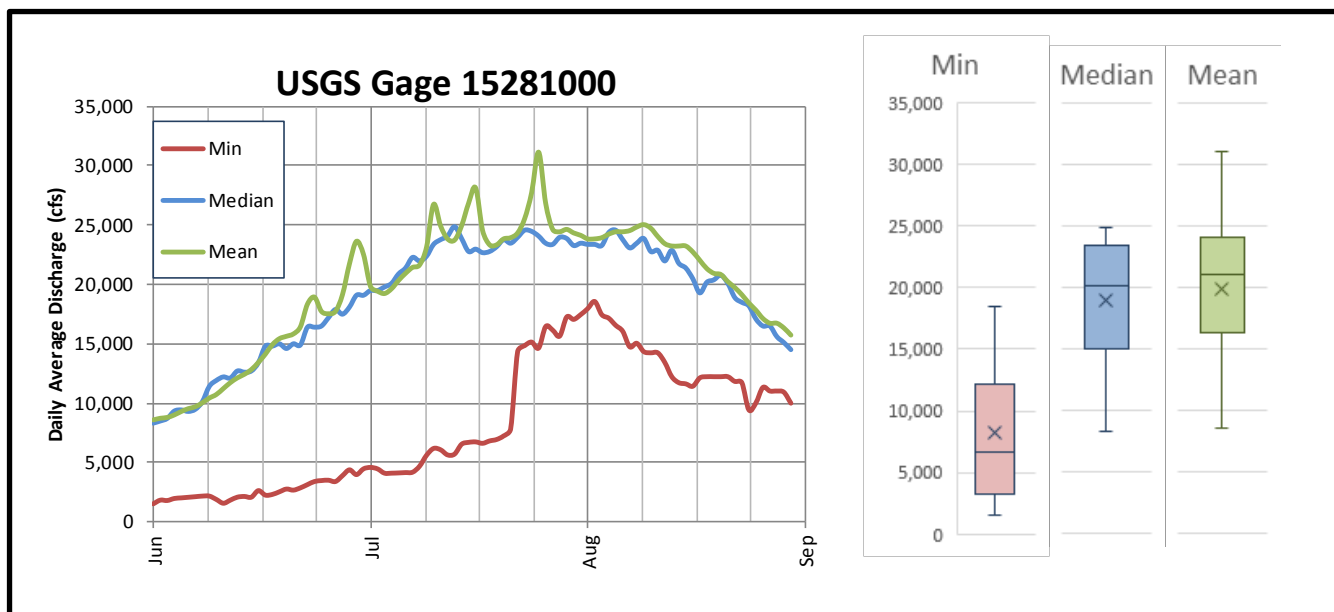
Figure 1 – Summary of 44 years of daily average flow data for Knik River USGS Gage 15281000.

The USGS has maintained a gage site on the Knik River near the Old Glenn Hwy Bridge. Gage 15281000 "Knik River near Palmer Alaska" has been in operation since 1 October 1959. A normal high water discharge measured in cubic feet per second (cfs) was estimated to be about 20,000 cfs using 44 years of daily average flow data for summer conditions (Figure 1). Measures of the central tendency (both median and mean) of both the median and average of the daily average flow data for 1-June to 31-August for the available data reasonably agree on about 20,000 cfs. The central tendency of the minimum flow for these data is about 7,500 cfs.

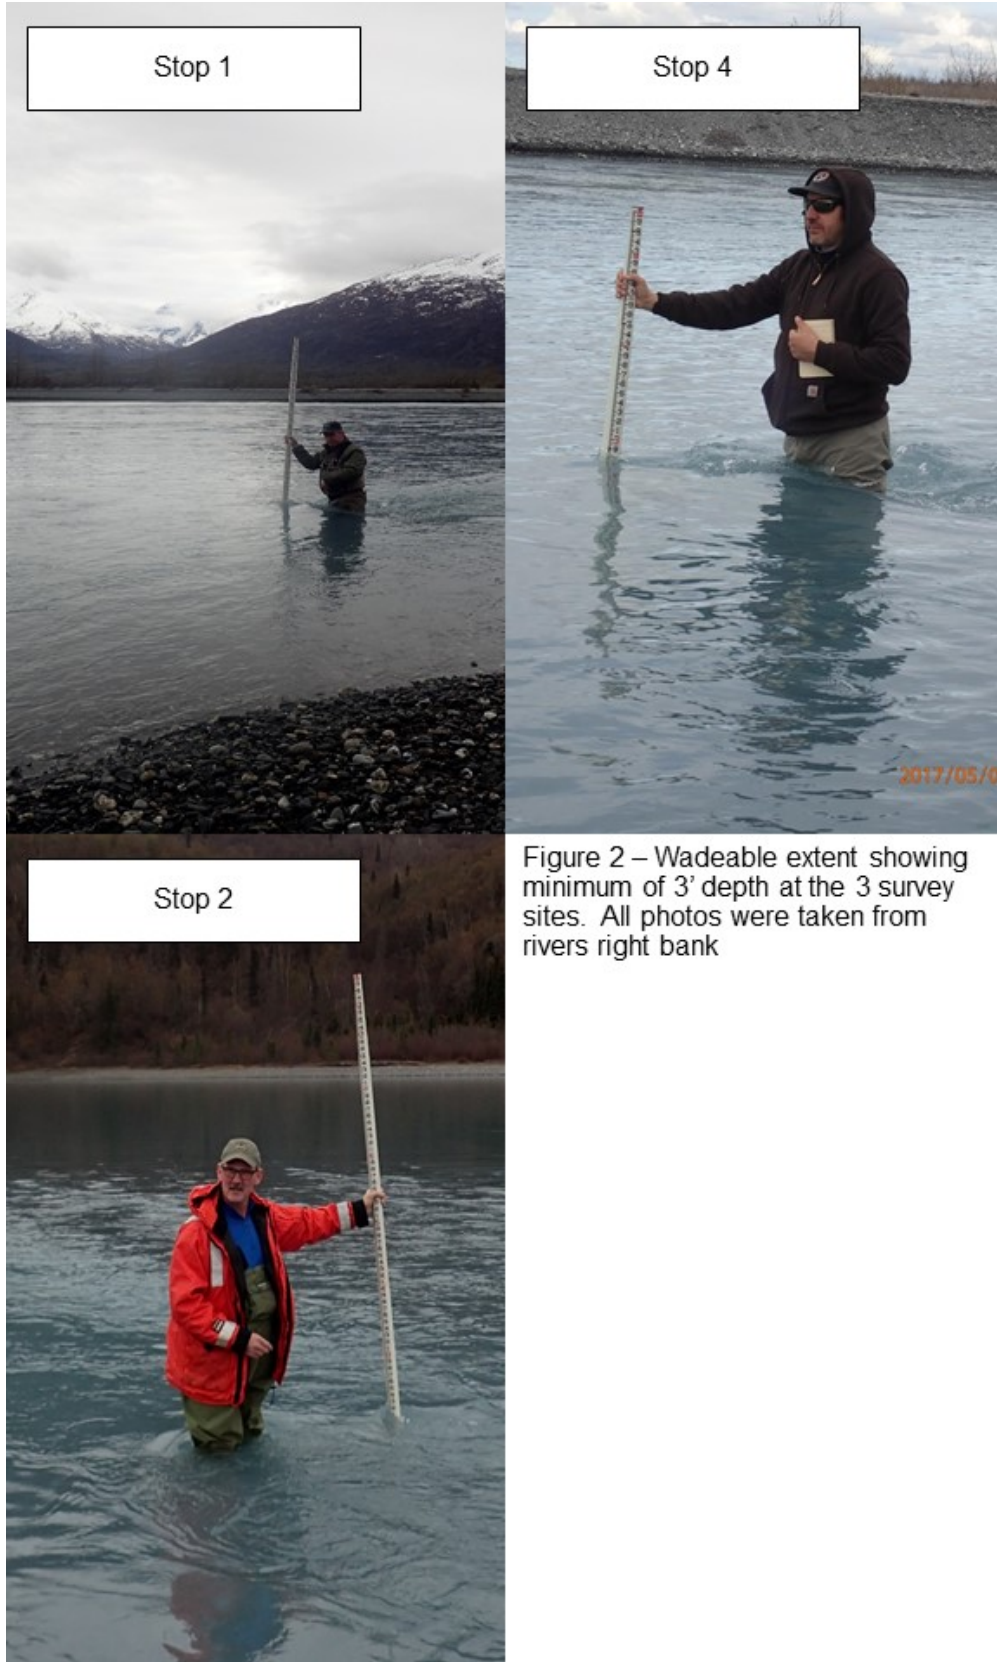
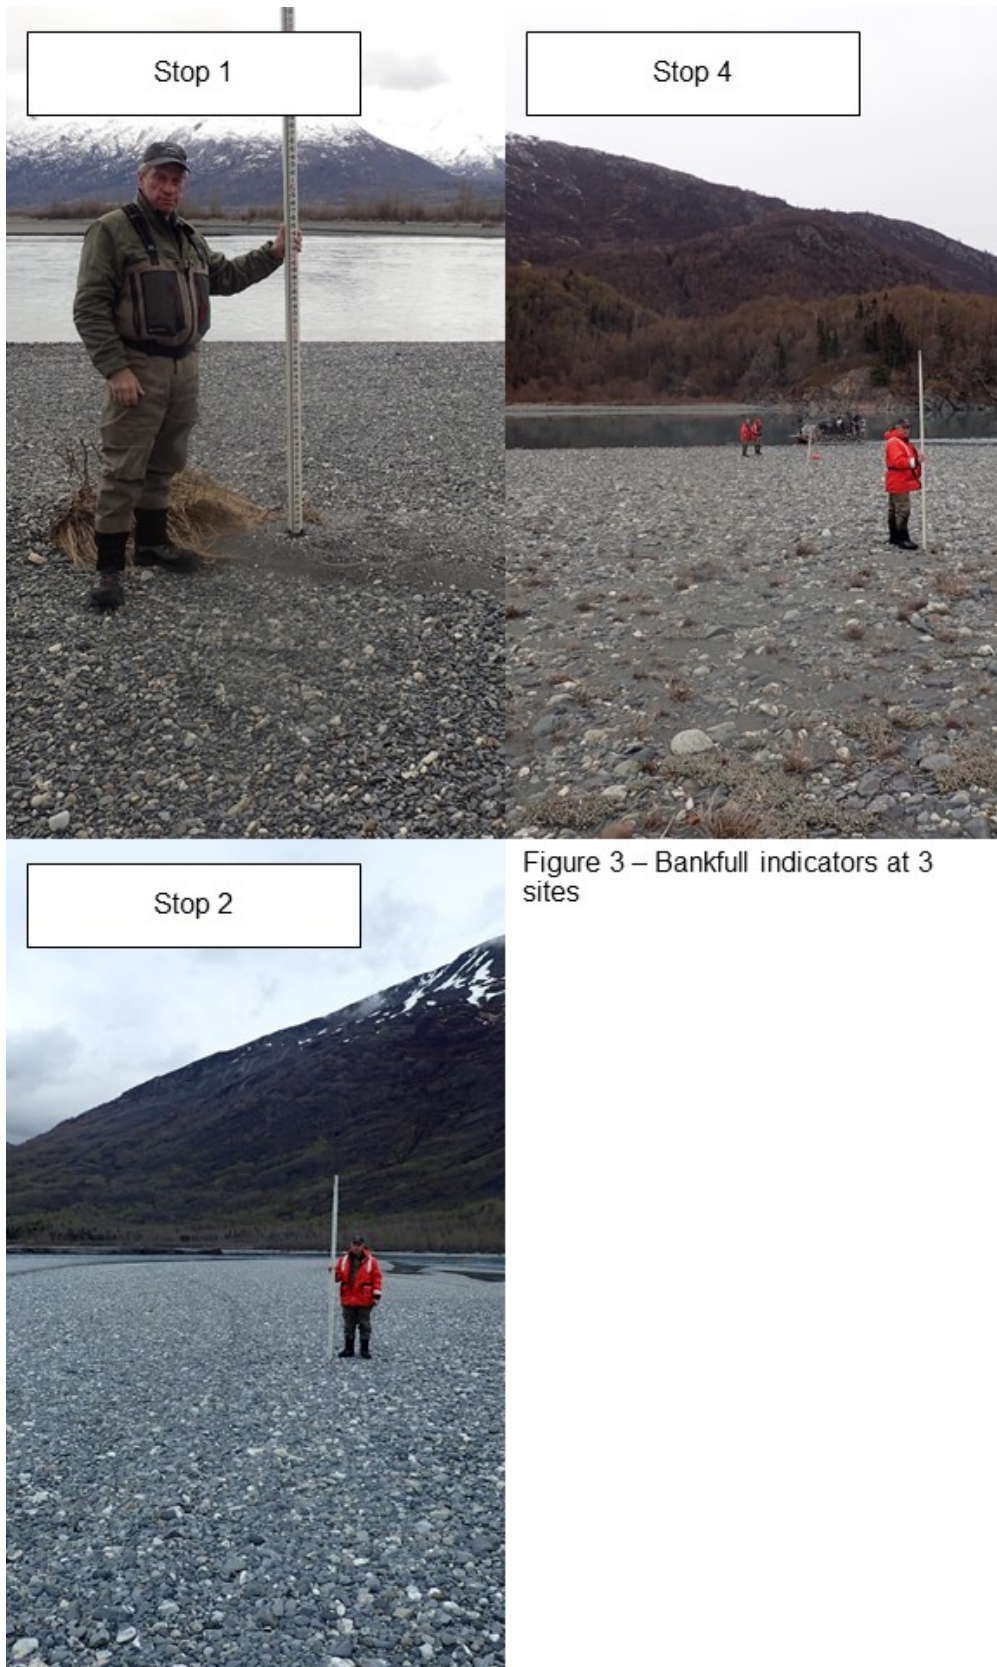
Figure 2 – Wadeable extent showing minimum of 3' depth at the 3 survey sites. All photos were taken from rivers right bank

At each site, the depth of the main channel was confirmed to be greater than 3' deep using a stadia rod (Figure 2). The elevation of normal high water was estimated using geomorphic indicators of bankfull flows. Bankfull indicators observed included the flat top of point bars and other depositional features; rock staining, and vegetation gradients (green line). The vertical distance from the current water surface to bankfull elevation was measured with a surveyor's level and stadia rod. This measurement represents the expected river elevation during normal high water. All three sites were found to have at least 3' of water at the time of the low flow (approximate 3500 cfs) field visit (Figure 3). In addition to the minimum of the 3' of water measured at the time of survey, Stop 1 is estimated to be 2' deeper during normal high flow, Stop 2 is estimated to be 4.5' deeper, and Stop 2 is estimated to be 1.5' deeper.
