Subject: Reconsideration of the Navigability Report Dated June 29, 1983, Regarding the West Fork of the Dennison Fork and the Dennison Fork of the Fortymile River in the Upper Yukon Region, Alaska

Maps of West Fork Dennison and Dennison Fork of the Fortymile River

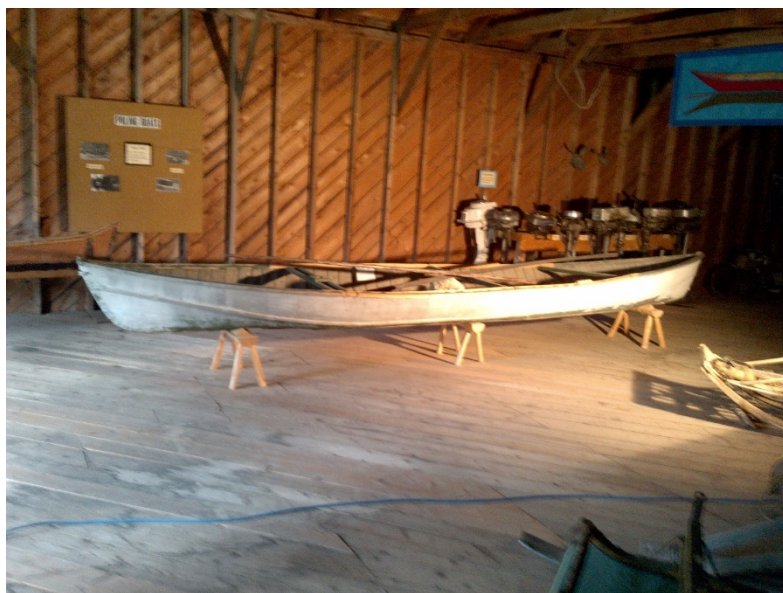
Picture 1- An example of a pole boat (approximately 20' long by 4.5' wide) used in the Fortymile Region located at Fort Egbert, in Eagle, Alaska. Photograph taken by Jack Frost, BLM, July 2018.

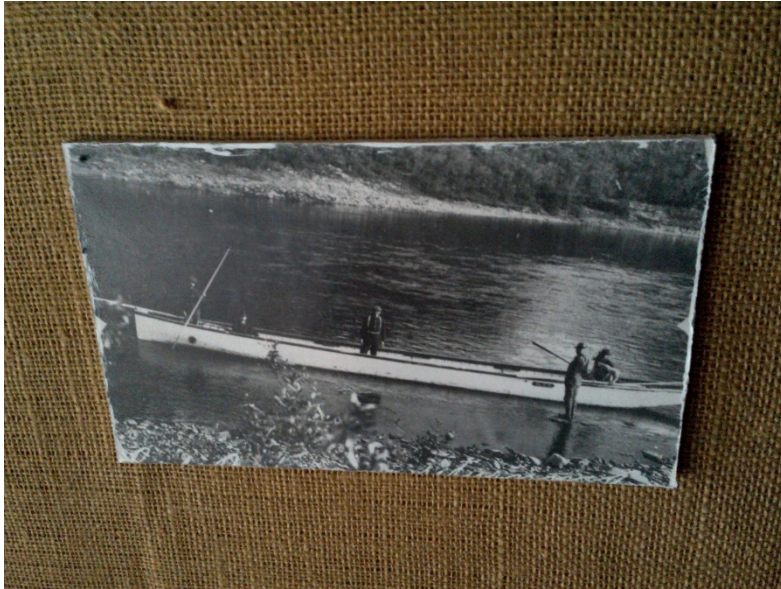
Picture 2- Photograph of a historical picture showing a very large pole boat used in the Fortymile Region to haul freight. Photograph taken at Fort Egbert, by Jack Frost, BLM, July 2018.

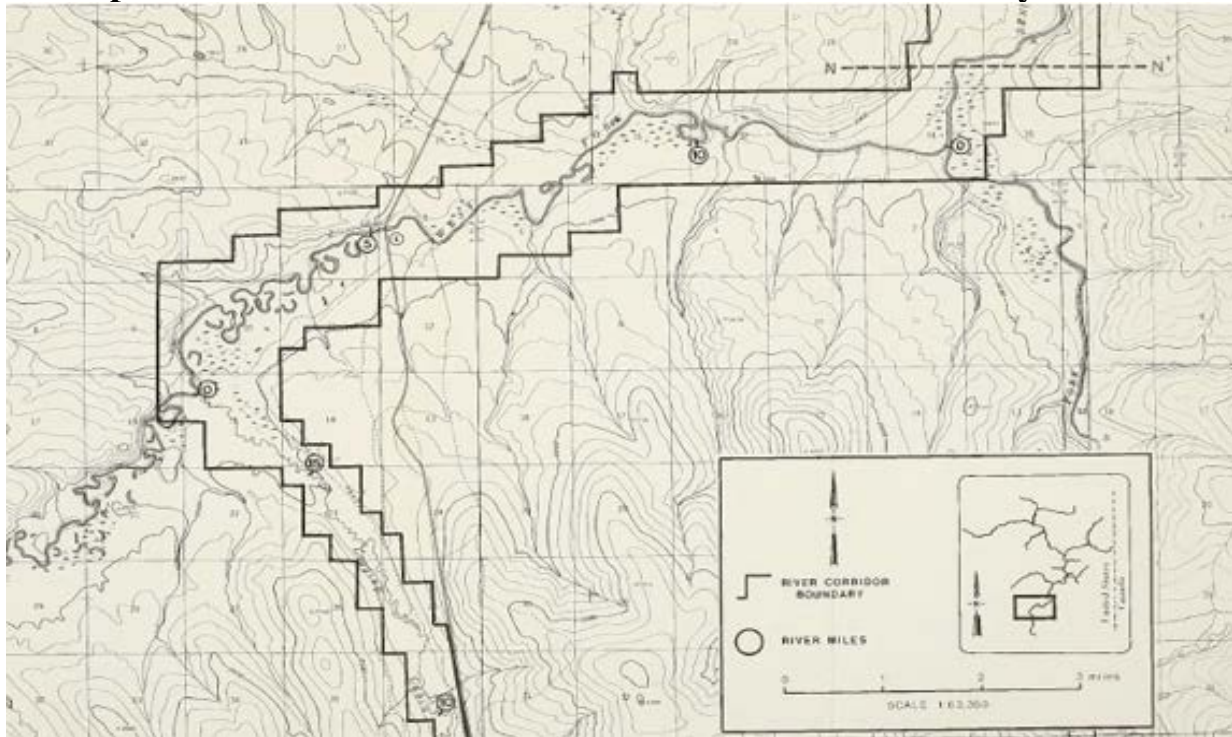
Figure 1a. USGS 1:63,360 Topographic Map Tanacross (D-3), Alaska 1956 base map showing West Fork of the Dennison Fork of the Fortymile River and WSR corridor boundary, BLM 1983 Fortymile River Management Plan.

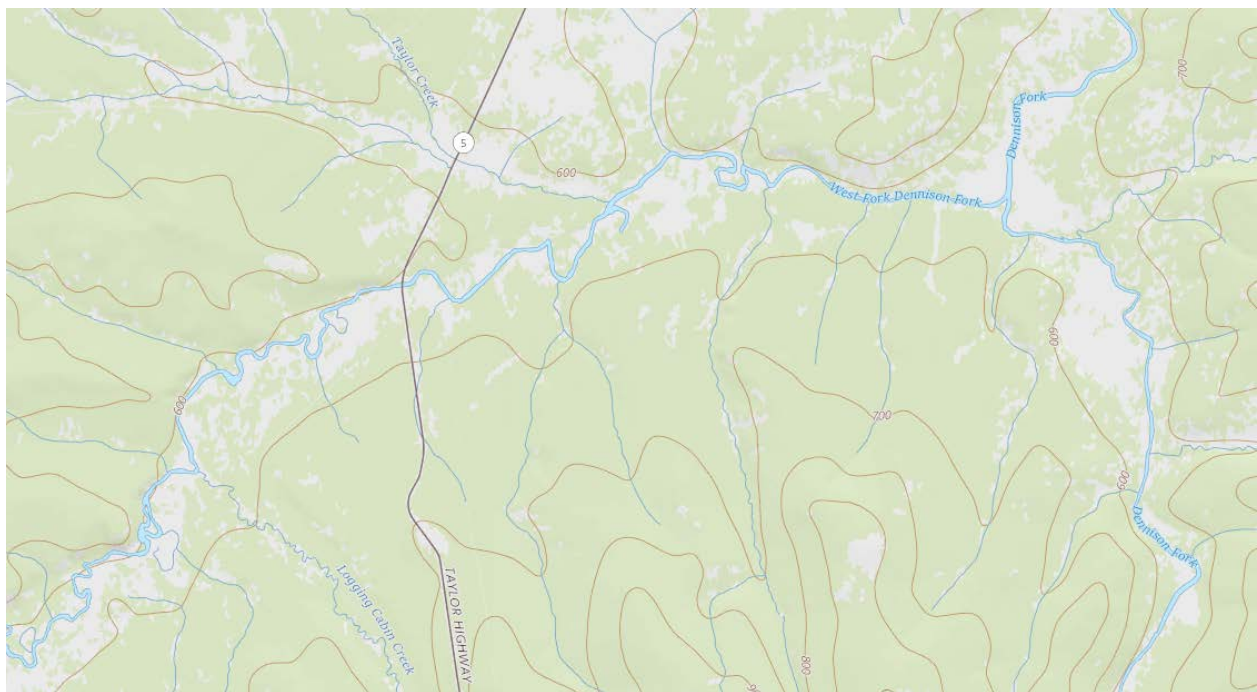
Figure 1b. USGS National Map and Elevation Data available at <https://viewer.nationalmap.gov/> (Last Modified: 26-Jun-18) showing West Fork of the Dennison Fork of the Fortymile River.

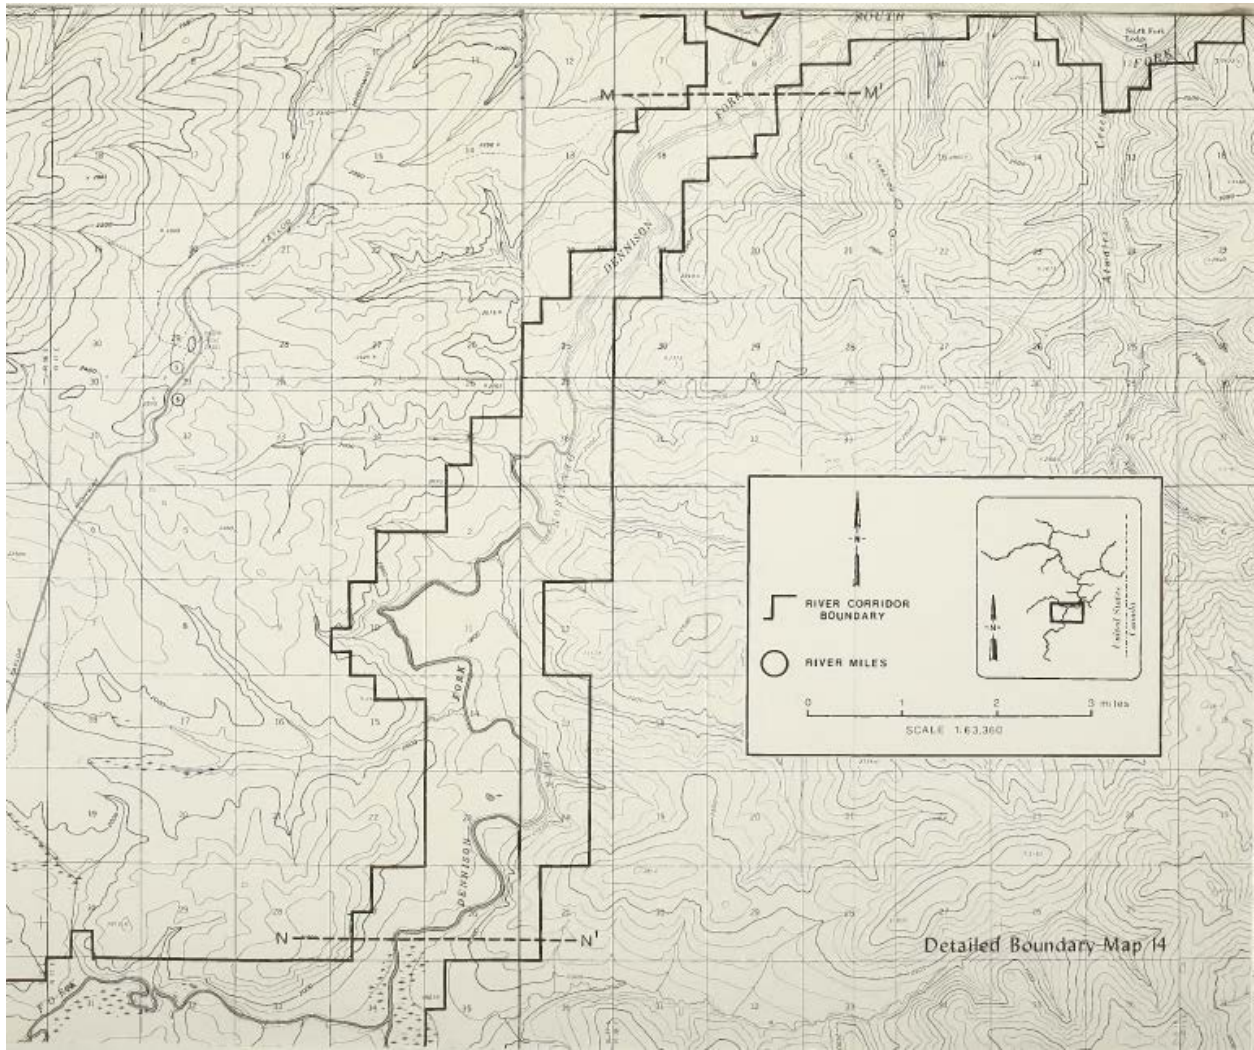
Figure 2a. USGS 1:63,360 Topographic Map Tanacross (D-3), Alaska 1956 base map showing Dennison Fork of the Fortymile River and WSR corridor boundary, BLM 1983 Fortymile River Management Plan.

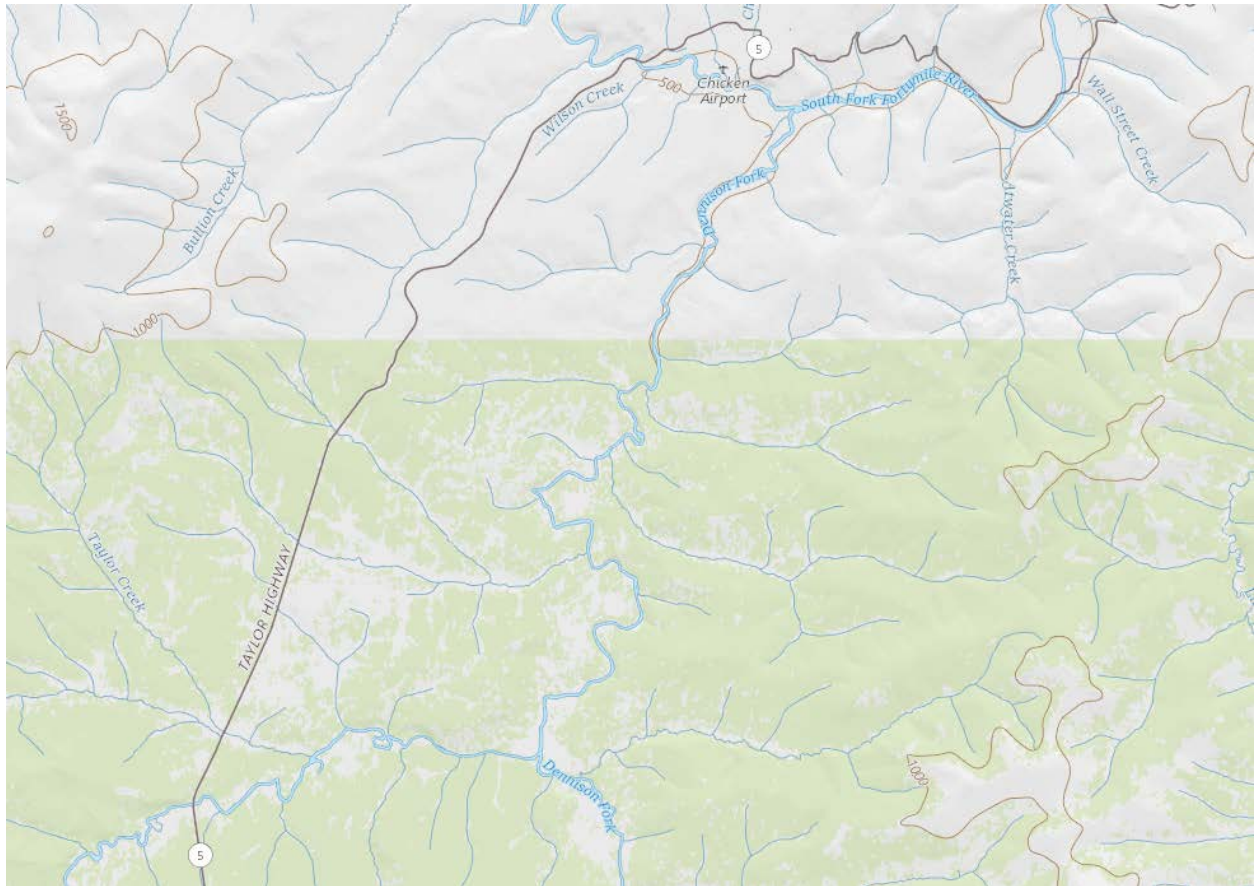
Figure 2b. USGS National Map and Elevation Data available at <https://viewer.nationalmap.gov/> (Last Modified: 26-Jun-18) showing Dennison Fork of the Fortymile River.

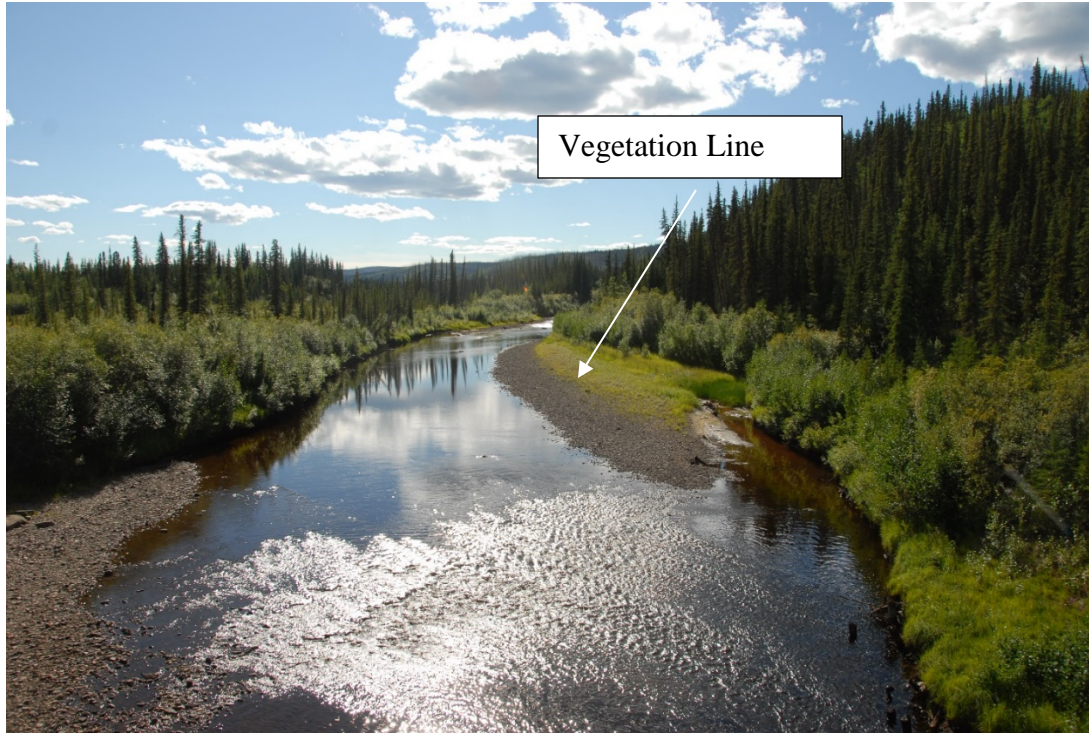
Figure 1a. Upstream view of West Fork Dennison channel at low flow, stream gage water level = 4.6 feet. Taylor Highway Bridge MP49, 1715 hours, July 29, 2018.

Figure	Date	Flow Condition	Water Surface Elevation (feet)	Discharge (cfs)	River Travel Rating
Figure 1	July 29, 2018	Low	4.6 feet	26	Very Difficult
Figure 2*	July 14, 2018	Moderate	5.7 feet	265	Fair
Figure 3	August 22, 2018	High	7.7 feet	1750	Good
		Flood	Overbank		Very Difficult

Vegetation features on gravel bars upstream and downstream of the bridge are annotated in Figures 1-3 to provide additional visual reference for changes in water surface elevation.

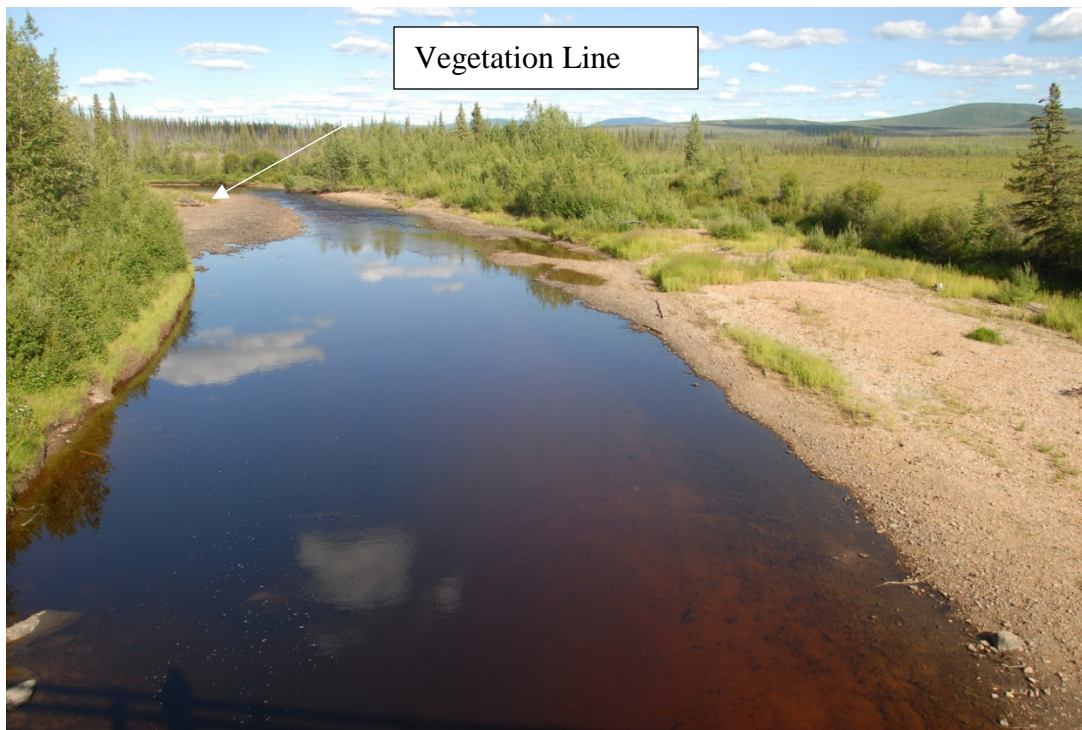
Figure 1b. Downstream view of West Fork Dennison channel at low flow, stream gage water level = 4.6 feet. Taylor Highway Bridge MP49, 1715 hours, July 29, 2018.

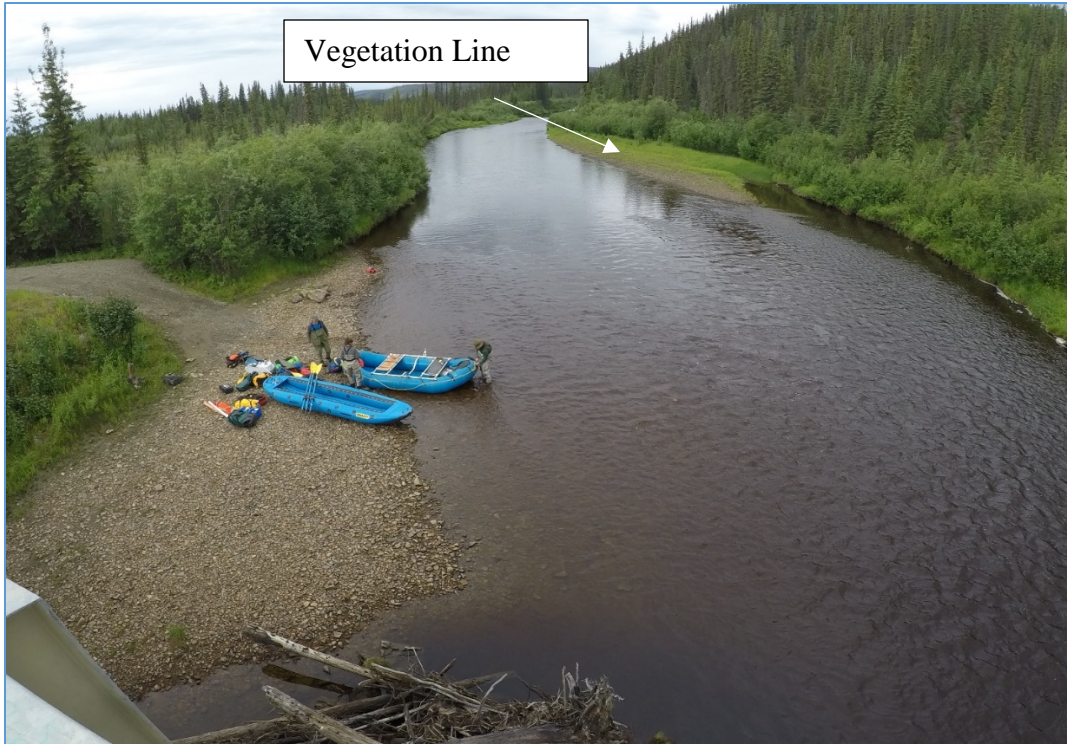
Figure 2a. Upstream view of West Fork Dennison channel at moderate flow, stream gage water level = 5.7 feet. BLM navigability float trip, Taylor Highway MP49, 1000 hours, July 14, 2018.

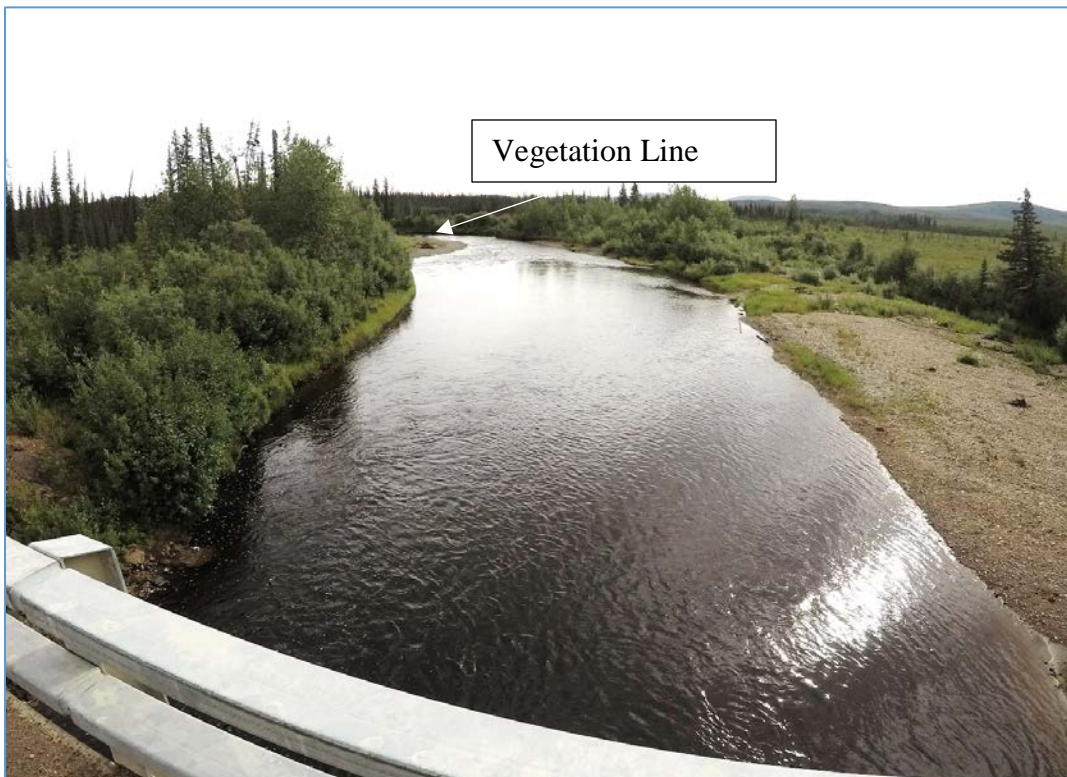
Figure 2b. Downstream view of West Fork Dennison channel at moderate flow, stream gage water level = 5.7 feet. BLM navigability float trip, Taylor Highway MP49, July 14, 2018.

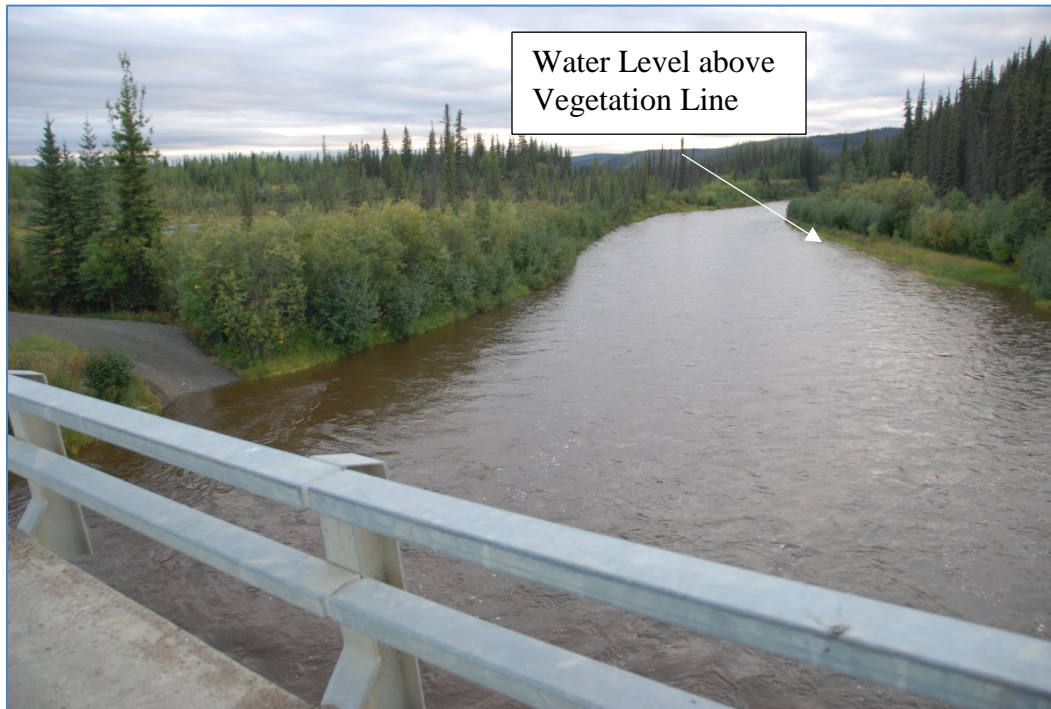
Water Level above
Vegetation Line

Figure 3a. Upstream view of West Fork Dennison channel at high flow, stream gage water level = 7.7 feet. Taylor Highway Bridge MP49, 2015 hours, August 22, 2018.

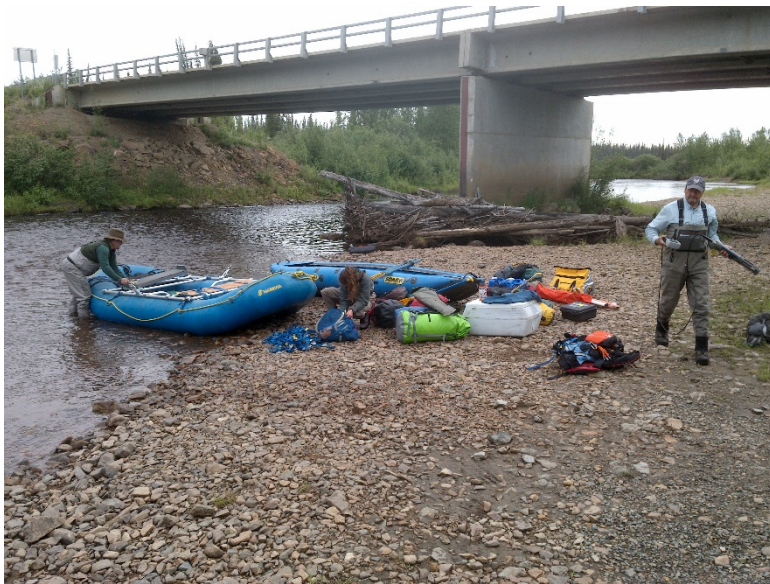
Picture 1- Put in location on the West Fork at the Taylor Highway Bridge.

The morning of July 14, we loaded up all of our gear on a truck and trailer at the Chicken field camp and drove to our put in location at the West Fork. Access is at the bridge crossing over the West Fork on the Taylor Highway (see Picture 1). While we inflated our rafts and assembled our gear on the rafts, Ben gathered some hydrological data at our put in location (see Picture 2). Ben recorded a water level of 5.67 feet from the wire-weight river gage located on the bridge and mentioned current water level was about average for mid- to late summer. Ben also noted high water events at this location were typically 2-3 feet higher than the current water level.

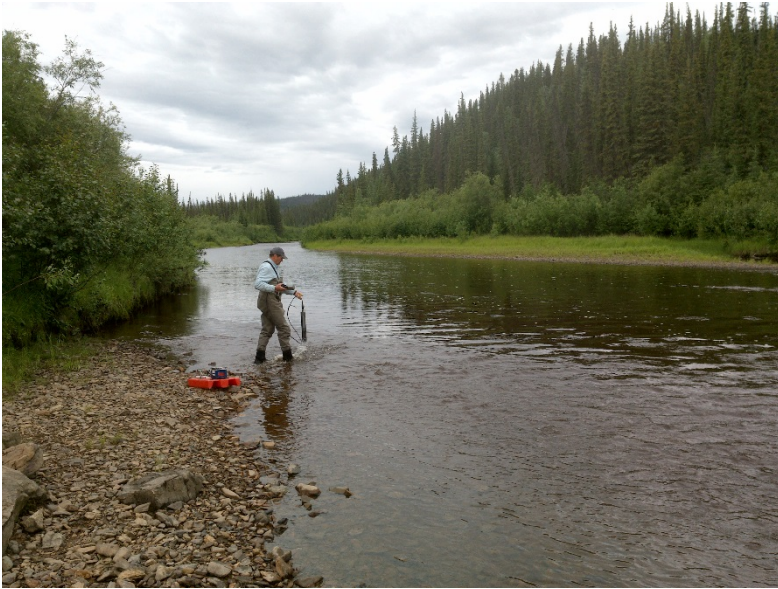
Picture 2- Ben gathering hydrological data on the West Fork at our put in location.

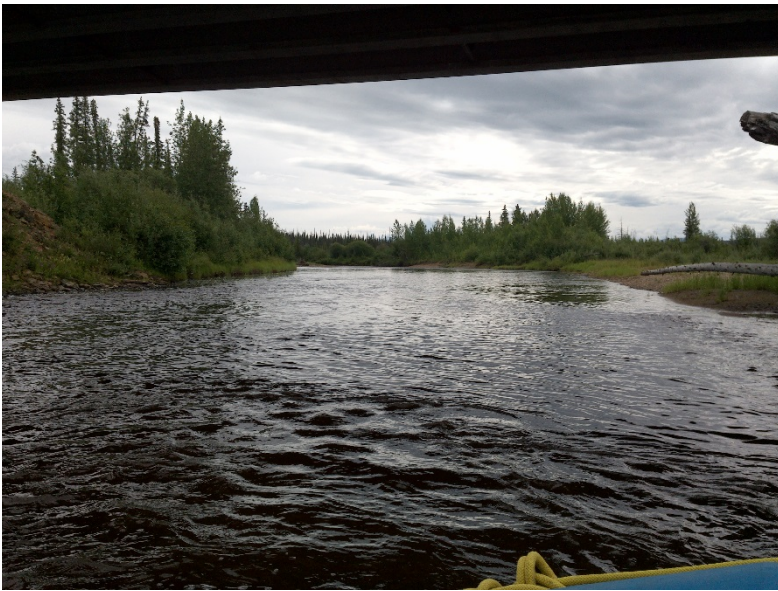
Picture 3- Approximate location of first depth reading on the West Fork.

We launched our rafts and started downstream at about 10:30 a.m. Our float on the West Fork would be short, only about seven miles in length until we encountered the Dennison Fork. My first depth reading at the bridge was noted as 2.6' and no obstructions noted there (see Picture 3). As we proceeded downstream, I took many measurements but most of the depth measurements that I took on the entire length of the West Fork averaged about two feet deep and about 100 feet wide. At first, we encountered a few minor riffles that we skirted around easily but then we encountered more riffles that we had to either maneuver our way around or drag our raft for short

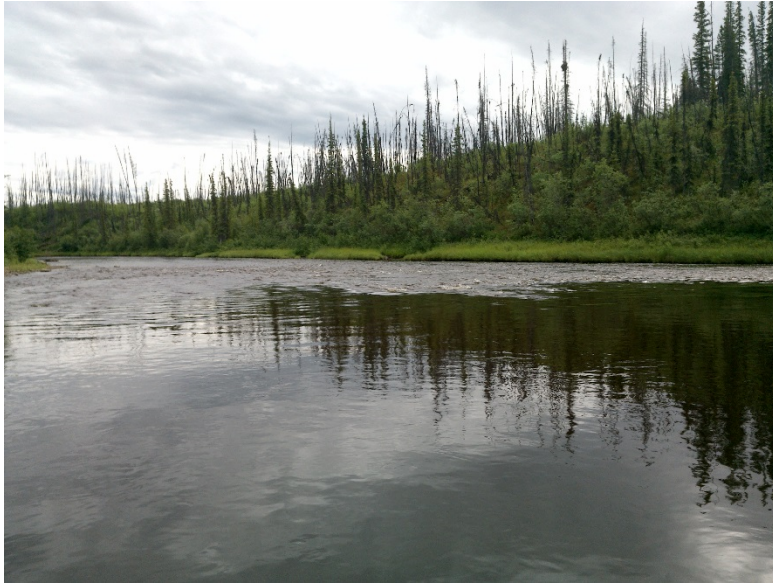
Picture 4- The first minor riffle we encountered on the West Fork about one mile downstream from the Taylor Highway Bridge.

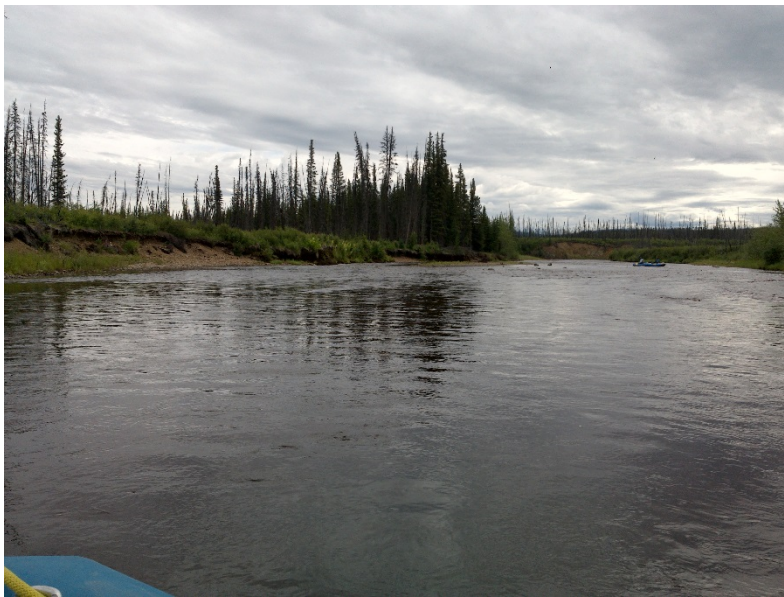
Picture 5- A riffle that required dragging through. See boat in upper right.

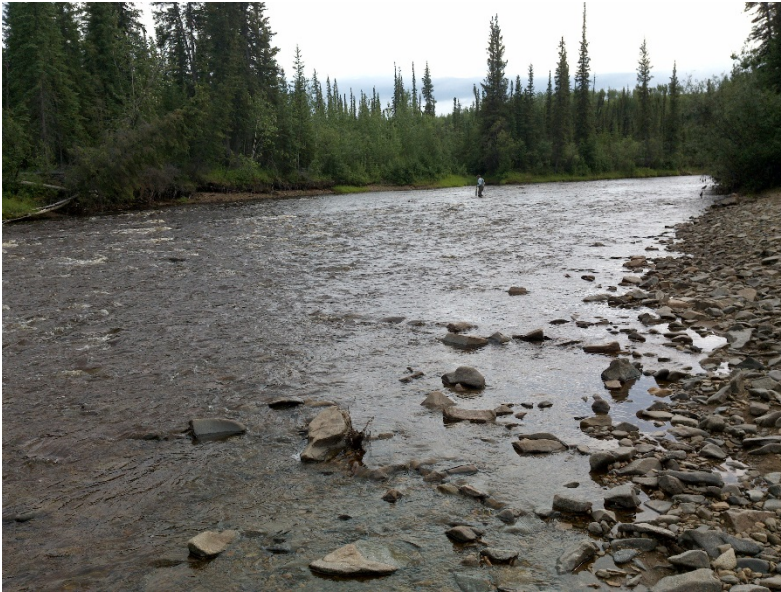
Picture 6- Ben collecting hydrological data at the confluence of the West Fork and Dennison Fork.

Once we arrived at the confluence with the Dennison Fork, Ben gathered more hydrological data on the lower West Fork for his assessment once we returned to the office (see Picture 6). This section of the West Fork was particularly shallow and rocky where it empties into the Dennison Fork but access around this short impediment can be accomplished by land. My final depth measurement at this location was noted at 1.2 feet deep.

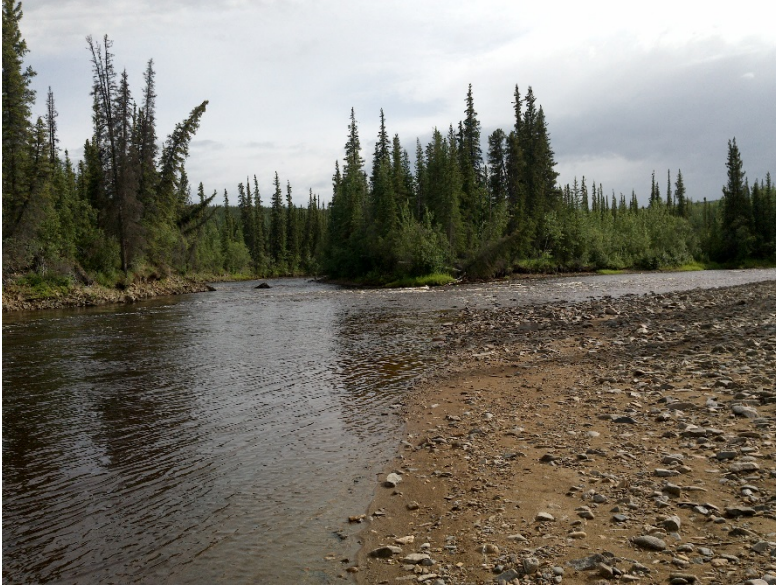
Picture 7- The confluence of the West Fork and Dennison Fork.

We arrived at the confluence of the West Fork and the Dennison Fork at 4:45 p.m. Ben began his work collecting data for his hydrologic research with the assistance of Kate. The Dennison Fork appeared to be at a normal flow level for the time of the year just like the West Fork. At about 6:30 p.m. we resumed floating downstream from the confluence on the Dennison Fork (see Pictures 7-8).

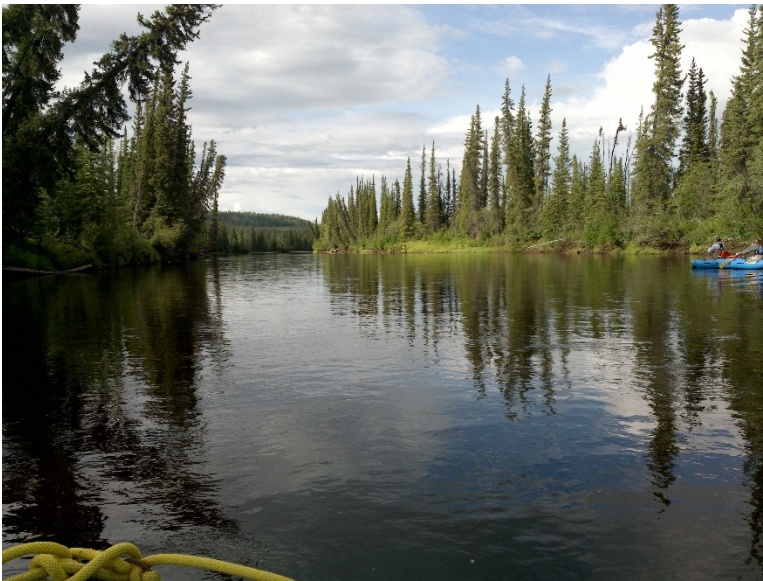
Picture 8- Looking downstream on the Dennison Fork just below the confluence with the West Fork. Also, near where I took my first depth measurement on the Dennison Fork.

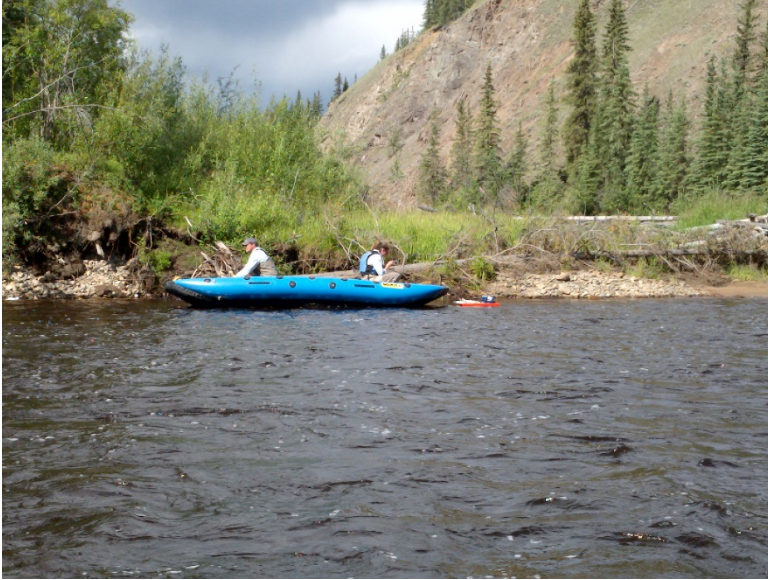
Picture 10- Ben and Kate gathering hydrological data near the confluence of the Dennison Fork and Mosquito Fork.

As stated previously, the average depth of the entire length of the Dennison Fork was over three feet deep. Ben stopped at the confluence with the Mosquito Fork to gather more hydrologic data (see Pictures 10-11). After the data was collected, we floated downstream to the boat launch on

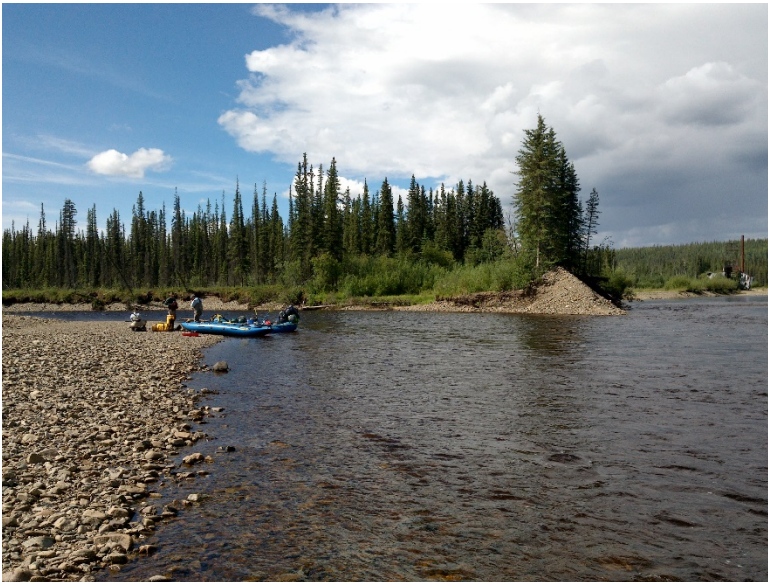
Picture 11- Confluence of the Dennison Fork and Mosquito Fork.

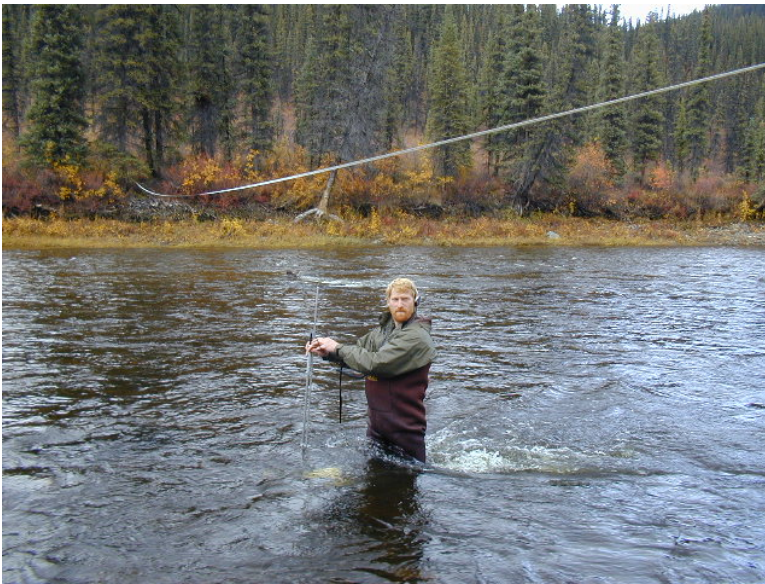
Fig. 1. A BLM field technician surveys the streamflow on the North Fork of the Fortymile River. Most rivers were surveyed by wading the cross section.

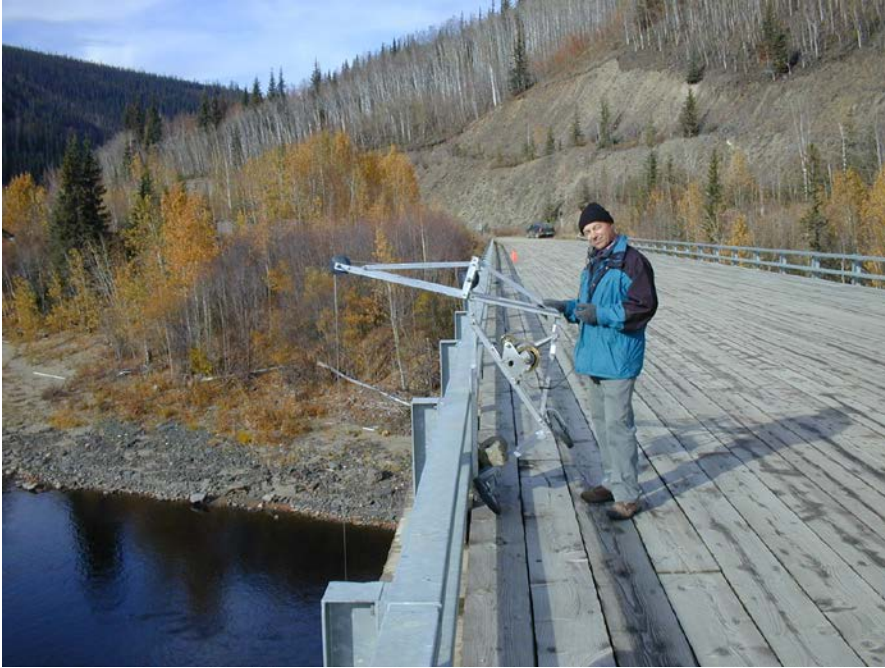
Fig. 2. Where the river was too deep to wade, such as the Fortymile River at the Taylor Highway Bridge, a flow meter and sounding weight were suspended by a cable and reel system to survey the river.

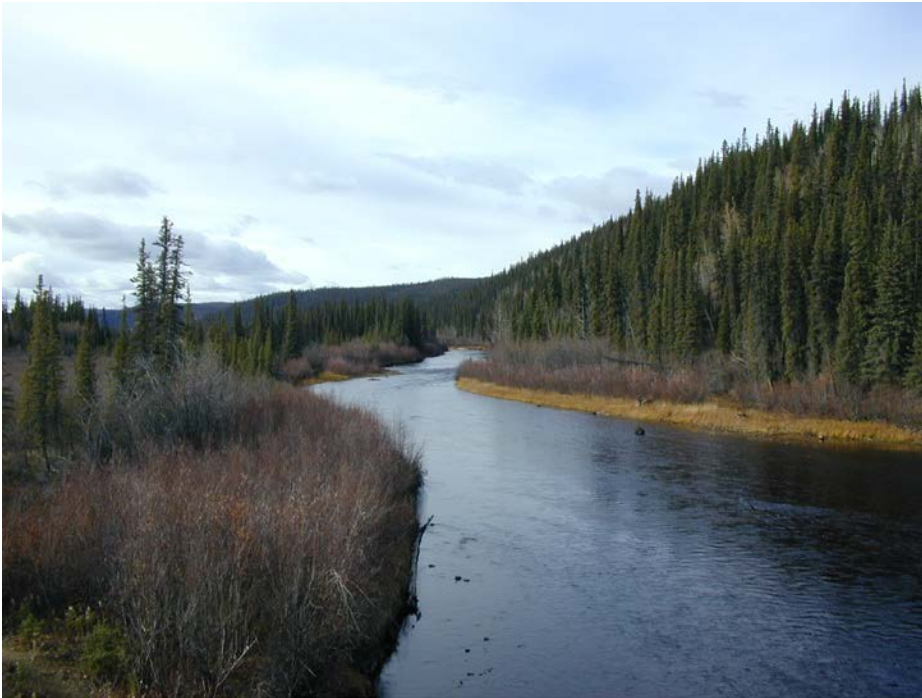
Fig. 3. The channel is relatively straight upstream of the bridge with few riffles or obstructions. The stream is confined by a low ridge to the north with a lower bank and wide floodplain to the south

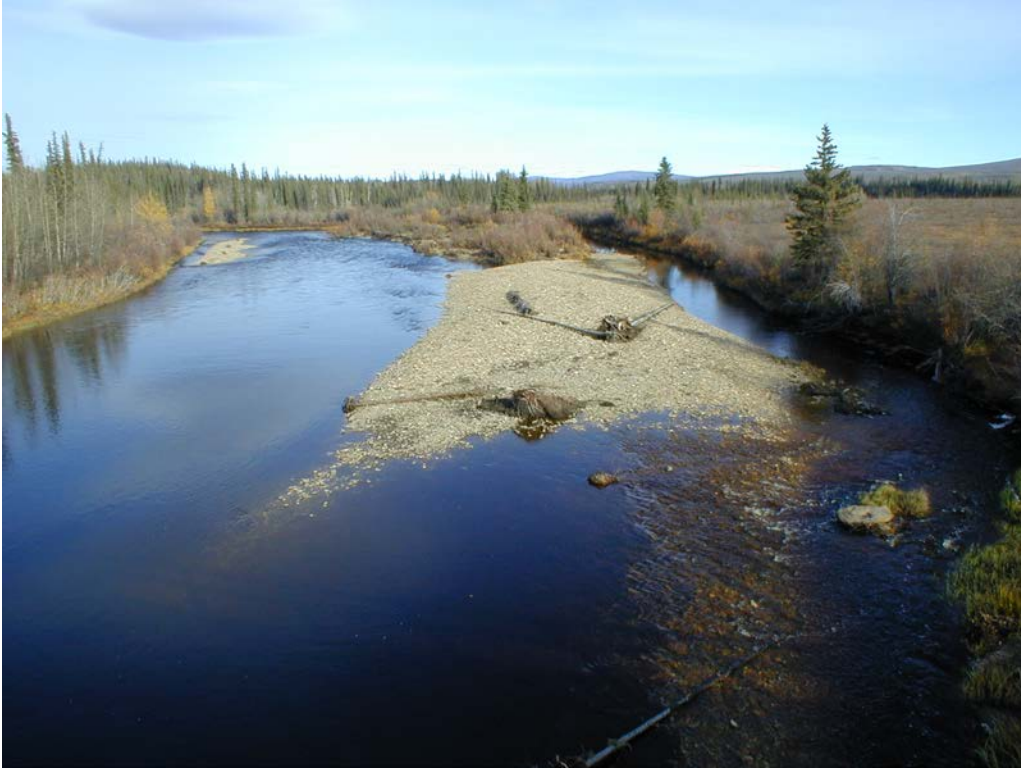
Fig. 4. Downstream of the bridge, the channel is wider, shallower, and has more obstructions from islands and boulders (rock gardens), than upstream of the bridge

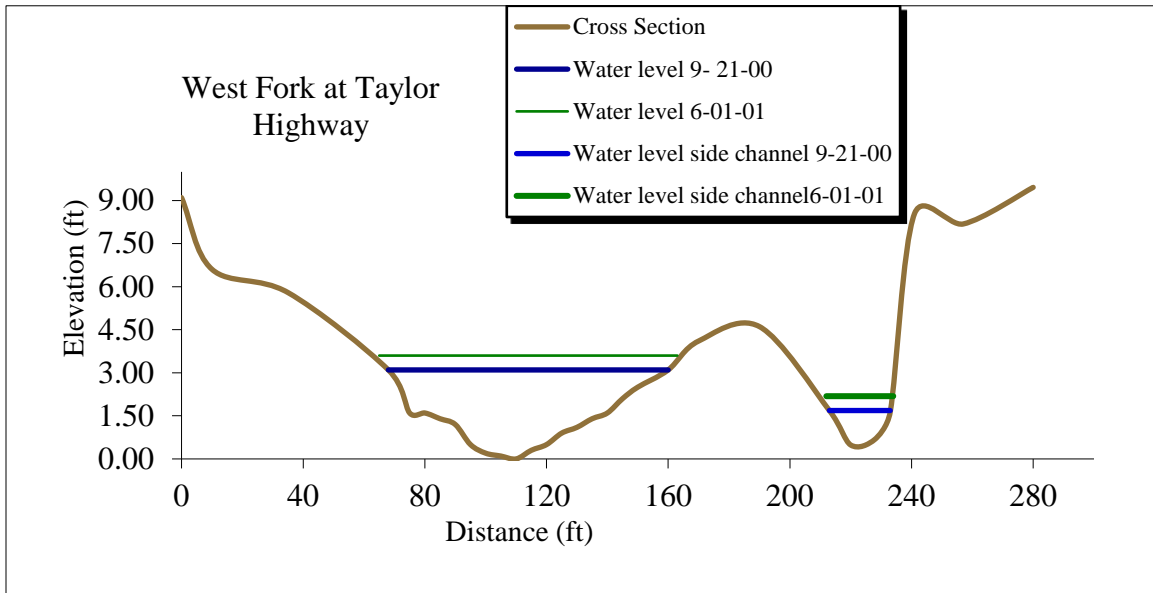
Fig.5 Channel cross section of the West Fork Fortymile River downstream of the bridge

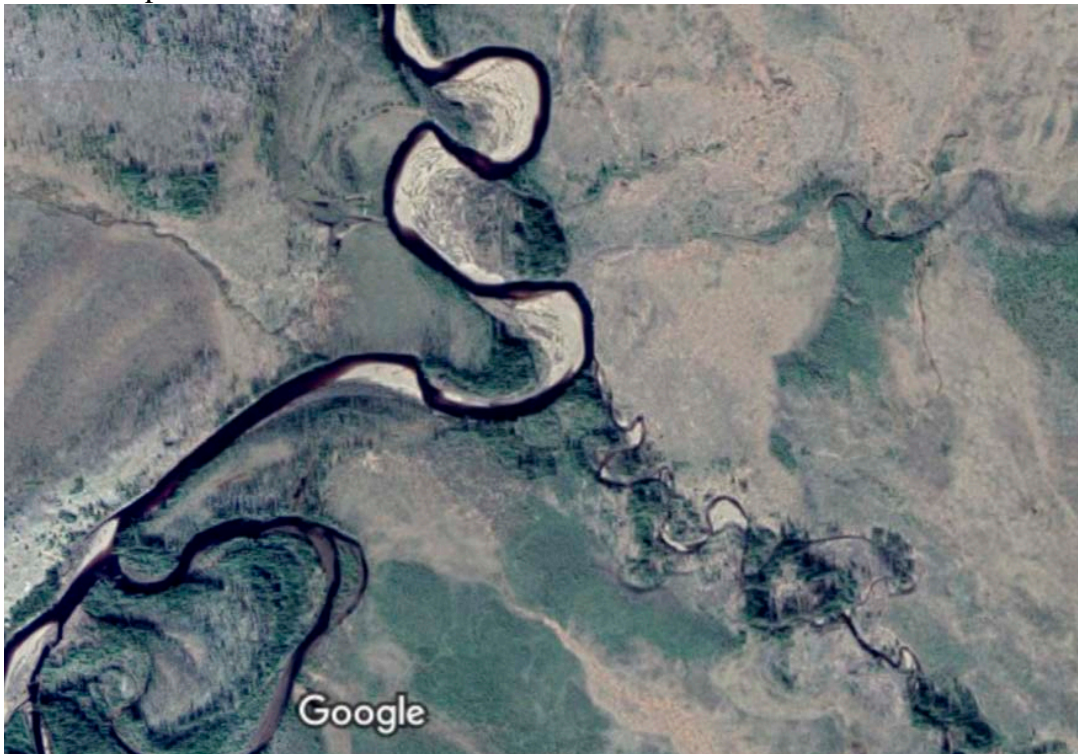
Fig.6 The channel meanders extensively near Logging Cabin Creek, but has a few straight reaches upstream. A large boulder was noted in the channel during the August survey (Photo courtesy of Google Maps)

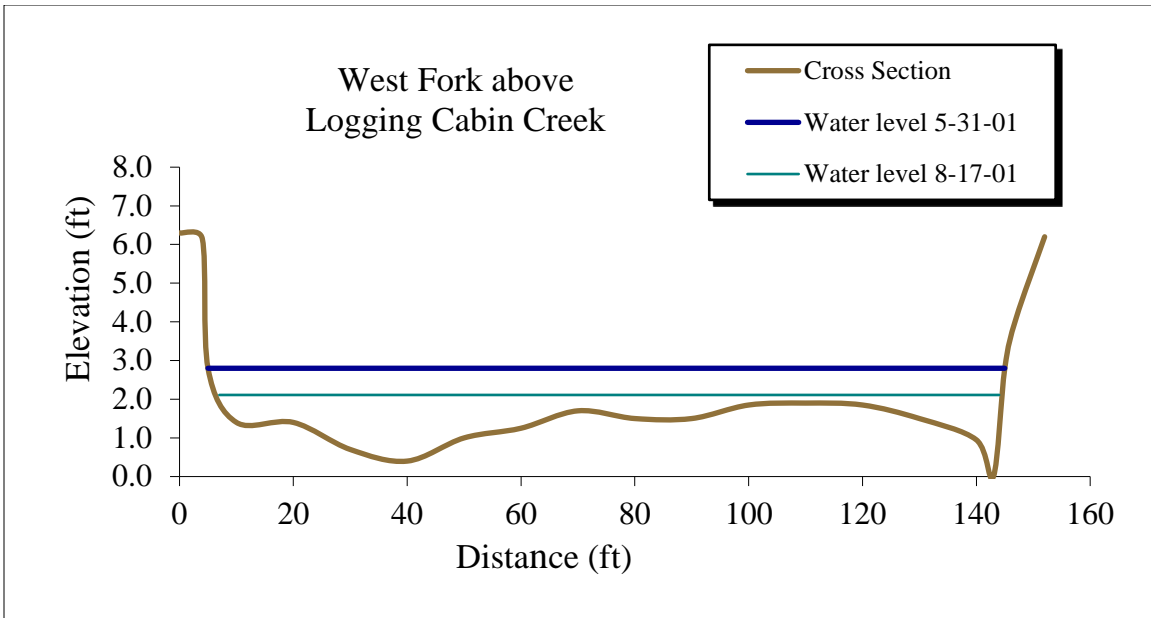
Fig. 7 Cross Section of West Fork Fortymile River above Logging Cabin Creek

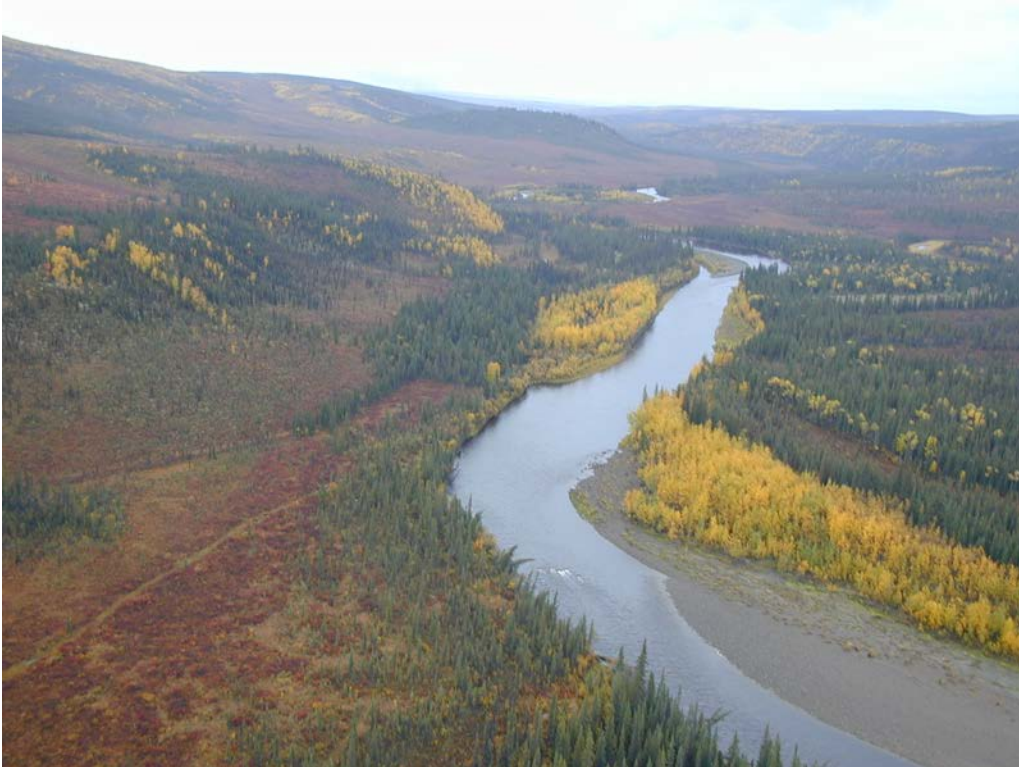
Fig. 8 Dennison Fork of the Fortymile River looking upstream of the mouth. The channel is relatively wide and braids out into two channels at low water. The 1991 cross section is the straight reach near the center of the center photo

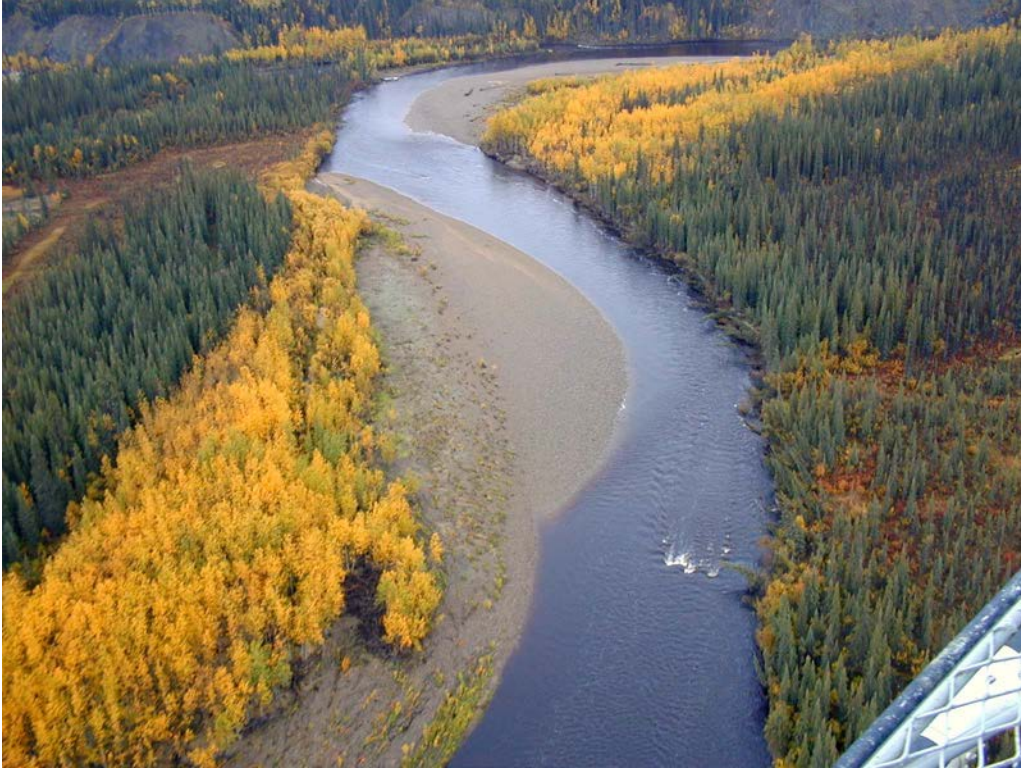
Fig. 9 Dennison Fork looking downstream to the mouth. Most streamflow measurements were near the center of the photo, where there was a single low water channel

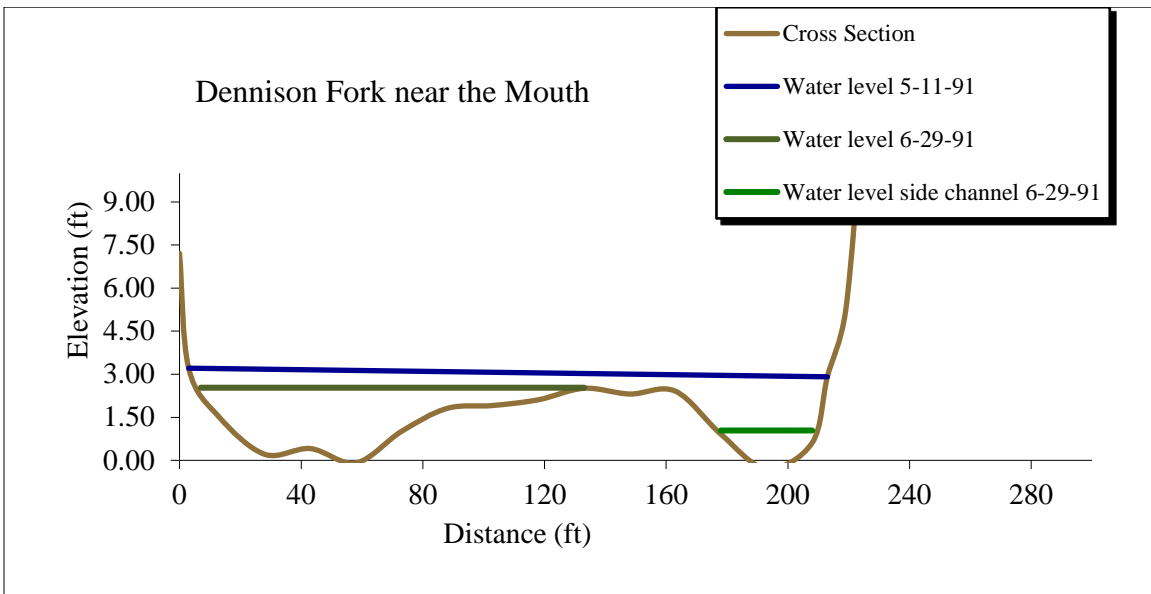
Fig. 10 Channel cross section for Dennison Fork near the mouth
