Subject: Reconsideration of the Navigability Report Dated June 29, 1983, Regarding the West Fork of the Dennison Fork and the Dennison Fork of the Fortymile River in the Upper Yukon Region, Alaska

Maps of West Fork Dennison and Dennison Fork of the Fortymile River

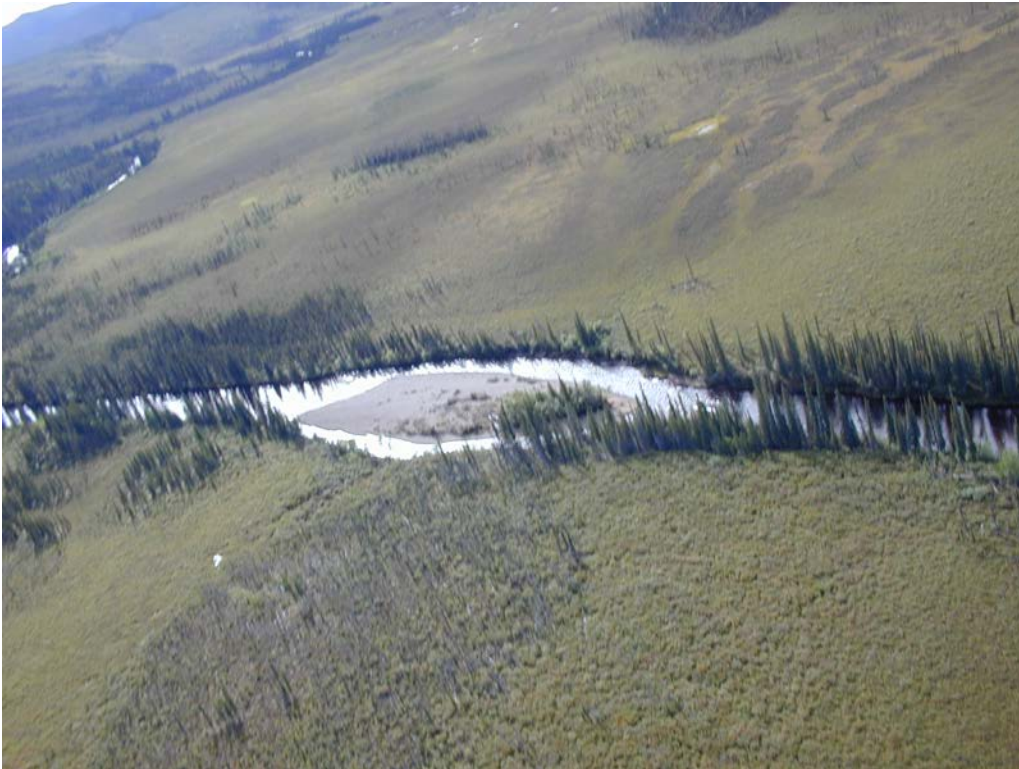
Fig. 11 Dennison Fork above West Fork, streamflow is from left to right. The surveyed cross section is to the left (upstream) of the island

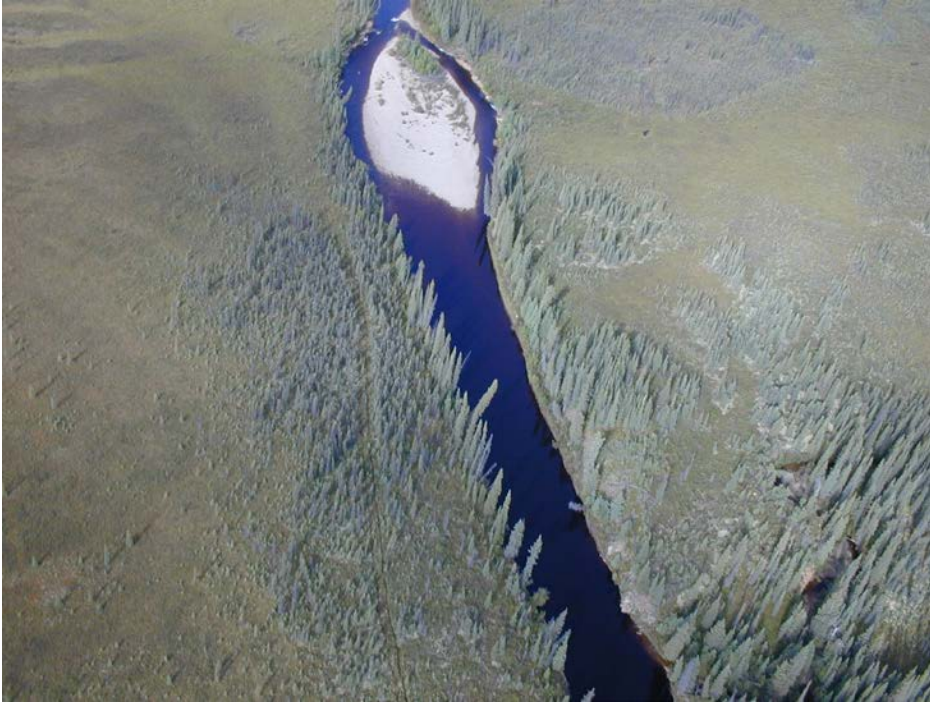
Fig. 12 Dennison Fork above West Fork looking downstream. The surveyed cross section is upstream of the island. The channel is fairly uniform, deep and slow in this reach.

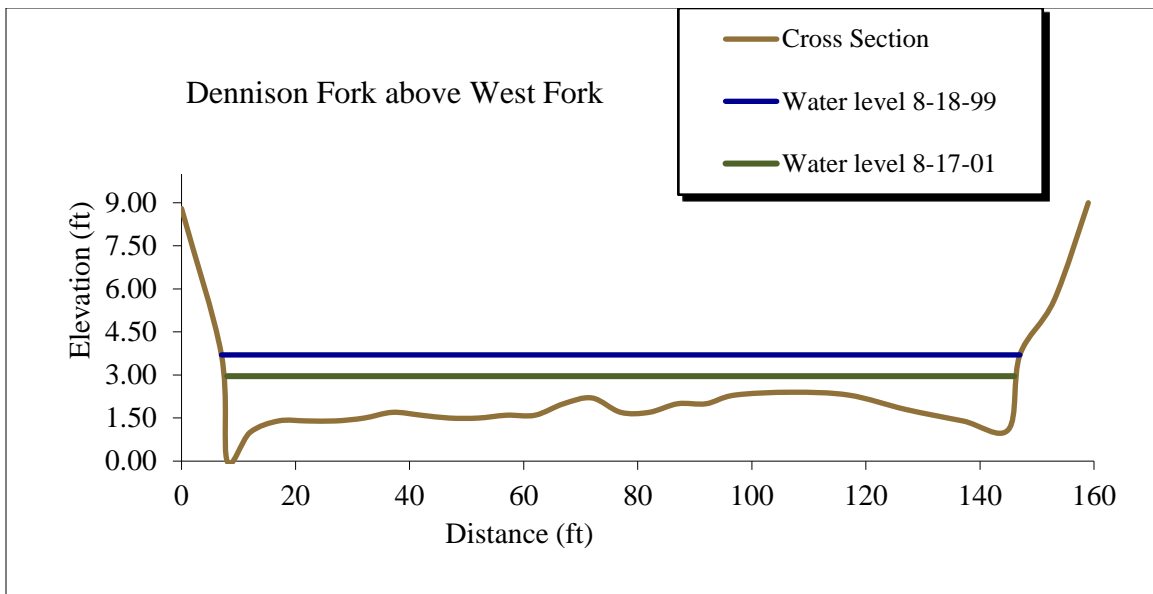
Fig. 13 Channel cross section at Dennison Fork above West Fork

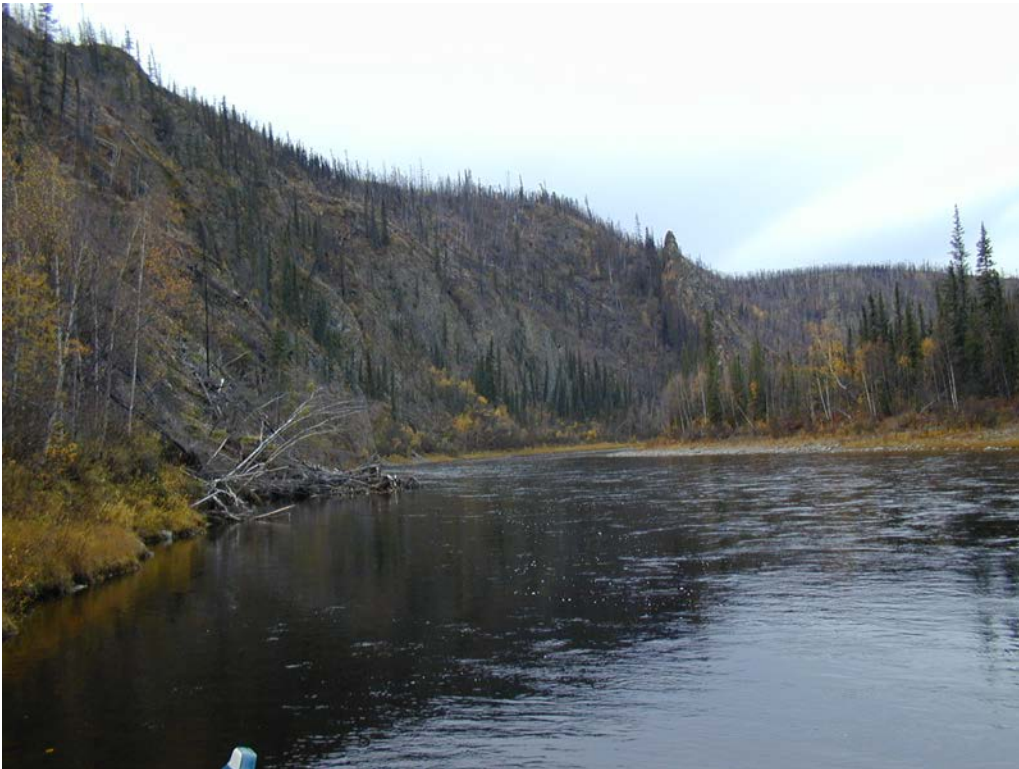
Fig. 14 North Fork at South Fork looking upstream. The surveyed cross section is just downstream. The channel is very uniform, deep and moderately fast in this reach

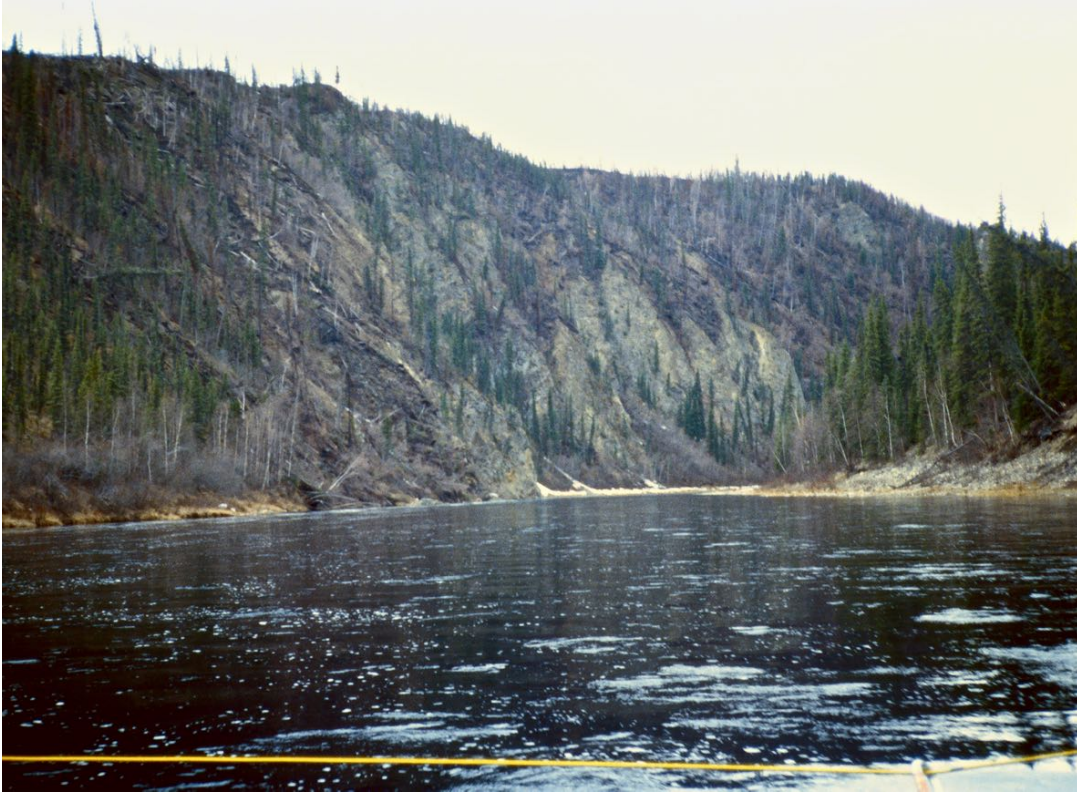
Fig. 15 North Fork at South Fork looking upstream at the cross section. The channel steepens, shallows, and becomes quite fast as the river approaches the confluence with the South Fork

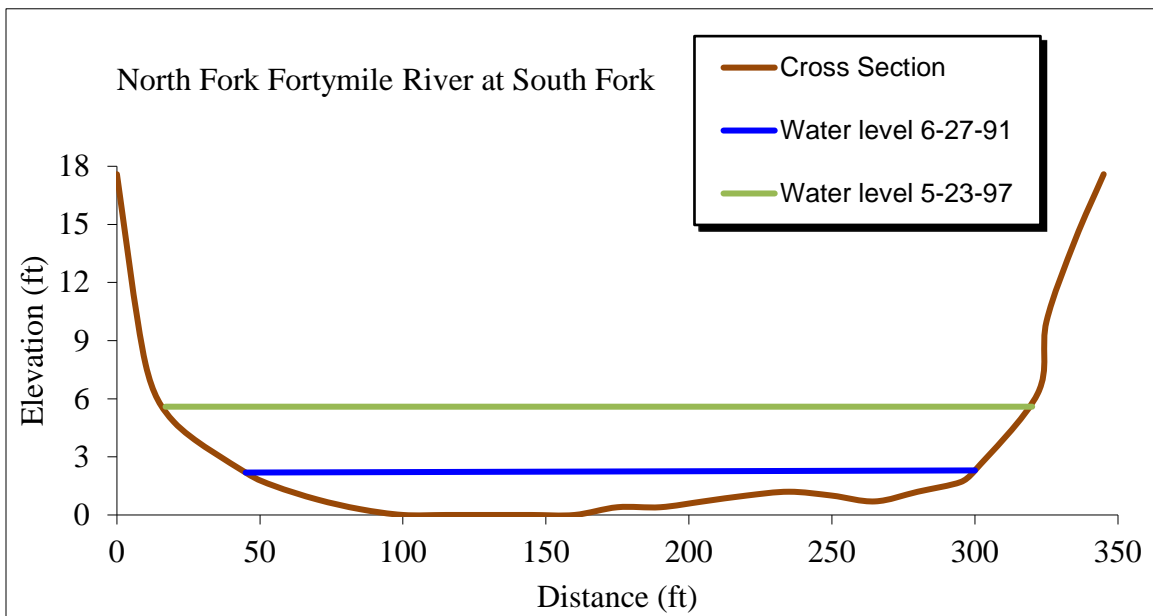
Fig. 16 Channel cross section at North Fork Fortymile River at South Fork

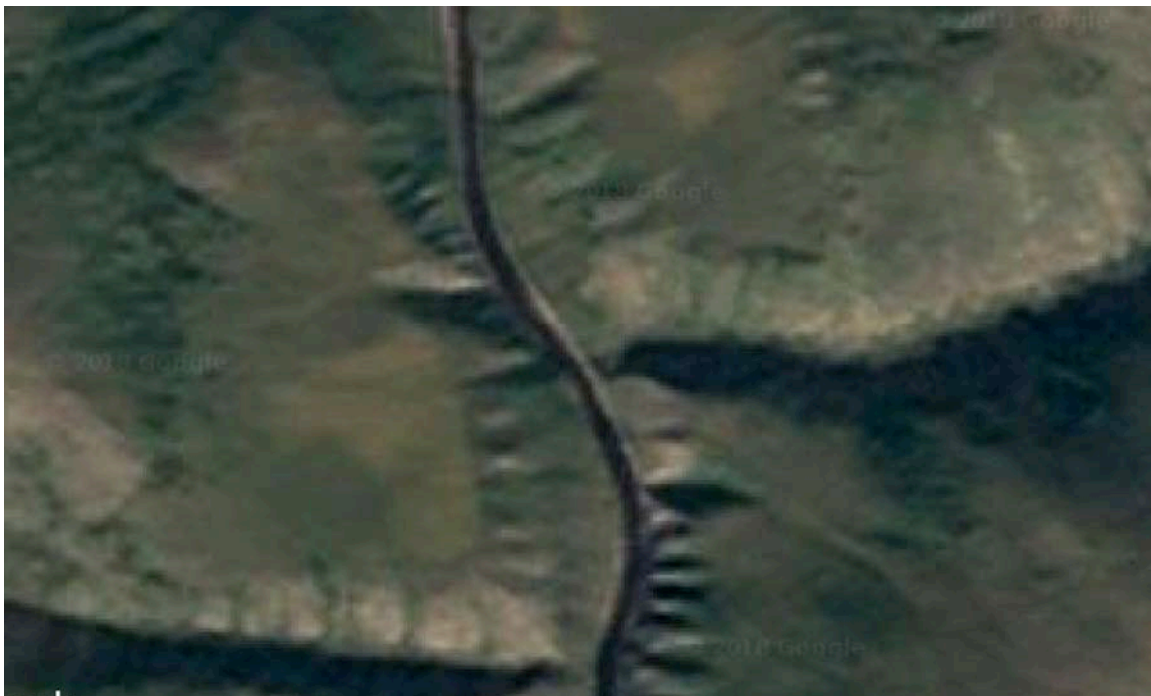
Fig. 17 The North Fork Fortymile at Hilda Creek (on the right) is a fairly straight uniform reach with no obstructions or constricted areas. (Photo courtesy of Google Maps)

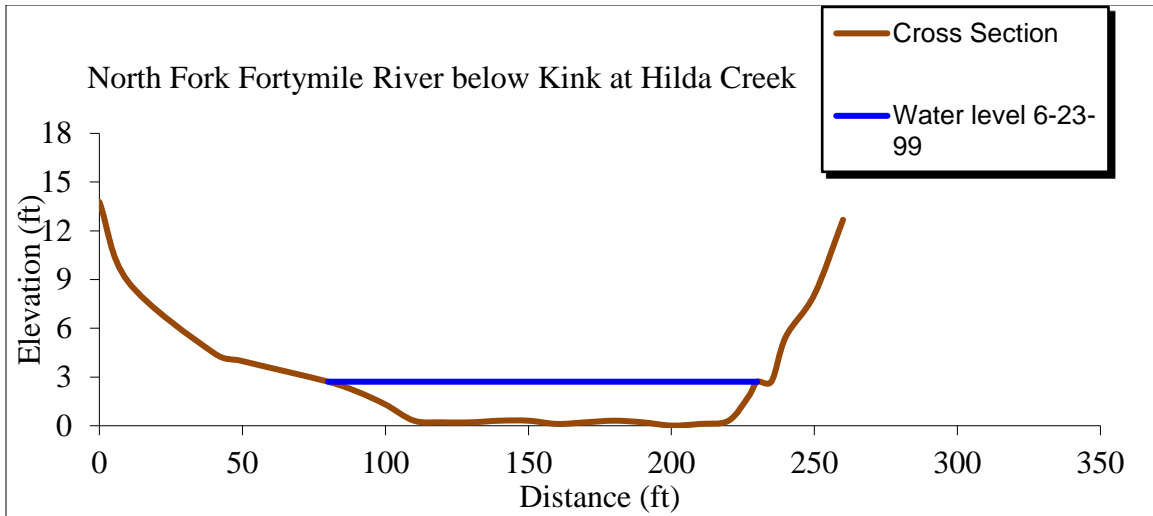
Fig. 18 The surveyed cross section on North Fork Fortymile at Hilda Creek.

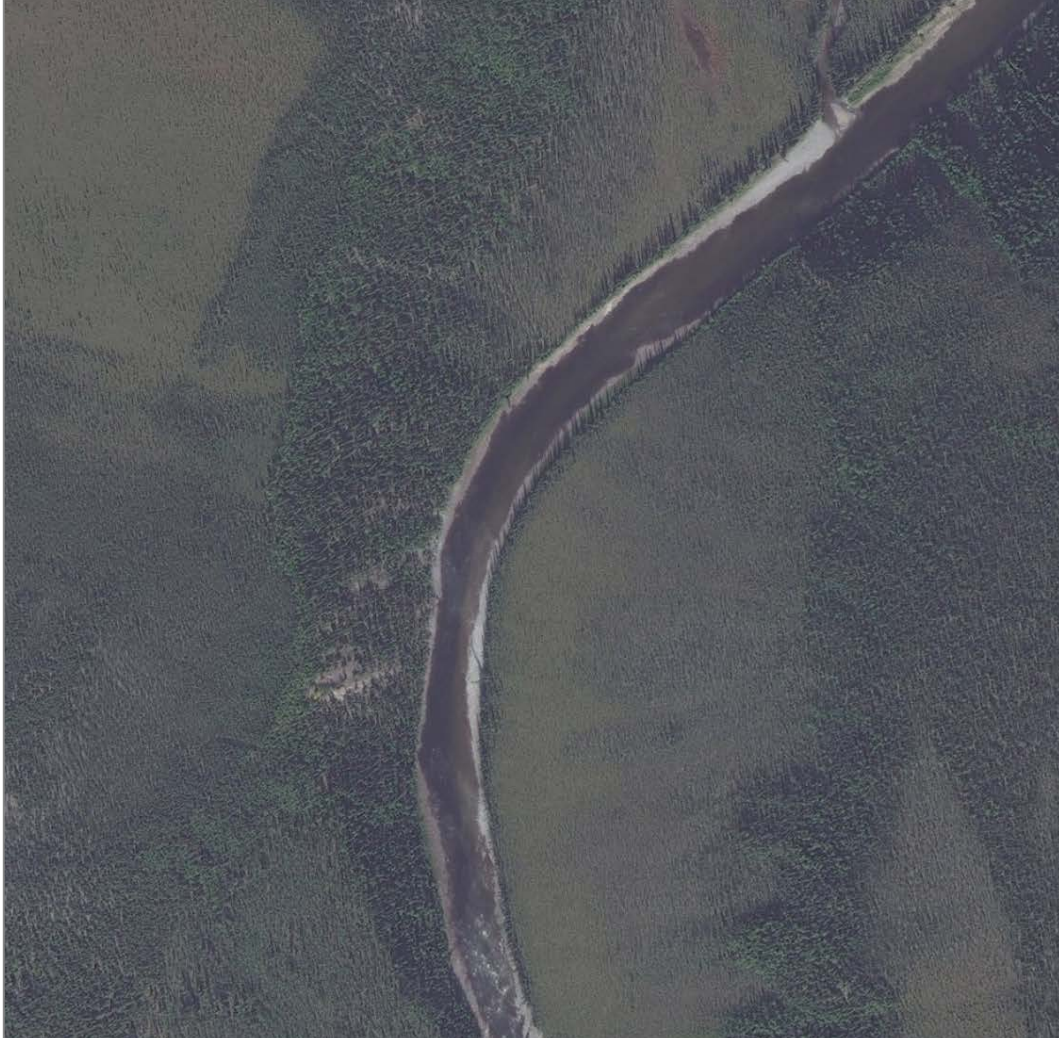
Fig. 19 The North Fork Fortymile River at Hutchinson Creek is a fairly straight, uniform reach with no obstructions or constrictions. The class V rapids at the Kink begin at the bottom of the photo (Photo courtesy of Apple Maps)

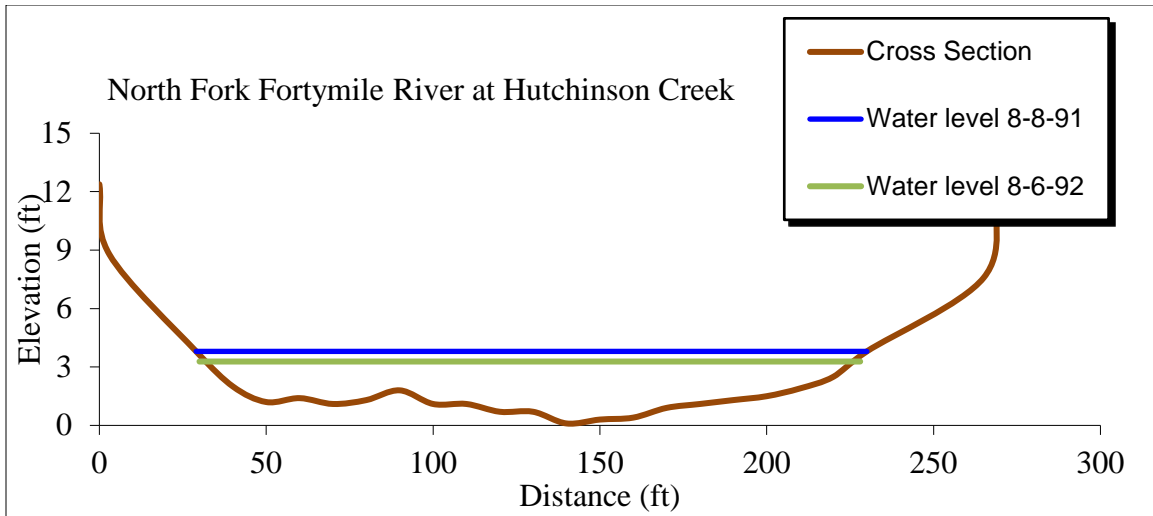
Fig. 20 The surveyed cross section on North Fork Fortymile River at Hutchinson Creek.

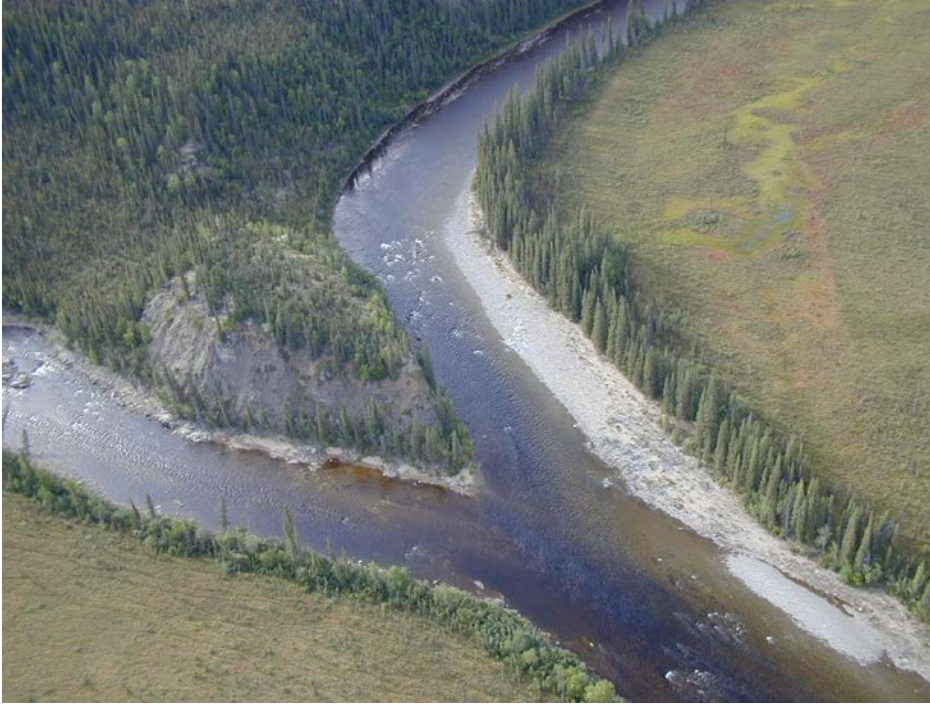
Fig. 21 The North Fork Fortymile River at Middle Fork looking upstream, with the Middle Fork on the left and North Fork on the right. There is a series of boulder bed rapids (rock gardens) just upstream and class III rapids downstream of the confluence

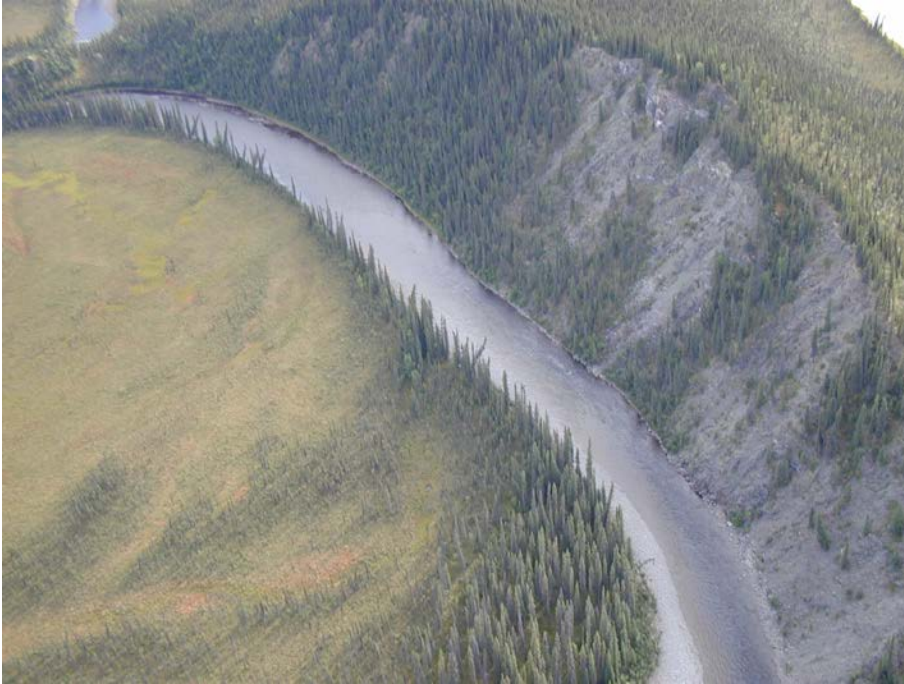
Fig. 22 The North Fork Fortymile River at Middle Fork looking downstream is a fairly straight, uniform reach with no obstructions or constricted areas

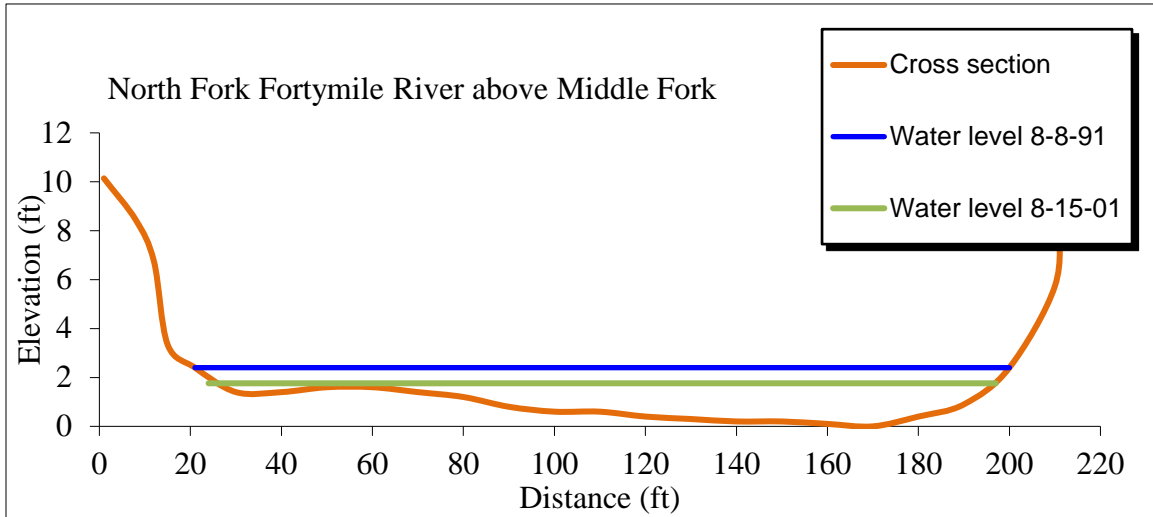
Fig. 23 The surveyed cross section on North Fork Fortymile River at Middle Fork

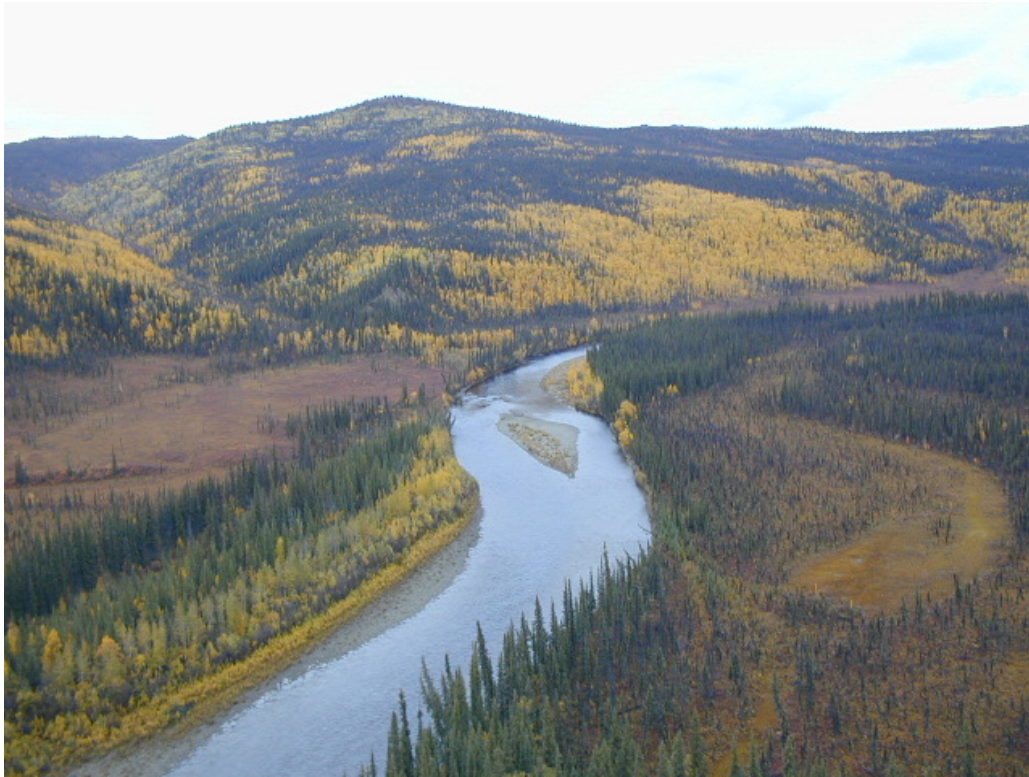
Fig. 24 North Fork Fortymile River above Champion Creek cross section is the relatively straight reach near the bottom of the photo

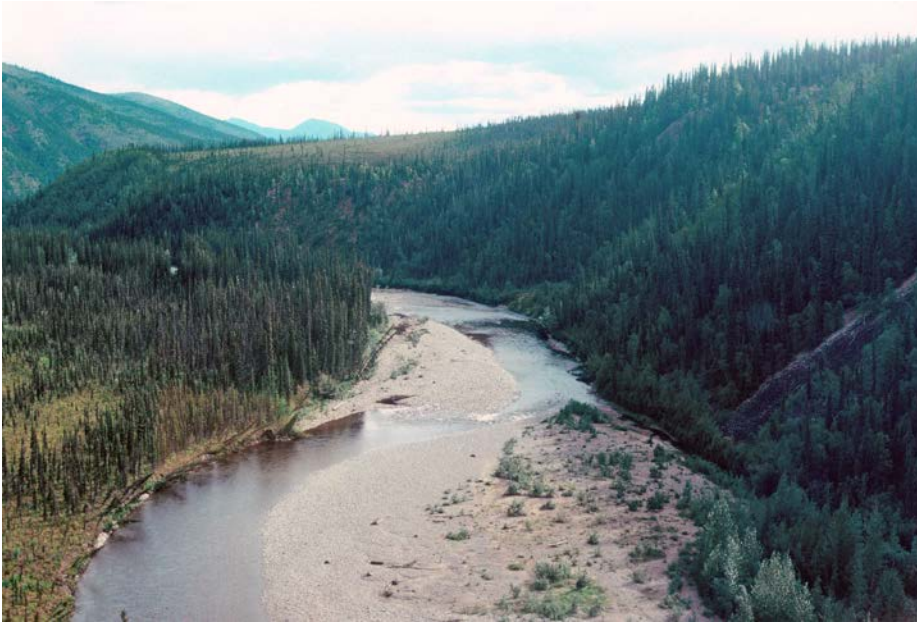
Fig. 25 North Fork Fortymile River above Champion Creek is a meandering stream with wide gravel bars and occasional islands

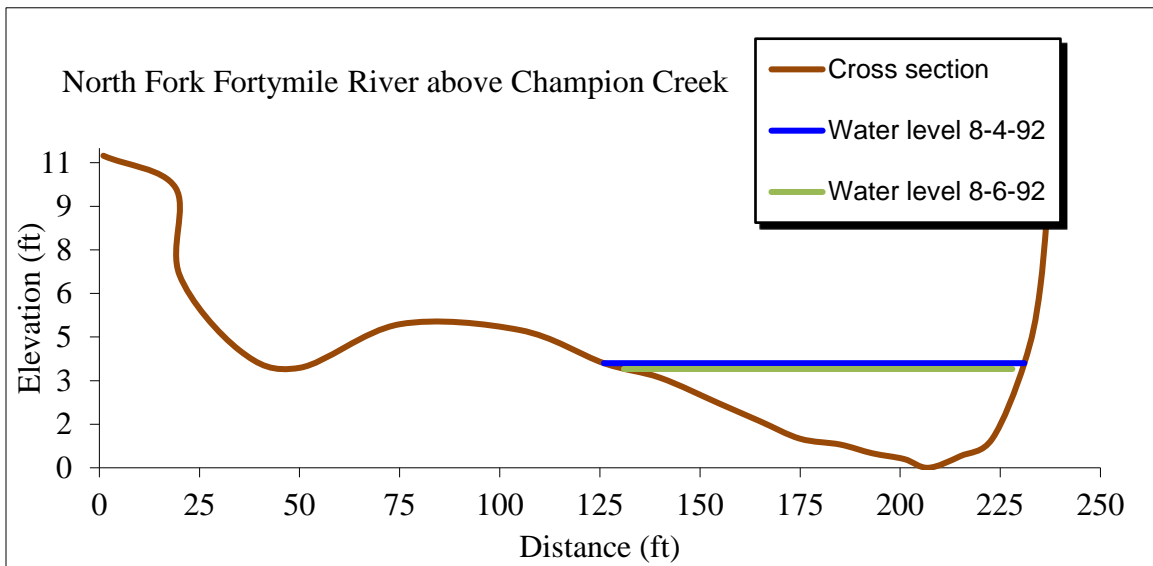
Fig. 26 The surveyed cross section on North Fork Fortymile River above Champion Creek

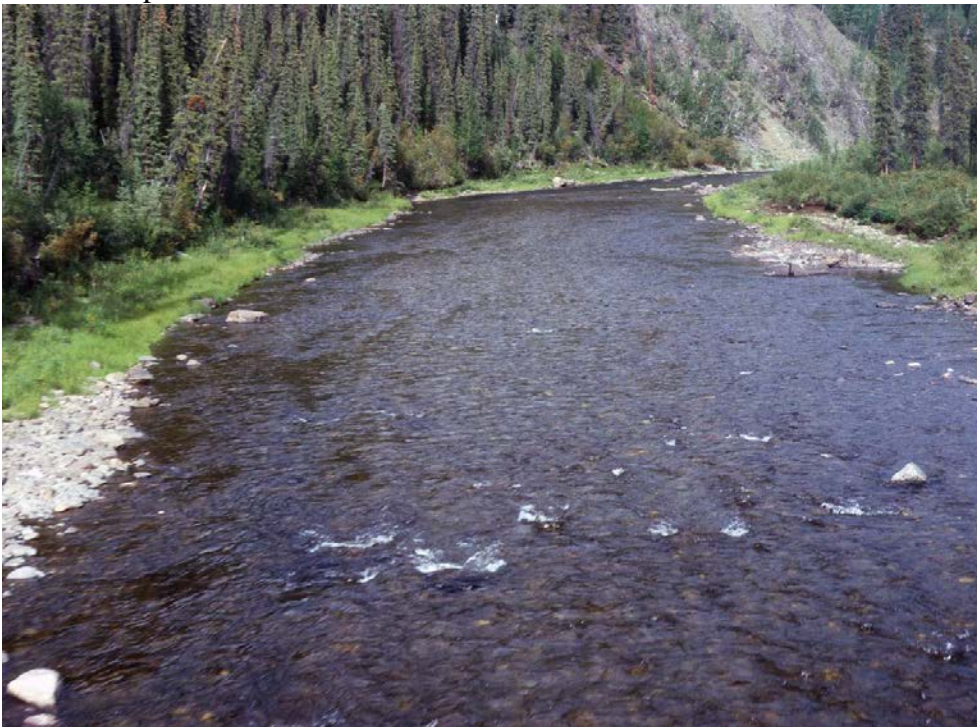
Fig. 27 North Fork Fortymile River above Little Bonanza Creek cross section #1 surveyed in 1992 is a shallow, uniform reach with a bed of cobbles and small boulders

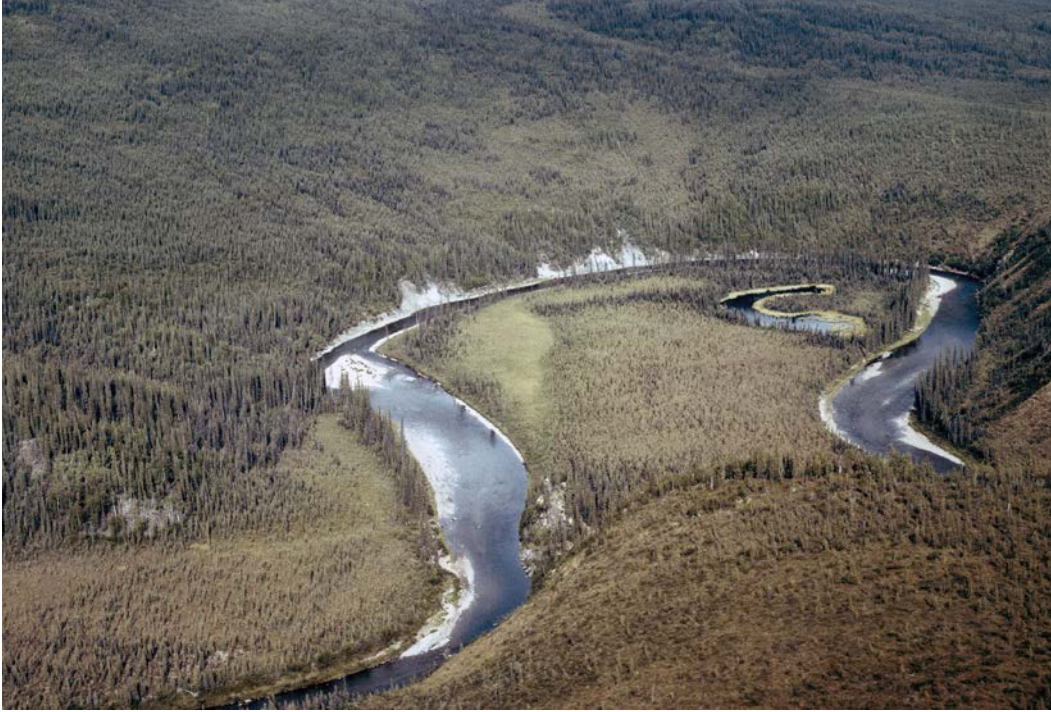
Fig. 28 North Fork Fortymile River above Little Bonanza Creek is a shallow stream with gravel bars and occasional constrictions at bends

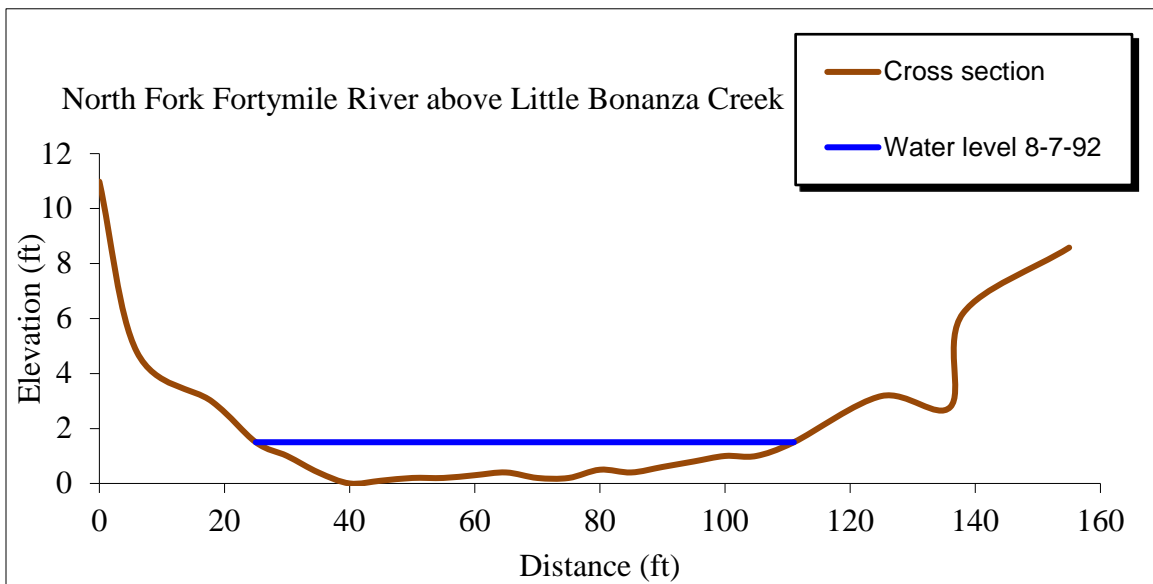
Fig. 29 The surveyed cross section on North Fork Fortymile River above Little Bonanza Creek

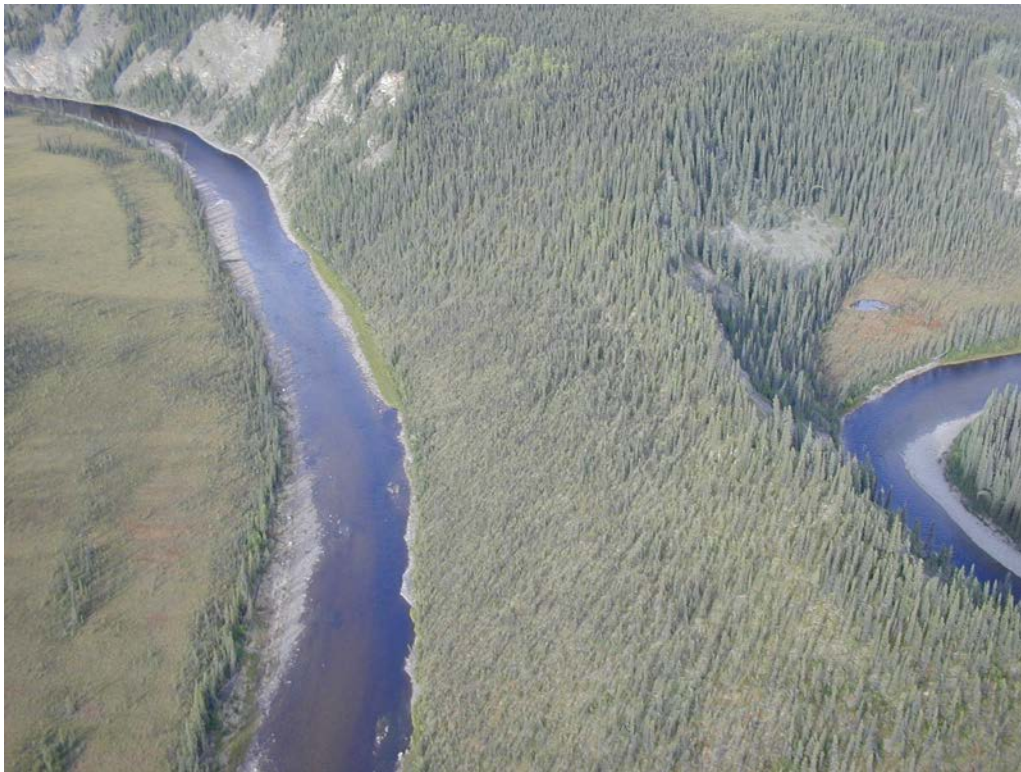
Fig. 30 Middle Fork Fortymile River (left) at North Fork (right) is a uniform, moderately deep channel with narrow gravel bars. Just downstream are the class II/III Eagle Rapids

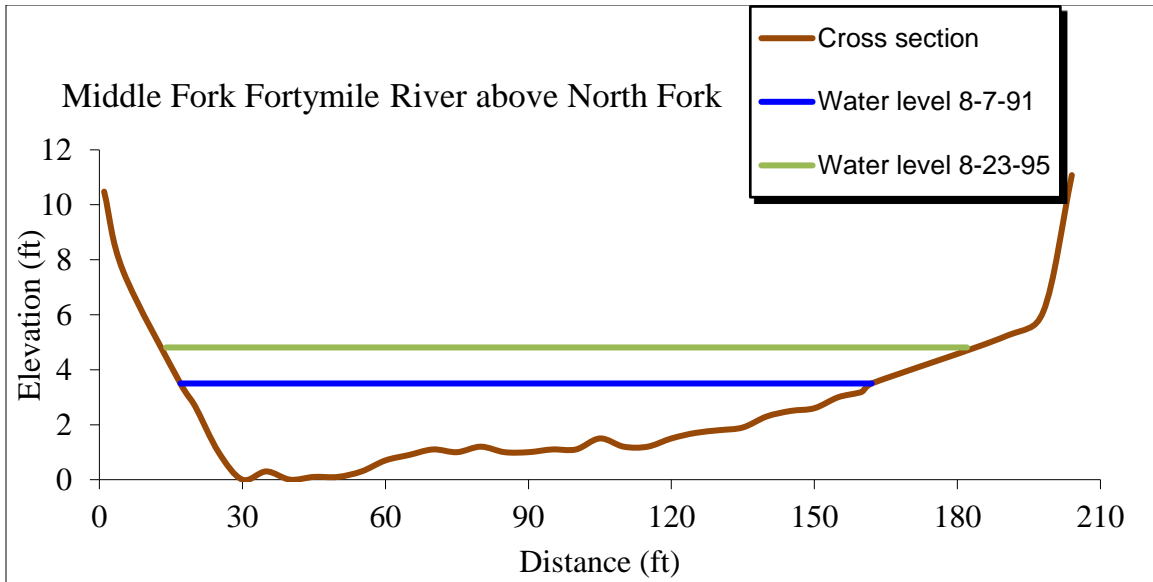
Fig. 31 The surveyed cross section on Middle Fork Fortymile River at North Fork

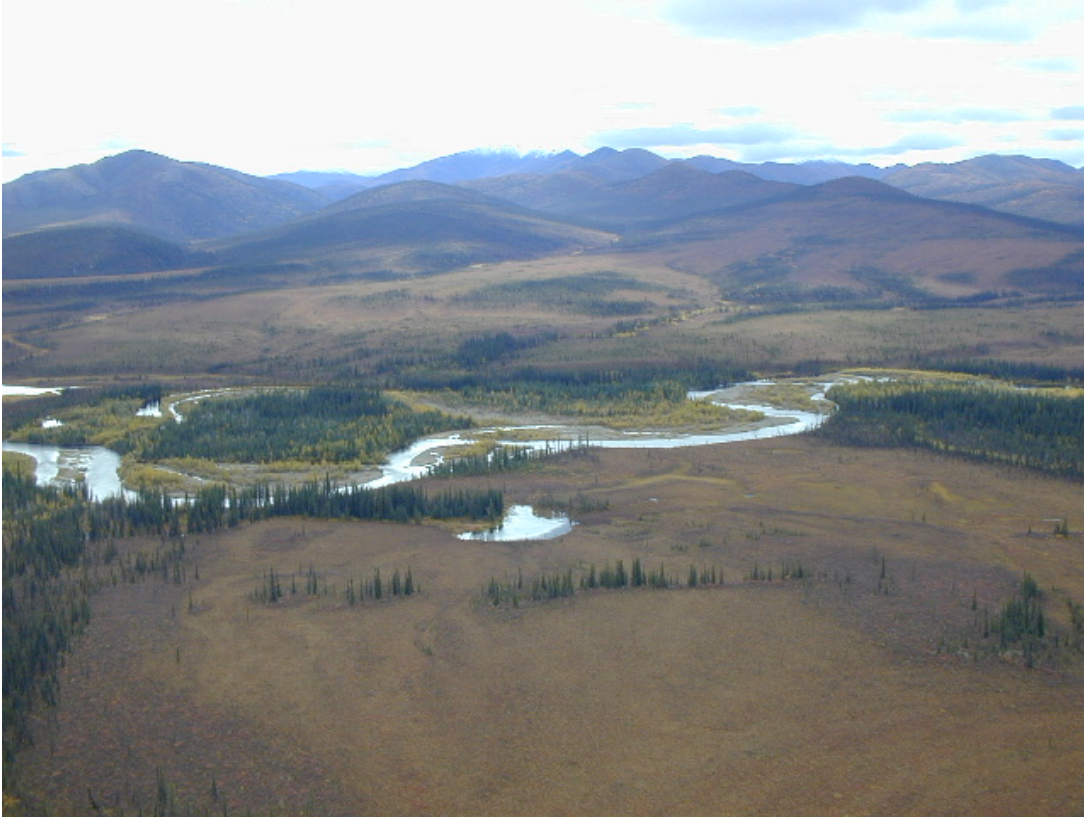
Fig. 32 Middle Fork Fortymile River downstream of Joseph airstrip is a moderately deep, meandering stream with sloughs and islands

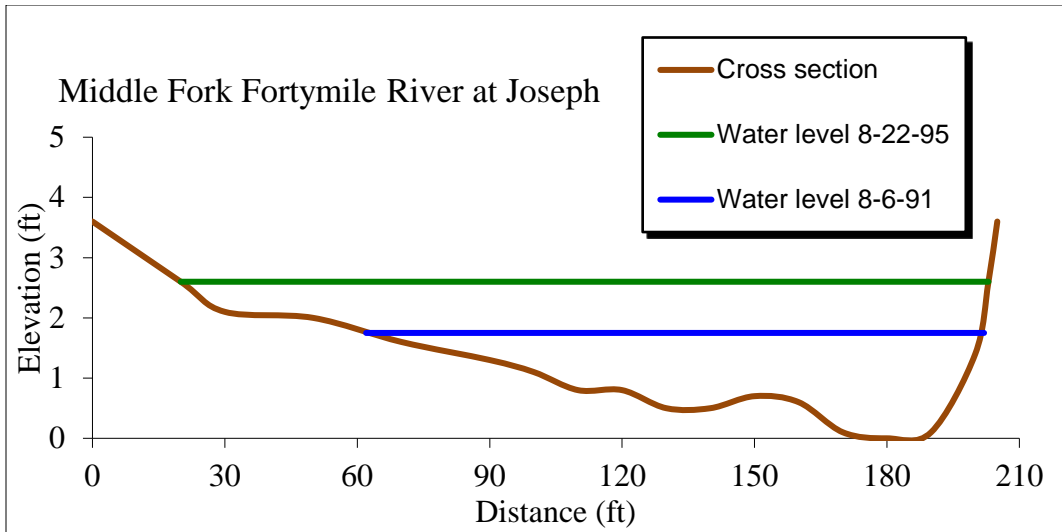
Fig. 33 The surveyed cross section on Middle Fork Fortymile River at Joseph airstrip

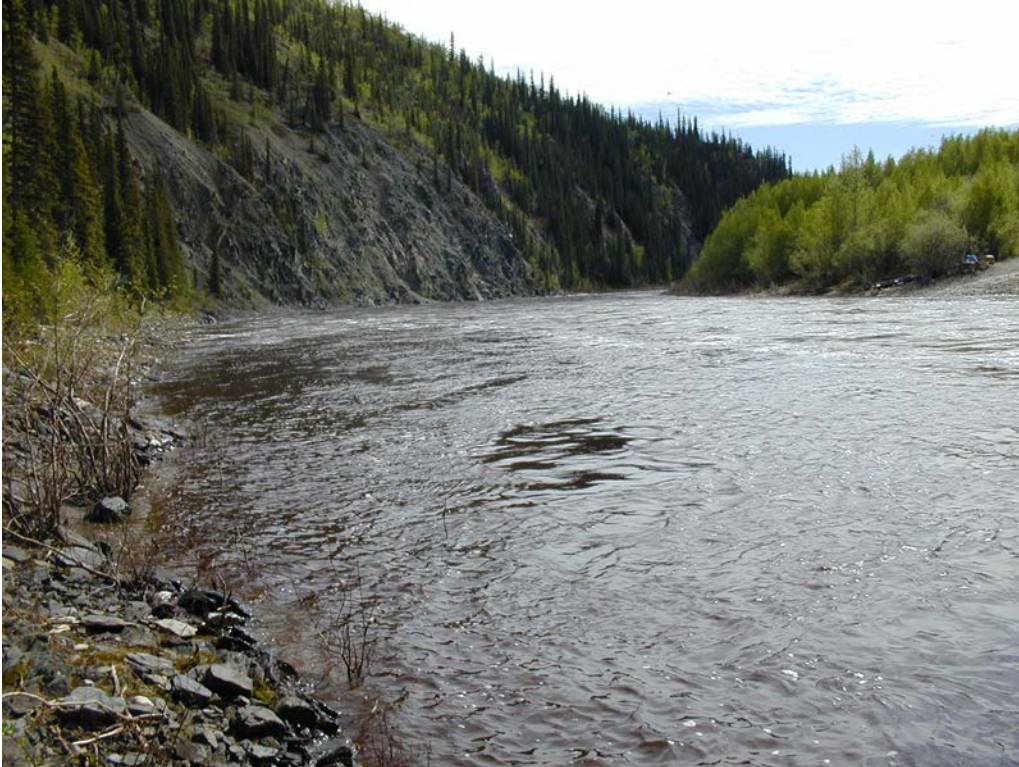
Fig. 34 The Fortymile River looking downstream of the bridge. The river is deep and fast in this reach, but widens out and is shallower and somewhat slower downstream of the bend

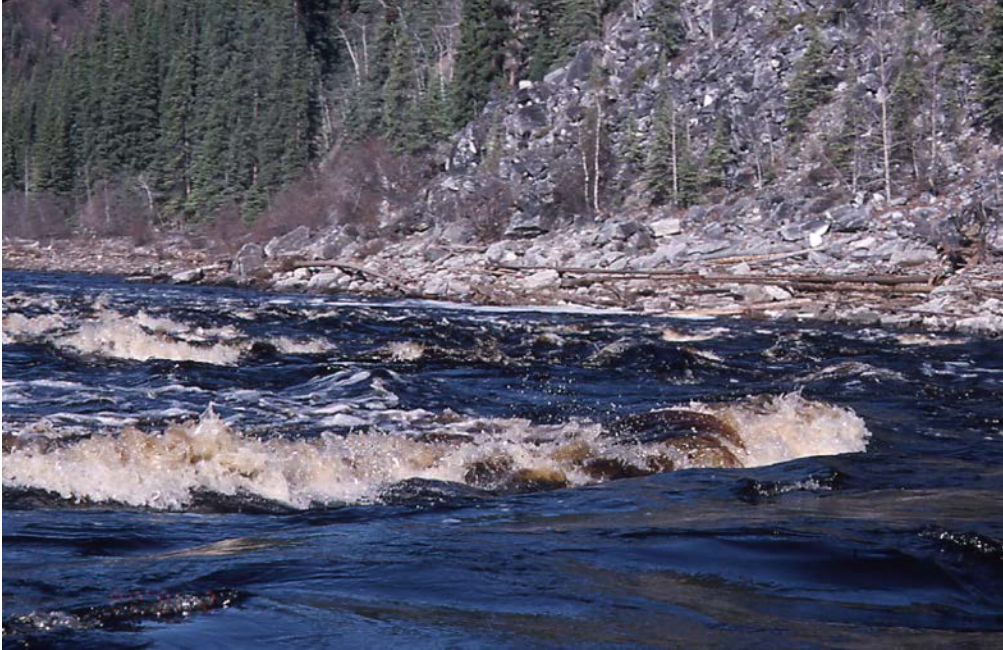
Fig. 35 The class II/III falls of the Fortymile River are about three miles upstream of the bridge

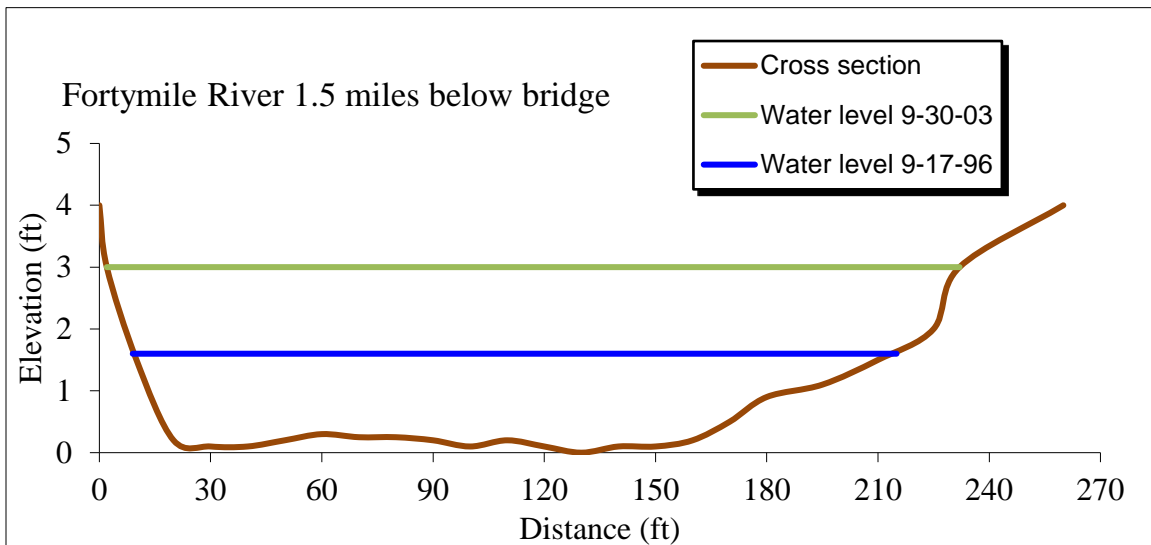
Fig. 36 The surveyed cross section at the Fortymile River approximately 1.5 miles downstream of the bridge
