**Work Plan  
Remedial Investigation/Feasibility  
Study  
Red Devil Mine, Alaska**

**March 2011**

**U.S. DEPARTMENT OF INTERIOR  
BUREAU OF LAND MANAGEMENT  
Anchorage Field Office  
4700 BLM Road  
Anchorage, AK 99507**

**ECOLOGY AND ENVIRONMENT, INC.  
720 3rd Avenue, Suite 17  
Seattle, WA 98104-1816**

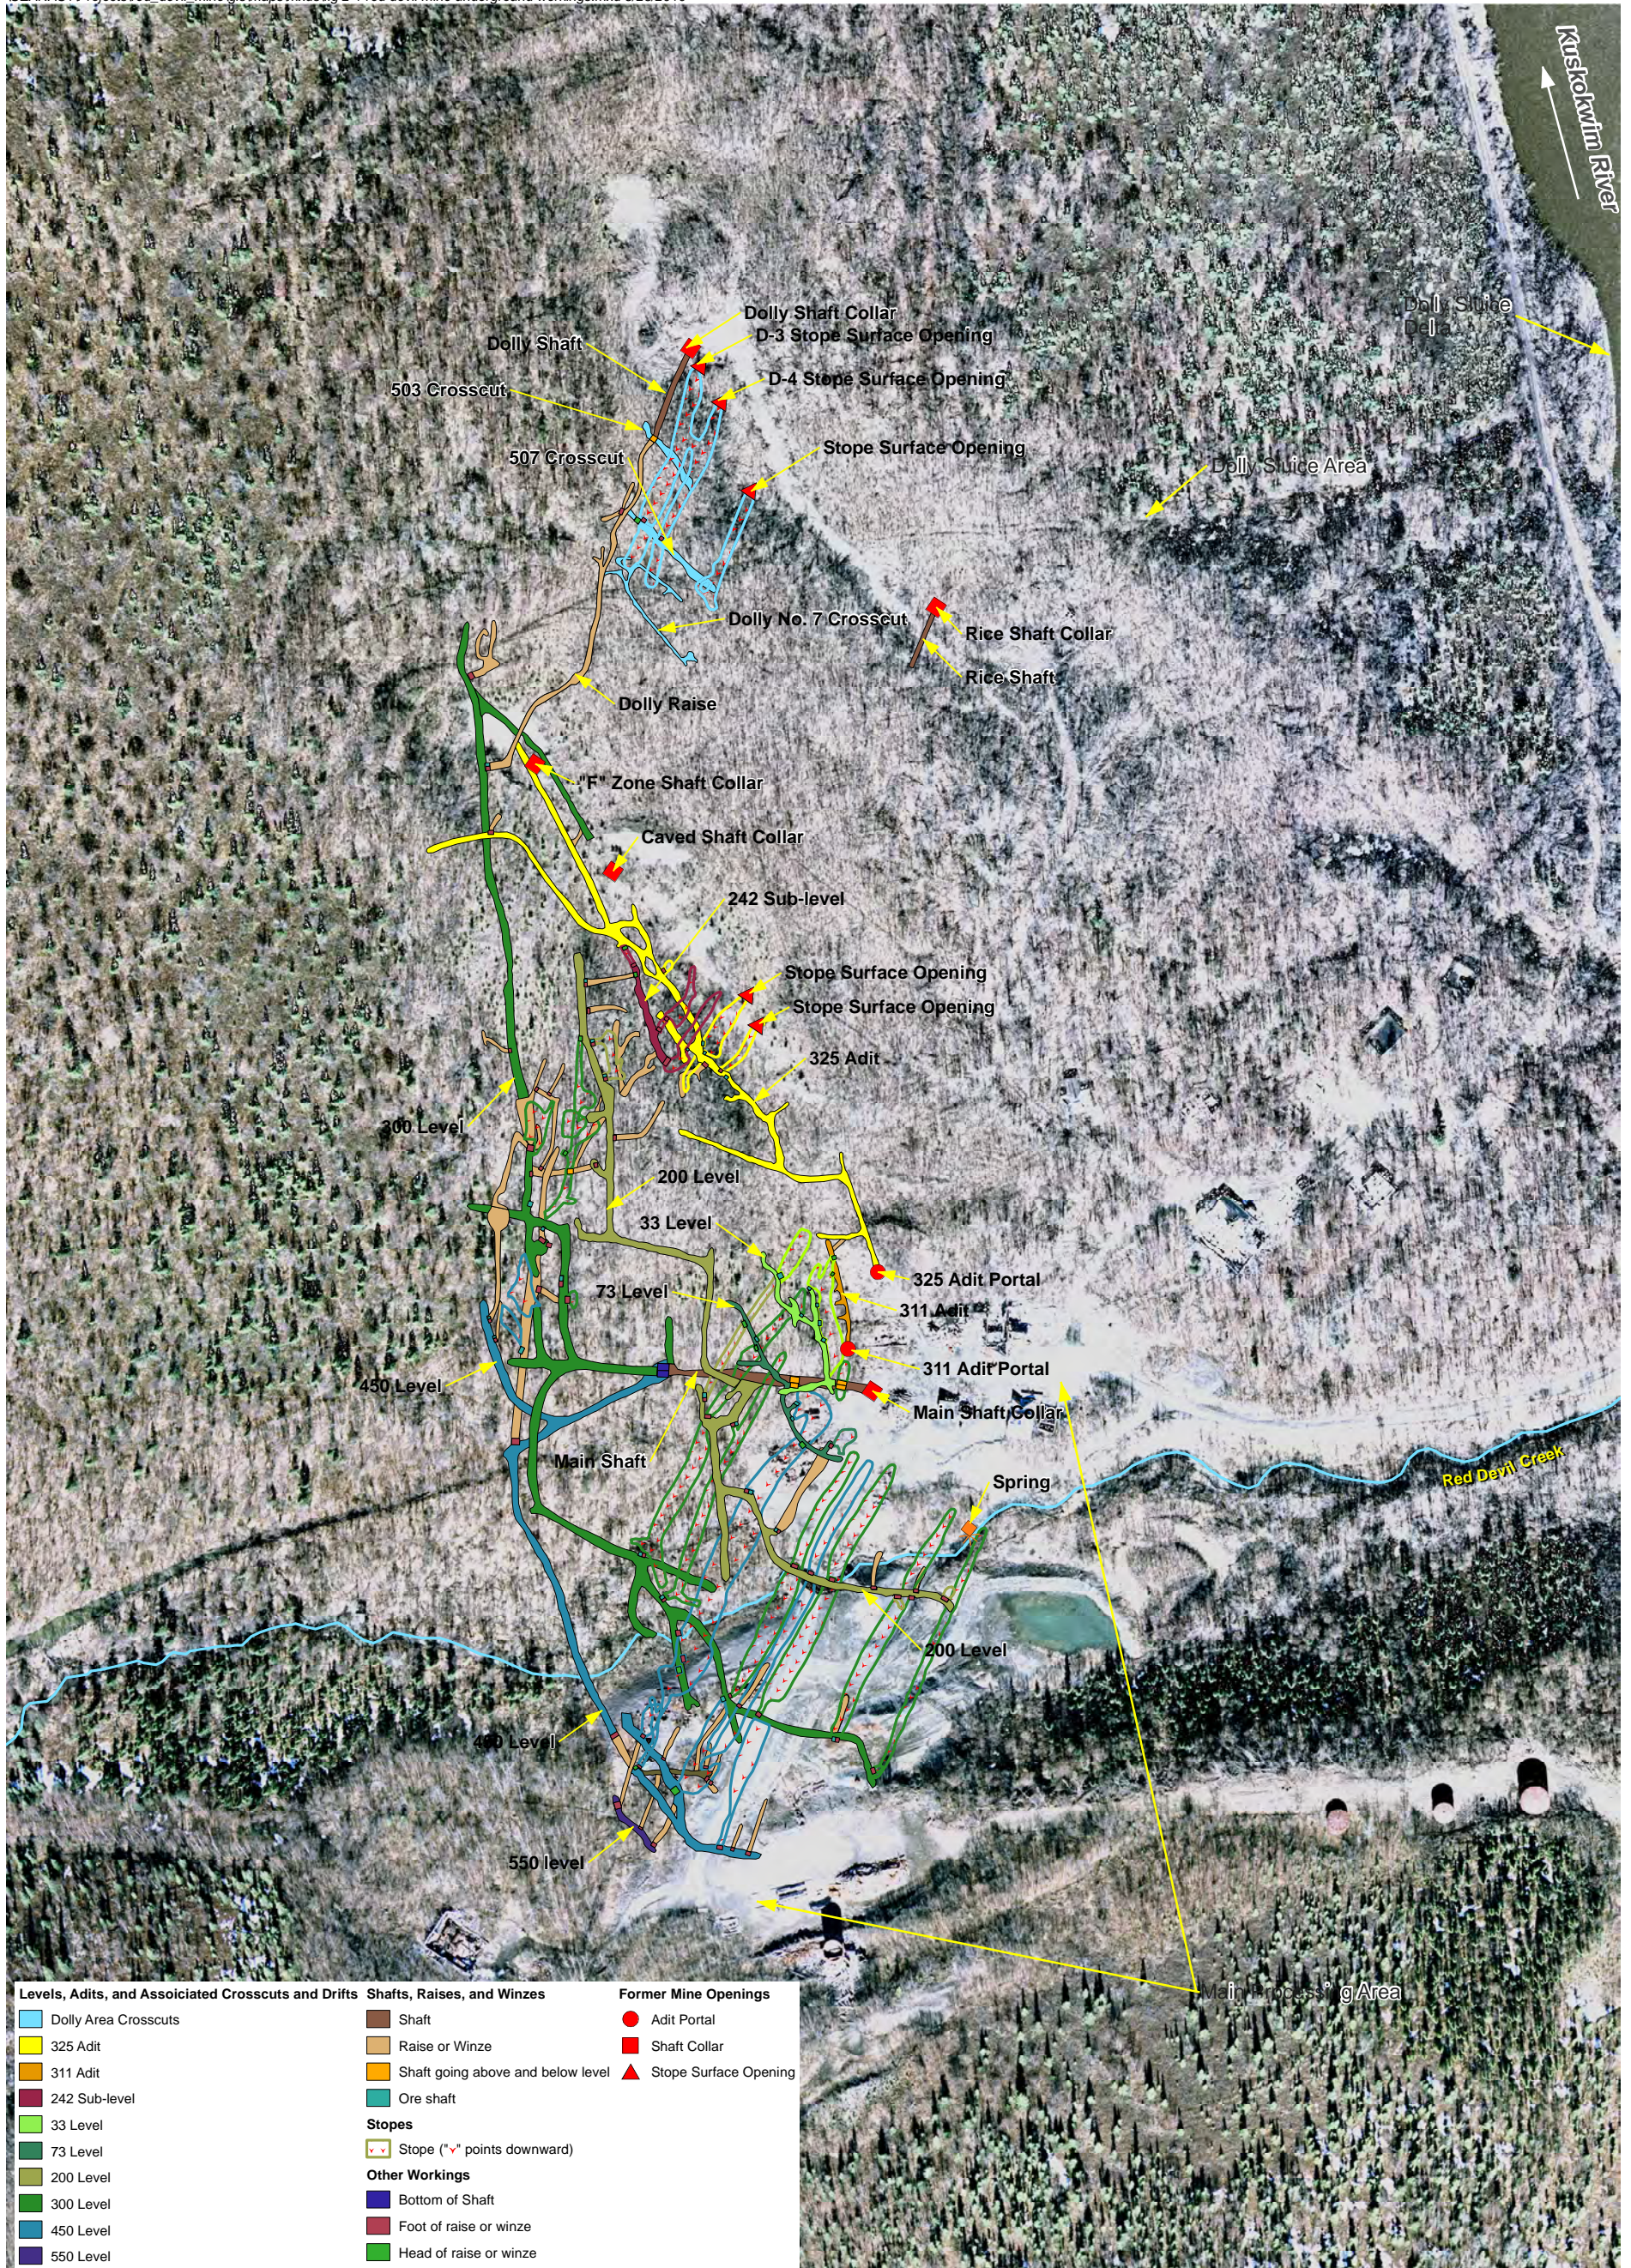
Levels, Adits, and Associated Crosscuts and Drifts	Shafts, Raises, and Winzes	Former Mine Openings
<span style="color: cyan;">█</span> Dolly Area Crosscuts	<span style="color: brown;">█</span> Shaft	<span style="color: red;">●</span> Adit Portal
<span style="color: yellow;">█</span> 325 Adit	<span style="color: tan;">█</span> Raise or Winze	<span style="color: red;">■</span> Shaft Collar
<span style="color: orange;">█</span> 311 Adit	<span style="color: orange;">█</span> Shaft going above and below level	<span style="color: red;">▲</span> Stope Surface Opening
<span style="color: purple;">█</span> 242 Sub-level	<span style="color: teal;">█</span> Ore shaft	
<span style="color: lightgreen;">█</span> 33 Level	<b>Stopes</b>	
<span style="color: green;">█</span> 73 Level	<span style="color: green;">█</span> Stope ("v" points downward)	
<span style="color: olive;">█</span> 200 Level	<b>Other Workings</b>

Sources: Malone 1962 and MacKevett and Berg 1963

The approximate locations of underground workings and associated mine openings as of 1962 are illustrated in Figure 2-1. As of 1963, many of the older shallow workings were caved and inaccessible (MacKevett and Berg 1963). It should be noted that nomenclature of the underground workings varies depending upon the report, potentially resulting in confusion as to the identification and depth of several mine levels. For example, Wright and Rutledge (1947) and Webber et al. (1947) refer to adits driven at the 311-foot level and 325-foot levels, and report that these adits were driven at 311 and 325 feet above sea level, respectively. These two adits are referred to in one subsequent report as the 311 Adit and 325 Adit (MacKevett and Berg 1963), and in another report as the 1311 Adit and 1325 Adit (Malone 1962). Furthermore, several levels referred to in earlier reports, such as the 236-foot level and 276-foot level, are not reported in subsequent reports (e.g., MacKevett and Berg 1963 and Malone 1962), likely because the levels were assigned different identifiers at later stages of mine development. The underground mine workings as presented in Figure 2-1 represent a combination of information presented in Malone (1962) and MacKevett and Berg (1963). Mine openings documented as of 1962 are as follows.

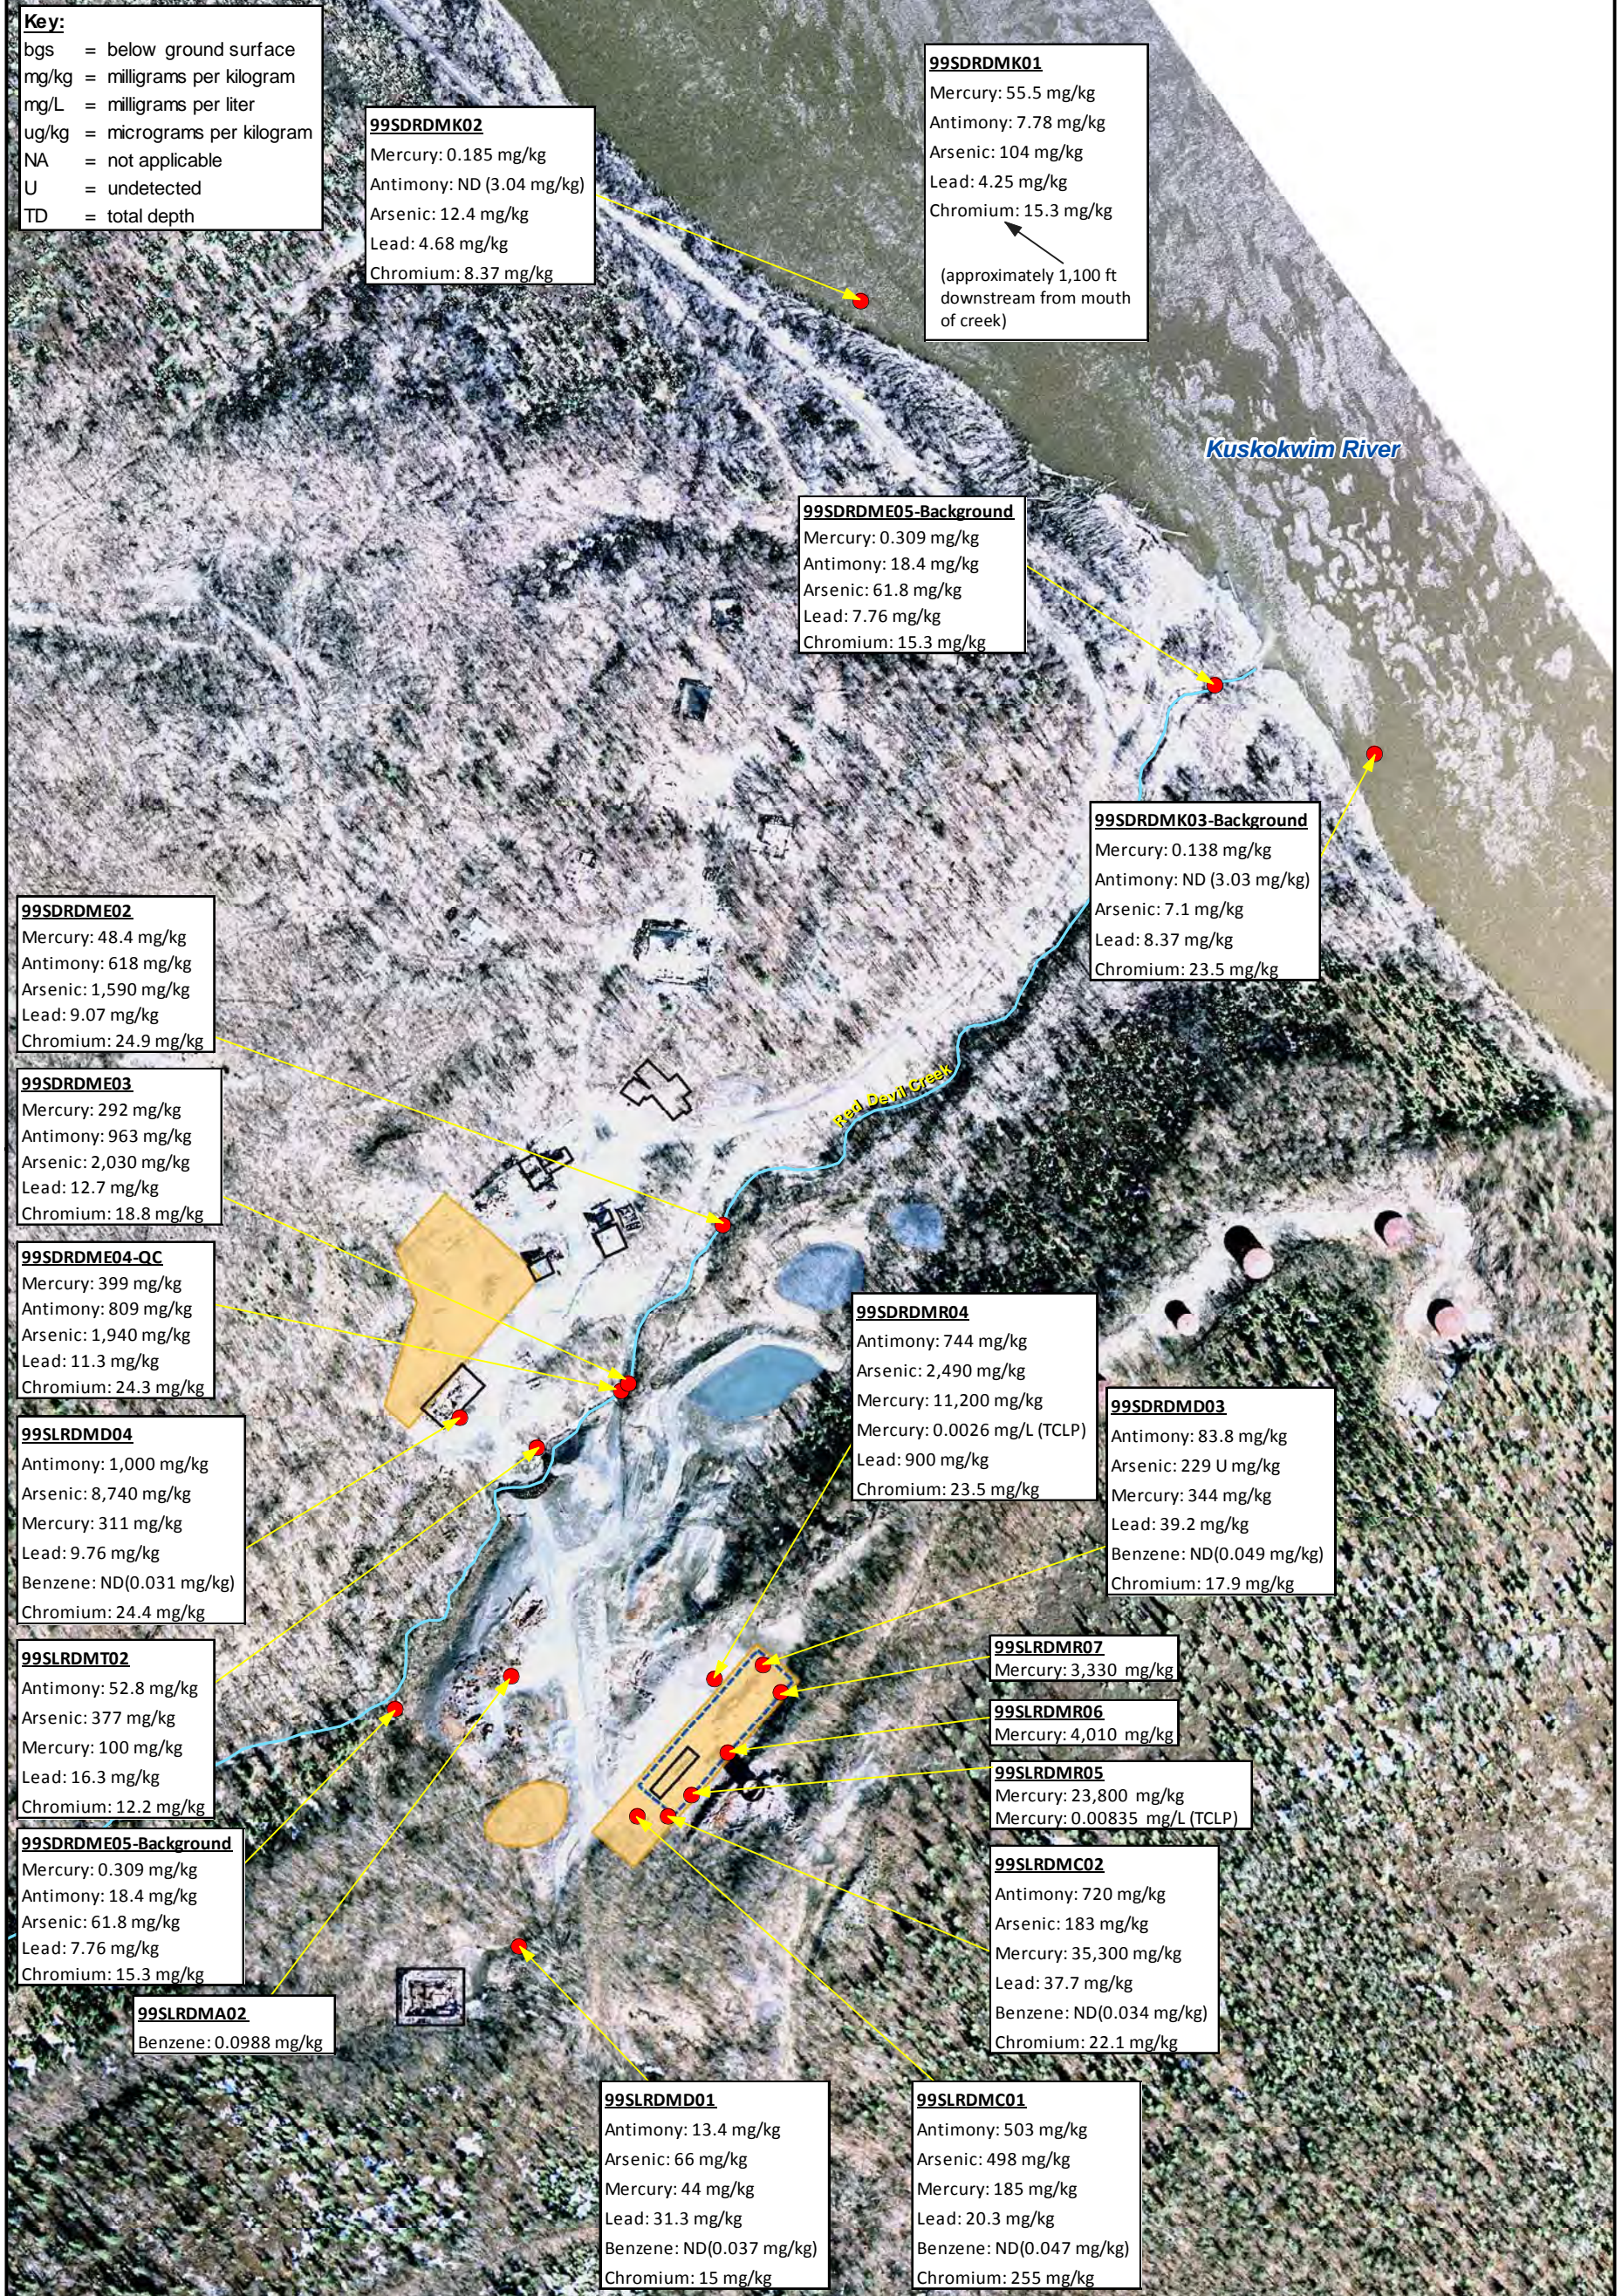
**Figure 3-3**  
 1999 Surface Soil and Sediment Sample Results for Antimony, Arsenic, and Mercury

Source: HLA/Wilder 1999. Note: Sample locations are approximate.

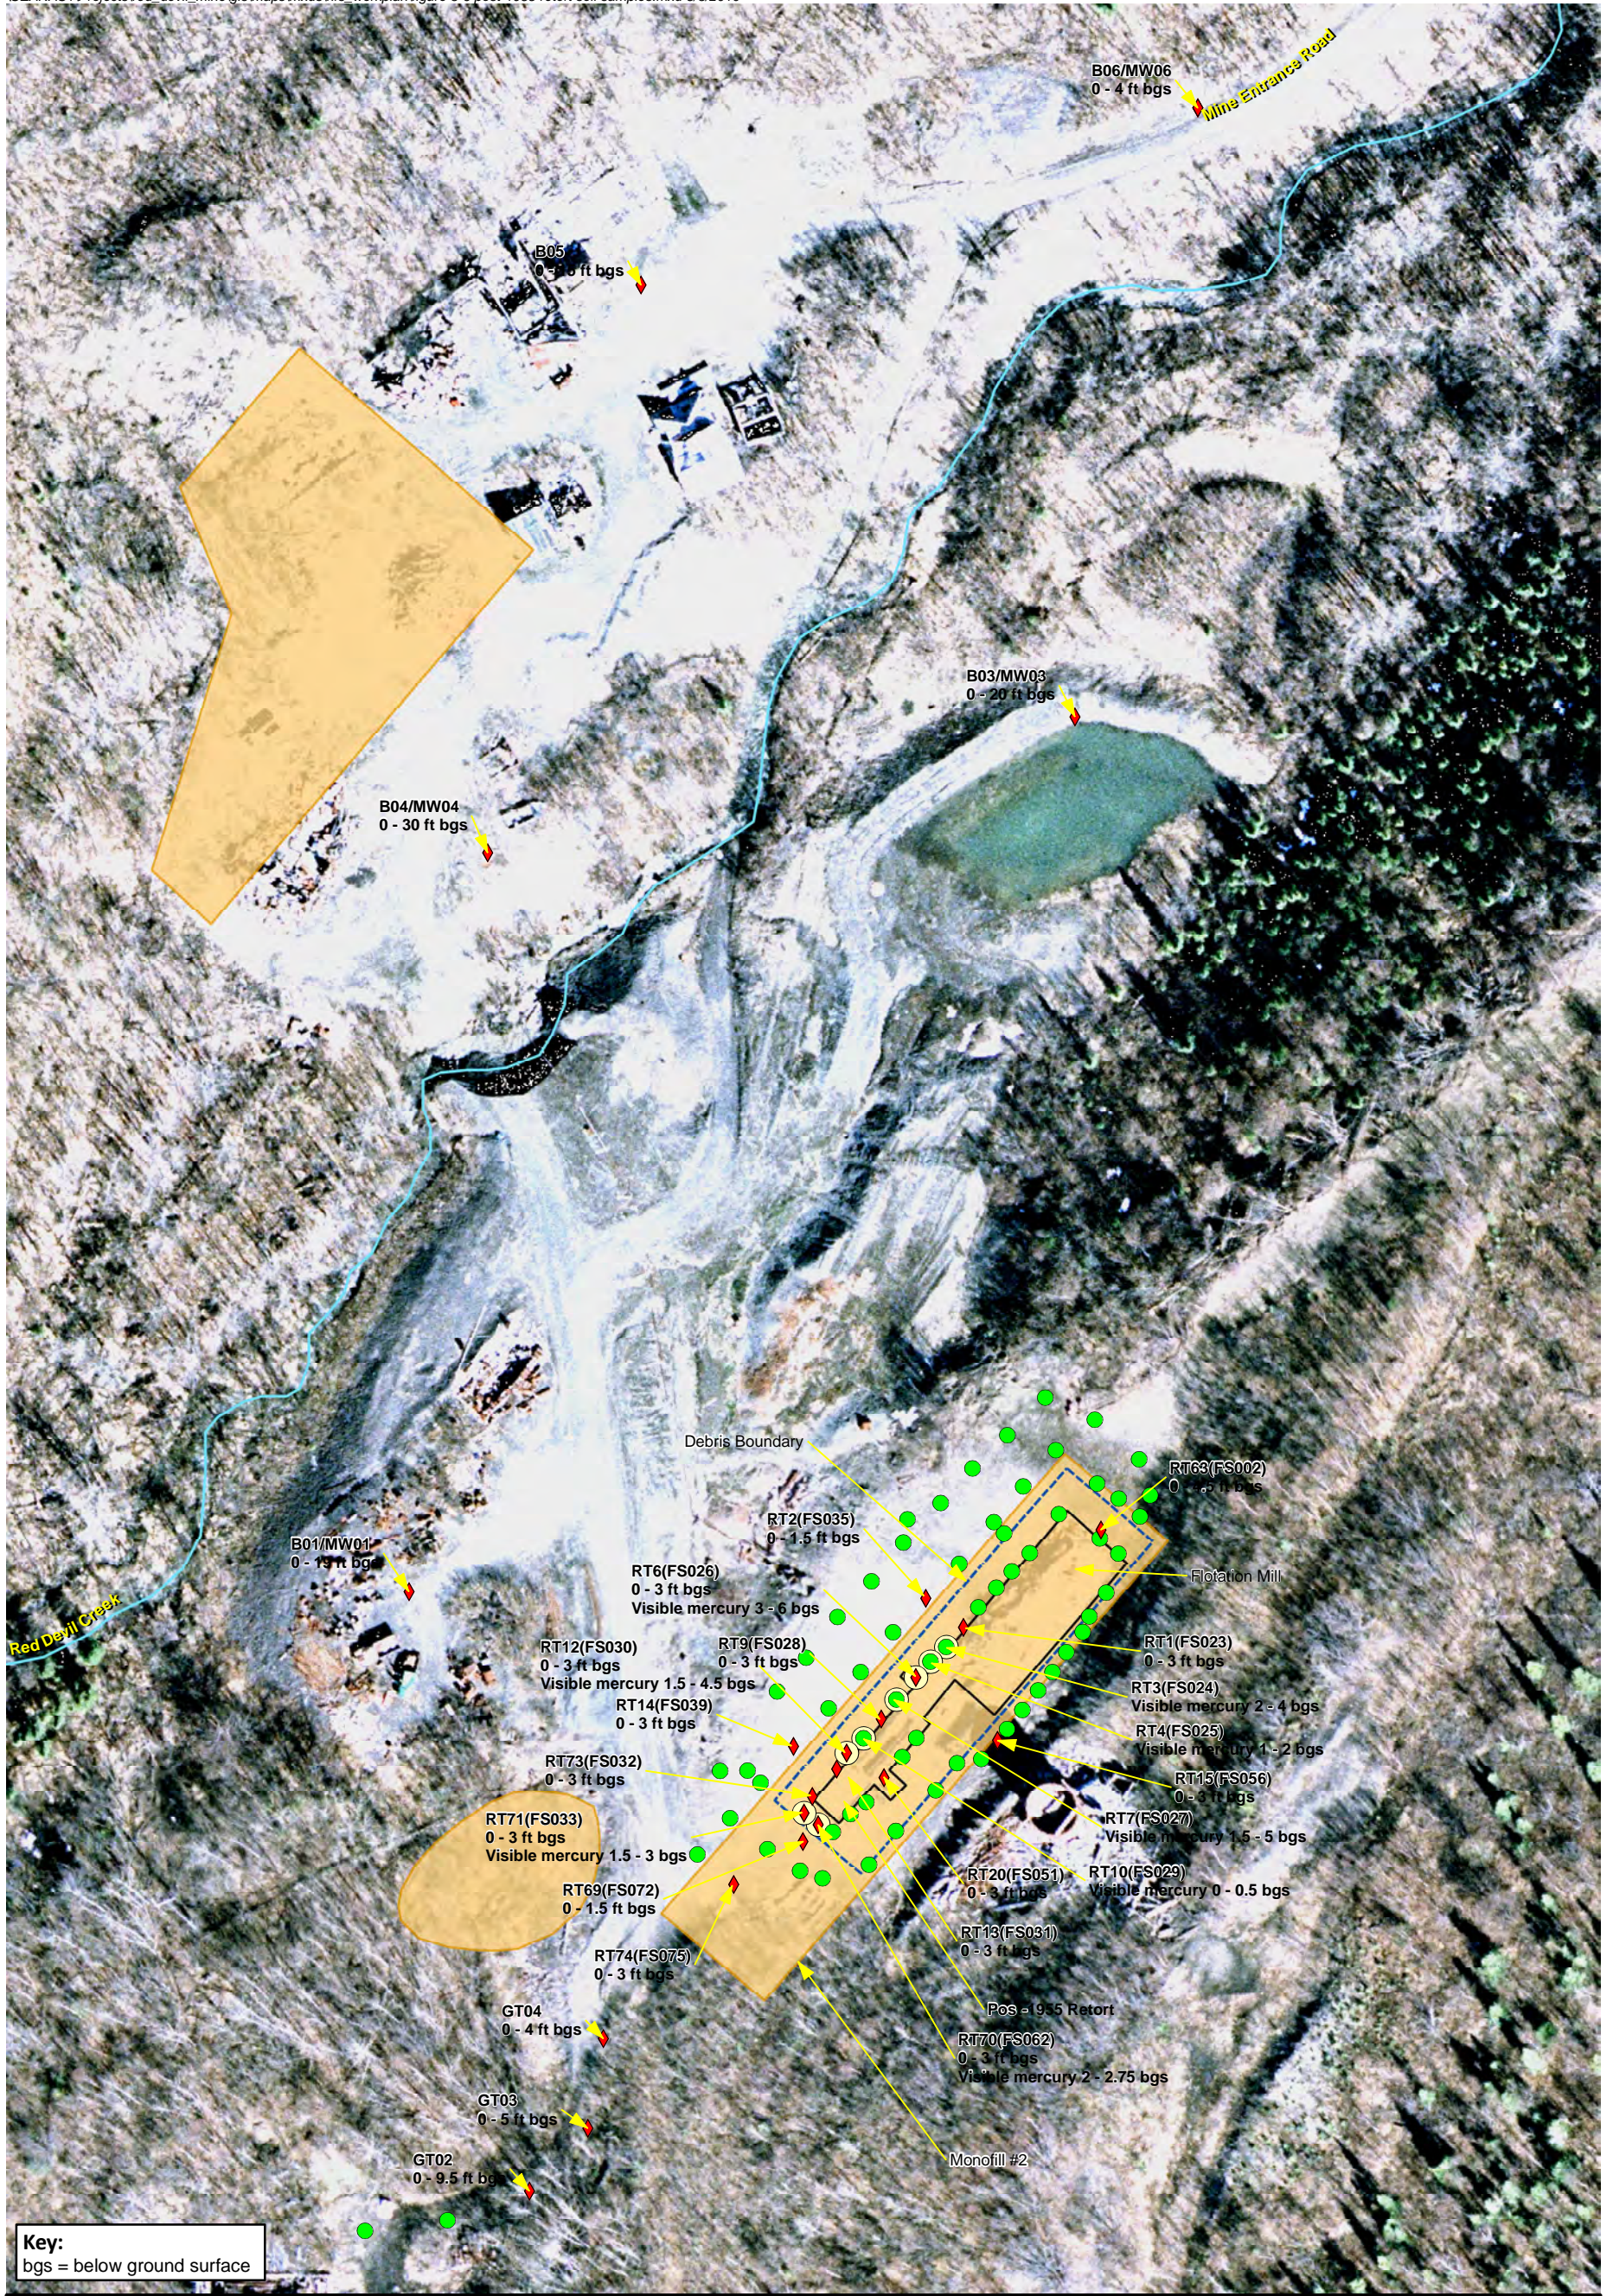
- ◆ Soil boring with reported tailings/fill
- Soil boring with no reported tailings/fill
- Soil Boring with visible mercury
- ▭ Debris Boundary
- Monofill Location
- ▭ Retort Building Foundation

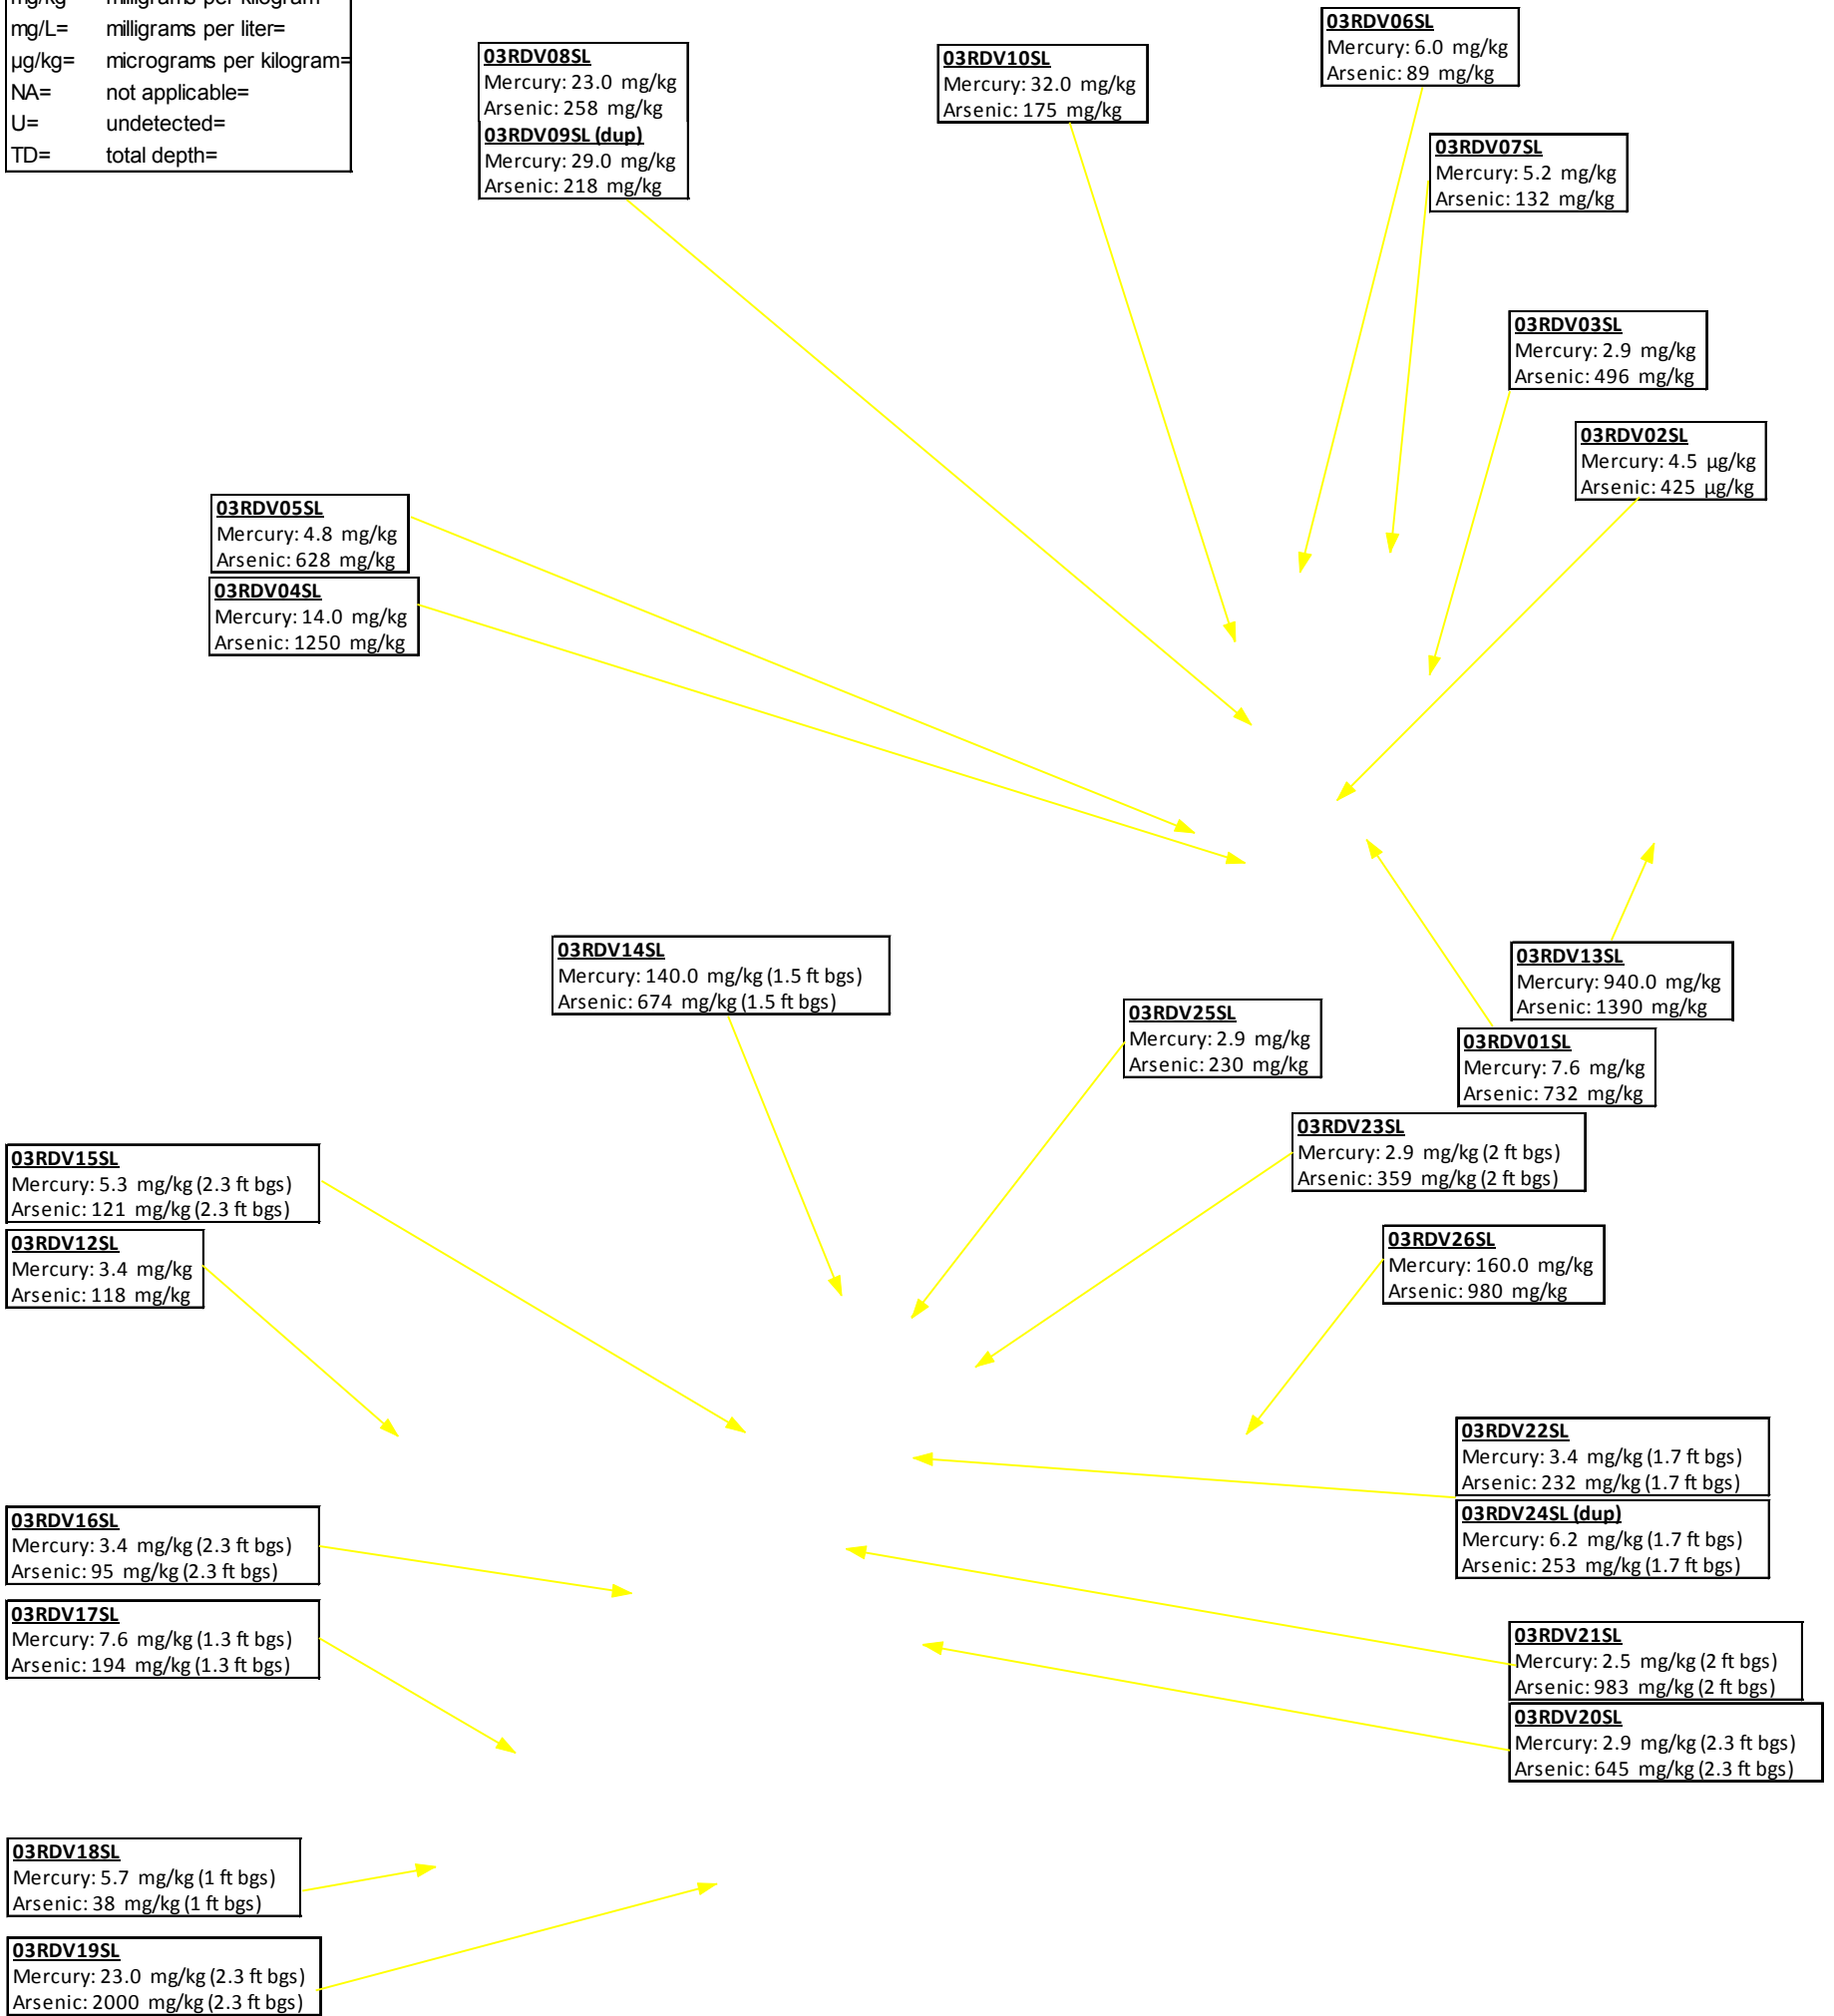
<ul style="list-style-type: none"> <li>● Surface Soil Sample Location=</li> <li>● Subsurface Soil Sample Location=</li> <li>■ Monofill=</li> <li>□ Historical Structure=</li> </ul>	<p><b>RED DEVIL MINE</b> Red Devil, Alaska</p>	<p><b>Figure 3-5</b> <b>2003 Historic Source Area</b> <b>Investigation Results</b></p>
<p>Source: MACTEC 2005. Note: Sample locations are approximate.=</p>		<p>Scale 1:300=</p>

Figure 3-5 illustrates soil sample results for mercury and arsenic from the 2003 investigation.

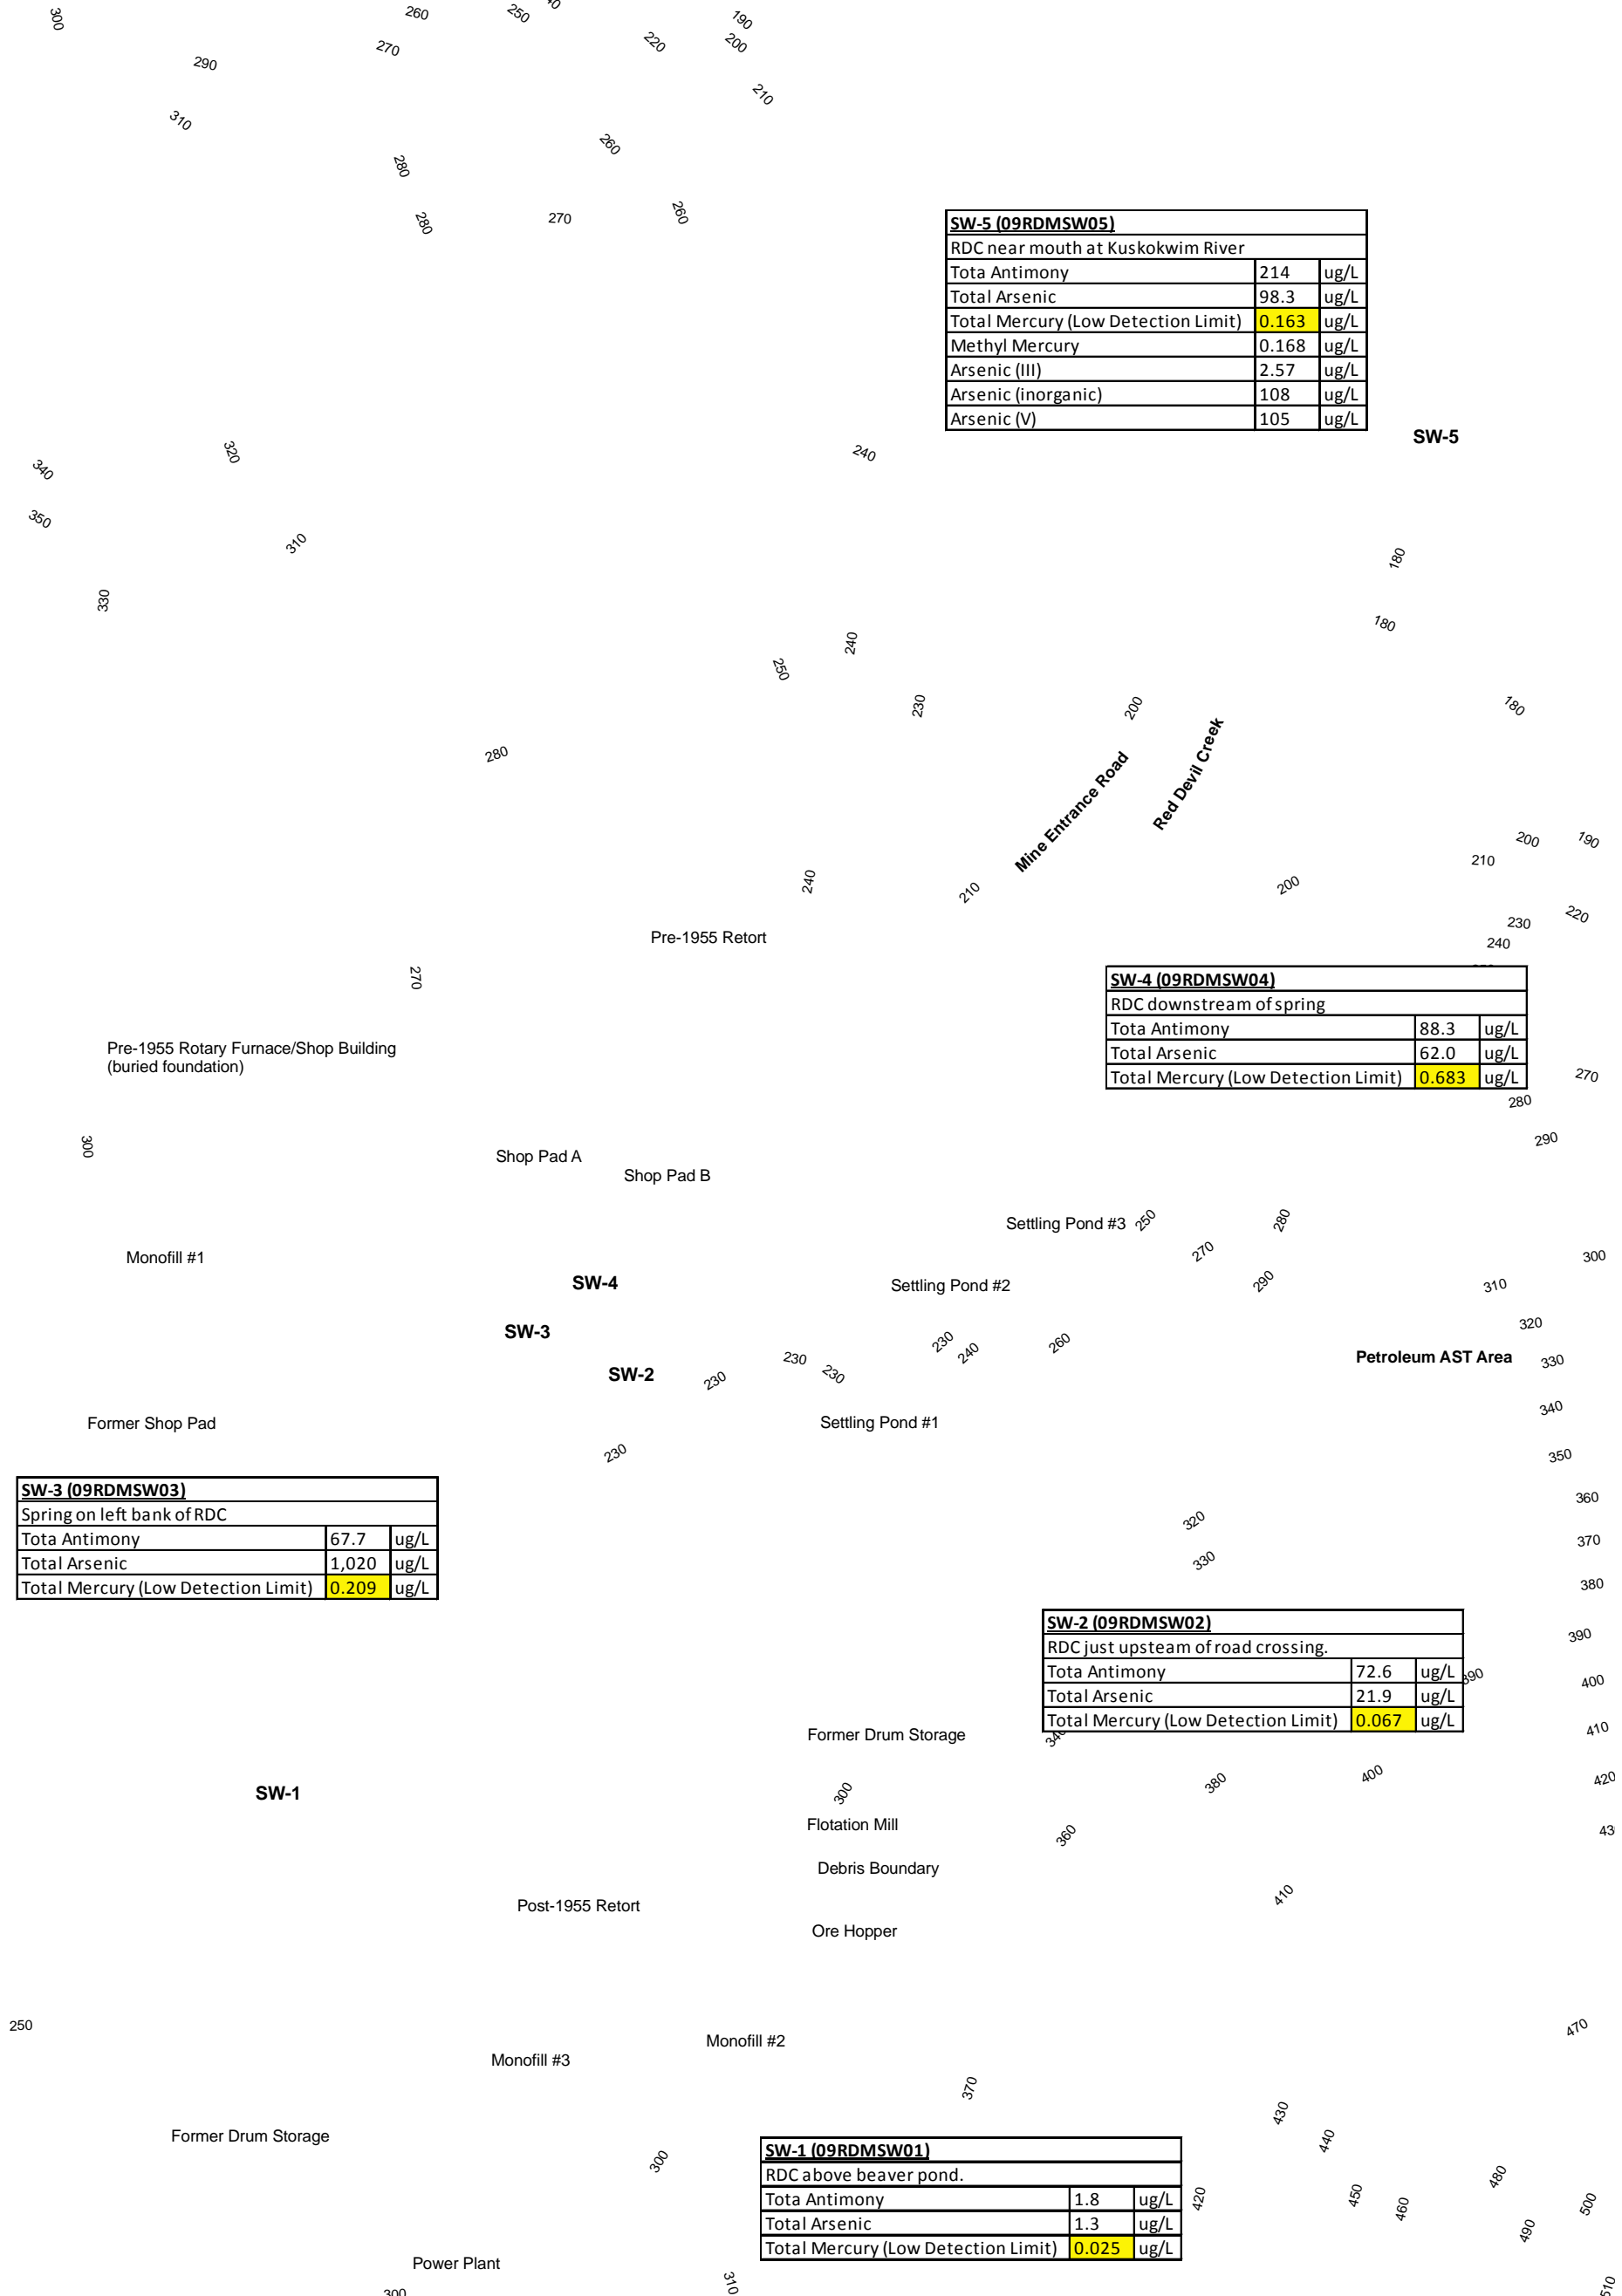
SW-5 (09RDMSW05)		
RDC near mouth at Kuskokwim River		
Total Antimony	214	ug/L
Total Arsenic	98.3	ug/L
Total Mercury (Low Detection Limit)	0.163	ug/L
Methyl Mercury	0.168	ug/L
Arsenic (III)	2.57	ug/L
Arsenic (inorganic)	108	ug/L
Arsenic (V)	105	ug/L
