**Work Plan  
Remedial Investigation/Feasibility  
Study  
Red Devil Mine, Alaska**

**March 2011**

**U.S. DEPARTMENT OF INTERIOR  
BUREAU OF LAND MANAGEMENT  
Anchorage Field Office  
4700 BLM Road  
Anchorage, AK 99507**

**ECOLOGY AND ENVIRONMENT, INC.  
720 3rd Avenue, Suite 17  
Seattle, WA 98104-1816**

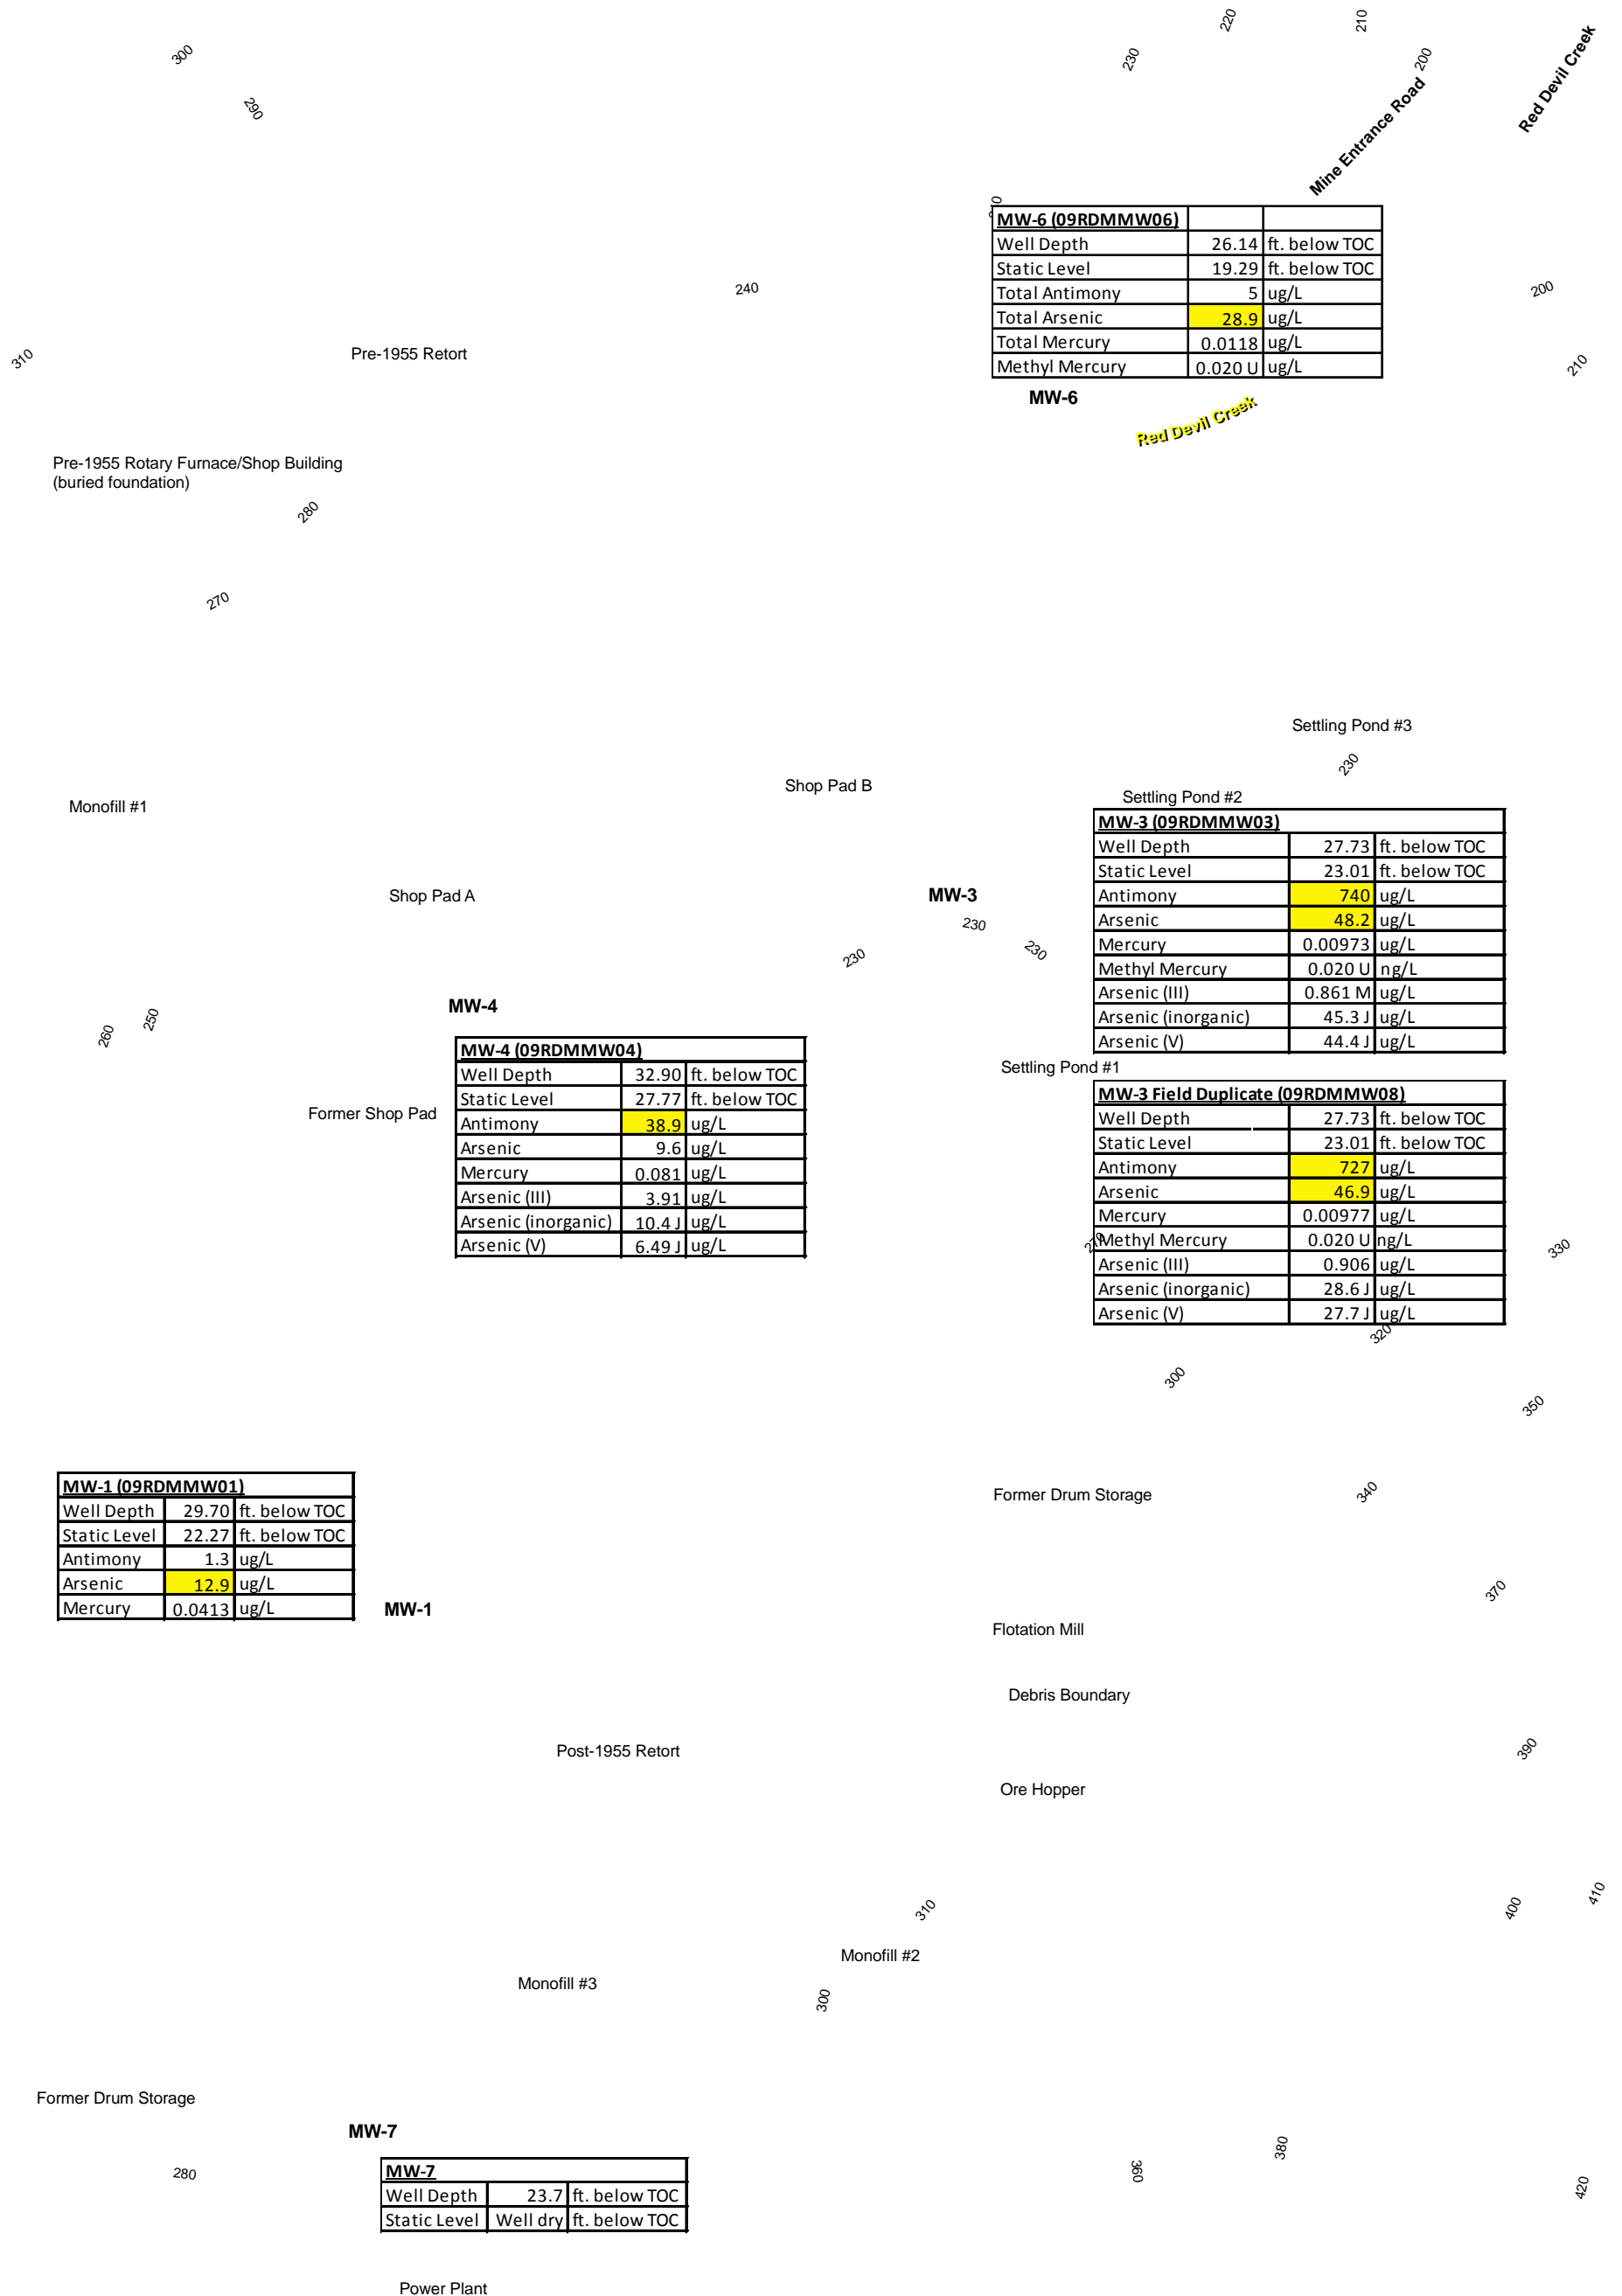
MW-6 (09RDMMW06)	
Well Depth	26.14 ft. below TOC
Static Level	19.29 ft. below TOC
Total Antimony	5 ug/L
Total Arsenic	28.9 ug/L
Total Mercury	0.0118 ug/L
Methyl Mercury	0.020 U ug/L

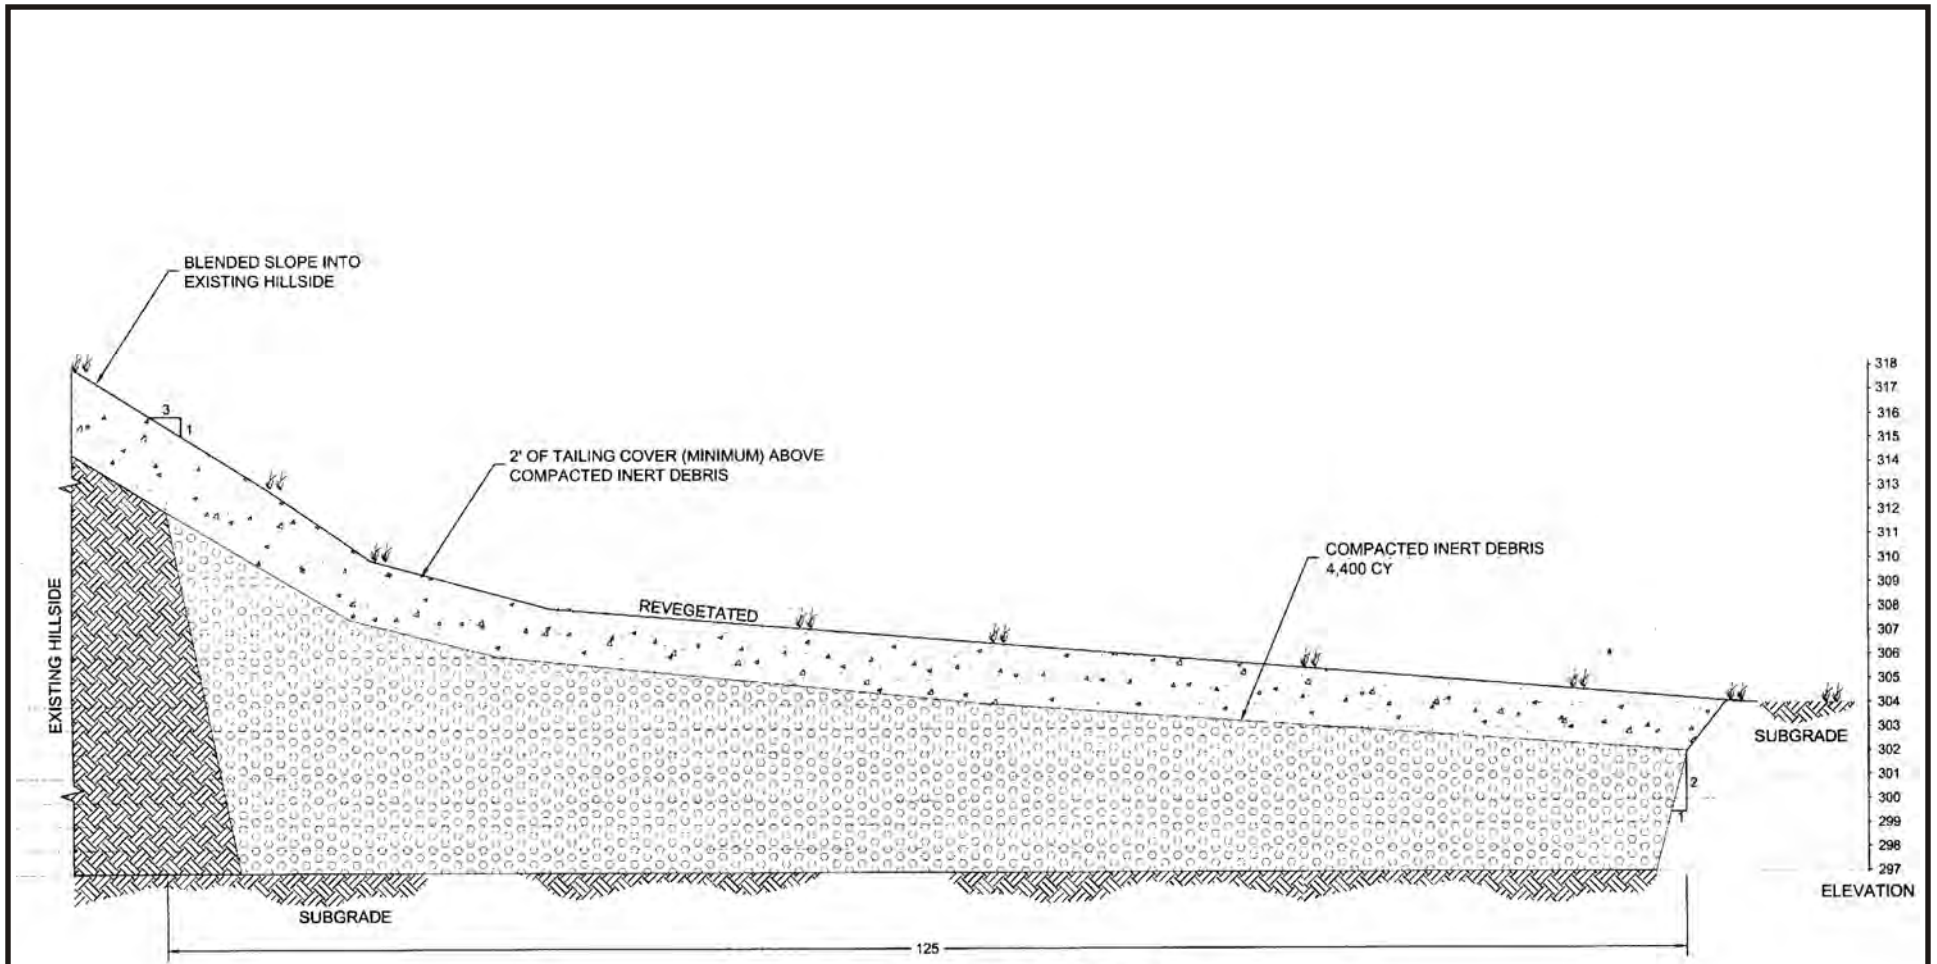
**SECTION A-A: TYPICAL SECTION**

1. ELEVATIONS IN FEET ABOVE MEAN SEA LEVEL
2. SURFACE AREA OF MONOFILL #2 IS 17,198.30 SQUARE FEET (IRREGULAR AREA)
3. MINE TAILINGS USED FOR MONOFILL #1 CONSTRUCTION TAKEN FROM WEST SIDE OF CREEK ONLY

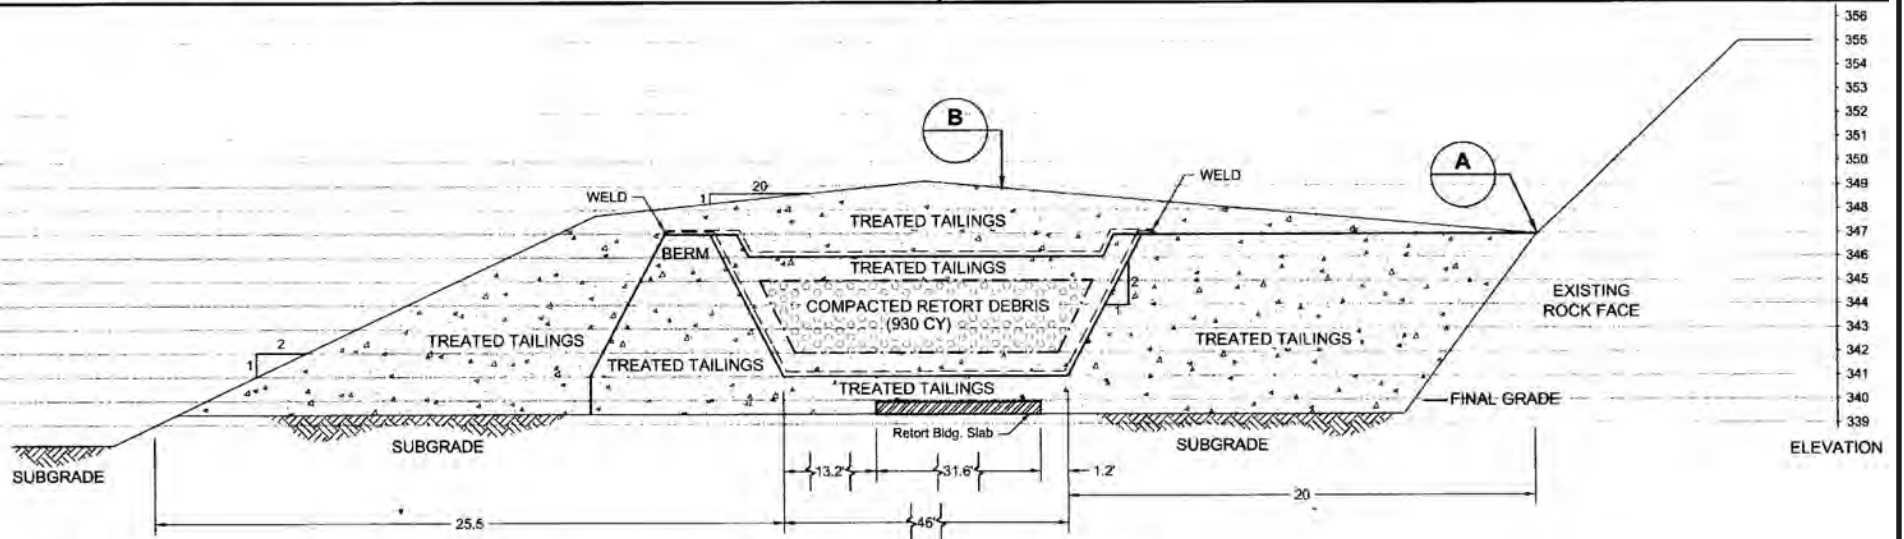
**SECTION B-B: TYPICAL SECTION**

1. BOTTOM LINER DIMENSIONS 72.5'x 259'
2. TOP LINER DIMENSIONS 55'x 240'
3. BOTTOM WIDTH OF MONOFILL IS NOT SHOWN TO SCALE, DIMENSIONS AS SHOWN
4. ELEVATIONS IN FEET ABOVE MEAN SEA LEVEL

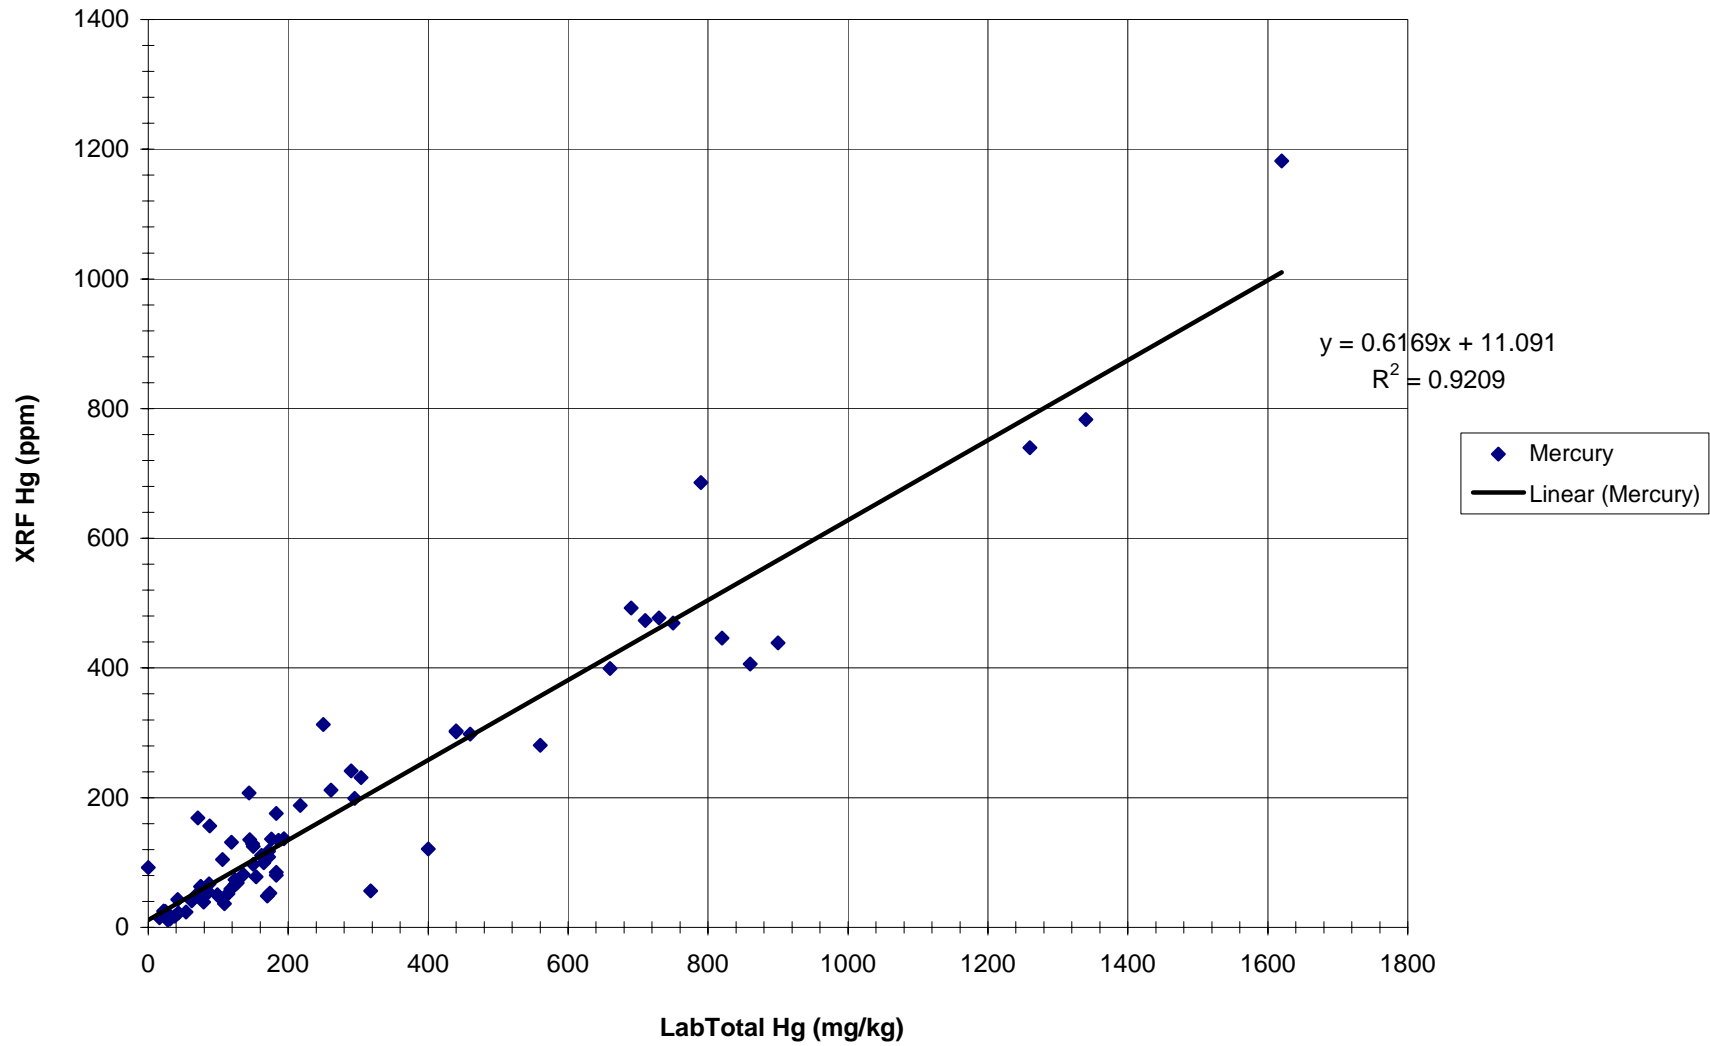
Chart 3-1. Linear Regression-Hg

Lab vs Field XRF Mercury

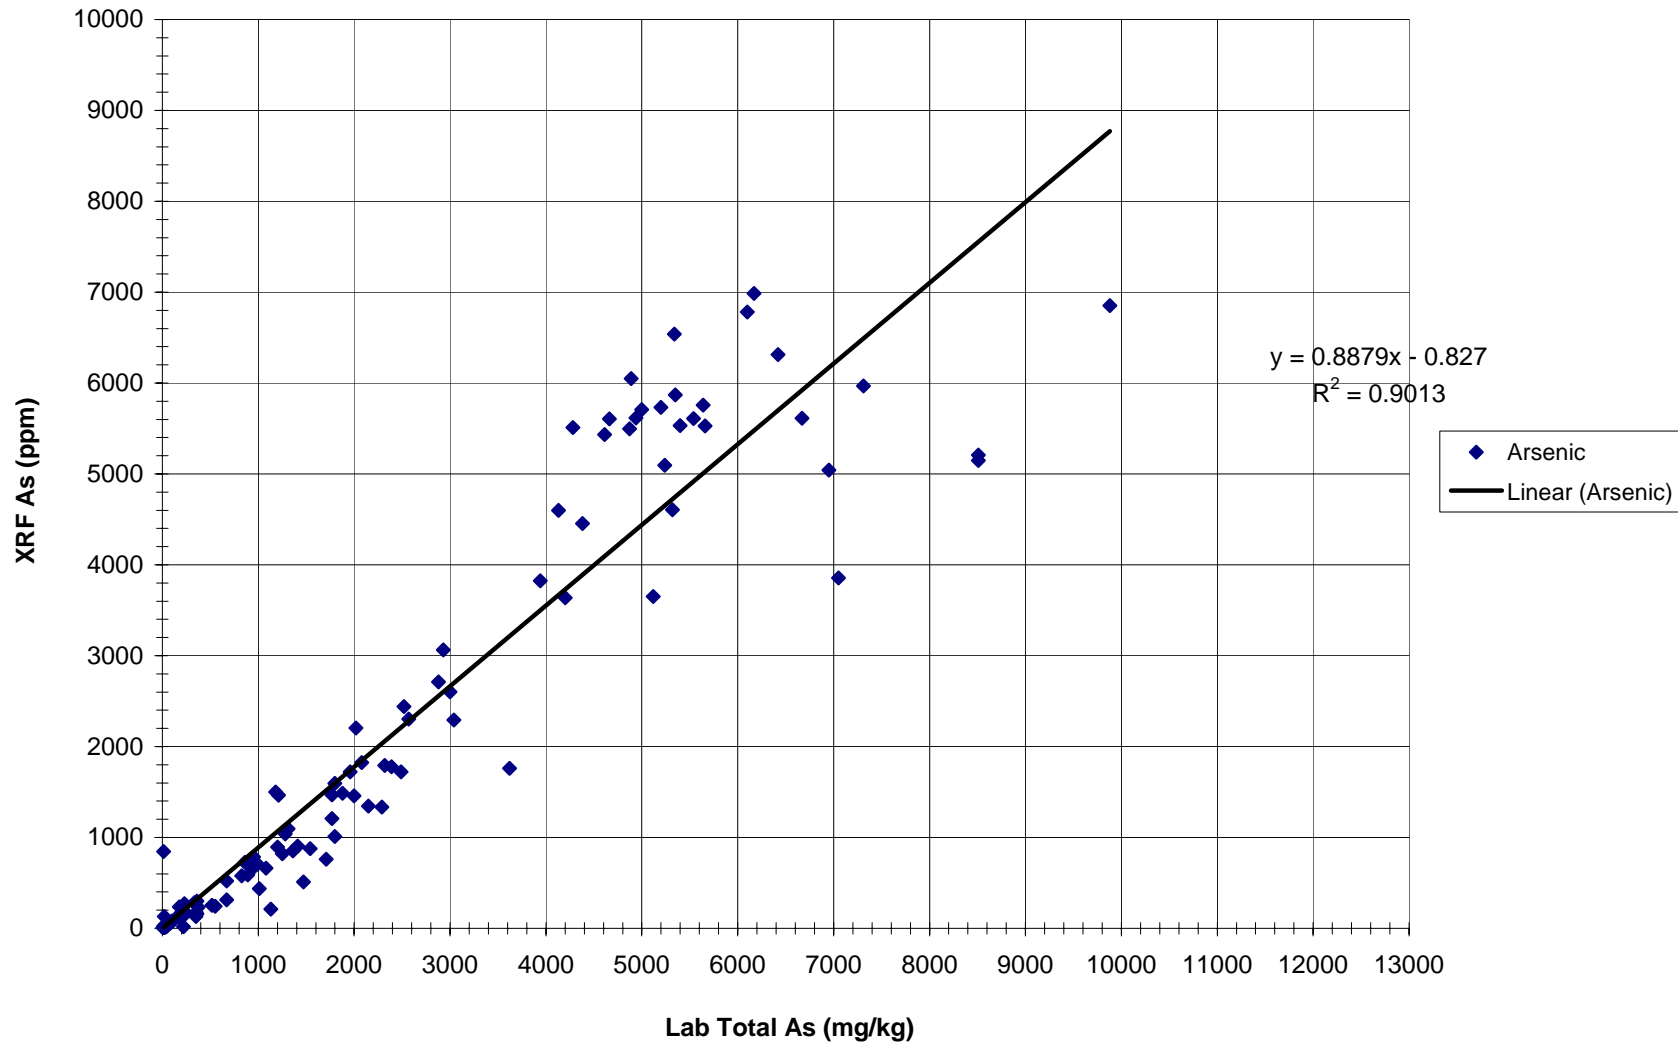
Chart 3-2. Linear Regression-As

Lab vs Field XRF Arsenic

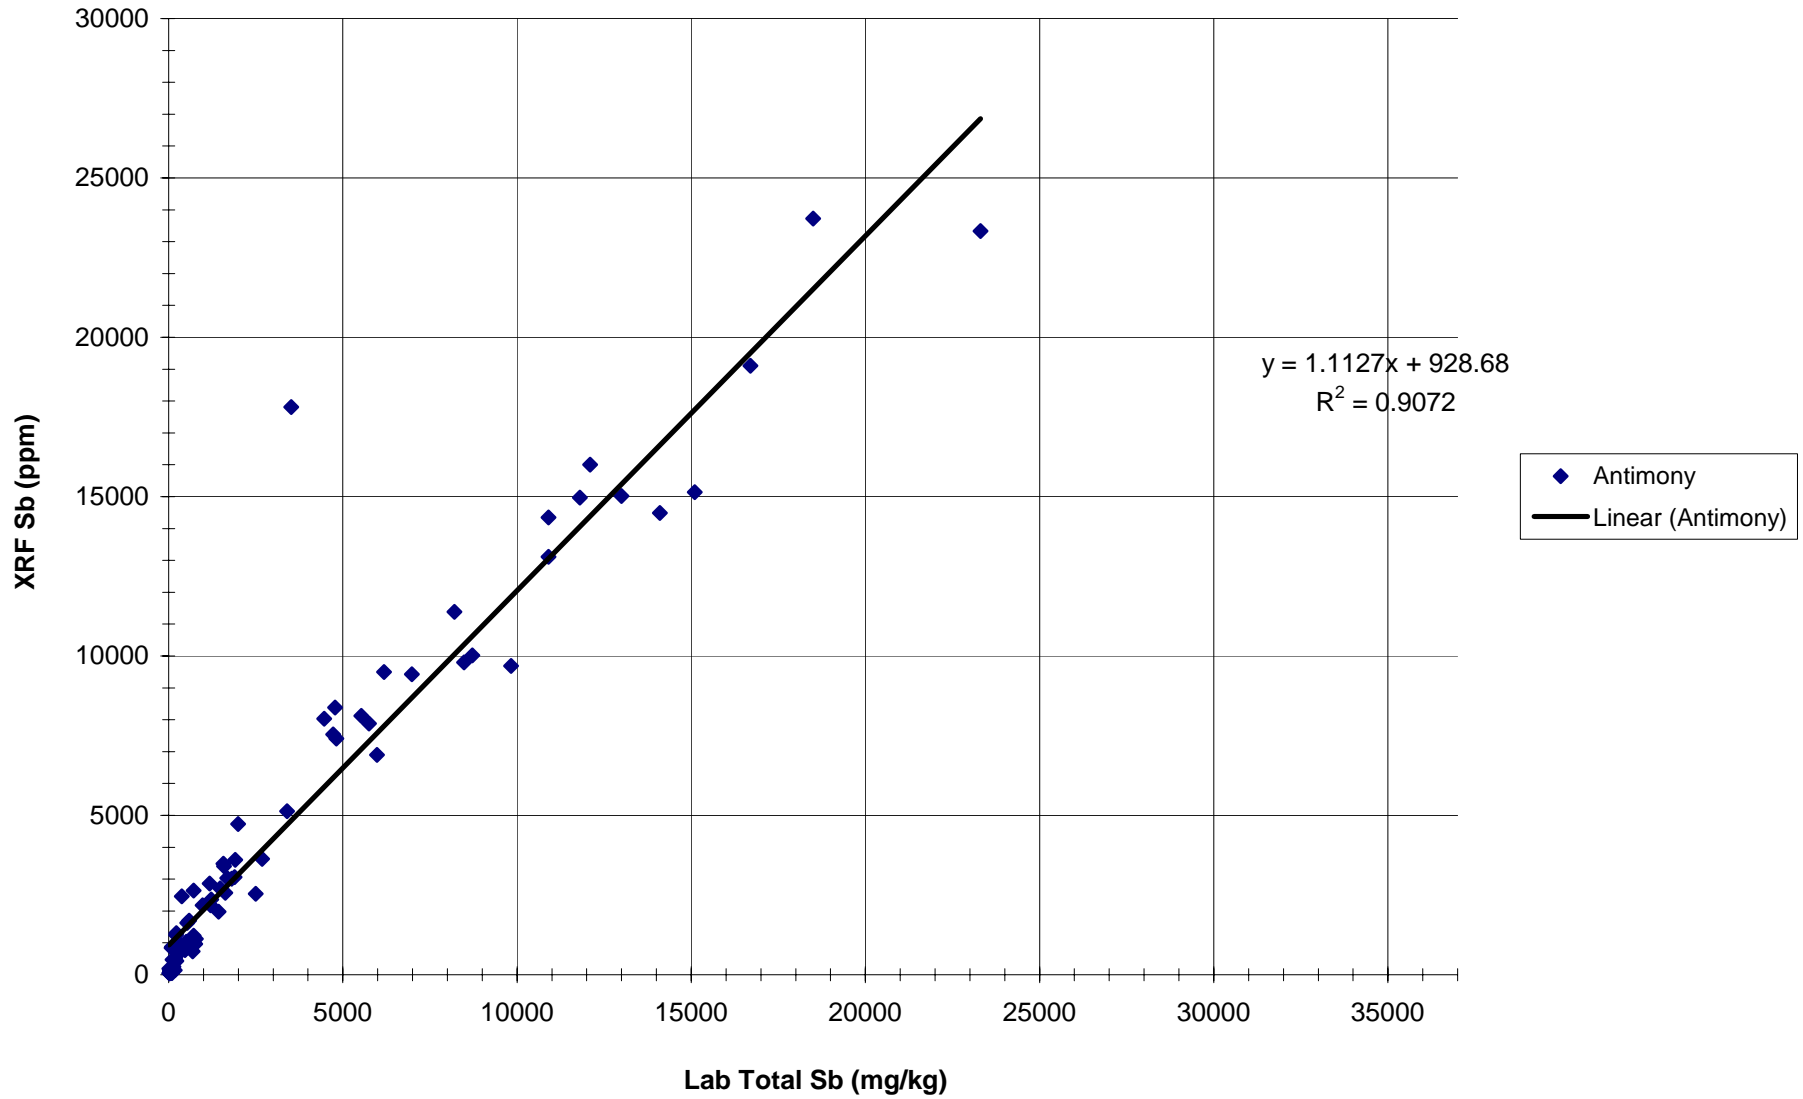
Chart 3-3. Linear Regression-Sb

### Lab vs Field XRF Antimony

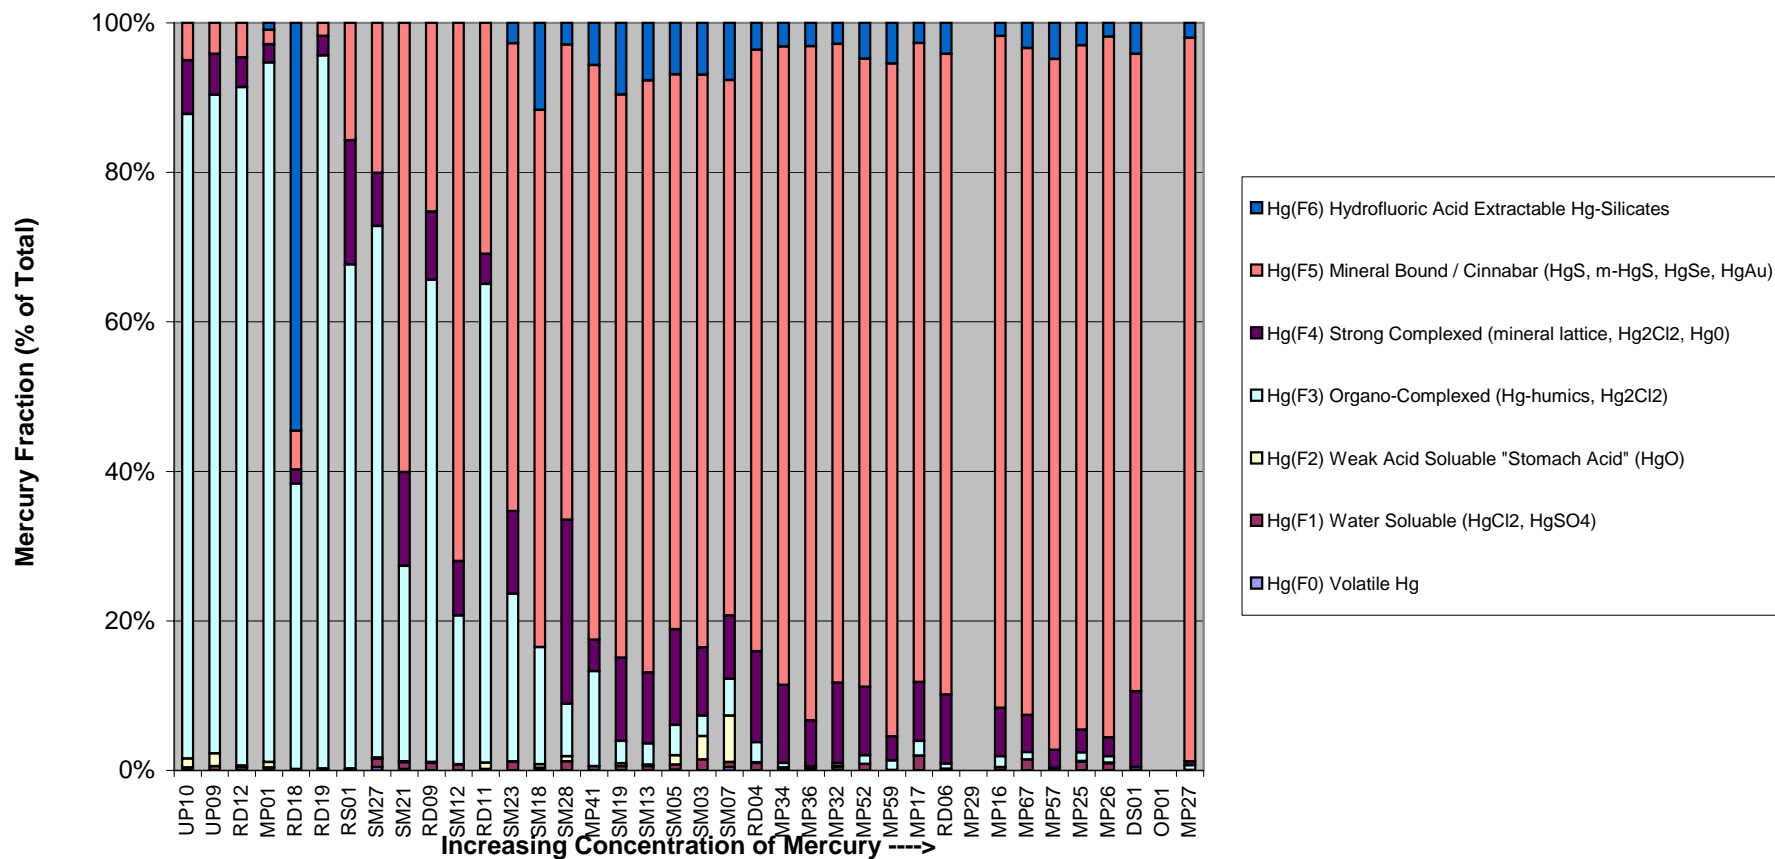
Chart 3-4. Mercury Fractions vs. Total Mercury vs. Sample Location

### Red Devil Mine Surface Soil Samples Mercury Fractions vs. Total Mercury vs. Sample Location

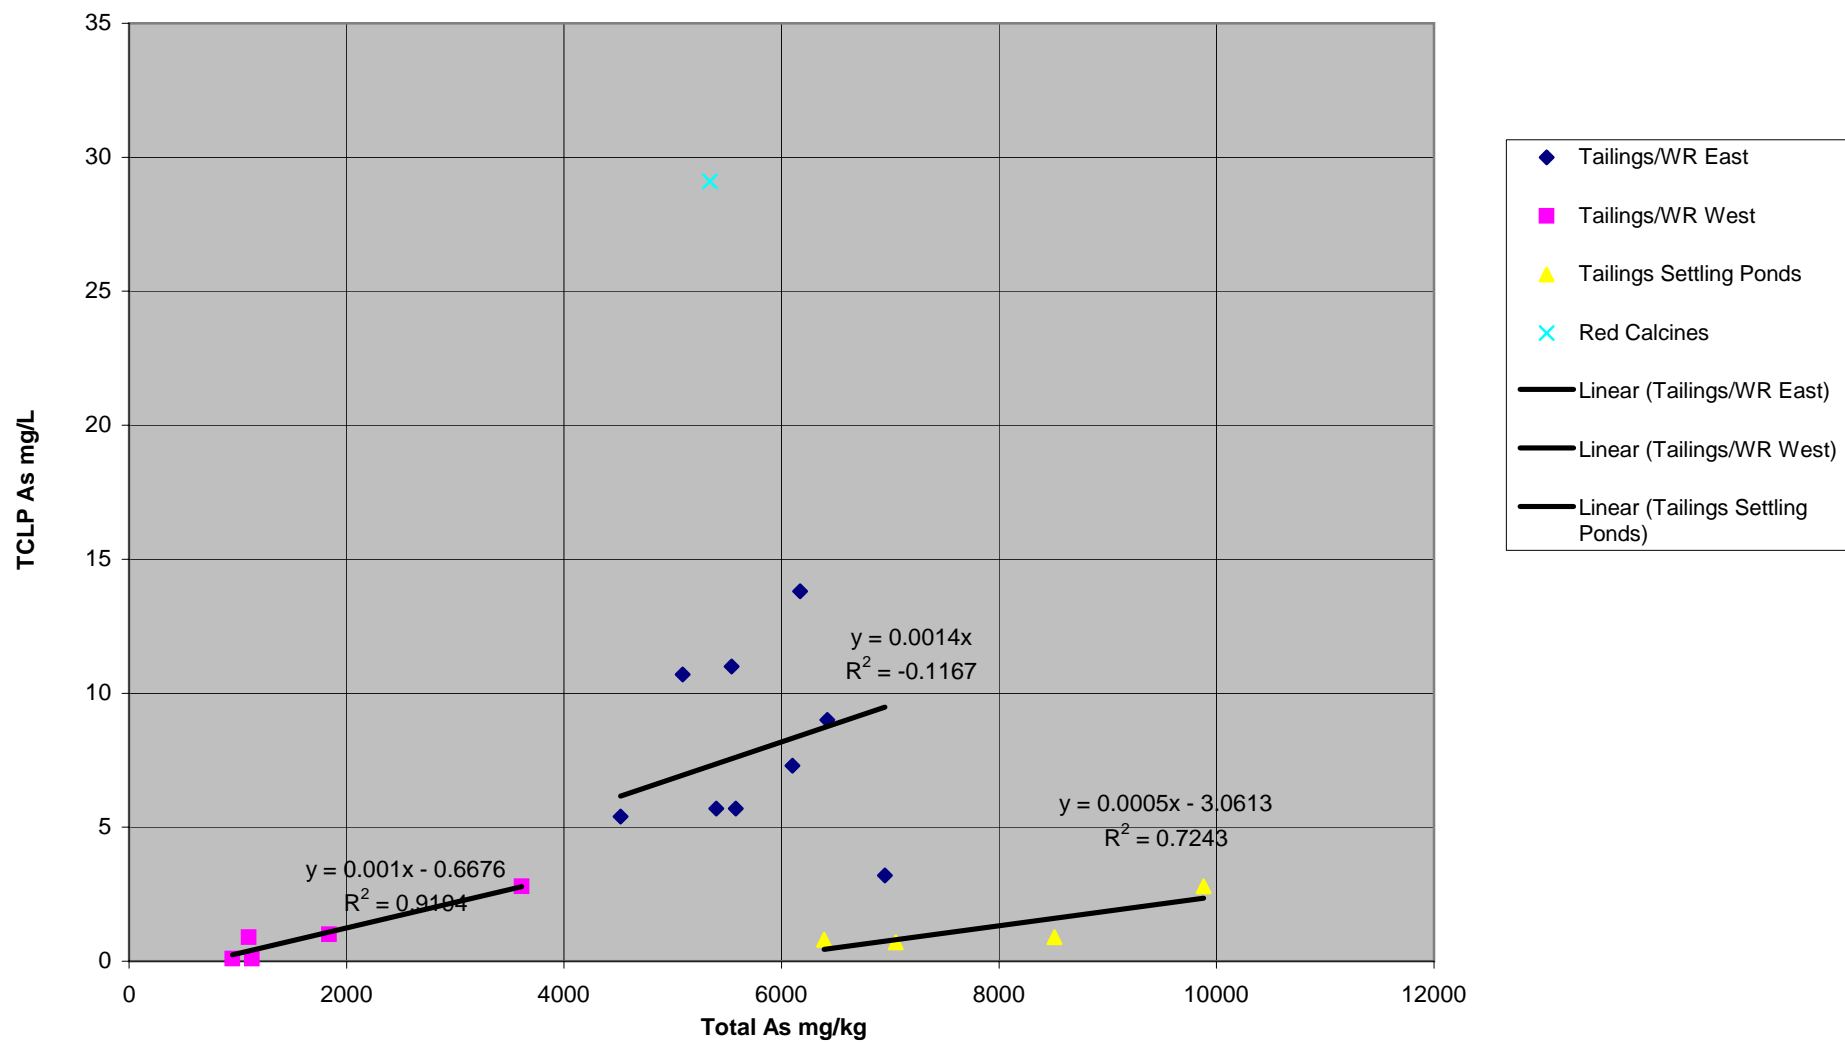
Chart 3-5. Arsenic Total vs. TCLP

### Arsenic Total vs TCLP

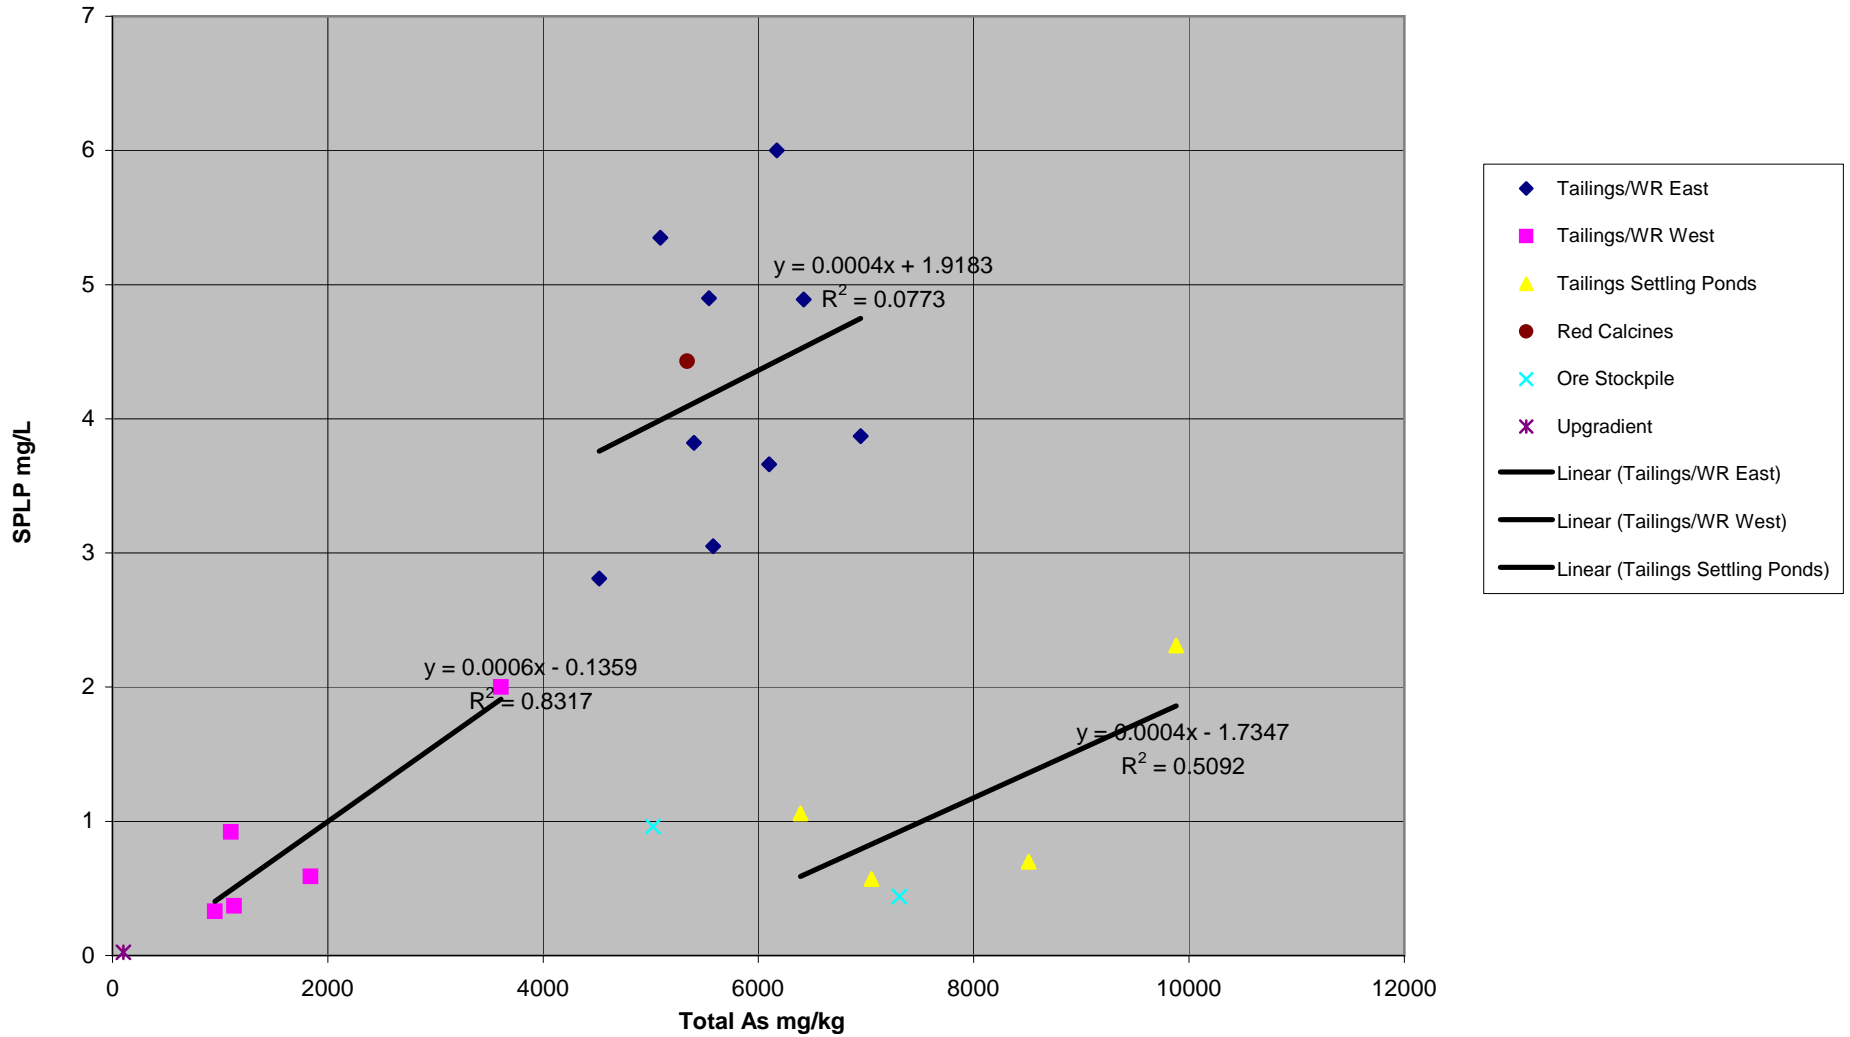
Chart 3-6. Arsenic Total vs. SPLP

### Arsenic Total vs SPLP
