**Wilderness Inventory Unit Index of Documents**  
**Squaw Creek OR-034-034, 23 total pages**

**Year:** 2009      **Unit Number/Name:** OR-034-034 -- Squaw Creek

**FORM 1 -- DOCUMENTATION OF BLM WILDERNESS INVENTORY FINDINGS ON RECORD**

**Wilderness Inventory Unit Name/Number: OR-034-034 -- Squaw Creek**

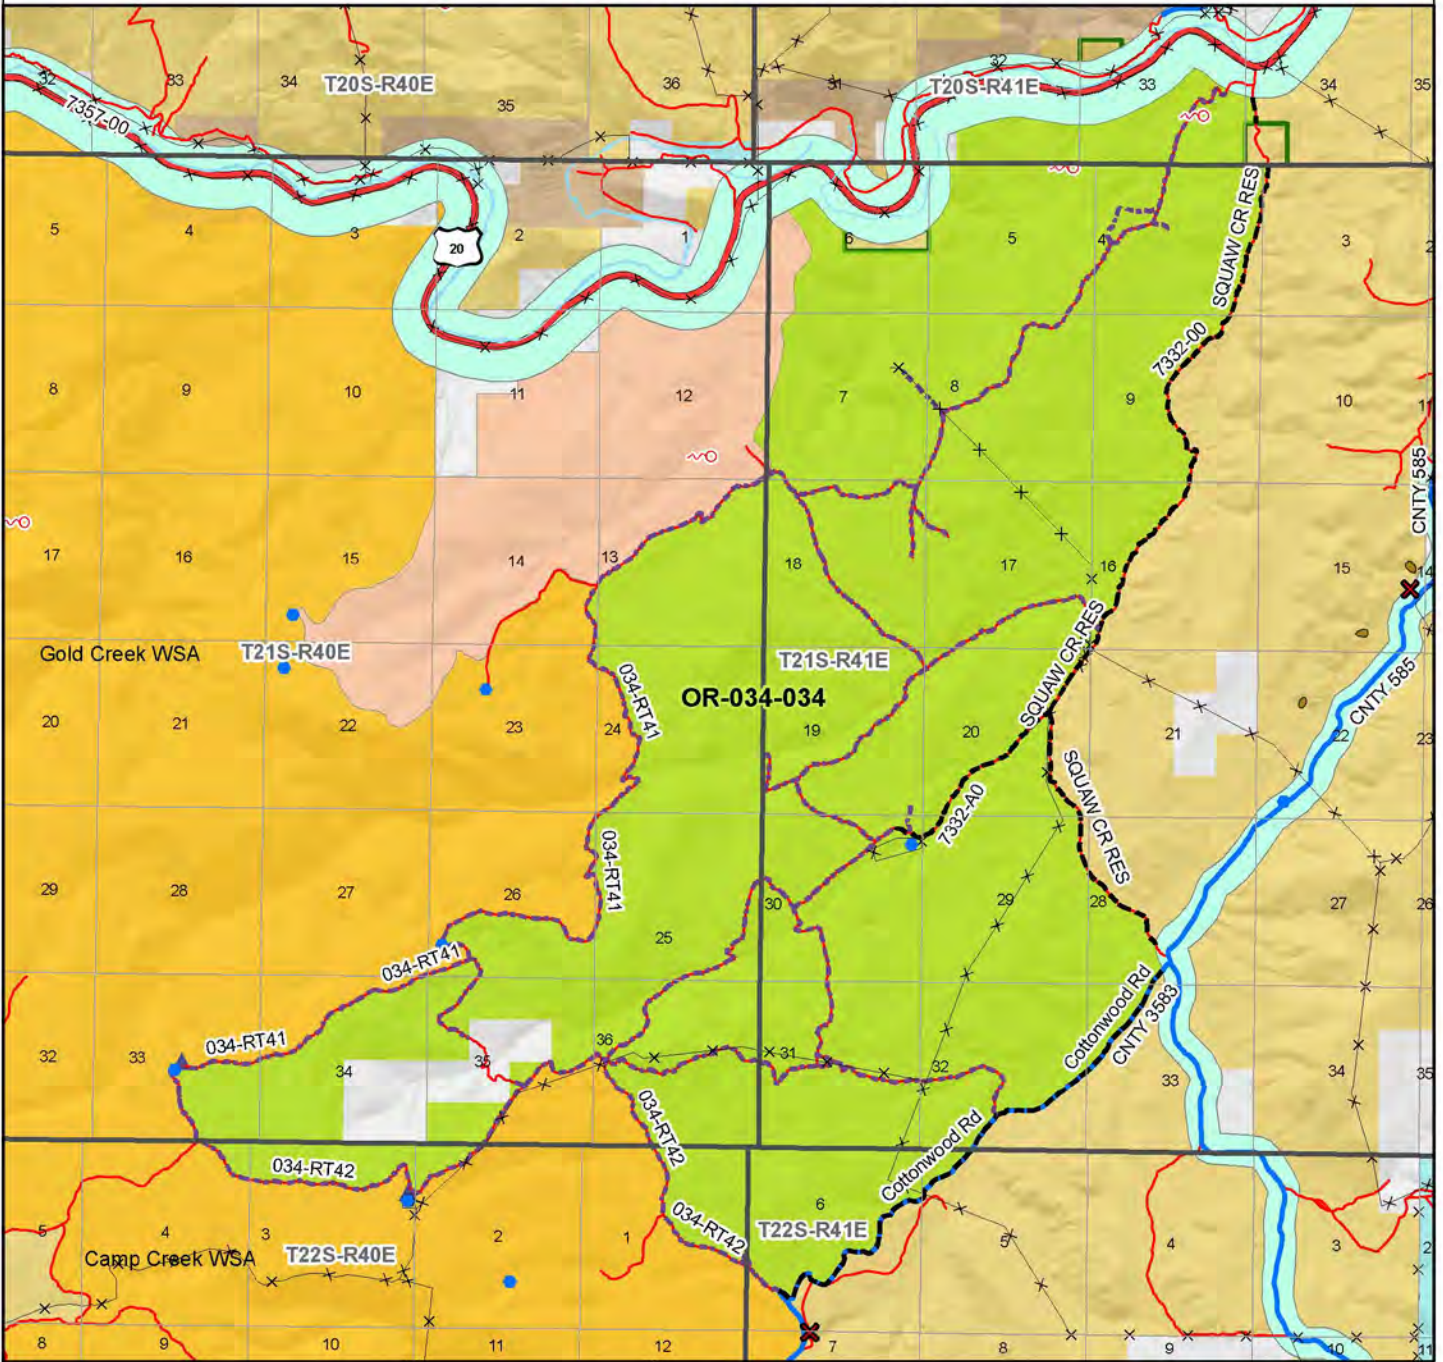
## Squaw Creek - OR-034-034 - Map 1 of 2

**Description:** Refer to this unit's associated Map 1 for its location. The boundary of 12, 646-acre unit encompasses substantially more area than the original 1970's BLM Squaw Creek inventory unit (3-34 of OR-03-03-04). Adjacent public lands to the original unit's north and to its southwest are now included due to BLM's conclusion that certain routes which were determined to be roads during the 1970's inventory are now motorized primitive trails (MPT). The unit's boundary consists of the BLM roads 7332-0-00 and 7332-0-0A0 (alias 7332-0-00 and 7332-0-0A0, depending on which map is referenced), County Road 3583, other roads traversing public lands on its central east, one cherry-stem road (1.3 miles), the US Highway 20/utility ROW, and a mineral materials site which abuts that ROW. One 320-acre private inholding is a feature of the unit's boundary. In addition, all of the abutting Gold Creek WSA's (OR-3-33) east boundary -- which was previously determined to be a road -- is now considered to be a MPT, as has a portion of the Camp Creek WSA's (OR-3-31) abutting east boundary route with this OR-034-034 Squaw Creek inventory unit.

Refer to the attached maps for human developments within the unit. They include 7.1 miles of rangeland fence, 3 earthen reservoirs, 2 developed springs, 2 fence enclosures, and 31.4 miles of 14 motorized primitive trails (which includes those portions abutting the two WSA's which changed from road to MPT status). There is remnant evidence of two abandoned vehicle route segments within the unit. Approximately 120 acres of a 1969 drilled seeding affected the unit along its east boundary road. A portion of a 1970 drilled seeding project affected approximately 1,900 acres of a southeast stretch of the unit along County Route 3583. While visually evident during the 1970's inventory, currently only small scattered remnants of the 1970 drilled affect is noticeable; none of the 1966 drilled is visual noticeable today. Due to the unit's topographic screening properties, appearance and wide distribution of its varied natural features (e.g., the complex and extent of steep, rugged draws and drainages), combined with the distribution, extent and types/nature of the human developments within the unit in context of the unit's size, the developments' presence -- when considered individually and collectively -- result in the unit appearing to be affected primarily by the forces of nature, with human imprints substantially unnoticeable to the average visitor.

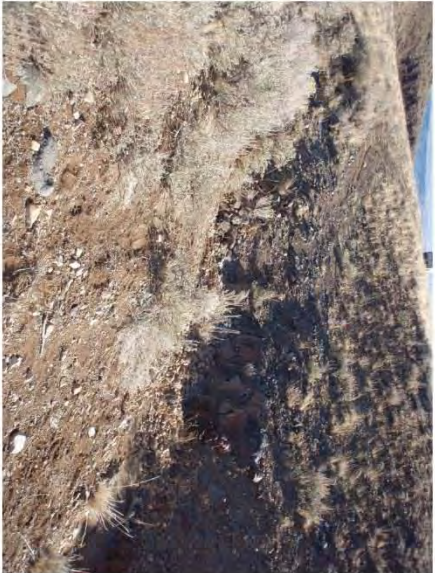
034-RT41-A-E.JPG

**Describe:** At photo point 034-RT-A-E, appears cut/fill was done to cross the drainage. No evidence of mechanical construction on remainder of this route.

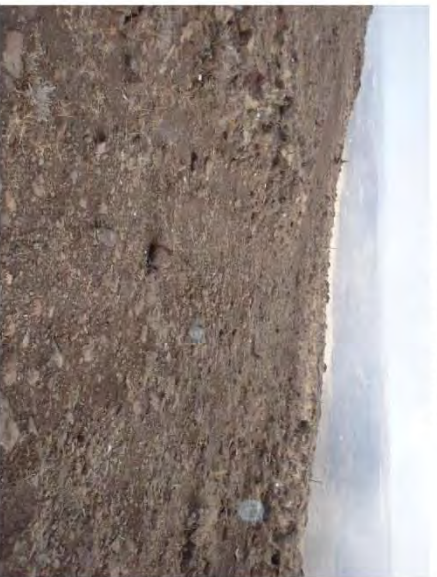
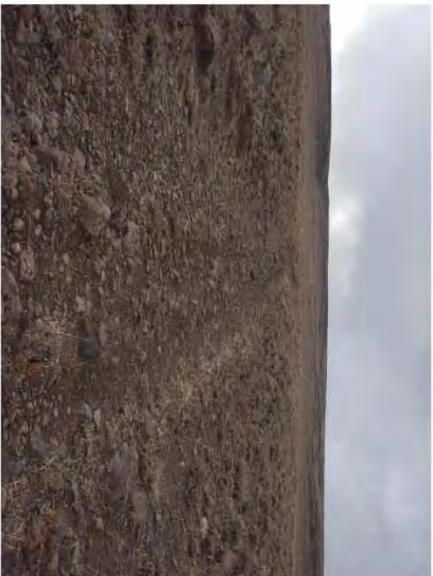
034-RT42-G-NE.JPG

**Comments:** Some segments of the more western portion of this route appear to be in fair condition (see PP 034-RT42-G as an example). This is due more so to the nature of the surface materials on fairly flat to slightly sloped terrain. Other

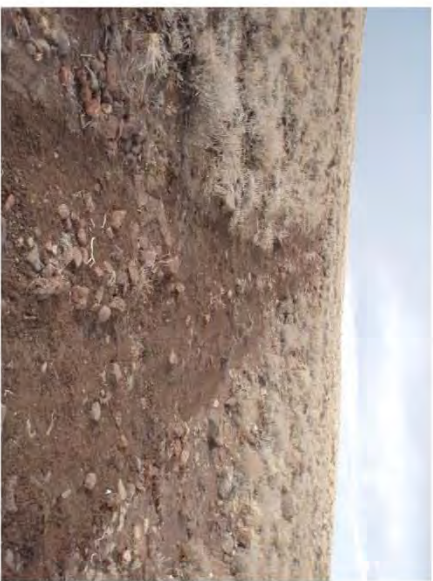
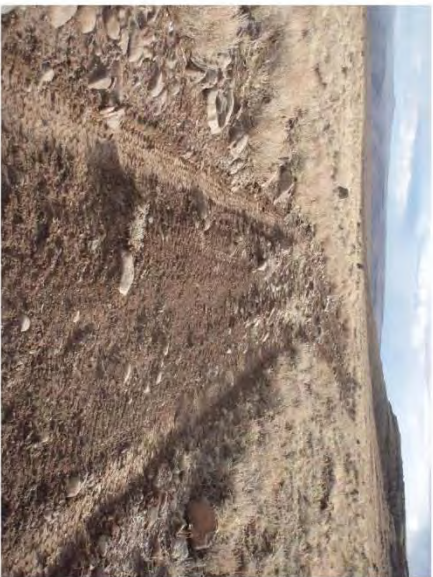
034-RT42-H-N.JPG

segments of this western portion of the route are in poor condition (see PPS 034-RT42-H as an example). Photo Points 034-RT42-A through 034-RT42-F reflect the route being in fair condition, most which traverses either a ridge line or steeper terrain than does the western portion of this route. None of the route is in good condition, though is passable by a high clearance vehicle. Motorized heavy equipment to maintain the earthen reservoirs associated with this route would not require mechanical maintenance of this route to access the reservoirs.
