# 3

## Physical Characteristics of the Study Area

**RED DEVIL MINE**  
**Red Devil, Alaska**

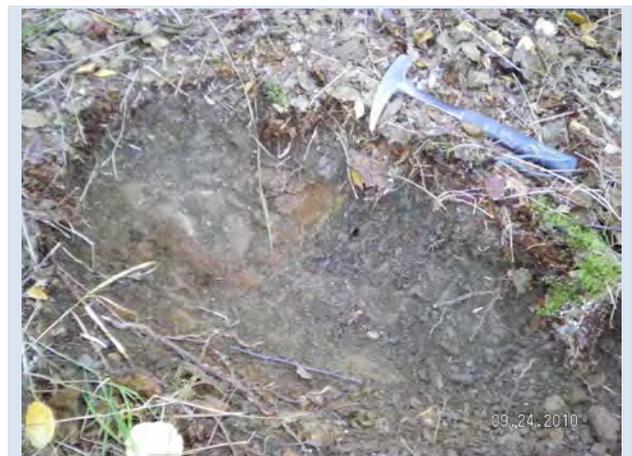
Soils derived from the weathering of Kuskokwim group bedrock contain silt, sand, and gravel derived from the underlying greywacke and argillite bedrock. Soil derived from the Kuskokwim group is found in both disturbed and undisturbed areas of the site. Undisturbed occurrences of Kuskokwim group–derived soils are present throughout much of the upland areas west of the Main Processing Area.

Kuskokwim Group–derived soil.

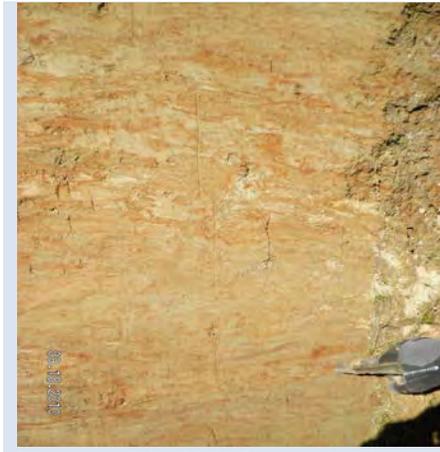
**Loess commonly overlies soil derived from the Kuskokwim group bedrock.** The loess deposits are buff, light brown, or gray colored and friable. Undisturbed de-

posits were reported to range from a few inches to about 30 feet in thickness and commonly lack bedding.

Loess near the Main Processing Area

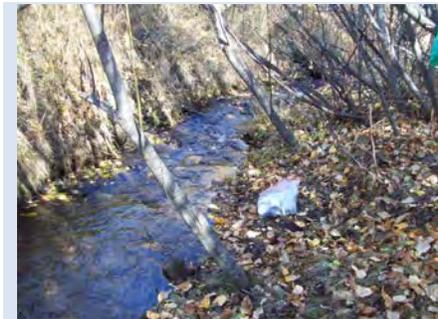
Red Devil Creek at sample station RD06.

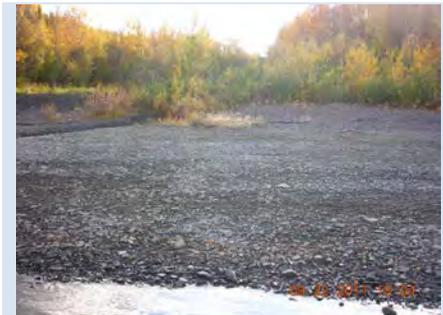
The Red Devil Creek delta on the Kuskokwim River.

The lowermost section of Red Devil Creek at the delta is likely a losing reach under most conditions, particularly at low Kuskokwim River levels. The decrease in discharge between stations RD07SW and RD08SW suggests that that section was losing at the time of the stream gauging event.

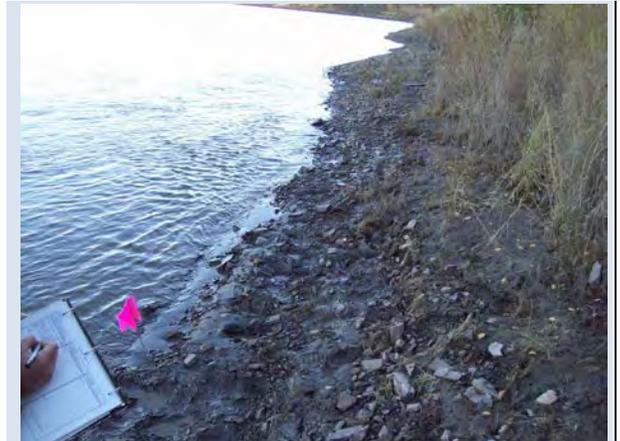
Kuskokwim River shoreline sediment.
