Subject: Reconsideration of the Navigability Report Dated June 29, 1983, Regarding the West Fork of the Dennison Fork and the Dennison Fork of the Fortymile River in the Upper Yukon Region, Alaska

Maps of West Fork Dennison and Dennison Fork of the Fortymile River

Attachment II

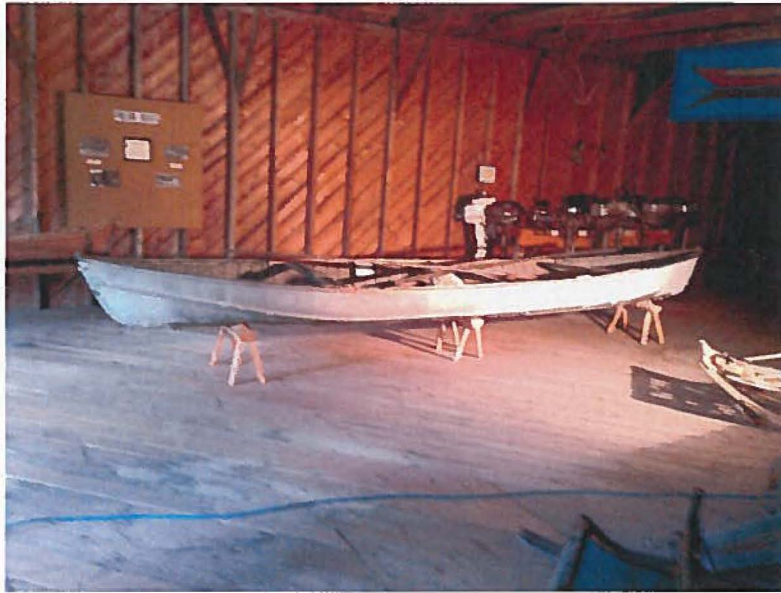
Picture 1- An example of a pole boat (approximately 20' long by 4.5' wide) used in the Fortymile Region located at Fort Egbert, in Eagle, Alaska. Photograph taken by Jack Frost, BLM, July 2018.

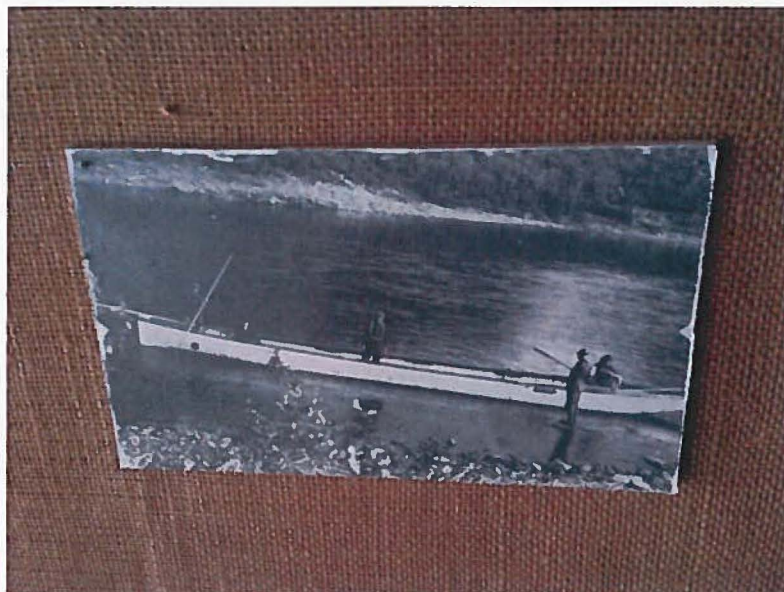
Picture 2- Photograph of a historical picture showing a very large pole boat used in the Fortymile Region to haul freight. Photograph taken at Fort Egbert, by Jack Frost, BLM, July 2018.

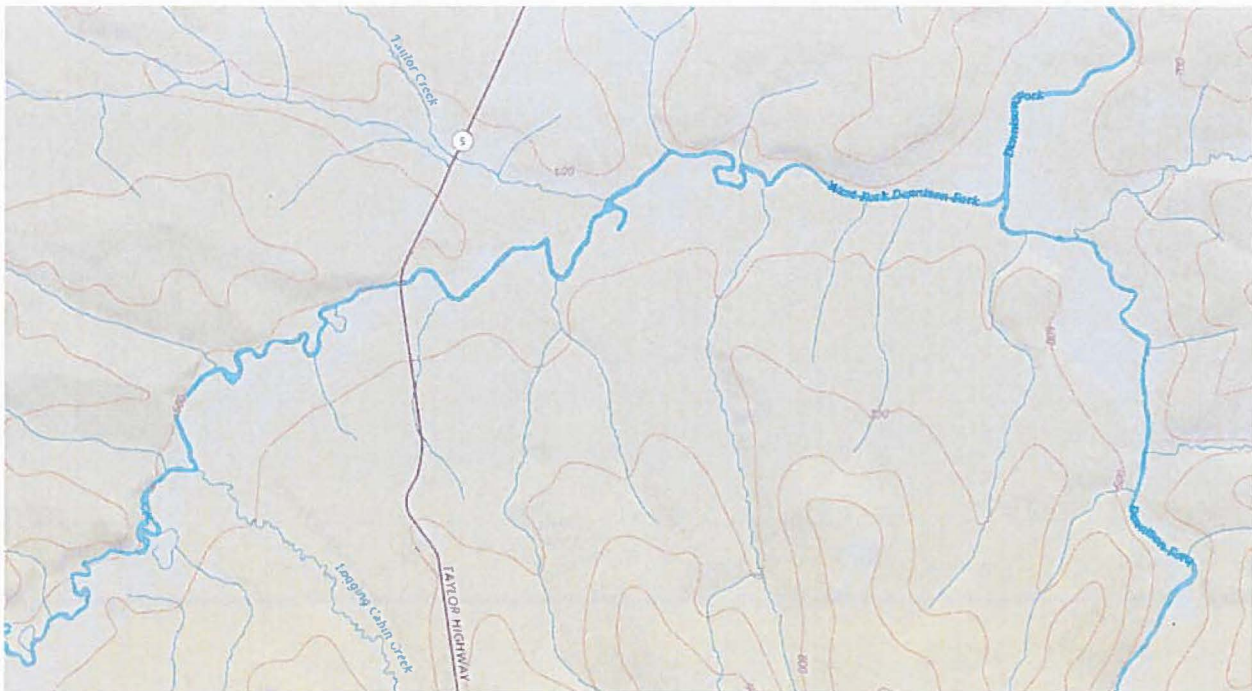
Figure 1b. USGS National Map and Elevation Data available at <https://viewer.nationalmap.gov/> (Last Modified: 26-Jun-18) showing West Fork of the Dennison Fork of the Fortymile River.

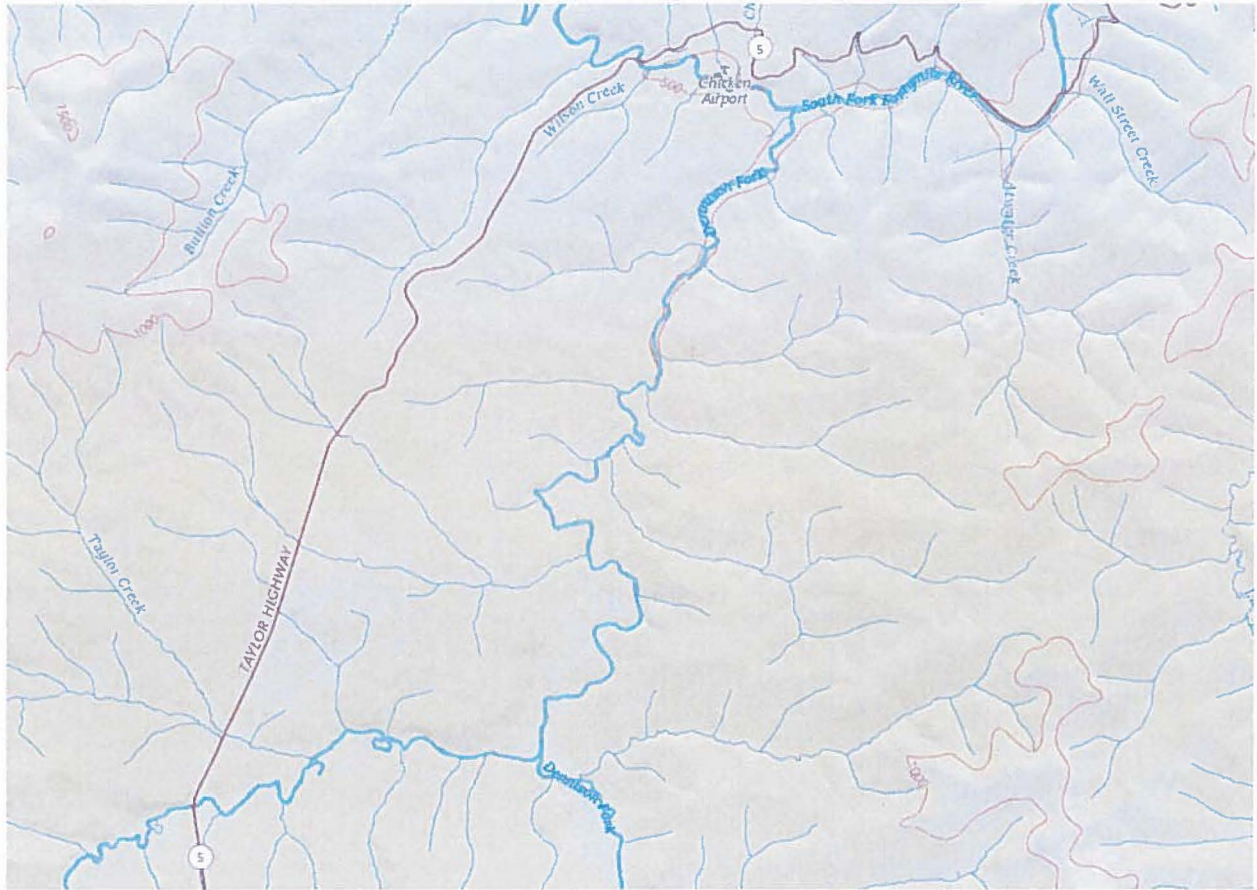
Figure 2b. USGS National Map and Elevation Data available at <https://viewer.nationalmap.gov/> (Last Modified: 26-Jun-18) showing Dennison Fork of the Fortymile River.

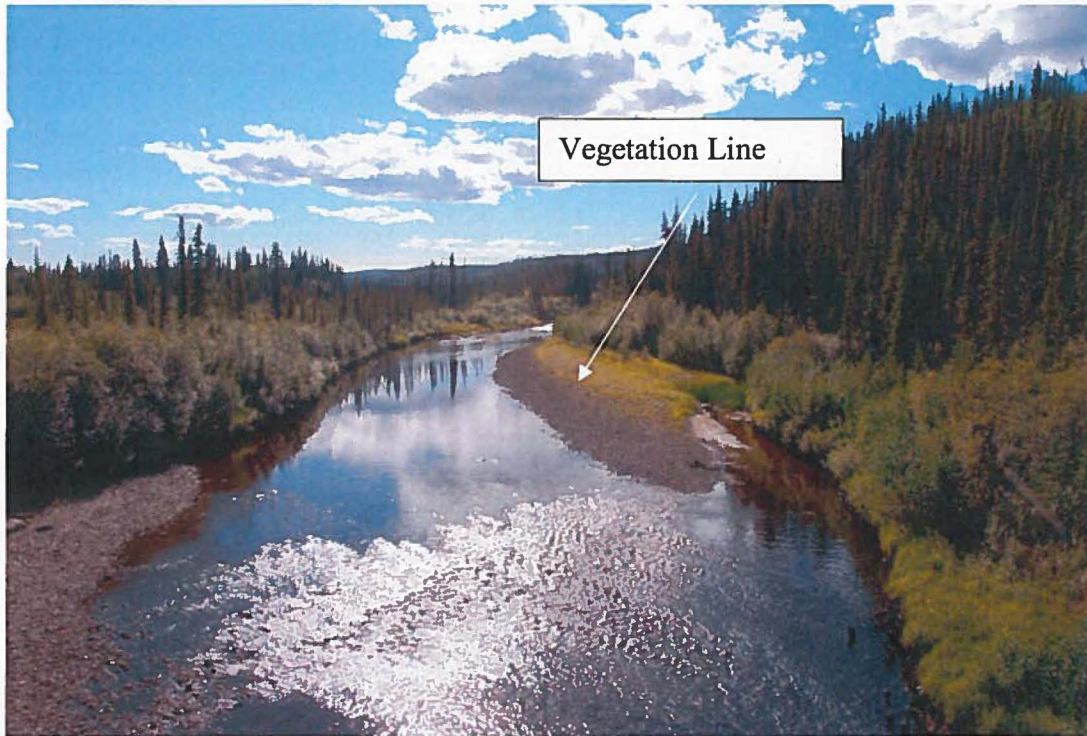
Figure 1a. Upstream view of West Fork Dennison channel at low flow, stream gage water level = 4.6 feet. Taylor Highway Bridge MP49, 1715 hours, July 29, 2018.

Figure	Date	Flow Condition	Water Surface Elevation (feet)	Discharge (cfs)	River Travel Rating
Figure 1	July 29, 2018	Low	4.6 feet	26	Very Difficult
Figure 2*	July 14, 2018	Moderate	5.7 feet	265	Fair
Figure 3	August 22, 2018	High	7.7 feet	1750	Good
		Flood	Overbank		Very Difficult

Vegetation features on gravel bars upstream and downstream of the bridge are annotated in Figures 1-3 to provide additional visual reference for changes in water surface elevation.

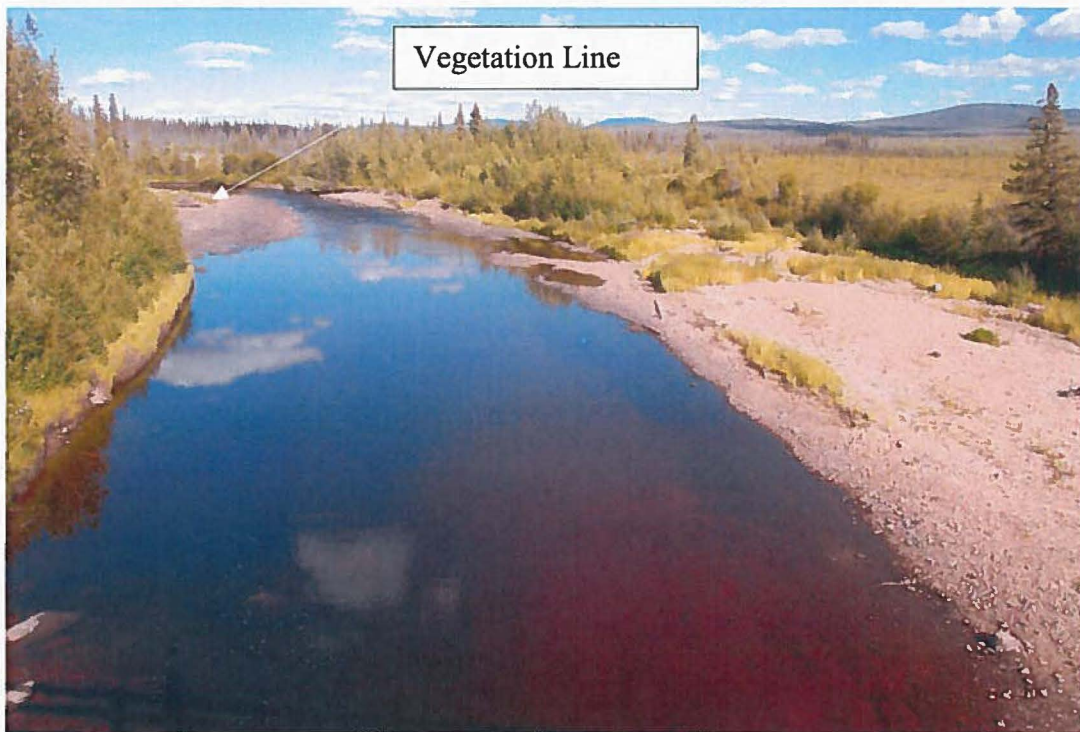
Figure 1b. Downstream view of West Fork Dennison channel at low flow, stream gage water level = 4.6 feet. Taylor Highway Bridge MP49, 1715 hours, July 29, 2018.

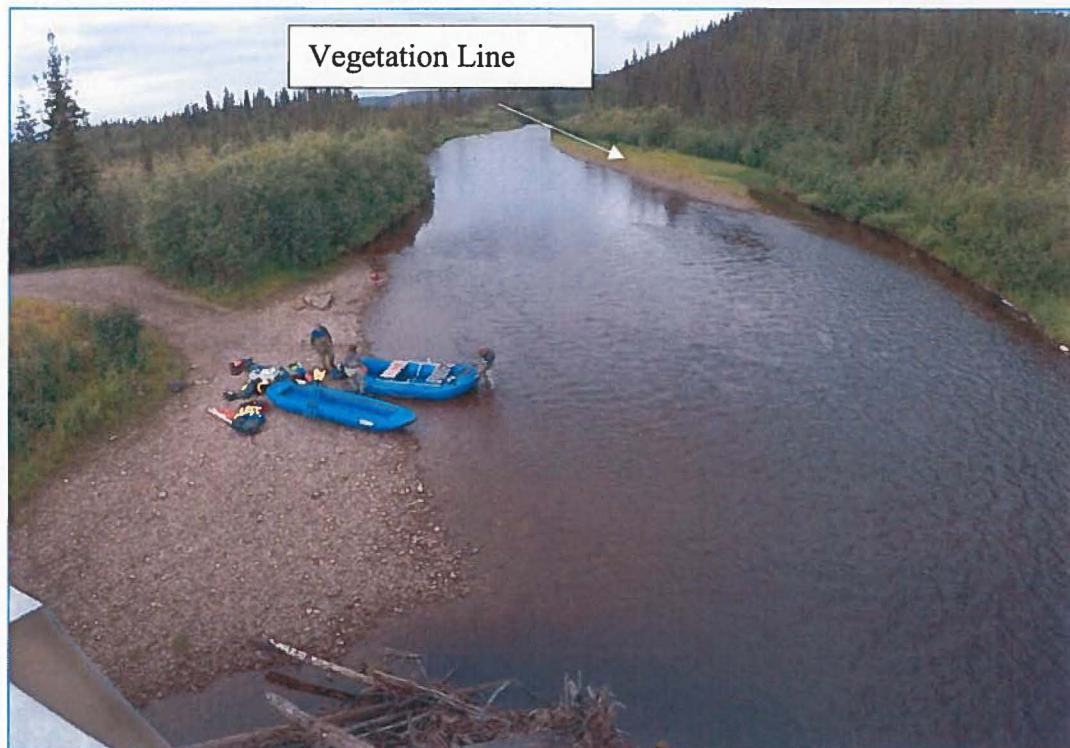
Figure 2a. Upstream view of West Fork Dennison channel at moderate flow, stream gage water level = 5.7 feet. BLM navigability float trip, Taylor Highway MP49, 1000 hours, July 14, 2018.

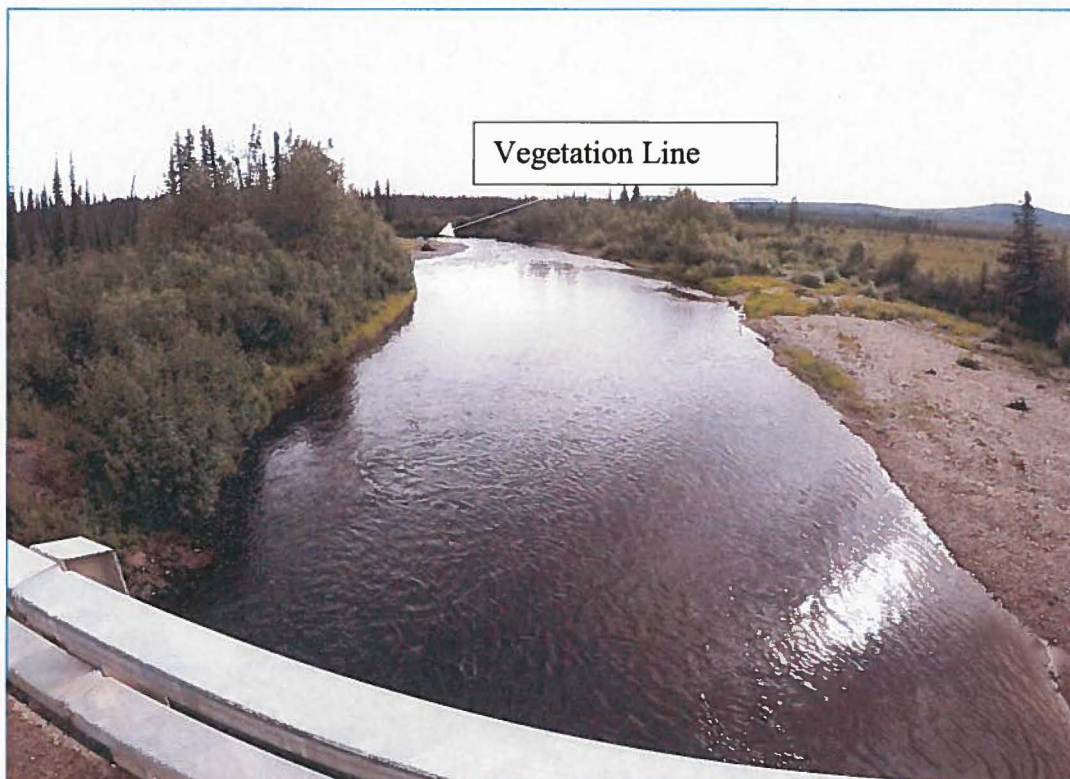
Figure 2b. Downstream view of West Fork Dennison channel at moderate flow, stream gage water level = 5.7 feet. BLM navigability float trip, Taylor Highway MP49, July 14, 2018.

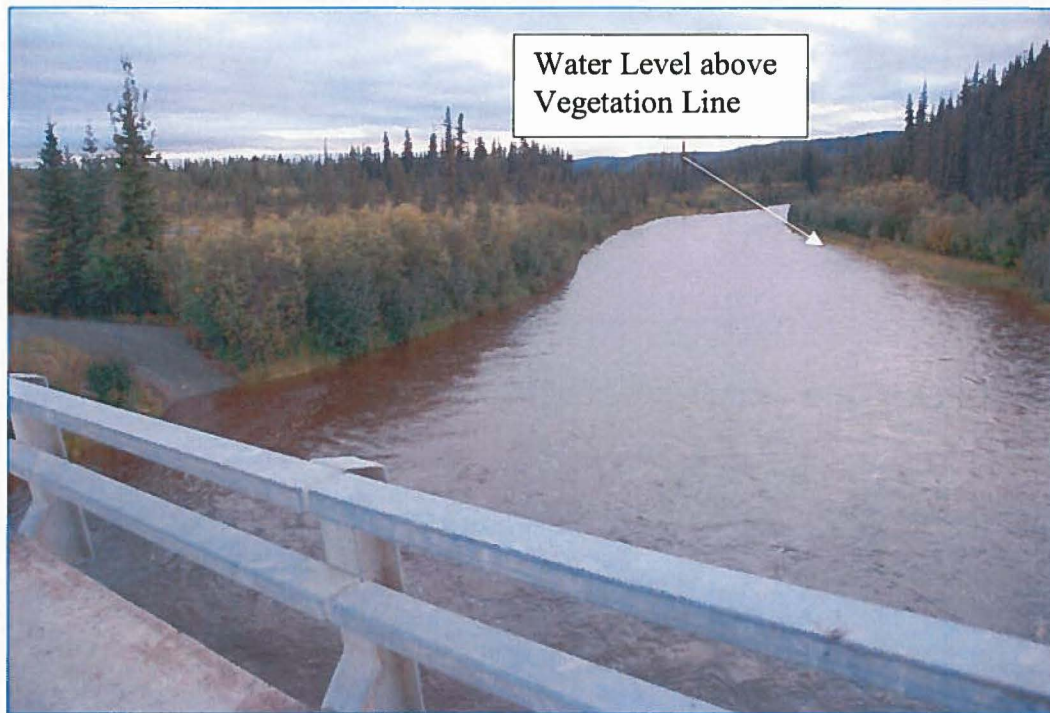
Figure 3a. Upstream view of West Fork Dennison channel at high flow, stream gage water level = 7.7 feet. Taylor Highway Bridge MP49, 2015 hours, August 22, 2018.

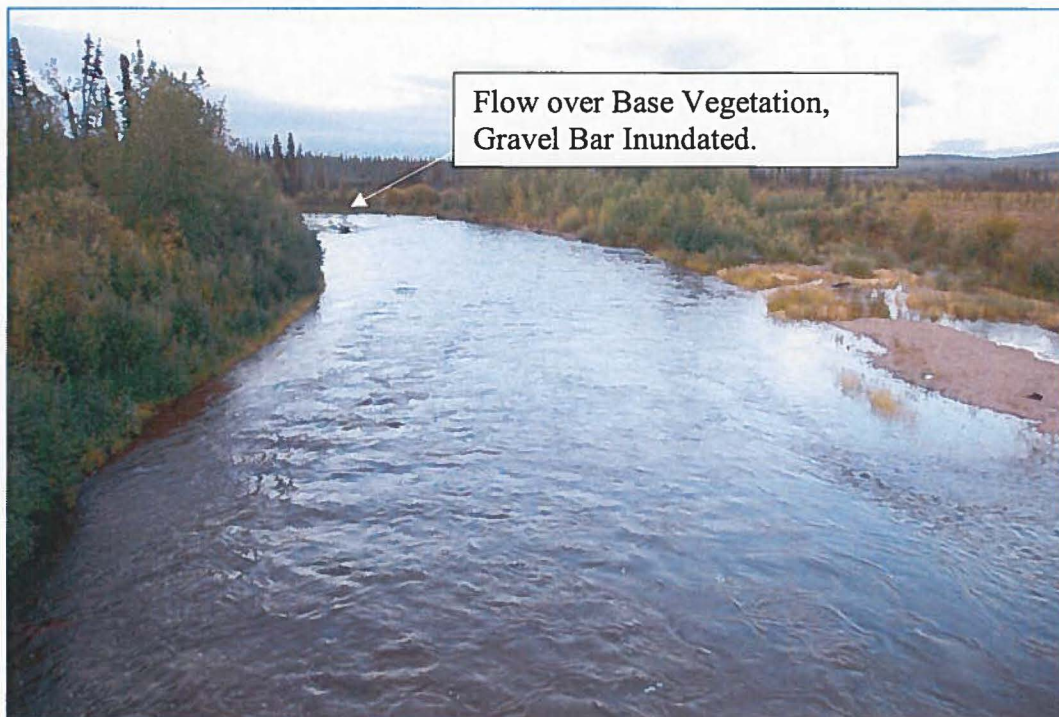
Figure 3b. Downstream view of West Fork Dennison channel at high flow, stream gage water level = 7.7 feet. Taylor Highway Bridge MP49, 2015 hours, August 22, 2018.

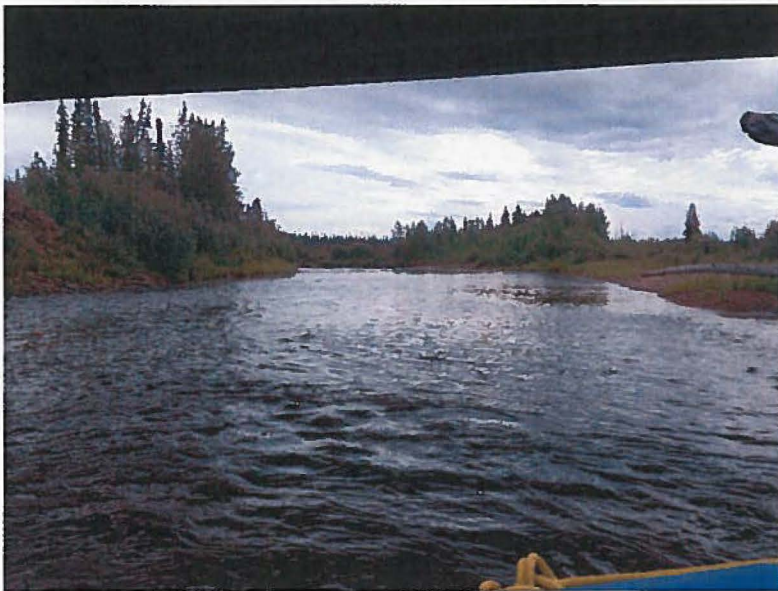
Picture 3- Approximate location of first depth reading on the West Fork.

We launched our rafts and started downstream at about 10:30 a.m. Our float on the West Fork would be short, only about seven miles in length until we encountered the Dennison Fork. My first depth reading at the bridge was noted as 2.6' and no obstructions noted there (see Picture 3). As we proceeded downstream, I took many measurements but most of the depth measurements that I took on the entire length of the West Fork averaged about two feet deep and about 100 feet wide. At first, we encountered a few minor riffles that we skirted around easily but then we encountered more riffles that we had to either maneuver our way around or drag our raft for short

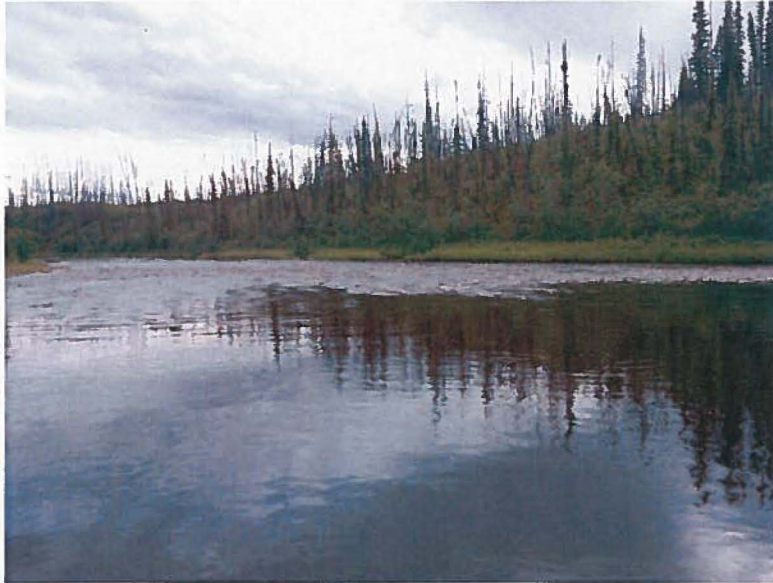
Picture 4- The first minor riffle we encountered on the West Fork about one mile downstream from the Taylor Highway Bridge.

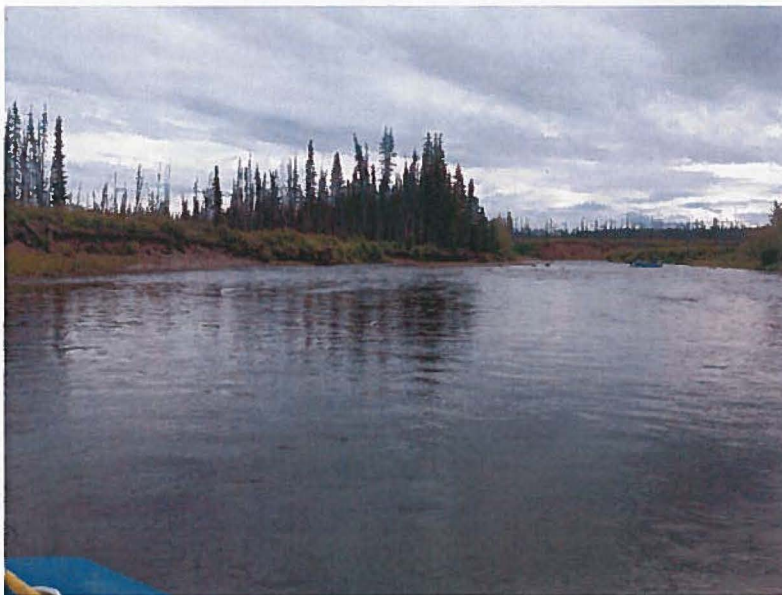
Picture 5- A riffle that required dragging through. See boat in upper right.

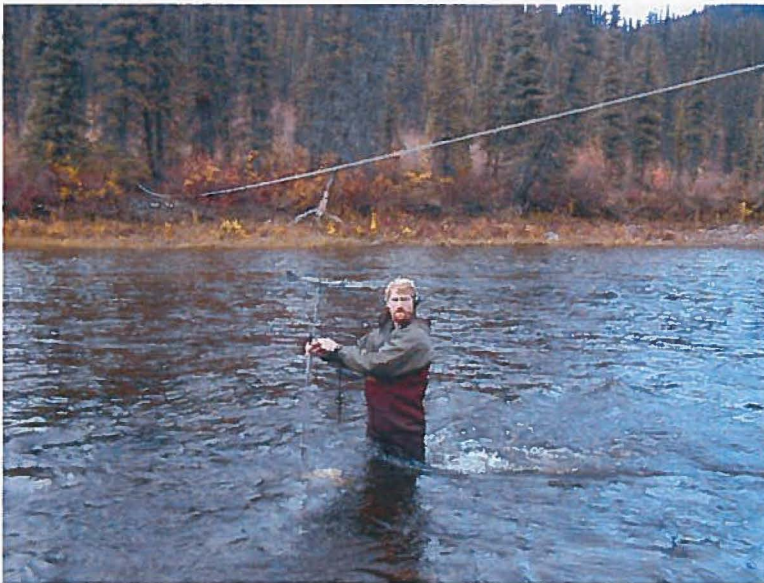
Fig. 1. A BLM field technician surveys the streamflow on the North Fork of the Fortymile River. Most rivers were surveyed by wading the cross section.

The methodology used to monitor streamflow at the selected sites (stream gages), by recording the water level (stage) and periodically measuring streamflow (discharge), are noted in Rantz and others (1982). Cross-sectional geometry surveys and analysis followed procedures in Parsons and Hudson (1983), Benson, and Dalrymple (1967). Six of the forks and main stem had long-term stream gages installed, while additional sites in the headwaters were surveyed intermittently for cross-sectional geometry and streamflow.

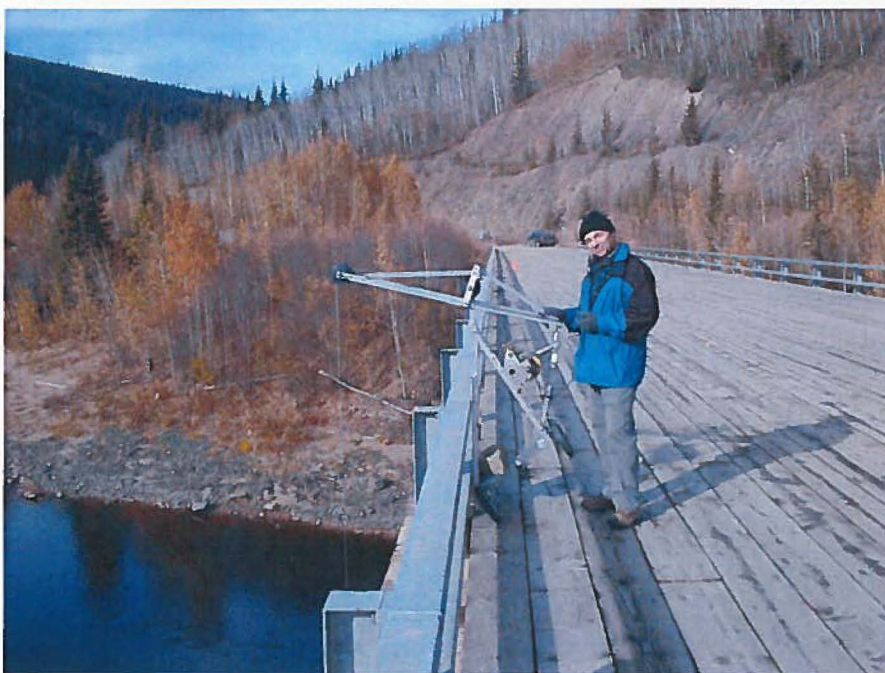
Fig. 2. Where the river was too deep to wade, such as the Fortymile River at the Taylor Highway Bridge, a flow meter and sounding weight were suspended by a cable and reel system to survey the river.

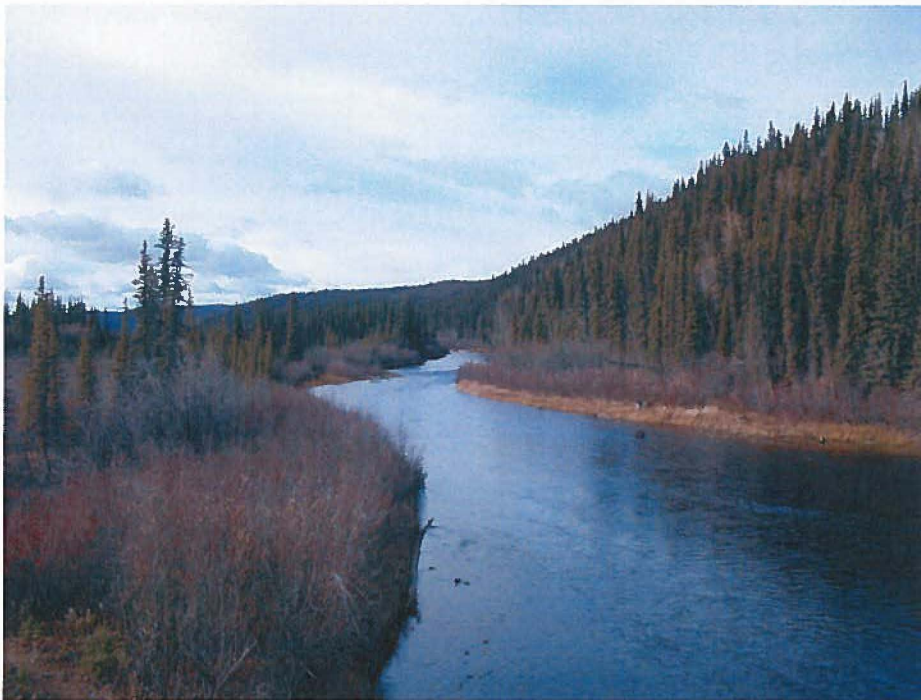
Fig. 3. The channel is relatively straight upstream of the bridge with few riffles or obstructions. The stream is confined by a low ridge to the north with a lower bank and wide floodplain to the south

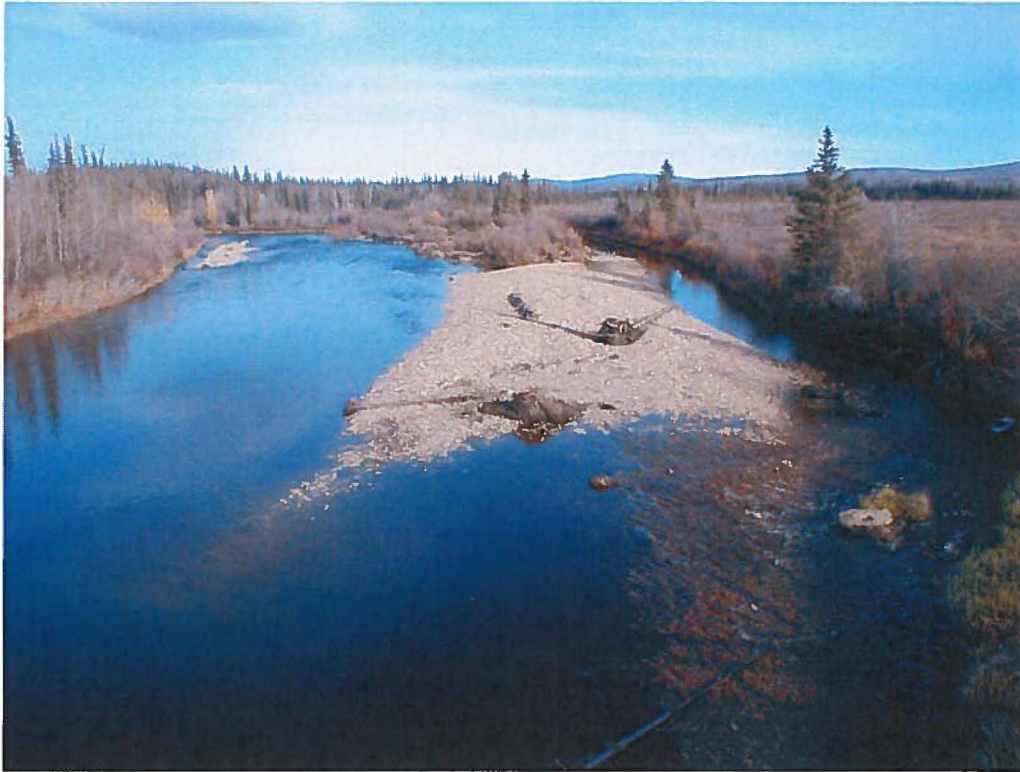
Fig. 4. Downstream of the bridge, the channel is wider, shallower, and has more obstructions from islands and boulders (rock gardens), than upstream of the bridge

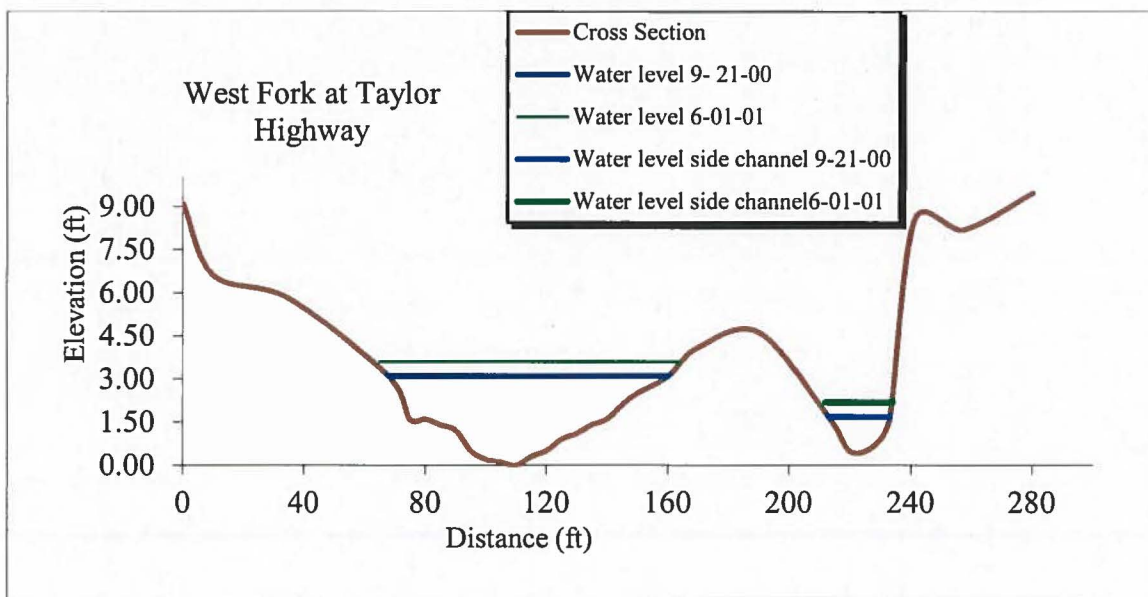
Fig.5 Channel cross section of the West Fork Fortymile River downstream of the bridge

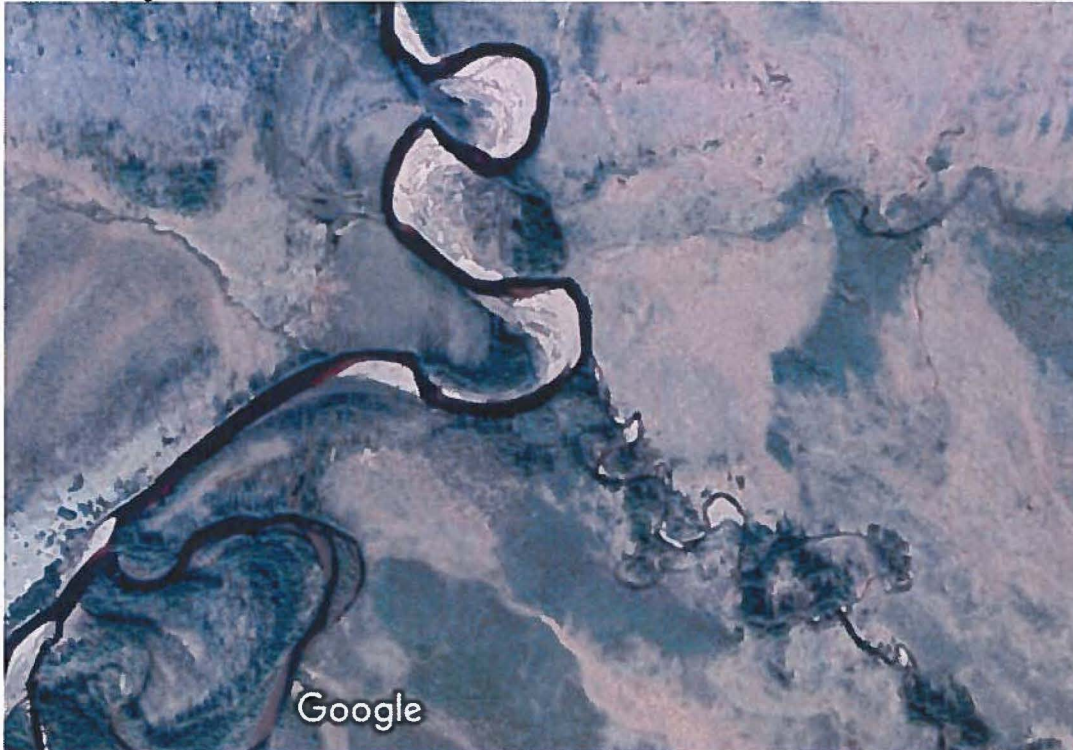
Fig.6 The channel meanders extensively near Logging Cabin Creek, but has a few straight reaches upstream. A large boulder was noted in the channel during the August survey (Photo courtesy of Google Maps)

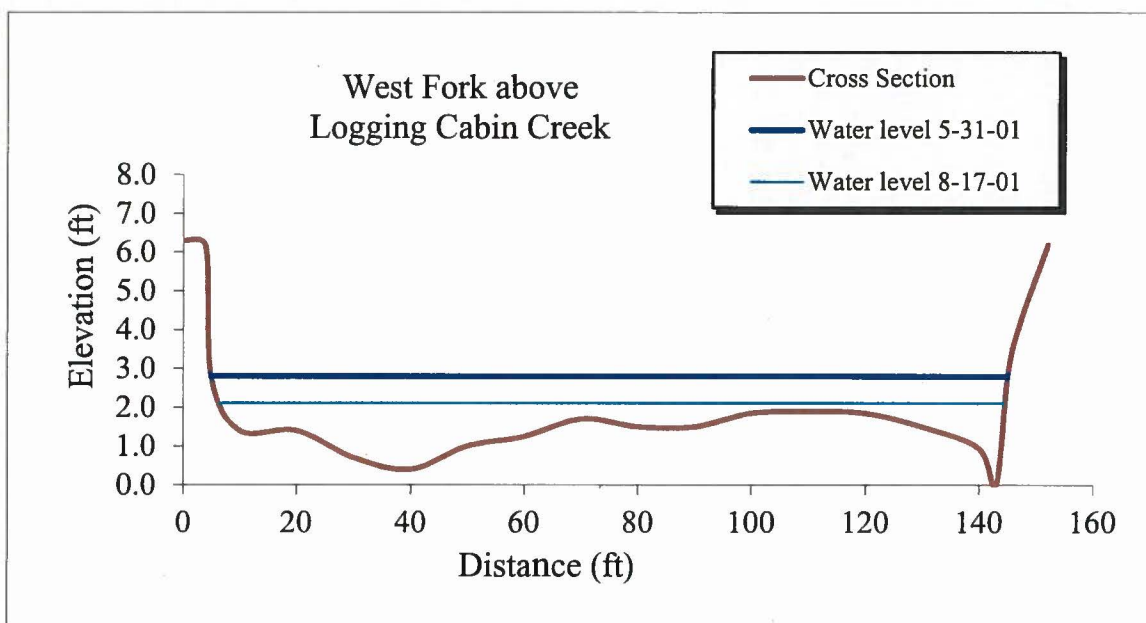
Fig. 7 Cross Section of West Fork Fortymile River above Logging Cabin Creek

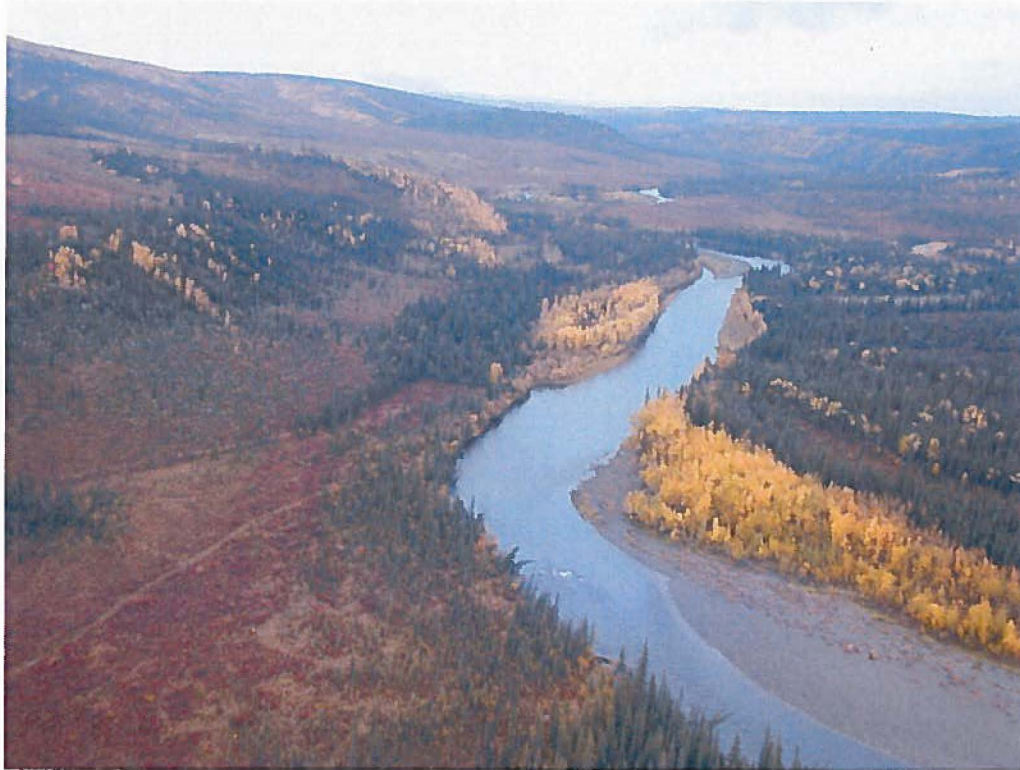
Fig. 8 Dennison Fork of the Fortymile River looking upstream of the mouth. The channel is relatively wide and braids out into two channels at low water. The 1991 cross section is the straight reach near the center of the center photo

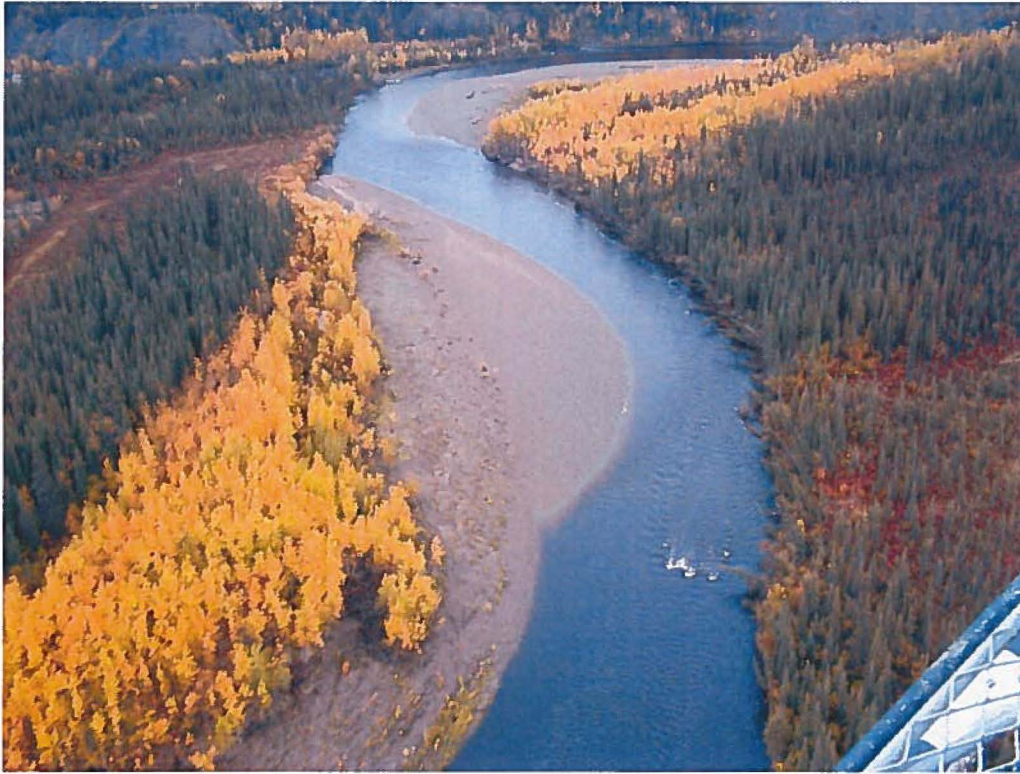
Fig. 9 Dennison Fork looking downstream to the mouth. Most streamflow measurements were near the center of the photo, where there was a single low water channel

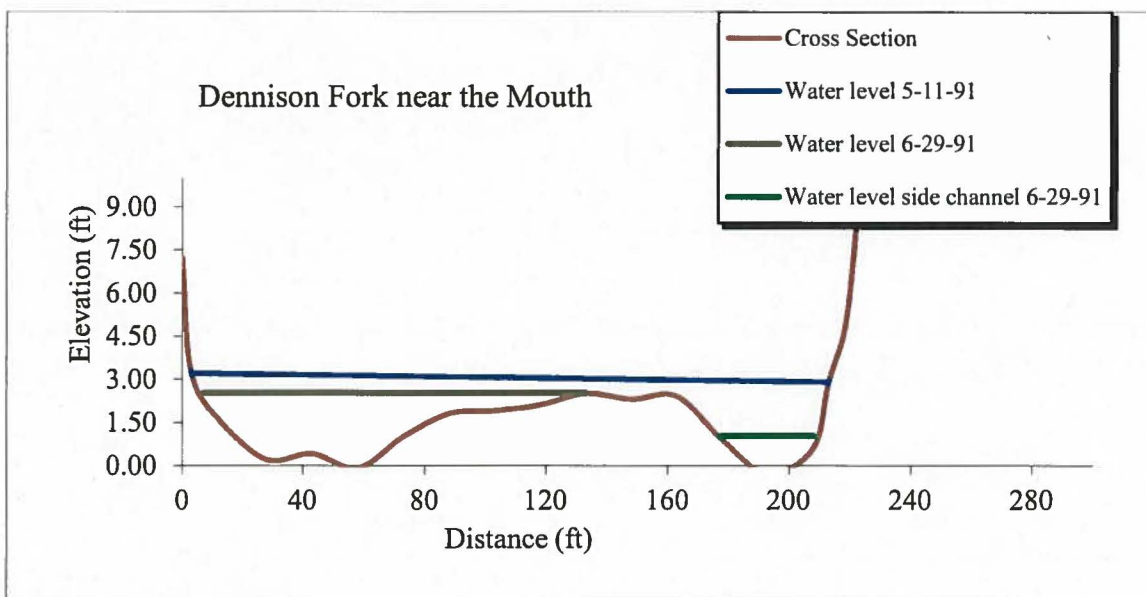
Fig. 10 Channel cross section for Dennison Fork near the mouth

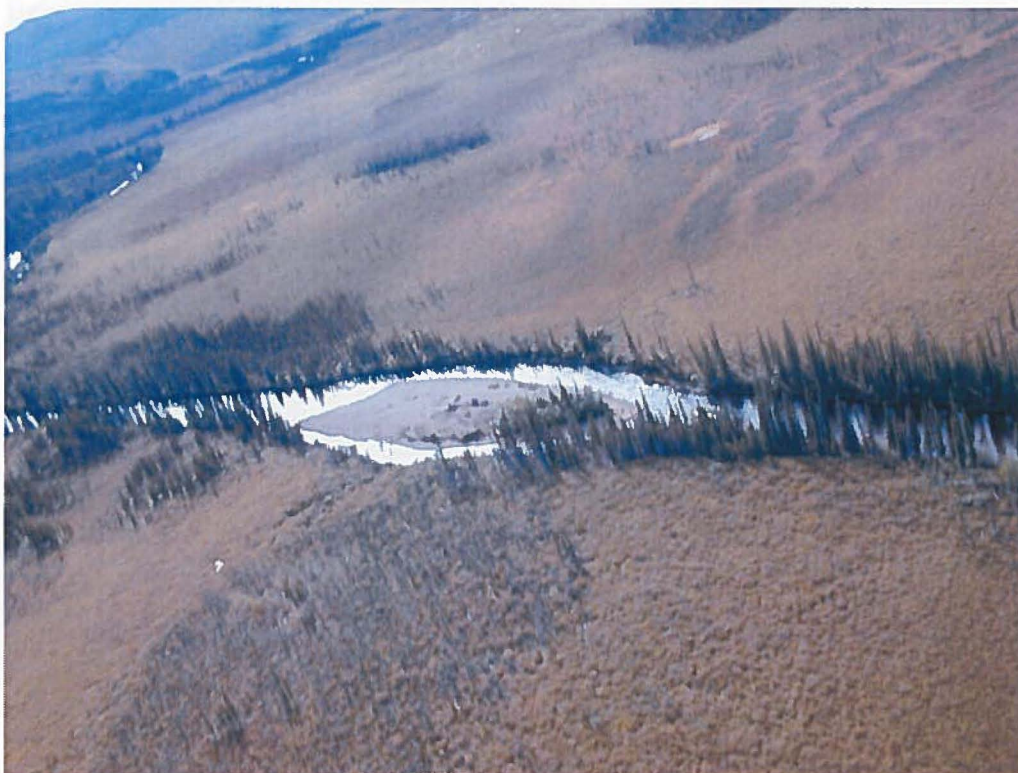
Fig. 11 Dennison Fork above West Fork, streamflow is from left to right. The surveyed cross section is to the left (upstream) of the island

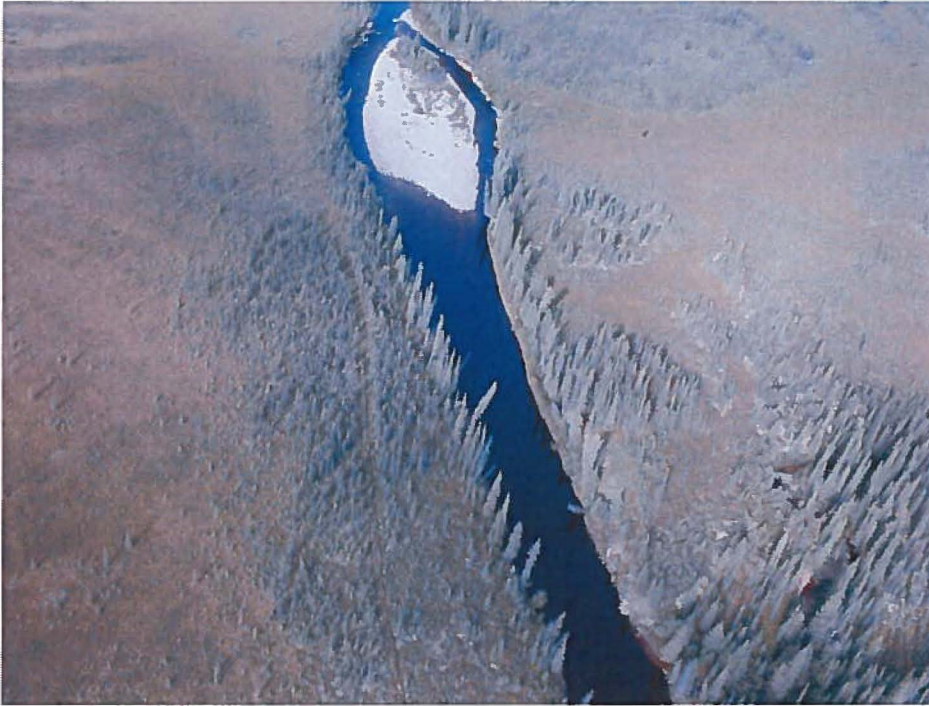
Fig. 12 Dennison Fork above West Fork looking downstream. The surveyed cross section is upstream of the island. The channel is fairly uniform, deep and slow in this reach.

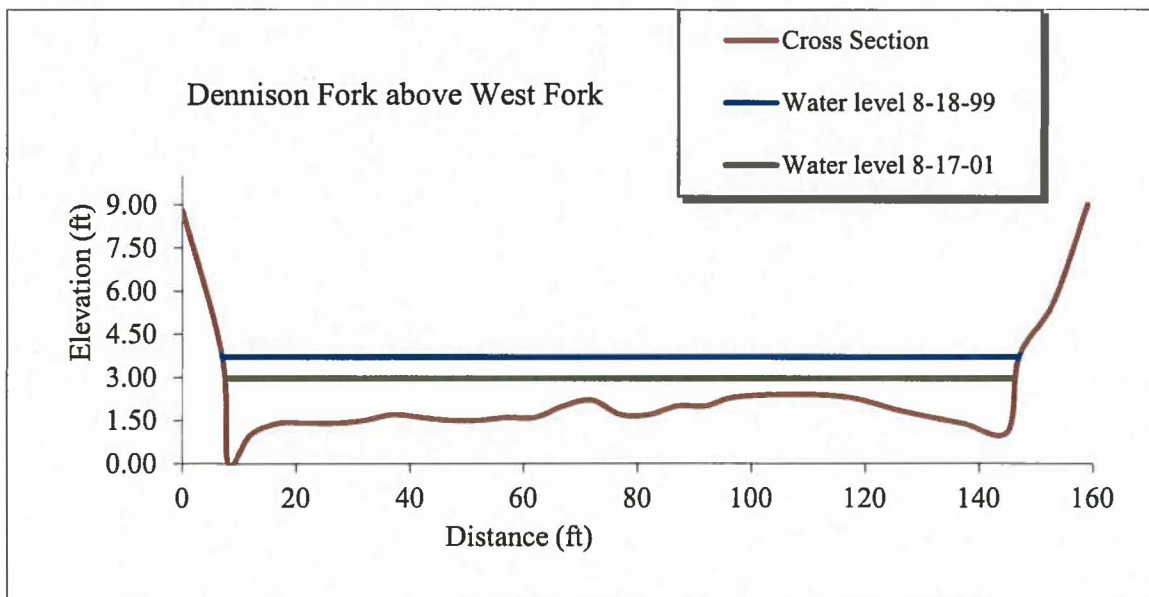
Fig. 13 Channel cross section at Dennison Fork above West Fork

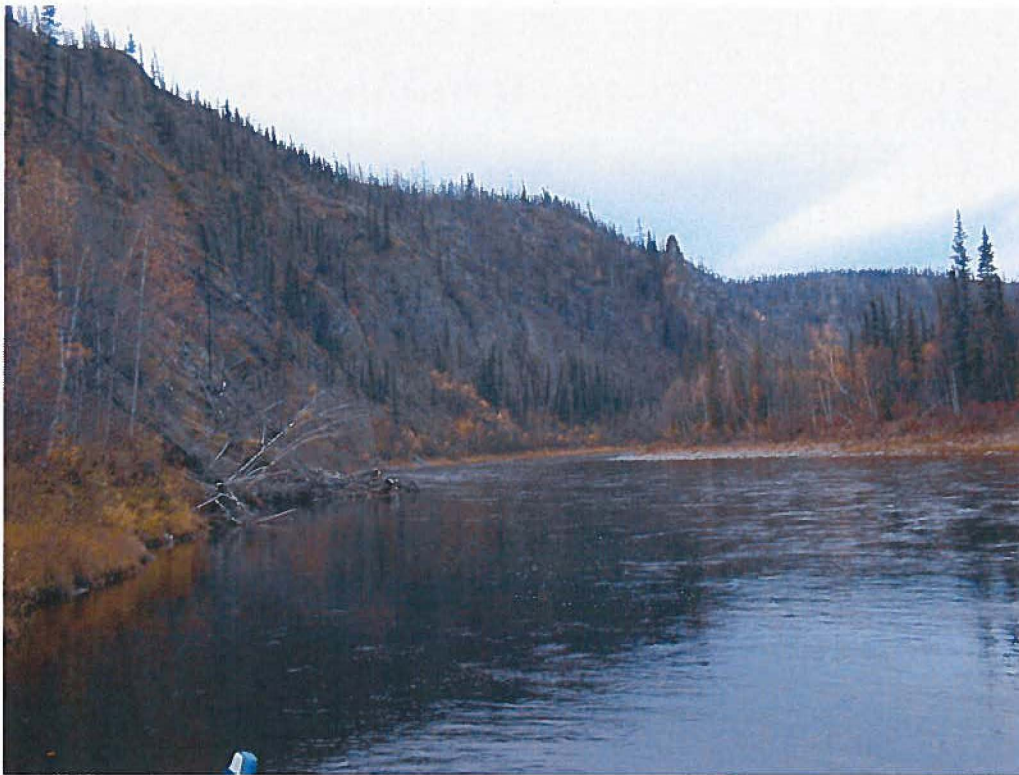
Fig. 14 North Fork at South Fork looking upstream. The surveyed cross section is just downstream. The channel is very uniform, deep and moderately fast in this reach

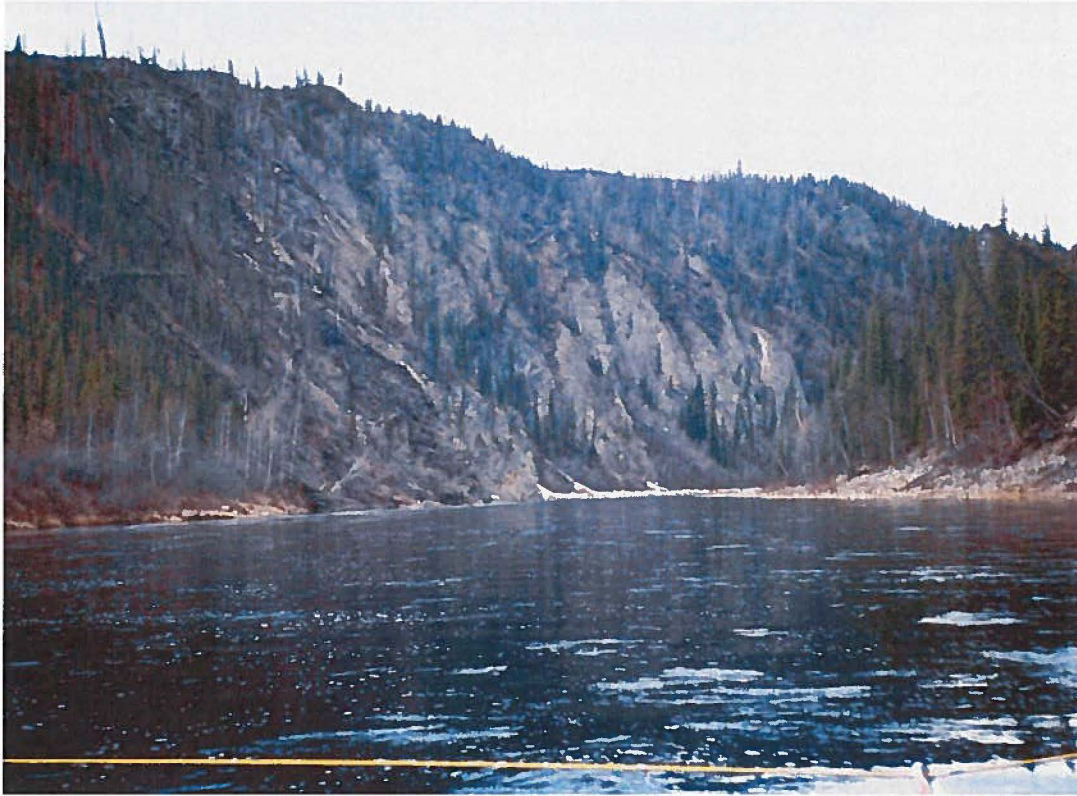
Fig. 15 North Fork at South Fork looking upstream at the cross section. The channel steepens, shallows, and becomes quite fast as the river approaches the confluence with the South Fork

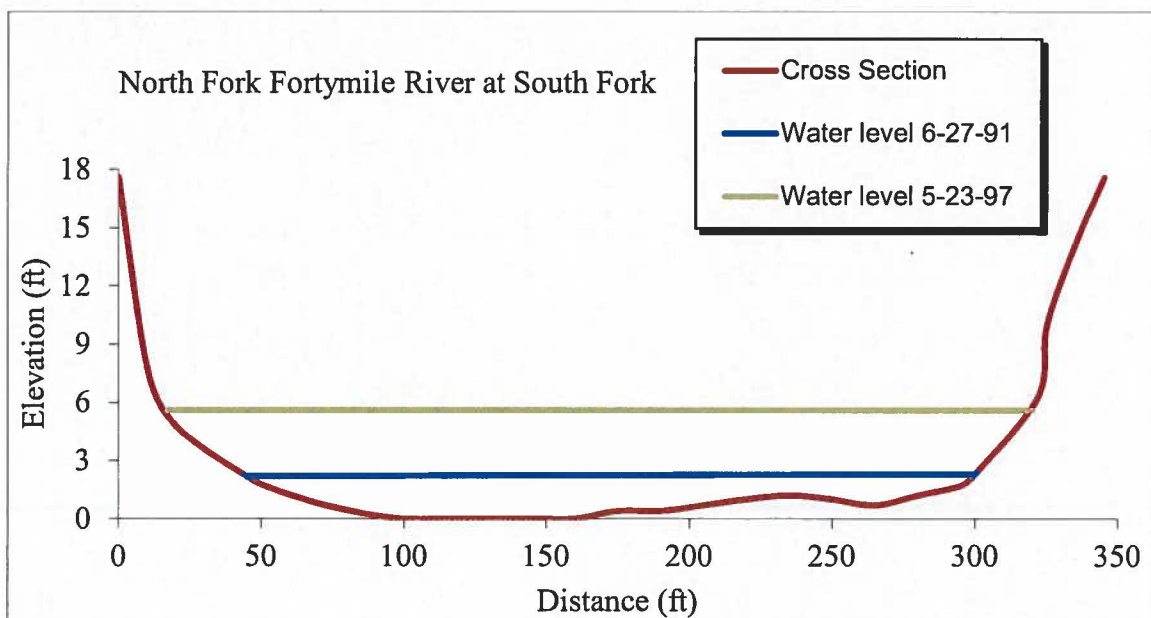
Fig. 16 Channel cross section at North Fork Fortymile River at South Fork
