Subject: Reconsideration of the Navigability Report Dated June 29, 1983, Regarding the West Fork of the Dennison Fork and the Dennison Fork of the Fortymile River in the Upper Yukon Region, Alaska

Maps of West Fork Dennison and Dennison Fork of the Fortymile River

Attachment II

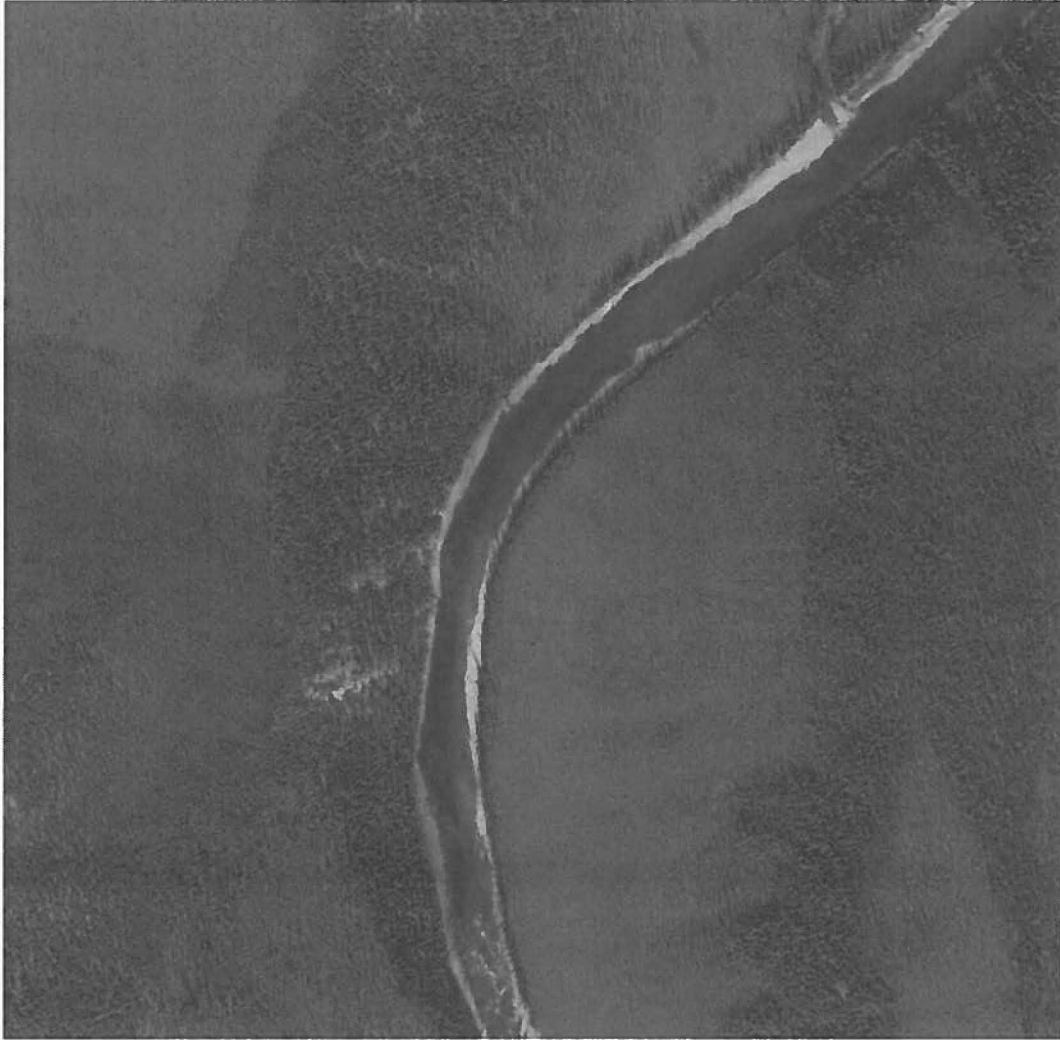
Fig. 19 The North Fork Fortymile River at Hutchinson Creek is a fairly straight, uniform reach with no obstructions or constrictions. The class V rapids at the Kink begin at the bottom of the photo (Photo courtesy of Apple Maps)

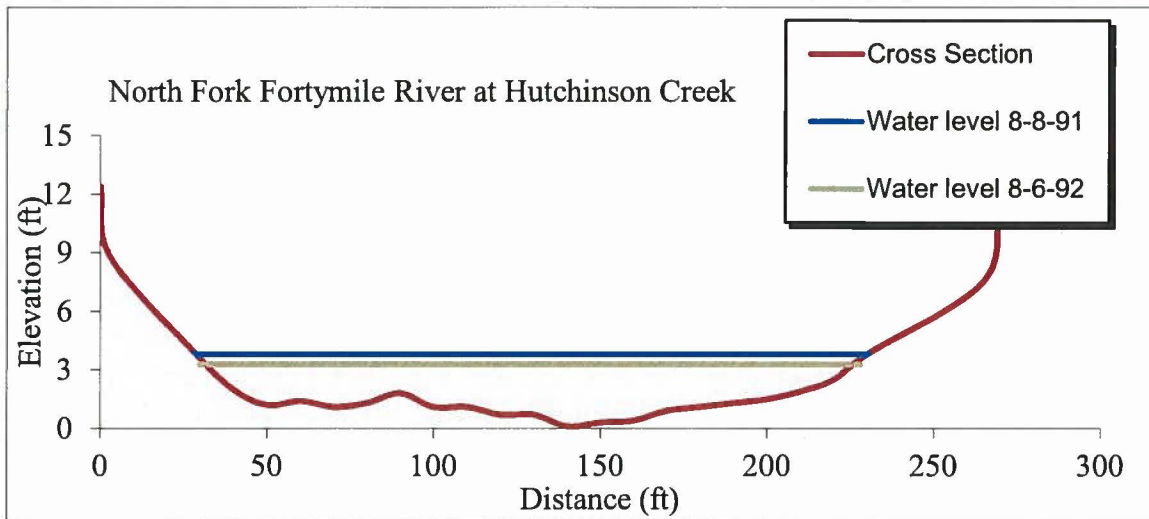
Fig. 20 The surveyed cross section on North Fork Fortymile River at Hutchinson Creek.

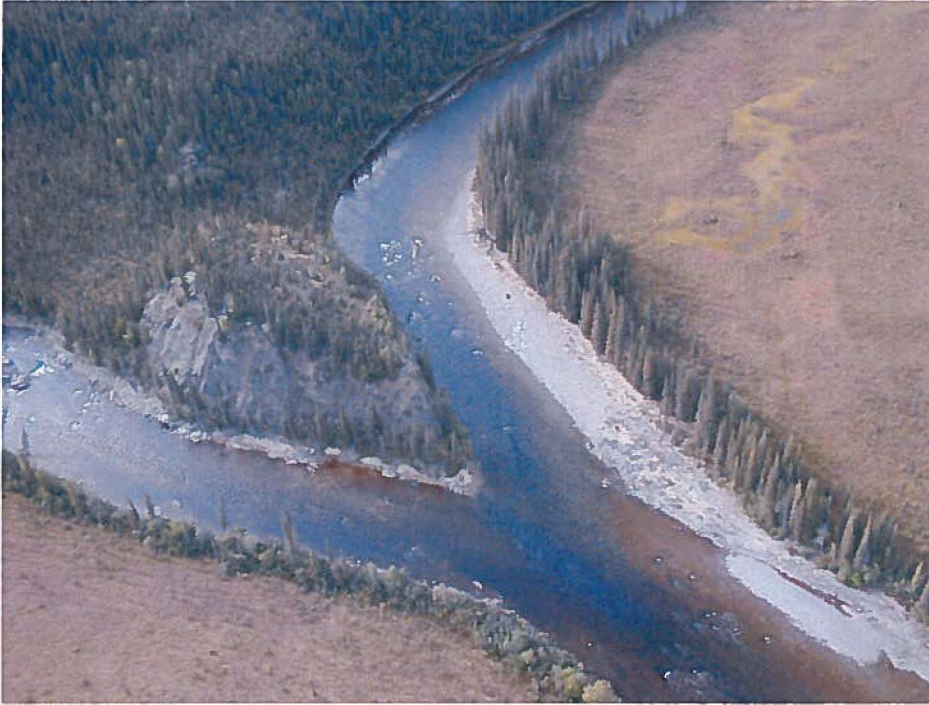
Fig. 21 The North Fork Fortymile River at Middle Fork looking upstream, with the Middle Fork on the left and North Fork on the right. There is a series of boulder bed rapids (rock gardens) just upstream and class III rapids downstream of the confluence

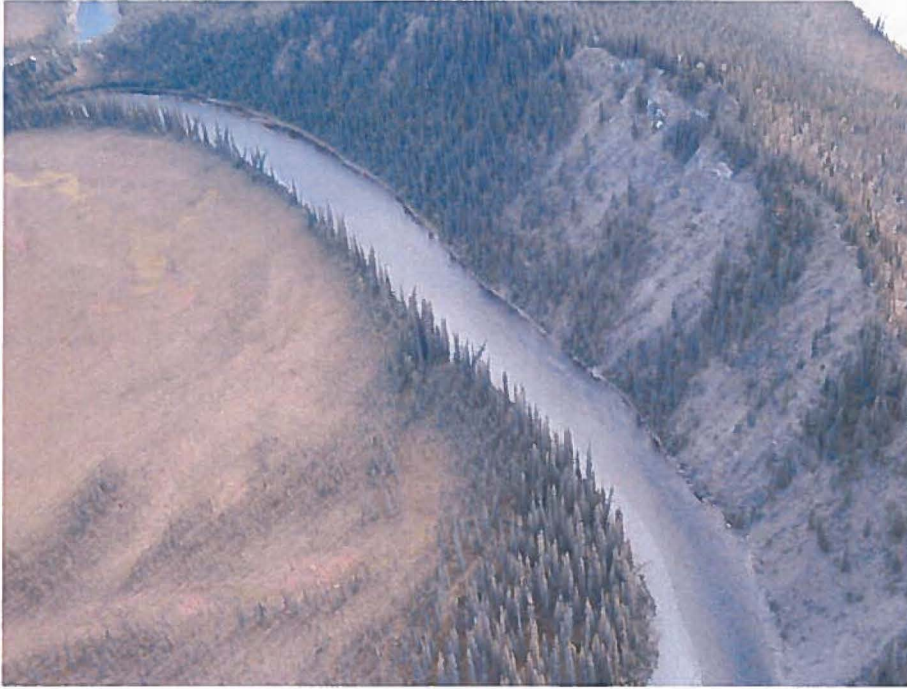
Fig. 22 The North Fork Fortymile River at Middle Fork looking downstream is a fairly straight, uniform reach with no obstructions or constricted areas

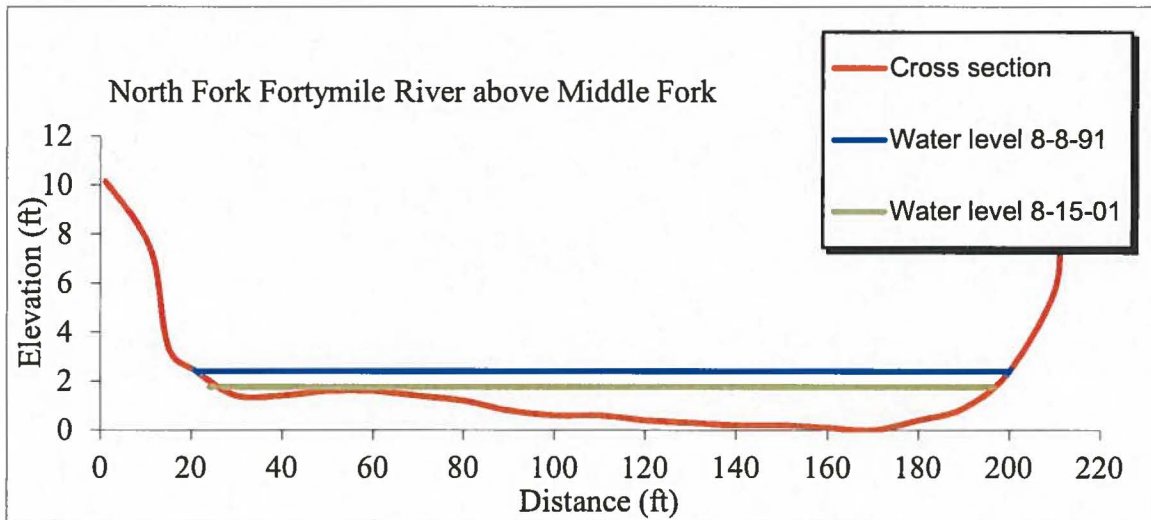
Fig. 23 The surveyed cross section on North Fork Fortymile River at Middle Fork

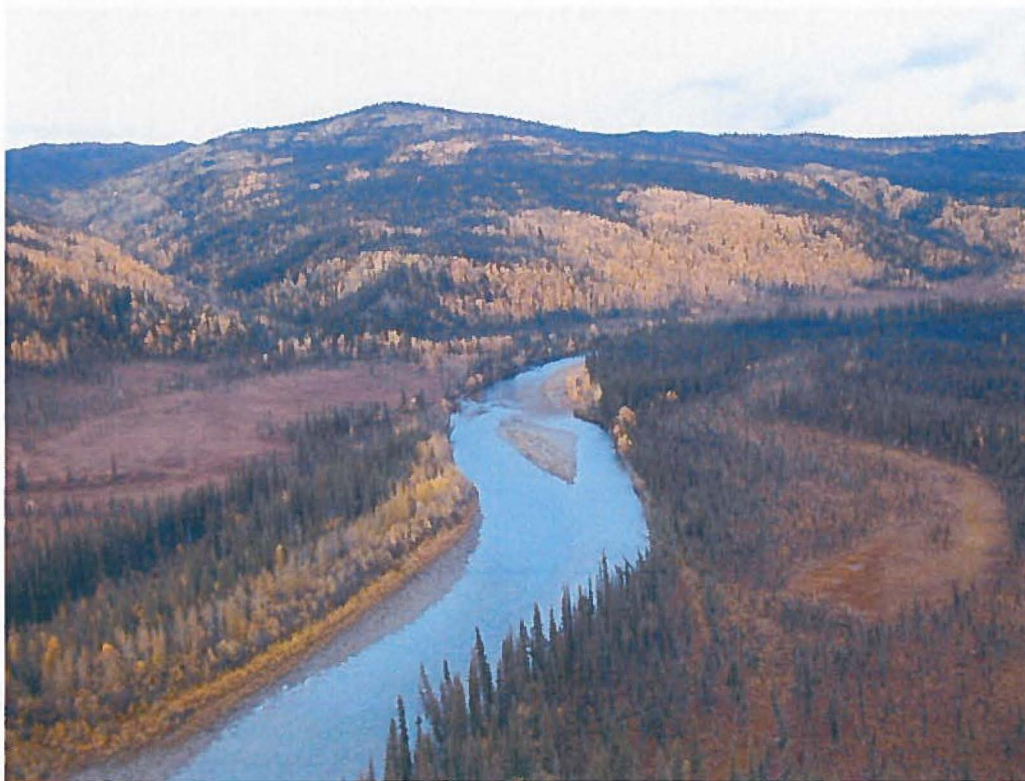
Fig. 24 North Fork Fortymile River above Champion Creek cross section is the relatively straight reach near the bottom of the photo

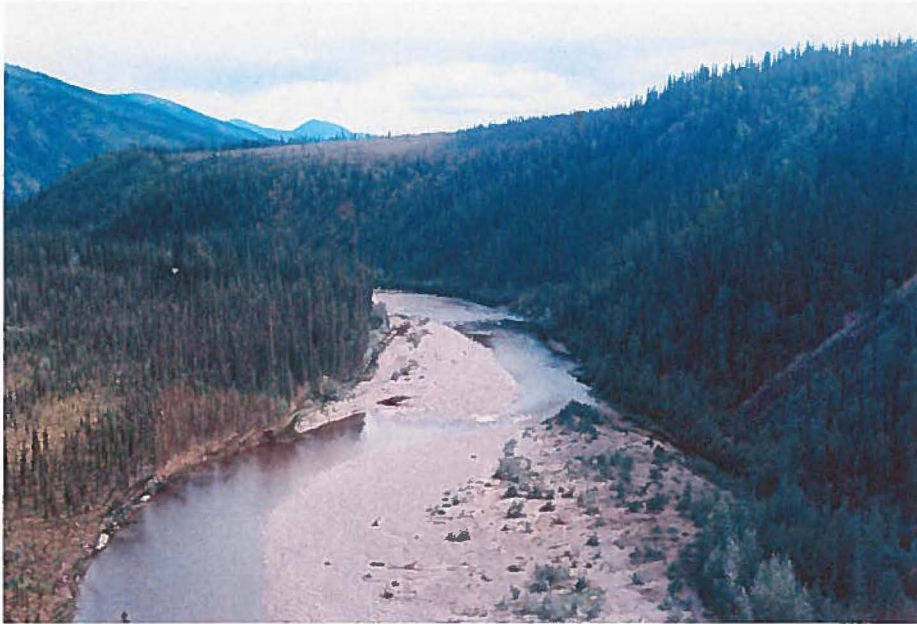
Fig. 25 North Fork Fortymile River above Champion Creek is a meandering stream with wide gravel bars and occasional islands

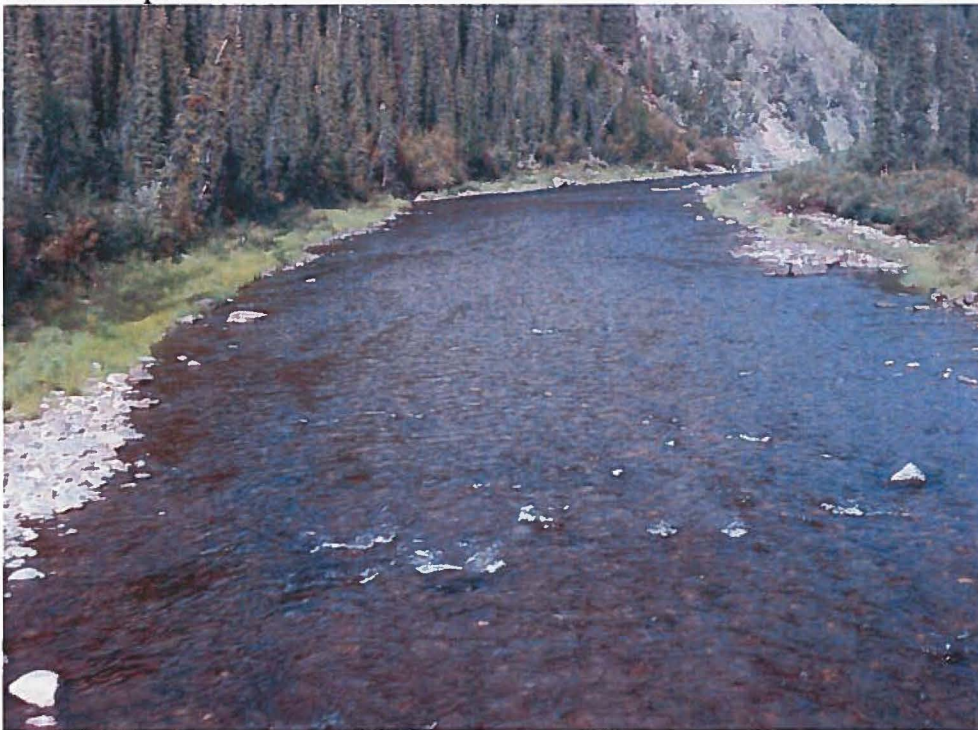
Fig. 27 North Fork Fortymile River above Little Bonanza Creek cross section #1 surveyed in 1992 is a shallow, uniform reach with a bed of cobbles and small boulders

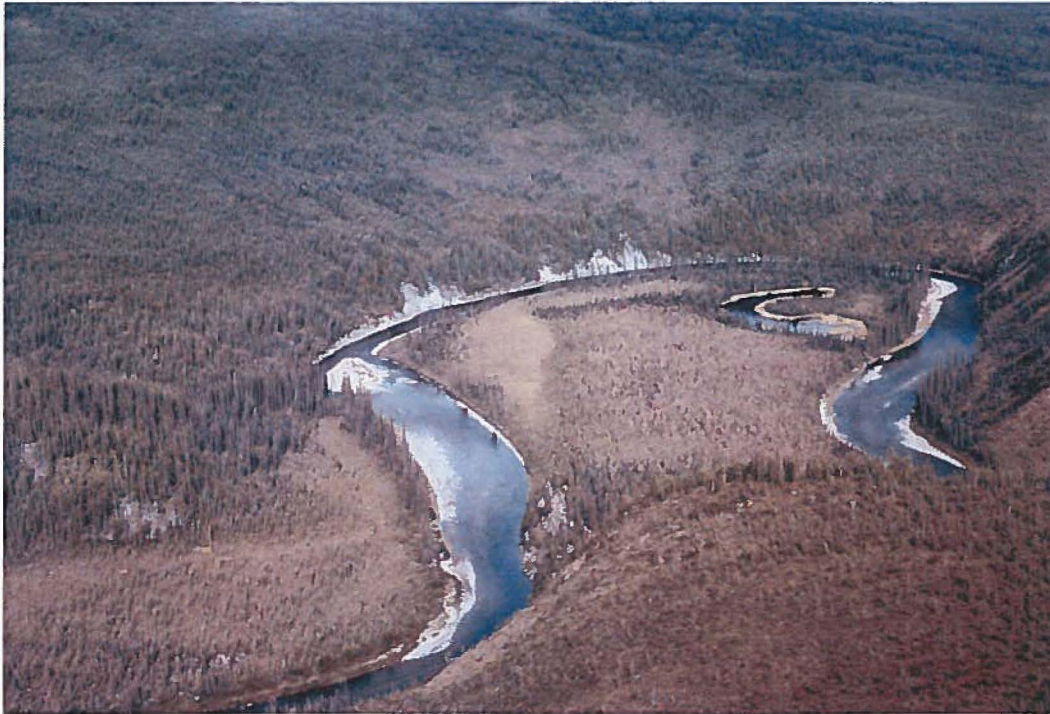
Fig. 28 North Fork Fortymile River above Little Bonanza Creek is a shallow stream with gravel bars and occasional constrictions at bends

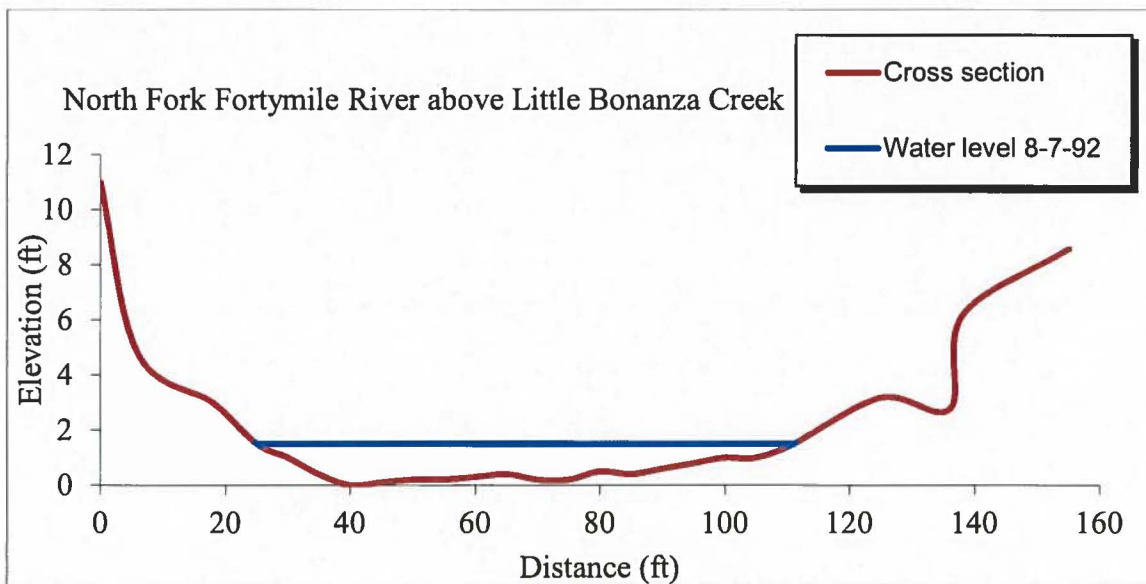
Fig. 29 The surveyed cross section on North Fork Fortymile River above Little Bonanza Creek

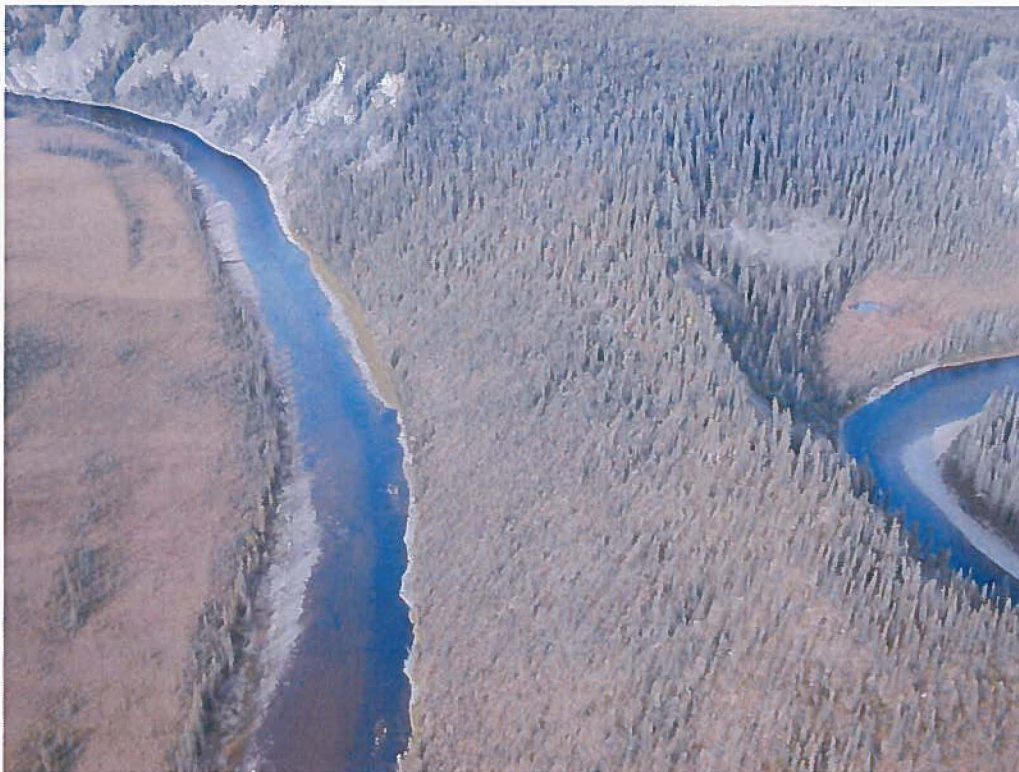
Fig. 30 Middle Fork Fortymile River (left) at North Fork (right) is a uniform, moderately deep channel with narrow gravel bars. Just downstream are the class II/III Eagle Rapids

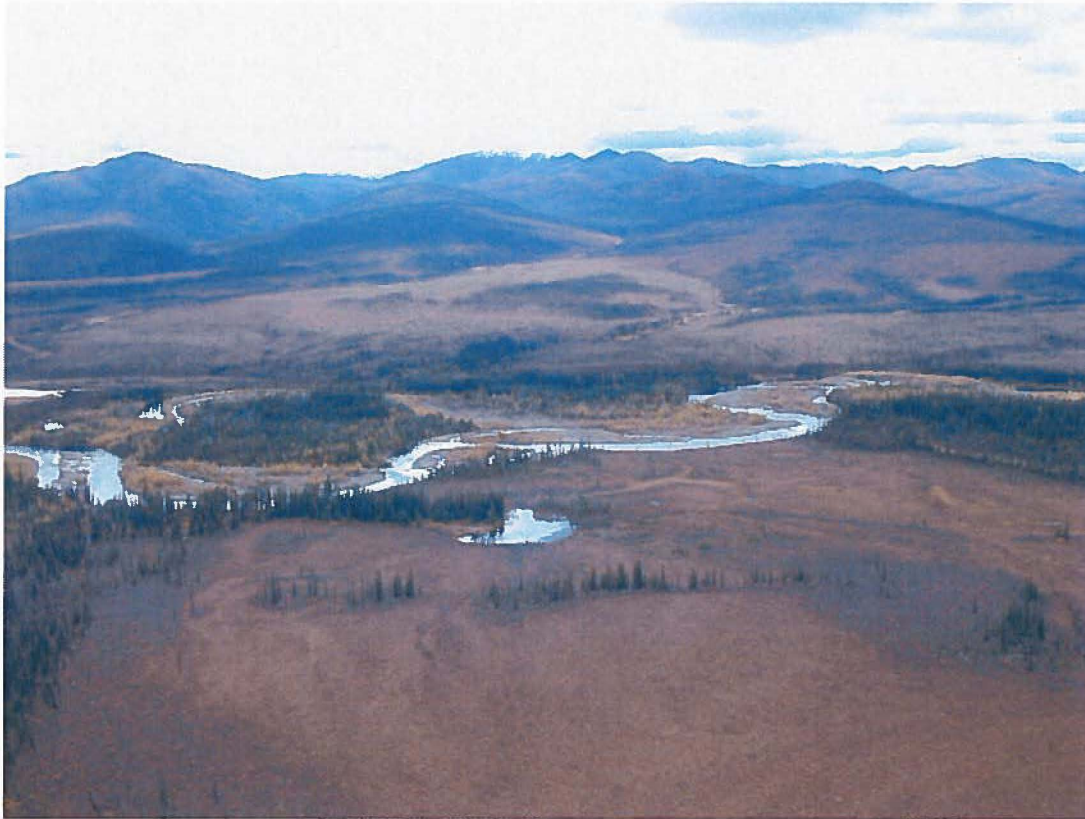
Fig. 32 Middle Fork Fortymile River downstream of Joseph airstrip is a moderately deep, meandering stream with sloughs and islands

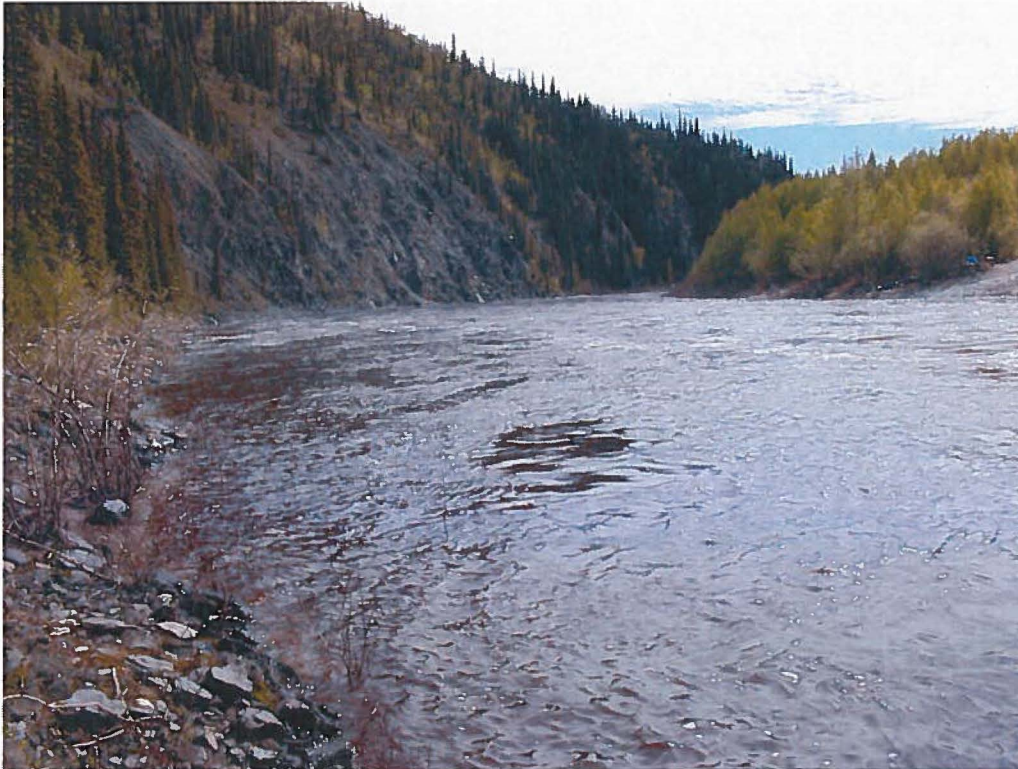
Fig. 34 The Fortymile River looking downstream of the bridge. The river is deep and fast in this reach, but widens out and is shallower and somewhat slower downstream of the bend

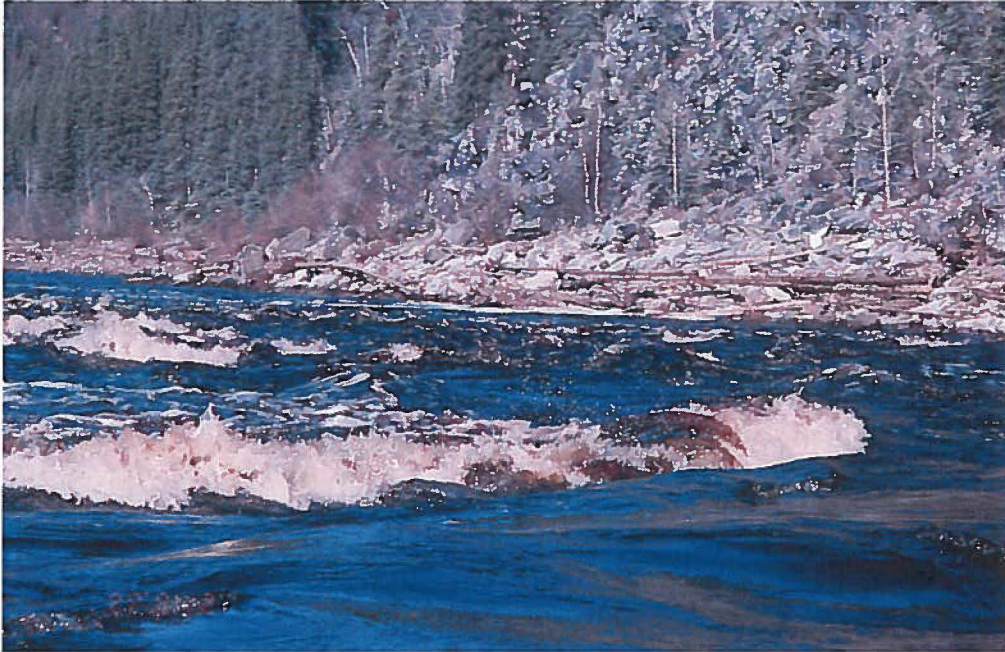
Fig. 35 The class II/III falls of the Fortymile River are about three miles upstream of the bridge

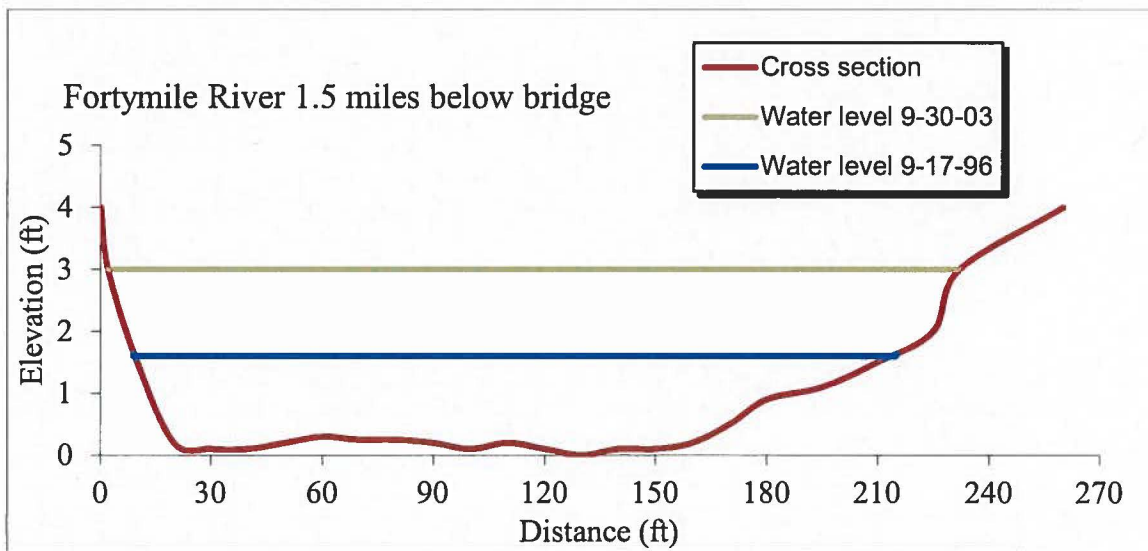
Fig. 36 The surveyed cross section at the Fortymile River approximately 1.5 miles downstream of the bridge
