# Salmon River Fish Passage Project

Anchorage Field Office, Alaska

## Summary

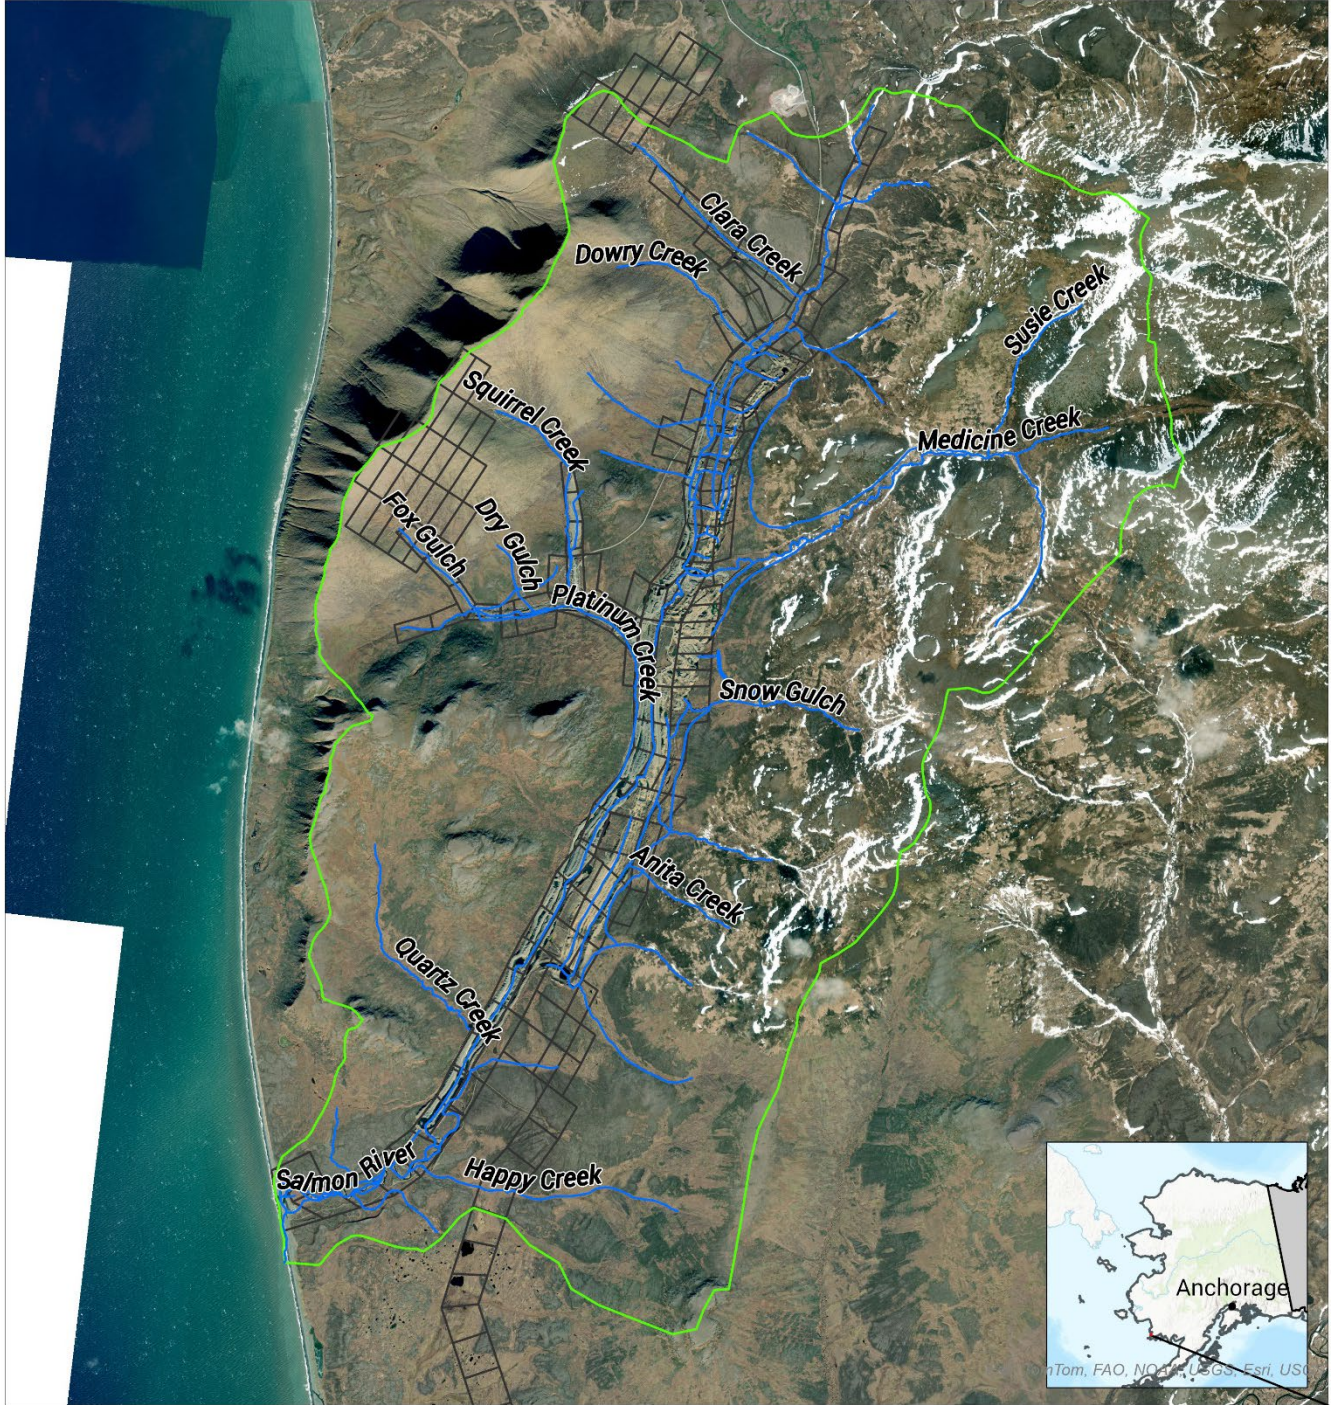
**Figure 1:** Salmon River Watershed including major streams and mining claims.

The Salmon River watershed contains 195 unpatented federal mining claims. The northernmost 174 claims are on federal land administered and managed by the BLM as part of the Bay Planning Area. The remaining federal mining claims are located on the Togiak National Wildlife Refuge, which is managed by the U.S. Fish and Wildlife Service (USFWS). Hanson Industries, Inc. (Hanson) is the current owner and operator of the federal mining claims, collectively known as the Platinum Mine.

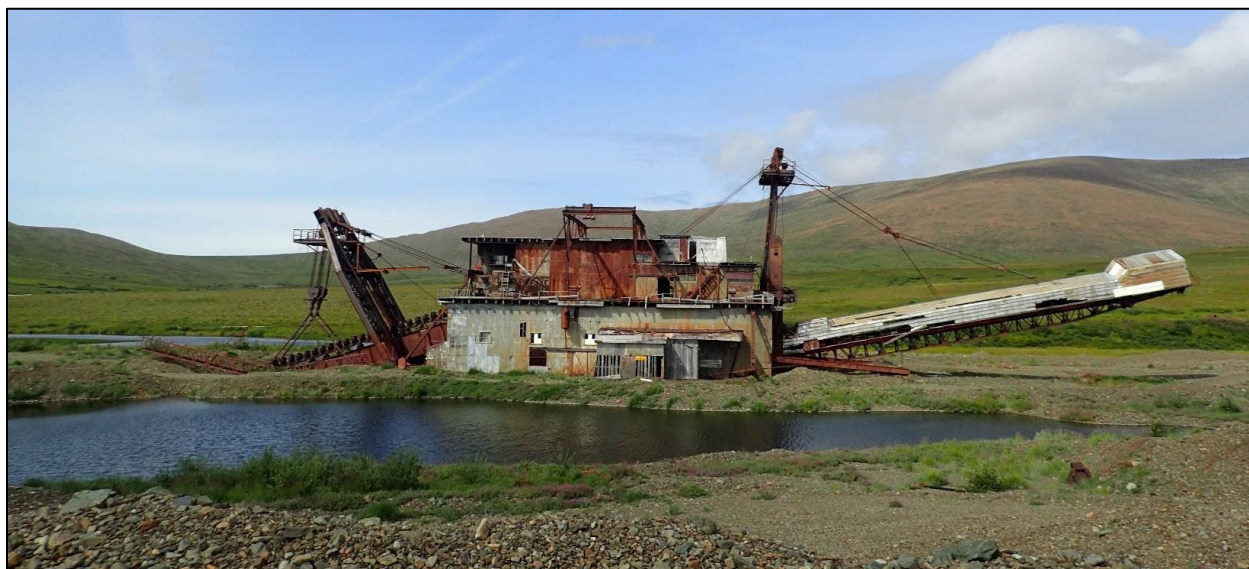
**Figure 2:** Yuba diesel electric dredge where it sank in 2005 on the Salmon River near the confluence with Medicine Creek. The base of Red Mountain is visible in the background.

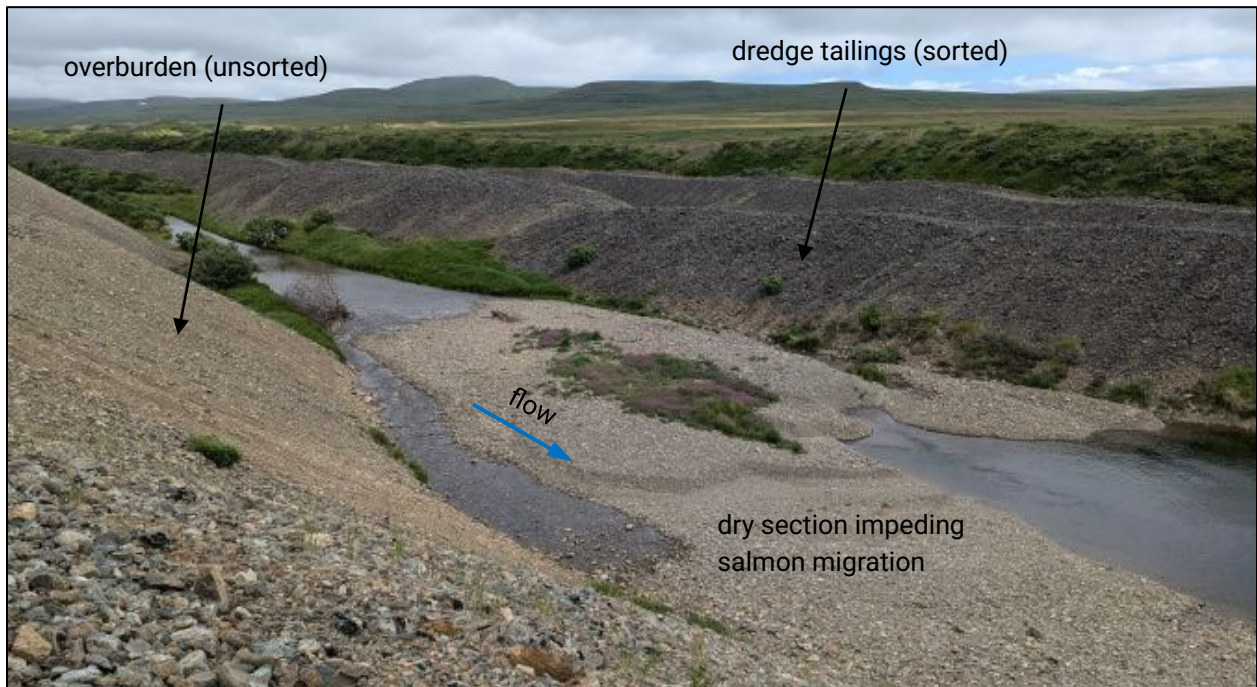
**Figure 3:** A channelized reach of the Salmon River mainstem on July 31, 2024, when the flow was subsurface. The river is ponded immediately downstream.

Dredge and dragline operations along the Salmon River mainstem had a pronounced and lasting influence on channel planform and fluvial processes. Historical aerial imagery and unmined stream sections suggest that the Salmon River was formerly an unconfined, single-thread, meandering system. The dredge made repeated passes upstream and downstream within the valley bottom converting the river into a series of parallel channels and ponded reaches up to 50 feet deep, bounded by overburden and tailings up to 70 feet tall (Figure 3). Overburden piles along the valley margins are generally taller and consist of unsorted sediments. Tailings piles are composed of gravel and cobble overlying sand and finer materials. They are highly permeable landforms between flowing channel segments. As a result of historical mining, the Salmon River no longer effectively conveys water and sediment from headwaters through the channel network – processes that are critical to both its function as an alluvial river and its potential for natural recovery following disturbance.

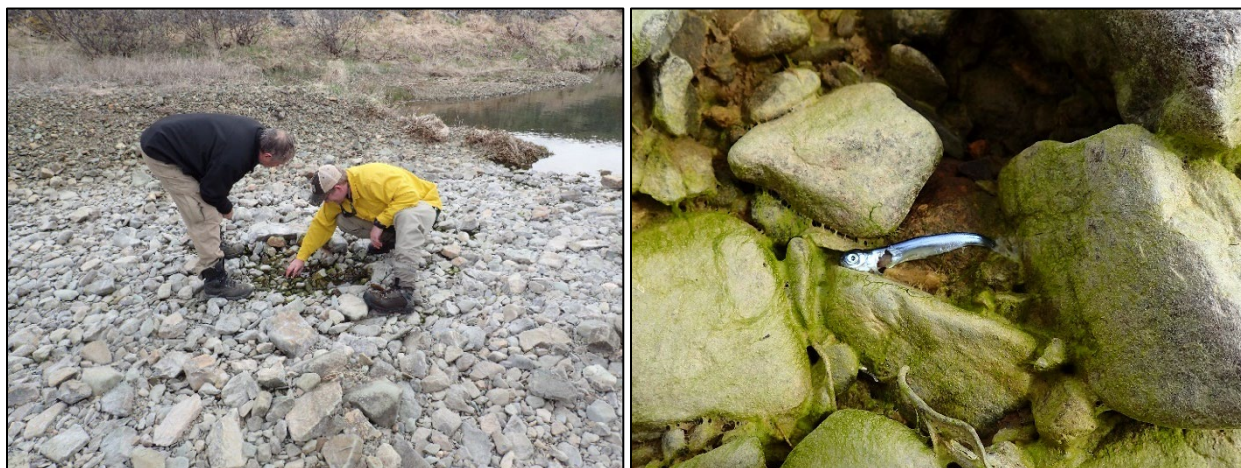
**Figure 4:** BLM fisheries biologists observing dead and dying salmon fry stranded in a dry reach May 16, 2019.

Since at least the 1980s, multiple organizations including the BLM and the ADFG have documented four stream reaches of the Salmon River within the block of previously mined claims that are barriers to fish migration due to lack of surface flow from late spring through the fall (BLM, 2019). These dry reaches block adult salmon migration to spawning areas, as well as juvenile outmigration (Figure 4). During summer baseflow, they range in length from 200 feet to 1,500 feet based on aerial imagery analysis.

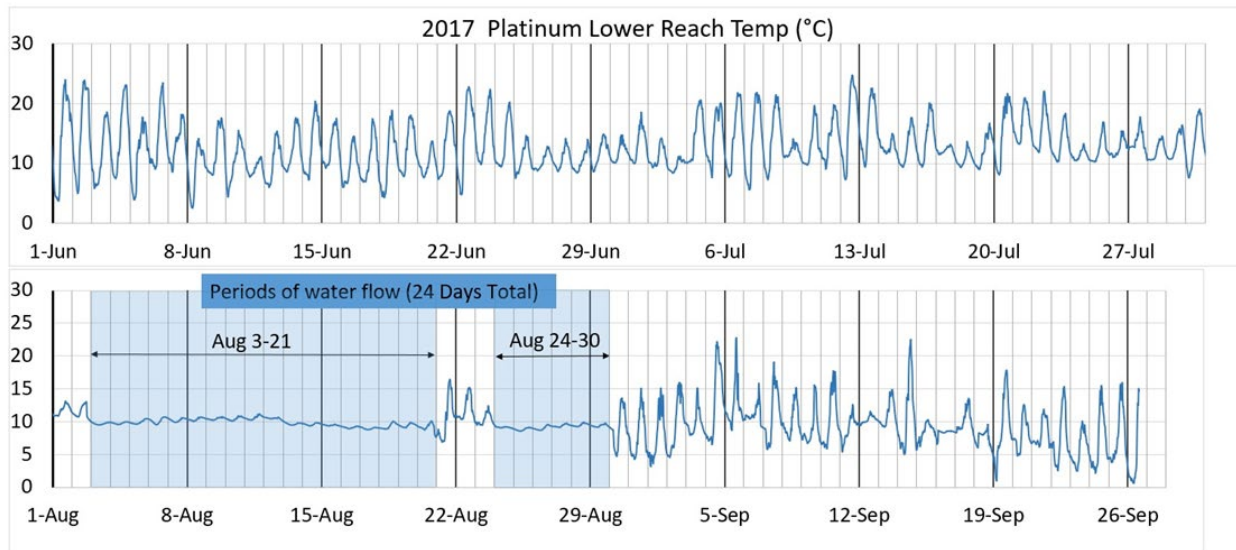
**Figure 5:** Hourly temperature readings from a sensor buried in the stream bed in the most downstream dry reach of the Salmon River during the summer of 2017. During most of the June 1 to September 26 deployment, the sensor was exposed to air, and the channel was not flowing. Highlighted regions of dampened diurnal fluctuations correspond to water temperatures.

sensors deployed in dry reaches provide insight into subsurface flow duration (Figure 5). Until recently, topographic information was limited to surveys of a few cross sections and a longitudinal profile performed at a subset of dry reaches.

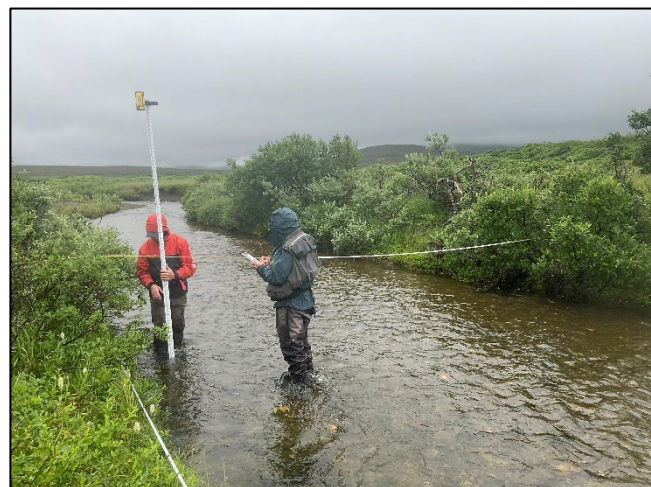
**Figure 6:** BLM Fisheries biologists surveying a cross section on Smalls Creek as part of a larger effort to characterize streams at minimally disturbed sites in the area.

To inform fish passage project design, stream surveys were conducted at reference sites within the Ahklun Mountains Ecoregion. Fifty-two sites were randomly selected and surveyed following the BLM's Lotic Aquatic Inventory and Monitoring (AIM) protocols. Surveys were completed by staff from the Alaska Department of Environmental Conservation (DEC) and University of Alaska Anchorage through a financial agreement between the BLM and ADEC. The BLM performed additional surveys of targeted sites within the Salmon River and adjacent Smalls Creek Watershed to support development of regional hydraulic geometry relationships and other design criteria (Figure 6, BLM, 2025). Field data will be integrated with LiDAR data acquired for the project through an agreement with the Salcha-Delta Soil and Water Conservation District.
