BLM-Alaska Open File Report 81  
BLM/AK/ST-00/03-6710-040  
September 2000

## Aerial Photography Assessment of Riparian Areas in the Unalakleet Drainage, Alaska

# Aerial Photography Assessment of Riparian Areas in the Unalakleet River Drainage

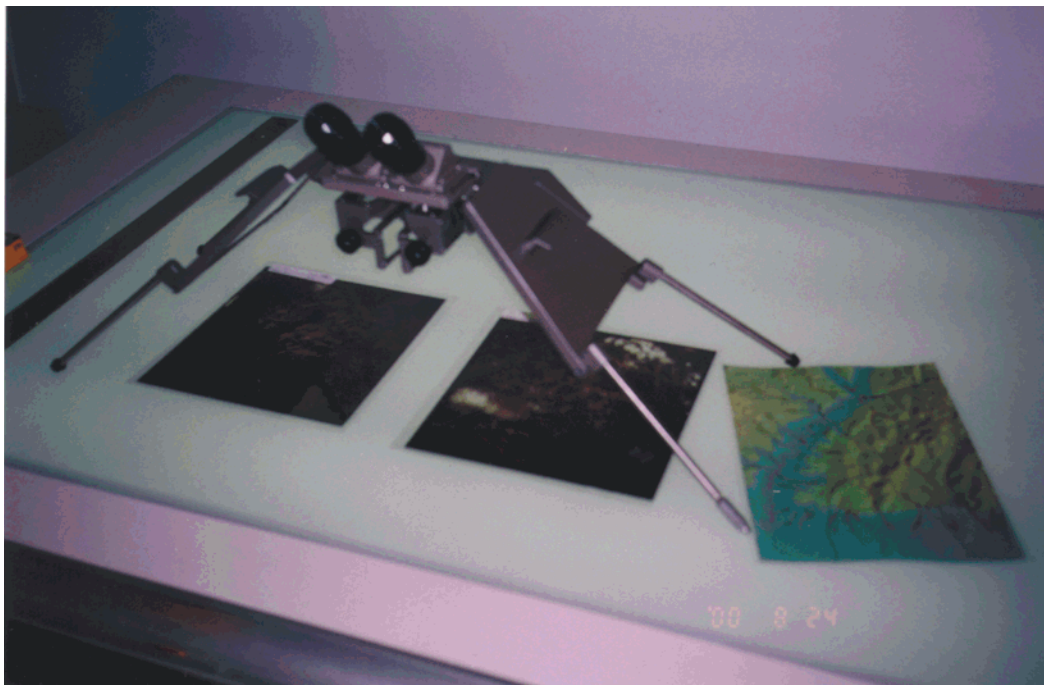
**Photo 2**  
**Light table, aerial photos and printout of the effective area of the aerial photo (far right). The print out with reaches and reach numbers created in ArcView layouts was useful in identifying reaches on the aerial photo.**

A map of each photo plot with the hillshaded relief of DEM and DLG coverages was created using ArcView layout. The stream reaches were labeled with their respective reach numbers on each of the maps. The maps were provided to all interpreters involved with the project to help them identify reaches on the aerial photographs. (*Photo 2*)

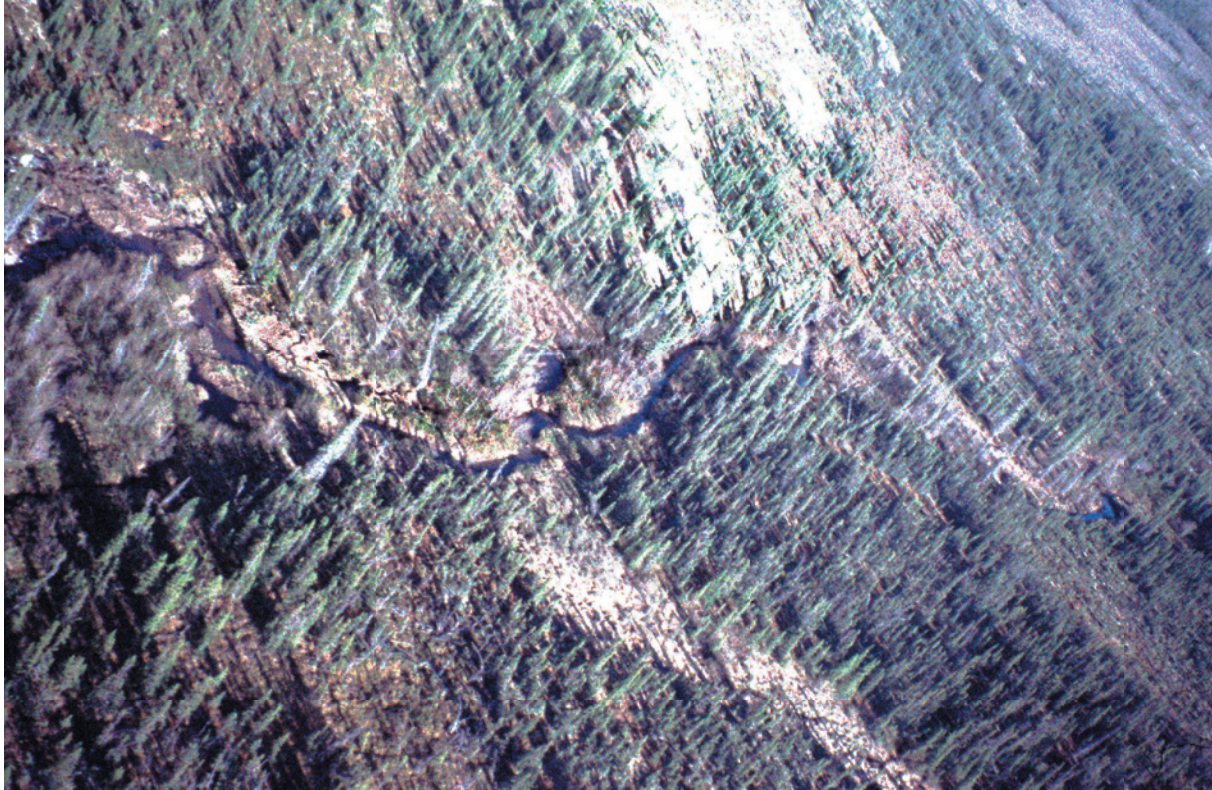
Photo 3.

**A typical small drainage that presented problems to the members of the team from Alaska. Open water and the channel were not readily visible from the small scale aerial photos. Meander patterns and spectral response were important attributes in assessing these streams.**

The initial attempt by the members of the team from Alaska to assess PFC from the photos was not encouraging. Less than 10 percent of the total number of reaches were interpreted, all of which were PFC. The results of these interpretations along with the aerial photos were sent to BLM's National Applied Resource Sciences Center (NARSC) for review and further evaluation. (*Photo 3.*)

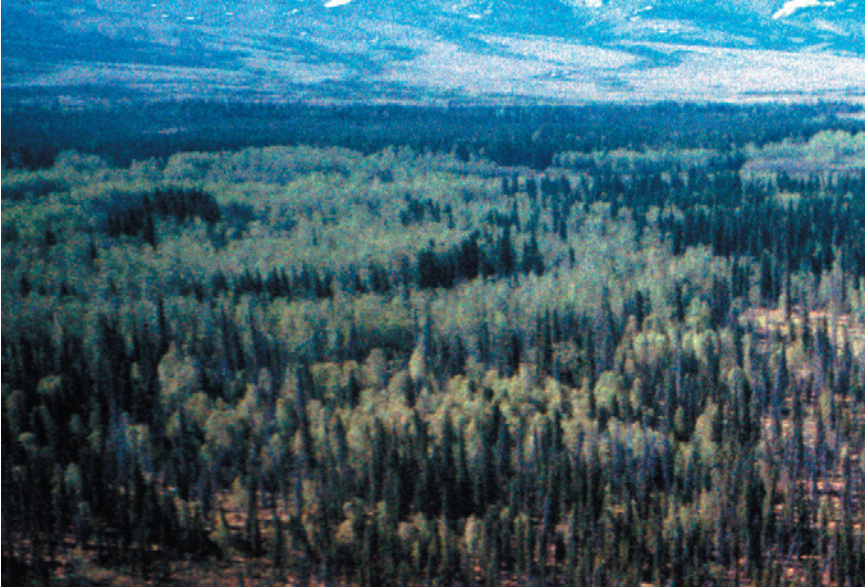
Photo 4.  
**Reach 79 R34, one of the 18 questioned reaches that drained an area of low relief and was depicted on the DLG as terminating on the tundra.**

Reaches 79R34, 35 and 36 were part of a large lentic wetland and would not be assessed as individual lotic systems. Although these sites eventually drained into the Unalakleet River, they should have been assessed as a lentic unit. (*Photo 4.*)

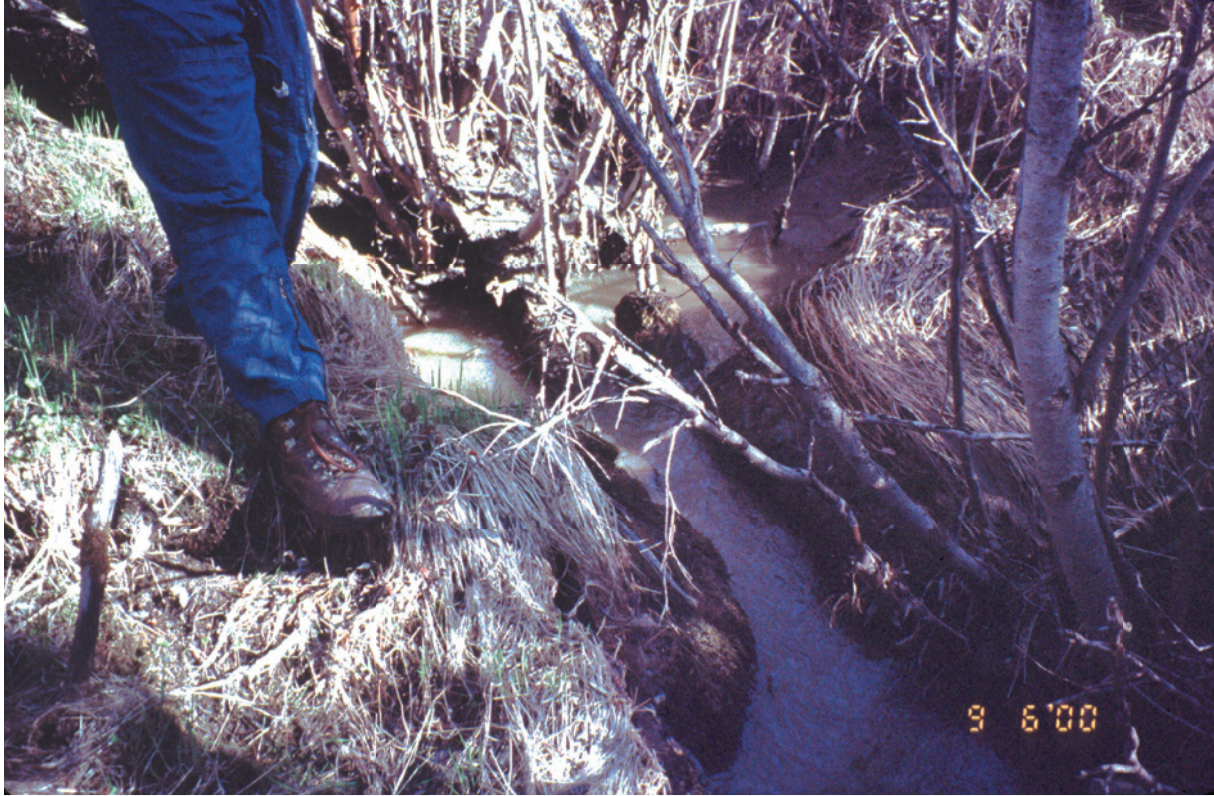
Photo 5.  
**A Rosgen E type channel about one foot wide and 1.5- to 2 feet deep that is preamial. Dense willow and alder makes seeing open channels on small-scale photos difficult.**

26 and 27. Photo interpretations for 247R12 and 14 indicated drier sites. These sites were probably ephemeral and would not be considered riparian areas. Concerns for 4960R25, 26 and 27 related to date of the photography (August). Results from field investigations indicated that there were lotic riparian areas that should have been assessed because they had a riparian-wetland community. The early fall (August) photography revealed the spectral response of the understory vegetation instead of alders and willows. Local field knowledge about these sites would have reminded the interpreters to adjust the interpretation key and identify them as riparian areas rated as PFC. (Photo 5.)

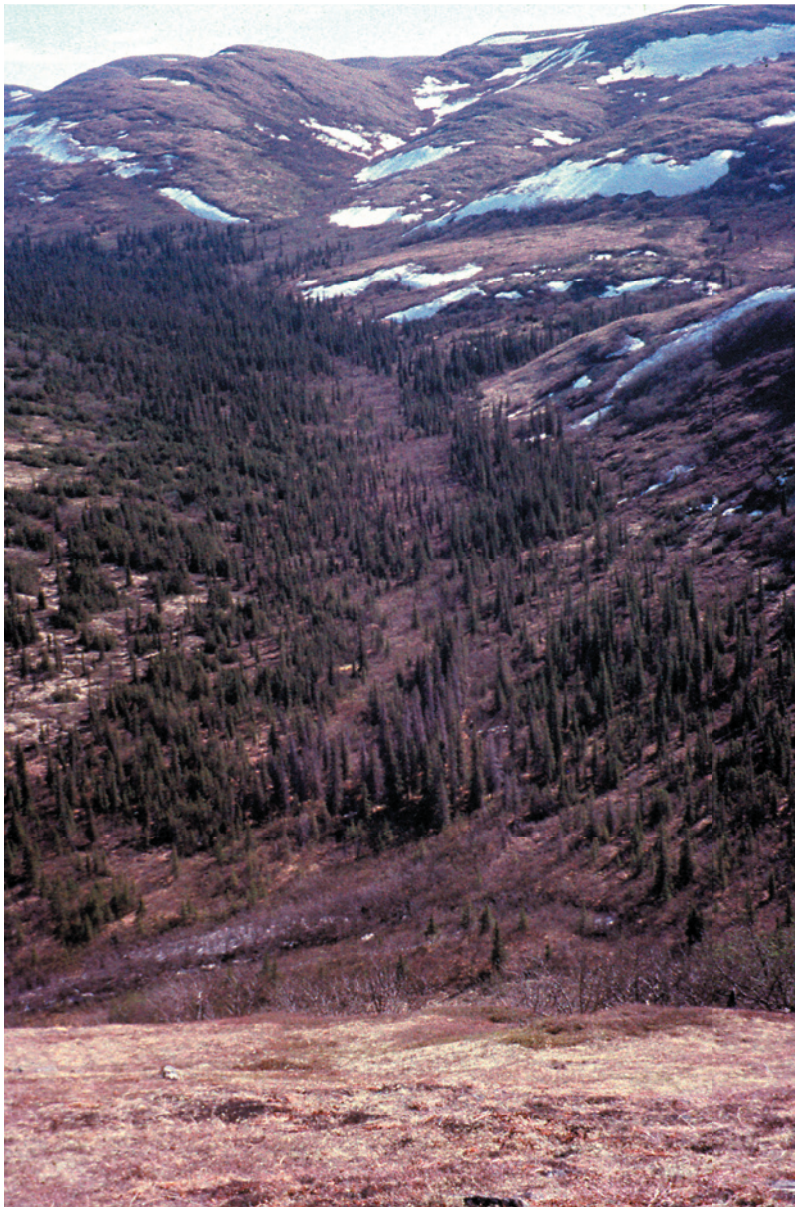
Photo 6.

**An example of a first-order stream in the basin that is represented on the digital line graph. Typically, the upper portions (above treeline) of these systems have few, if any, side drainages and should not have been included in the assessment. The lower portion (having channel or vegetation attributes characteristic of lotic systems) should be assessed.**

Primary consideration was given to the breaks in the hill-shaded relief coverage to define reaches. The use of this data proved adequate particularly on the medium-to-large drainages within the photo plots. Several adjustments should be made in the way reaches are defined on the sample plots. Accretion of flow should be one of the criteria used to define reaches. However, the upper reaches of many small, moderate-to-steep gradient, notable first-order systems with no side drainages should have been truncated approximately midway up the drainages because it was determined that these reaches were not riparian areas. (*Photo 6.*)
