BLM-Alaska Open File Report 85  
BLM/AK/ST-02/005-6610-020  
February 2002

## Adult Salmon Runs and Streamflow Data at a Resistance Board Weir on Beaver Creek, Alaska, 1998-2000

Nathan Collin, Lon Kelly and Jon Kostohrys

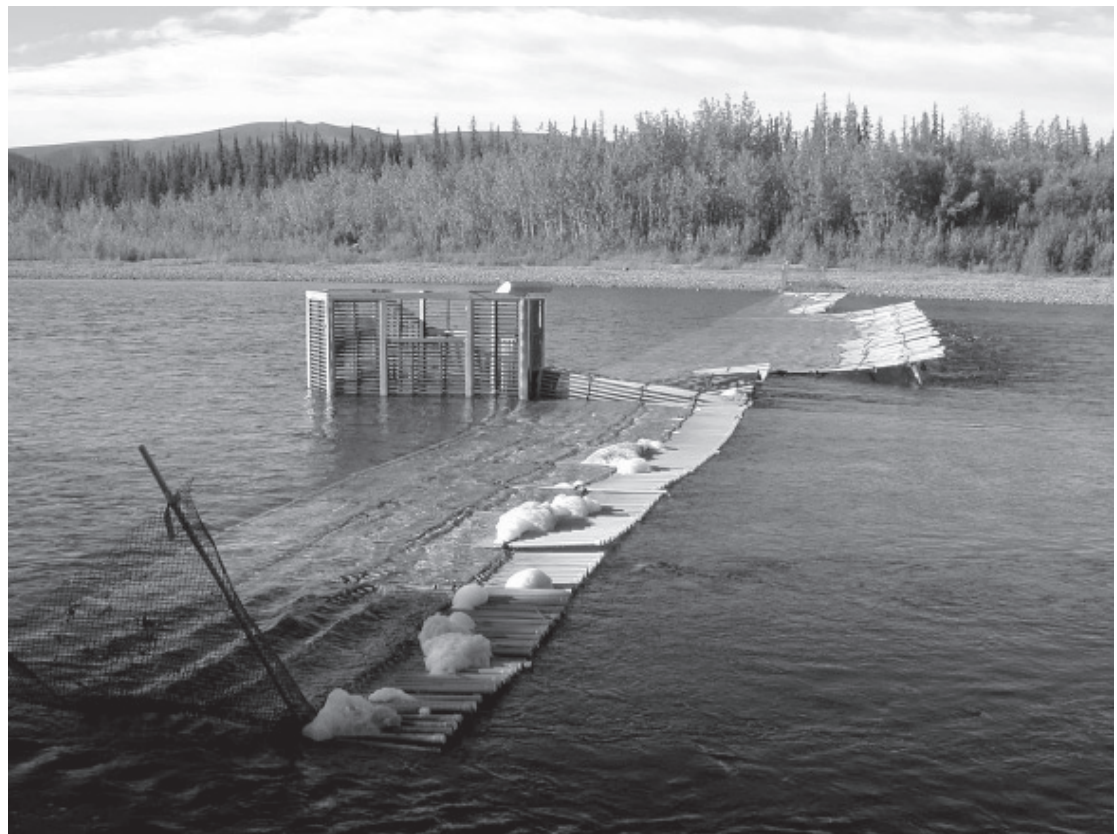
Beaver Creek weir and trap, 2000. BLM photo.

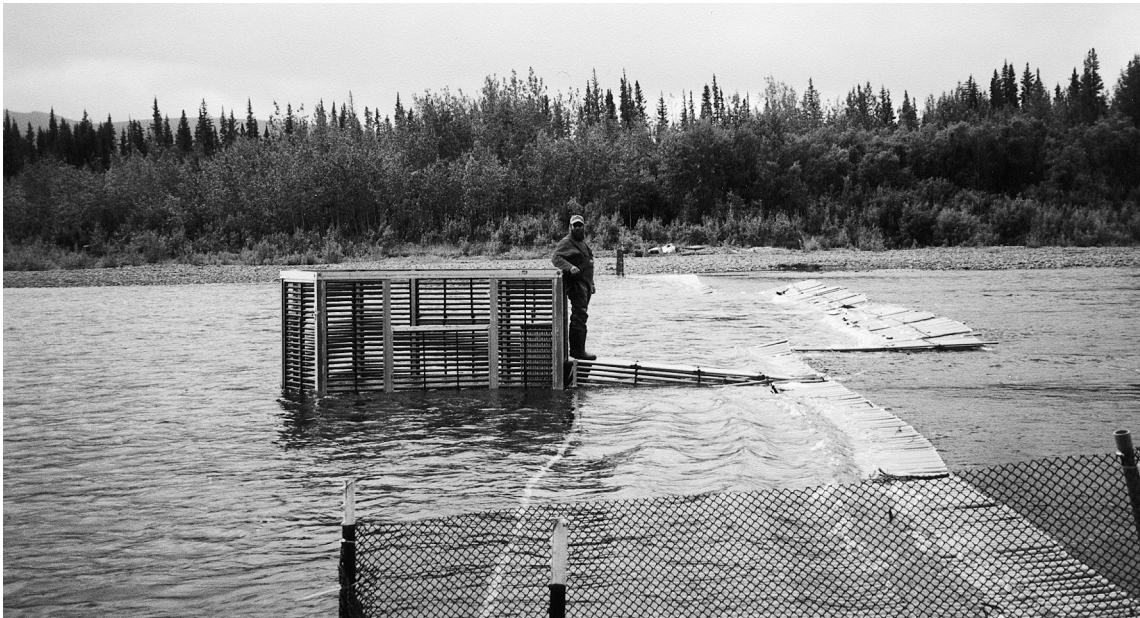
FIGURE 2 Installed weir and trap.

The materials, construction methods, and installation of the weir are generally described by Collin and Kostohrys (1998). In 1999 picket panels were added between the trap and the bank to move the trap out into the stream to maintain adequate depth at low flows. The weir installation is shown in Figure 2.

The weir was operated in the same manner as in 1996 and 1997 (Collin and Kostohrys, 1998). Visual inspections for holes and structural problems were conducted daily. Fish carcasses and debris were cleaned from the weir as they accumulated. Cleaning typically involved walking on the weir panels until they were partially submerged to allow the current to flush the debris off. At times it was necessary to remove debris fouling the weir by hand.

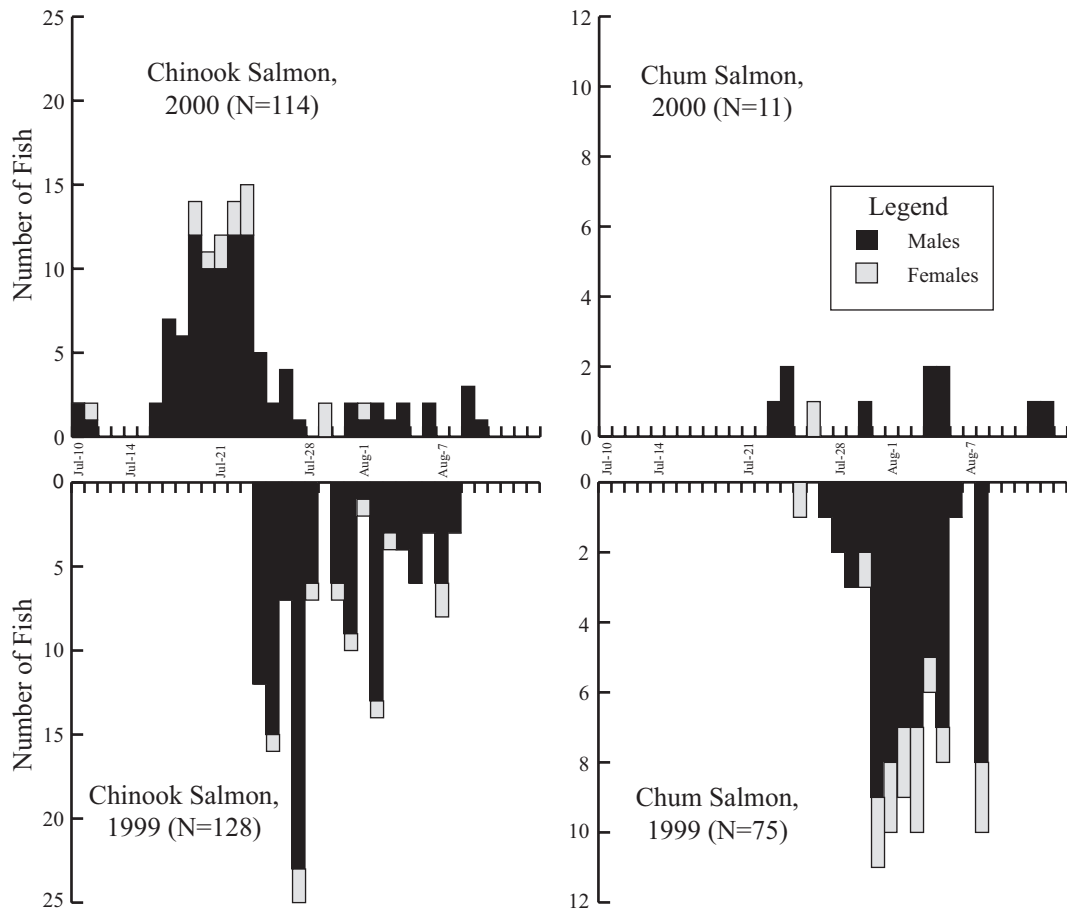
FIGURE 3 Daily counts of summer chum and chinook salmon passing through the Beaver Creek weir, 1999 and 2000. Weir operated from July 9 to August 8, 1999, and July 8 to August 14, 2000.

A total of 114 chinook salmon were counted in 2000. The peak of the migration for chinook salmon occurred July 23 and then daily counts declined quickly (Figure 3). The marked disparity between male and female numbers observed in 1999 persisted. Fourteen female chinook salmon passed through the weir in 2000.

A total of 11 chum salmon were counted through the weir in 2000. Chum salmon never showed a peak (Figure 3). Chum salmon continued to appear at the weir through the end of the period, one or two at a time.

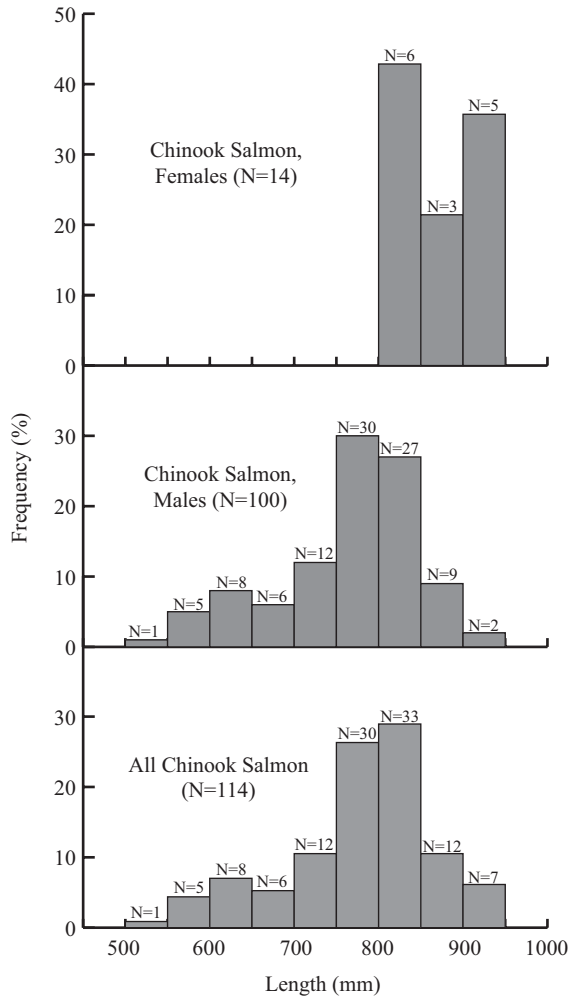
FIGURE 5 Length-frequency histograms for chinook salmon at the weir, 2000.

Figure 5 provides length-frequency histograms for the chinook salmon passing through the weir in 2000. Two chinook salmon that had been marked with blue spaghetti tags by the Alaska Department of Fish and Game near the mouth of the Yukon passed through the weir.
