# RIPARIAN AREA MANAGEMENT

TR 1737-12 1996 (Revised 1999)

*Using Aerial Photographs to Assess Proper  
Functioning Condition of Riparian-Wetland Areas*

BLM/RS/ST-96/007+1737+REV99

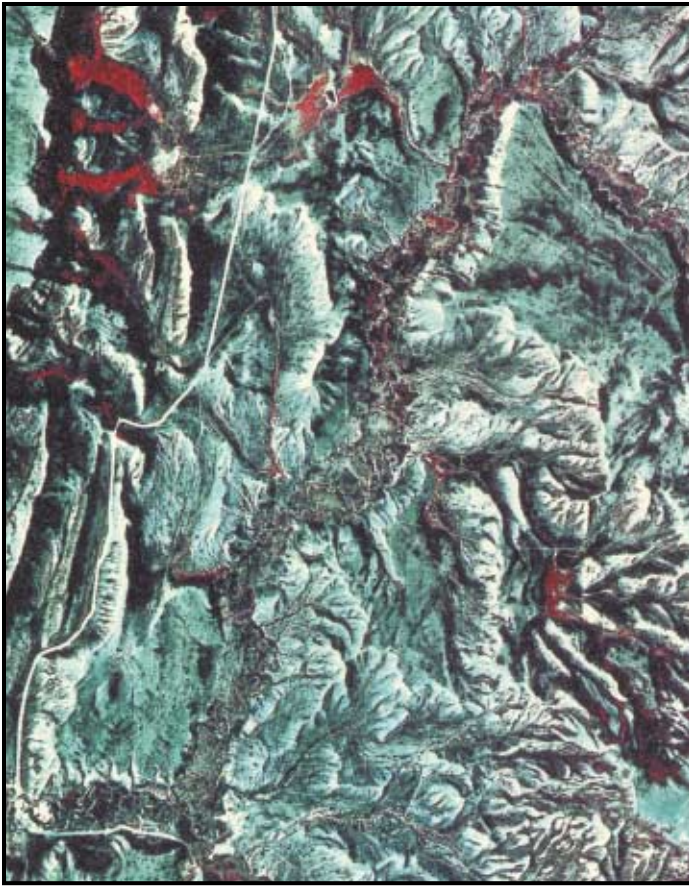
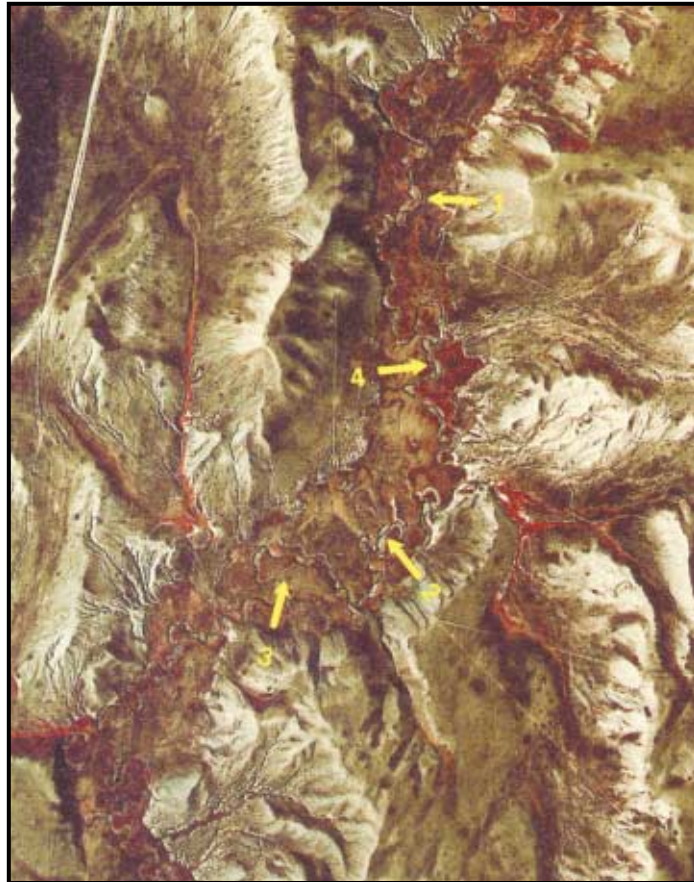
The presence of midchannel bars (arrow 4) suggests that the floodplain and channel characteristics are not adequate to dissipate energy. Deposition of materials also indicates the system is not in balance with its sediment load.

The color balance difference in the two photos should be noted. Color balance in CIR photography is difficult to control.

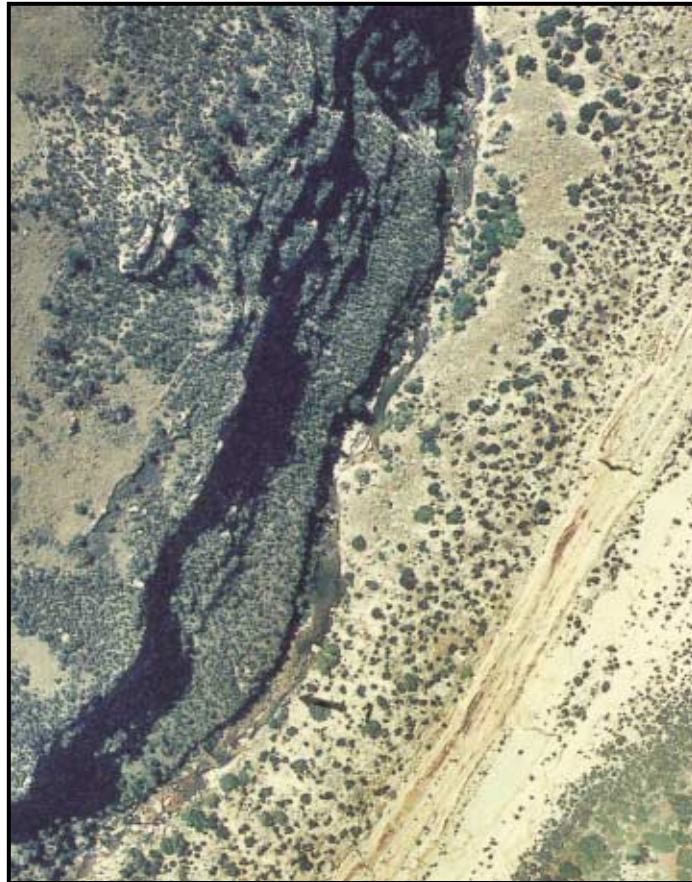
**Photo 3a** — July 1989

Photo 3a is a CIR photo of the Middle Fork Powder River at a nominal scale of 1:40,000. Photo 3b is a natural color photo of the same area at a nominal scale of 1:3,000. Photo 3c is a field photo taken from a ledge approximately 200 feet above the valley floor. This series of pictures shows how landform is important in determining the condition of a riparian-wetland area.

Under stereo magnification, unvegetated spots (arrow 1) can be seen in the channel in photo 3a. The slope of the valley bottom and the gradient of the stream suggest that these could be rock rather than sand, gravel, or soil bars; the other two photos confirm the presence of large rocks and possible bedrock in the channel.

Vegetation items on a PFC checklist could be answered "N/A" or "Yes" because vegetation plays a limited role in dissipating stream energy.

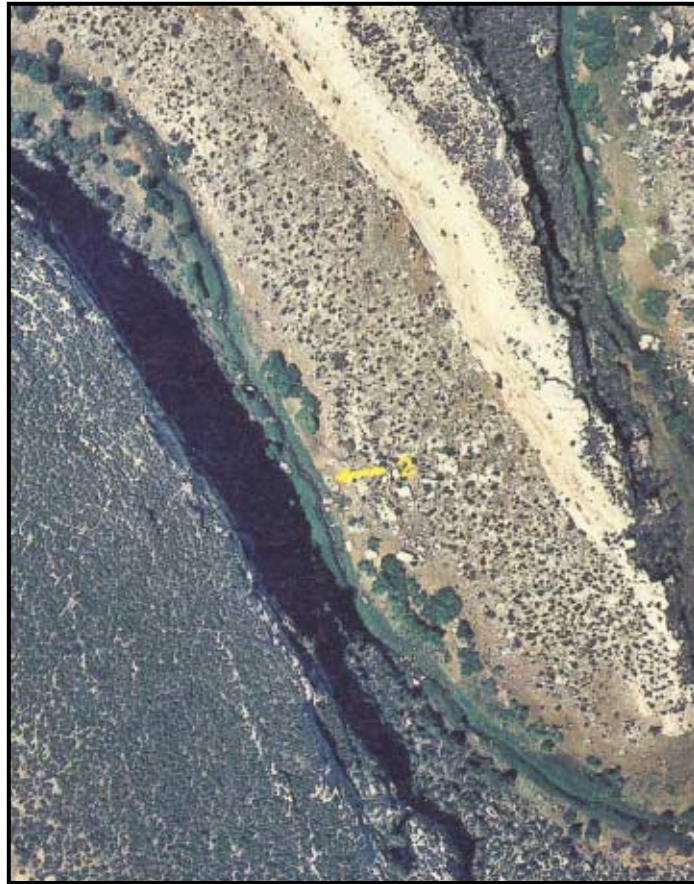
**Photo 4a** — June 1989

Photo 4a is a CIR photo of Buffalo Creek at a nominal scale of 1:40,000. Photo 4b is a natural color photo of the same area at a nominal scale of 1:3,000. Photo 4c is a ground photo.

Photo 4a shows a bright red signature throughout the valley floor due to a wet year (arrow 1). This would be interpreted as excellent riparian-wetland vegetation condition throughout the reach. However, an interpreter must compensate for photos that were taken while upland species are still actively growing. Photos 4b and 4c show that there is a high percentage of upland vegetation, especially grasses, growing on the streambanks (arrow 2). Upland plants do not count when deciding if there is adequate vegetation to protect streambanks. Vegetation items on a PFC checklist would be answered "No."

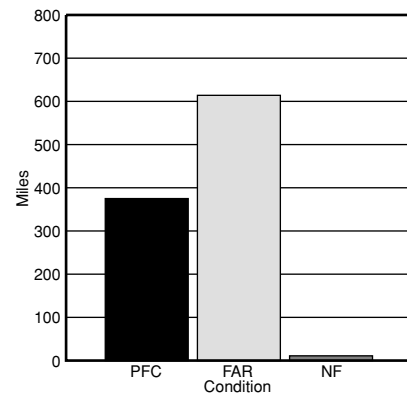
**Figure 1.** Functioning condition of reaches assessed.

Riparian assessments were conducted on six watersheds of the Crow Reservation. Overall, 208 stream reaches, covering 1,000 miles of perennial streams, were evaluated (Figure 1). Of the 208 reaches assessed:

- 95 reaches (375 miles) were rated PFC (proper functioning condition)
- 109 reaches (614 miles) were rated FAR (functional—at risk)
- 4 reaches (11 miles) were rated NF (nonfunctional)

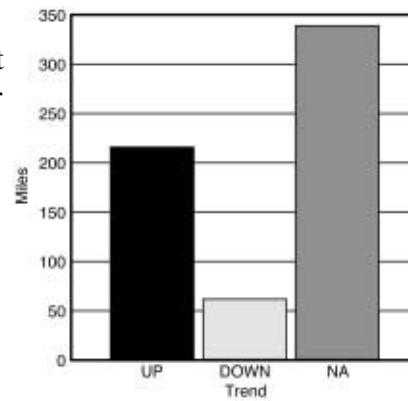
**Figure 2.** Trend ratings for reaches that are functional—at risk.

Trend was determined for reaches rated FAR (Figure 2). Trend is only determined on FAR reaches because all NF reaches need improvement and PFC is considered a stable situation. Trend can be upward, downward, or not apparent. An upward trend indicates that physical recovery is occurring and the functional condition of the reach is moving toward PFC. A downward trend indicates that conditions in the reach are continuing to deteriorate, and if left unchecked, could result in a reach that is nonfunctional.

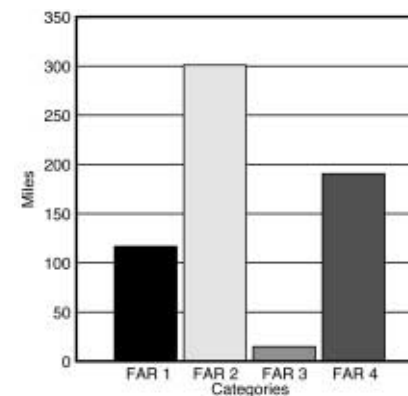
**Figure 3.** Categories for reaches that are functional—at risk.

Because of the large volume of data from the reaches rated FAR, four categories were established to segregate data by potential causes for riparian-wetland deterioration (Figure 3):

- FAR1 included reaches affected by grazing management
- FAR2 included reaches affected by cropland encroachment
- FAR3 included reaches affected by both grazing management and cropland encroachment
- FAR4 included reaches affected by channel straightening, structures, and road encroachment, and reaches where the cause of deterioration was not readily apparent

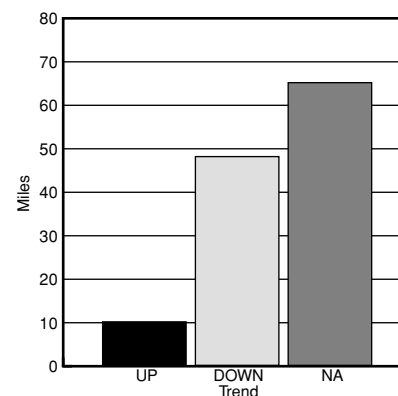
**Figure 2.** Trend ratings for reaches that are functional—at risk.

The assessment of riparian conditions resulted in 56 percent of the reaches, or 124 miles, receiving FAR ratings (Figure 2). Of the 31 reaches rated FAR:
