**Nevada Strip Fishery Survey**

**Nevada Department of Wildlife**

**Bureau of Land Management**

**Technical Bulletin ID-2005-06**

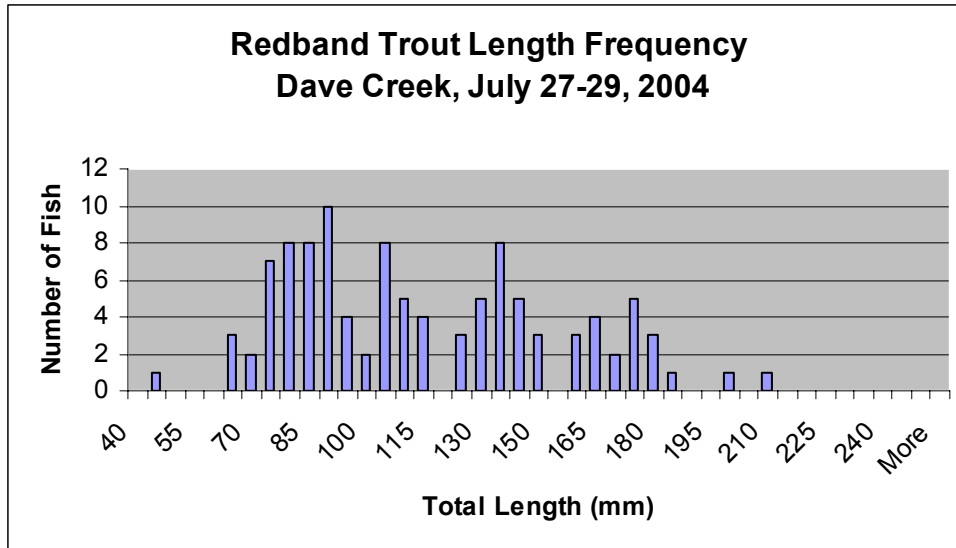
Figure 1. Dave Creek redband trout length frequency, July 27-29, 2004.

There were seven fish population sample sites completed in Dave Creek during the period of July 27-29 (Appendix II). The 6.4 mile reach of Dave Creek below the Forest Boundary had an average of 844.8 redband trout per mile. An estimated 5407 redband trout resided within the surveyed reach. Length frequency analysis of the sample of 105 redband trout revealed five age groups including a single young-of-year, a large age-I class, age-II, age-III, and two age-IV fish (Figure 1).

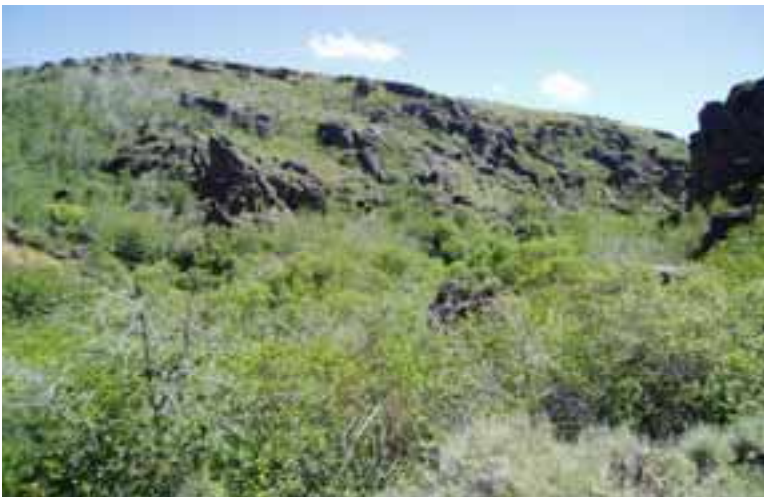
Figure 2. Cherry Creek SS-1 located near the stateline.

A total of six sample sites were slated for survey on Cherry Creek during July 7-8 (Appendix II). Only SS-1 was not surveyed due to the extreme density of riparian vegetation (Figure 2).

The water status of lower Cherry Creek should be assessed in late-August.
