**Standards for Rangeland Health  
and  
Guidelines for Livestock Grazing Management  
for  
Public Lands in Oregon and Washington**

**UPDATE for the**

**FRF Flynn Allotment #501**

**5/31/13**

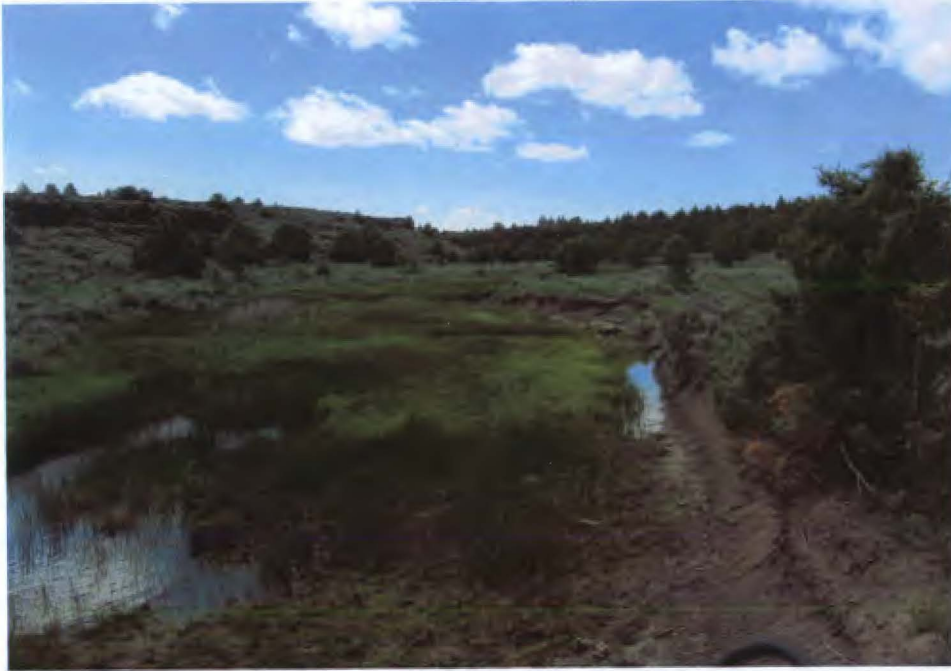
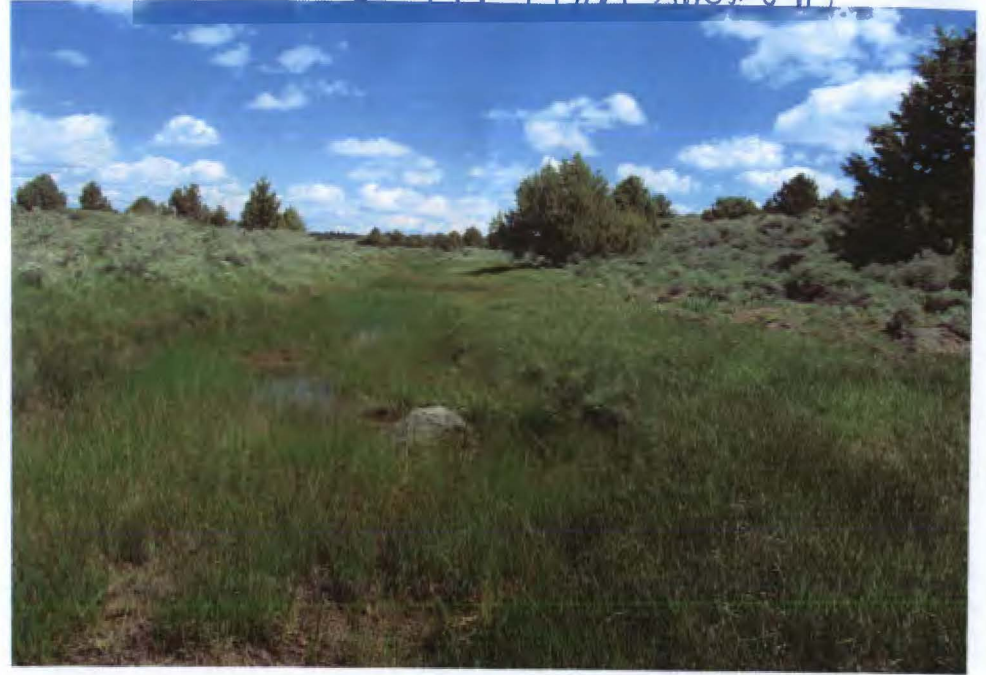
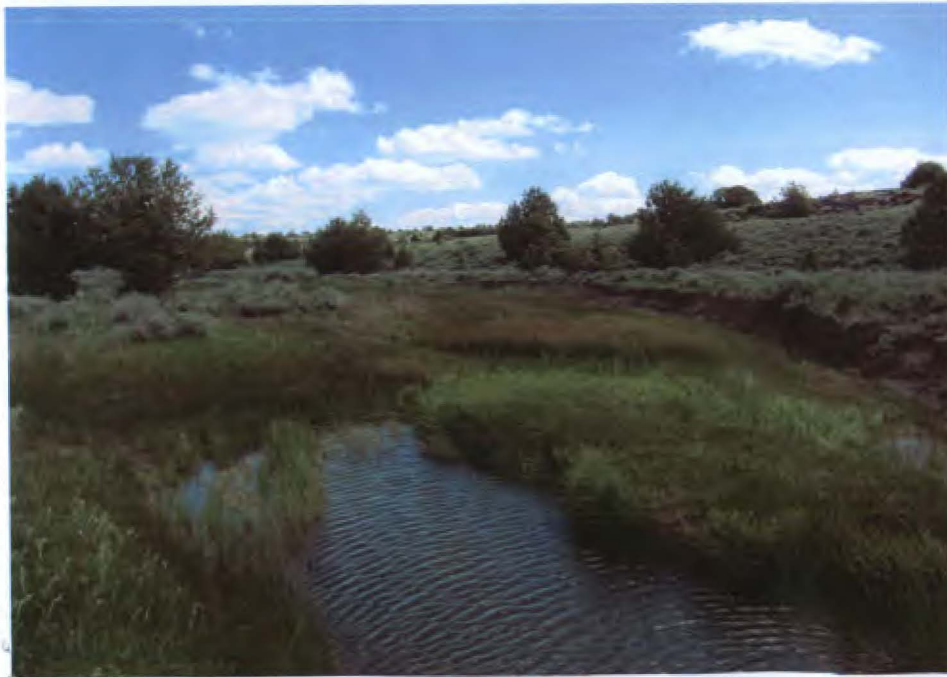
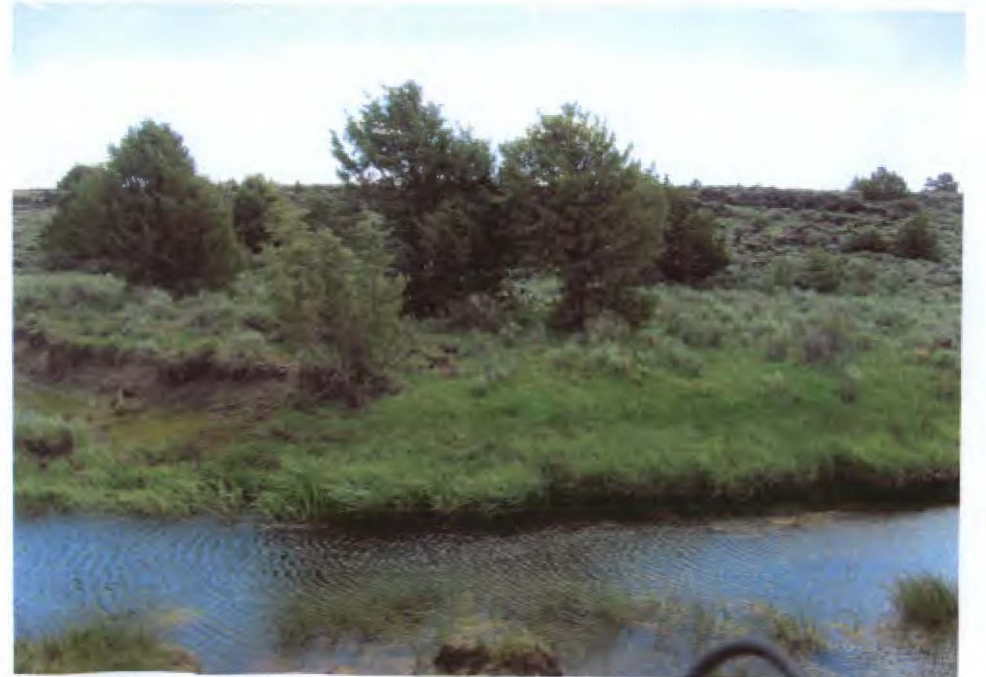
Drake creek

3) still expanding laterally in some areas. 6) No old willow, but lots of recent recruitment;  
10) some heavy willow browse; some isolated dead willows, but mostly good signs  
11) too many bare stream banks in upper reaches  
15) see #3  
17) some deposition, but natural for this depositional / low gradient reach

\*Willows have increased since 1979 photos.

In 2003, Munnell noticed heavy spring grazing causing a detriment to the improvement of the stream reach. The permittee shifted spring grazing to winter grazing after Nov 1st & in October winds has whittled the last 10 yards. The stream is recovering & improving but is still at risk.
