**Bureau of Land Management**

**Environmental Assessment**  
Campbell Creek Stream Restoration  
Bureau of Land Management  
Anchorage Field Office  
AK-040-06-EA-029

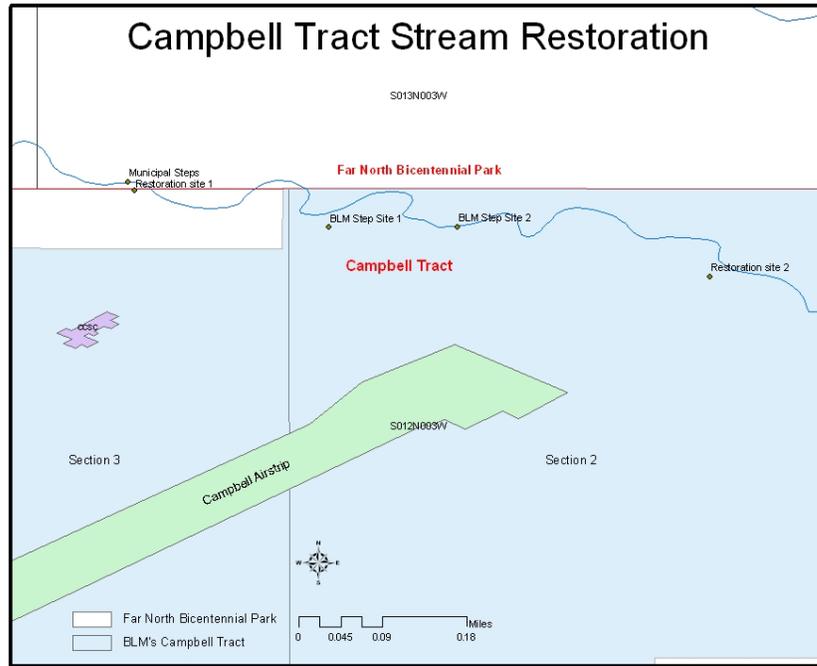
**Map 2**

1. provide visitor access steps to the bank of the creek in two areas of potential erosion (BLM Step Sites 1 and 2);
2. restore a portion of the bank in one area of erosion (Restoration Site 2); and
3. vegetate another area of erosion (Restoration Site 1); *See* Map 2 below.

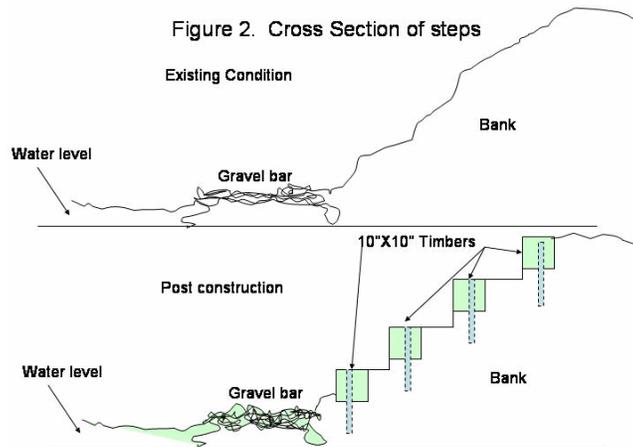
**Figure 2**

Two sites (BLM Step Sites 1 and 2) have been selected for creek access from the cut banks to the waters’ edge. These were selected because they are already being used by the CCSC and local fishermen. They are located along safe reaches of the stream (shallow with few downstream hazards), and they are good locations for streamside educational programs. They will allow the public access to the water’s edge without trampling vegetation.

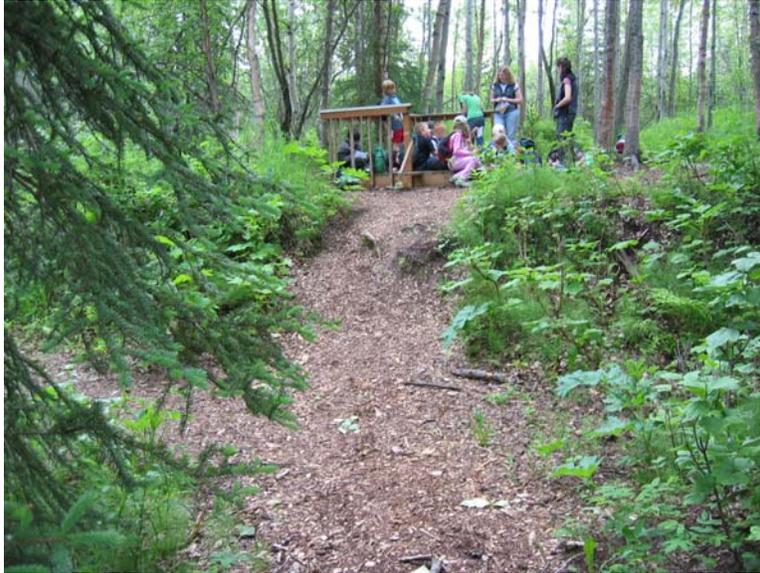
**Photo 1**

In order to provide access down to the creek from the elevated bank 4 foot 10" X 10" (BLM Step Site 2 – Photo 1 below) EPA approved landscape timbers will be set into the bank and anchored by 2 ft pieces of 3/8" steel rebar to form steps, *see* above. Wood chips will be placed on the steps to further reduce erosion. Steel cables may also be used to help anchor the timbers into place, *see* Photo 2 below for an example of cabling.

BLM Step Site 1 is in need of approximately two to three steps and BLM Step Site 2 is need of four or five steps.

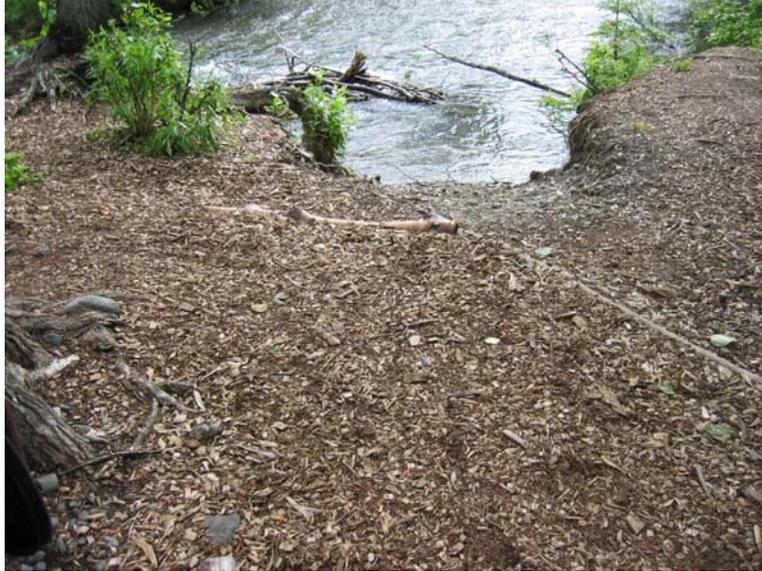
**Photo 3, Restoration Site 1**

There are two areas in the creek where human impact and a fallen tree have caused erosion deep into the cut bank (see Photos 3 & 4). For Restoration Site 2, the ford site, the creek bank cannot be restored without placing structures in the stream.

Restoration Site 1 would be restored by burying several approximately four-foot sections of willow bundles into the soil. The root structures of the resulting willow growth should anchor the bank and prevent future erosion.

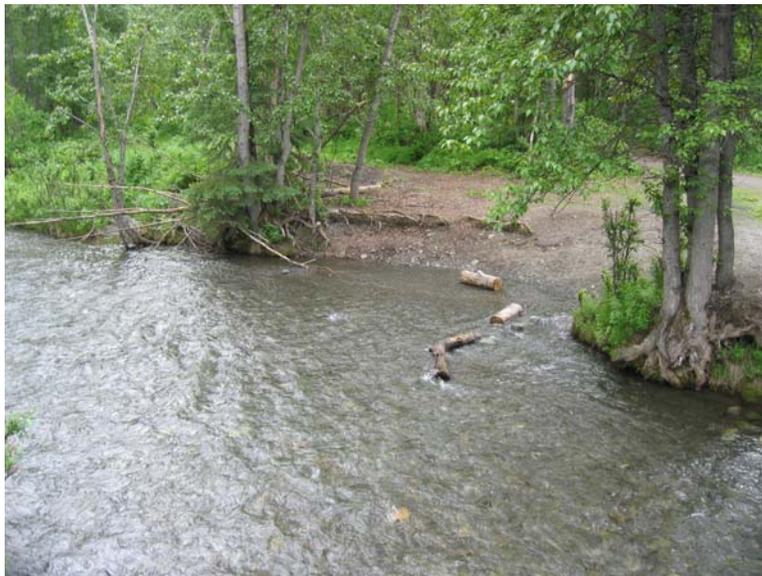
**Photo 4, Restoration Site 2**

Restoration Site 2 is located approximately 40 ft. upstream of the pedestrian bridge at the northern end of the Campbell Tract runway (Map 1). Restoration and rehabilitation efforts will be performed on approximately 30-35 ft of compacted and eroded stream bank at this site (Photo 5). Twenty feet of stream bank will be restored to resemble a reach of stream bank (reference reach) that more closely resembles natural conditions (Photo 5), while an additional 12 ft of stream bank will be rehabilitated to provide pedestrian access to the gravel bar and the water's edge. Providing an area of easy access to the water's edge will presumably reduce traffic across the restored section of stream bank to promote vegetative growth and overall stabilization.

Two sections of damaged stream-bank have been identified. The larger section of damaged stream-bank, Restoration Site 2, is a former creek ford originally used by the military to get tanks and other motorized equipment across the creek. A thirty-five foot section of stream-bank is collapsed and heavily eroded. Extensive traffic by recreational users of the CT has not allowed any vegetation to re-establish itself. A second section of collapsed stream-bank, Restoration Site 1, is located approximately ½ miles downstream where it appears that a large cottonwood tree once stood. A well trampled ramp approximately 5 feet wide leads down to the creek. The constant foot traffic again has not allowed vegetation to re-establish itself.

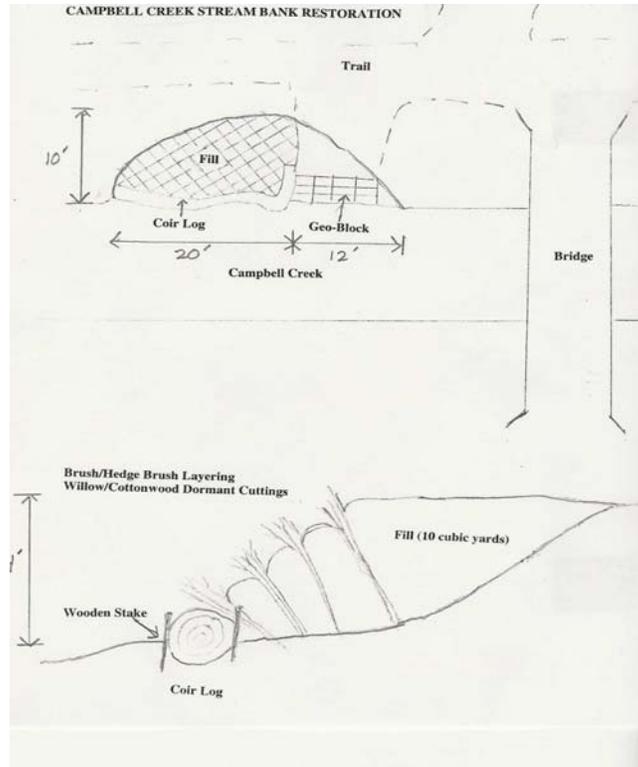
Figure 3, Plan and side view of proposed action at Restoration Site 2.

The restoration reach will be made to mimic the physical and functional characteristics of the reference reach. This will be accomplished by building-up the stream bank to a height of approximately 5 feet. Initially silt fencing will be installed in the project area. A coir log, constructed of biodegradable rolled coconut fiber, will be used to shore fill material and prevent erosion during high water. This log will consist of a 20 ft section of 1 ft diameter log laid parallel to the stream channel at the trailing edge of the designed floodplain. This 20 ft piece of the coir log will be butted up against the stream bank at the upstream end of the project area, and then wrap approximately 5 feet around the downstream end.

A small percentage on the fill will be placed within the mean high water portion of the stream. The work will be timed to occur during a period of low water when none of the reconstructed bank structure will extend into the creek and spawning salmon will not be affected. The intention is that the coir log will decompose over time, allowing the root structure of the vegetation to establish itself anchoring the stream bank and helping to prevent erosion during high water events.

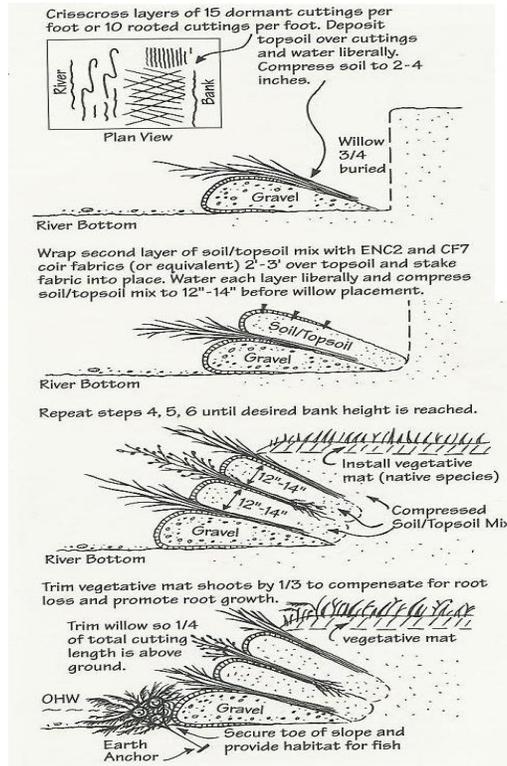
Figure 4, Technique to restore soil column. (State of Alaska, 1998)

Material will be backfilled and layered to best represent the soil column of the reference reach. The soil profile of the restoration reach will consist of a six inch top layer of 70/30 percent topsoil/sand atop three 14 inch layers of 40/30/30 percent gravel/sand/topsoil with a six inch bottom layer of 100% gravel/cobbles. Each layer will be wrapped with biodegradable coir fabric (Figure 4) to stabilize the soil layers until natural soil cohesion properties take affect, primarily vegetation root growth and soil compaction.

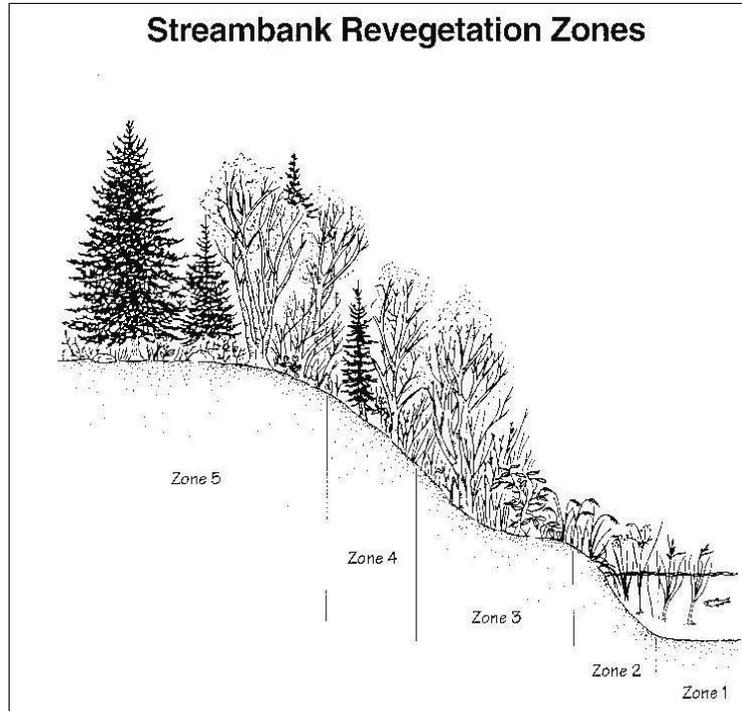
Figure 5, Moisture regime zones for re-vegetation of disturbed areas. (State of Alaska, 1998)

Riparian vegetation native to Alaska will be planted/seeded throughout the project site. Re-vegetation techniques using moisture regime zones will assist in determining proper vegetation type and planting (Figure 5). The primary vegetation used will be dormant cuttings of willow and cottonwood. The result of planting/seeded operations is to closely reflect conditions at the reference site but immediate soil stabilization requirements may necessitate deviations, such as a greater concentration of annual grasses or other vegetation.

The coir log and fill placement will not occur within moisture regime zones 1 and 2 but will begin at the transition between zones 3 and 4. Sandbar willow (*Salix interior*) will be planted in zone 3 (across the coir log) to mimic the reference reach and reduce high water forces acting upon the restored stream bank.

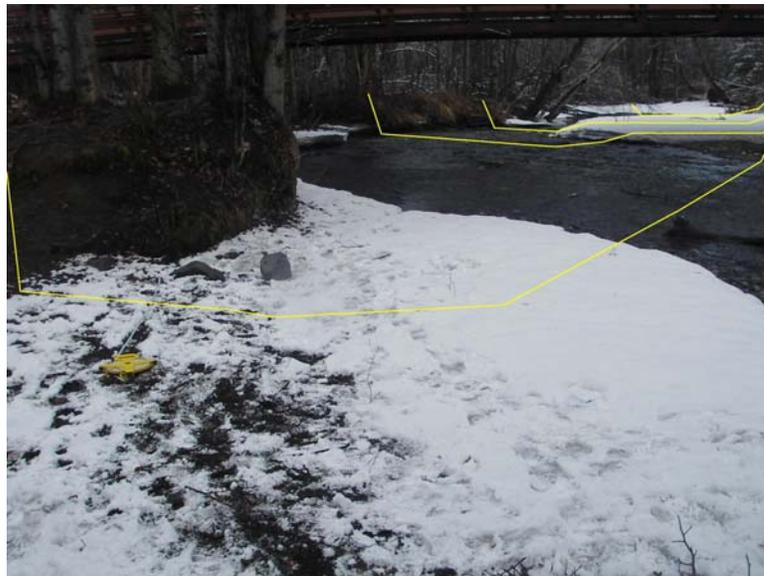
Figure 6, Cross-sections (yellow) to be surveyed for monitoring of stream channel response to restoration action.

Four stream cross-sections (Figure 6) will be used to monitor affects from restoration efforts. Each cross-section will be surveyed once before restoration efforts begin and annually (mid-June) thereafter to identify stream channel fill/scour characteristics and excessive downstream stream bank erosion. Survey results will be inputted to WinXS-Pro, cross-section computer model, for trend analysis. Excess erosion trends will be determined using empirical knowledge of the fluvial geomorphic system. Mitigation measures to excess erosion may consist of stream bank reinforcement, in-stream structures to reduce flow velocities. Primary restoration objectives for this project include improving bank and floodplain stability by increasing riparian vegetation cover and root mass. A monitoring study should include objectives to measure the effectiveness of riparian vegetation restoration. A monitoring study should answer the following questions: (1) did planted vegetation survive at an acceptable rate? (2) did the restoration practice increase the cover of riparian vegetation?
