Red Devil Mine Retort Building Demolition and Limited Site Investigation

**Retort Building Demolition
and Site Investigation
Red Devil Mine
Red Devil, Alaska**

HLA Project 51192

March 30, 2001

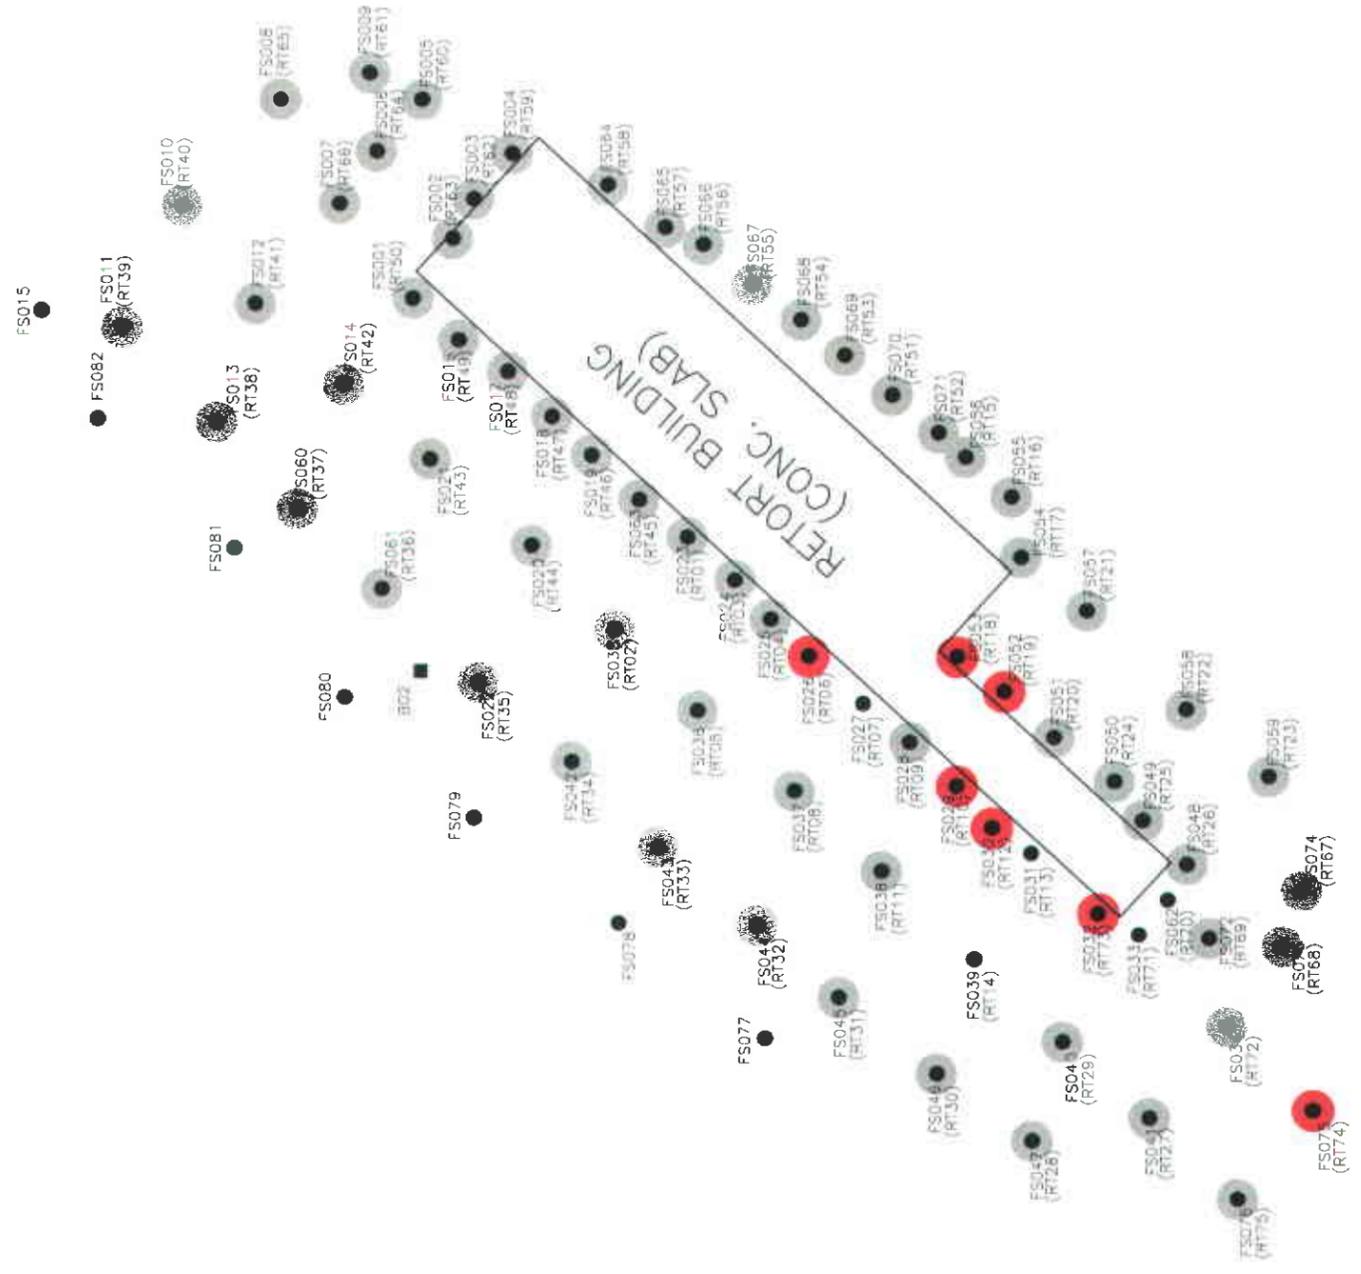
XRF Mercury in Retort Building Area Soil (Sample Interval of 1.5-3.0 feet bgs)

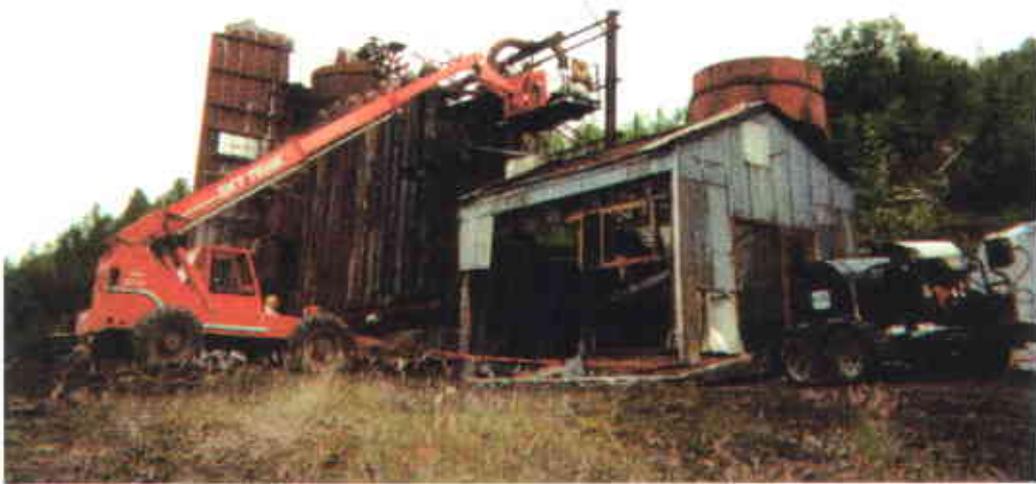
July 21, 2000 – Asbestos removal, west side of Retort Building

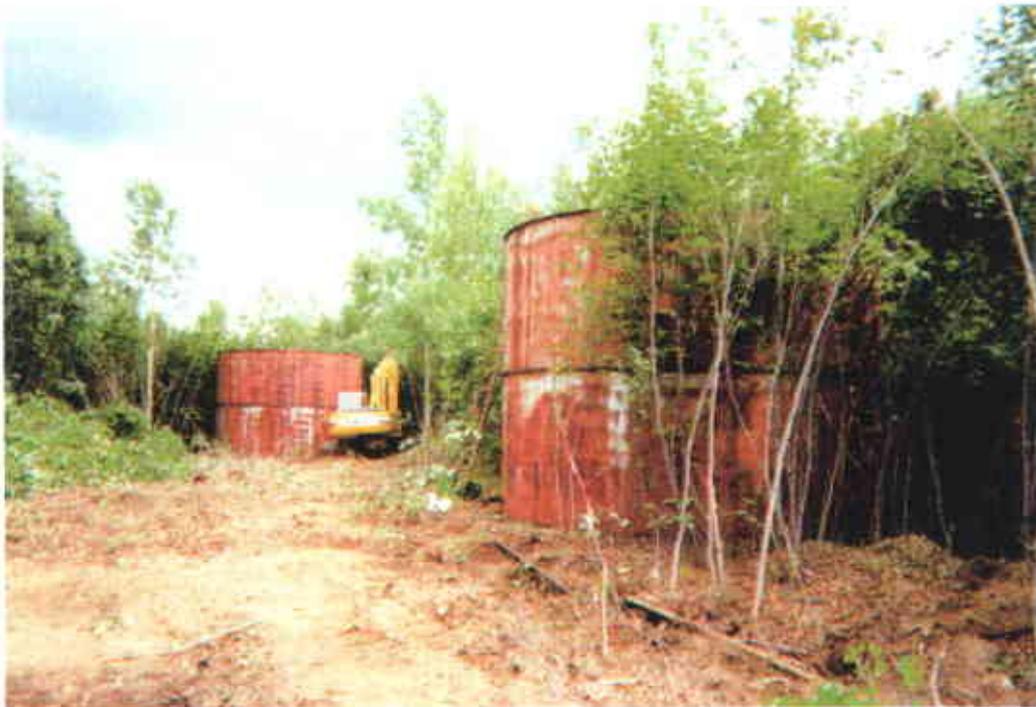
July 21, 2000 – Track hoe used to remove brush and improve access to lower ASTs No. 1 and 2

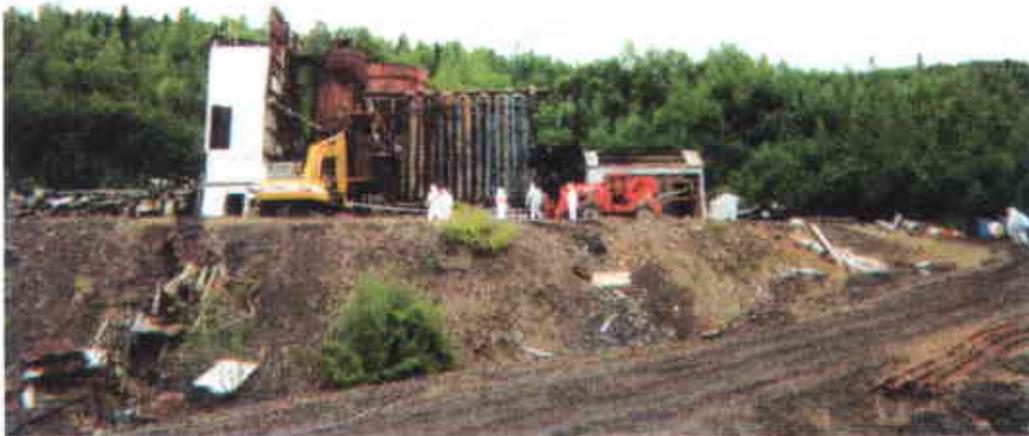
July 23, 2000 – Retort Building before removal of condenser pipe manifold

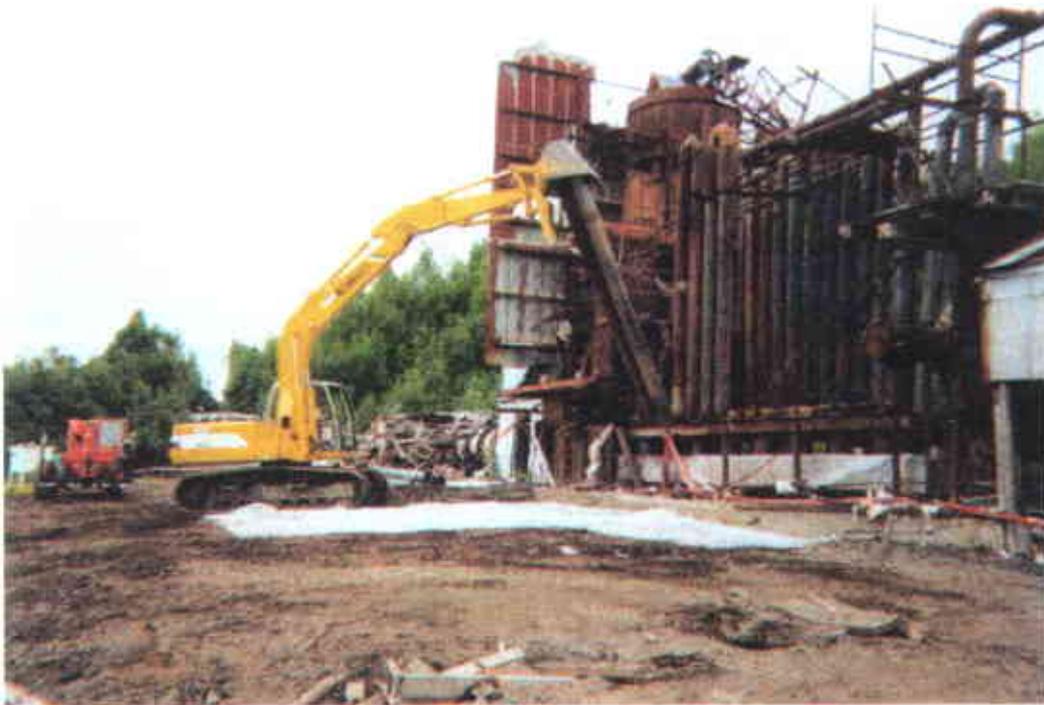
July 23, 2000 – Removal of metal condensing piping with the excavator

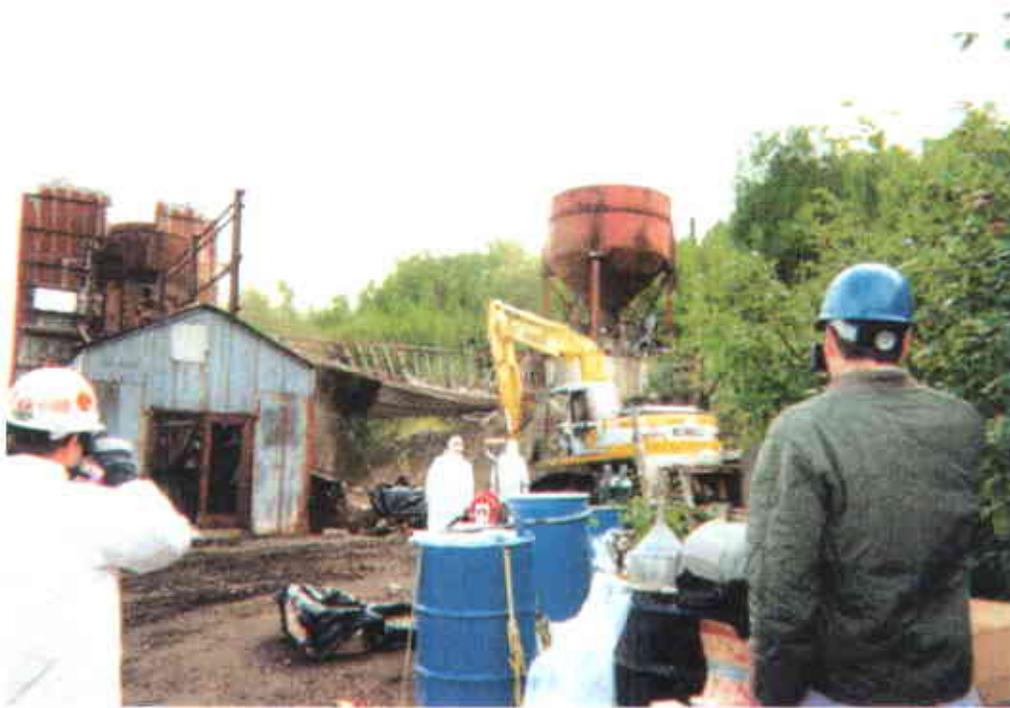
July 26, 2000 – Demolition activities with the excavator
(Removal of conveyor belt)

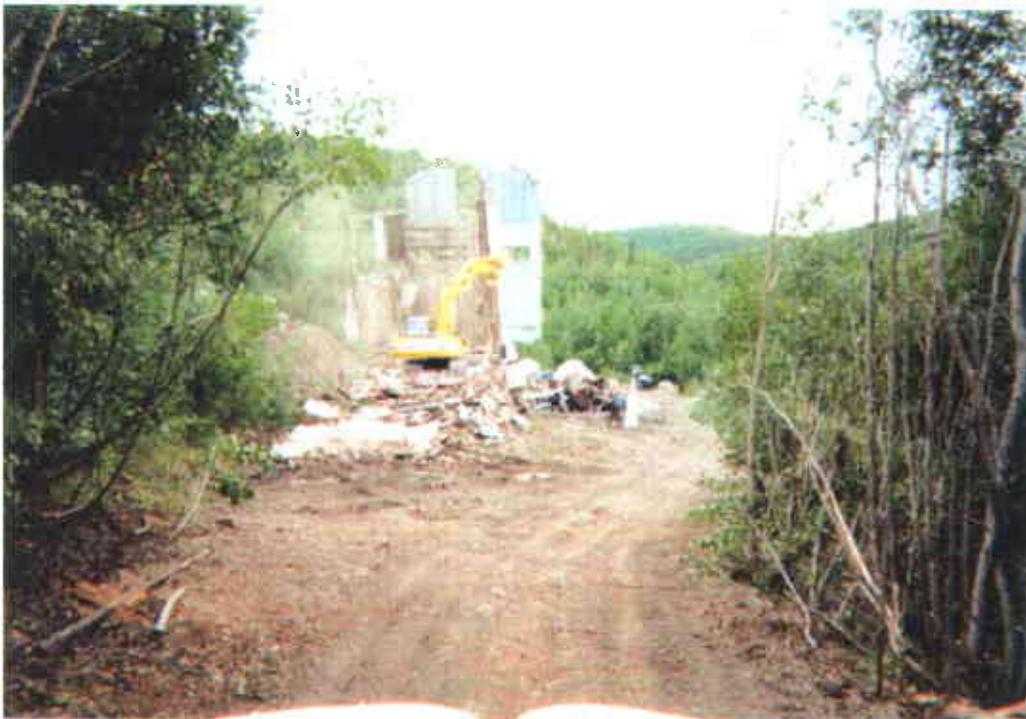
July 26, 2000 – Demolition of north end of Retort Building

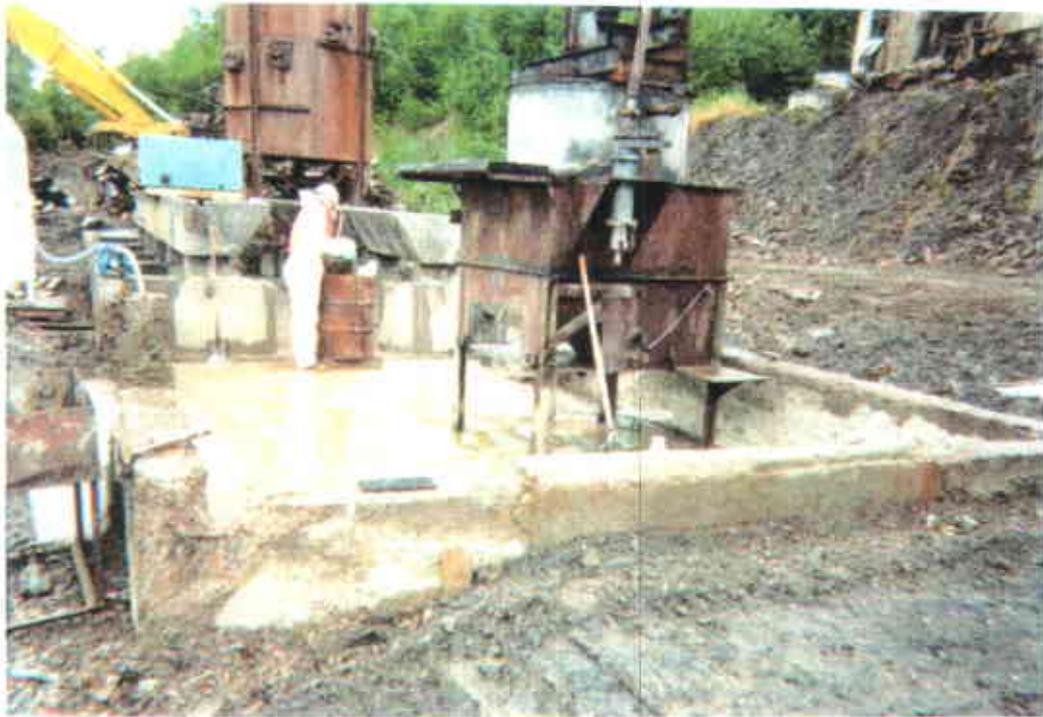
July 28, 2000 – Retout Building pad cleaning activities.

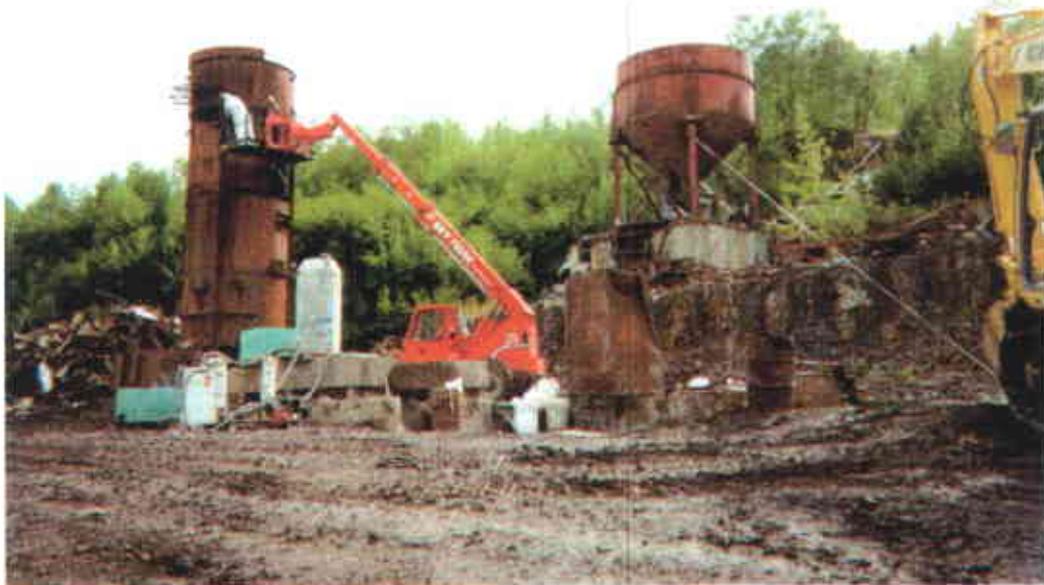
July 30, 2000 – Demolition activities with manlift (Preparing to drop upper furnace)

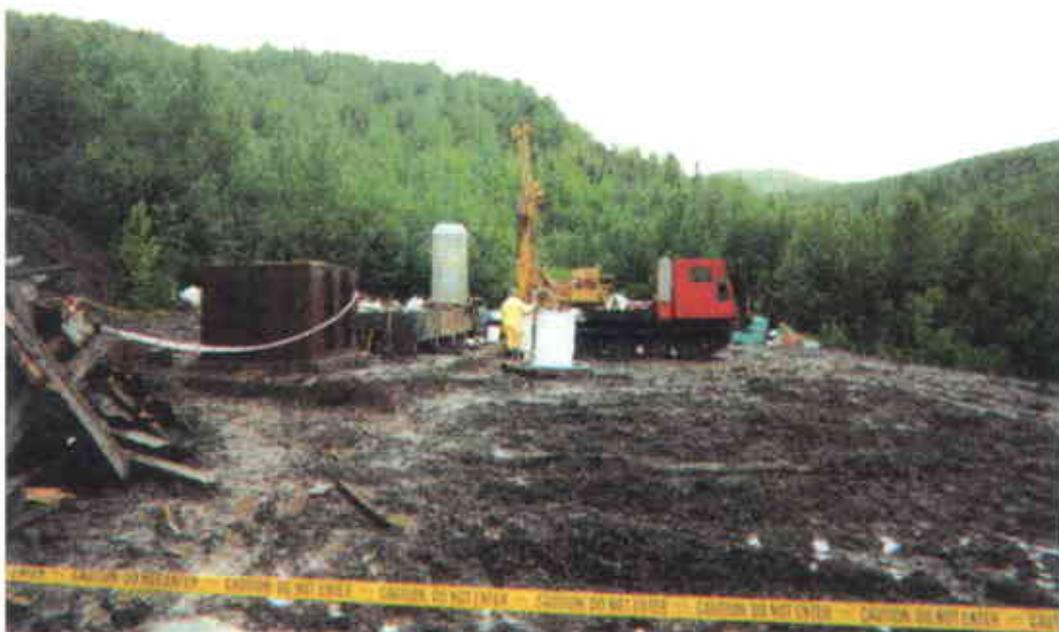
August 2000 – Retort shallow soil boring

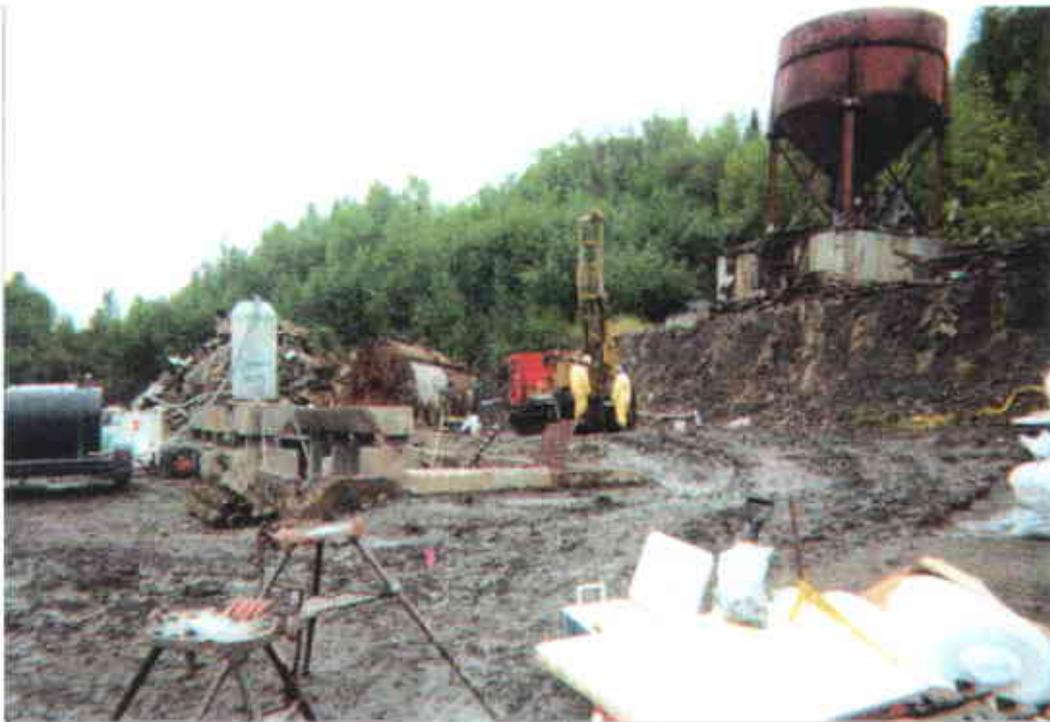
August 2000 – Drilling on east side of Retort Building pad

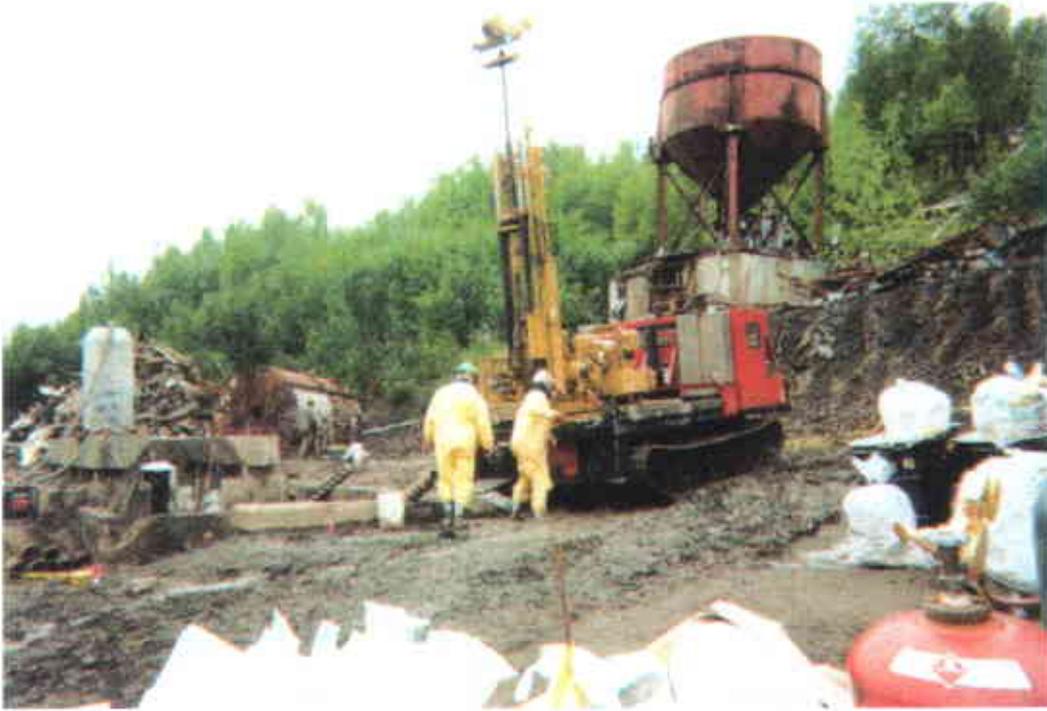
August 2000 – Drilling activities on southeast end of the Retort Building pad area.

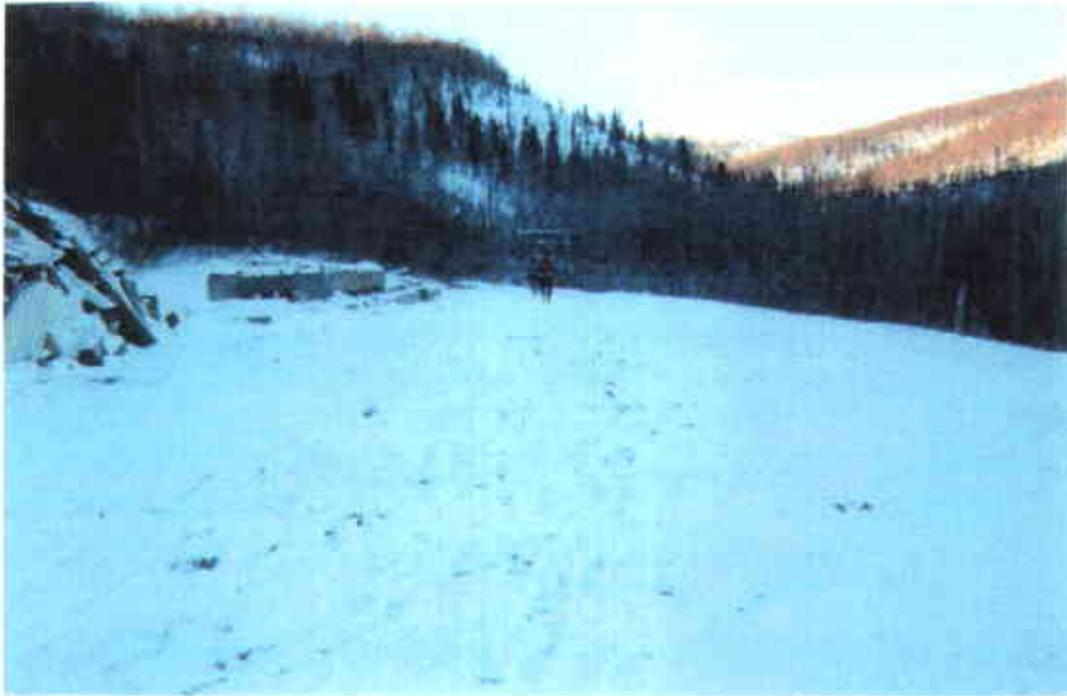
October 2000 – Retort pad and building area

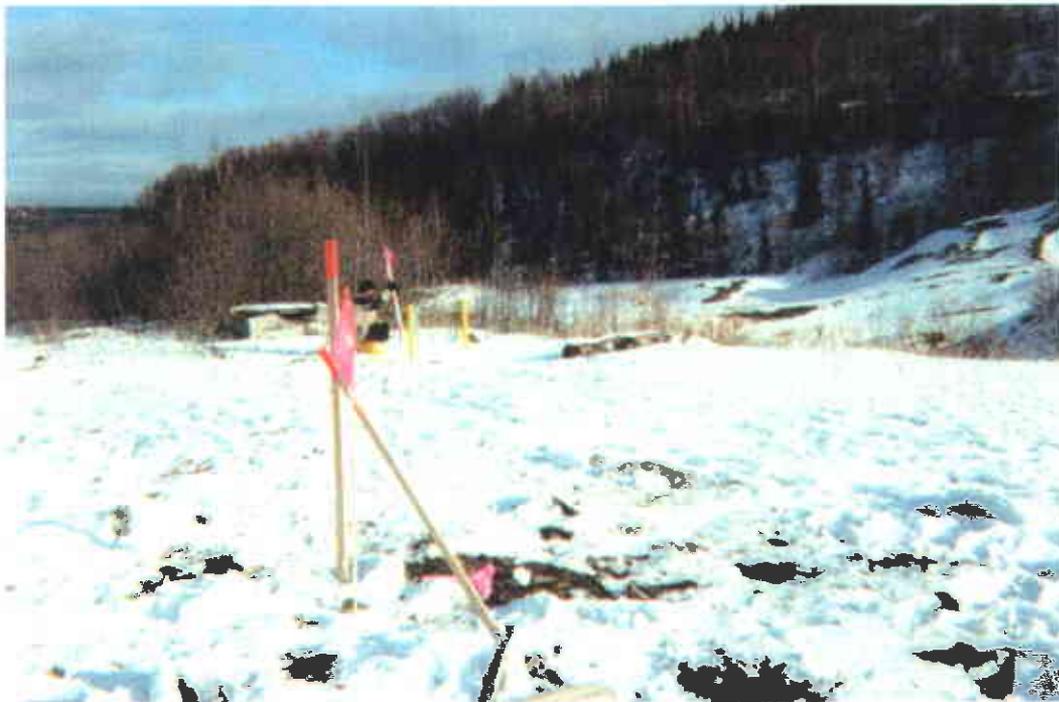
October 2000 – Monitoring well MW04 in the background.
Photograph taken from benchmark #3, looking northeast

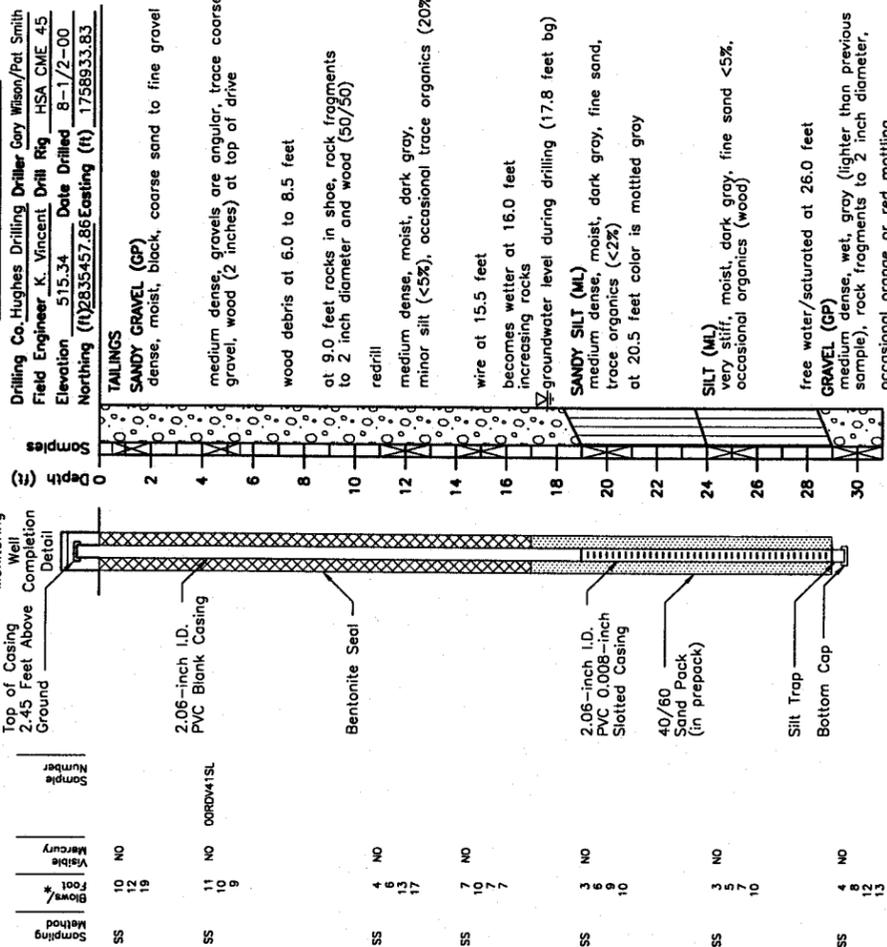
LOG OF BORING B02

Monitoring Well Completion Detail
 Top of Casing 2.45 Feet Above Ground
 2.06-inch I.D. PVC Blank Casing
 Bentonite Seal
 2.06-inch I.D. PVC 0.008-inch Slotted Casing
 40/60 Sand Pack (in prepack)
 Silt Trap
 Bottom Cap

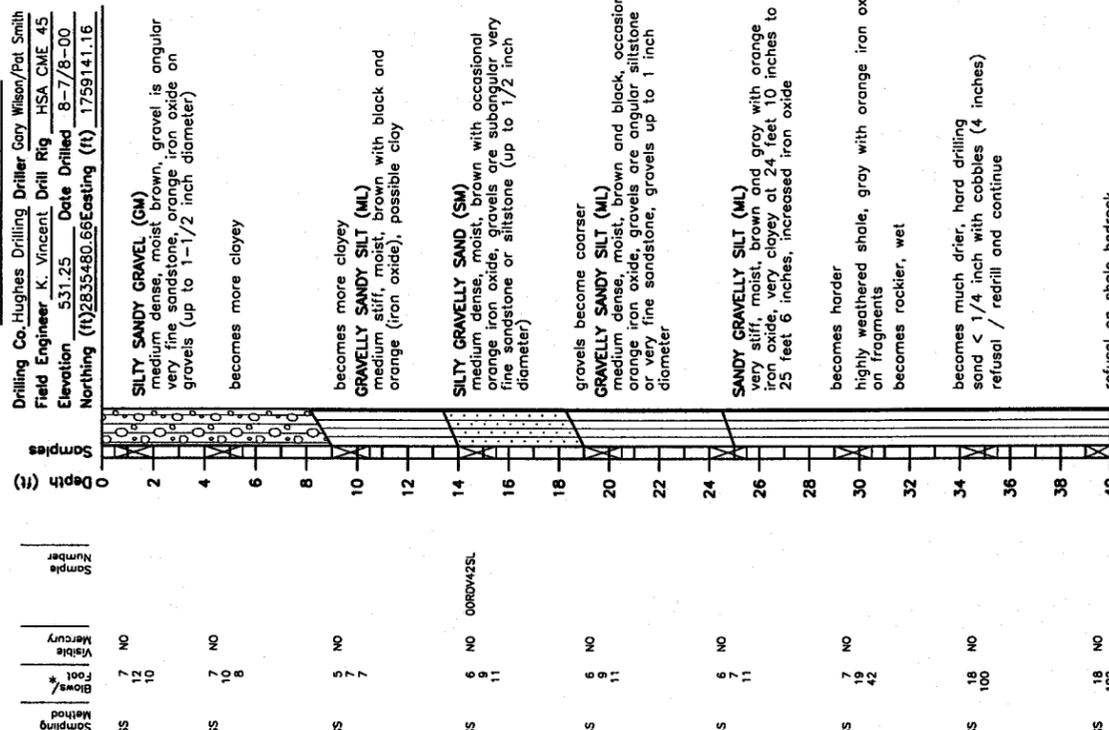
LOG OF BORING B03/MW03

Monitoring Well Completion Detail
 Top of Casing 2.25 Feet Above Ground
 2.06-inch I.D. PVC Blank Casing
 Bentonite Seal
 2.06-inch I.D. PVC 0.008-inch Slotted Casing
 40/60 Sand Pack (in prepack)
 Silt Trap
 Bottom Cap

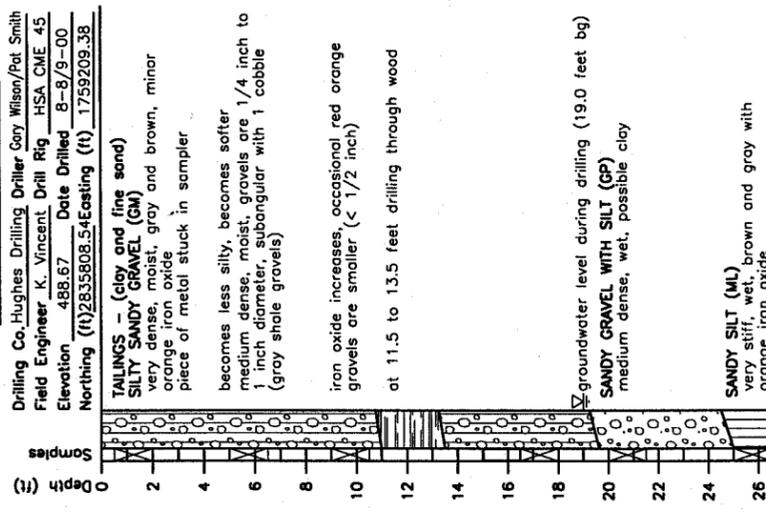
LOG OF BORING B04/MW04

Monitoring Well Completion Detail
 Top of Casing 2.25 Feet Above Ground
 2.06-inch I.D. PVC Blank Casing
 Bentonite Seal
 2.06-inch I.D. PVC 0.008-inch Slotted Casing
 40/60 Sand Pack (in prepack)
 Silt Trap
 Bottom Cap
