***Final
Hazardous Material Removal Summary
Report, Red Top Retort Site, Alaska***

**Final
Hazardous Material Removal Summary Report
Red Top Retort Site, Alaska**

Contract No. L11PX00872

**Prepared for:
Bureau of Land Management
Anchorage Field Office
4700 BLM Road
Anchorage, AK 99507**

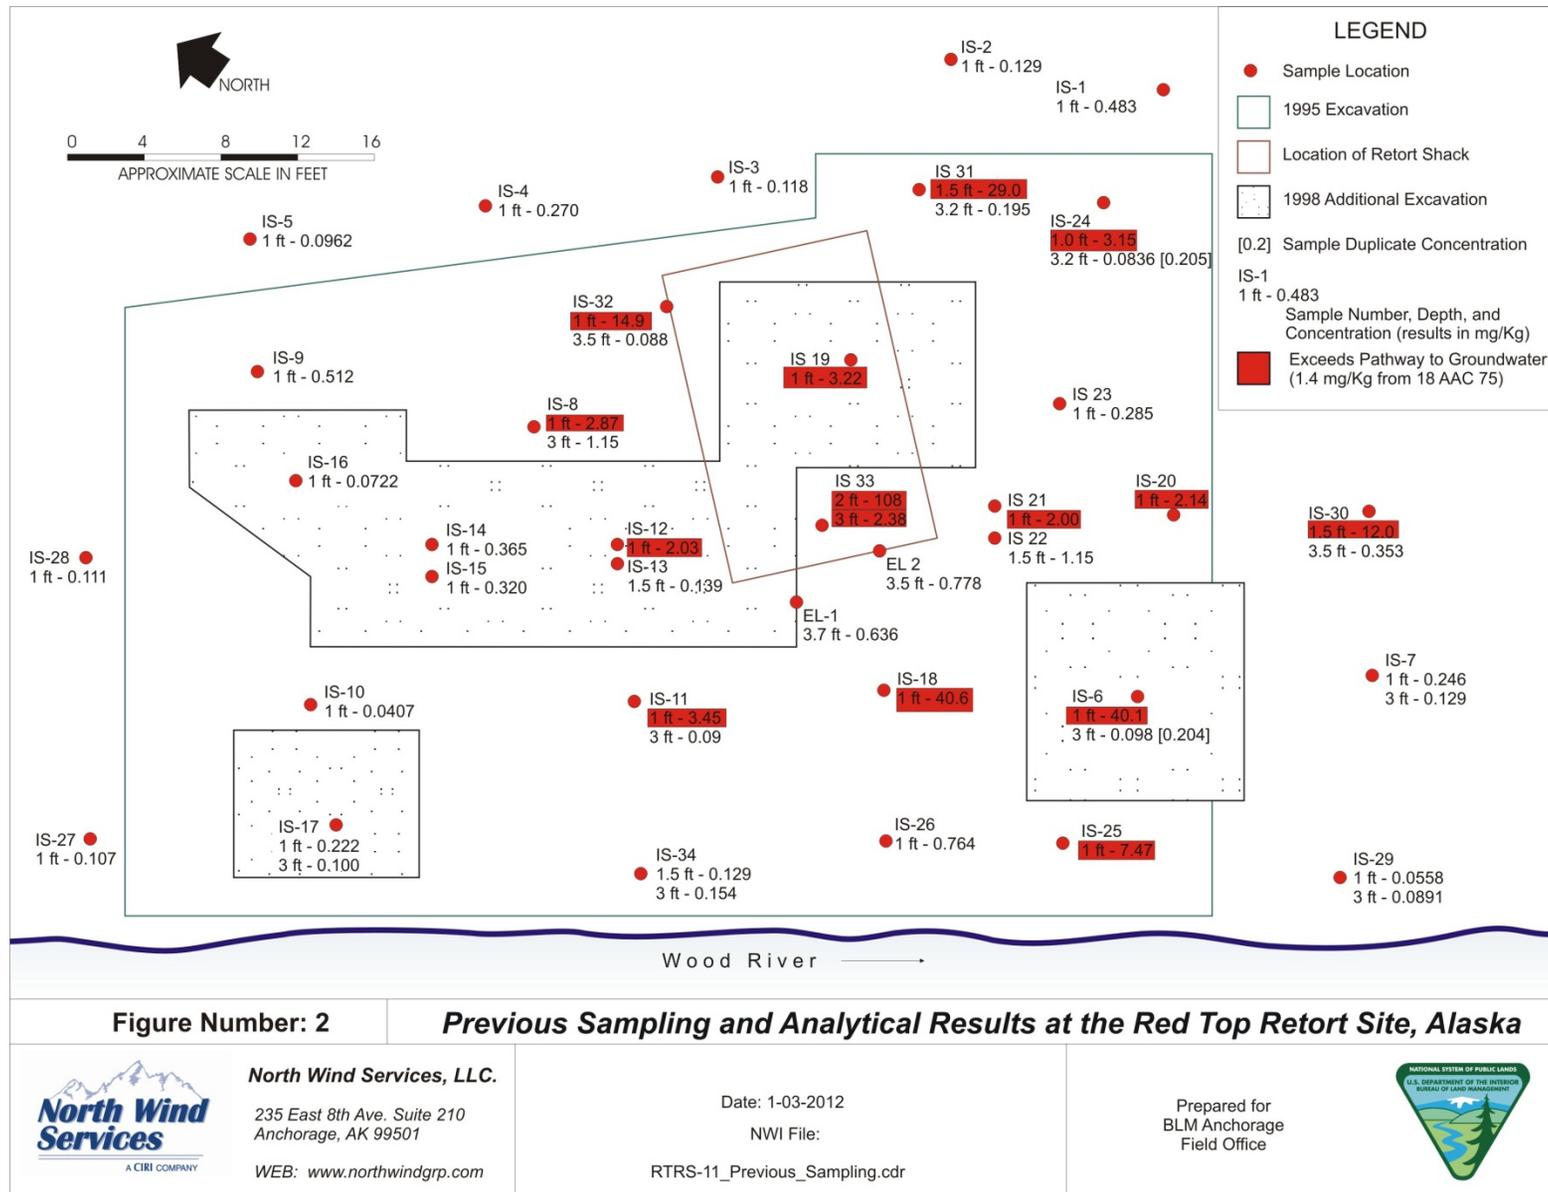
Figure 2. Previous Mercury Sample Locations and Results.

Soil samples were collected in 1998 and 1999 following the excavation of soils at the site (Harding Lawson, 2000). The locations of these previous soil samples, the depth of collection, and the mercury concentrations are shown in Figure 2. The data from these sample locations indicated that the site contains residual mercury contamination exceeding the ADEC soil migration to groundwater cleanup level (1.4 mg/Kg). The mercury contamination was characterized as burned cinnabar ore, unburned cinnabar ore, and native soil that may have been contaminated with elemental mercury that was released from the piping associated with the retort chamber.

Analytical data indicated that the residual mercury contamination ranged from a low of 0.1 mg/Kg to a high of 108 mg/Kg directly below the location of the former retort chamber. Most of the mercury contamination identified above ADEC cleanup levels was located at a depth of approximately 1 foot below ground surface (bgs). However, in small areas, contamination above the ADEC cleanup levels appeared to extend to a maximum depth of approximately 3 feet bgs. The sampling data from 1998 and 1999 are presented in Table 1.

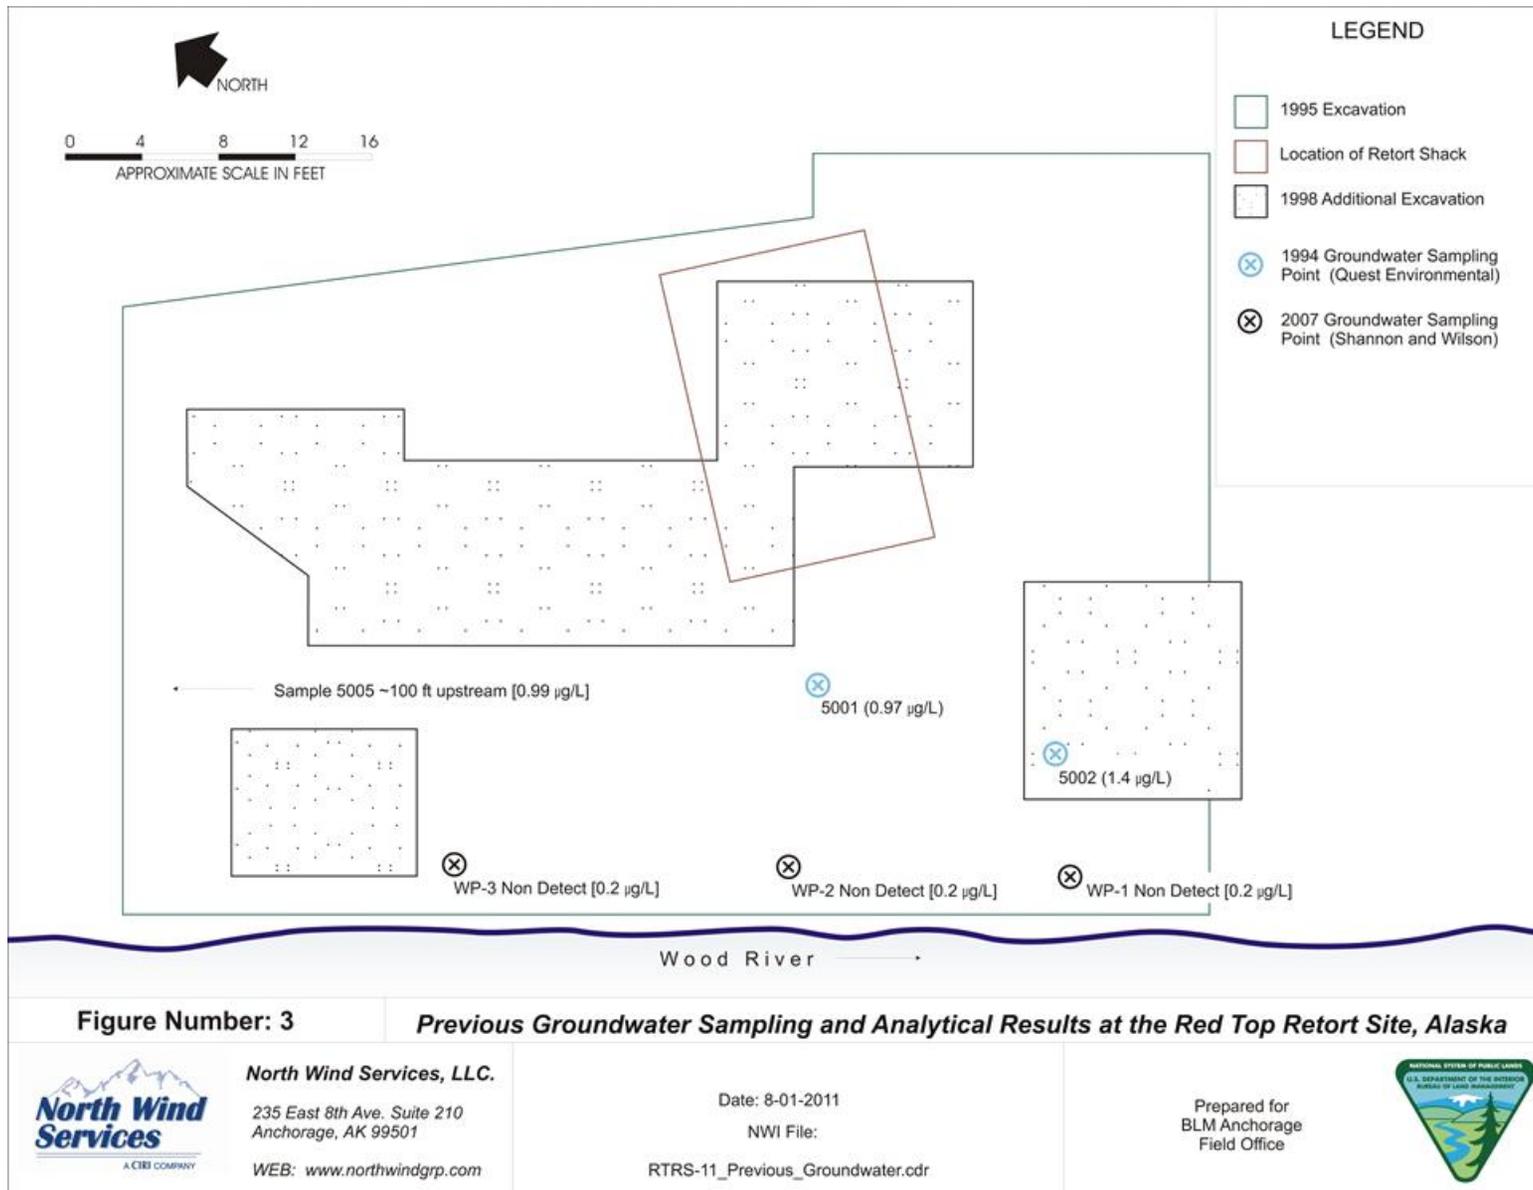
Figure 3. Previous Groundwater Sample Locations.

In August of 2007, three temporary well points were installed along the bank of the Wood River adjacent to the RTRS, as shown in Figure 3 (Shannon and Wilson, 2008). The temporary wells were installed to assess the potential for the presence of mercury in the groundwater. The temporary well points were constructed of 3/4-inch-diameter stainless steel pipe with a 1-foot long stainless steel screen at the end. The groundwater samples collected from the three well points were all found to have non-detect concentrations of mercury at a practical quantification limit of 0.2 µg/L.

All groundwater samples collected in 1994 and 2007 were less than the groundwater cleanup level of 2.0 µg/L for mercury, as specified in 18 AAC 75.345, Table C. The temporary groundwater sampling points were removed following the 2007 sampling event.

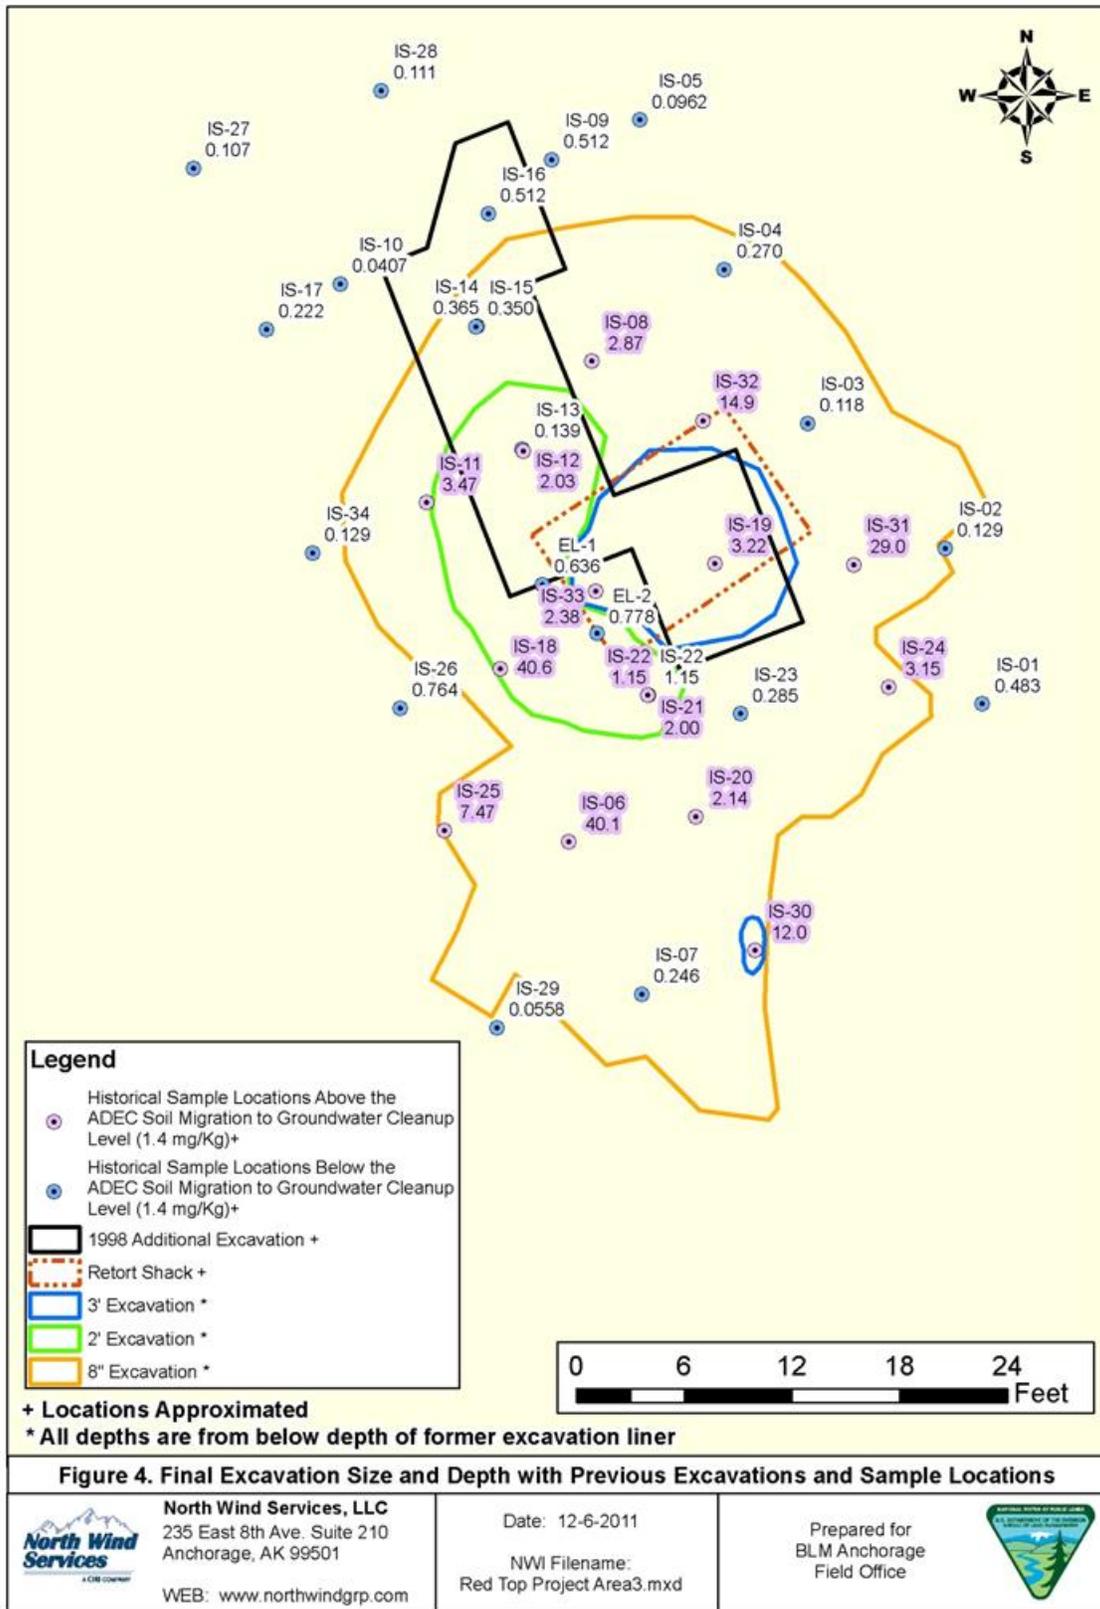
Figure 4. Final Excavation Size and Depth with Previous Excavations and Sample Locations.

Field screening of the bottom and side-walls of the excavation occurred concurrently with soil removal to guide the direction of the excavation activities. A final field screening was conducted after all soil removal was complete. The final screening was conducted on a 1-meter grid on the bottom of the excavation and a 2-meter linear interval on the side-wall of the excavation. The field screening interval adopted was more conservative than the ADEC cleanup requirements obtained from Table 2B of the "Draft Field Sampling Guidance" (ADEC, 2010), which are 1 screening per 100 square feet for the bottom of the excavation and 1 screening per 10 linear feet on the sidewall. The final area and perimeter for the excavation was approximately 1,100 square feet and 130 feet, respectively. The ADEC field screening guidance required 11 bottom samples and 13 sidewall samples. During the final confirmation screening of the excavation, approximately 90 bottom samples and 20 sidewall samples were screened. All final field screening results for mercury, using the XRF unit, were non-detect. The XRF unit was checked daily using the check source per manufacturer's instructions and documented in the field logbook.

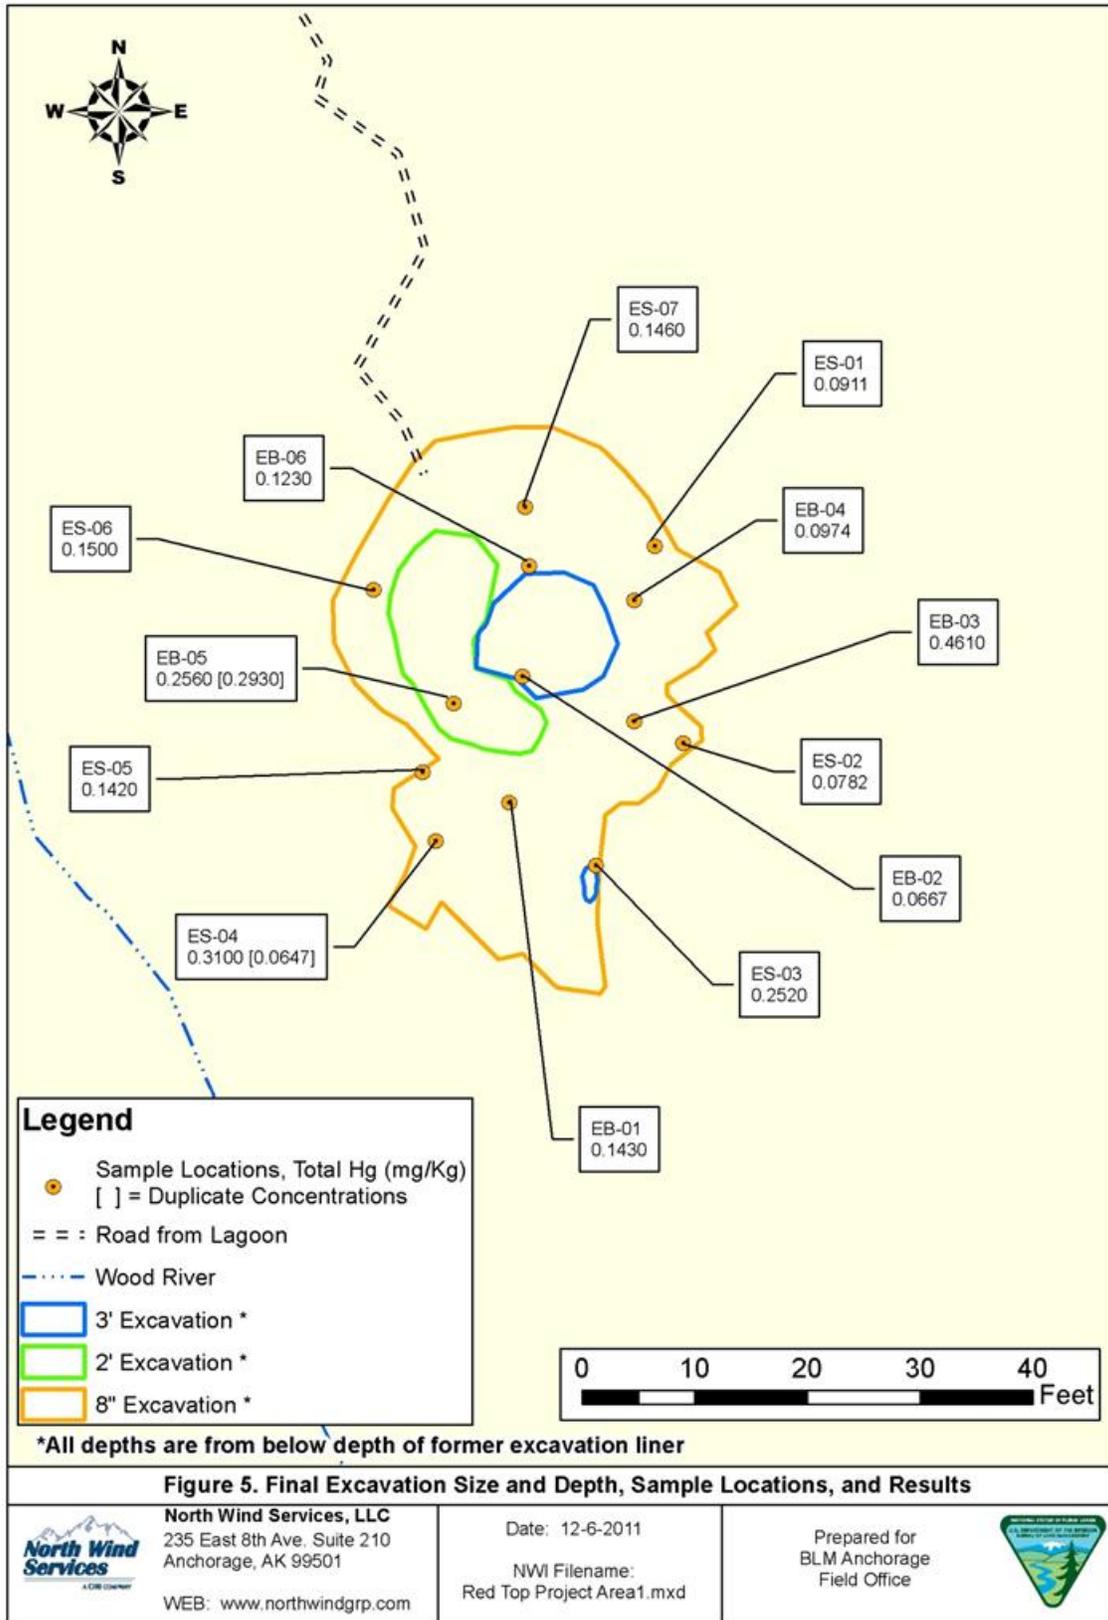
Figure 5. Final Excavation Size and Depth, Sample Locations, and Results.

On September 16, 2011, the team returned to RTRS to remove additional mercury contaminated soil from the western section of the excavation. West of the 3-foot excavation area, approximately 1 foot of soil was removed (see Figure 5). The handheld XRF unit was used to guide the excavation effort and to ensure that all contamination above the cleanup level was removed. After the additional excavation effort, another confirmation sampling event occurred and consisted of six grab samples from the floor of the excavation plus one duplicate. Seven grab samples were taken from the sidewalls of the excavation. All follow-up samples were collected from the same locations as the initial samples. All soil samples were analyzed for mercury (EPA Method SW7471B). One grab sample from the decontamination water rinsate was submitted with this sample group and analyzed for total mercury (EPA Method SW7470A/E245.1). All new sample locations were documented using a GPS unit.

The samples from the backfill source and supersacks were not resampled because the results came back as non-detect or showed very low levels of mercury, and it was decided that having these results estimated would not impact the intended use of the data.

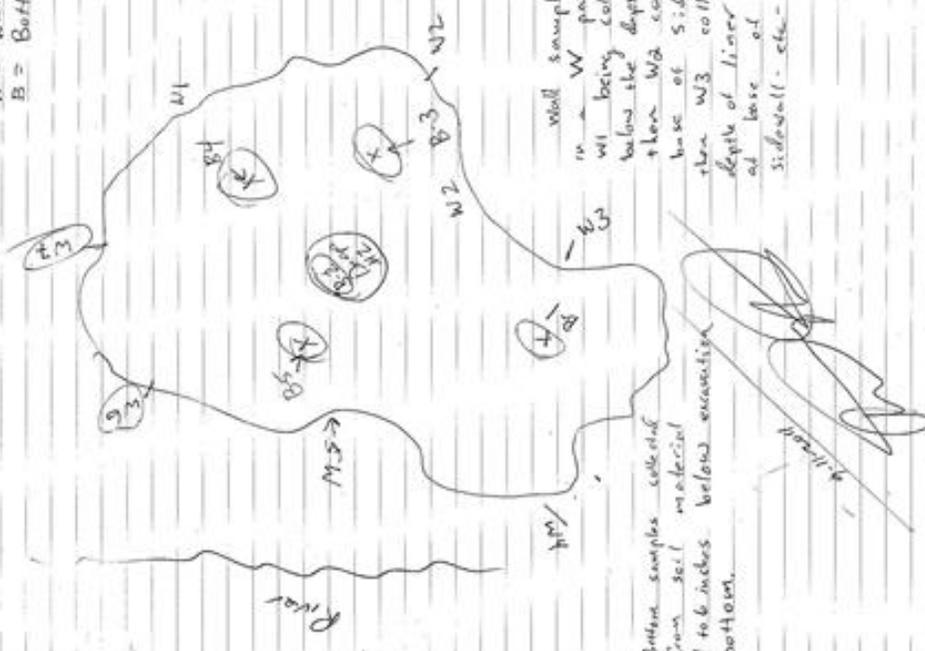
W = wall samples
 B = Bottom samples

Wall samples collected in W pattern with W1 being collected at depth below the depth of liner - then W2 collected at base of side wall and then W3 collected at depth of liner then W4 at base of excavation sidewall - etc.

Bottom samples collected from soil material 1 to 6 inches below excavation bottom.

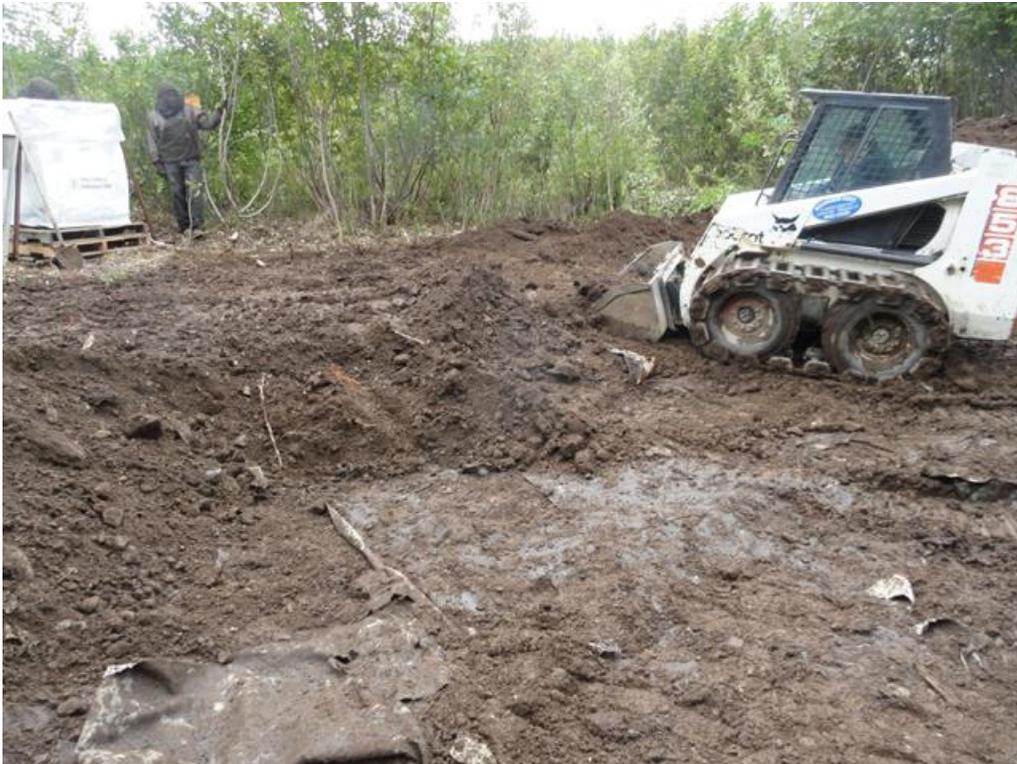
Photograph 8. SITE CLEARING. Removing clean soil overburden from top of liner.

After the vegetation had been cleared, the crew began removing the top soil from above the former excavation liner using the front bucket of the Bobcat. As the excavation neared the liner, soils were removed using hand shovels in order to prevent damage to the liner. Soils in contact with the liner were screened for mercury contamination using an Innov-X Delta model DP-4000 x-ray fluorescence (XRF) unit to ensure the overburden was clean. All measurements from soils above the liner were non-detect for mercury on the XRF. Depths of topsoil above the liner were approximately a foot.

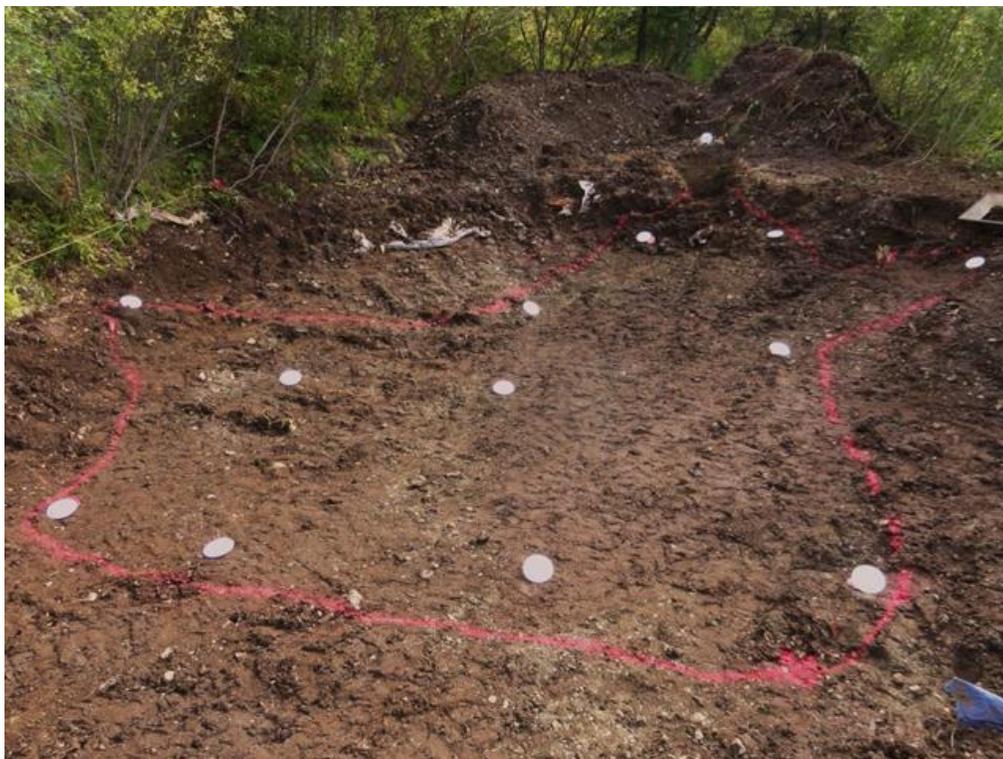
Photograph 10. EXCAVATION. Previous sample locations and outline of the approximate excavation area are marked.

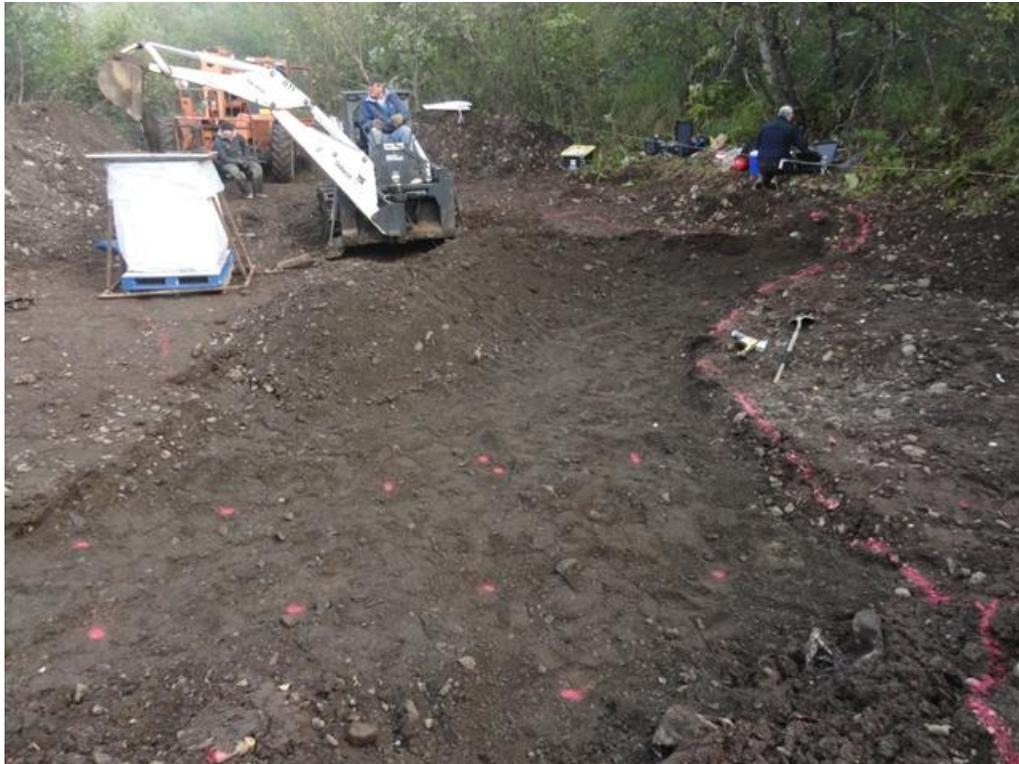
Photograph 12. EXCAVATION. Layout of XRF field screening locations in one meter grids.

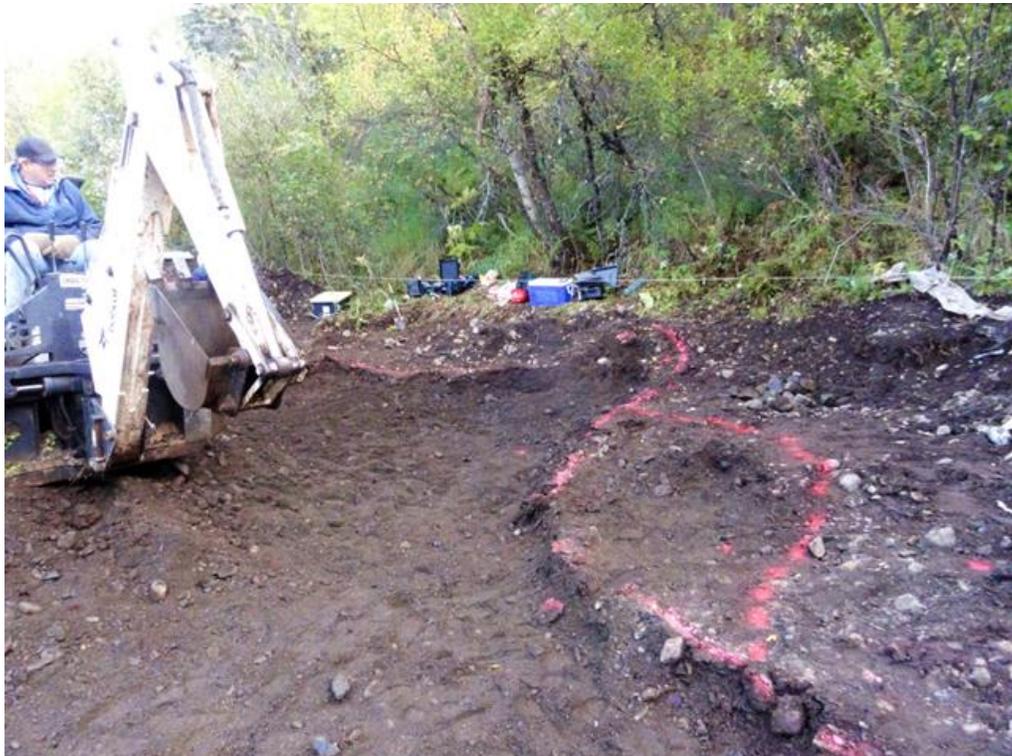
Photograph 14. EXCAVATION. Expanding the contamination boundary to include historical sample location IS-24 due to contamination.

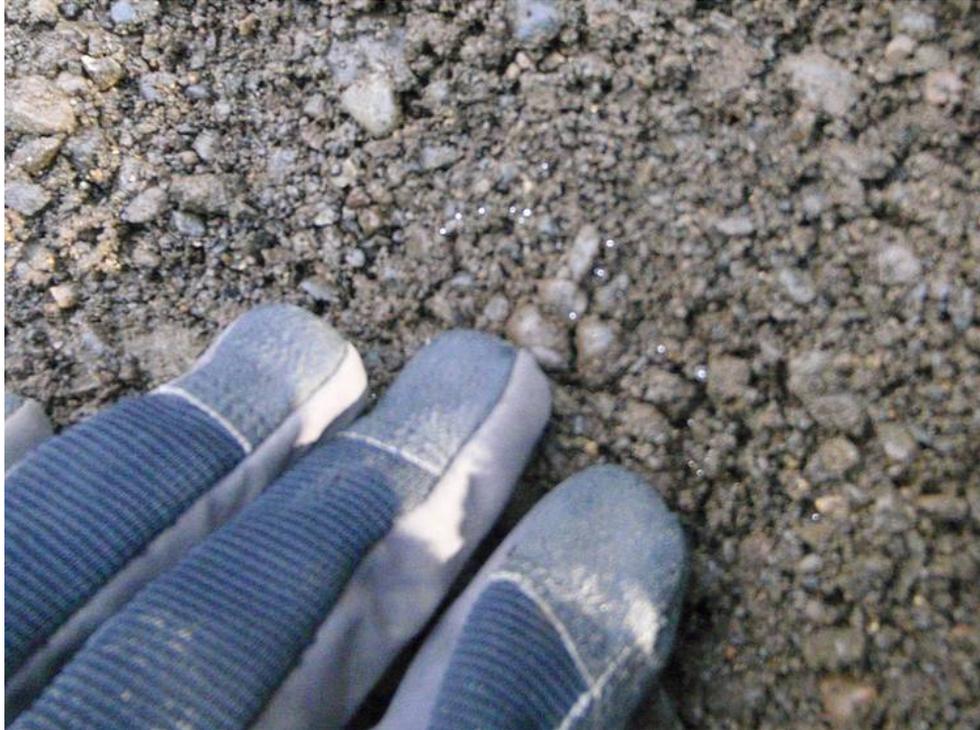
Photograph 15. EXCAVATION. Free mercury near historical sample location IS-33. Note tip of glove in the photograph for scale.

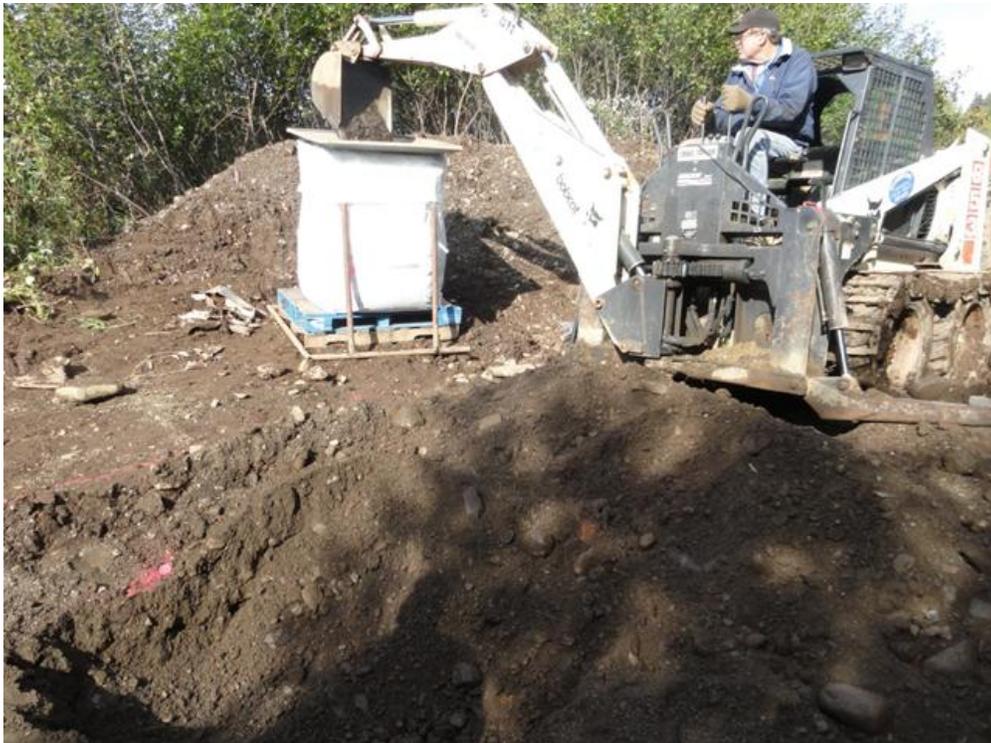
Photograph 16. EXCAVATION. Remove contaminated soil at IS-33 and containerization in a 1-cubic yard supersack.

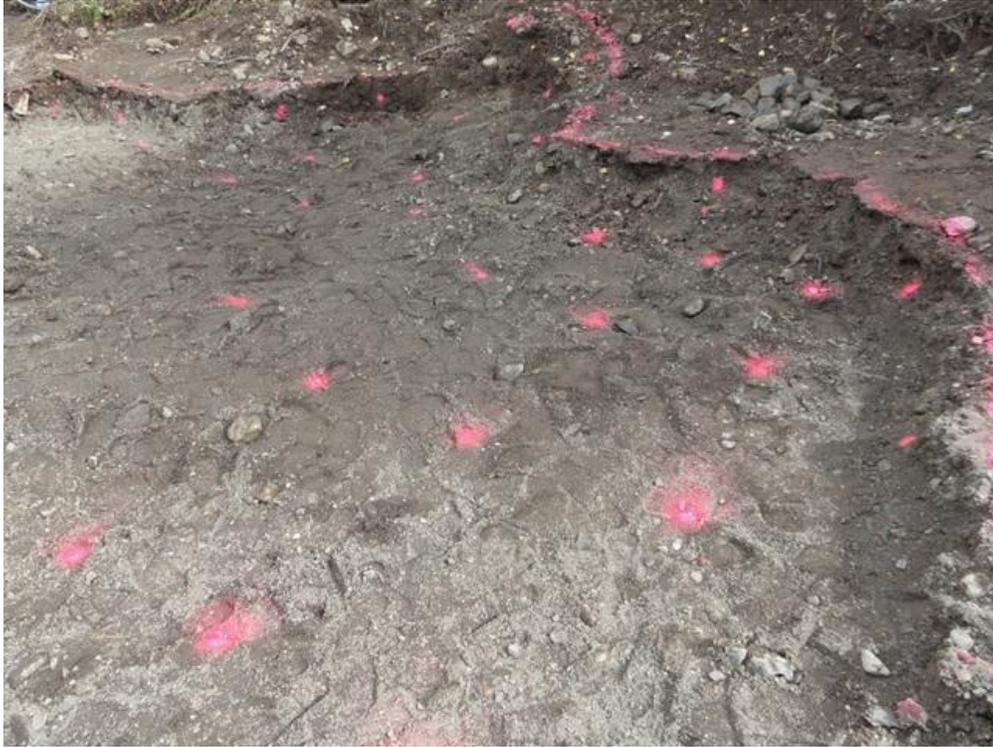
Photograph 17. EXCAVATION. XRF field screening locations in the south-east quadrant of the excavation.

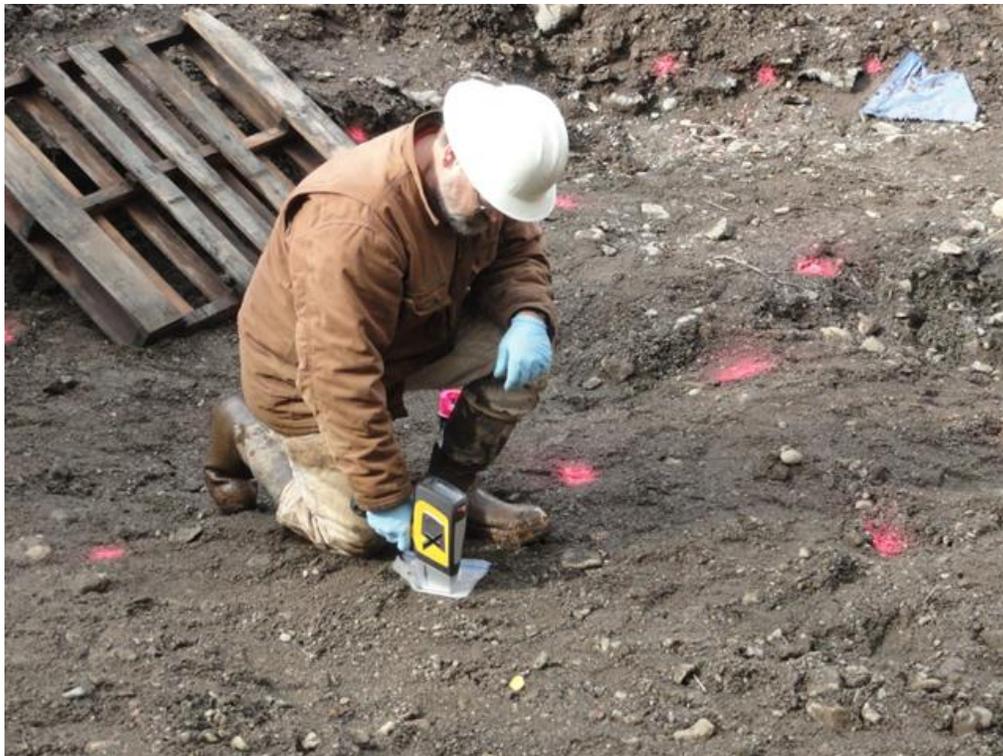
Photograph 18. EXCAVATION. Field screening for mercury using a hand held XRF unit.

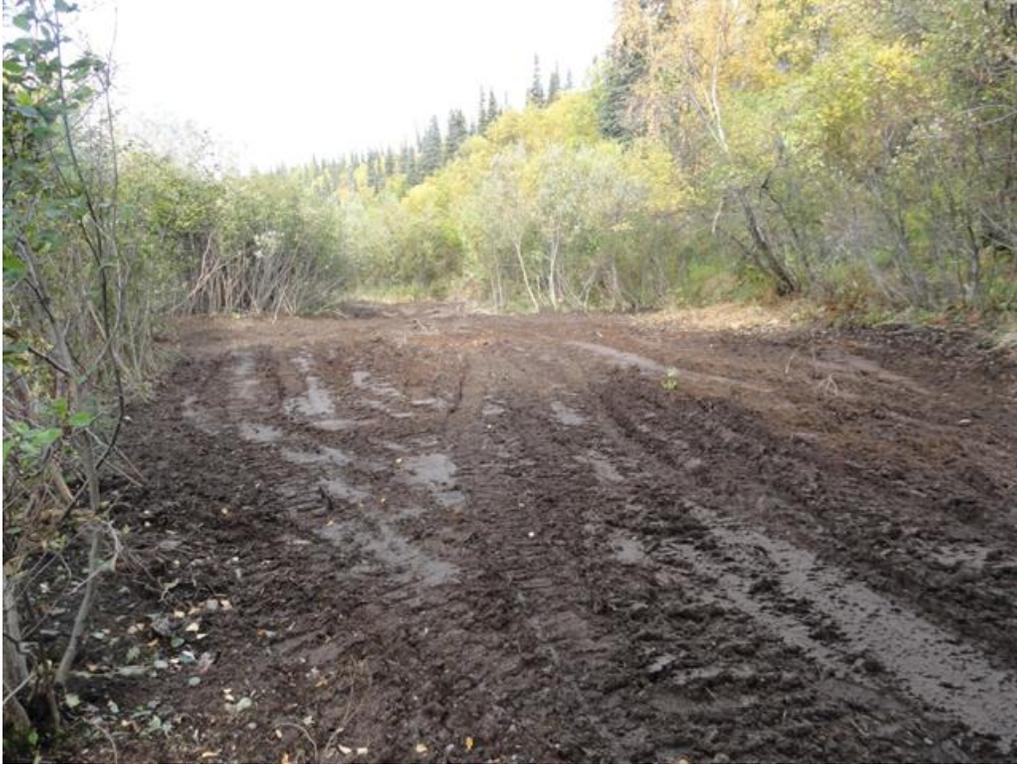
Photograph 23. SITE RESTORATION. Grade and appearance of site after backfill and re-vegetation.
