## REPORT

### RED DEVIL MINE 2002 DEBRIS CONSOLIDATION AND DISPOSAL PROJECT

### RED DEVIL, ALASKA

March 17, 2003

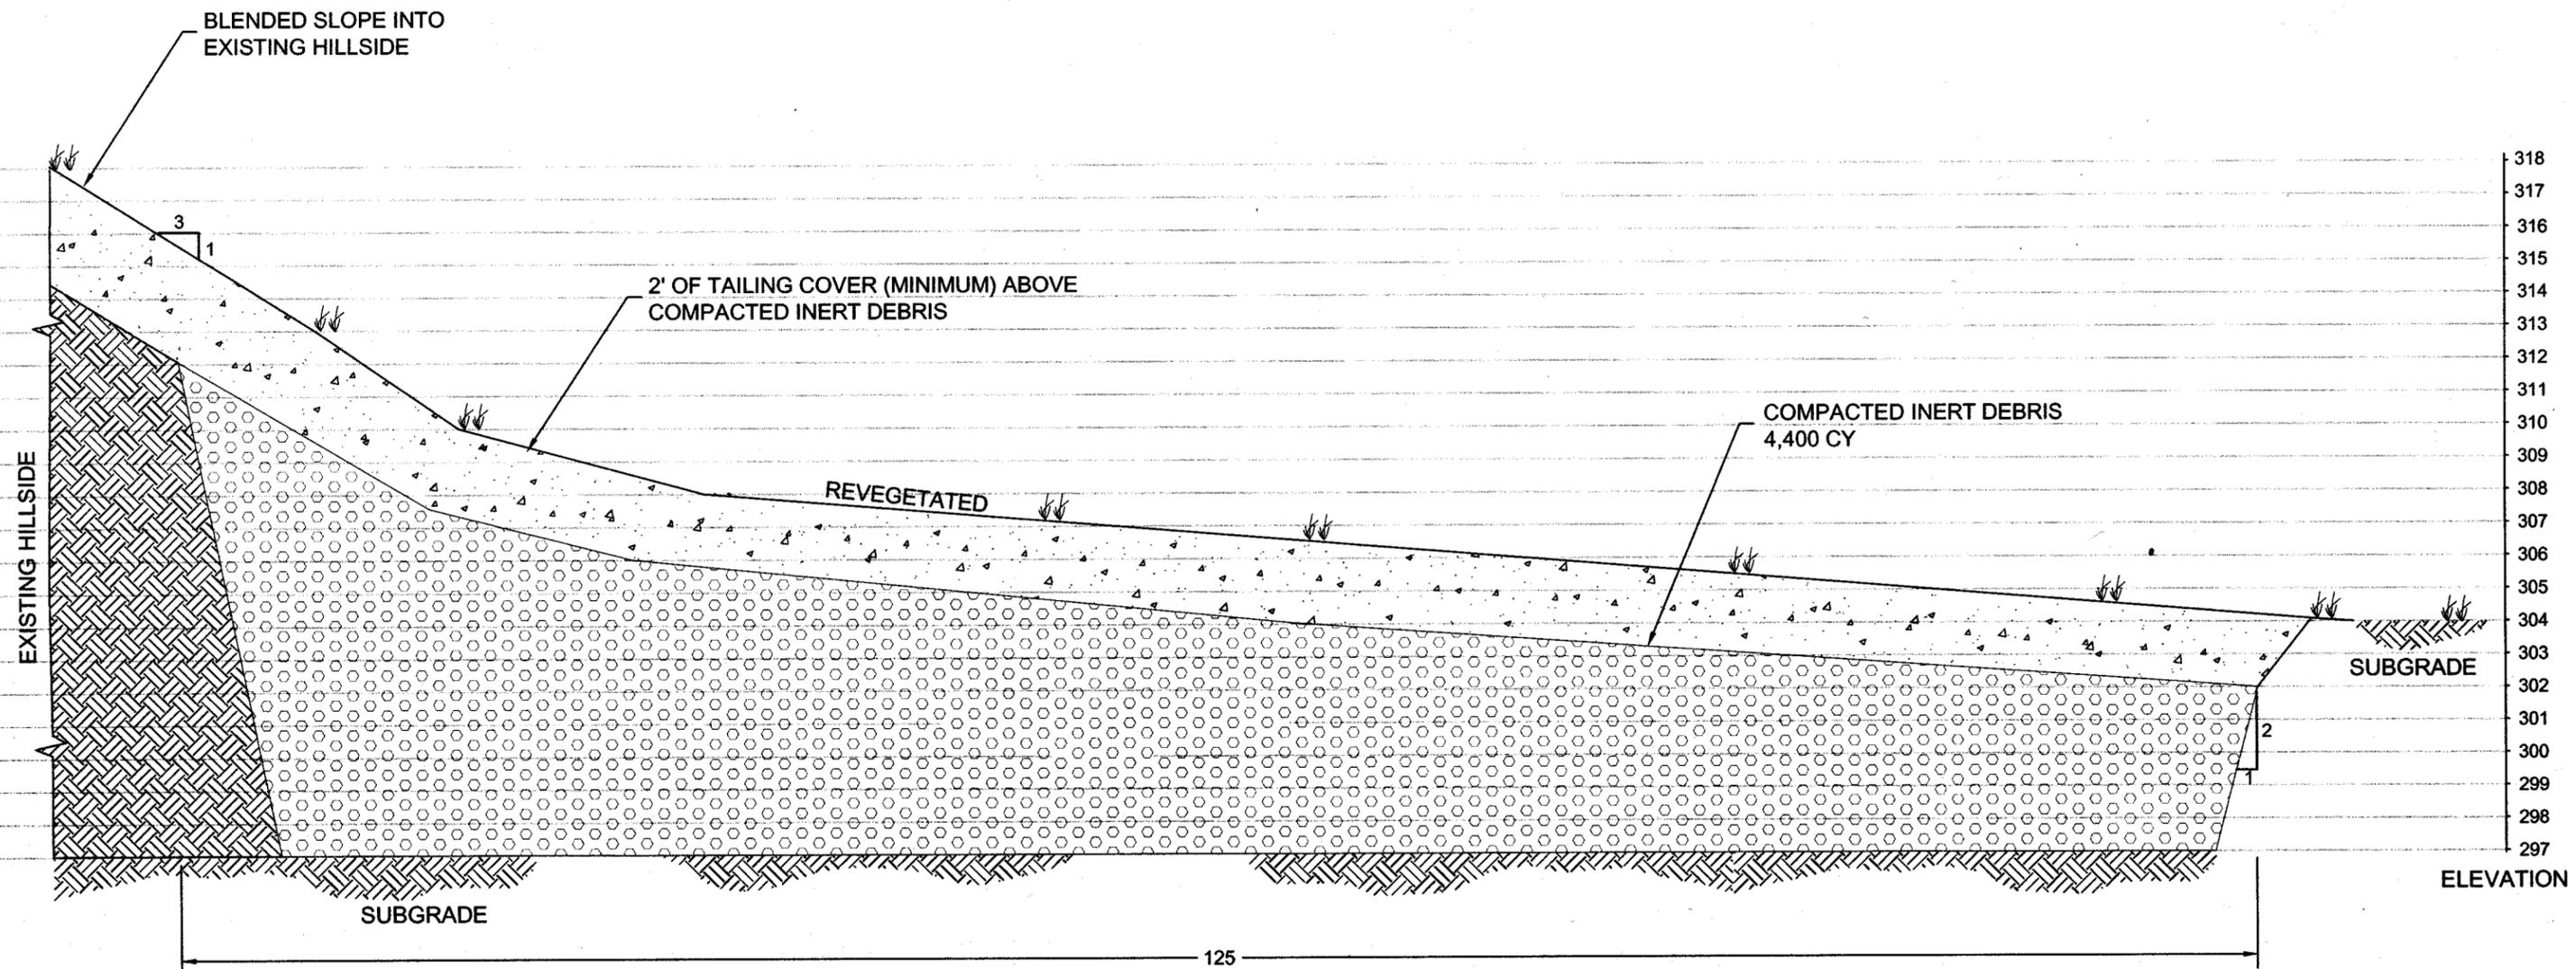
**SECTION A-A: TYPICAL SECTION**

APPROXIMATE SCALE: 1" = 10' HORIZONTAL, 1" = 5' VERTICAL

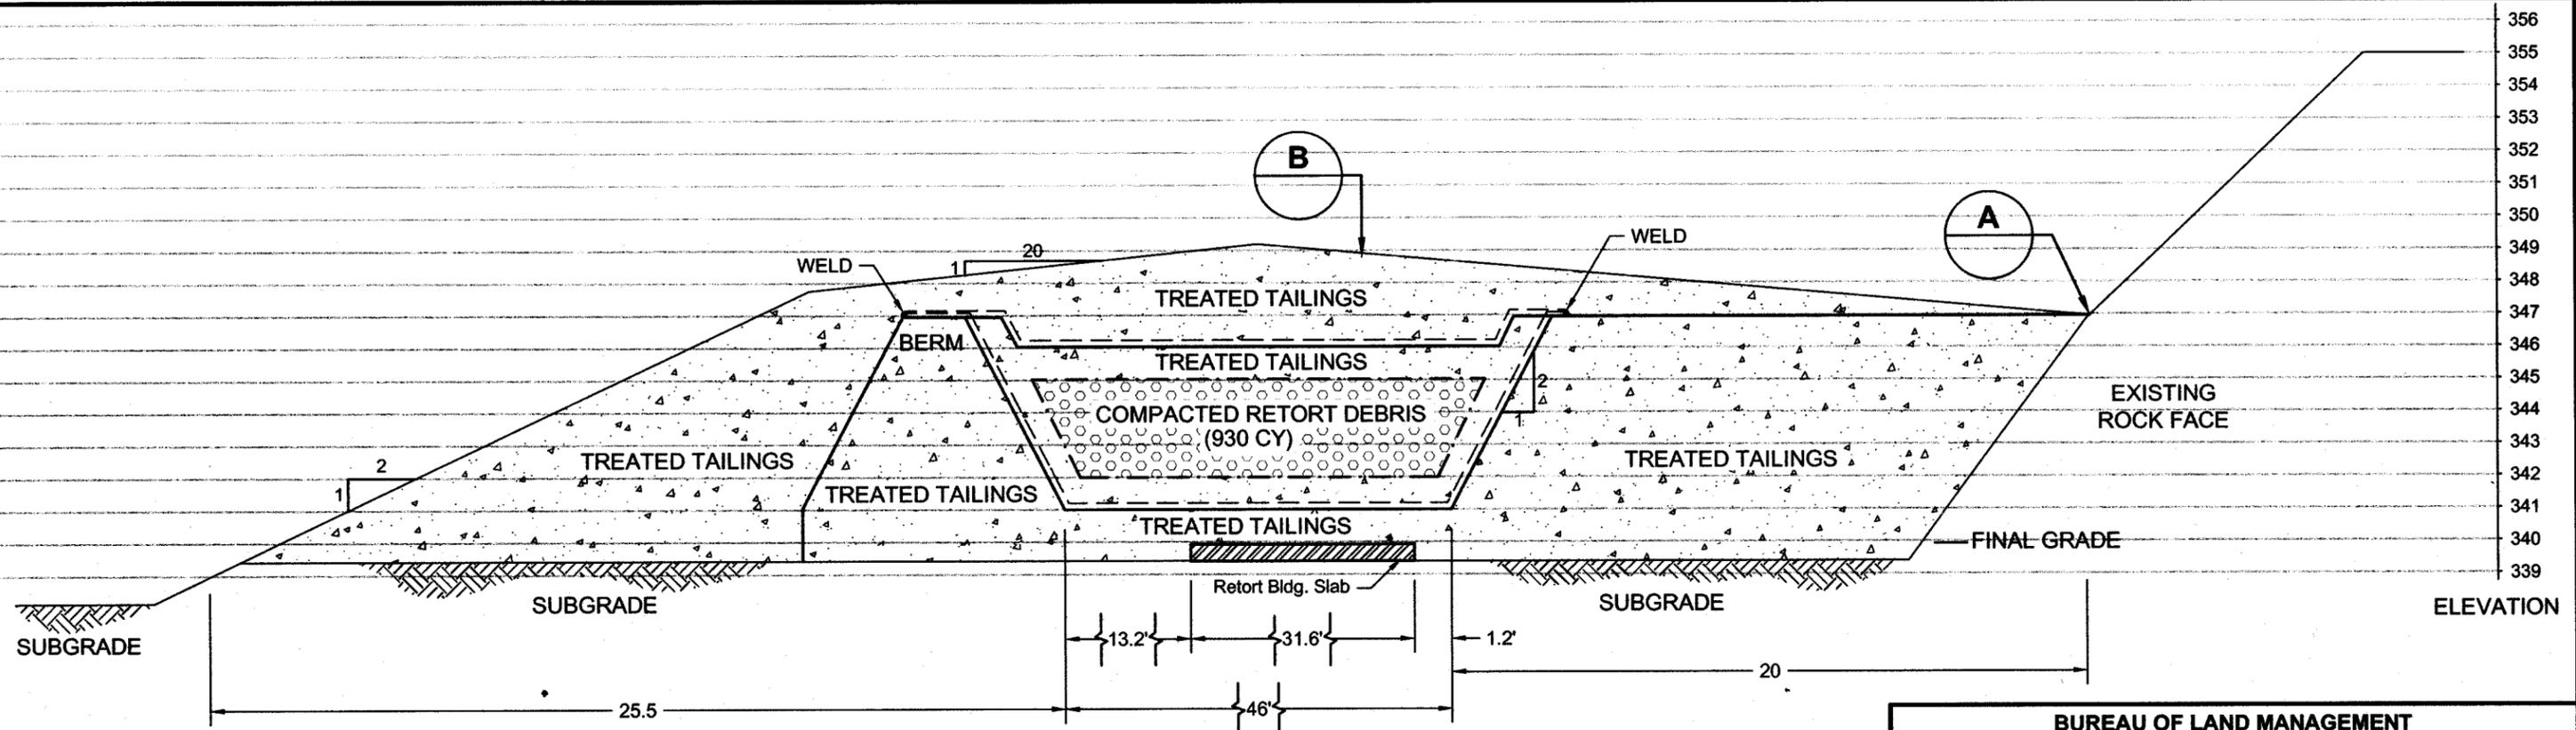
**SECTION B-B: TYPICAL SECTION**

APPROXIMATE SCALE: 1" = 5' HORIZONTAL (OR AS SHOWN), 1" = 5' VERTICAL

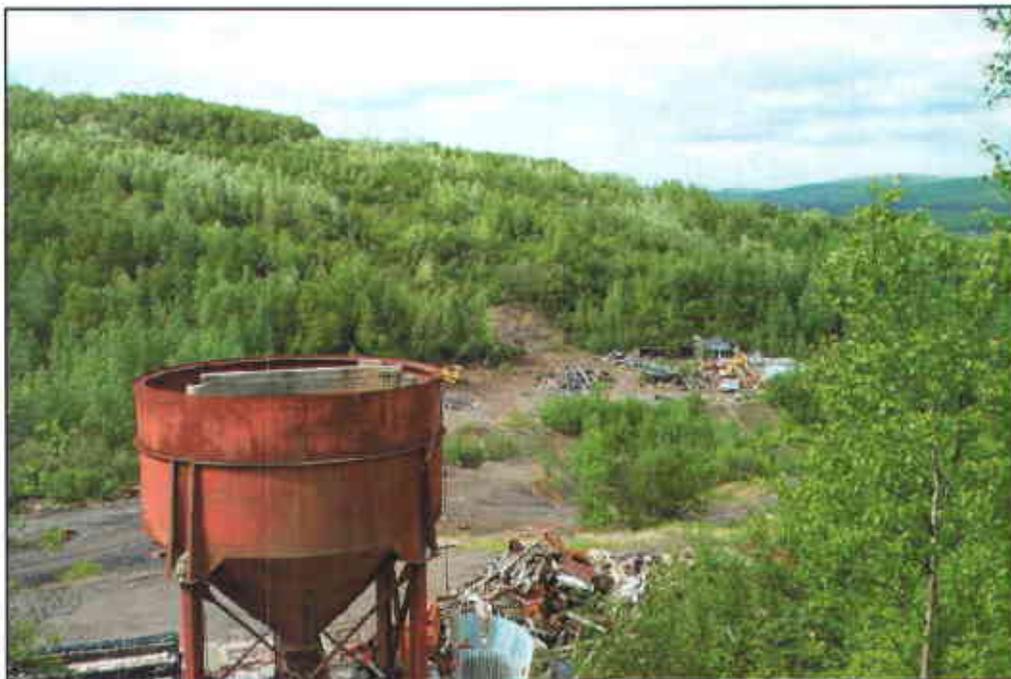
2. North view of ore hopper and debris at mine site prior to consolidation.

The second part of the project included management of debris from the retort building (Photos 2 and 3) and construction of a geomembrane-lined monofill for disposal of all retort building debris at Monofill #2. Retort bricks and retort slag were chemically treated to render the material non-hazardous as defined by EPA TCLP analysis for mercury and arsenic (40 CFR 261). Under a previous contract, retort building debris was pressure washed during previous work at the mine site in 2000. Representative samples of the retort building debris (e.g., wood, scrap metal) were analyzed during a 2001 site inspection and found to be below RCRA toxicity characteristic standards for arsenic, lead, and mercury. Therefore, the retort building debris did not require treatment to render it a non-hazardous waste prior to placement into Monofill #2. However, as a conservative measure, after placement of the retort building debris into Monofill #2, the debris was also treated with a mercury chemical encapsulant.

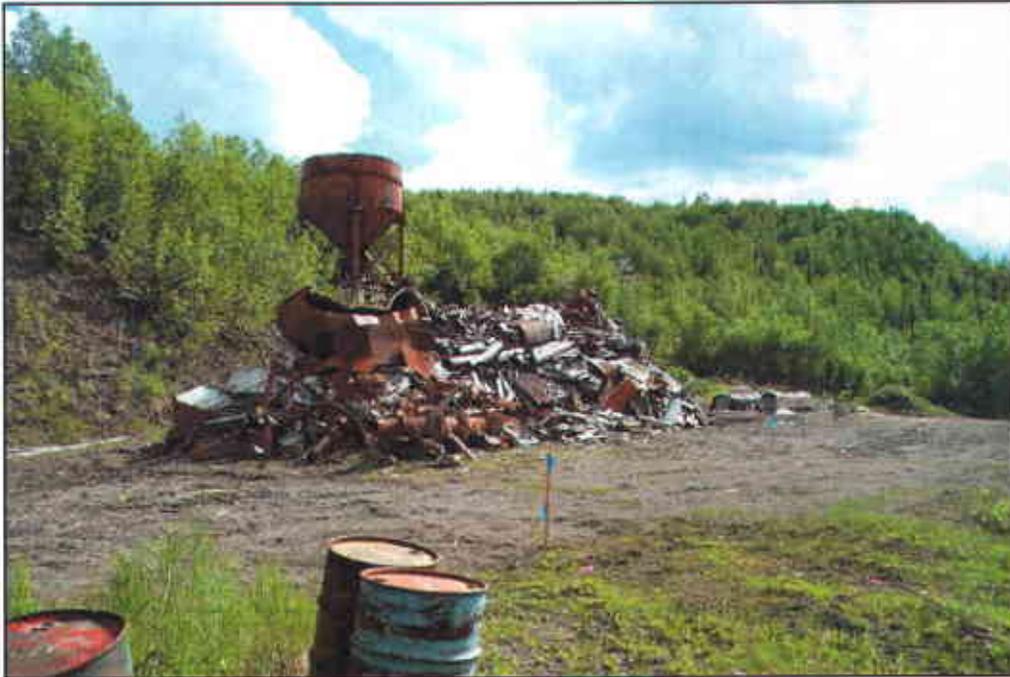
3. South view of Retort Building debris pile prior to commencing construction of Monofill #2.

This area included the former retort building foundation, debris pile, and ore hopper (Photo 3). The retort building was used to process mercury ore (cinnabar). Mercury- and arsenic-contaminated soils are present around and below the concrete retort building foundation. The retort building had already been demolished and the debris pressure-washed prior to the 2002 project. The retort building debris pile was approximately 87 feet by 35 feet by 15 feet high and located on the retort building foundation pad (Photo 3). Mercury- and arsenic-contaminated slag and retort brick were also located in this area and were managed as described in Section 2.3.10. Monofill #2, a 930-cubic yard, geomembrane-lined monofill for the retort building debris (see Section 4.0) was constructed at this area for consolidation of retort building debris. Table 2 shows a description of the estimated debris quantities for Monofill #2.

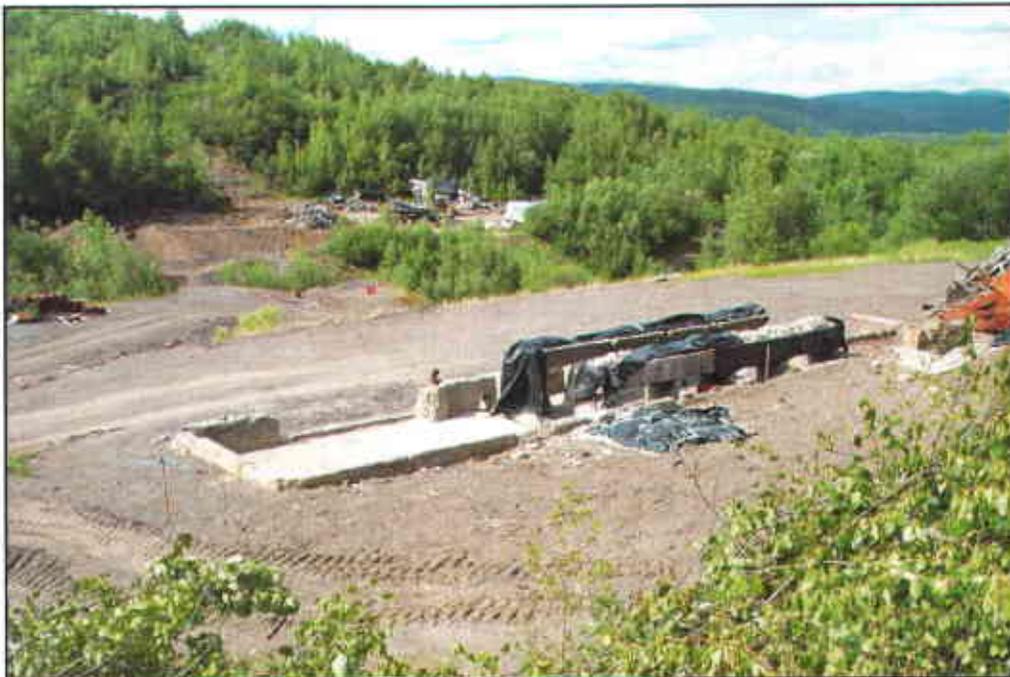
4. North view of Retort Building foundation prior to demolition of sidewalls and construction of berms for Monofill #2.

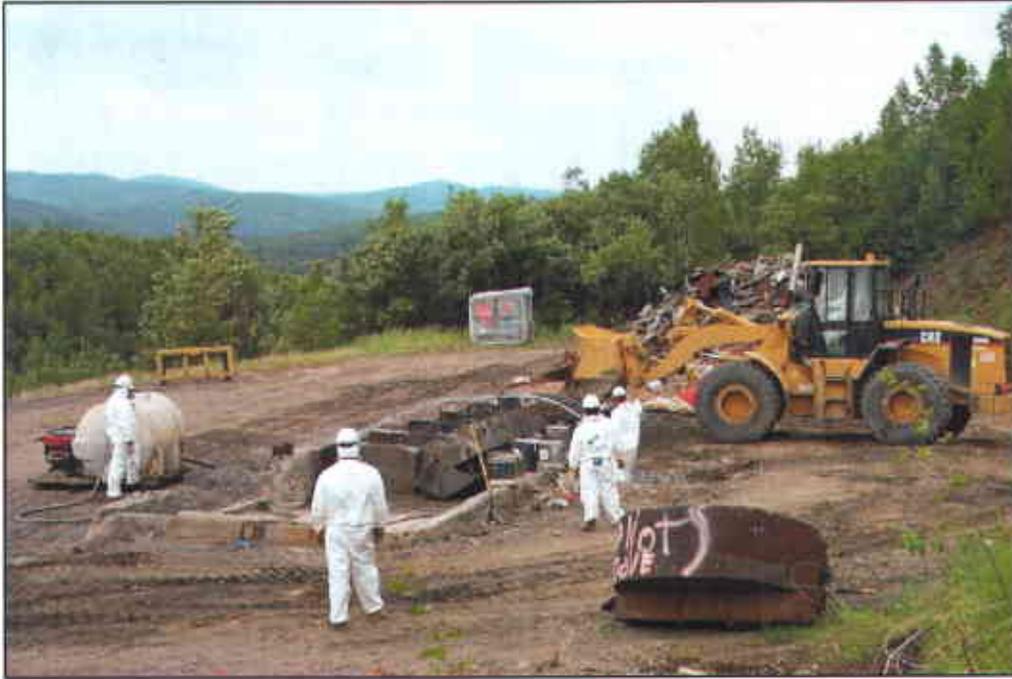
5. Northeast view of Retort Building foundation during demolition of sidewalls.

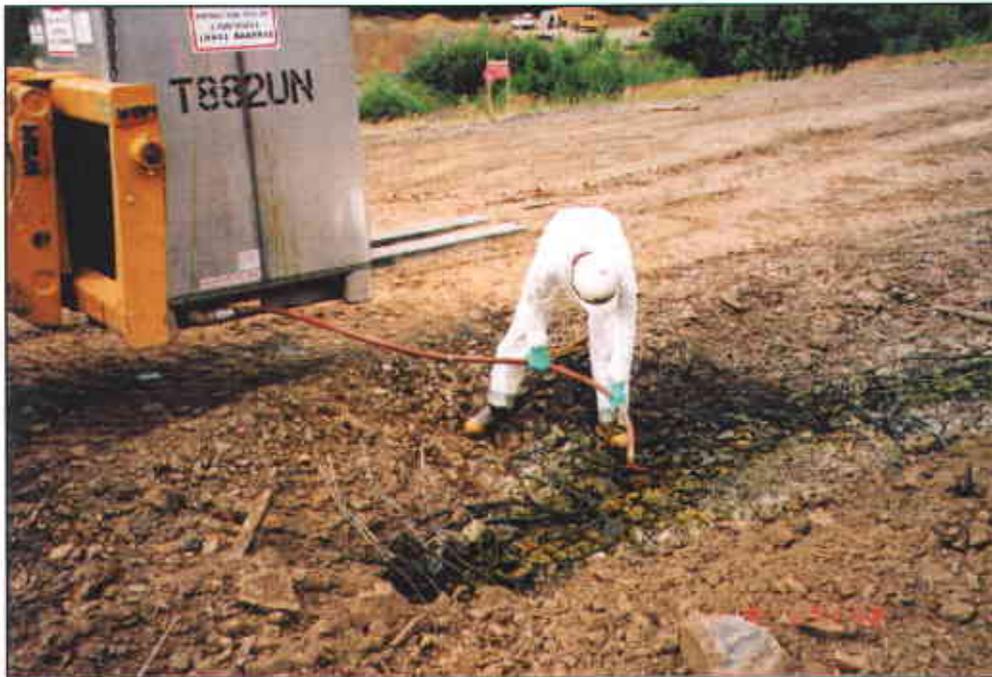
6. Applying Ecobond™ mercury encapsulant treatment into Retort Building foundation cracks prior to bringing area to final grade for placement of bottom geomembrane for Monofill #2.

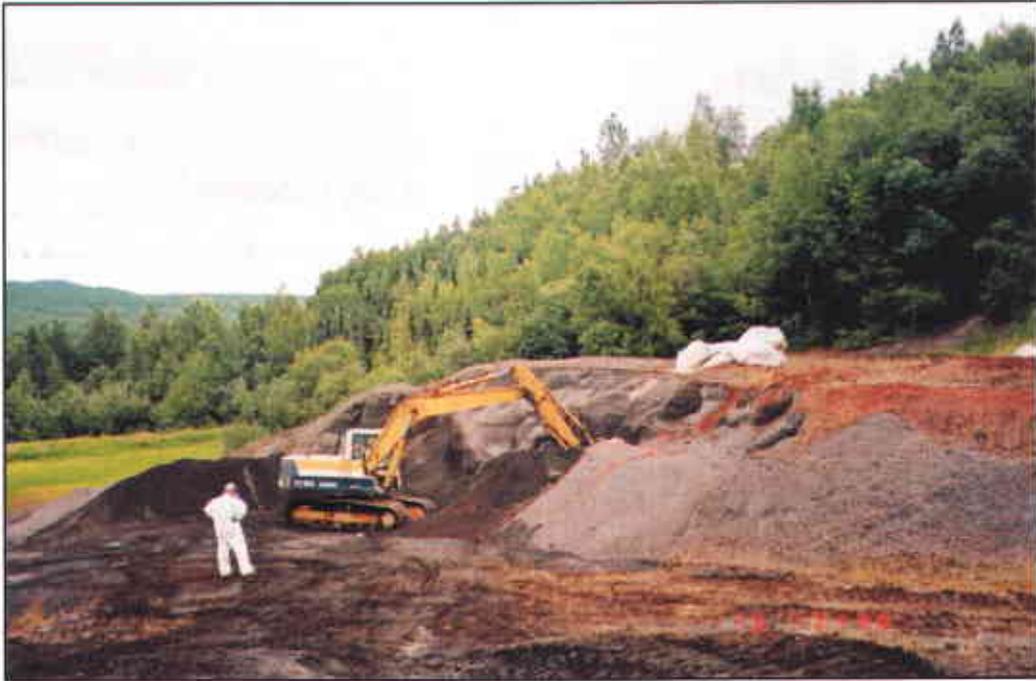
7. Northeast view of process mine tailings area during application of Ecobond™ encapsulant for use as backfill material at Retort Building debris monofill (Monofill #2).

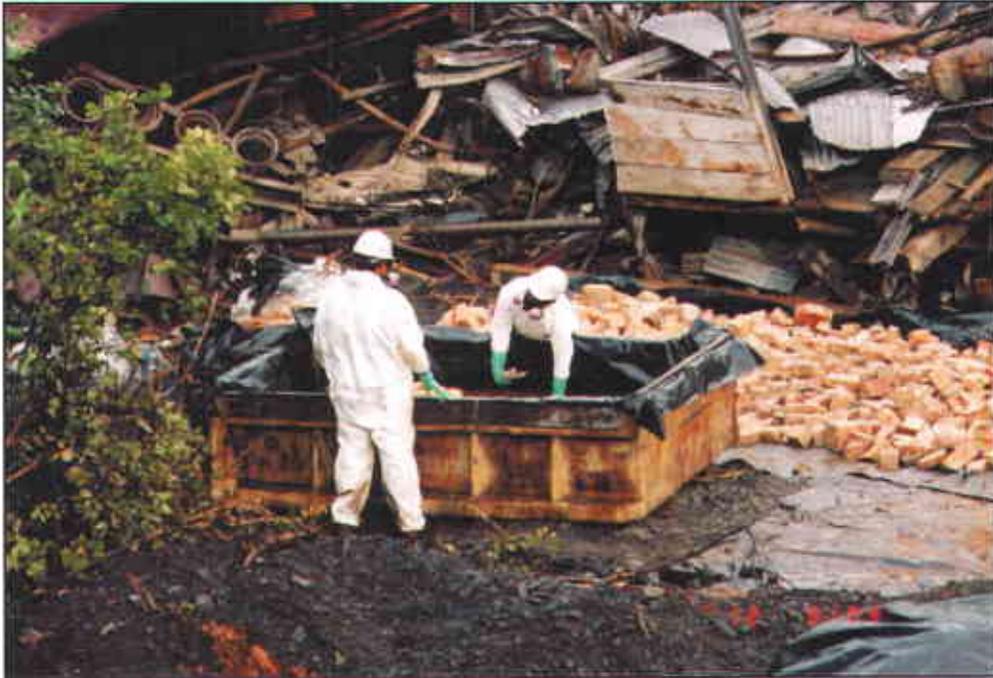
9. Treating retort furnace bricks with Ecobond™ bath for mercury fixation treatment.

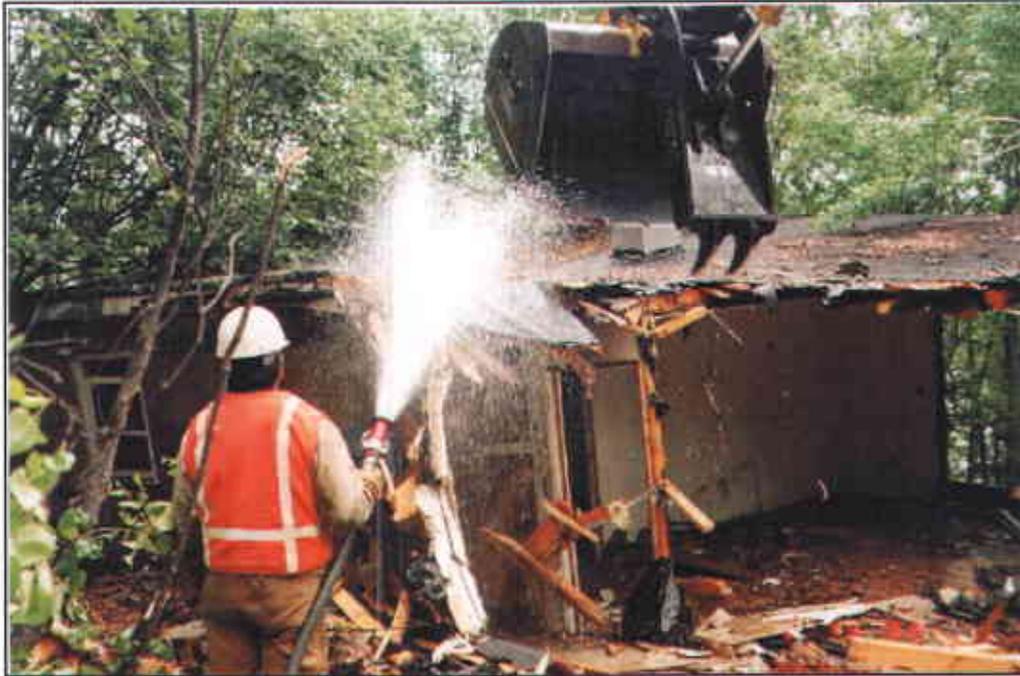
11. Typical view of activities during demolition of housing area buildings. Debris was wetted down to minimize dust.

The excavator was used with a thumb and/or bucket to demolish intact buildings (Photo 11) and load the haul truck for transport to the appropriate monofill (Photo 14). Many of the buildings at the site had already collapsed or have been demolished during previous debris removal activities or were in poor condition (Photo 10). Therefore, most of the demolition phase of the project focused on proper inspection and segregation of debris. Inspection of the debris piles was required to verify compliance with the Alaska Department of Environmental Conservation (ADEC) and EPA disposal regulations for the on-site monofills.

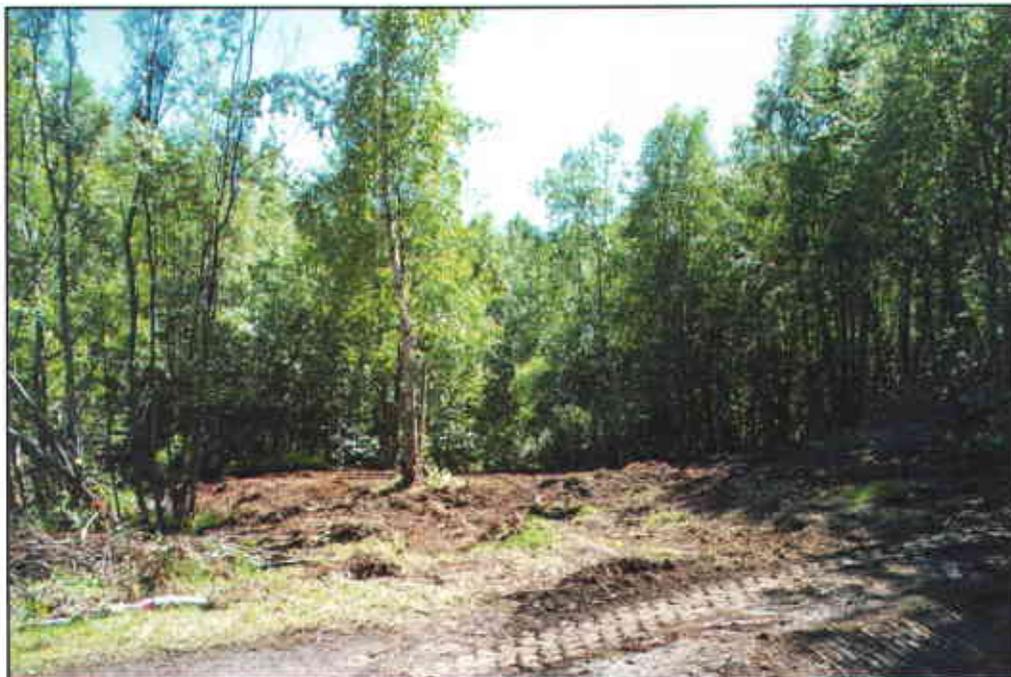
12. Typical view of housing areas after removal of debris to inert debris monofill (Monofill #1).

Vegetation and trees (slash) cleared during construction of the monofills was not burned due to the high fire danger in the area during the project. The small volumes of cleared material was placed into Monofill #1 or left at the cleared location. To the extent possible, care was taken to minimize the clearing of vegetation (Photo 12).

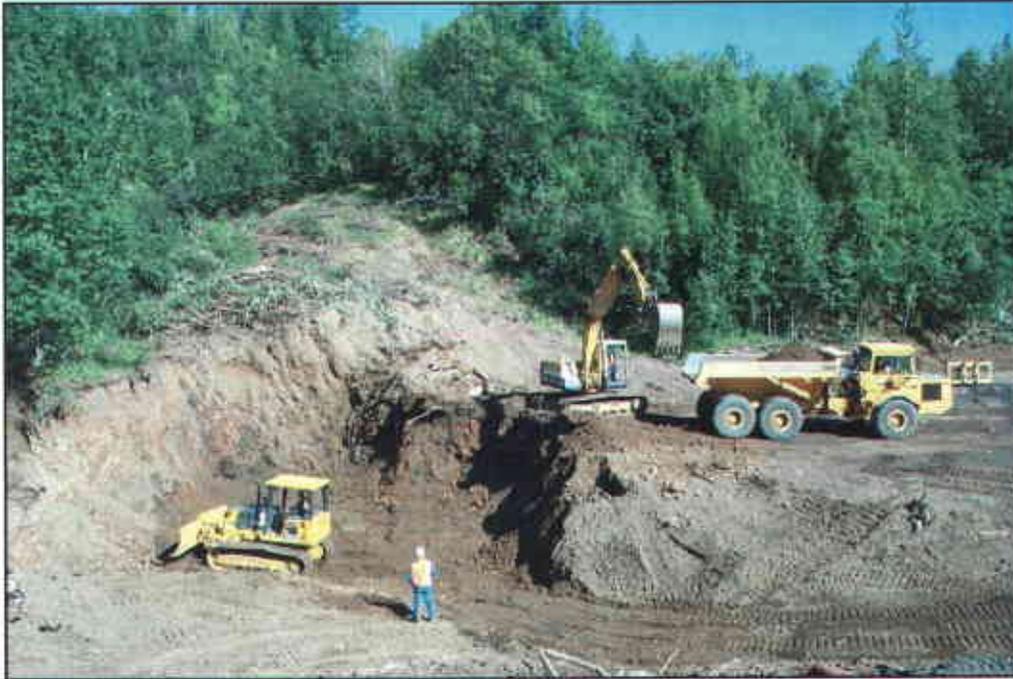
13. North view during construction of Monofill #1 on north side of site, prior to disposal of inert debris.

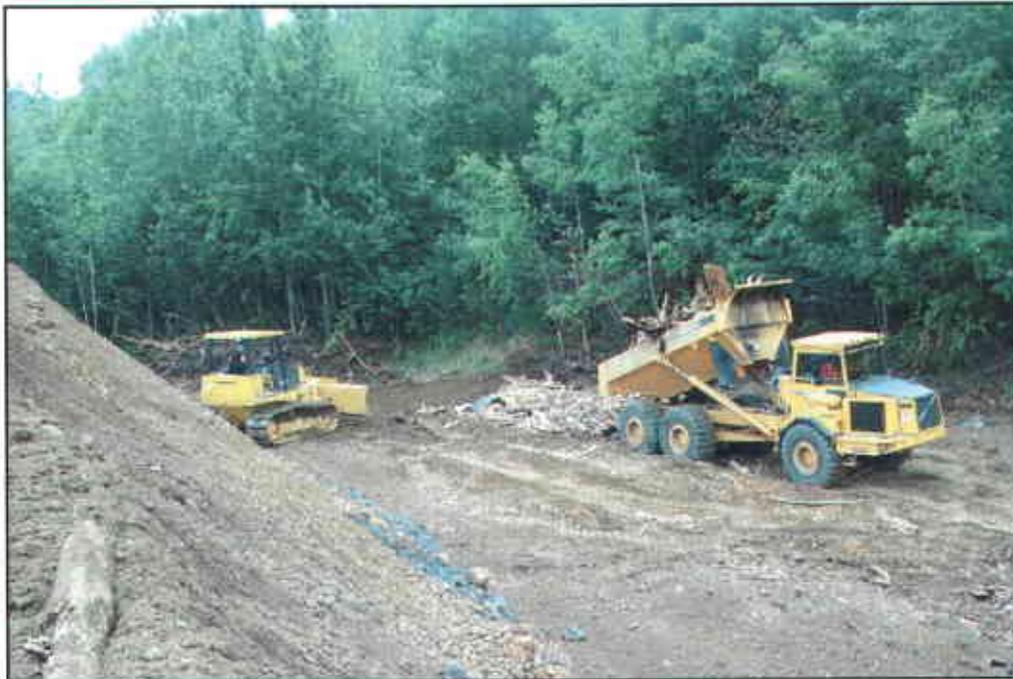
14. West view during placement of inert demolition debris in Monofill #1. Temporary stockpile of soil cap material shown at left.

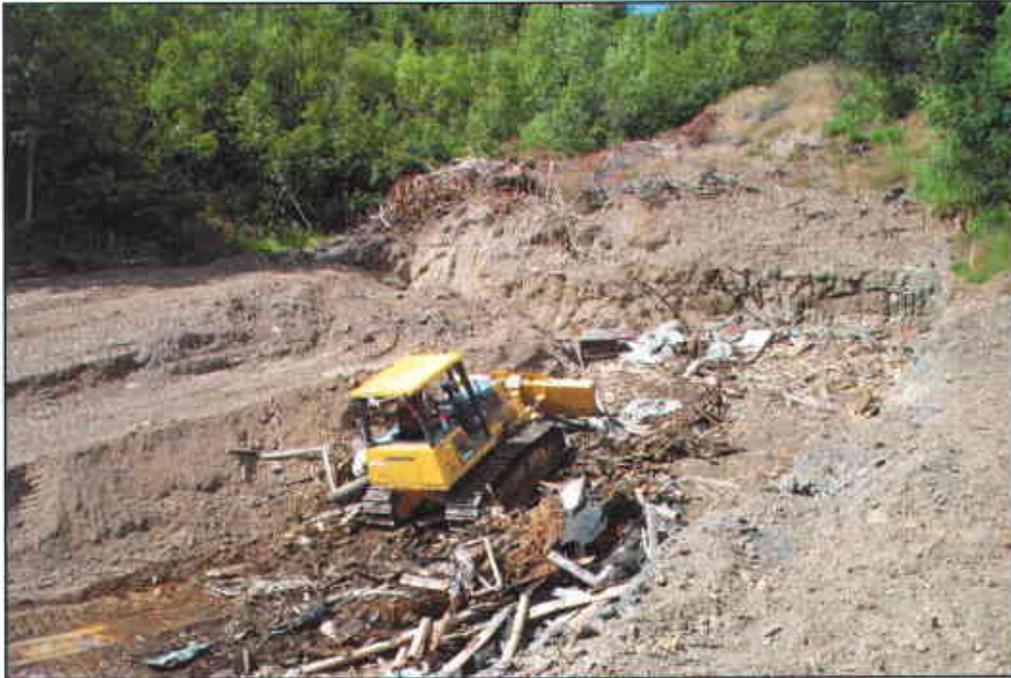
15. Western view during compaction of inert debris and placement of soil cover at Monofill #1.

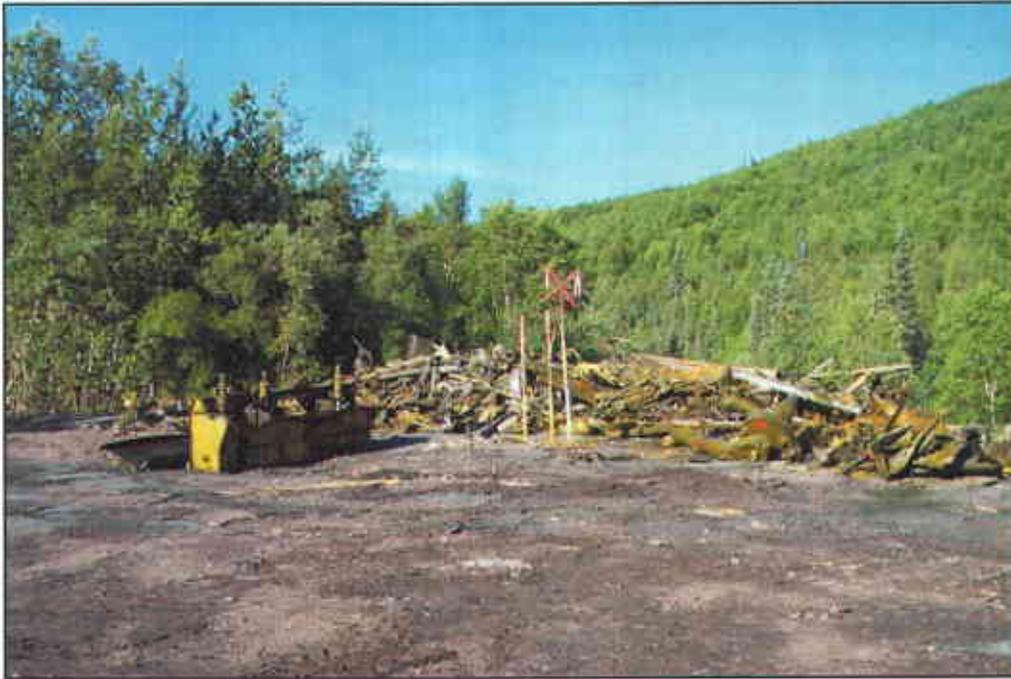
17. Western view of Gravel Storage Pad debris after treatment with Ecobond™ mercury encapsulant, which gives the debris a green hue. Flagging for monitoring well seen in center of photograph.

The gravel storage pad is on the eastern side of the site (Photos 17 and 18). The pad was used as a temporary staging area to facilitate waste consolidation, a temporary storage area for debris during construction of Monofill #2, and as a work area. This area was also used to apply Ecobond™ encapsulant chemicals to the retort debris to render the debris non-RCRA hazardous waste as discussed in Section 2.3.10. Ecobond™ mercury encapsulant was applied to the gravel storage pad surface soil after removal of all debris.

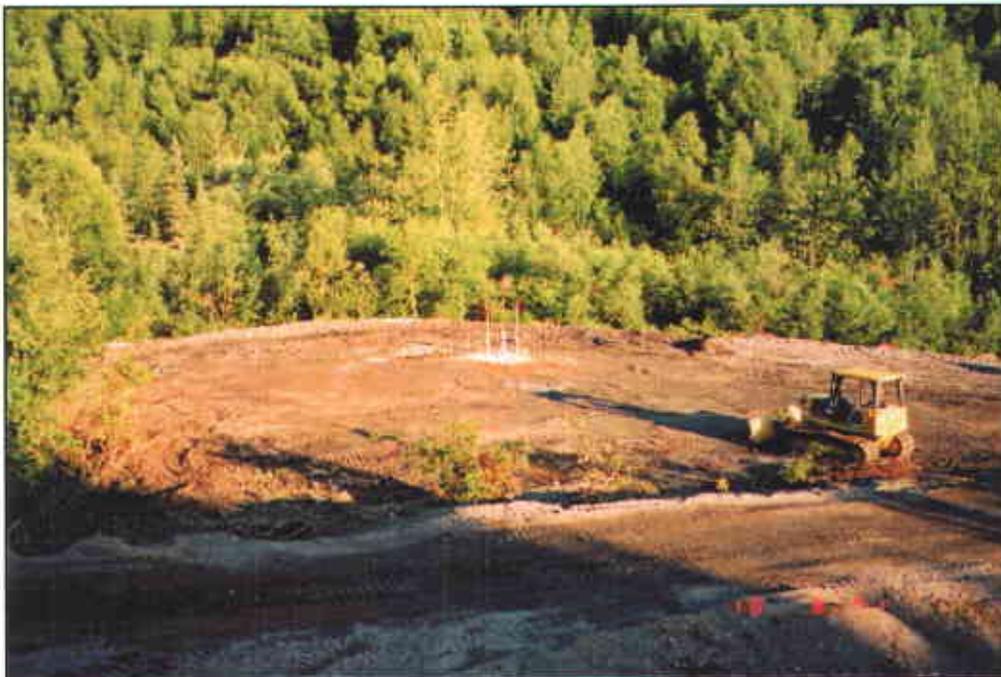
18. Southwest view of Gravel Storage Pad after removal of all debris. Monitoring well visible in center of photograph with flagging.

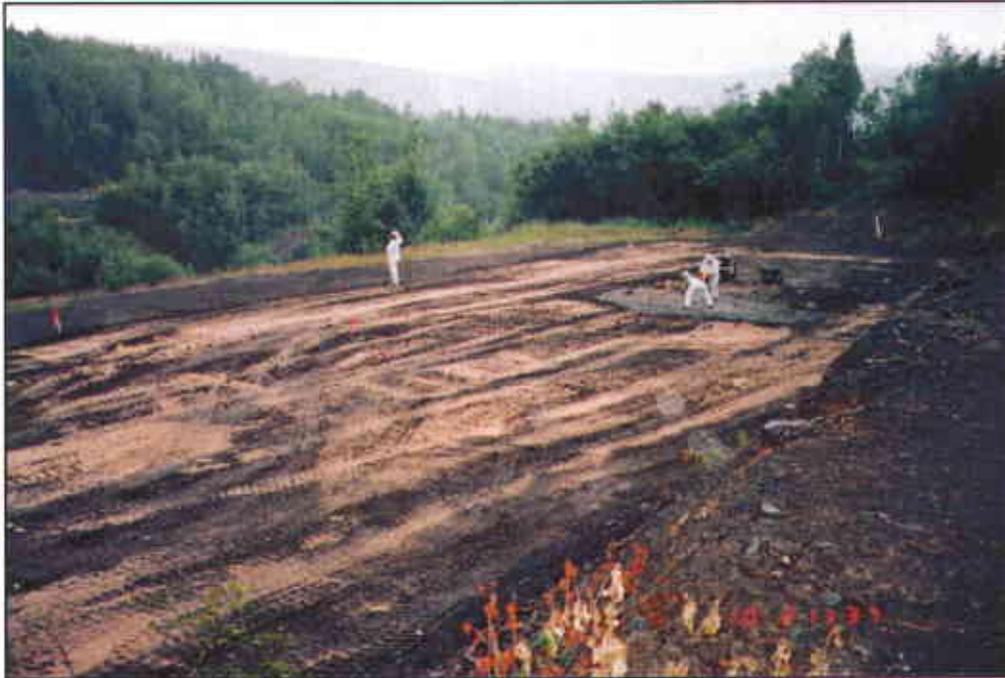
19. Northwest view of Monofill #2 after demolishing Retort Building foundation sidewalls. View is during construction and leveling of base course prior to placement of bottom liner geomembrane and geotextile. Tailings have been treated with Ecobond™ arsenic encapsulant.

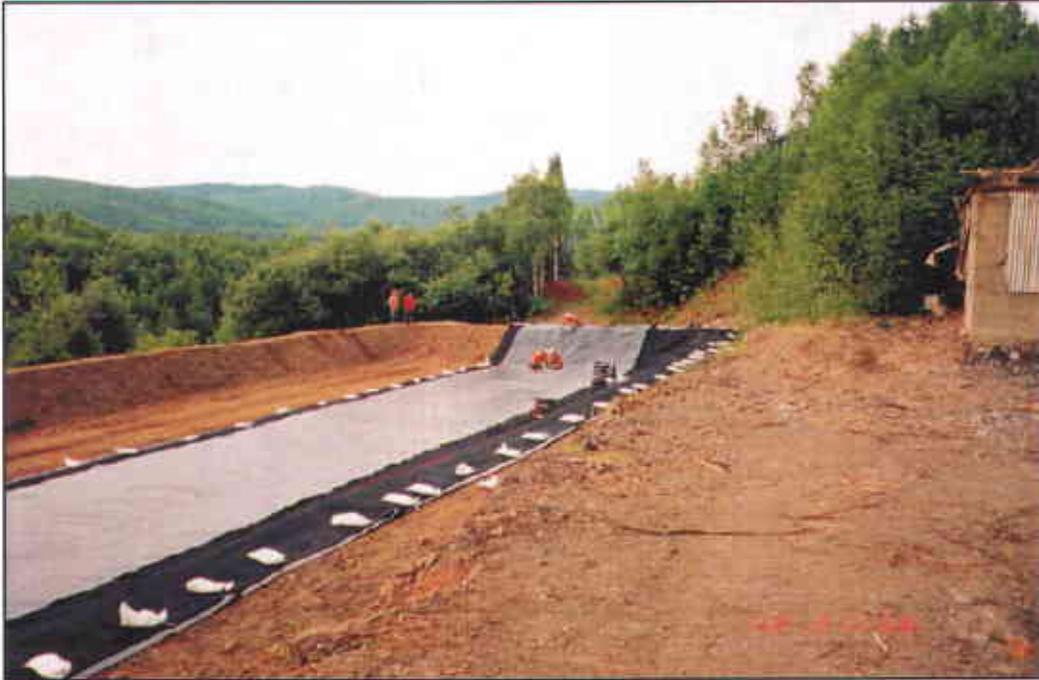
21. North view of Monofill #2 during placement of geotextile layers and bottom geomembrane.

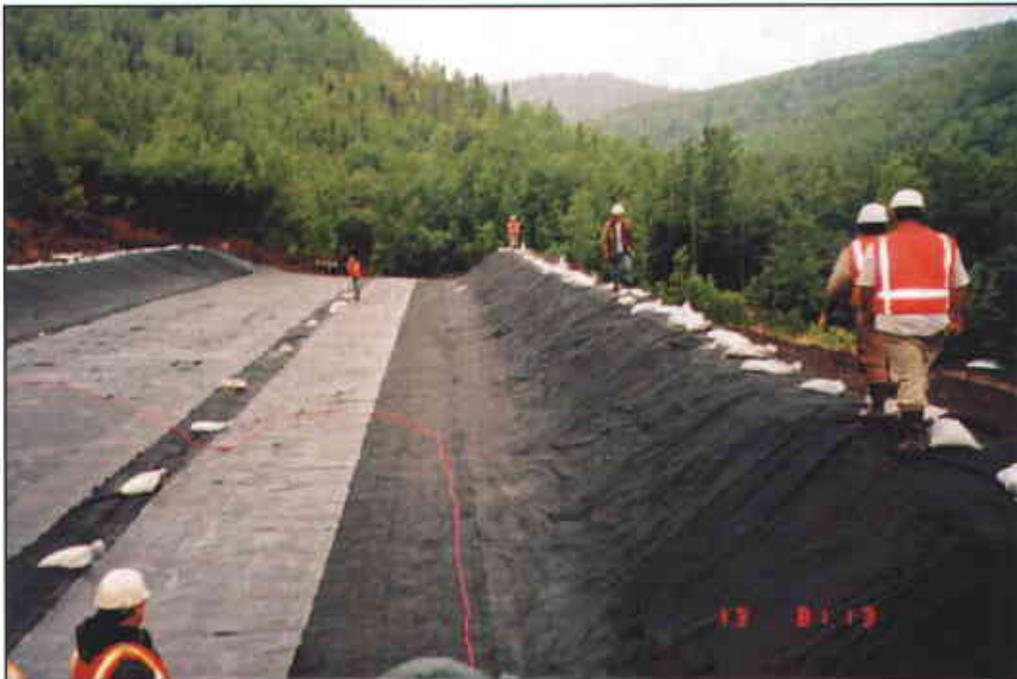
22. Southwest view of Monofill #2 during construction. Bottom liner and geotextile visible.

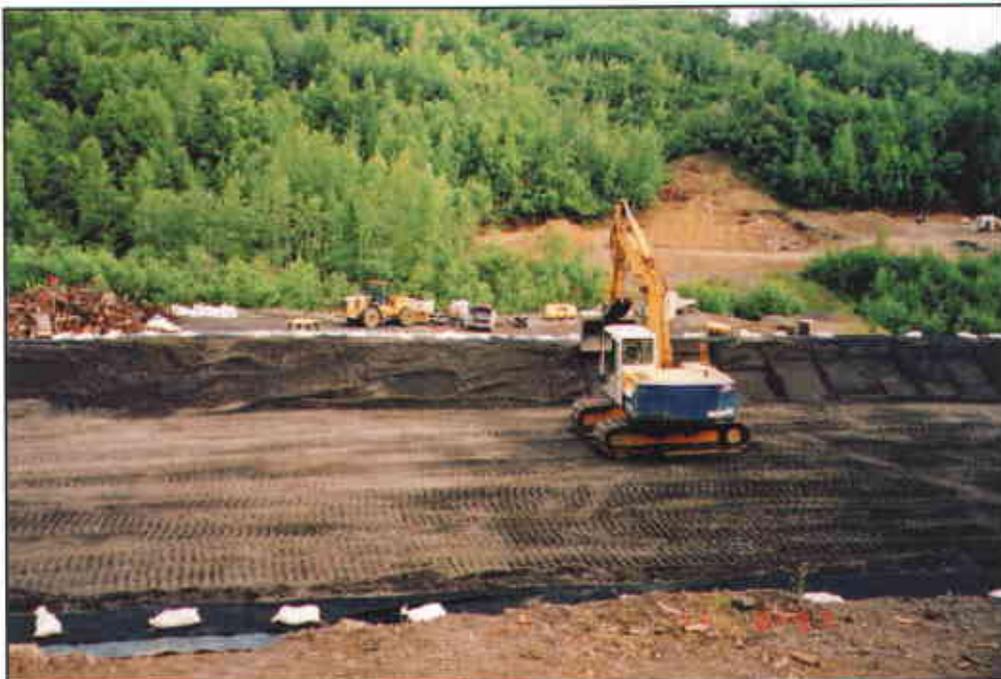
24. Northwest view of Monofill #2 during placement of a 1-foot layer of tailings treated with Ecobond™ arsenic encapsulant. Tailings layer placed above bottom liner and geotextile layer.

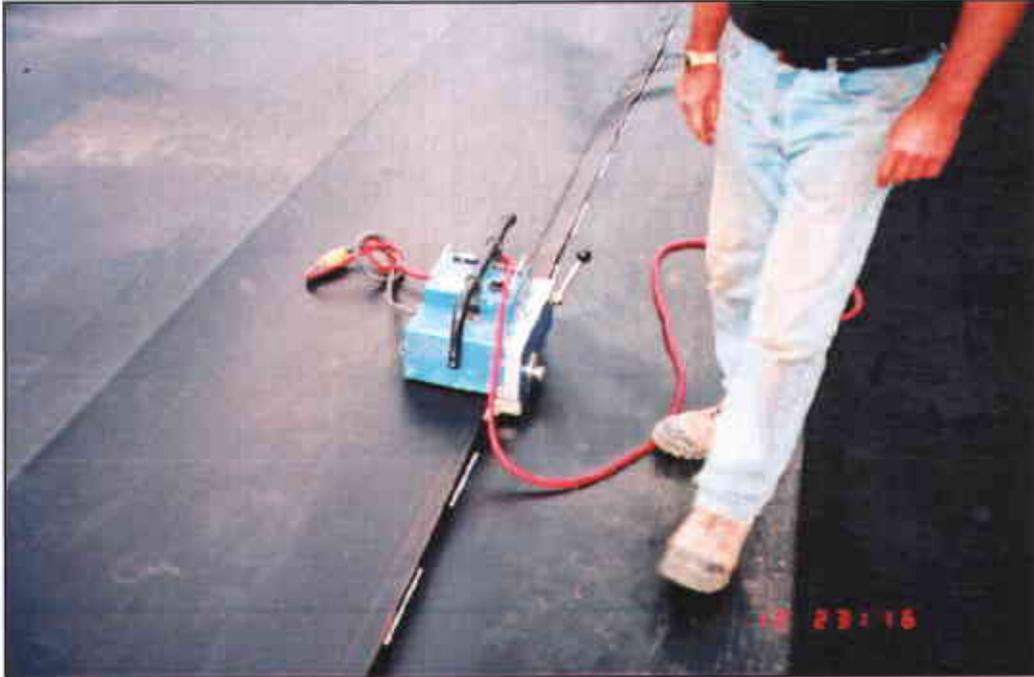
25. Extrusion welding unit used during construction of geomembrane for Monofill #2.

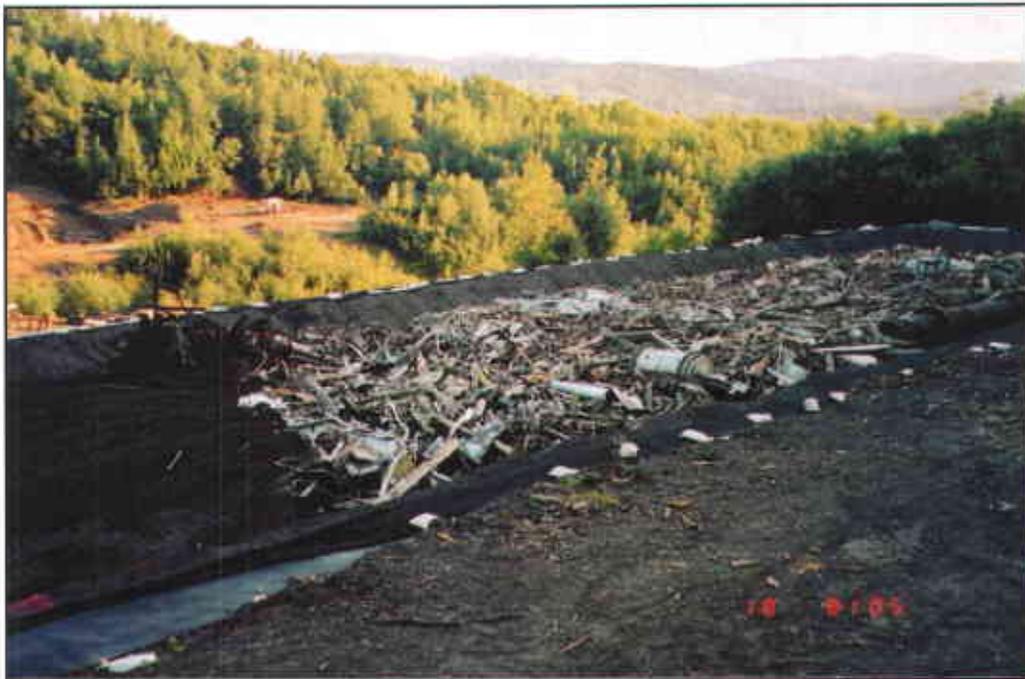
26. North view of Monofill #2 during placement of Retort Building debris and tailings treated with Ecobond™ arsenic encapsulant. Tailings used as void filling material.

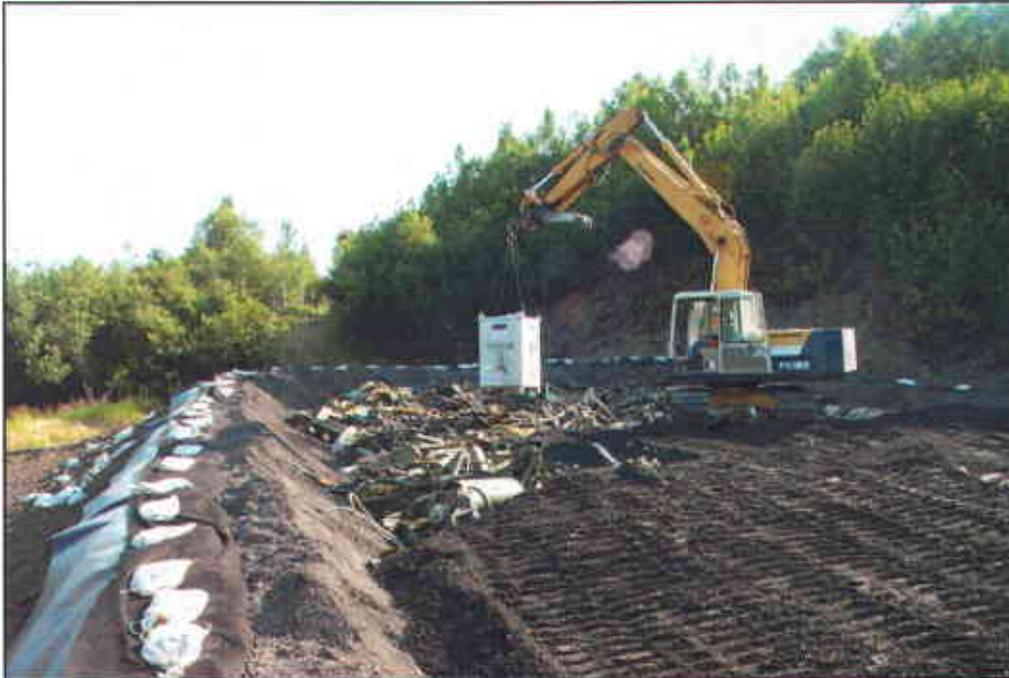
27. Northeast view during placement of tailings treated with Ecobond™ arsenic encapsulant on top of Retort Building debris for use as void filler. Excavator is lifting Ecobond™ mercury encapsulant treatment container for spray application on debris.

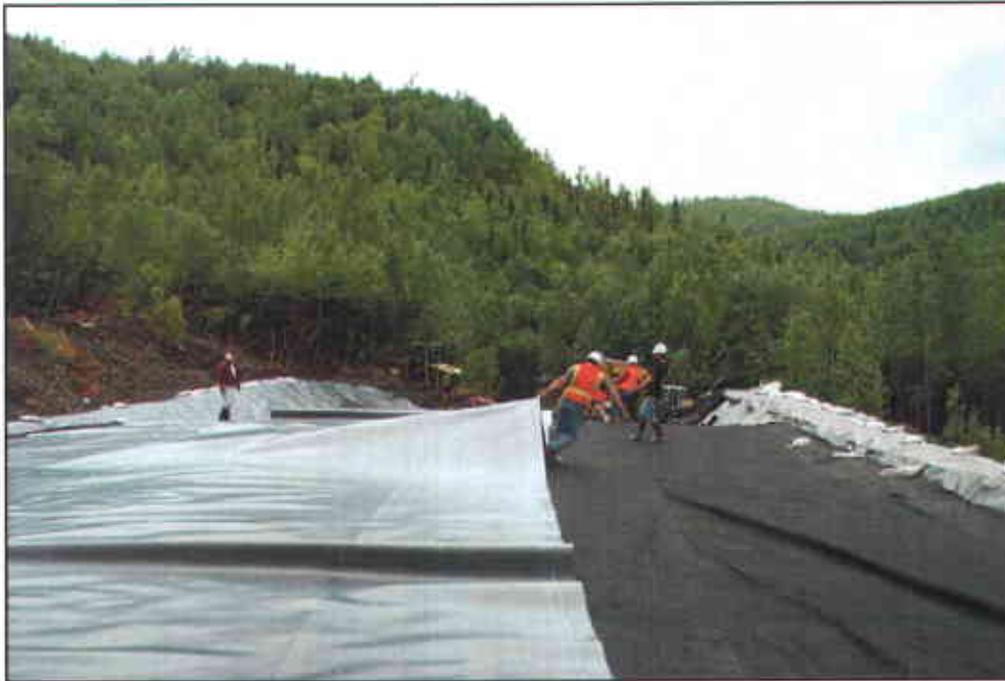
31. Southwest view during placement of top geomembrane cover for Monofill #2. Geotextile layer visible underneath the geomembrane.

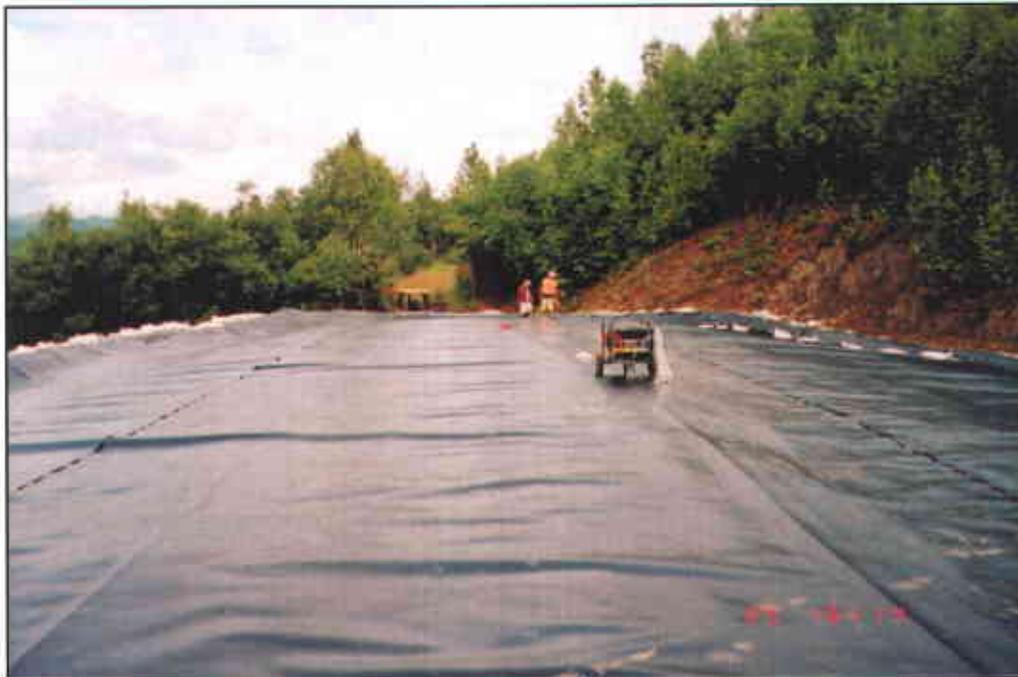
32. Northeast view of Monofill #2 geomembrane top cover during seam welding operations.

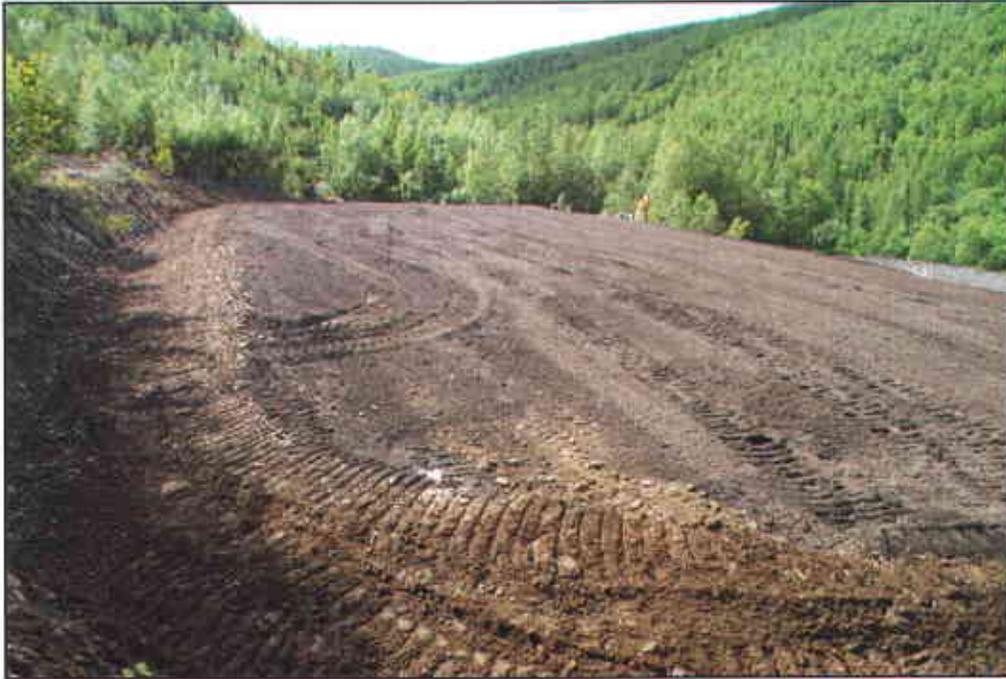
33. West view of Monofill #2 at completion of soil cover above geomembrane. Drainage channel visible at left.
