## REPORT

### RED DEVIL MINE 2002 DEBRIS CONSOLIDATION AND DISPOSAL PROJECT

### RED DEVIL, ALASKA

March 17, 2003

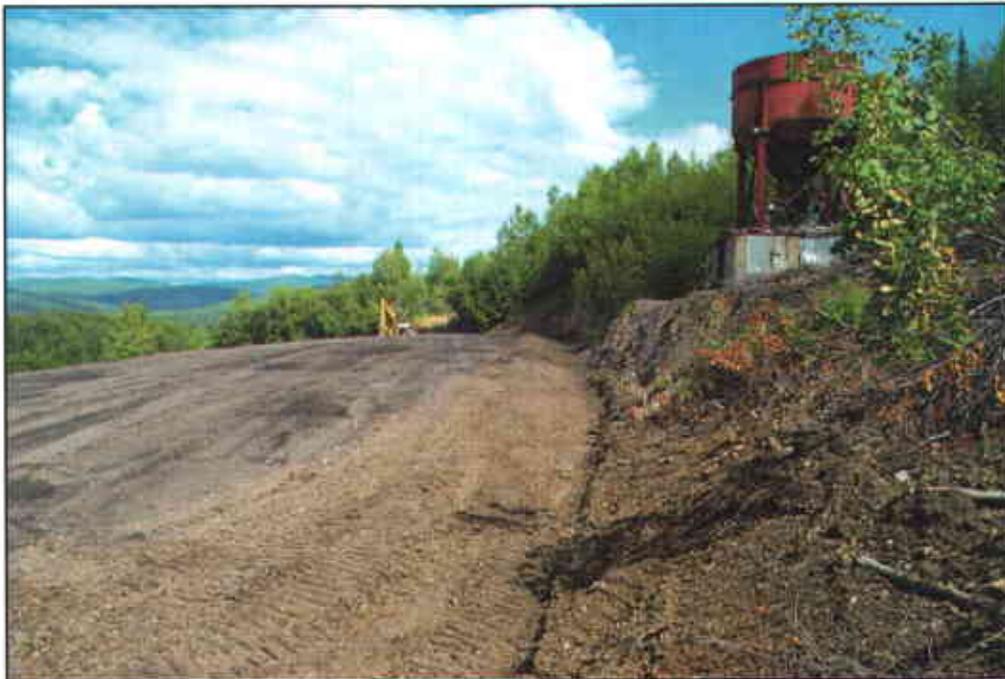
34. Northeast view of Monofill #2 at completion. Drainage channel visible at right. Ore hopper left in place for eventual disposal under separate contract (visible at top-right of photo).

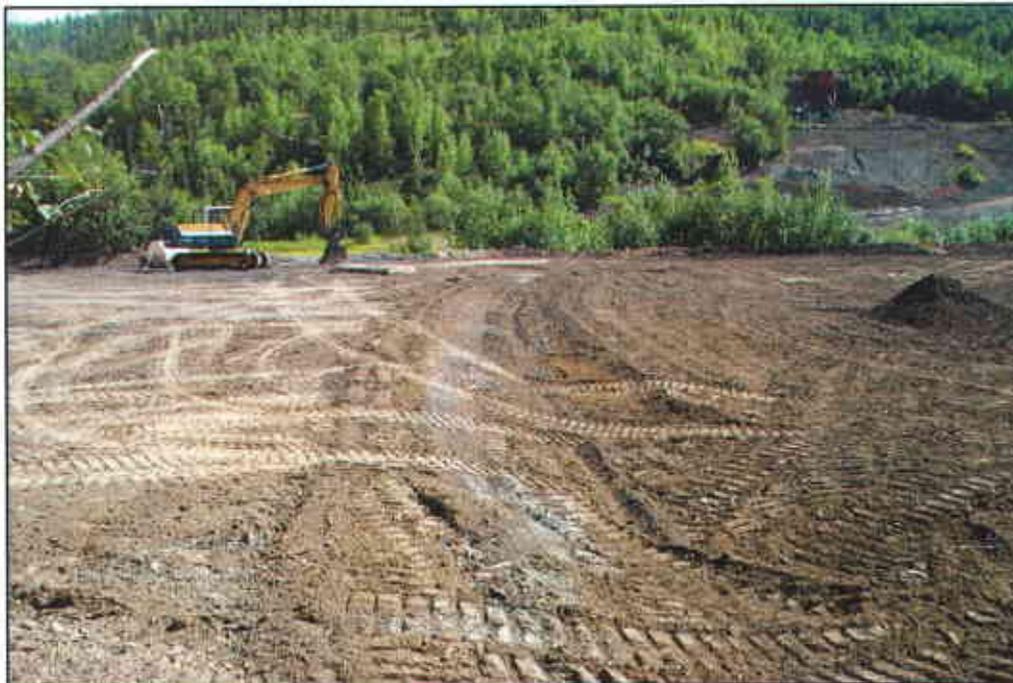
36. View southeast of inert debris Monofill #1 during final cover placement and construction of drainage channel along north perimeter. Former hoist shack foundation in view near excavator.

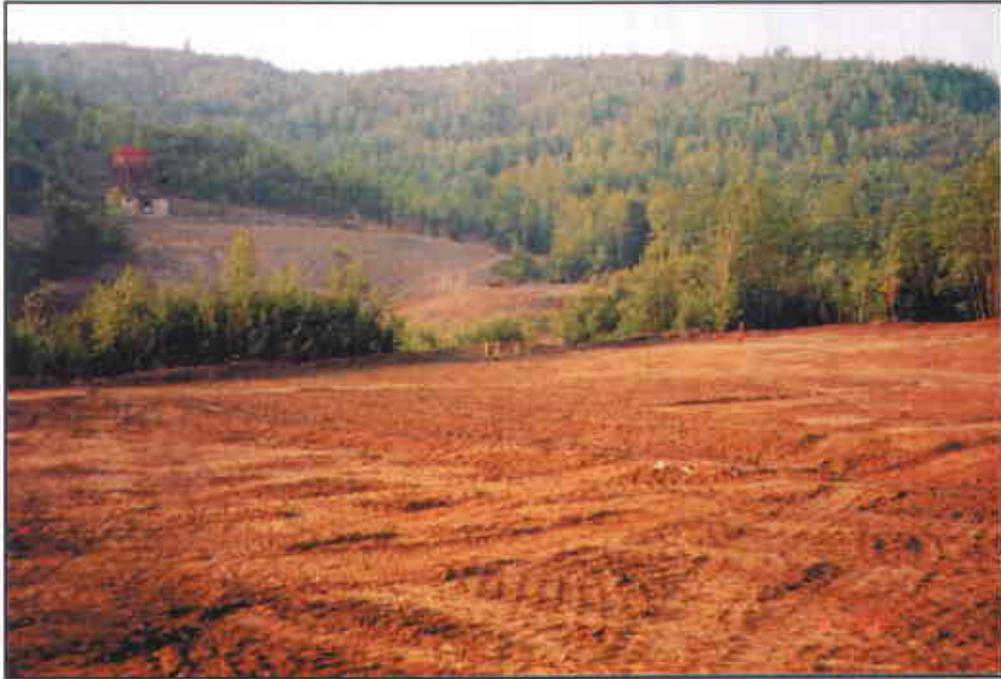
39. Southeast view of inert debris Monofill #1 at completion. Monitoring well MW-04 visible at center of photo.
