United States Department of the Interior

8100(042)
February 24, 2000

Determination of Eligibility
of the Red Devil Mine
Kuskokwim River, Alaska

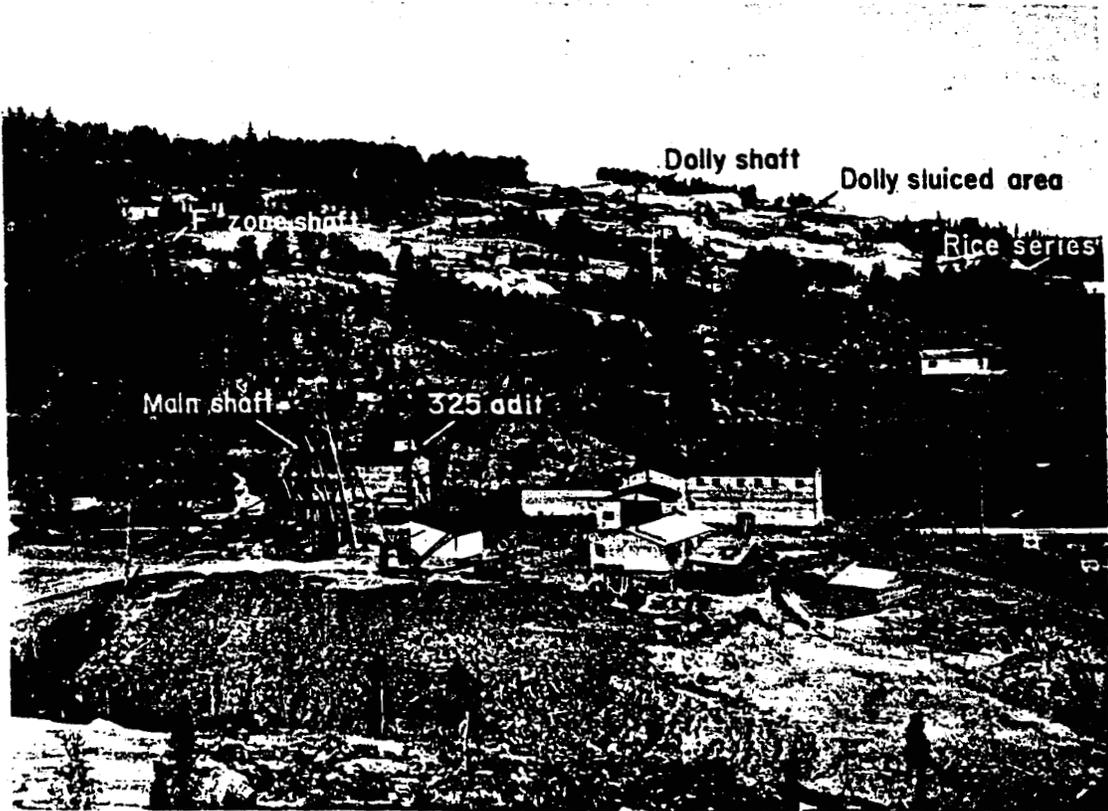
PHOTO 1

None of the buildings at the Red Devil mine have structural integrity. Salvaging of materials has been an ongoing process since the mine was shut down in 1972. A photo (photo #1) of the camp from 1962 shows several buildings that are no longer present. In particular, the two-story building on the left behind the head frame exists only as a foundation. The other two-story building on the right retains one wall from the one-story entrance(photo #4).

The metal building shown in the upper left-hand area of photo #1 is collapsed. A similar metal building shown in photo #6 (and also the left-hand section of photo # 2) is in the process of collapsing. It served as a machine shop and office. It is missing one wall and several of the supports have given way. Two sheds (photo #2) are open to the elements and have been heavily scavenged.

The head frame structure seen in photos #1-3 has partially collapsed. Since the more recent photos were taken, unauthorized salvaging has occurred and several of the 6"x 6" frame supports have been removed with a chain-saw.

1962 photo of the Red Devil Mine looking northwest (MacKevett and Berg 1963)

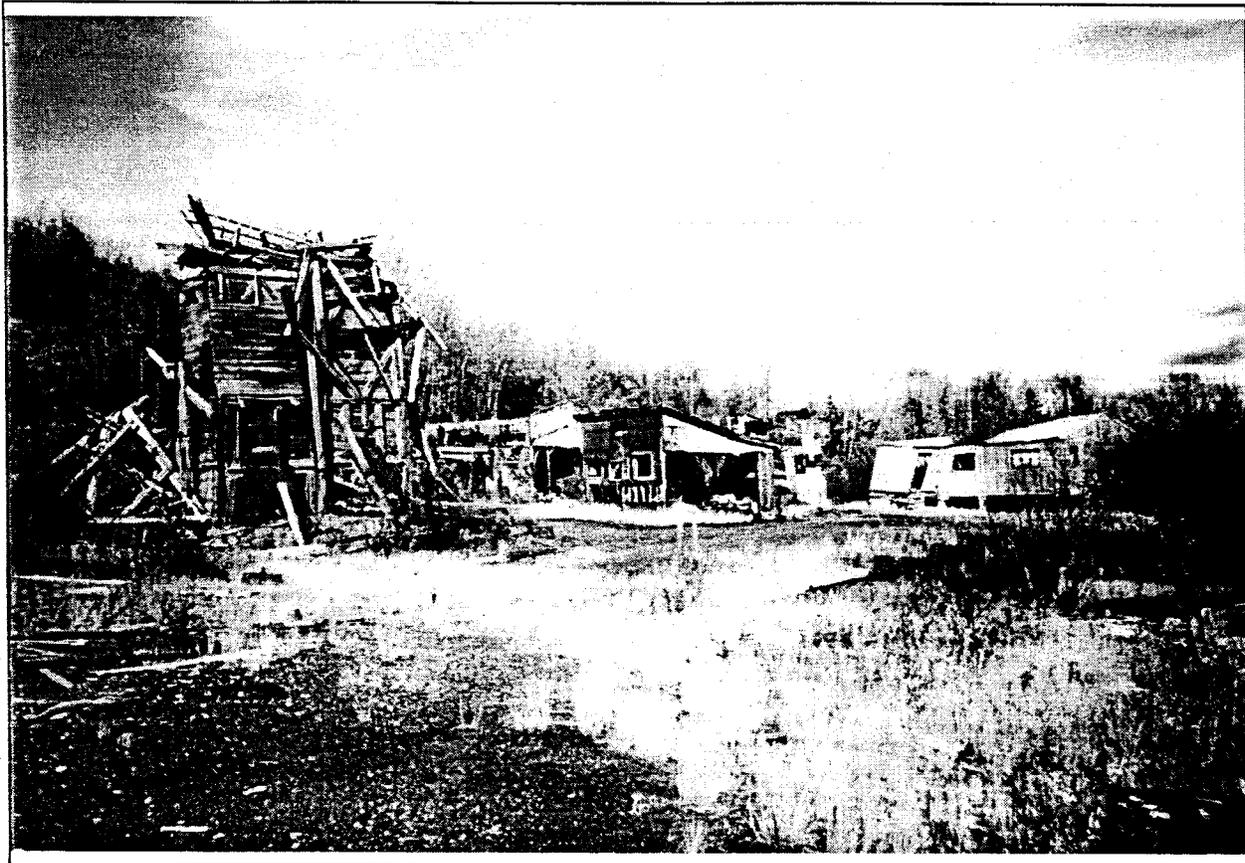
PHOTO 2

from left to right: head frame structure, front entrance to two-story building, shed, metal building, shed

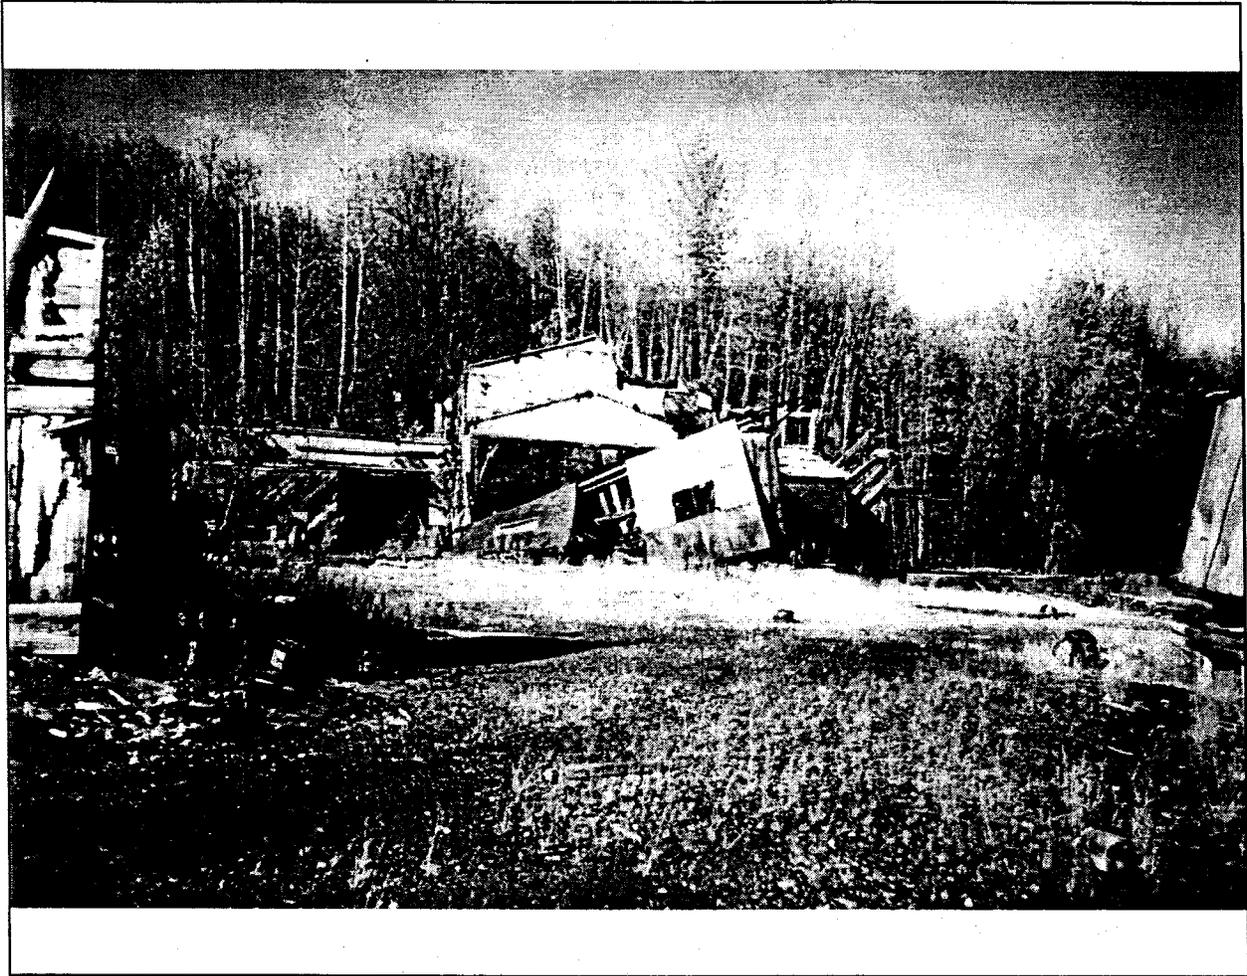
PHOTO 4

Remains of two-story building- entrance.

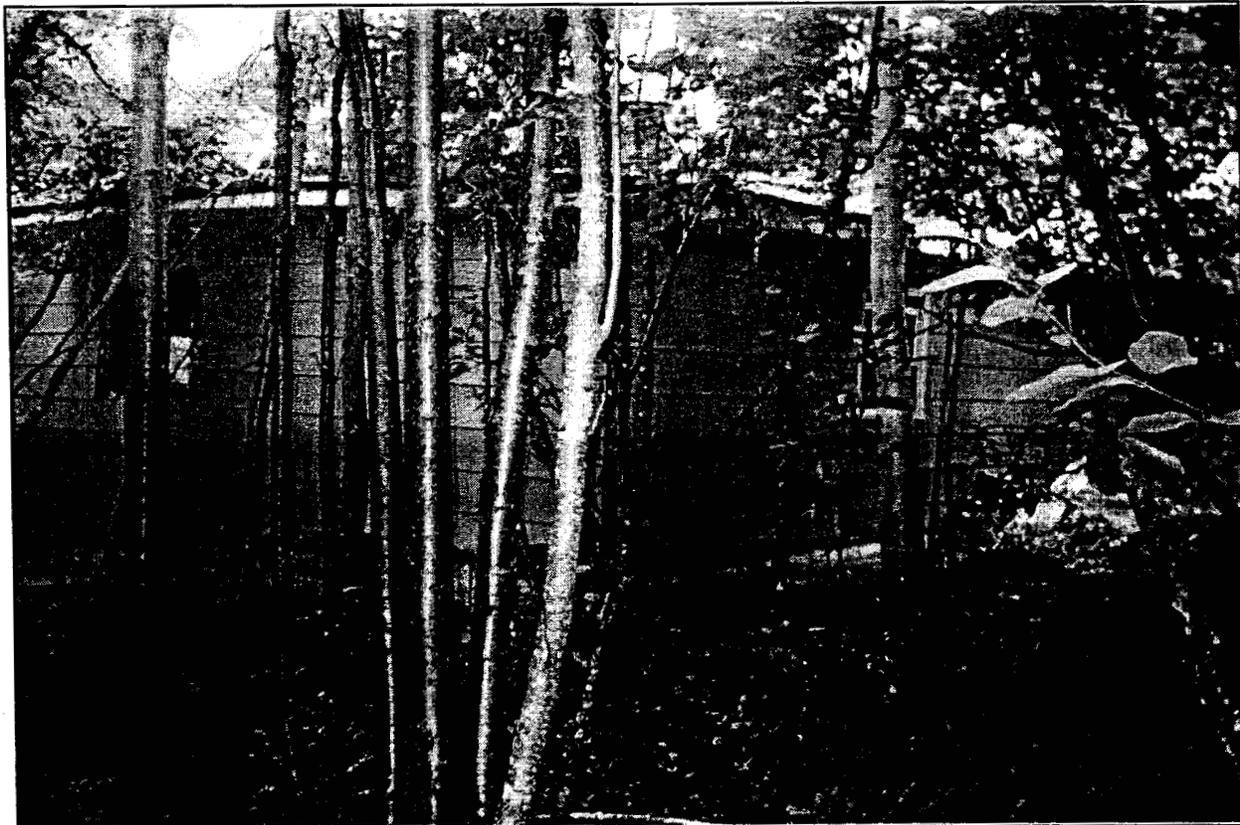
PHOTO 5

Eight houses identical to the one seen in photo # 5 were said to have been present during the DeCoursy Mt. Mining Company operation. Only two houses are now standing. These are open to the elements. The windows have been removed and the insides have been gutted. Foundation remains account for most of the rest of the houses, but the remains of several houses could not be found. They were most likely removed or scavenged when the mine discontinued operations.

One of two remaining houses.

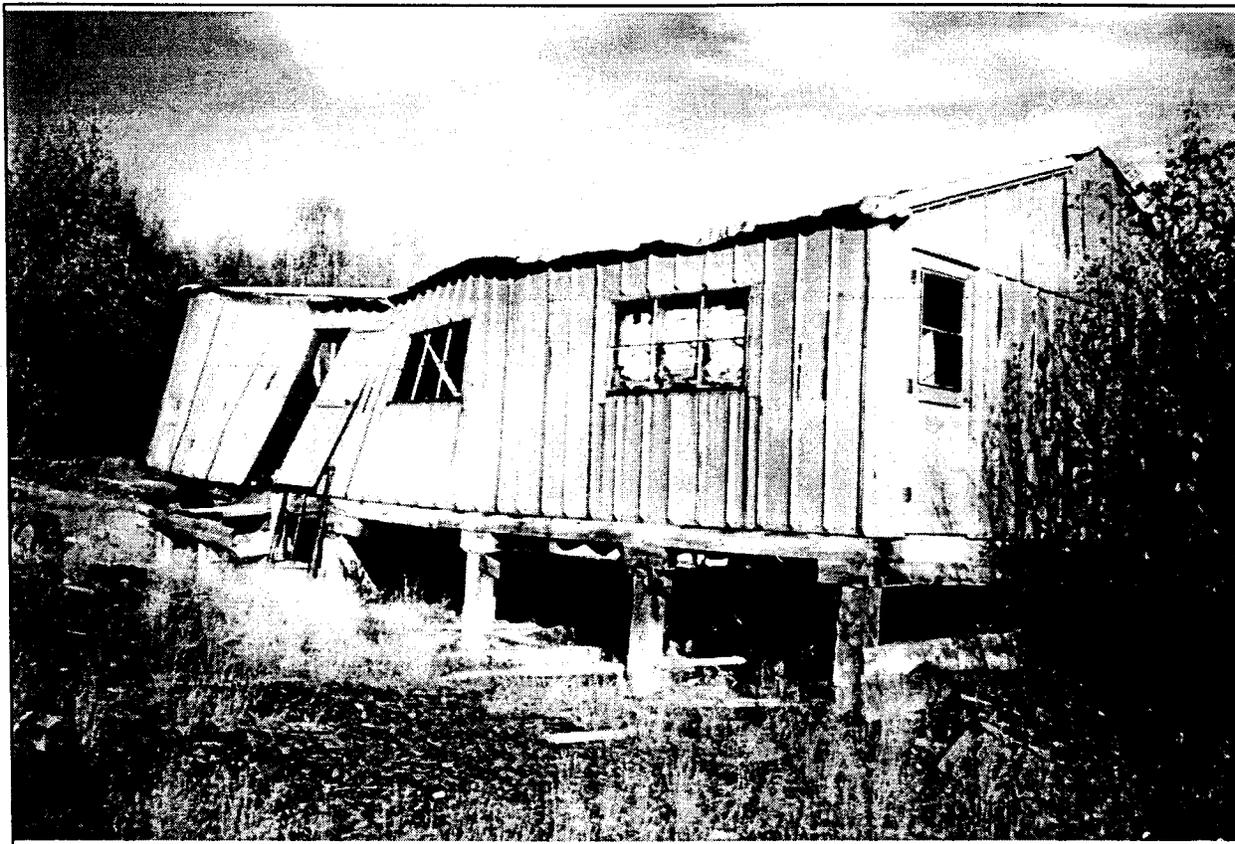
PHOTO 6

Collapsing metal building used as a machine shop and office.

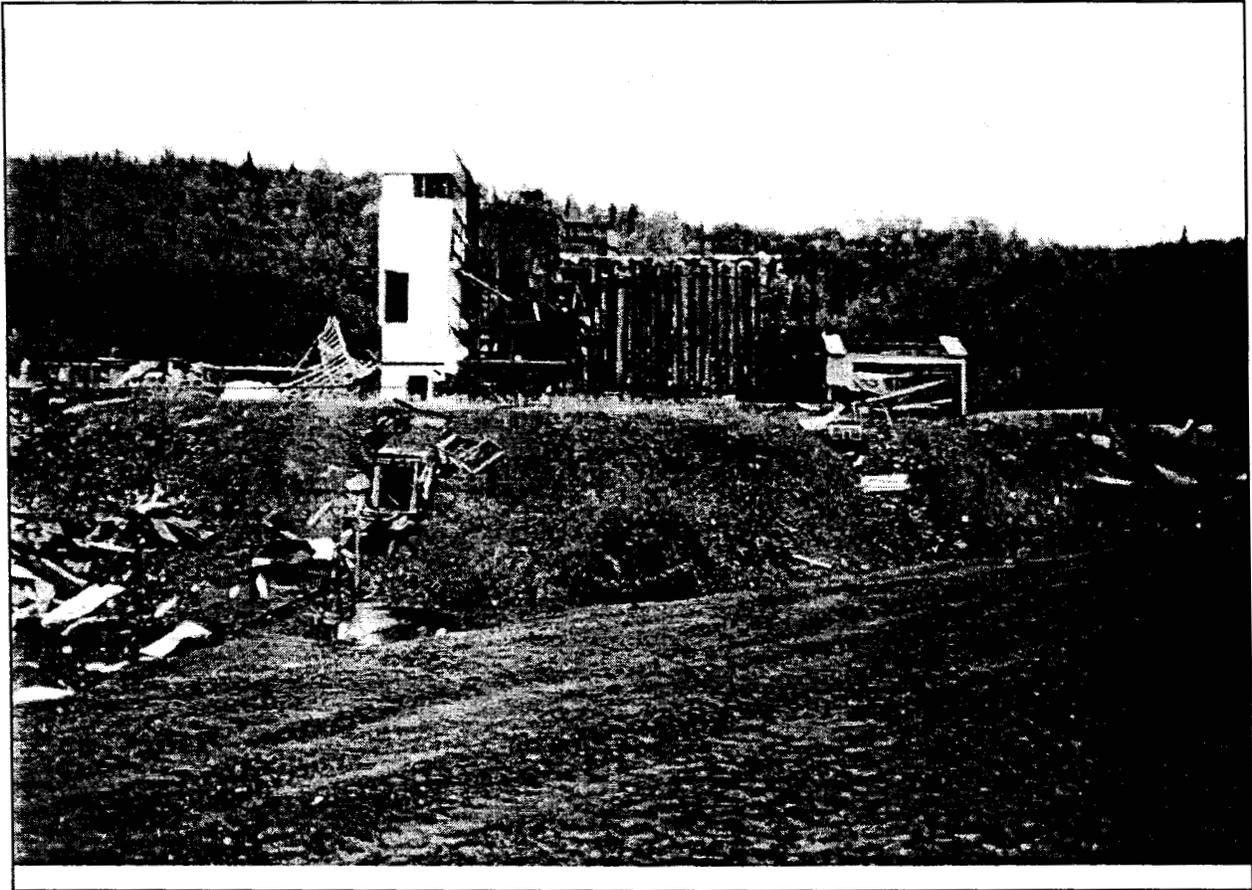
PHOTO 7

The retort building seen in photo #7 is in a state of incipient collapse. It is also contaminated by mercury and will have to be completely removed for public safety and environmental protection.

Mercury contaminated retort building.
