BLM-Alaska Open File Report 64
BLM/AK/ST-97/022+8111+040
April 1997

HISTORIC BUILDING SURVEY REPORT FLAT, ALASKA

by Rolfe G. Buzzell and Darrel L. Lewis

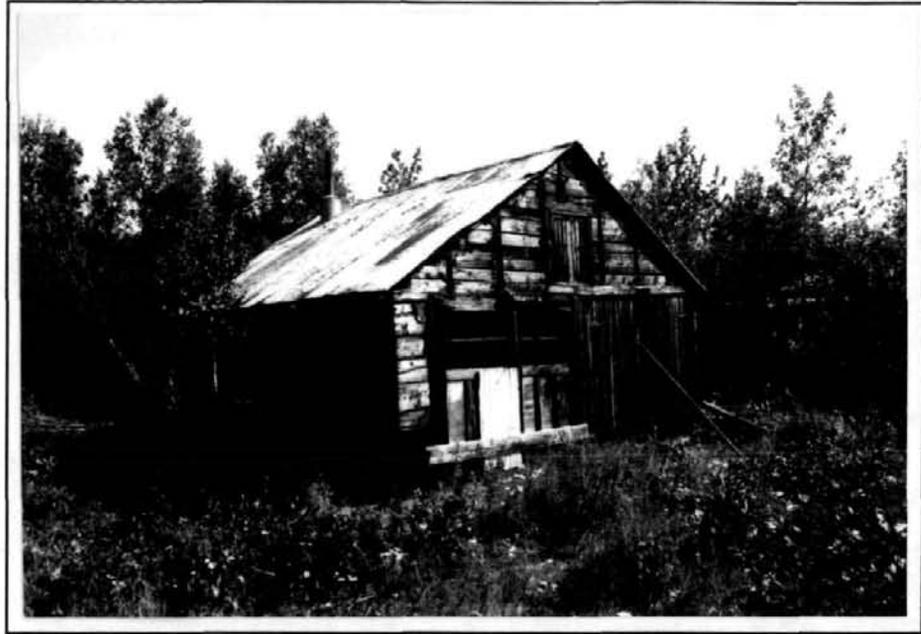
Figure 19. The Savage/Fullerton Garage, 1993.
The view is looking northeast.

The Savage/Fullerton Garage (IDT-074) is a square 1.5 story, wood frame building (Figure 19). Each side measures 20'4". The building rests on a timber foundation. The main entrance faces south. The siding consists of felt paper over 1"x8" boards. The gable roof is

covered with corrugated metal. A nine light fixed sash window is located on the north and west elevations and a six-light fixed sash window is located in the north gable. Two sets of large double doors are located in the south elevation and a hay door is centered in the gable. The garage is in good condition. A horse buggy is stored inside the building.

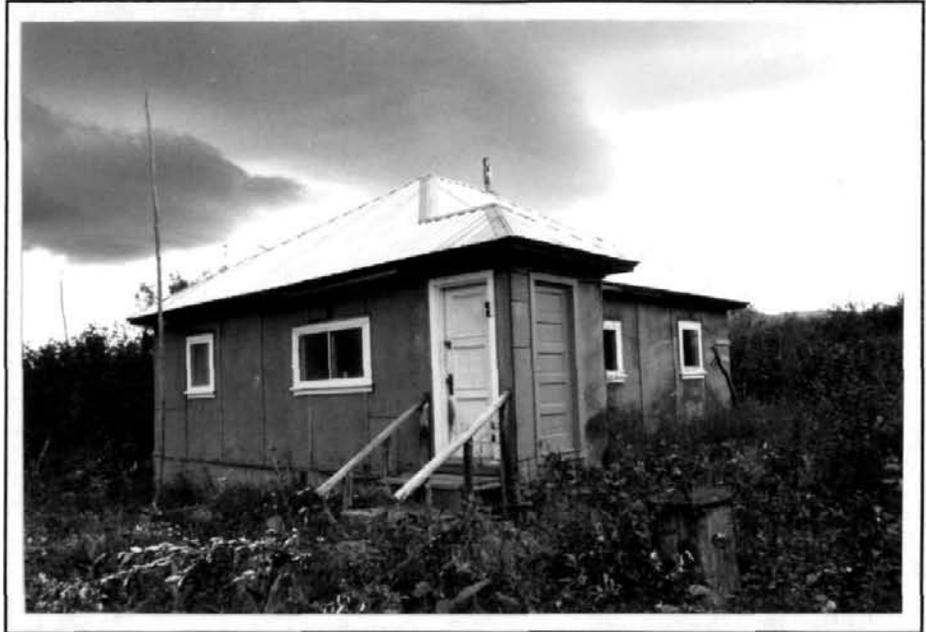
Figure 22. The Hill/Day/Agoff House, 1993. The view is looking southeast.

John Hill built this house near the slough in Iditarod in the 1930s. Glen Day and his wife lived in the house until his death in 1943. His widow lived in the house until her son, Clyde Day, moved the building to its present location in 1945 so his mother would not be alone in Iditarod while he was away on river-boat trips. Andrew Miscovich acquired the building and sold it to Alvin and Cathy Agoff in 1968 (Agoff 1995:218).

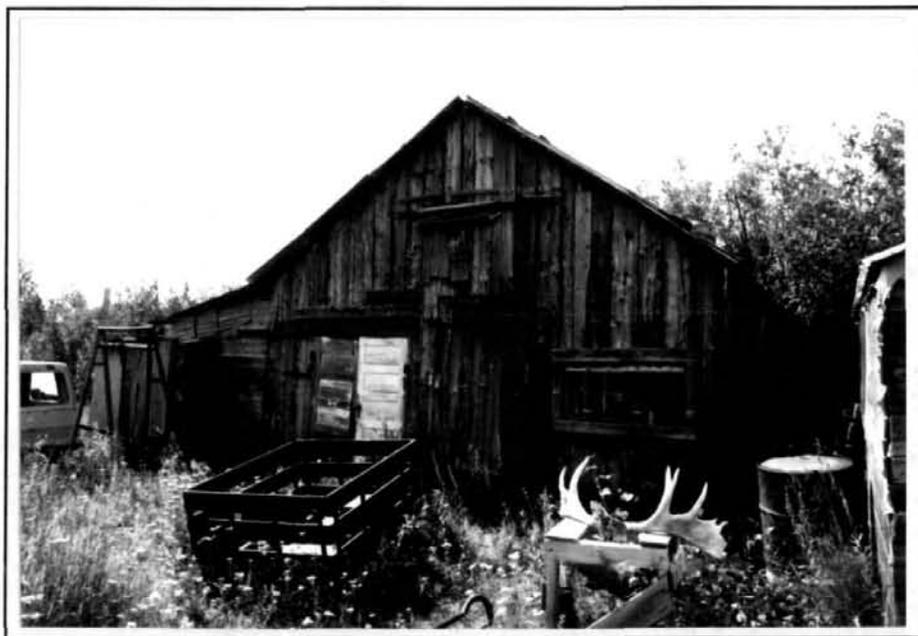
Figure 24. The Miscovich House/Uotila Shop, 1993. The view is looking southwest.

The Miscovich House/Uotila Shop (IDT-243) is a rectangular, 1.5 story building (Figure 24) located about 25' northwest of the Guggenheim Office/Uotila House. The foundation consists of logs. The building is 20' square. It has a gable roof covered with corrugated metal and is sided with vertical lumber. The east

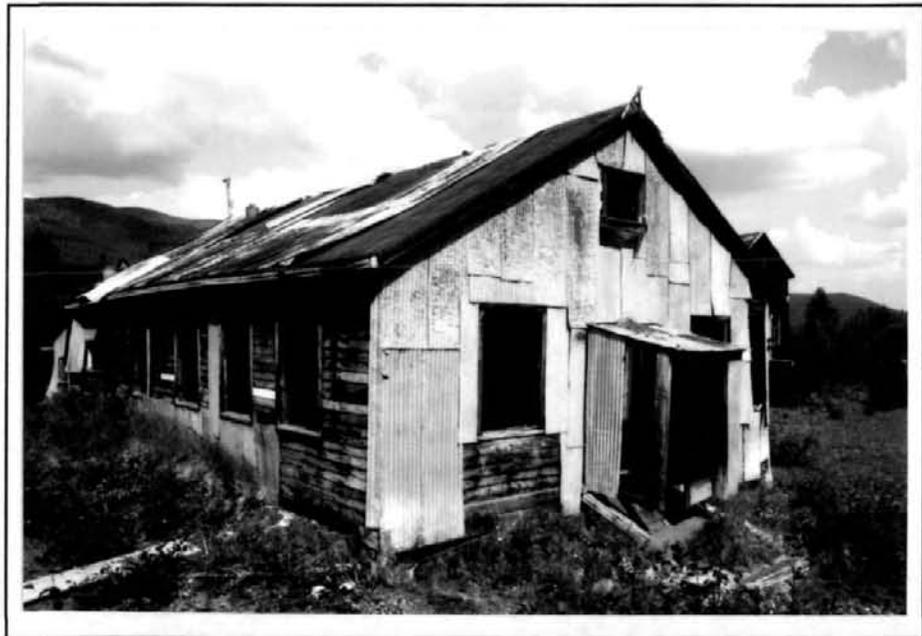
Figure 25. The Guggenheim Hospital/Schoolhouse, 1993. The view is looking northwest.

The **Guggenheim Hospital/Schoolhouse (IDT-093)** is a rectangular, 1.5 story, wood frame building (Figure 25) measuring 29'6"x52'9". The foundation consists of horizontal stacked timbers. The

gable roof is covered with corrugated metal. Sections of metal have been stripped away, exposing wood decking. Corrugated metal over shiplap covers the exterior walls. The south elevation has two 1/1, single-hung windows. Between the windows is a shed roof arctic entry, which opens into the classroom. Four 6/6, fixed sash windows are located on the east elevation and five 6/6, fixed sash windows are located on the west elevation. A 6/6 fixed

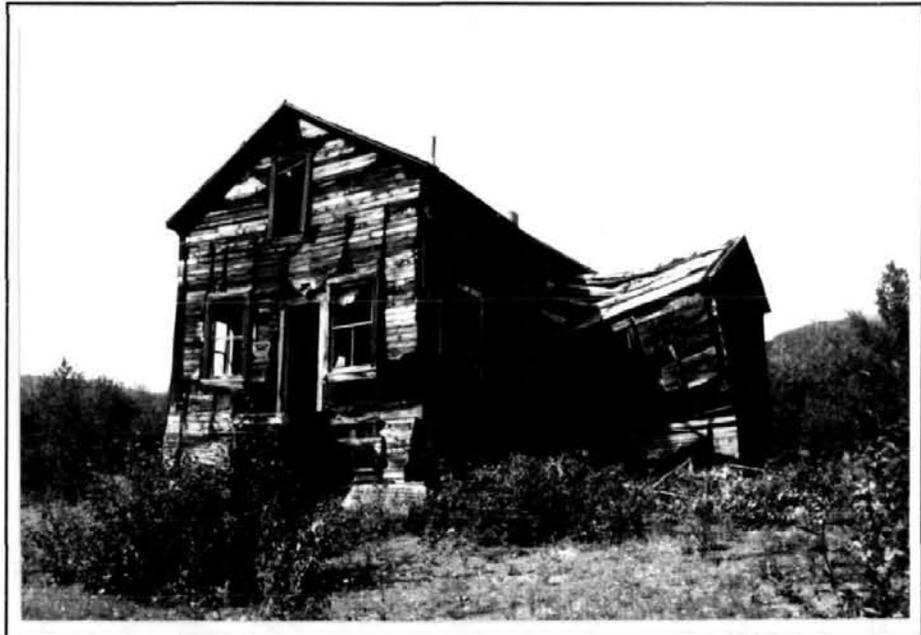
Figure 26. The Mutchler/Miscovich House, 1993. The view is looking northeast.

**The Mutchler/
Miscovich House
(IDT-094)** is a 1.5 story, rectangular, wood frame building (Figure 26). It measures 21'10"x33'. The foundation consists of 55 gallon steel drums. Weathered felt paper covers the gable roof and exterior walls. Stairs, which are no longer present, rose to an entry centered on the south elevation. A 2/2 single-hung window flanked each side of the door-way. A large window frame is centered in the south

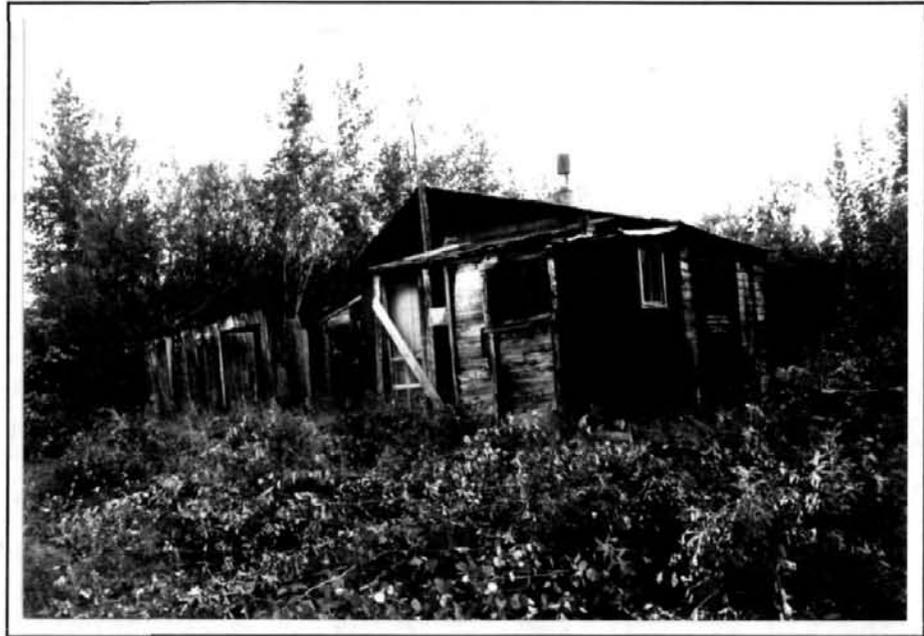
Figure 27. The Michaels/Miscovich House, 1993. The view is looking southeast.

The **Michaels/Miscovich House (IDT-095)** is a modified rectangular, one-story, wood frame building (Figure 27) measuring 12'x14'2". The foundation is on grade. The gable roof is covered with corrugated metal. Roofing felt over wood siding covers the exterior walls. The main entrance faces north and has a 6/6 double-hung window. The south elevation has a four-light, fixed sash window. A shed roof addition is located on the northwest end of the building. A six-light, fixed sash window is located on the west side and a four-panel door on the east side. An addition on the west side of the house measures 7'3"x14'2". It has a shed roof covered with corrugated metal. The west elevation has a two-light, fixed window and the south elevation has a window opening covered with corrugated metal. An addition on the east side measures 6'x15'2" and has a shed roof covered with corrugated metal. The north elevation has a door opening and a single-light, fixed sash window. The east elevation has a window opening but no frame. A shed roof storage building is located 6' northeast of the house. The roof and sides of the 7'2"x11' shed are covered with corrugated metal.

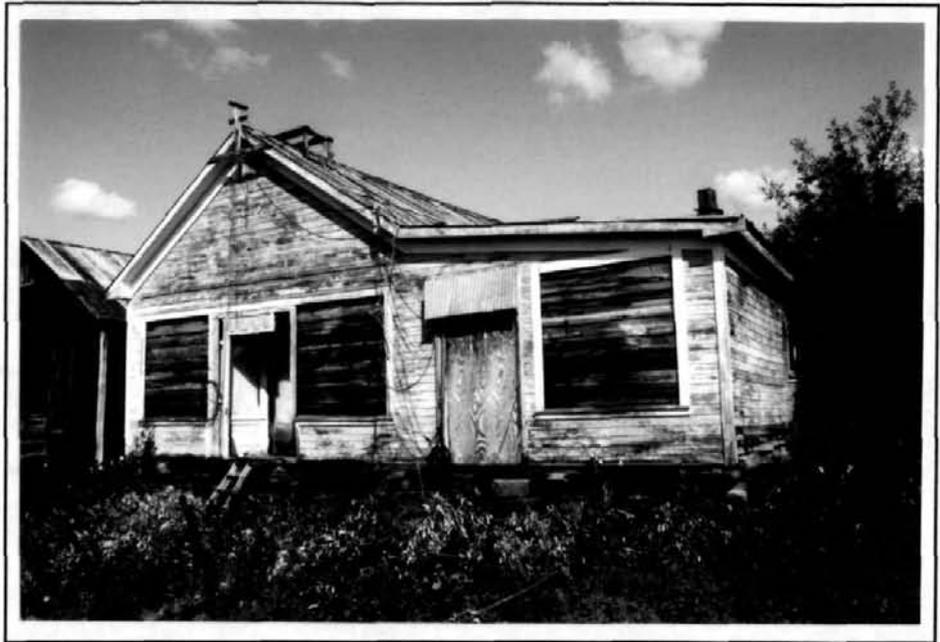
Figure 35. The Donnelley and Sheppard Store, 1993. The view is looking northeast.

of the building. A recessed storefront entry is centered on the east and west elevations. Each entry is flanked by a four-light window that is boarded over. Each recessed entry has a two-light, fixed sash window on each side of the door. The door has a single-light window and a transom window. The outer part of the west entry has a single-light, fixed sash window on the north side and a transom window. The outer door and the

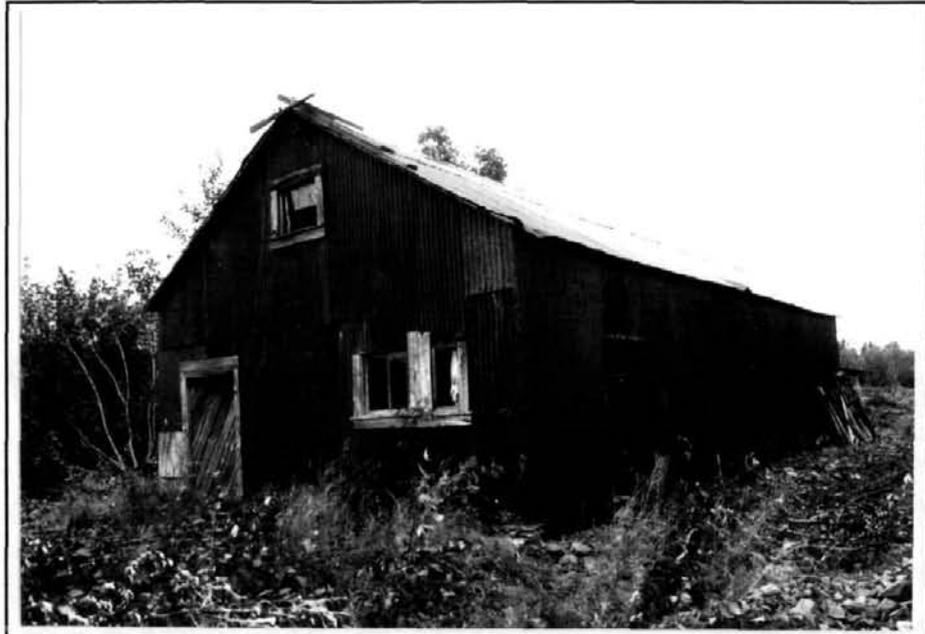
Figure 36. The Donnelley and Sheppard Cold Storage Building, 1993. The view is looking southwest.

The **Donnelley and Sheppard Cold Storage Building (IDT-078)** is a rectangular, 1.5 story, wood frame building (Figure 36). The foundation is logs and wood beams. The gable roof and exterior walls are covered with corrugated metal. The building measures 20'3"x52'4". A six-light, awning window is centered in the east and west gables. The east elevation has a large diagonal plank door and a pair of two-light, fixed sash windows. The north elevation has a door opening at the east end. The west elevation has a two-panel door with one-light and a three-light, fixed sash window. A two-light, fixed sash window is located on the west end of the south elevation. Inside the building is a large walk-in refrigerator. The condensers that operate the refrigerator are located in the west end of the building. A hand operated gasoline pump is laying next to the outside wall at the east end of the south elevation.

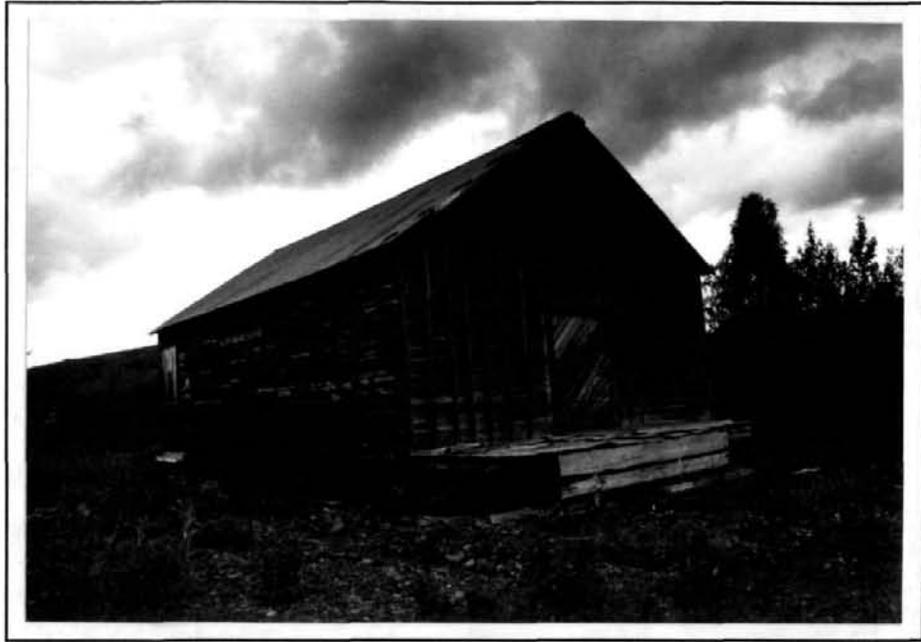
Figure 38. The Turner/Donnelley Hardware Building, 1993, The view is looking northwest.

The shed roof is covered with corrugated metal. The building measures 19'x40'. Celotex covers the exterior walls although portions of the south and west wall covering is missing. Corrugated metal covers some of those missing wall sections. The main entrance faces north
