6310 - Wilderness Characteristics Inventory

Area Unique Identifier: CA-080-198 Kramer Hills

**WILDERNESS CHARACTERISTICS INVENTORY
APPENDIX B – PHOTO LOG**

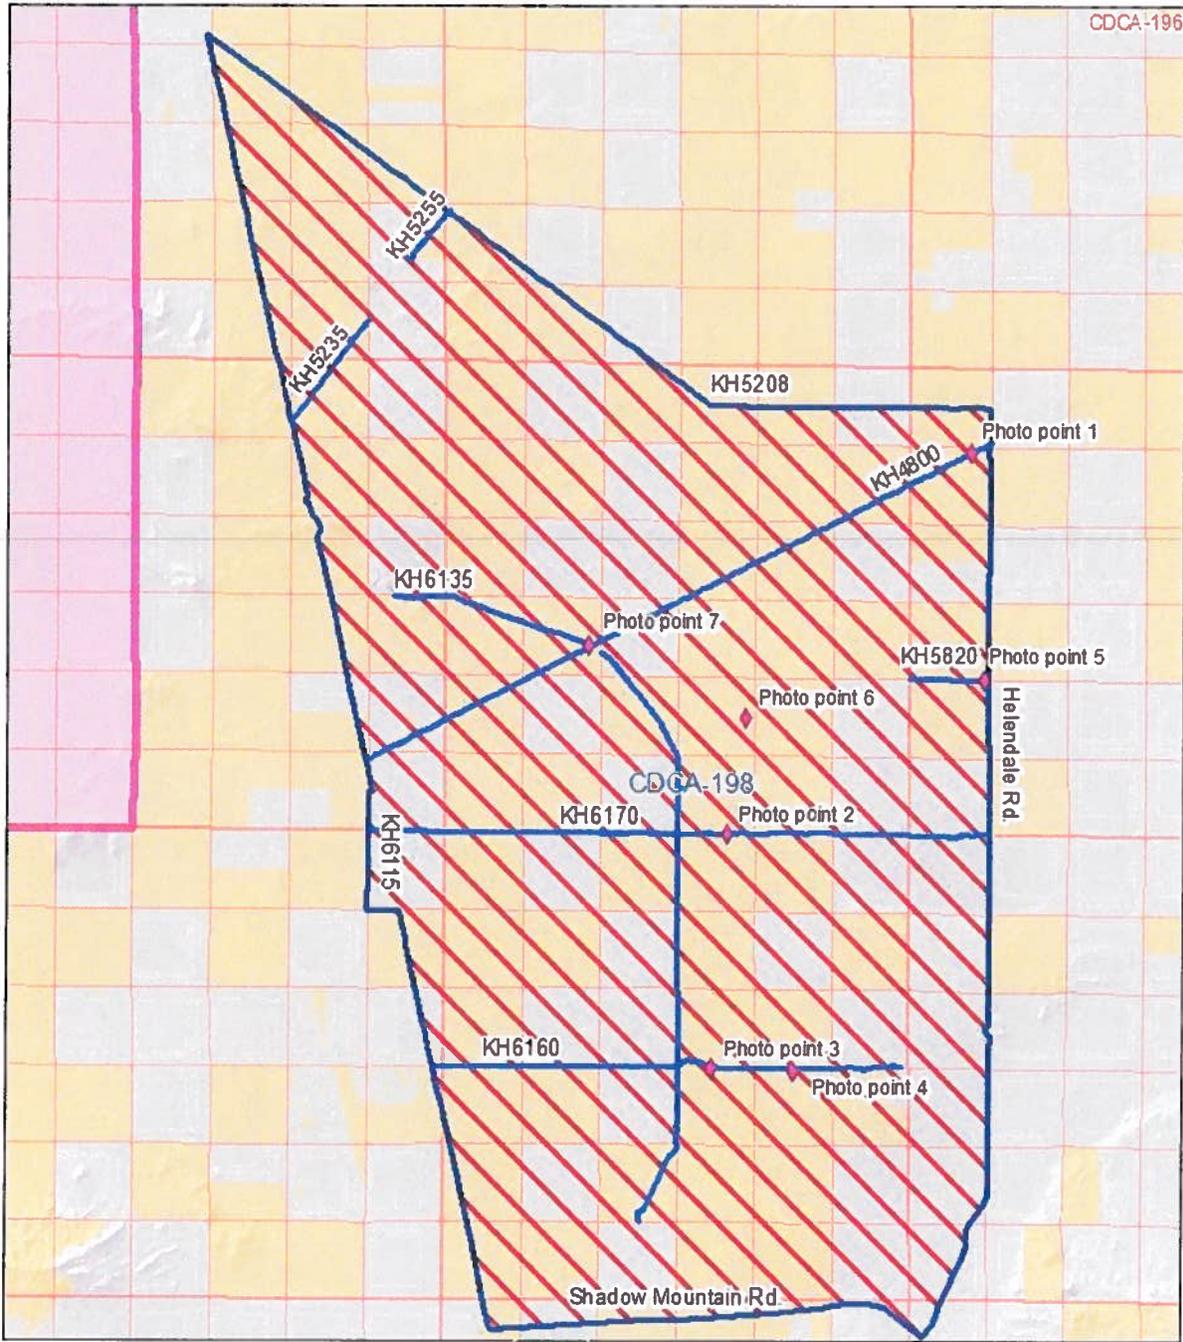
WIU 198 Kramer Hills

- Roads
- Lands with wilderness characteristics**
- No
- Land managed by AGENCY**
- Bureau of Land Management
- Department of Defense
- Unclassified
- Photo points

Even though the total acreage meets the size requirement, the existing public land does not meet the necessary size due to multiple areas that are bisected by roads as well as areas dominated by popular routes (see attached map). The most prominent road that cuts through the entire unit is road KH4800 located in the Northern area of unit 198. Furthermore, other roads that cause the unit to be disqualified for lands with wilderness characteristics are roads: KH5235, KH5255, KH6170, KH6160, and KH6135. As well as these roads, many primitive routes that are driven constantly dominate the landscape throughout the inventory unit.

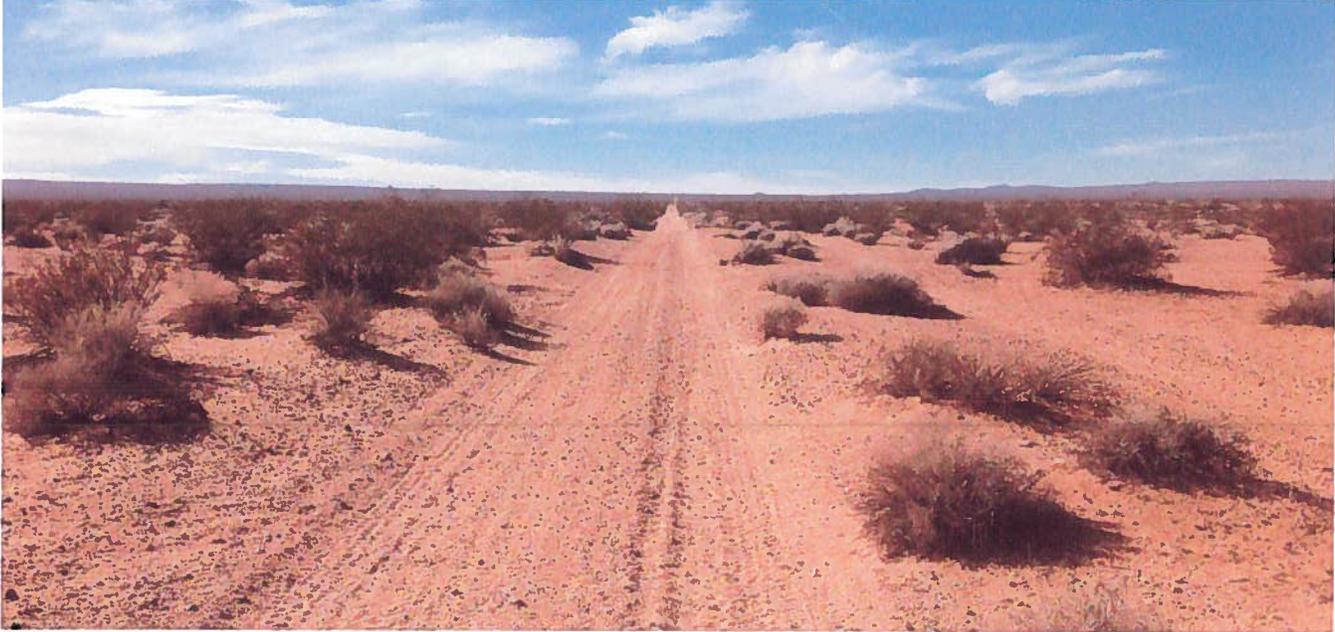
Photo point 1- The photo below was taken looking into the unit at road KH4800. This road travels through the entire inventory unit and is visible all the way to the horizon. It has small berms but it is in consistent use for private inholding access and recreation. It cuts off a large section of land in the northern region of the unit, affecting the size requirement for lands with wilderness characteristics. 1/7/15

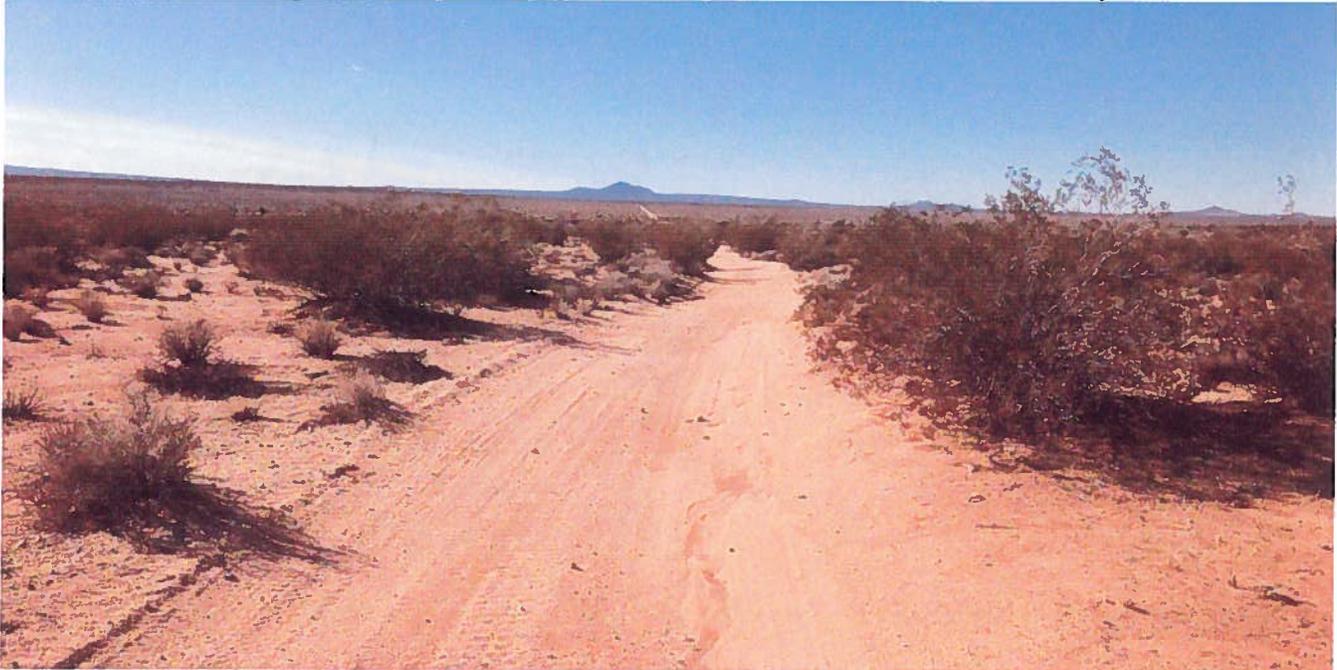
Photo point 2- This photo is looking west into the unit at road KH6170, which also cuts through a large portion of the inventory unit. It separates the central region from much of the inventory unit area. 1/7/15

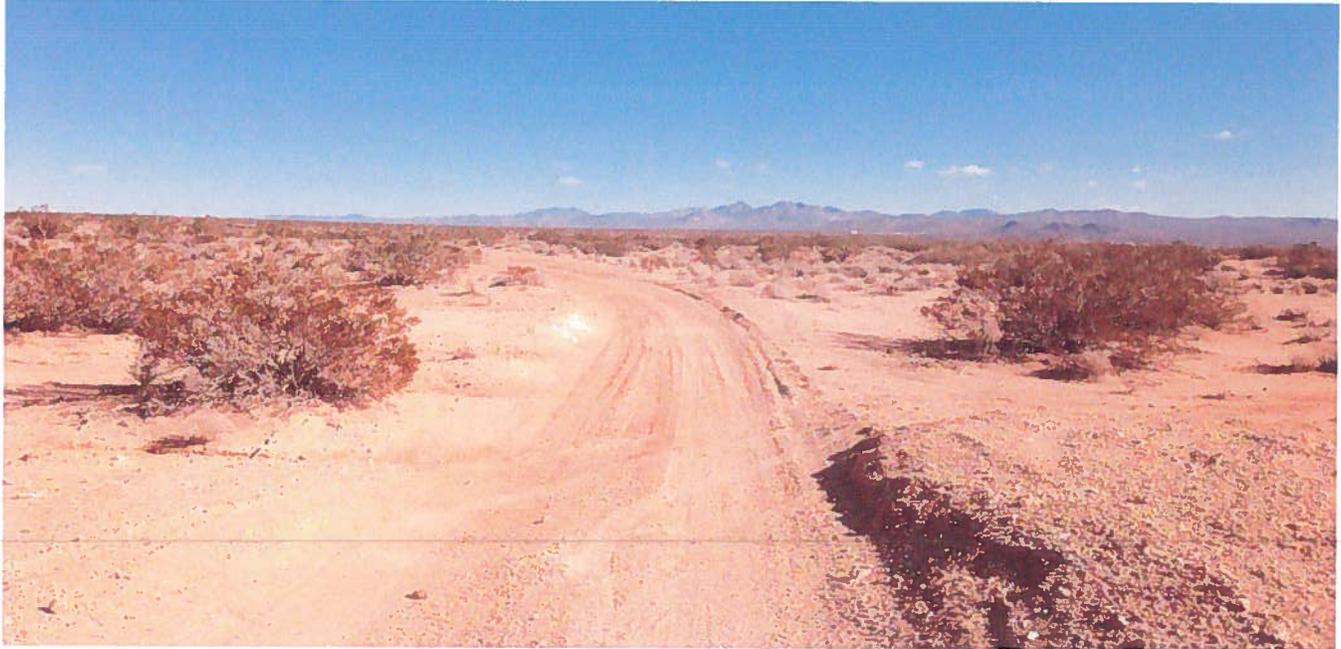
Photo point 3- This photo is looking at road KH6160 and separates the southern region from the inventory unit area. 1/7/15

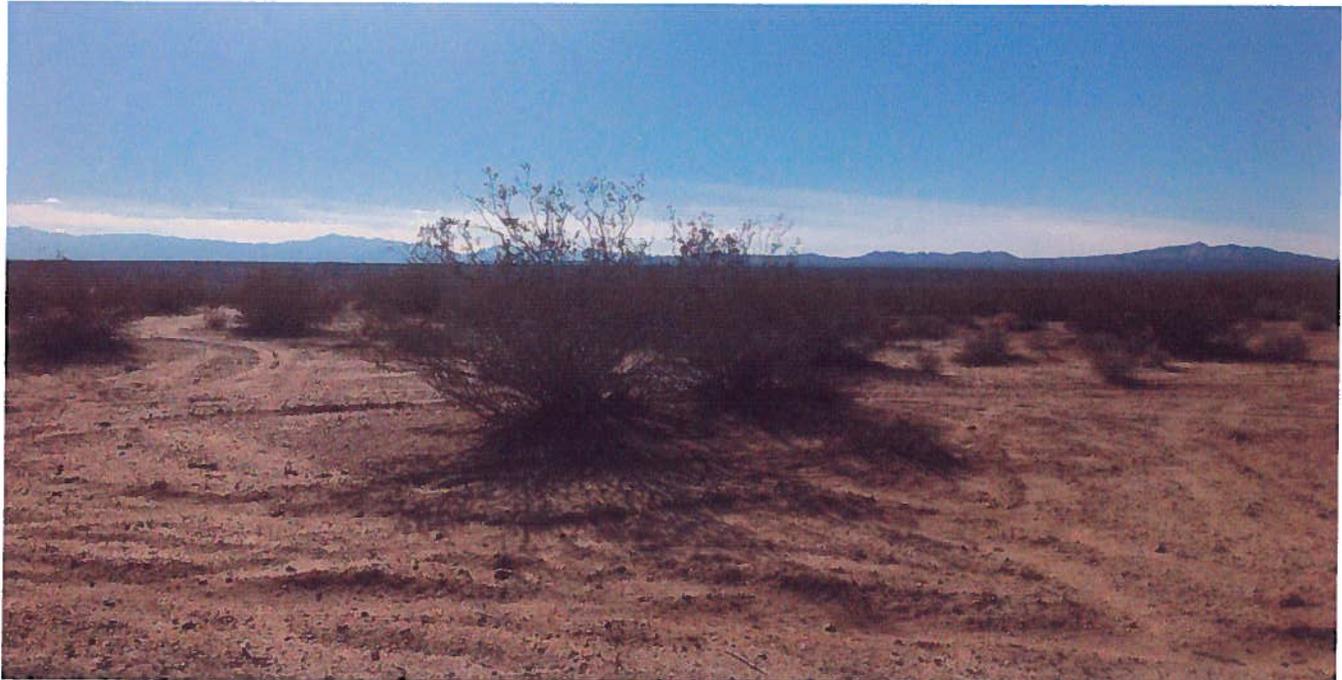
Photo point 4- Frame 1- The photo below is facing east along route KH6159. Networks of routes are visible and common of the entire inventory unit. These routes dissect contiguous areas of public lands into sections smaller than 5,000 acres. 1/7/15

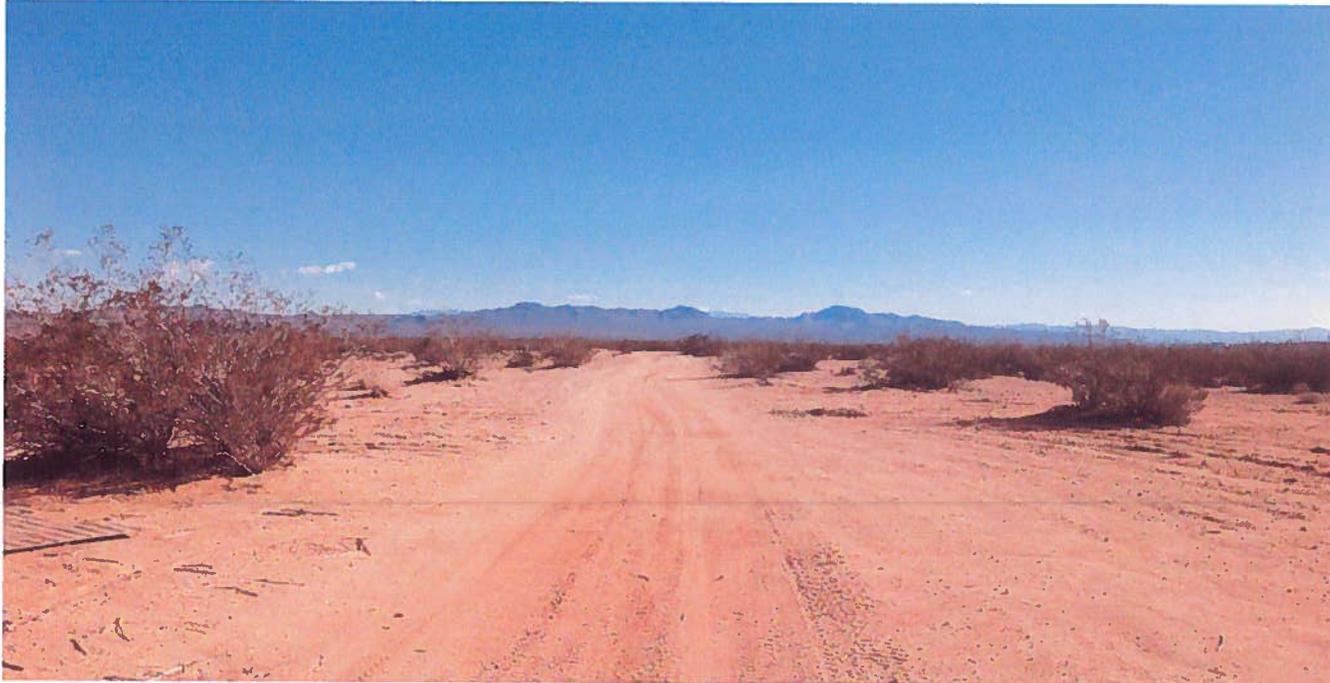
Photo point 4- Frame 2- Facing south on road KH6159 in the southern area of the unit. This road and other routes lace the southern portion making the area even harder to meet the minimum acreage for lands with wilderness characteristics. 1/7/15

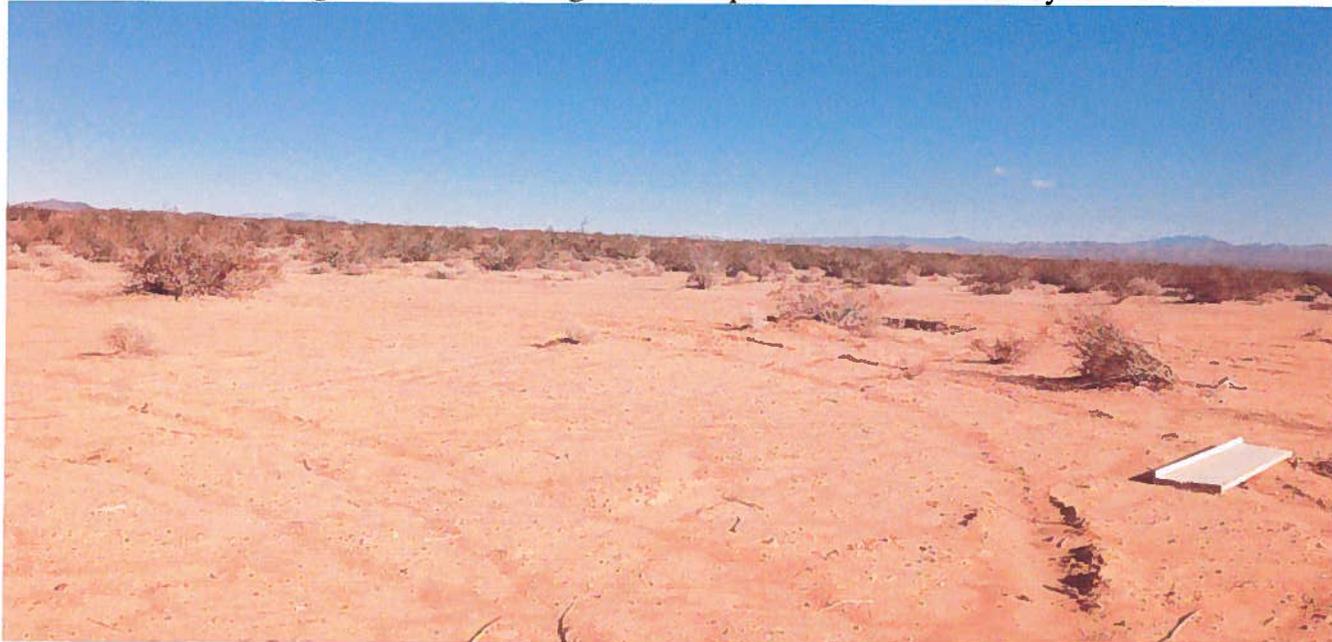
Photo point 4- Frame 3- This photo is facing west on road KH6159. This route along with many others cross over and cut through KH6160 affecting the size requirement of the inventory unit. 1/7/15

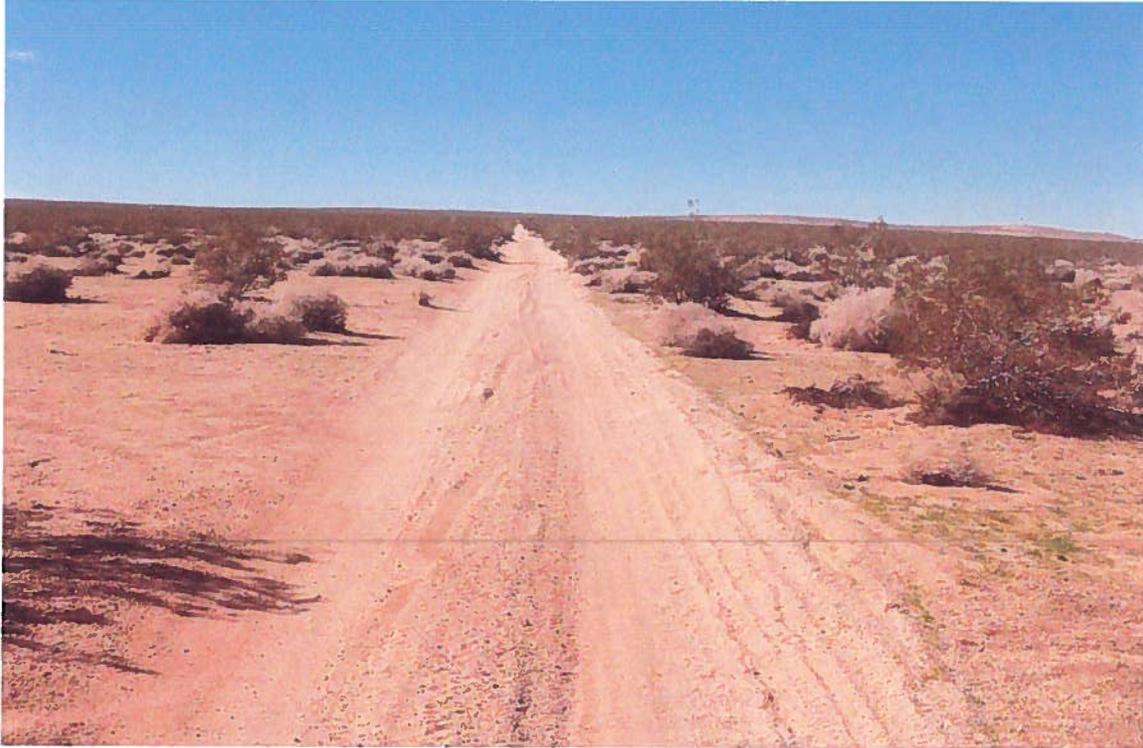
Photo point 5- This designated route, KH5820 cuts through the eastern central region of the unit and bisects S19 and 30, T9N R4W. 1/7/15

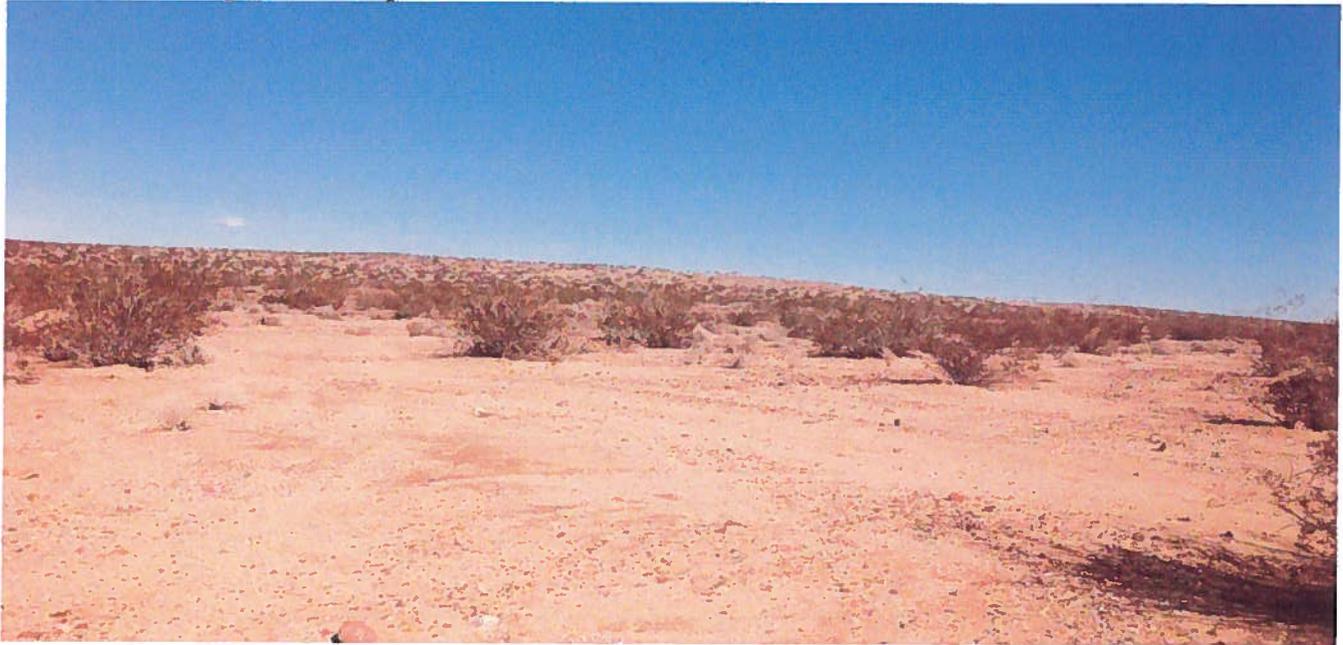
Photo point 6- Impacts like this are common throughout the inventory unit and create a network of routes dominating the landscape, and detract from naturalness. 1/7/15

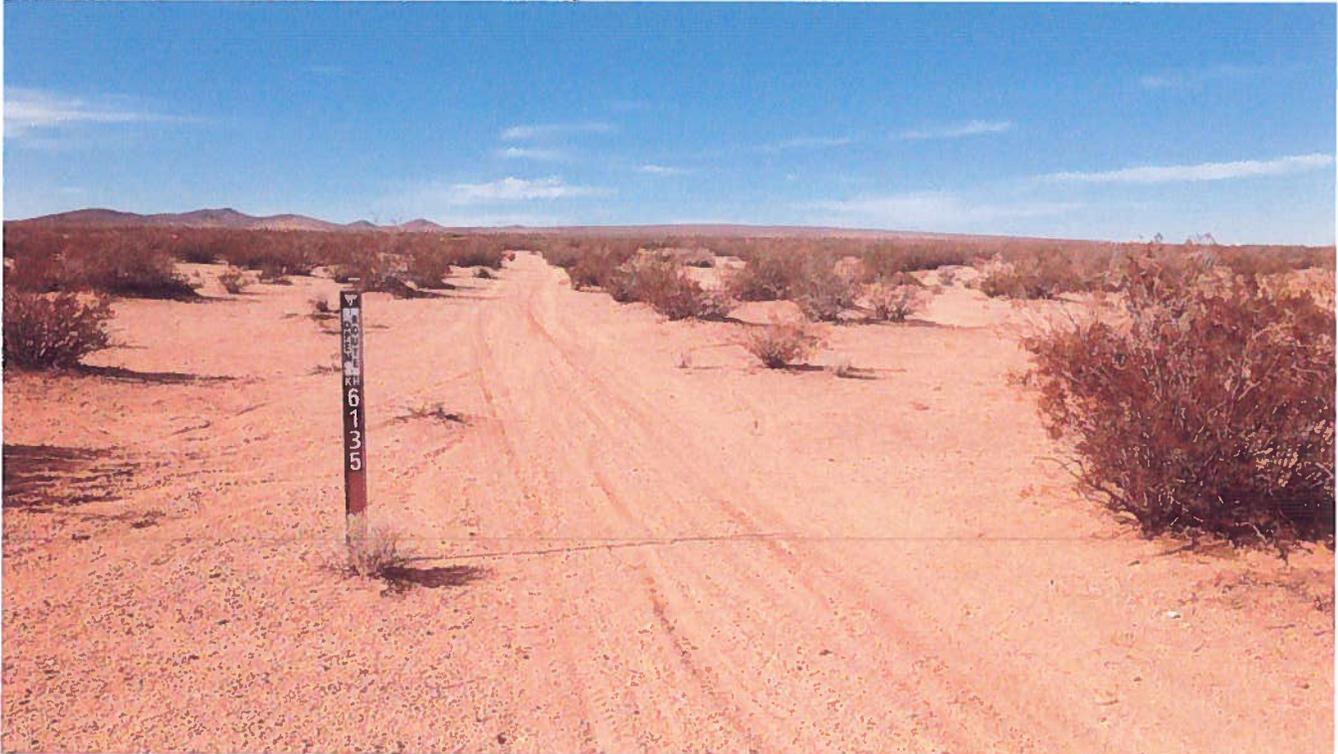
Photo point 7- This photo was taken facing north along designated route KH6135, which runs north and south through the unit, bisecting it into multiple sections with less than 5,000 acres. 1/7/15
