PROJECT: DESERT SUNLIGHT SOLAR FARM

ENVIRONMENTAL COMPLIANCE MONITORING PROGRAM MONITORING REPORT

Report Number: FS-DSSF-2

Date of Report: 9/5/2011

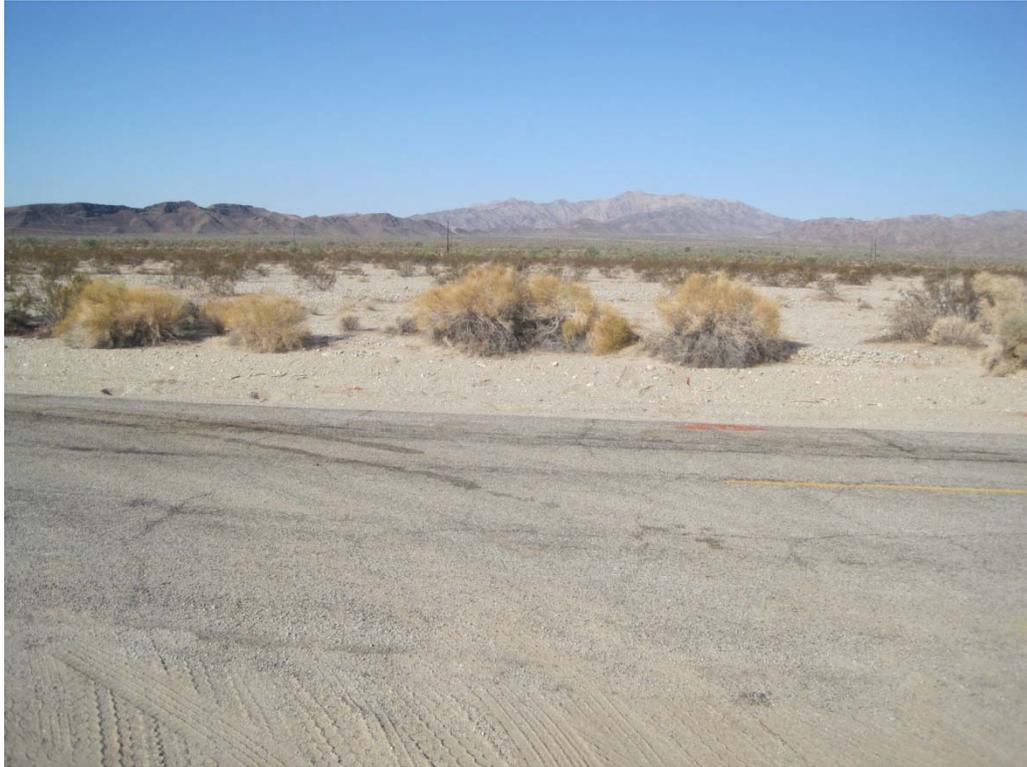
Photo of track-out from Move-On Area onto Kaiser road from the northern most entrance to the site. In order to maintain compliance all track-out must be removed at the end of the work day and must never extend more than 25 feet onto the road.

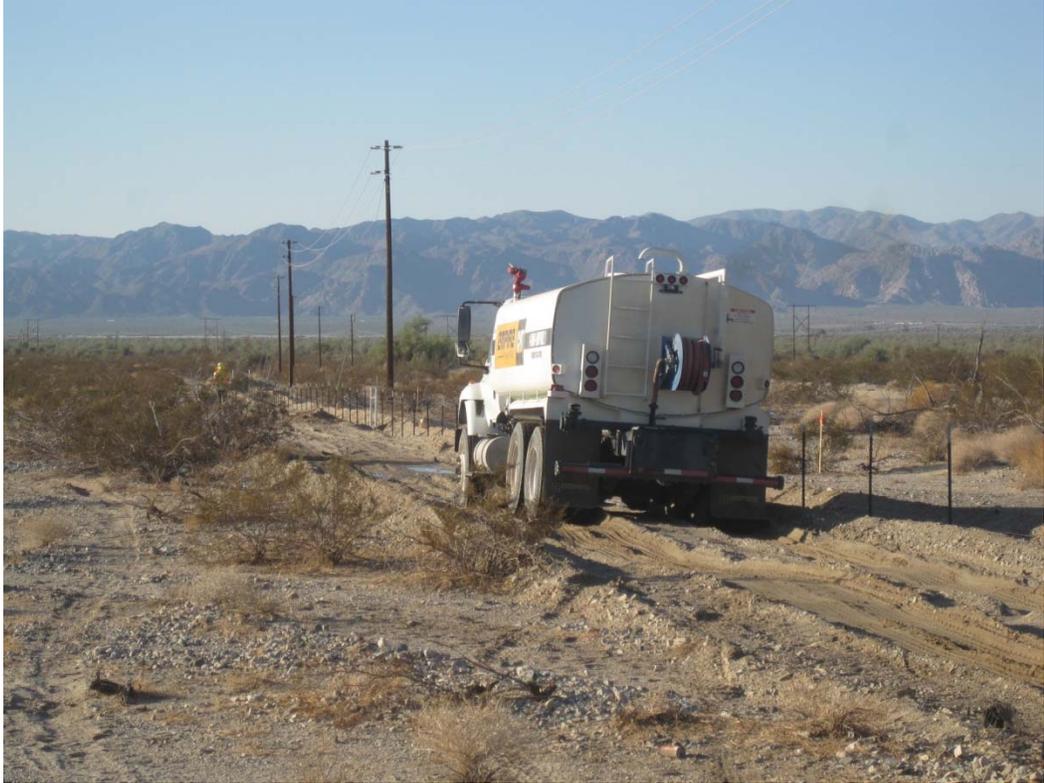
Photo of water truck actively applying water along the fence line as a means of dust control.
