# Phase I Environmental Site Assessment of the Proposed Desert Sunlight Solar Farm Project Riverside County, California

Prepared By Kirsten Bradford, REA

AECOM was retained by First Solar to perform a Phase I ESA of the proposed Desert Sunlight solar farm project located in Riverside County, California (subject property). The purpose of the ESA was to identify the presence of RECs, HRECs, and de minimis conditions as defined by ASTM Standard Practice Designation E 1527-05, which may be associated with the subject property. This Phase I ESA was performed pursuant to AECOM's letter proposal dated February 5, 2010. The purpose of this Phase I ESA is to provide the client with information for use in evaluating potential environmental concerns associated with the subject property.

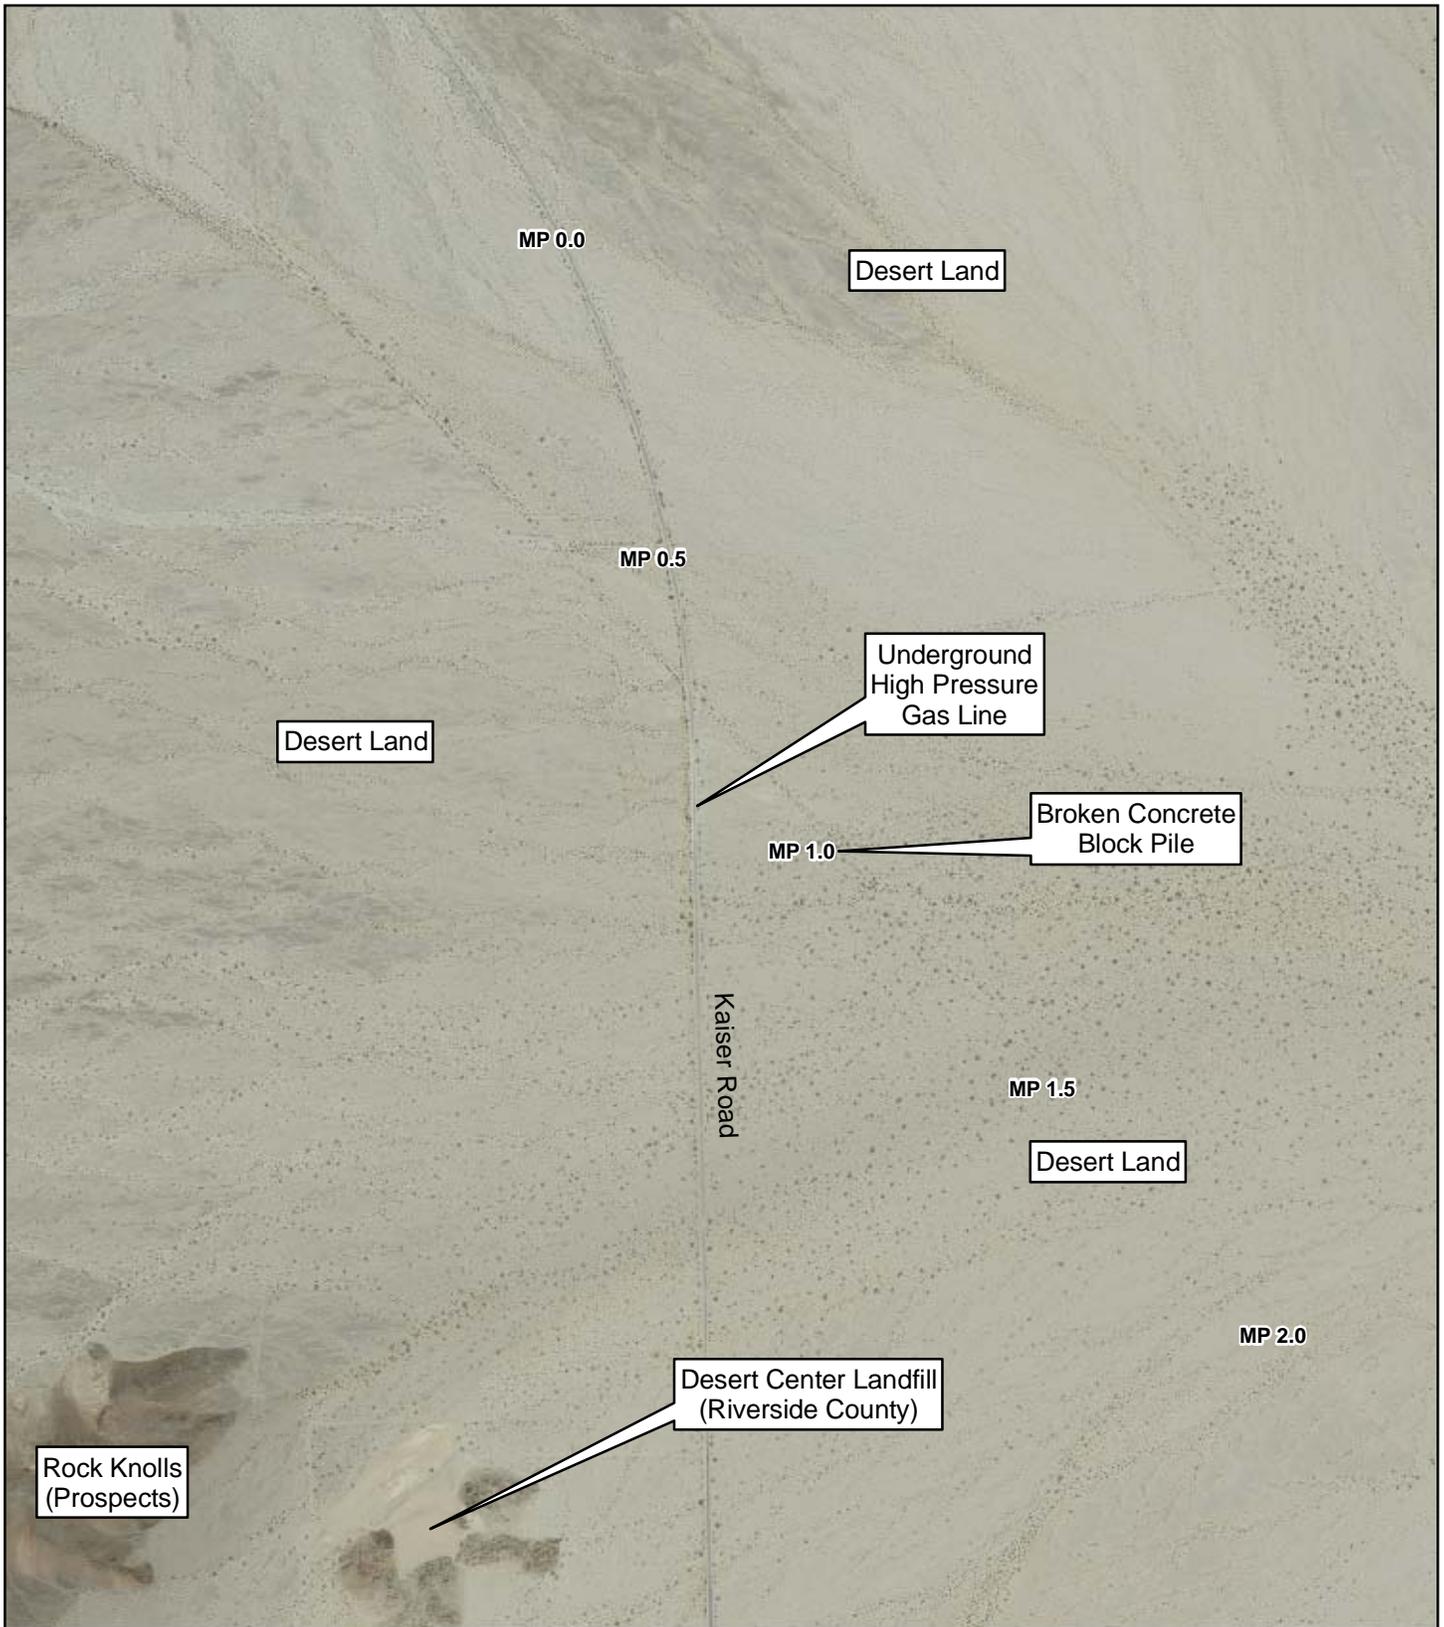
**Figure 3-3a  
Gen-Tie Line –  
Alternative A2  
Mapsheets 1 of 4**

- At mileage point 1.0, an approximate 30 cubic-foot pile of broken concrete block including red bricks was observed along the east side of the gen-tie line - alternative A2 (Figure 3-3a).
- At mileage point 2.3, AECOM observed an automotive steel wheel located along the west side of the gen-tie line - alternative A2.

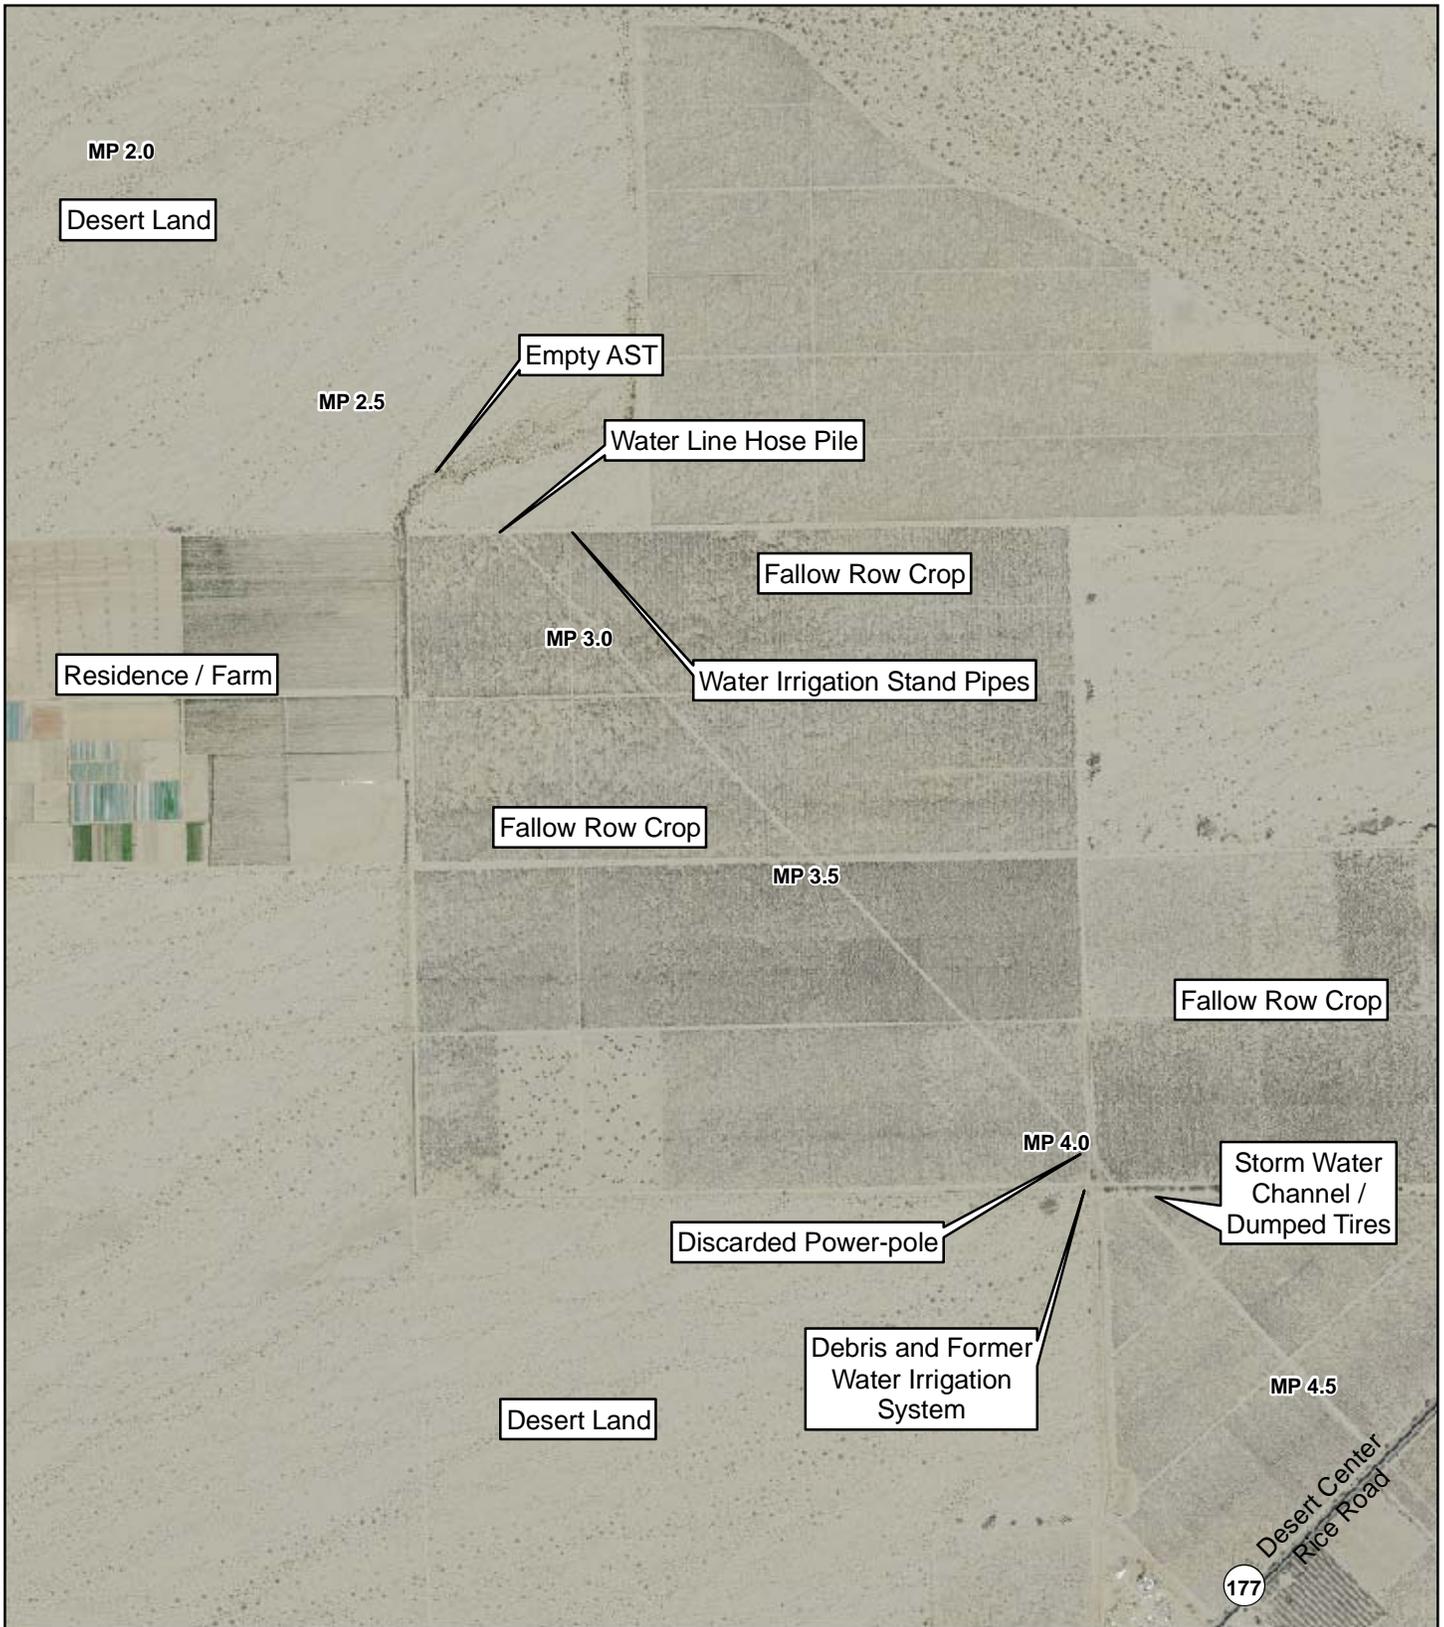
**Figure 3-3b  
Gen-Tie Line –  
Alternative A2  
Mapsheets 2 of 4**

- At mileage point 2.7, AECOM observed an empty (presumably water) 250-gallon aluminum AST that was dumped along the eastern side of the gen-tie line - alternative A2 and used for target-shooting (Figure 3-3b).

- At mileage point 2.8, AECOM observed an approximate 500 square-foot pile of old irrigation water-line hoses located along the east side of the gen-tie line - alternative A2 (Figure 3-3b).

- At mileage point 4.0, AECOM observed a discarded power-line pole located along the western side of the gen-tie line - alternative A2 (Figure 3-3b).
- At mileage point 4.2, AECOM observed approximately 24 tires dumped (some partially buried) along the east side of the gen-tie line - alternative A2, in the storm water channel, that traverses across the gen-tie line - alternative A2.

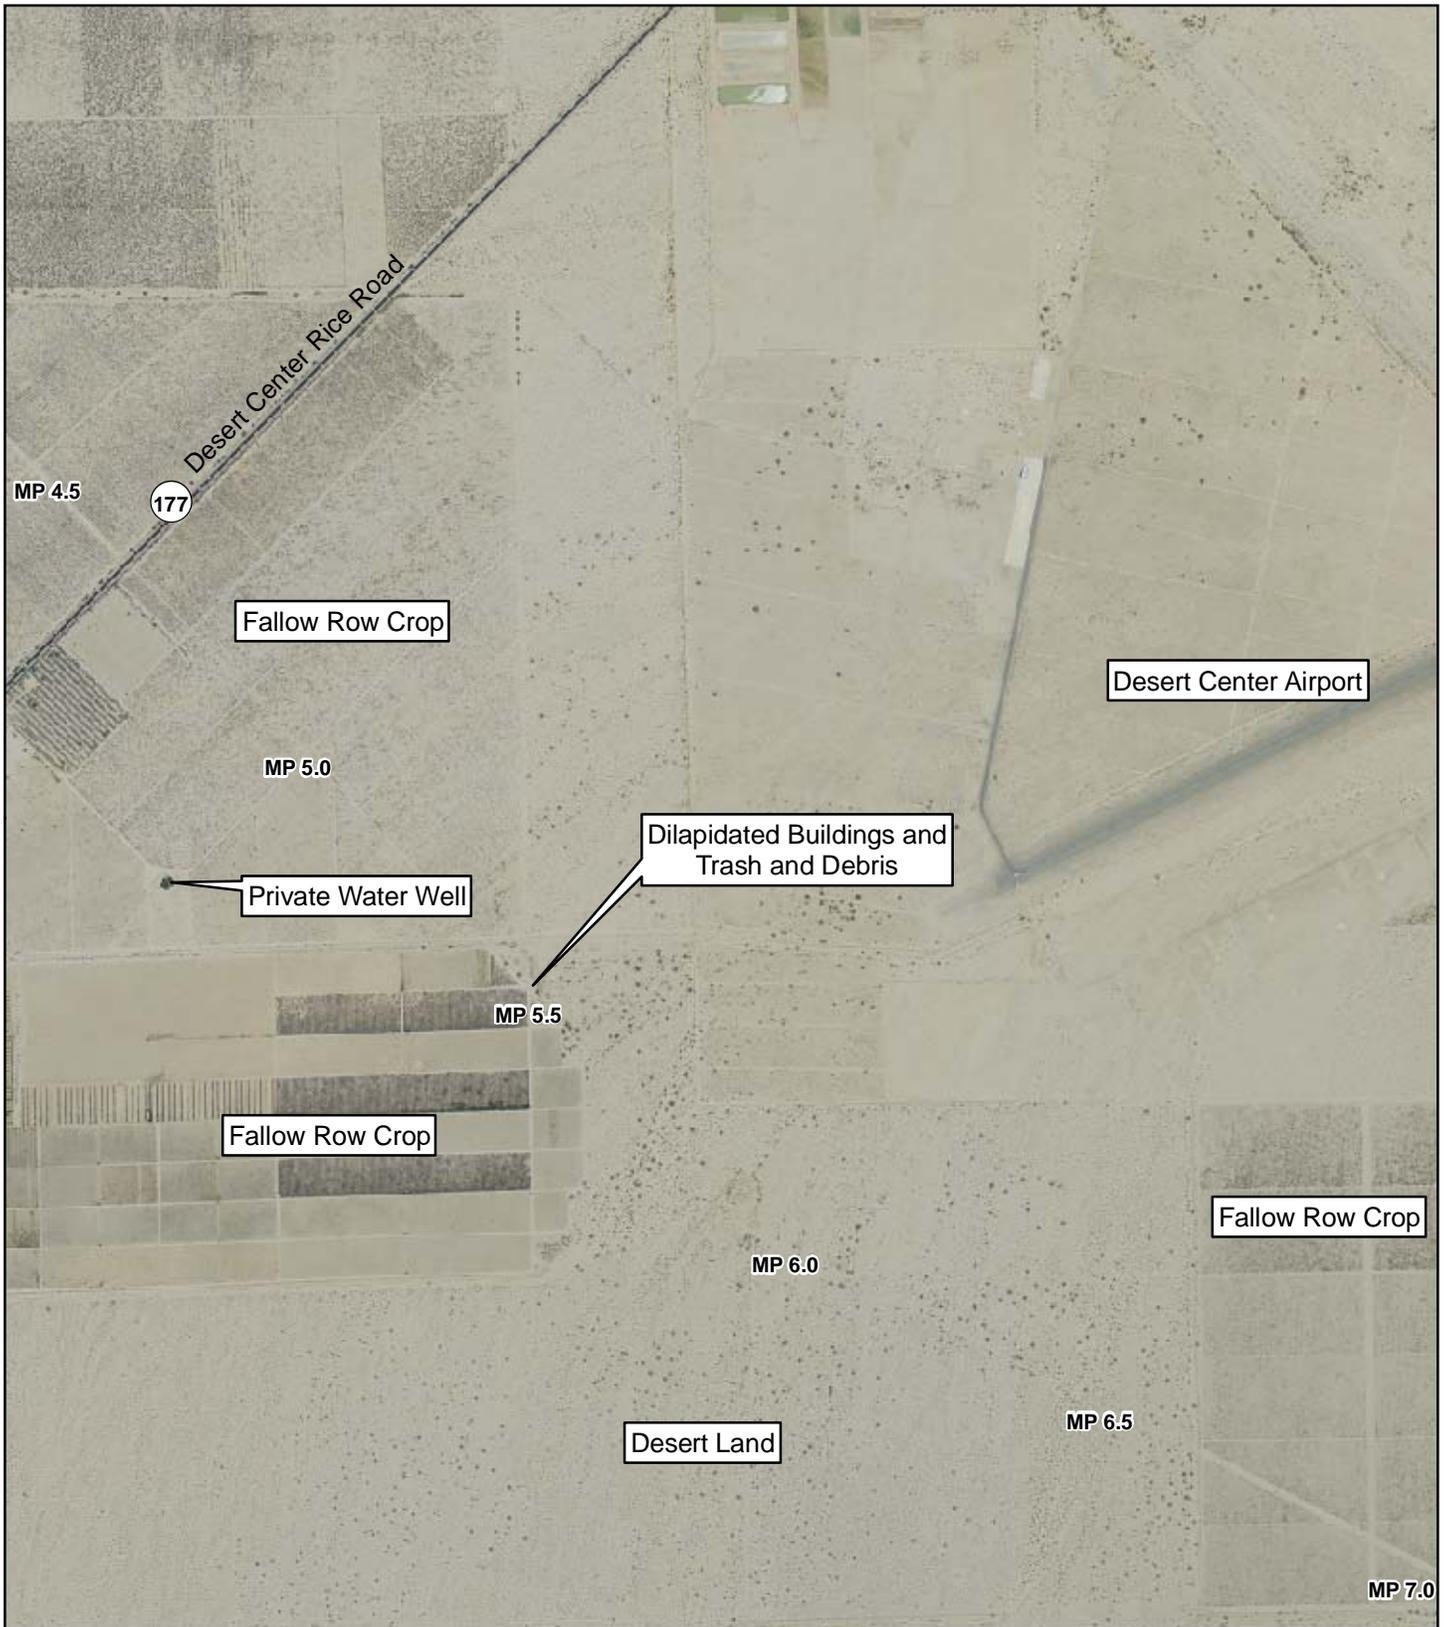
**Figure 3-3c  
Gen-Tie Line –  
Alternative A2  
Mapsheet 3 of 5**

- At mileage point 6.5, AECOM observed trash and debris and two dilapidated approximate 500-square foot buildings located on the east side of the gen-tie line - alternative A2. The trash and debris included scattered wood and metal building materials and household items such as a couch and a mattress box spring, approximately six concrete culverts, and another approximate 500 square-foot pile of old irrigation water-line hoses (Figure 3-3c).

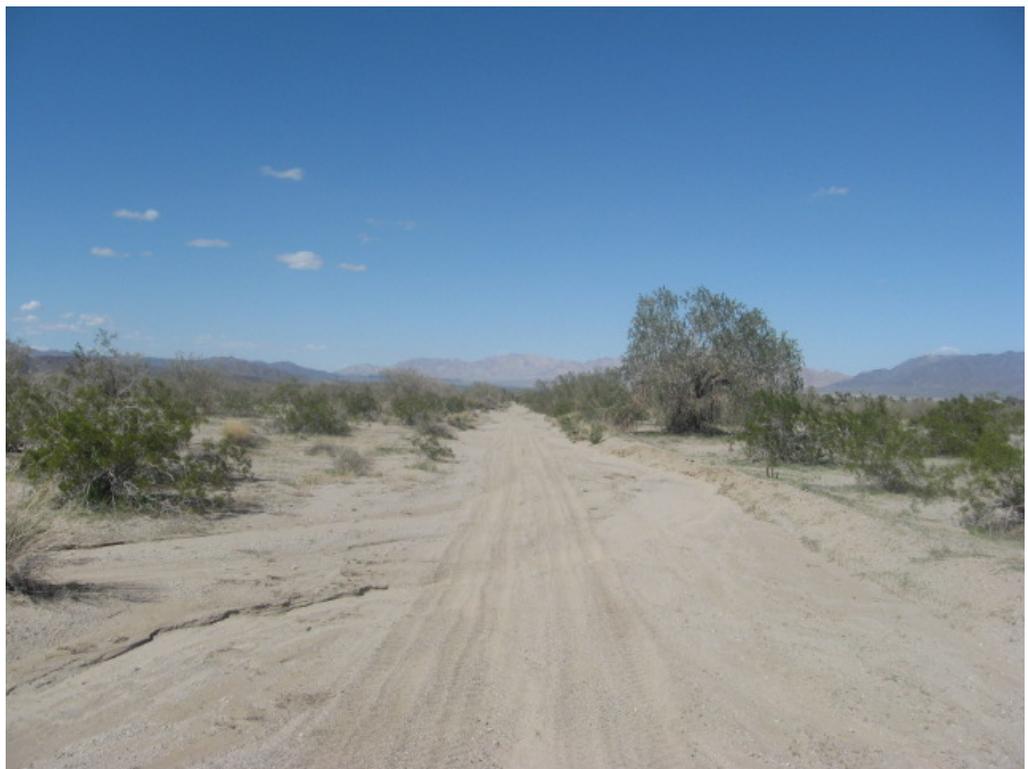
<b>Photo No.</b> <b>4</b>	<b>Date:</b> 03/02/10
------------------------------	--------------------------

Typical view of the gen-tie line - alternative A1 and gen-tie line - alternative B2 (approximate mileage point 0.5).

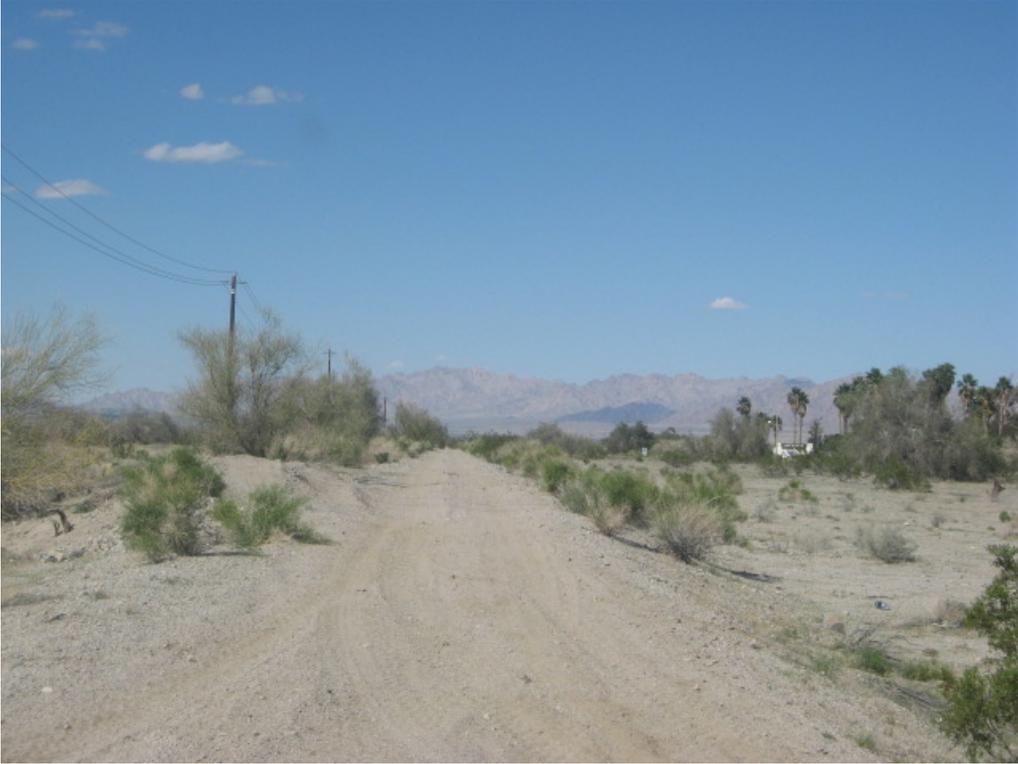
<b>Client Name:</b> First Solar		<b>Site Location:</b> Proposed Desert Sunlight Solar Project	<b>Project Number:</b> 60149119-100
<b>Photo No.</b> <b>5</b>	<b>Date:</b> 03/02/10

<b>Direction Photo Taken:</b>  North			
<b>Description:</b>  View of the gen-tie line - alternative A1 and gen-tie line - alternative B2 (approximate mileage point 5.0).  Note Lake Tamarisk (residential) in the background (right).			
<b>Photo No.</b> <b>6</b>	<b>Date:</b> 03/02/10

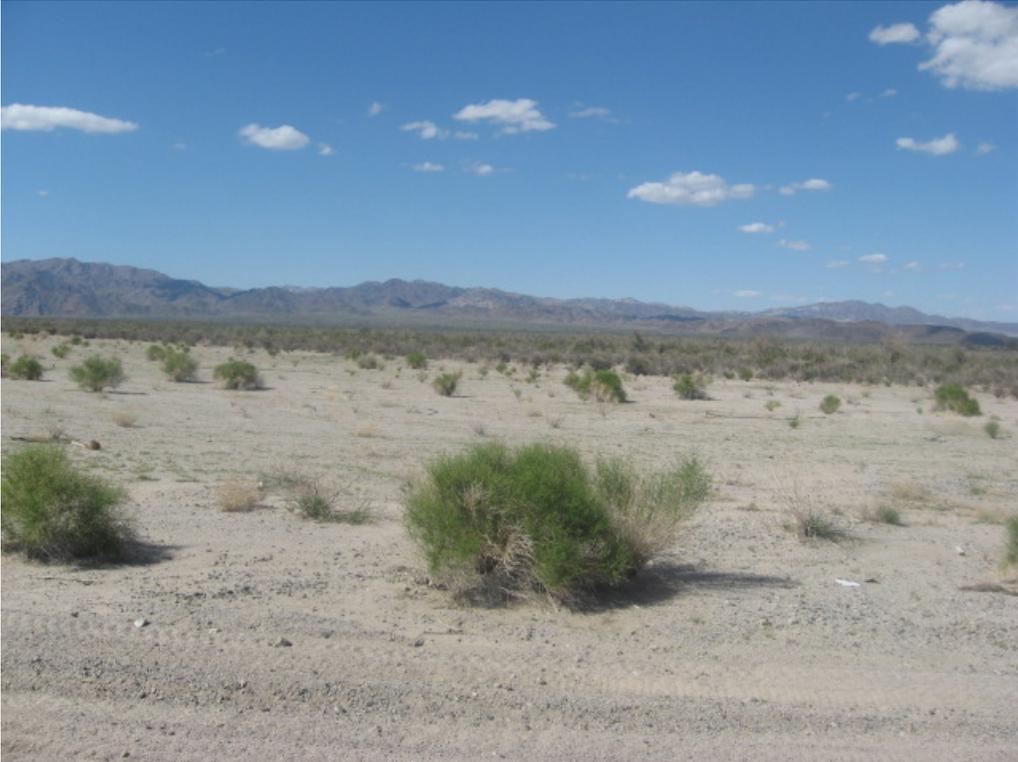
<b>Direction Photo Taken:</b>  West			
<b>Description:</b>  View of the gen-tie line - alternative A1 and area of and gen-tie line - alternative B2 from Kaiser Road.

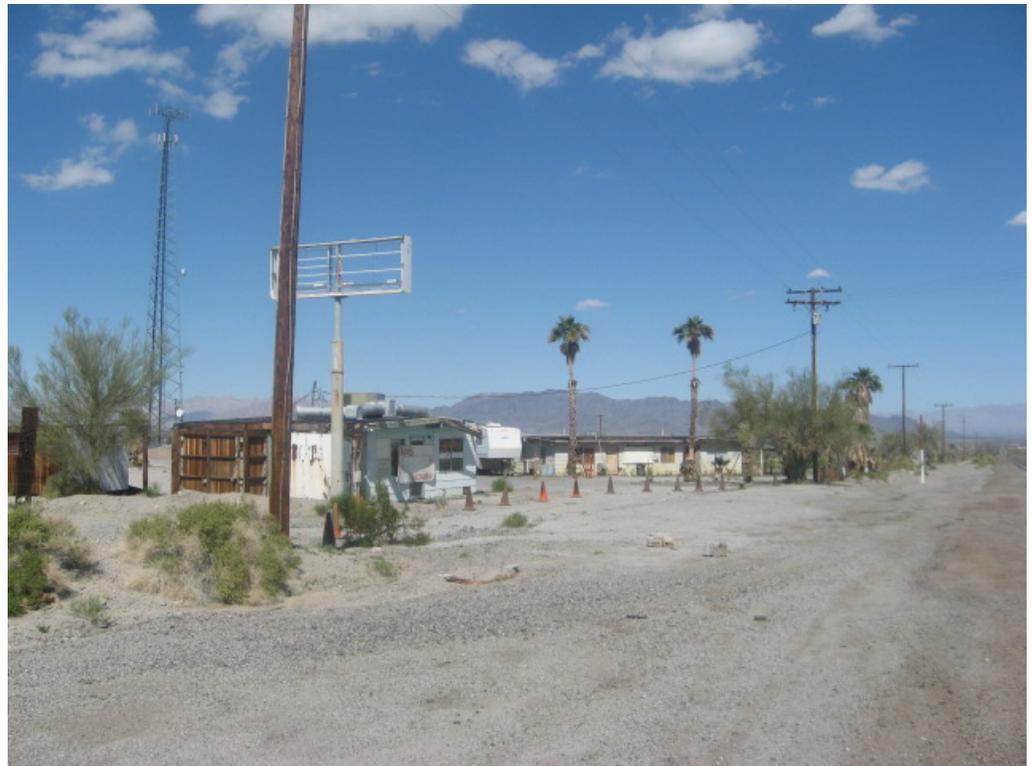
View of the vacant Chavez Auto and Truck.

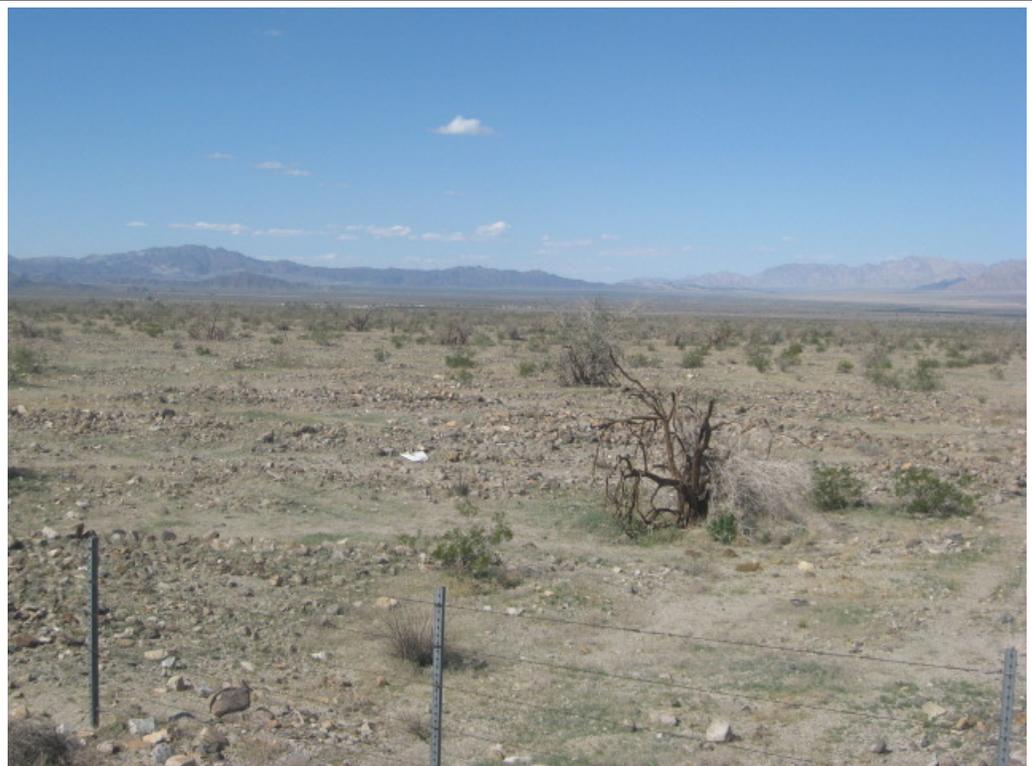
<b>Photo No.</b> <b>8</b>	<b>Date:</b> 03/02/10
------------------------------	--------------------------

View of the gen-tie line - alternative A1 from Interstate 10.

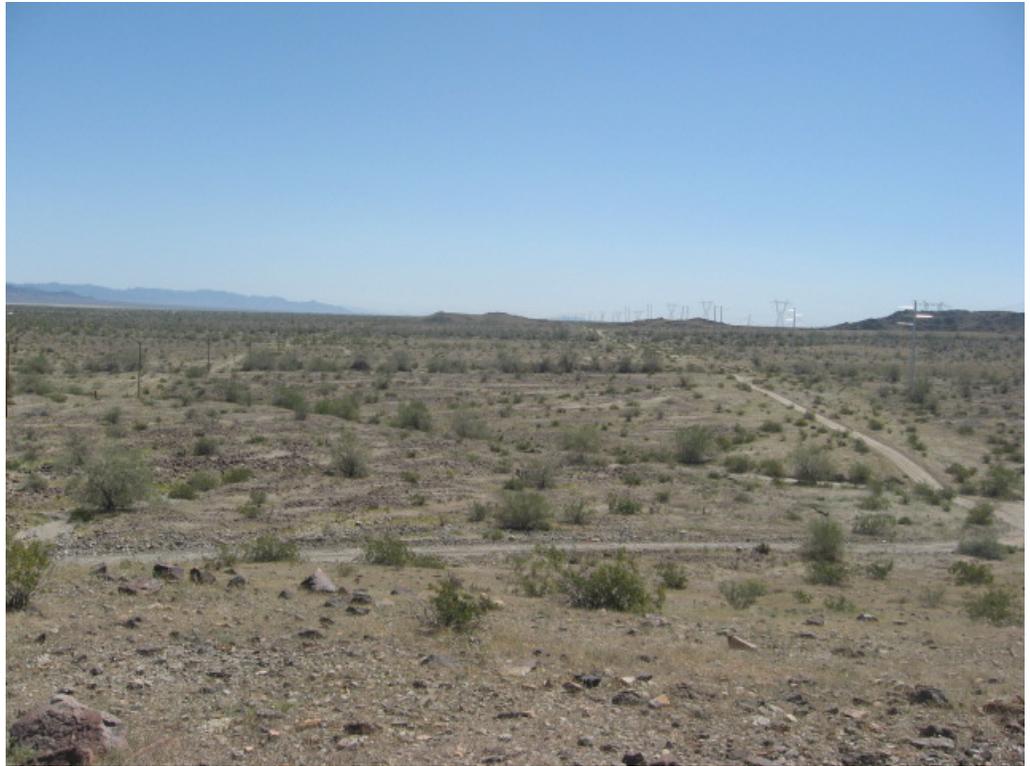
View of the approximate location of substation site – alternative A from the western side of the site.

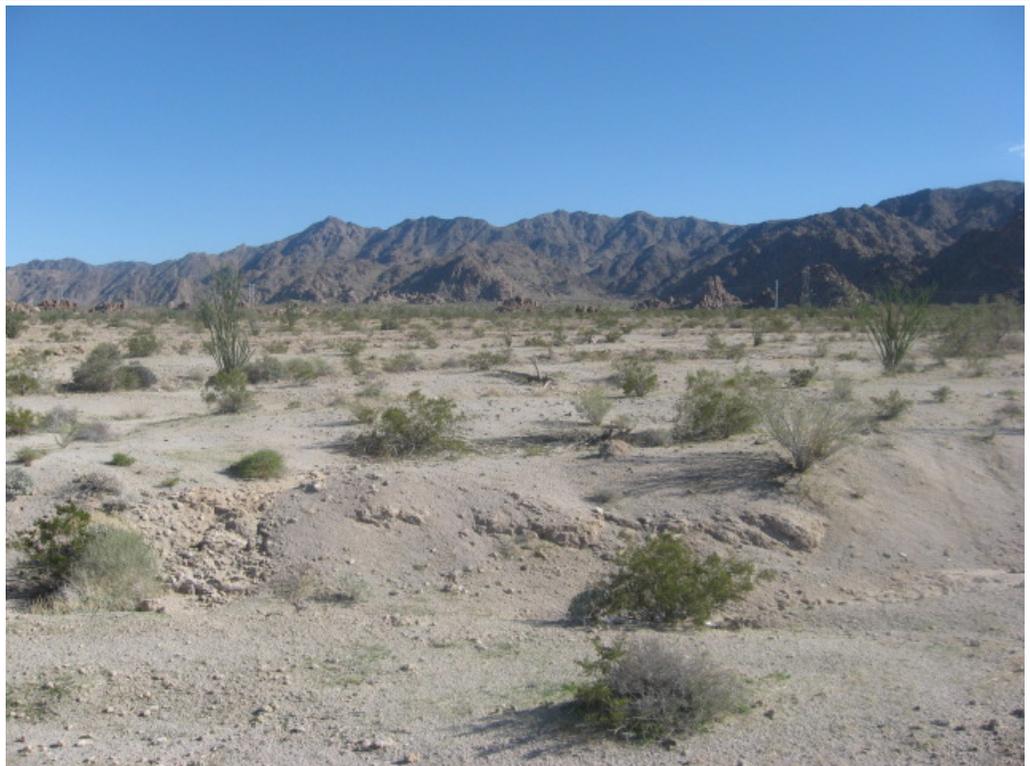
<b>Photo No.</b> <b>10</b>	<b>Date:</b> 03/02/10
-------------------------------	--------------------------

View of the approximate location of substation site – alternative B from the northern portion of the site.

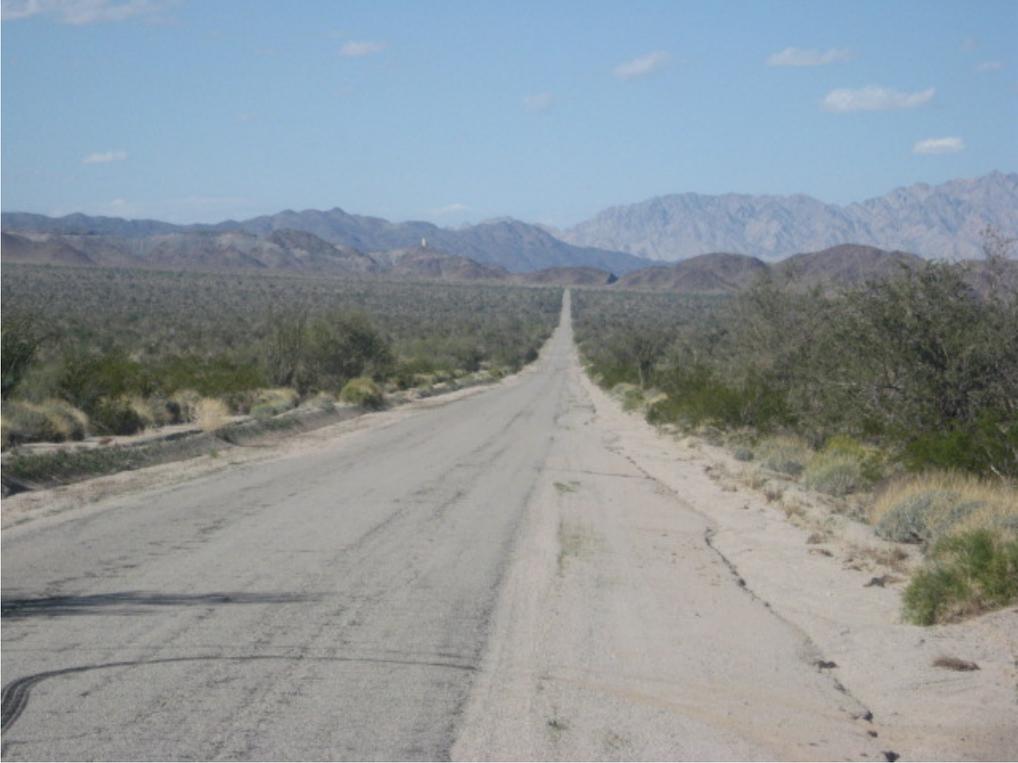
<b>Client Name:</b> First Solar		<b>Site Location:</b> Proposed Desert Sunlight Solar Project	<b>Project Number:</b> 60149119-100
<b>Photo No.</b> <b>11</b>	<b>Date:</b> 03/02/10

<b>Direction Photo Taken:</b>  North			
<b>Description:</b>  View of the gen-tie line - alternative B1 from mileage point 8.0.			
<b>Photo No.</b> <b>12</b>	<b>Date:</b> 03/02/10

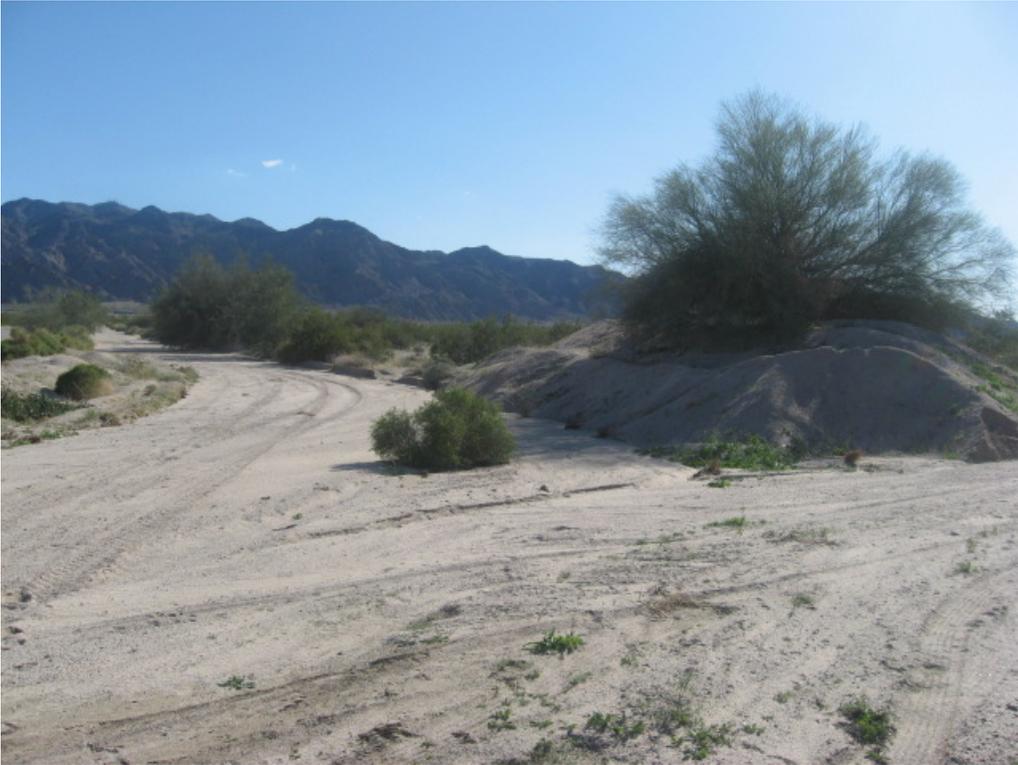
<b>Direction Photo Taken:</b>  South			
<b>Description:</b>  Typical view of the gen-tie line - alternative B1 (approximate mileage point 7.8).

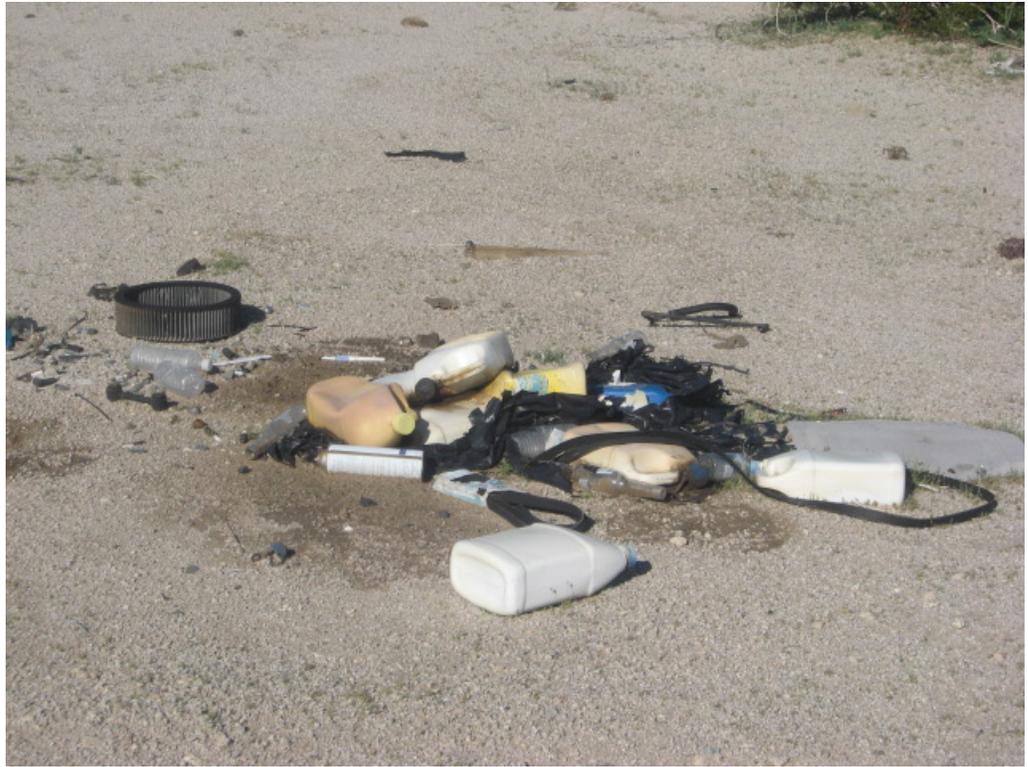
AECOM observed black stained surface soil measuring approximately two square feet beneath trash/debris that appeared to have been dumped along the proposed transmission line route. The source of this staining appeared to be from containers of lubricating oil that were observed on the surface of the soil. Given the limited nature of this staining, it is AECOM's opinion stained soil does not present a significant environmental concern to the subject property.

View of trash/debris, including rubber fan belts, one air filter, eight 1-gallon or smaller containers of lubricating oil, and one aerosol can, observed adjacent to the east of Eagle Mountain Road, at mileage point 7.9, along the gen-tie line - alternative B1.

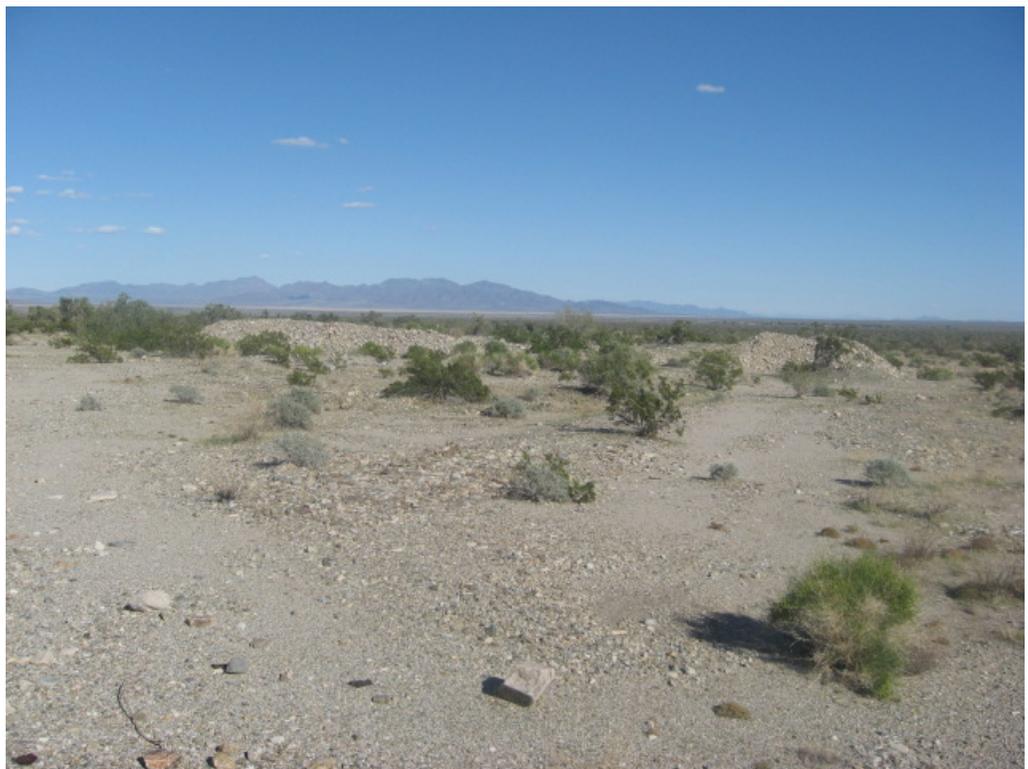
View of a gravel pit is located adjacent to the east of Eagle Mountain Road, at mileage point 5.7, along the gen-tie line - alternative B1.

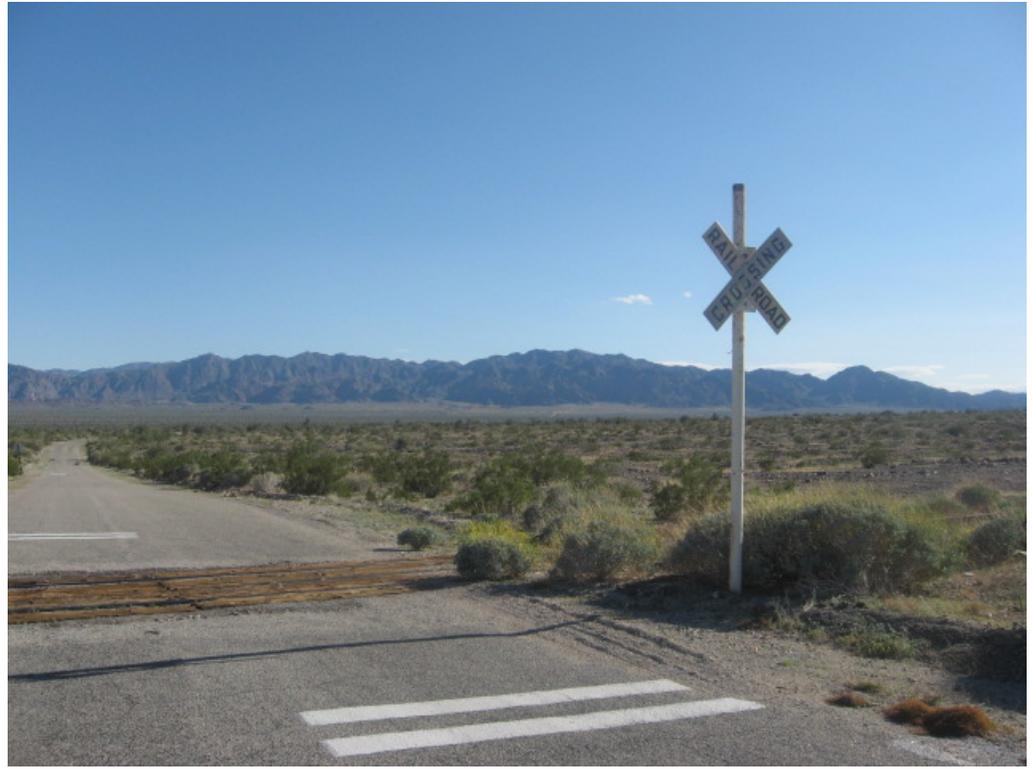
View of Eagle Mountain Railroad crossing the gen-tie line - alternative B1, at mileage point 3.9.

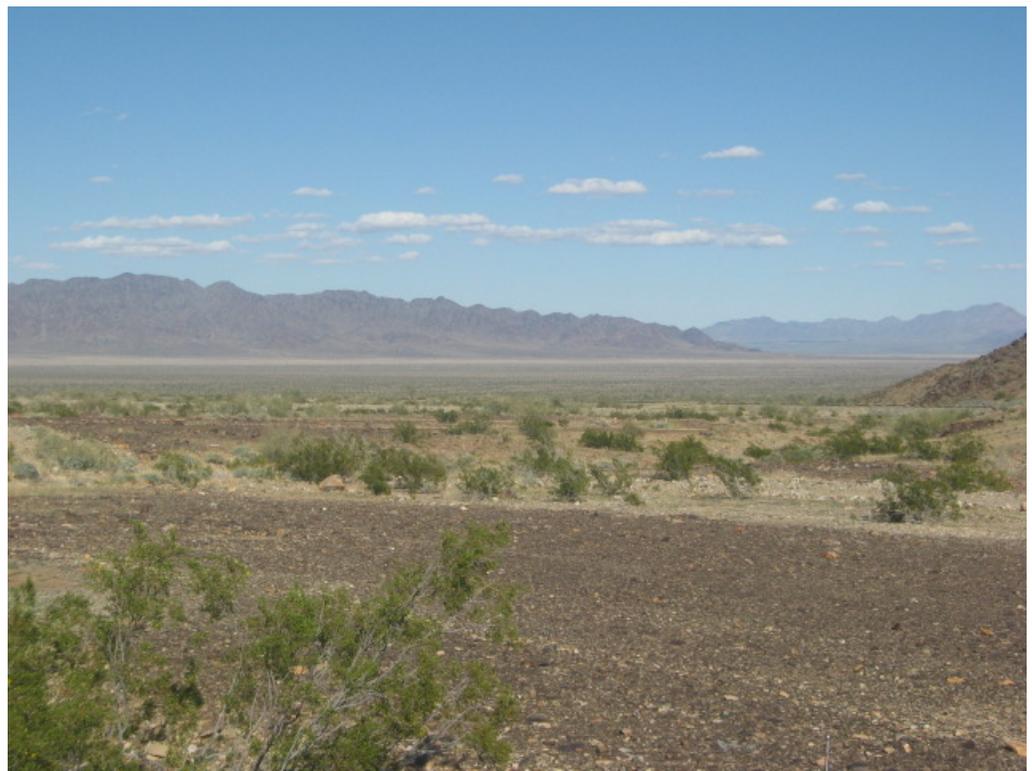
<b>Photo No.</b> <b>16</b>	<b>Date:</b> 03/02/10
-------------------------------	--------------------------

View of the area of gen-tie line - alternative B1 from Eagle Mountain Road.

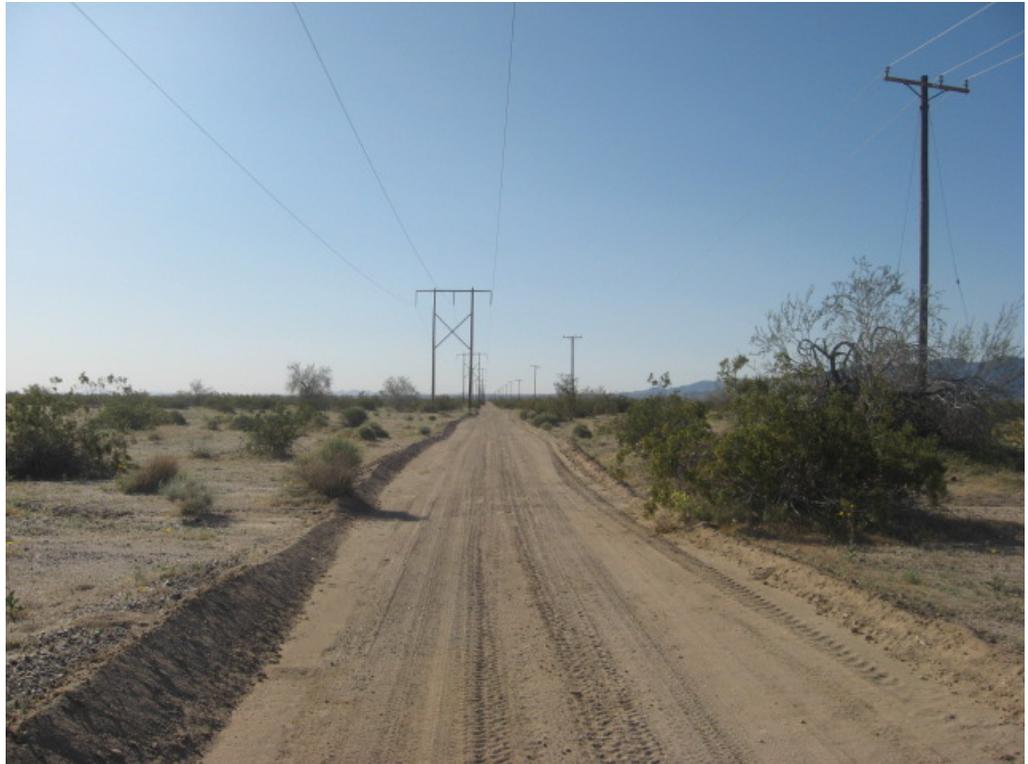
View of the northern portion of gen-tie line - alternative A2.

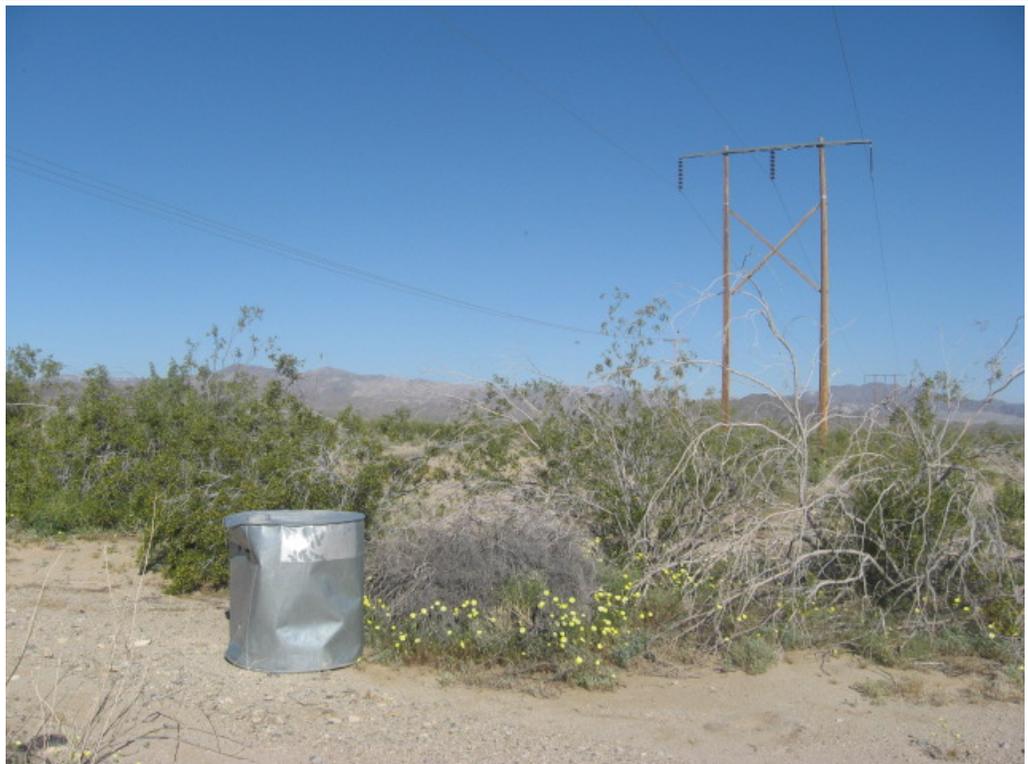
View at mileage point 2.7, of an empty (presumably water) 250-gallon aluminum AST, dumped along the eastern side of the gen-tie line - alternative A2 and was used for target-shooting.

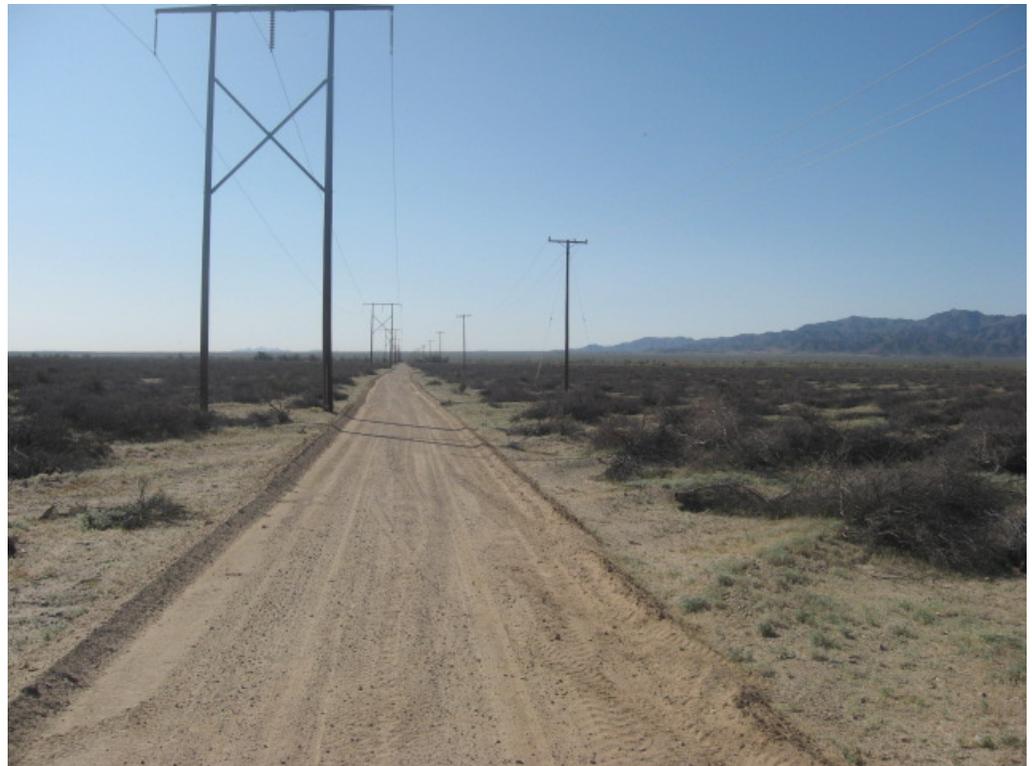
Representative view of gen-tie line - alternative A2 traversing through fallow row crop.

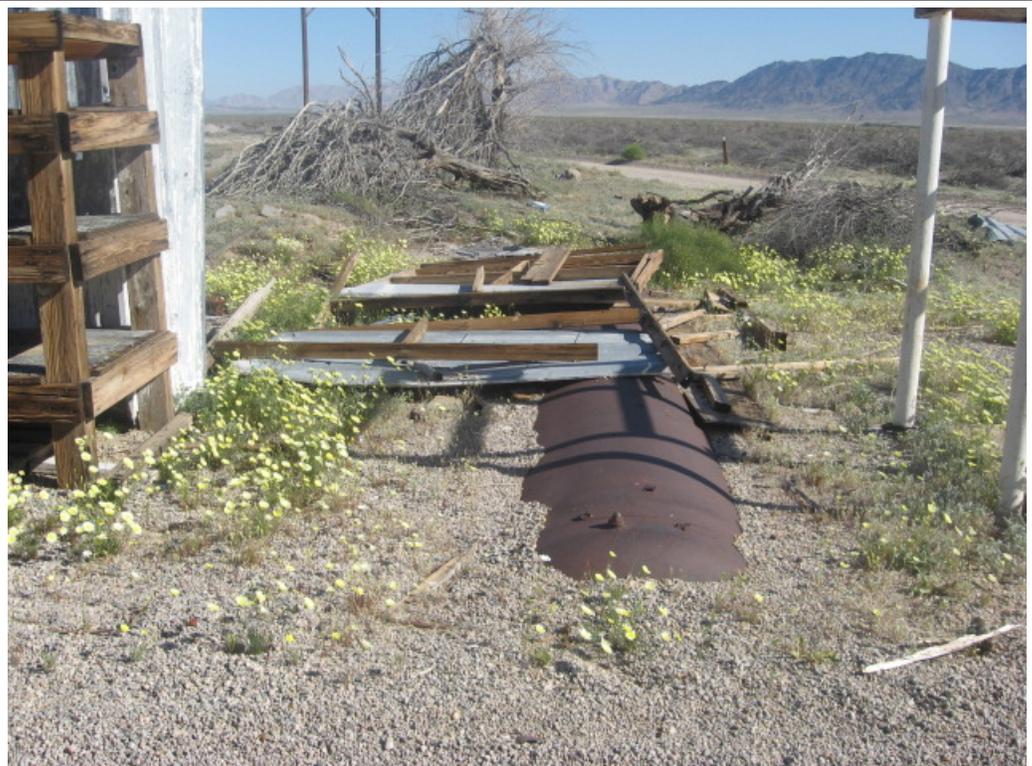
- At mileage point 4.1, AECOM observed remnants of agricultural row crop related debris and materials located to the east and west of the gen-tie line - alternative A2, in the area of a former water irrigation system located on the west side of the gen-tie line - alternative A2 (Figure 3-3b). The debris and materials included approximately twelve scattered wooden totes, approximately six wooden pallets, other scattered wood and metal debris, approximately four tires. AECOM observed four concrete foundations, an apparent irrigation water-line hose pumping system/rack, and an approximate (presumably water) 5,000-gallon bunked UST, each of which were presumably used for a former irrigation water pumping system. AECOM observed an approximate 24 square-foot concrete foundation presumably a foundation from a former pump house-type structure (see Section 4.2).

View of an approximate (presumably water) 5,000-gallon bunked UST, presumably used for a former irrigation water pumping system in the vicinity. Located along the west side of gen-tie line - alternative A2 at mileage point 4.1.

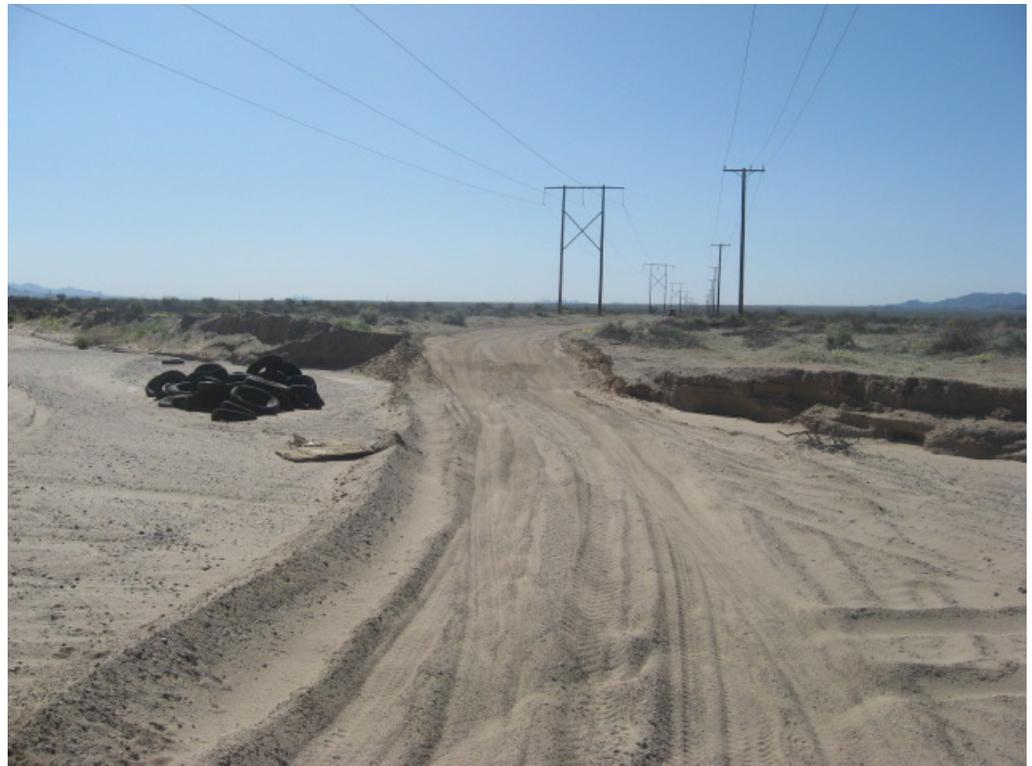
View at mileage point 4.2, of approximately 24 tires dumped (some partially buried) along the east side of the gen-tie line - alternative A2, in the storm water channel, that traverses across the gen-tie line - alternative A2.
