# Phase I Environmental Site Assessment of the Proposed Desert Sunlight Solar Farm Project Riverside County, California

Prepared By Kirsten Bradford, REA

AECOM was retained by First Solar to perform a Phase I ESA of the proposed Desert Sunlight solar farm project located in Riverside County, California (subject property). The purpose of the ESA was to identify the presence of RECs, HRECs, and de minimis conditions as defined by ASTM Standard Practice Designation E 1527-05, which may be associated with the subject property. This Phase I ESA was performed pursuant to AECOM's letter proposal dated February 5, 2010. The purpose of this Phase I ESA is to provide the client with information for use in evaluating potential environmental concerns associated with the subject property.

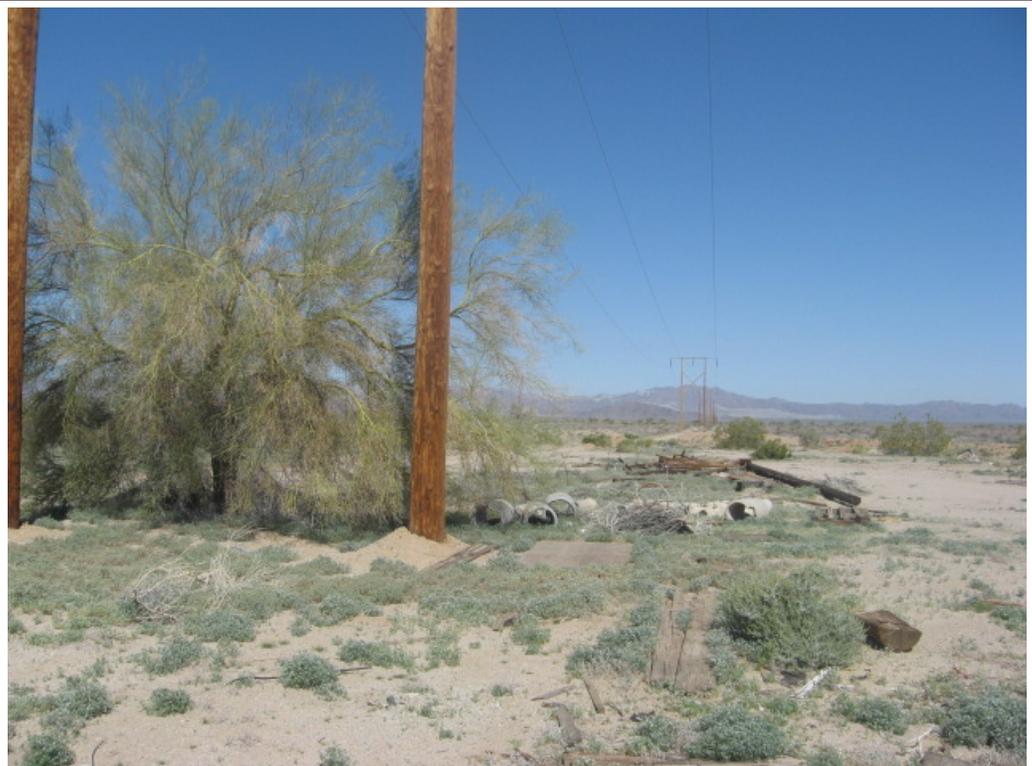
View at mileage point 6.5, of trash and debris located on the east side of the gen-tie line - alternative A2.

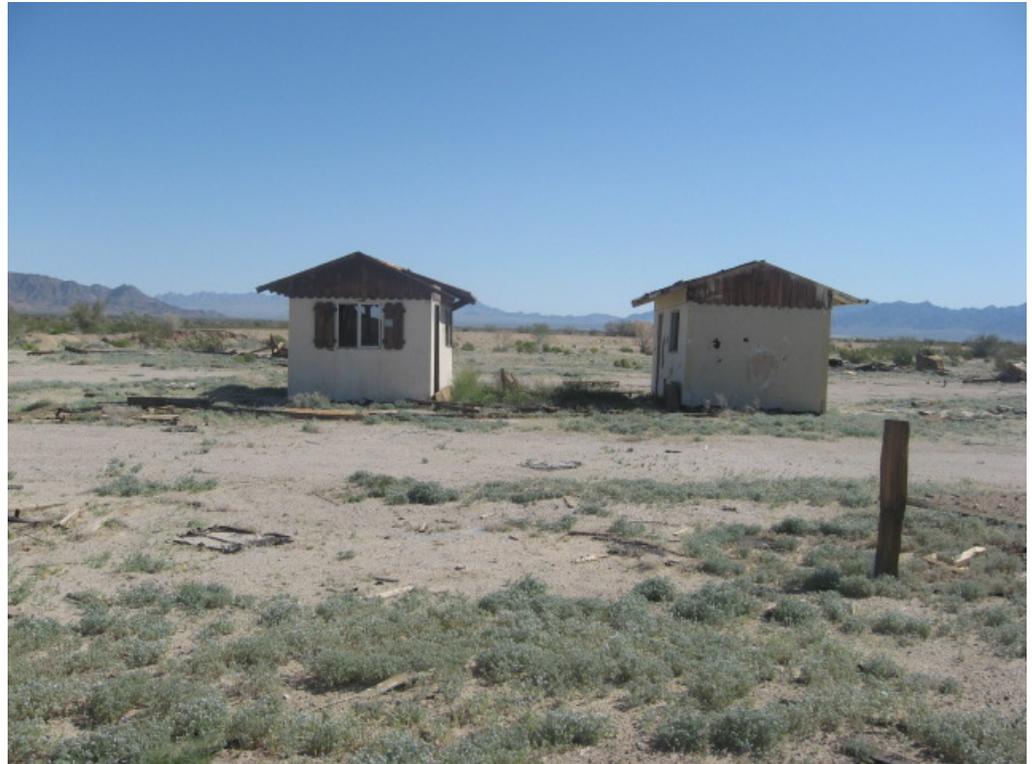
<b>Photo No.</b> <b>23</b>	<b>Date:</b> 04/09/10
<b>Direction Photo Taken:</b>  East

View at mileage point 6.5, of two dilapidated approximate 500-square foot buildings located on the east side of the gen-tie line - alternative A2.

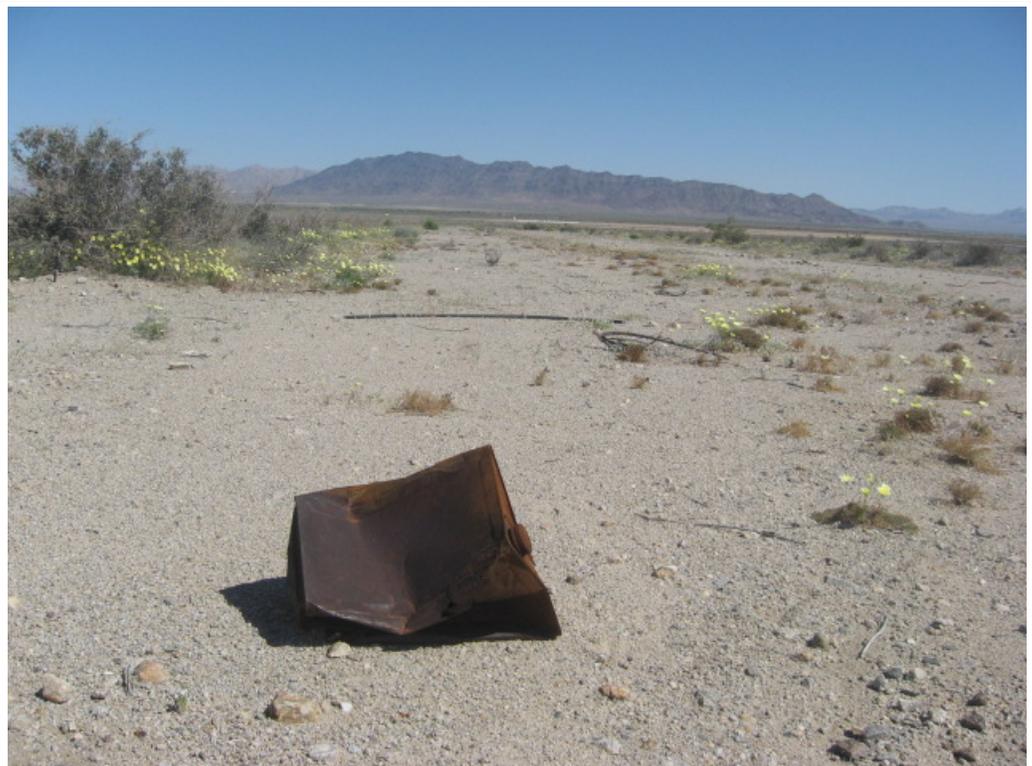
<b>Photo No.</b> <b>24</b>	<b>Date:</b> 04/09/10
<b>Direction Photo Taken:</b>  North

- At mileage point 7.8, AECOM observed one empty rusted metal 5-gallon fuel container located along the north side of the gen-tie line - alternative A2. No staining was observed on the soil in the vicinity of the container.

View of one empty rusted metal 5-gallon fuel container located along the north side of the gen-tie line - alternative A2 at approximate mileage point 7.8.
