**RECORD OF NON-APPLICABILITY (RONA)
FOR CLEAN AIR ACT CONFORMITY
RIVERSIDE COUNTY, NON-PALO VERDE VALLEY PORTION OF THE
MOJAVE DESERT AIR BASIN**

Proposed Action Name: Marine Corps Air Station (MCAS) Yuma Communication Tower at Spring Hill

**MCAS Yuma, Communications Tower at Spring Hill
Rare and Sensitive Plant Survey Final Report**

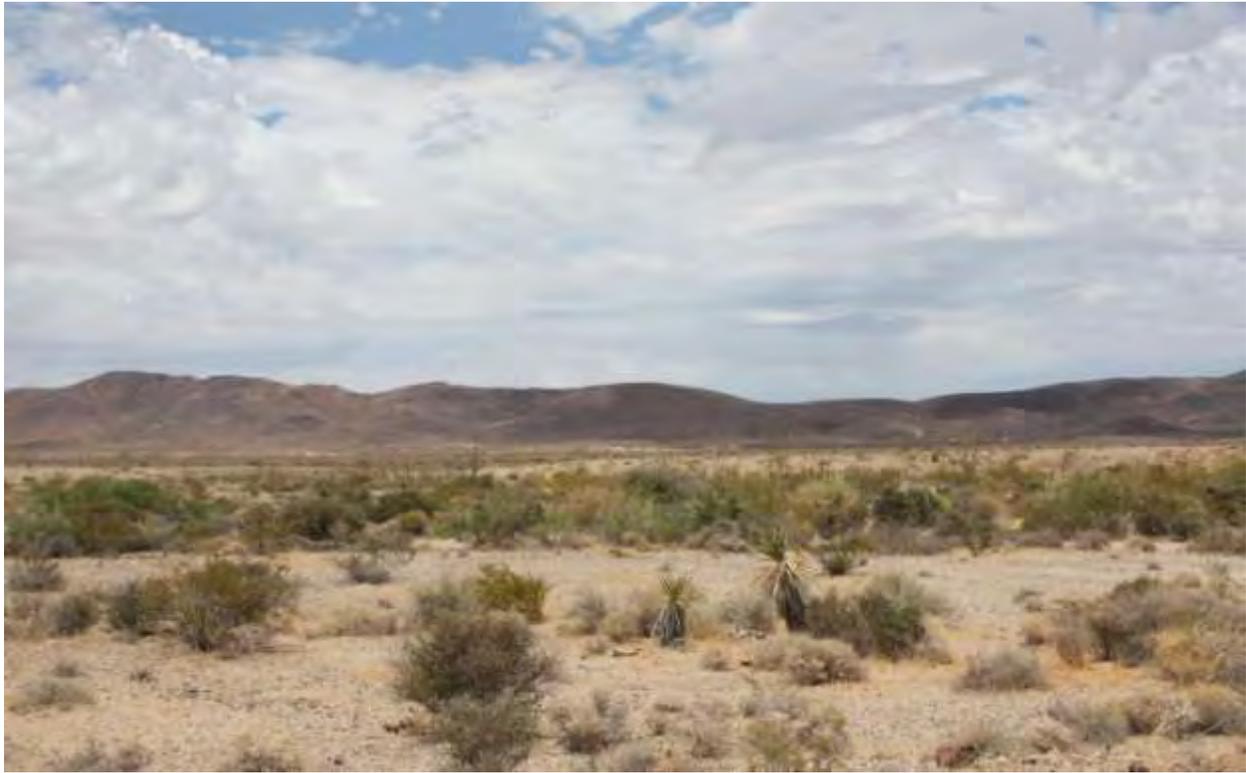
Figure 4: View of tower location from KOP #1 (50mm equivalent focal length)

Contrasts at KOP #1 are mostly weak (Figures 4 and 5). The weak contrasts are a result of greater distances involved with KOP #1 and the angle of observation. At a distance of almost 2 miles, only the upper portion of the tower can be seen from KOP #1. It is visible against the sky but does not attract attention without scrutiny. The other facilities at the communications site are not visible because of the great distance involved and also because they are set back from the edge of the slope such that the line of sight of the observer is above them. The access road is hidden from view behind a low ridge but the unnamed jeep road is quite visible extending up the mountain slope. The gray color of the metal tower is similar to the grays of the surrounding natural landscape. From this KOP, the objectives of a Class III VRM class are exceeded. Class III objectives allow for a moderate level of contrast and the contrast is rated at this location as weak.

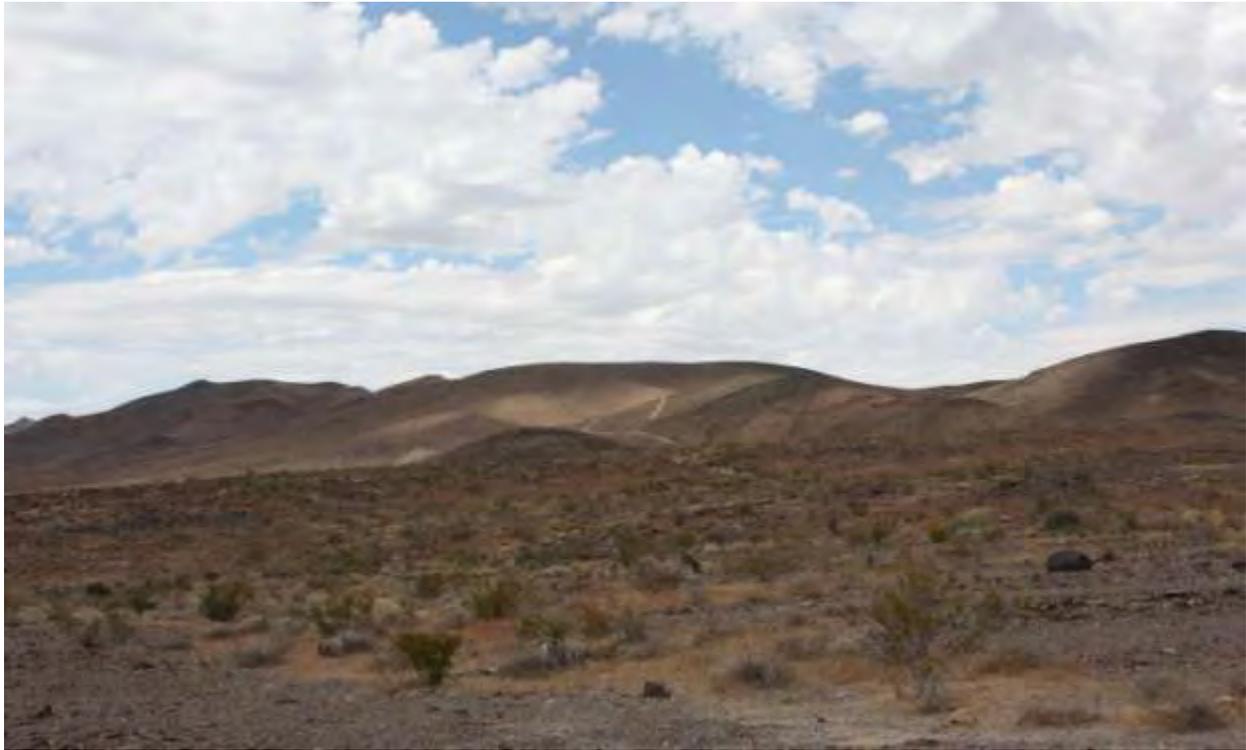
Figure 6: View of tower location from KOP #2 (50mm equivalent focal length)

Contrasts at KOP #2 are strong because of the closer proximity to the tower location and the angle of observation renders more of the associated facilities and the access road visible to an observer (Figures 6 and 7). The entire tower, the solar array, and the small shed are all visible from this angle because the set back from the edge of the slope is considerably less. The unnamed jeep road and the access road are quite prominent in this view. The strong contrasts are a result of dissimilar forms, lines, and

textures with the land and vegetation. Color contrasts are weak as the gray metal of the tower, red-brown color of the shelter, and gray-brown color of the solar array are similar to those colors in the natural landscape.

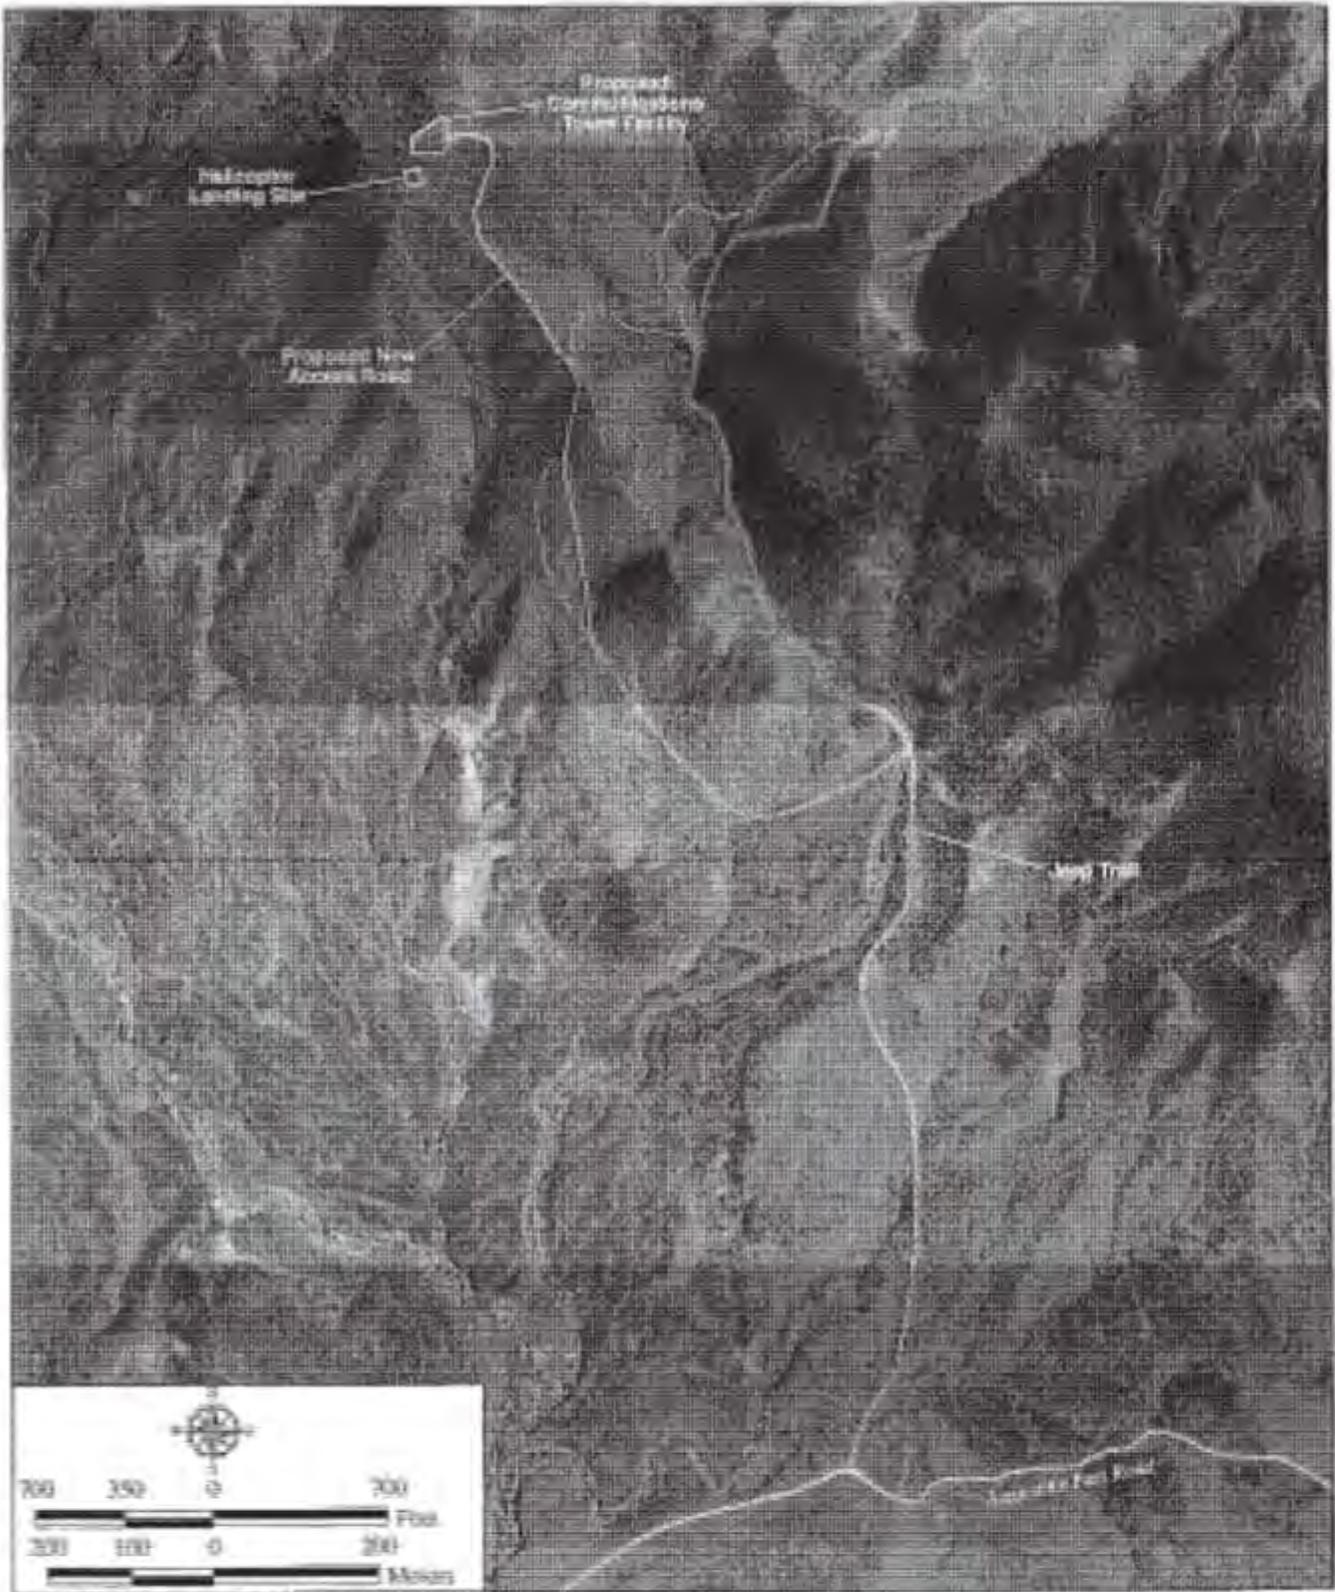
Figure 4

Communications Tower and Helicopter Pad Locations

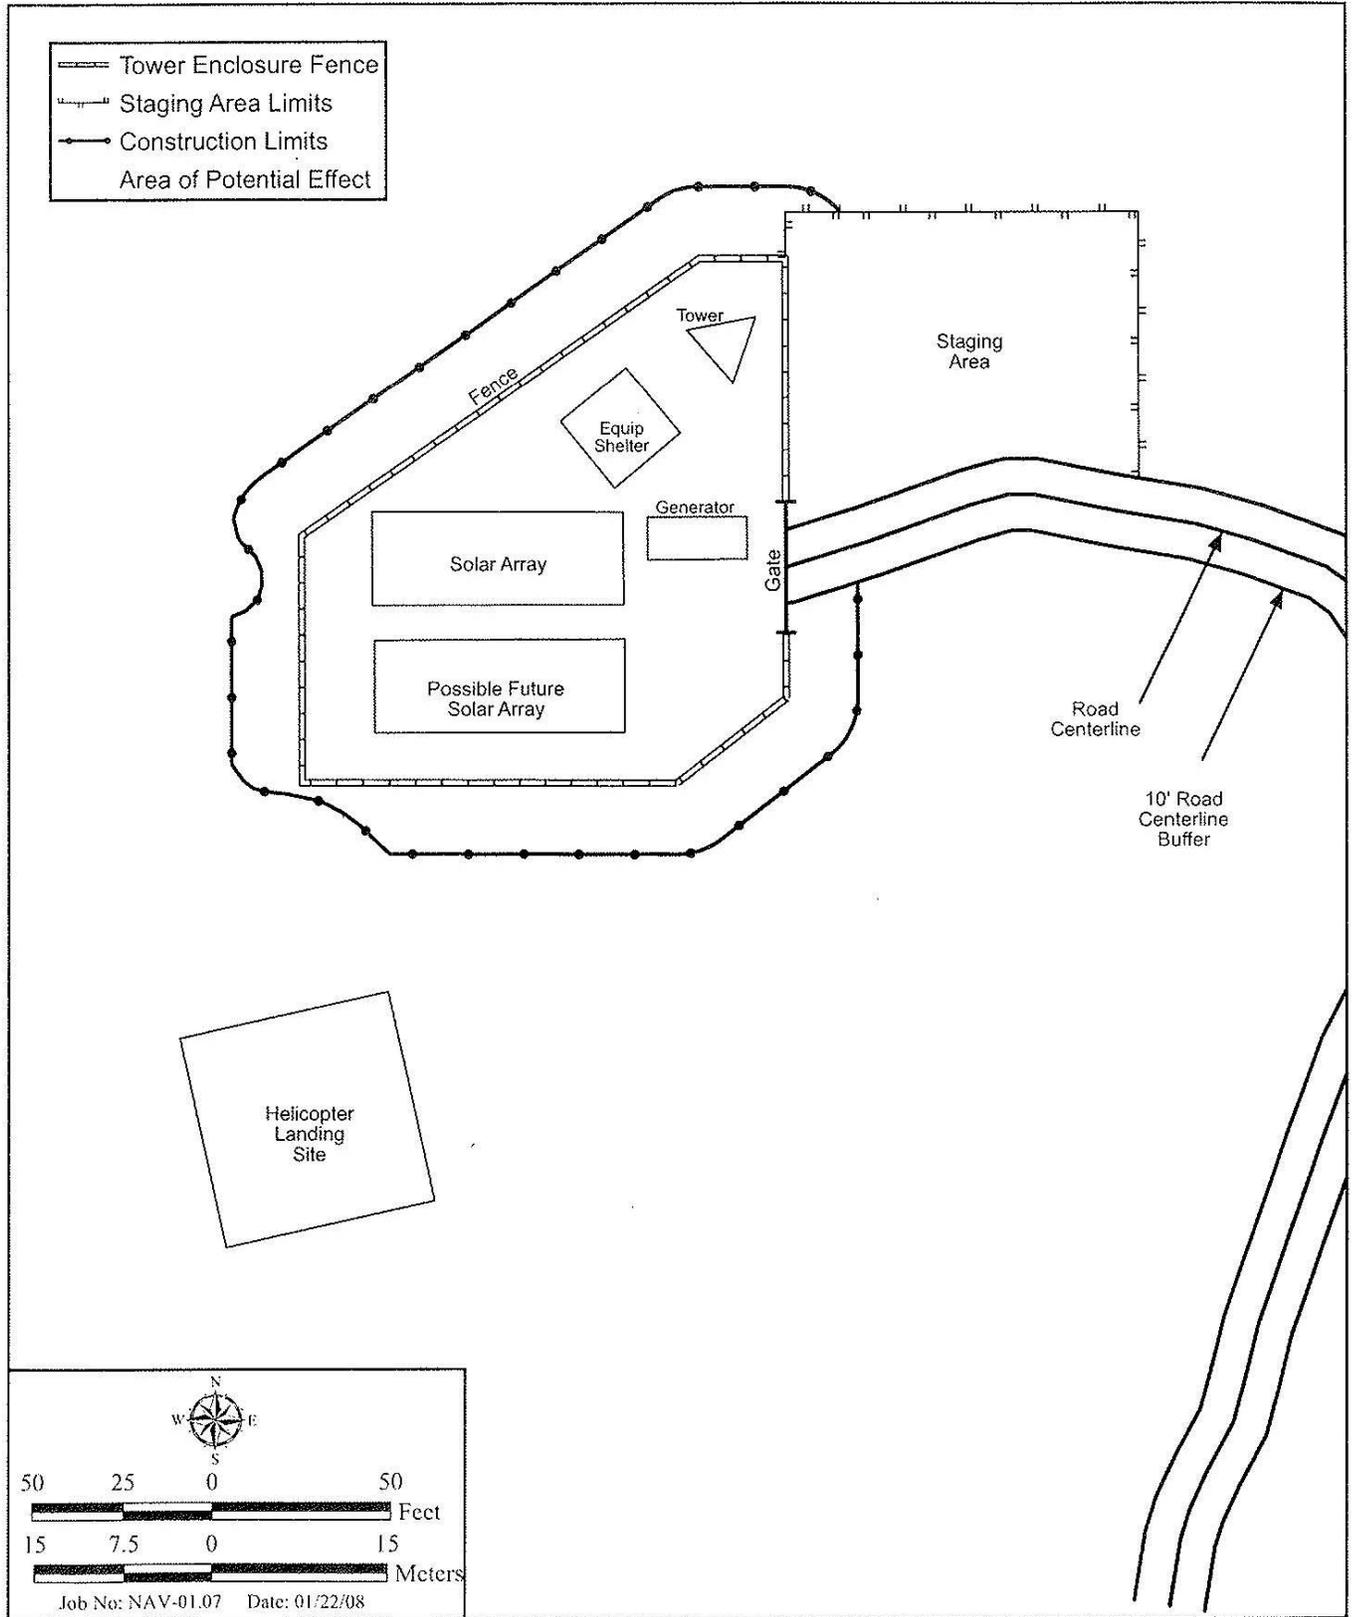
Figure 5

Proposed Site Layout/Area of Potential Effect

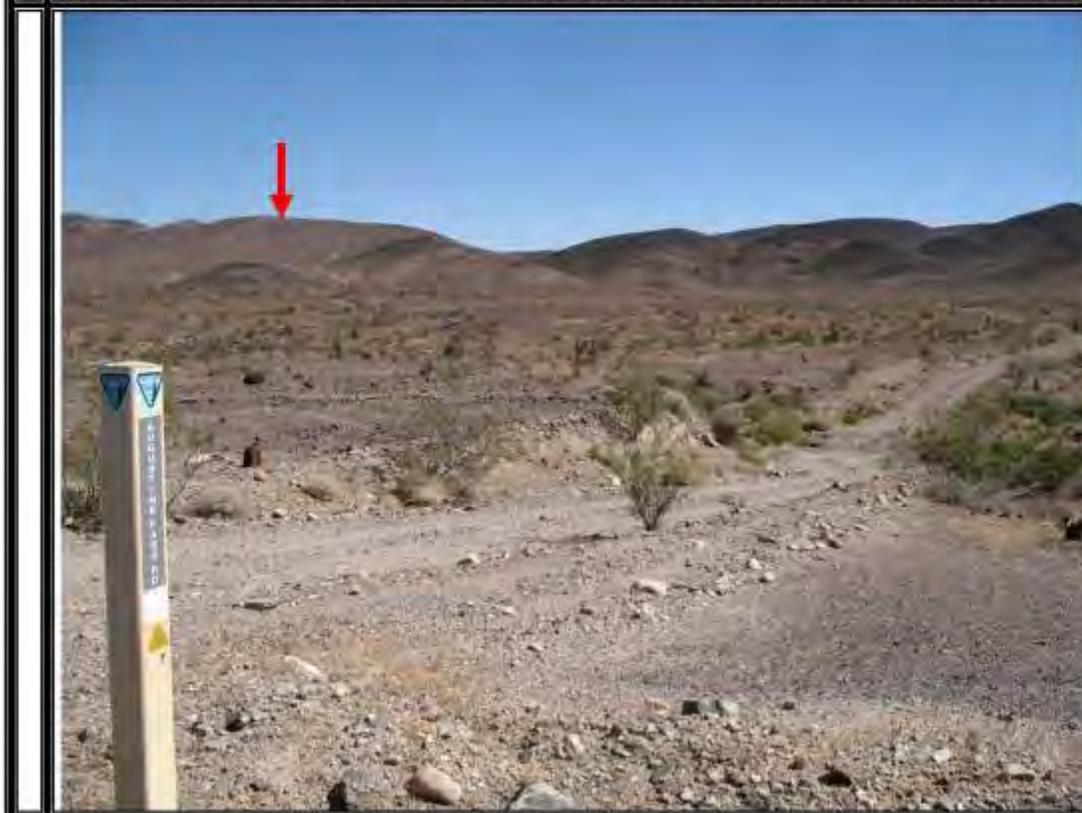
Photograph: 2

Location: Photo Point Location #1
(Augustine Pass Trail and jeep trail intersection)

Comment:
Ephemeral Waterway #1 at dip in roadway.
(Red arrow depicts proposed tower and helicopter pad site).

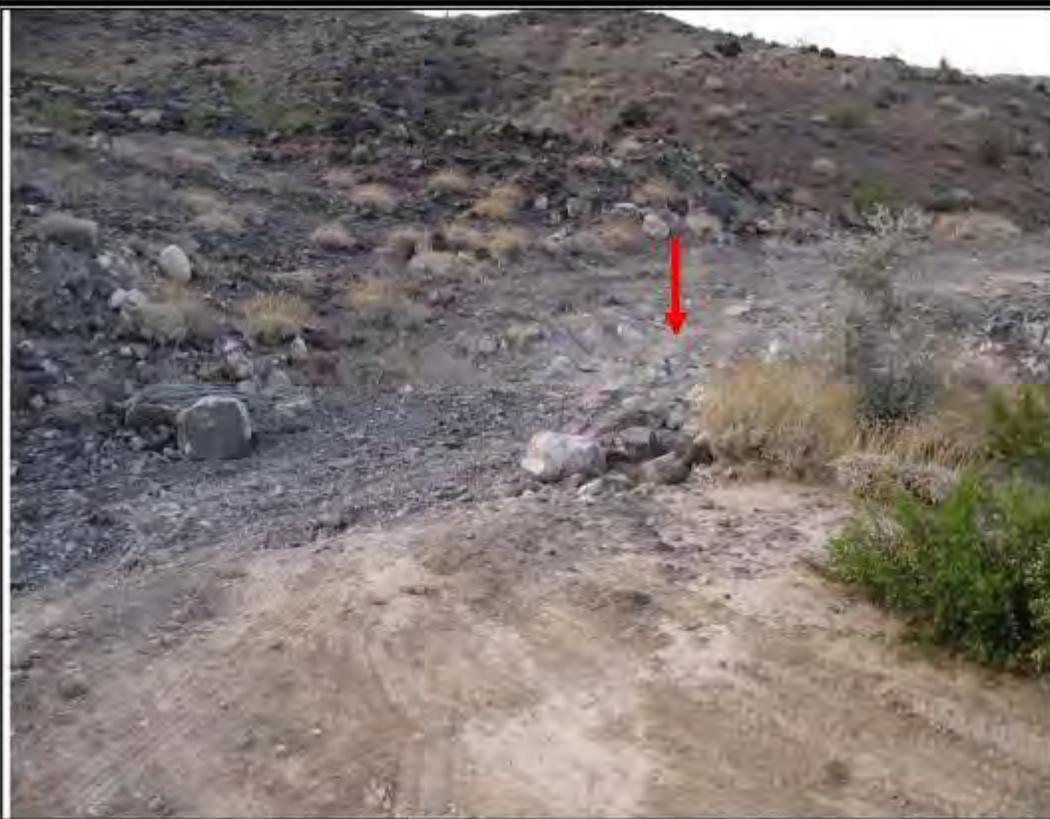
Photograph: 5

Comment: Ephemeral Waterway #3, crossing. Channel incising and scour visible (*red arrow*) due to heavy intermittent storm flows.

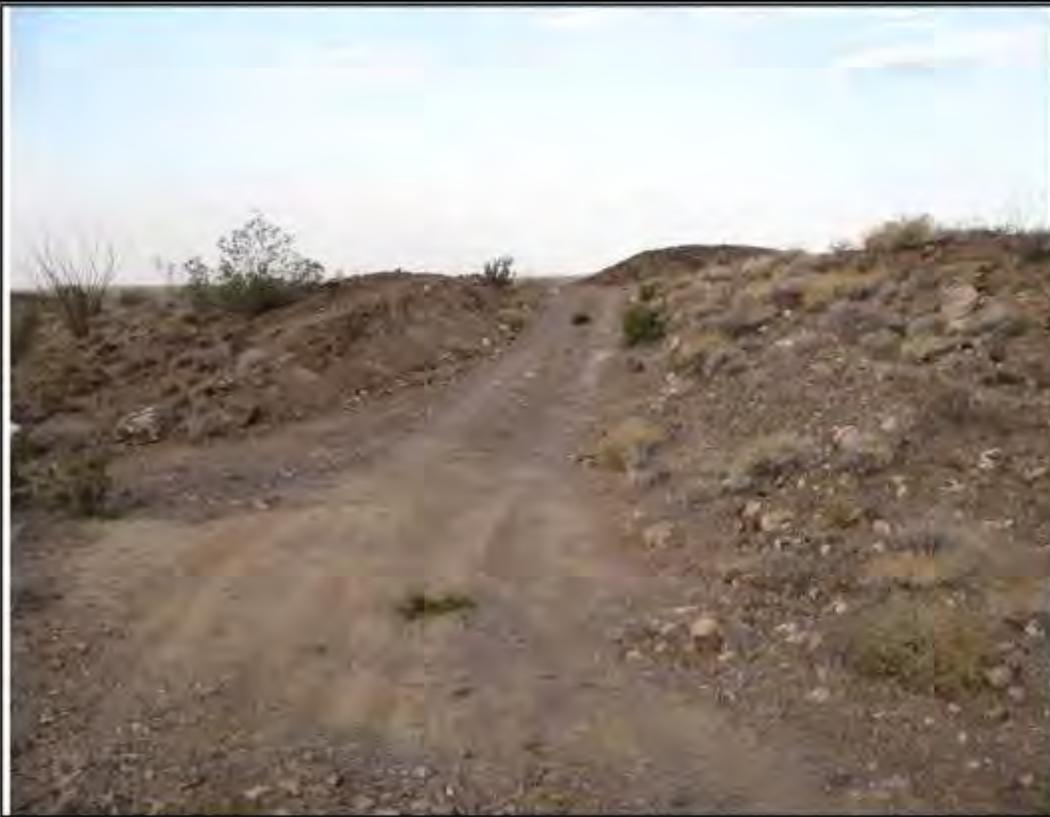
Photograph: 6

Comment: Minimal incising and scouring on southwest side of Ephemeral Wash #3 crossing.

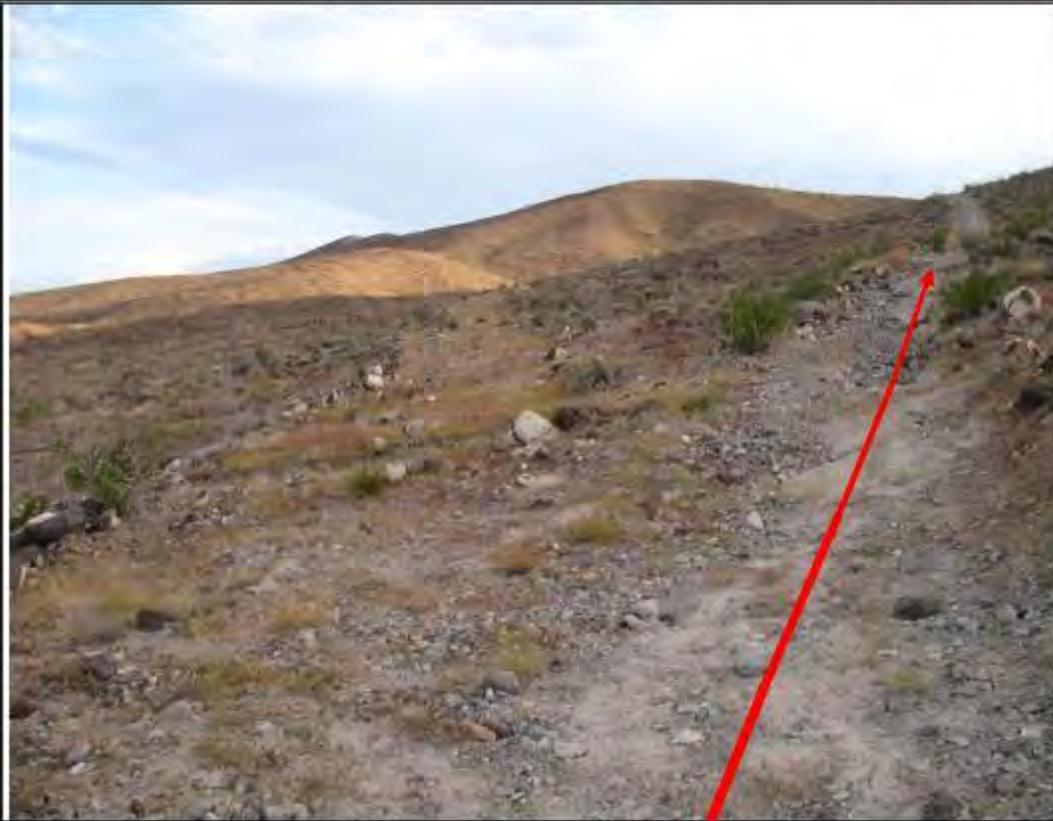
Photograph: 8

Location: Photo Point Location #3
(jeep trail)

Direction: Facing north northwest

Comment: Split in jeep trail. Proposed facility access road is to the right (*red arrow depicts road centerline*).

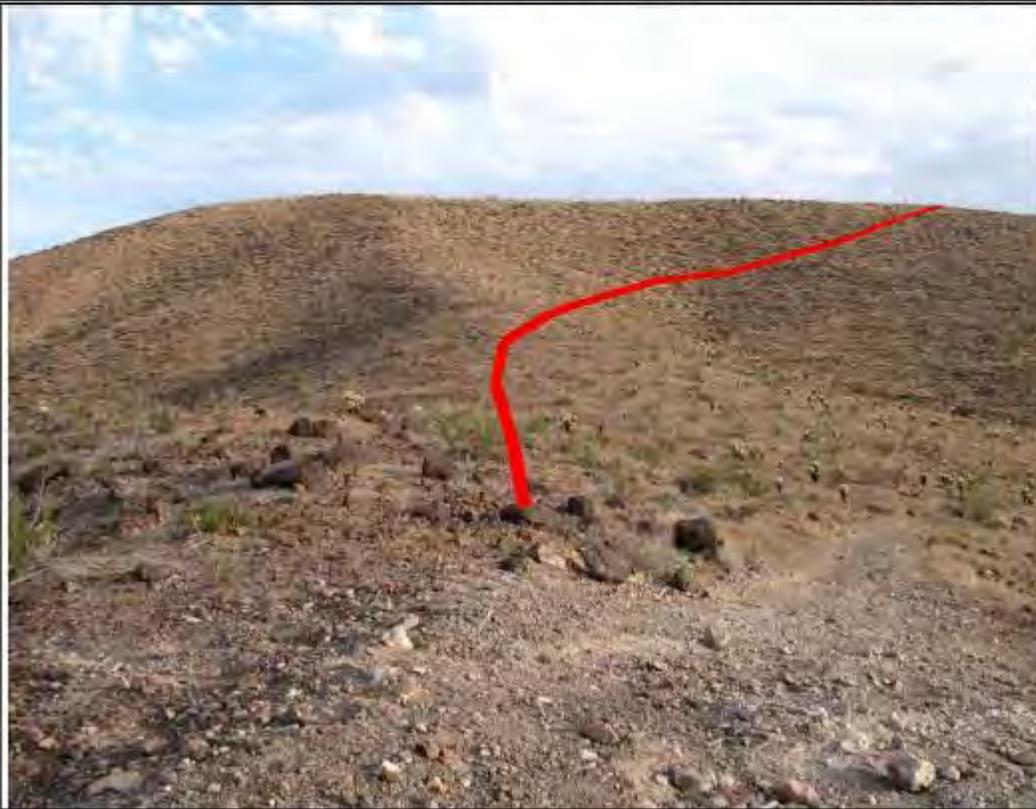
Photograph: 10

Comment:
Proposed facility access roadway (red line depicts approximate road centerline location) will follow ridgeline and side-slope toward hilltop.

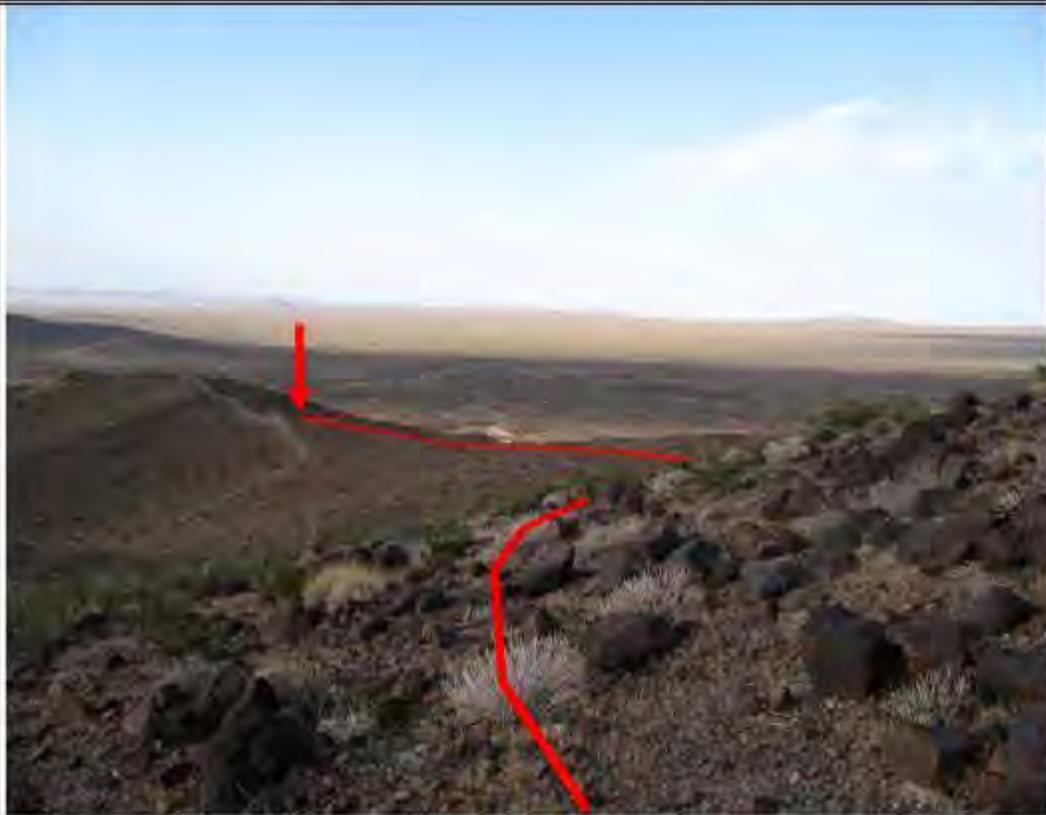
Photograph: 11

Comment:
Proposed facility access road down side-slope (*red line depicts approximate centerline of proposed access road*). The existing jeep trail/access road split is visible in the background (*red arrow*).

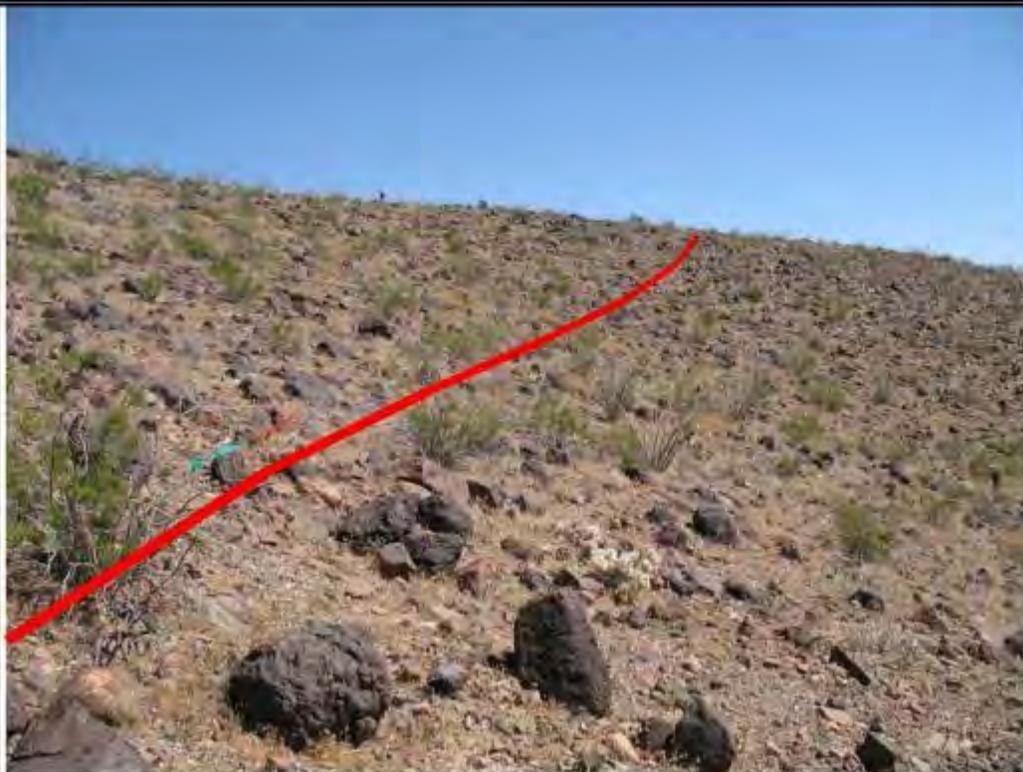
Photograph: 12

Comment:
Facility access road leading to top of hill along the side slope. (*Red line depicts approximate centerline of proposed access road*).

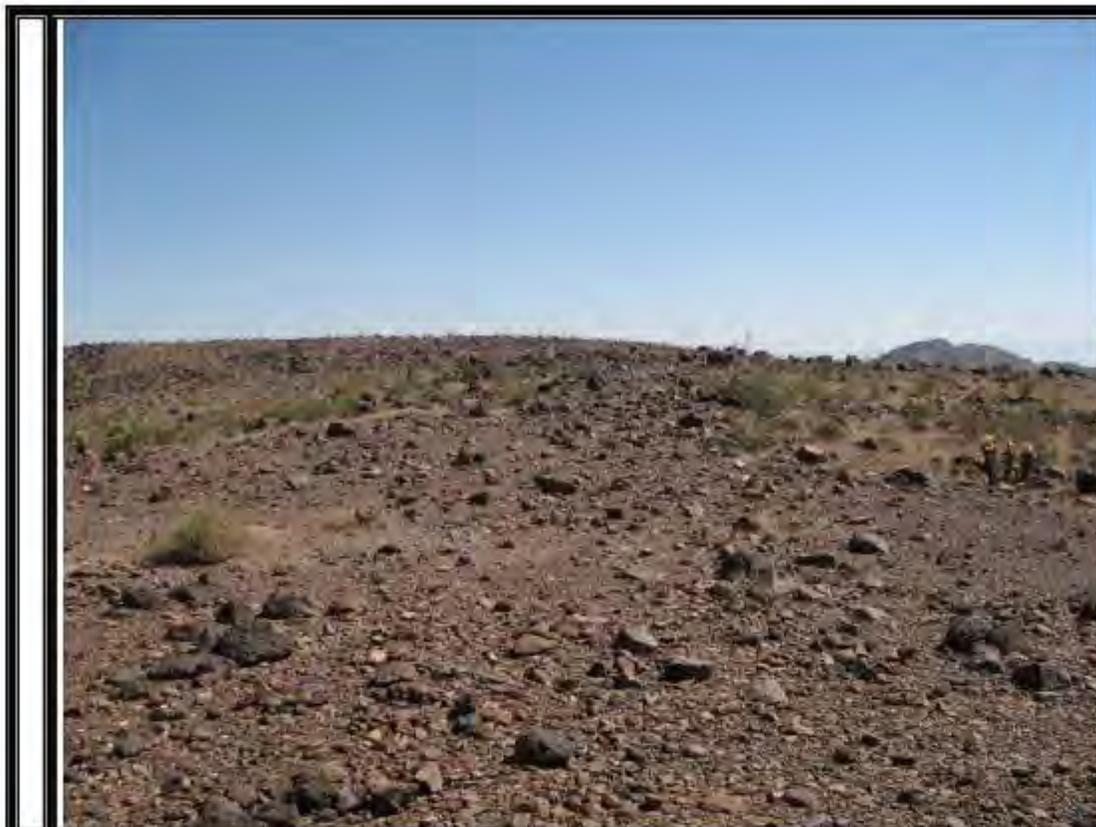
Photograph: 13

Location: Photo Point Location #7
(proposed communication facility)

Direction: Facing southeast

Comment:
Vantage point encompassing the proposed tower facility and helicopter landing pad.

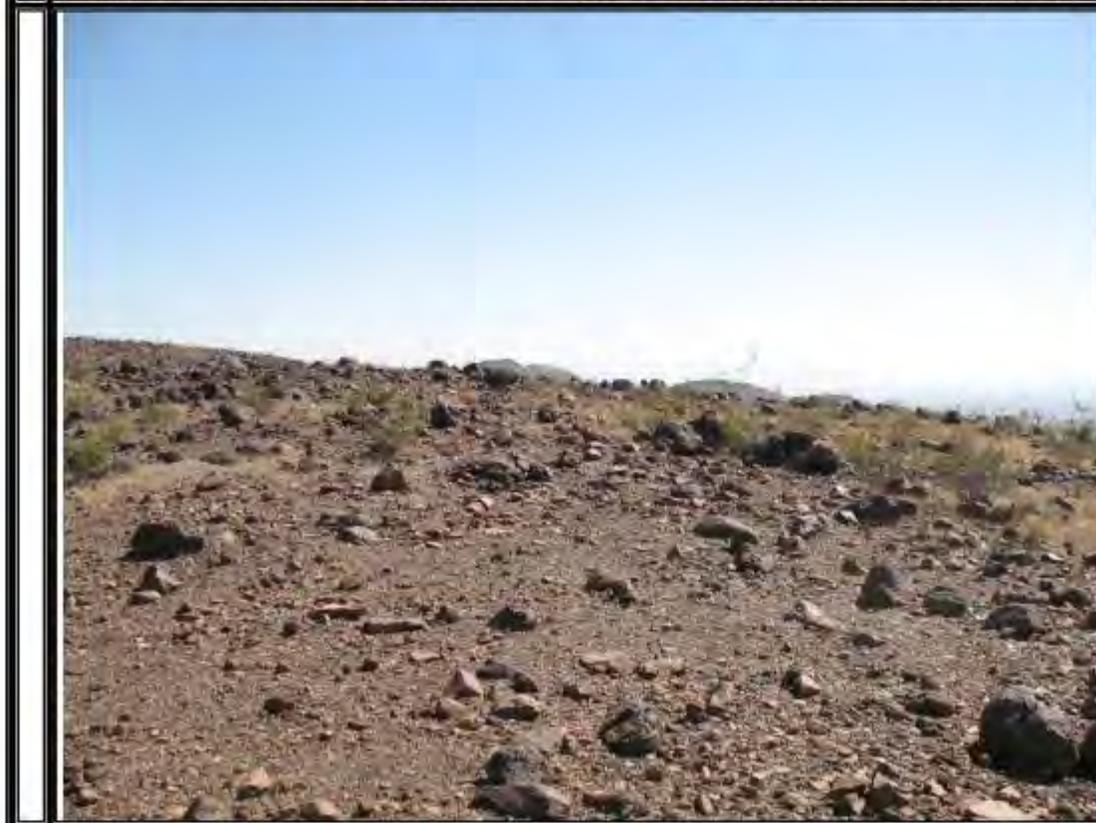
Photograph: 14

Location: Photo Point Location #7
(proposed communication facility)

Direction: Facing northwest

Comment:
Vantage point encompassing the proposed tower facility and staging area.

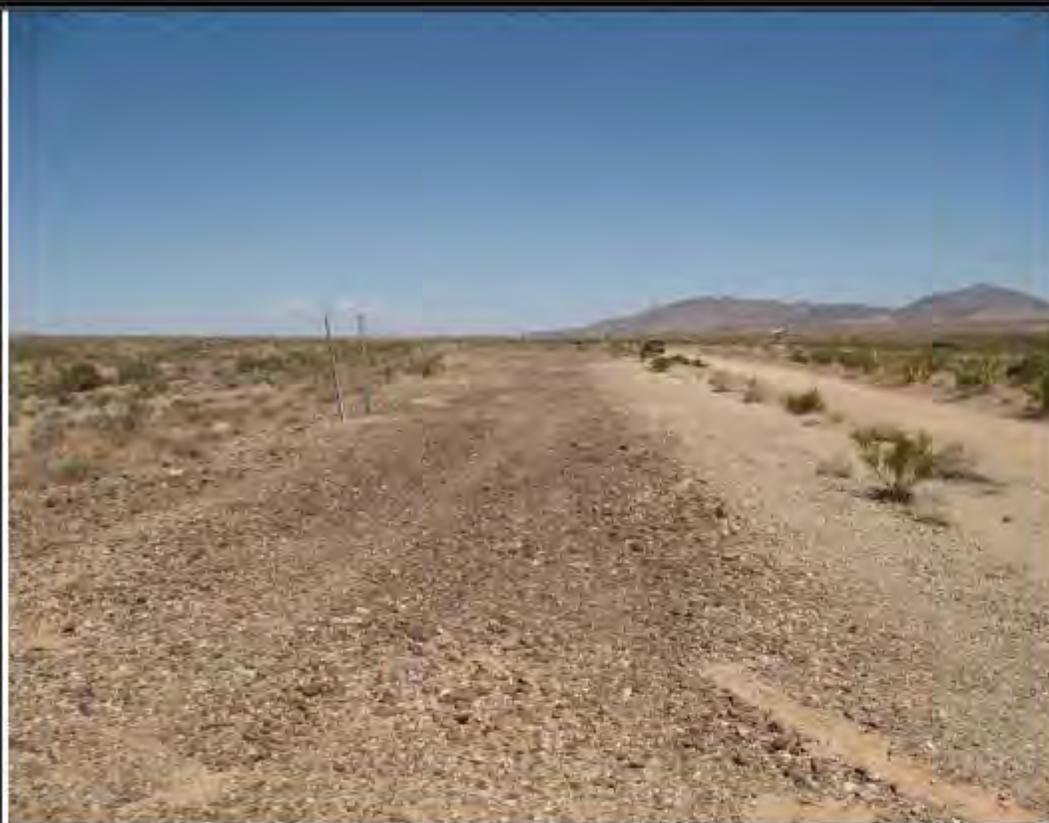
Photograph: 15

Location: Photo Point Location #8 (proposed southeastern staging area).

Direction: Facing northwest

Comment: Bradshaw Trail to the right of the photo. Visual evidence of disturbance in staging area limits.

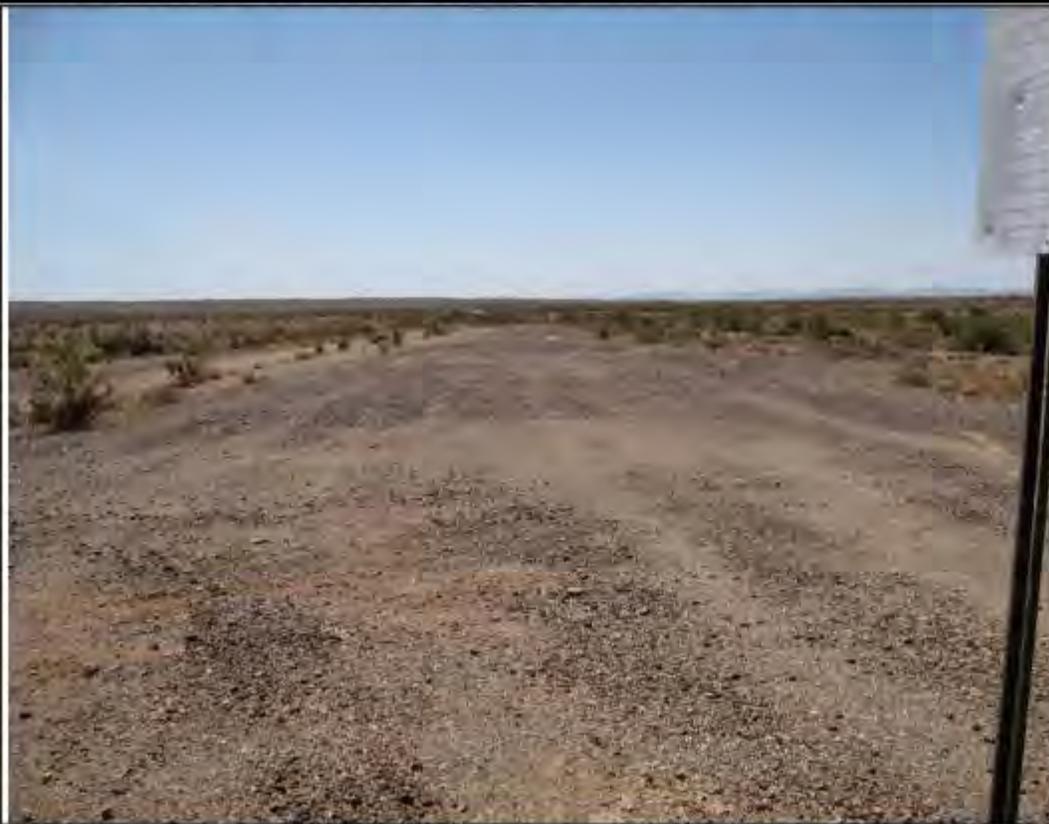
Photograph: 16

Location: Photo Point Location #9 (proposed southeastern staging area).

Direction: Facing southeast

Comment: Bradshaw Trail to the left of the photo. Visual evidence of disturbance in staging area limits.

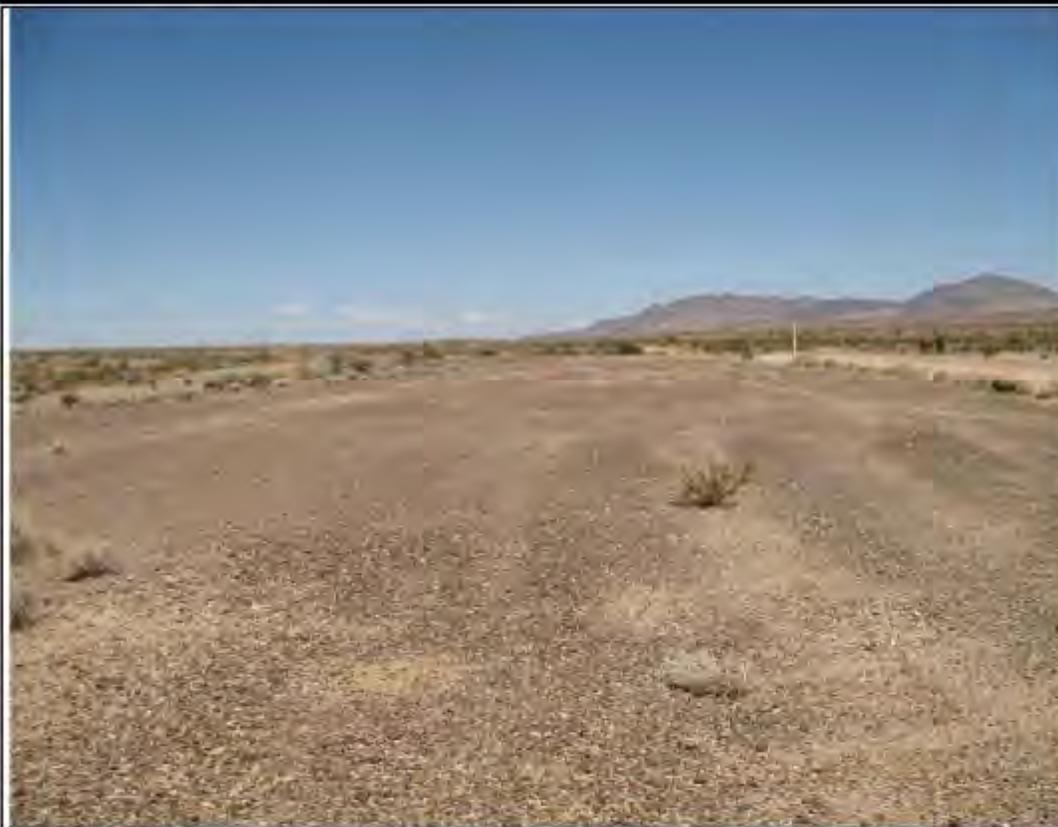
Photograph: 17

Location: Photo Point Location #10 (proposed northwestern staging area).

Direction: Facing northwest

Comment: Bradshaw Trail to the right of the photo. Visual evidence of disturbance in staging area limits.

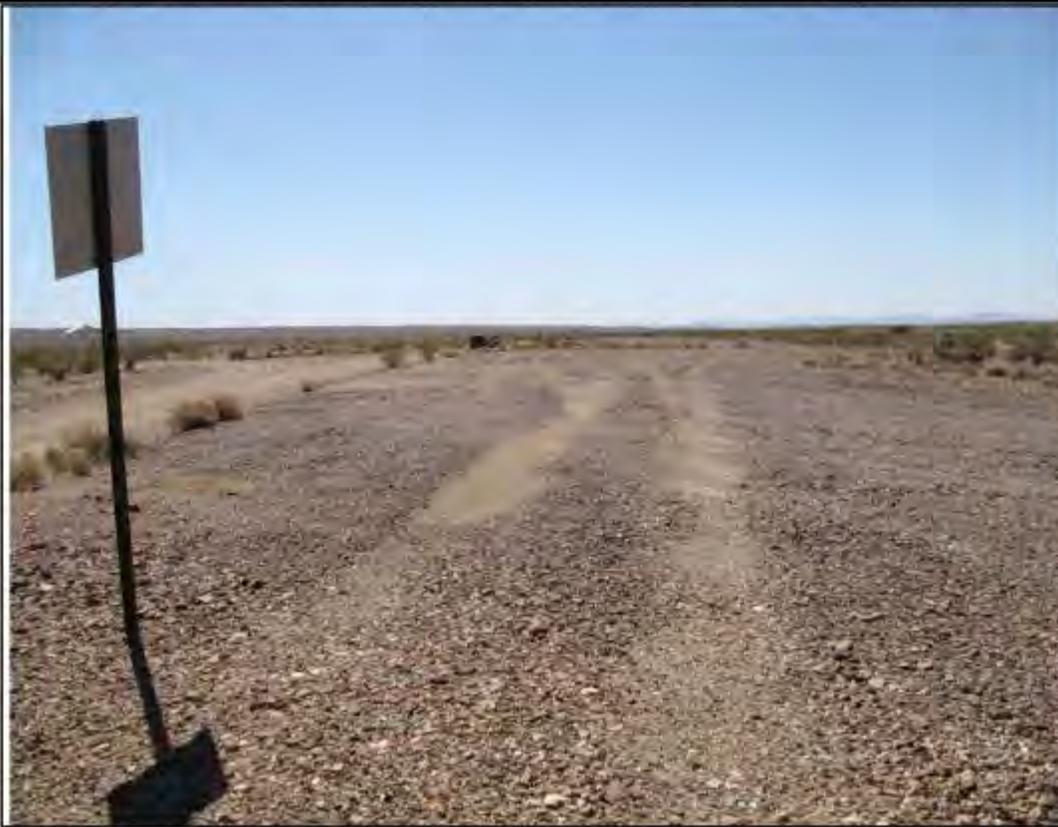
Photograph: 18

Location: Photo Point Location #11 (proposed northwestern staging area).

Direction: Facing southeast

Comment: Bradshaw Trail to the left of the photo. Visual evidence of disturbance in staging area limits.

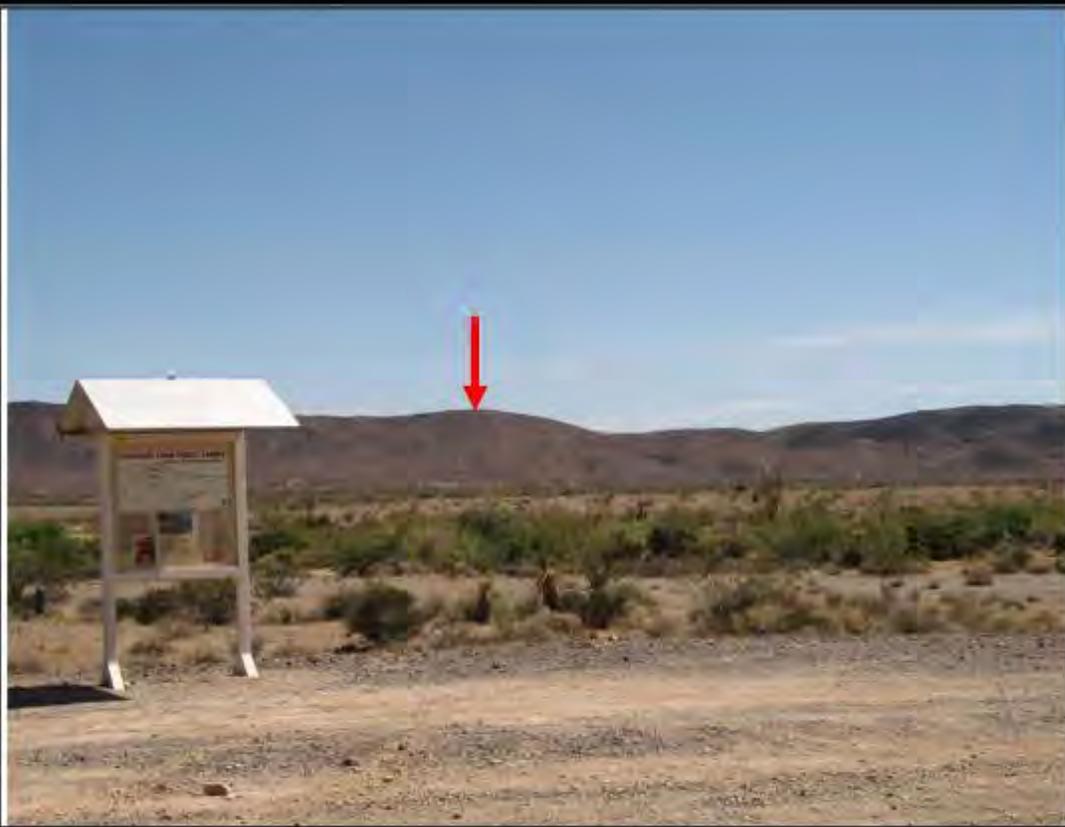
Photograph: 19

Location:
Bradshaw Trail

Direction: Facing north.

Comment:
Chuckwalla bench and mountain view. (Red arrow depicts proposed communication facility at Spring Hill).
