**REVEGETATION REPORT**

**SUPER CREEK QUARRY – CA MINE ID # 91-33-0003**

**WHITEWATER, COUNTY OF RIVERSIDE, CALIFORNIA**

**April 2009**

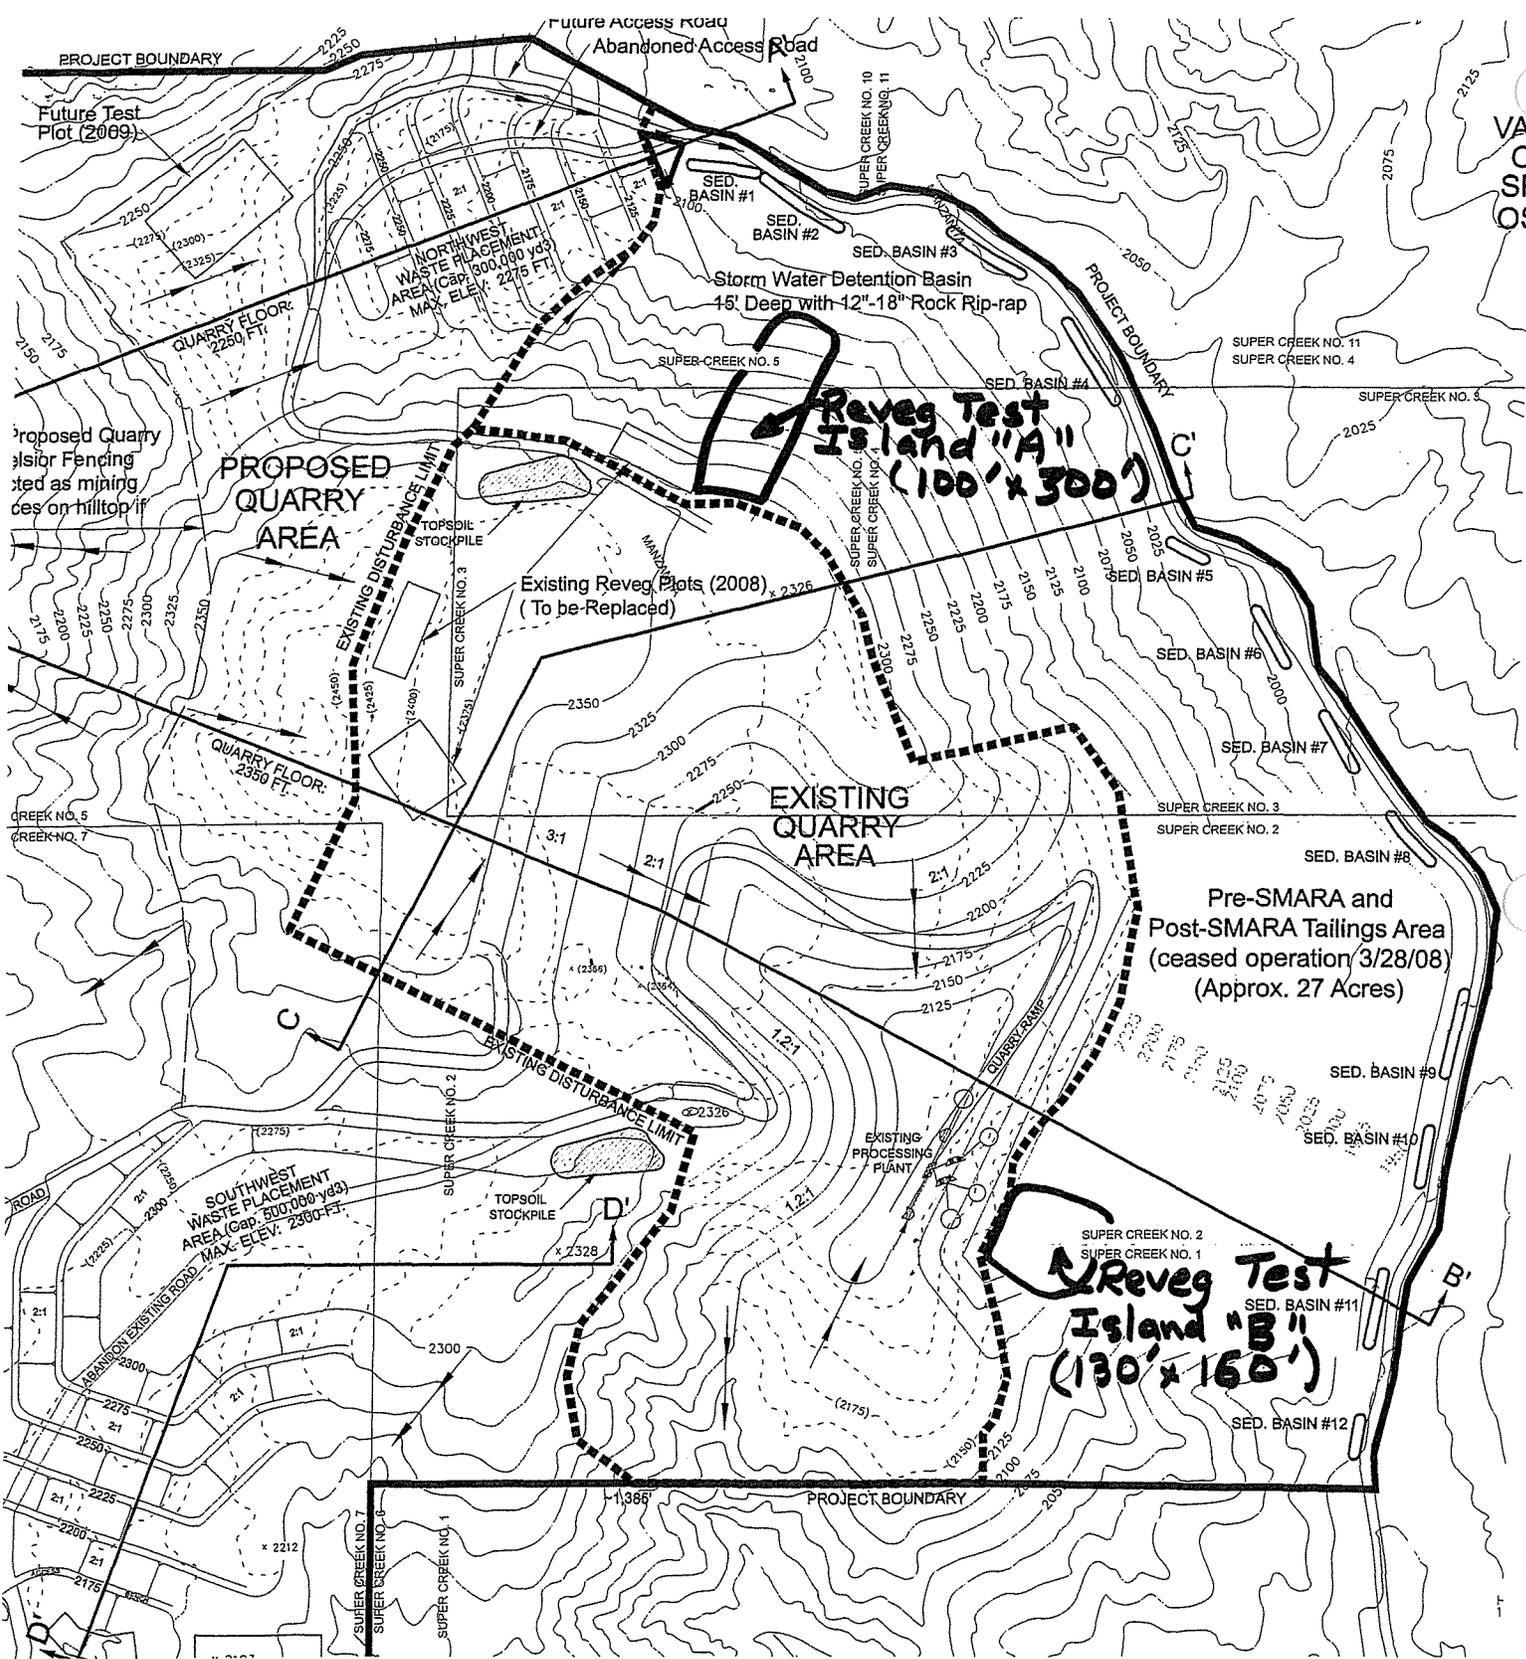
**Reveg Test  
Island "A"  
(100' x 300')**

**Reveg Test  
Island "B"  
(130' x 160')**

Excavation has not been completed in any area of the quarry therefore there are no areas within the quarry to prepare for revegetation. The slopes outside the quarry were prepared and planted beginning in December 2008 and ending in April 2009. Two (2) "islands" ("A" and "B") were prepared and planted on the slopes (Figure 2).

The first island ("A") is located upon an older surface which has been subject to wind and removal of fines and has become "encrusted". The second surface island ("B") is not encrusted. Island "A" is approximately 100 feet wide and 300 feet long sloping to the north. Island "B" is approximately 130 feet wide and 160 feet long sloping to the east. Island "A" contains 10 terraces and Island "B" contains 6 terraces.

Preparation of the slopes consisted of filling rills in the older surfaces (Island "A") using rock from the quarry which was end dumped from the top-of-slope and then by cutting terraces (Island "A" and Island "B") by hand, across the slope, as the slopes are not accessible by equipment. This created cross-slope terraces which provide breaks in the down slope movement of water as well as catchment of wind born seeds and surface water and provides protection from sun and wind to seedlings.

Work was conducted by crews via use of harness and ropes tied off at the top-of-slope. Terraces were cut approximately 2' wide at 25-foot intervals beginning at the top-of-slopes. Maintenance of the drainage berm along the quarry rim may result in moving material, which would change the distance to the top terrace. Precipitation recorded at the Palm Springs Airport was 4.7 inches this season, which is about 90 per cent of the long-term average of 5.2 inches. Seed was obtained from collections conducted during the previous year as well as from commercial sources. The seeding rates are included in Table 1 below.

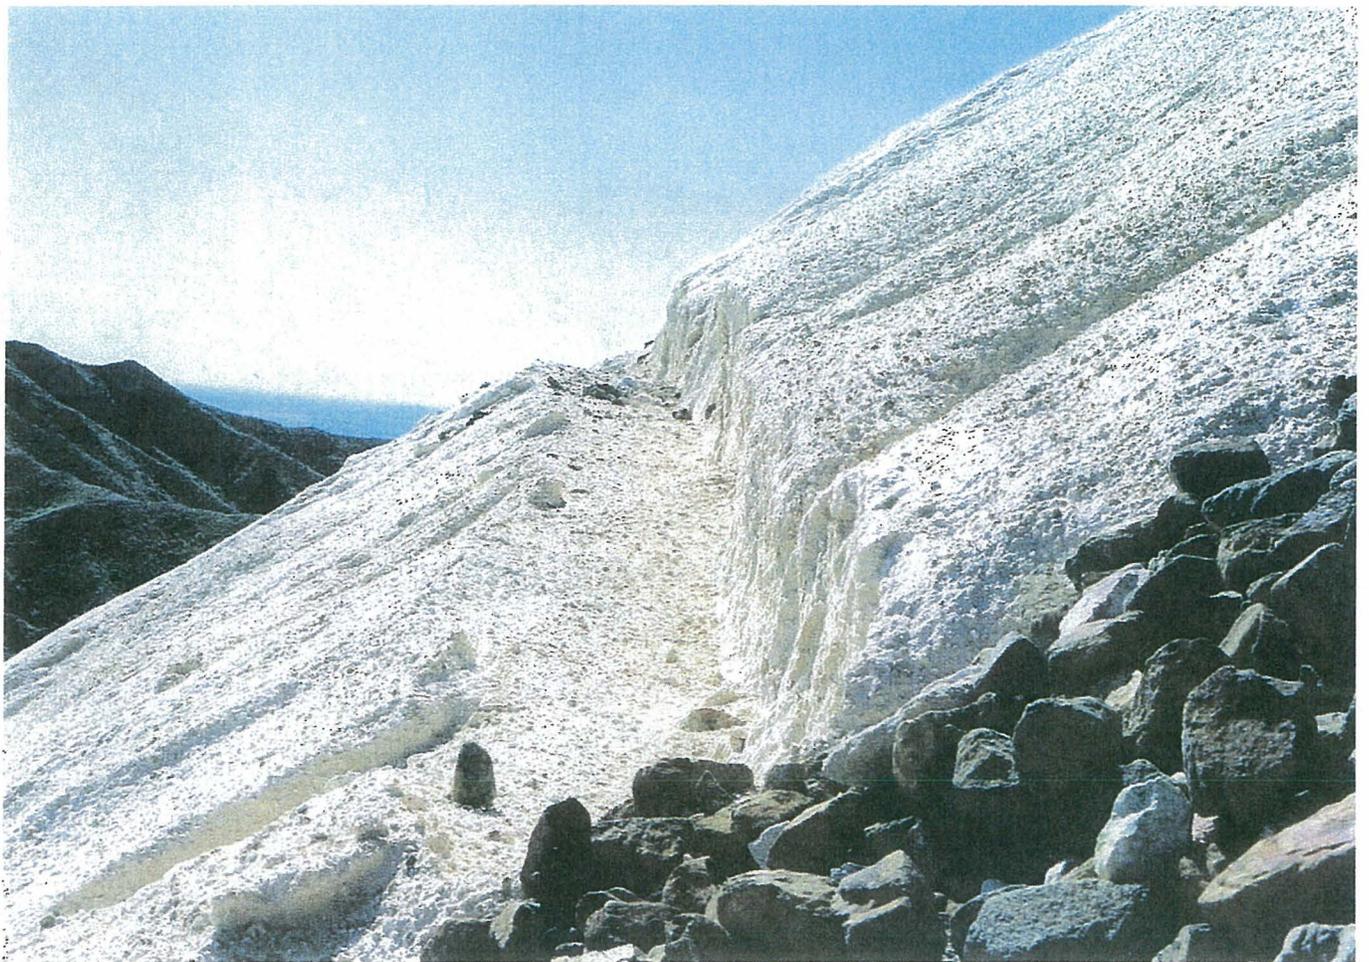
**Lower** - View of cross-slope terrace looking east.

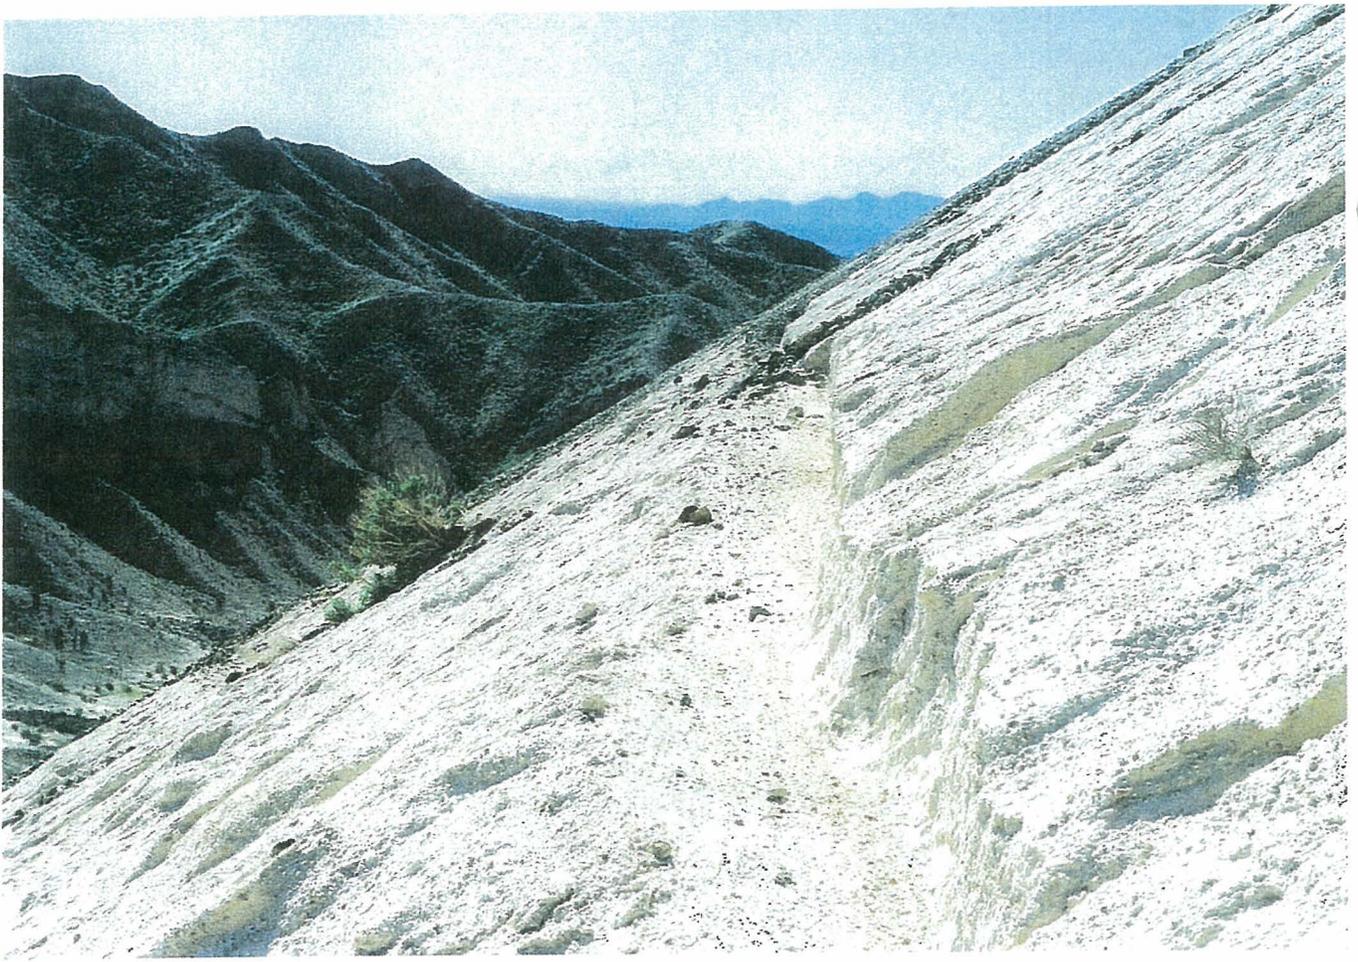
**Upper** – View of cross-slope terrace looking east to unmined areas.

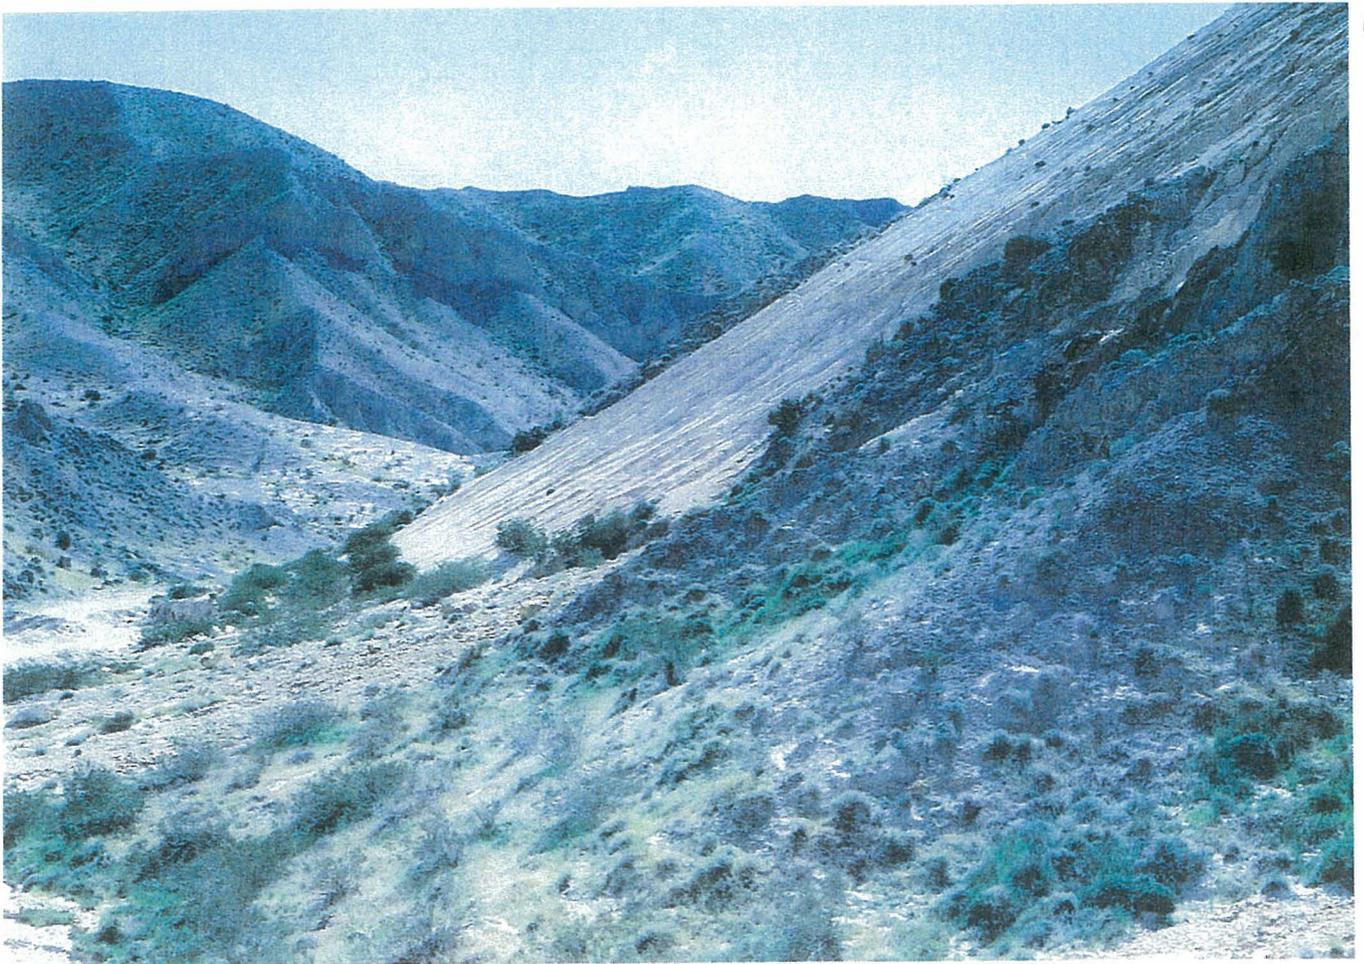
**Lower** - View of slope from west.
